SALVAGING OLD PAVEMENTS BY RESURFACING

N. A. Billingsley, Jr.
Sr. Laboratory Engineer
District Eight

Special Study No. SS-4.0

July 1966

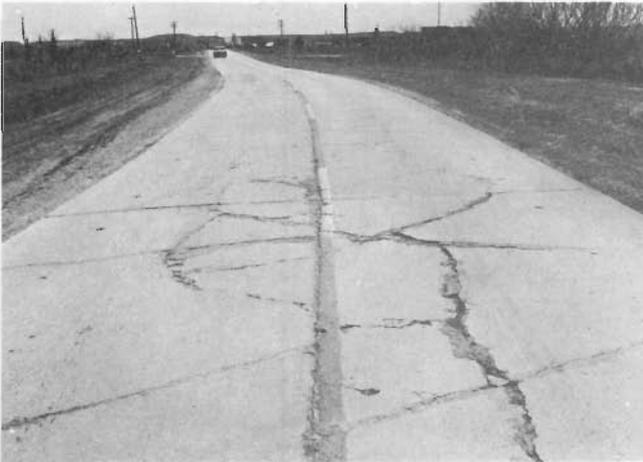
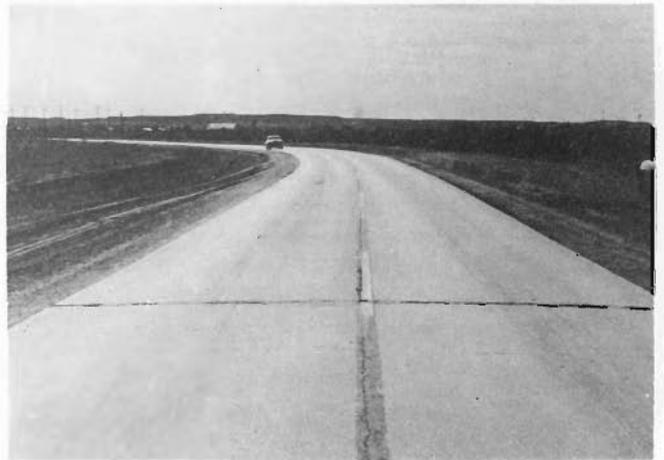
Photographs number (1) and (2) indicate the original pavement condition before overlay of HMAC surface.

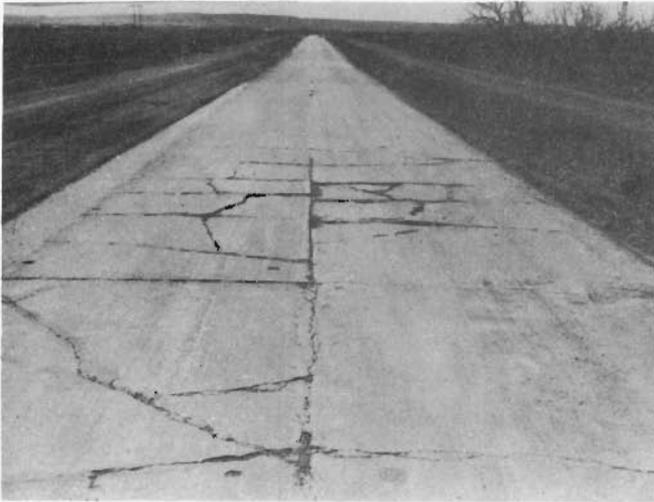
PHOTOGRAPH (3)

Photographs number (3) and (4) indicate the condition of the concrete pavement prior to construction.

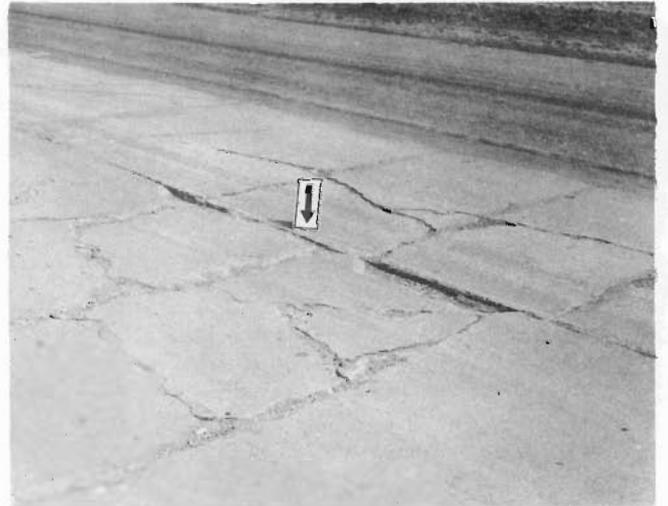
PHOTOGRAPH (4)

It is believed that this failure resulted from faulty structure support. Comparison should be made between Photographs (4), (8), and (21).

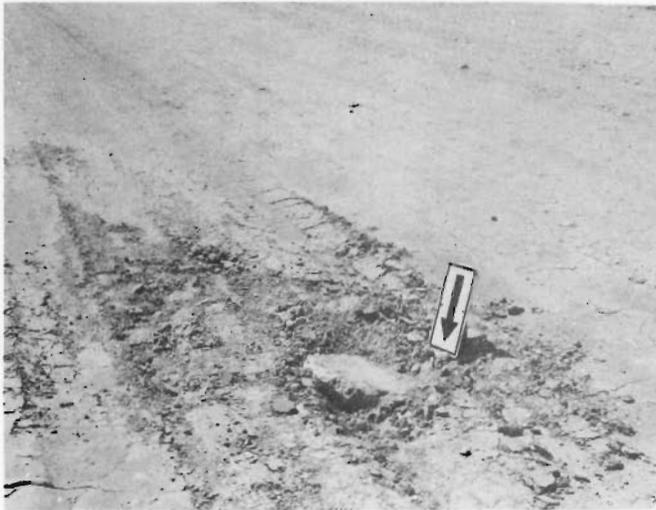
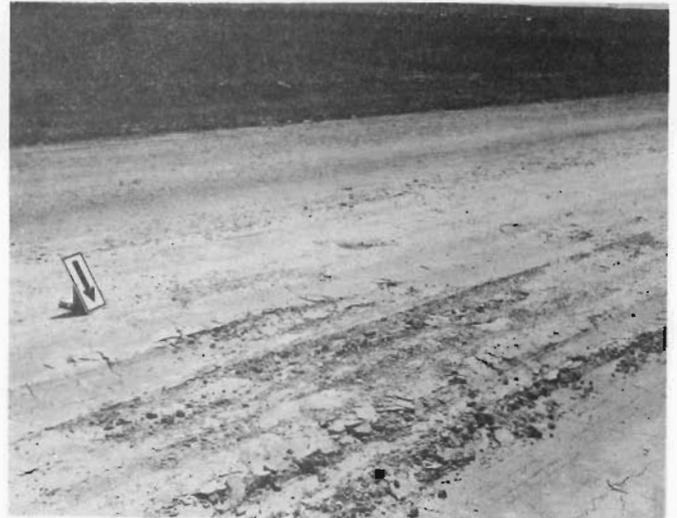
The heavy pneumatic rolling proved useful because it showed flaws in the seating of the old concrete pavement. Photographs (8) and (9) indicate improper seating. These places were reworked to the satisfaction of the Engineer before subsequent construction was performed.

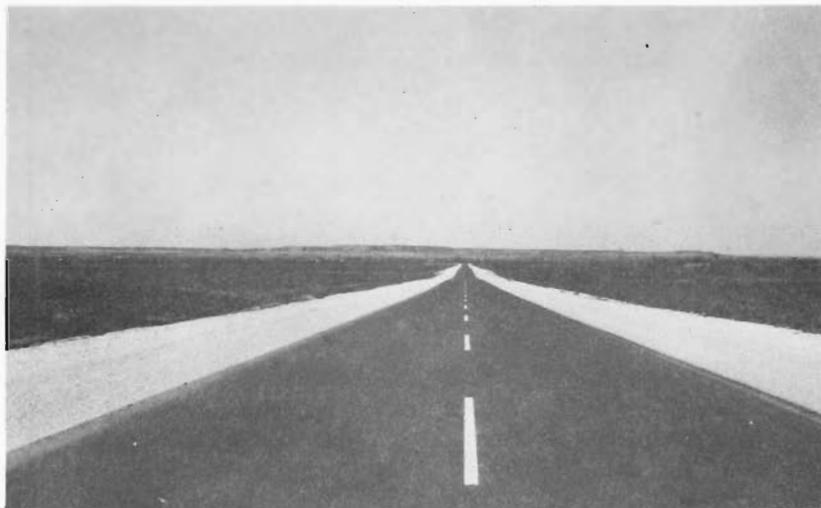
PHOTOGRAPH (10)

Photograph (10) shows a section of the completed highway.

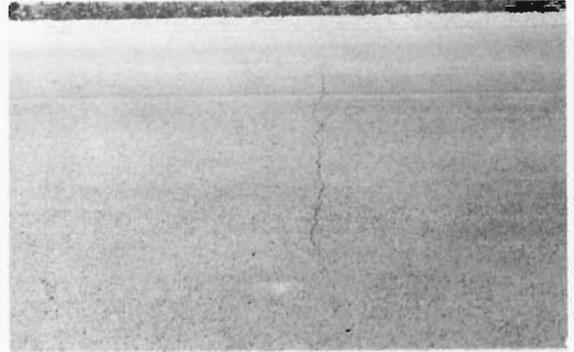
PHOTOGRAPH (11)

The first section to show signs of distress was that of section (1). Cracks began to show at joints of the old concrete pavement.

These cracks began to show, Photograph (11), within three months after job completion. Crack sealing operations were started, Photograph (12), on this section in January, 1958. Photographs (13), (14), and (15), show how one particular failure had progressed through March, 1959, and

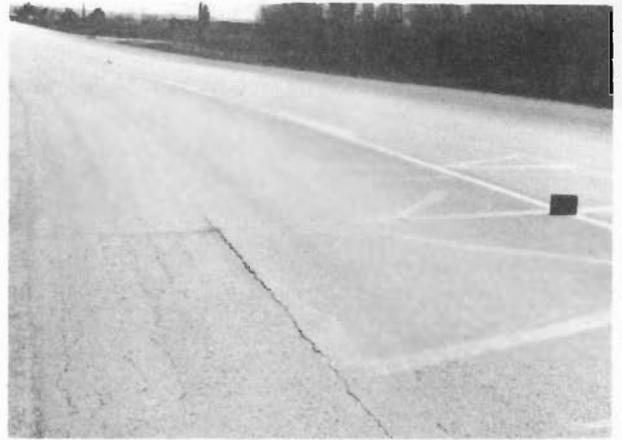
PHOTOGRAPH (16)

Photograph (16) shows the general condition of typical section (1) in April, 1961.

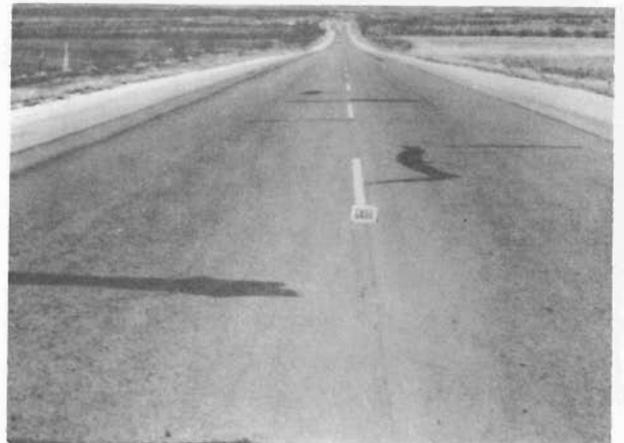
PHOTOGRAPH (19)

Photograph (19) shows the general condition of this section in April, 1961.

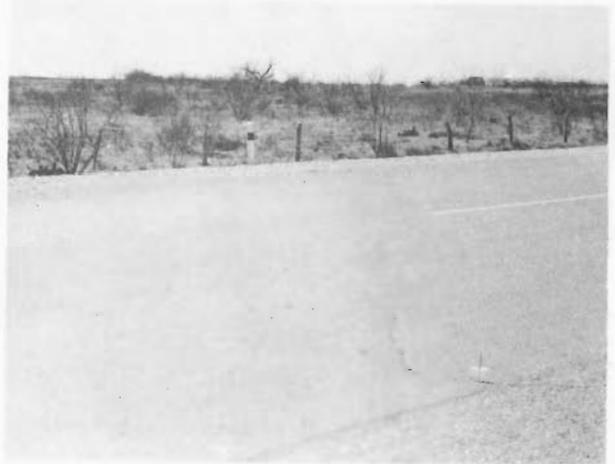
PHOTOGRAPH (20)

The section of highway represented by typical section (2) had begun showing signs of distress by March, 1959, as evidenced in Photograph (20). By April, 1961, the general condition of this section was good with the exception of one particular failure shown in Photograph (21).

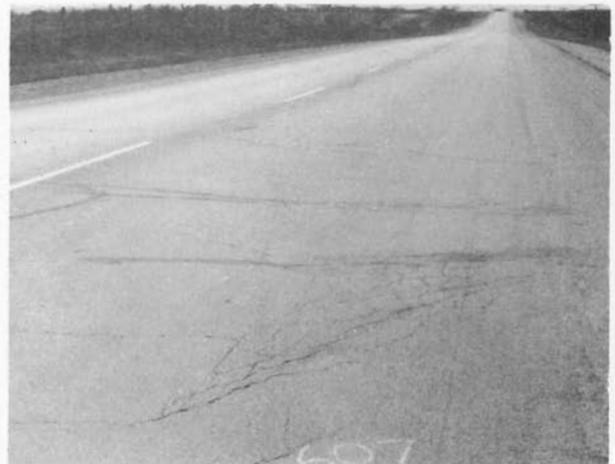
PHOTOGRAPH (22)

Photograph (22) shows a typical failure prior to seal coat being applied in the summer of 1964.
