PERFORMANCE OF
METAL REINFORCED
BITUMINOUS OVERLAYS
IN TEXAS

TEXAS HIGHWAY DEPARTMENT

TEXAS HIGHWAY DEPARTMENT
JUNE 1971

Supplement for District 2 - Fort Worth

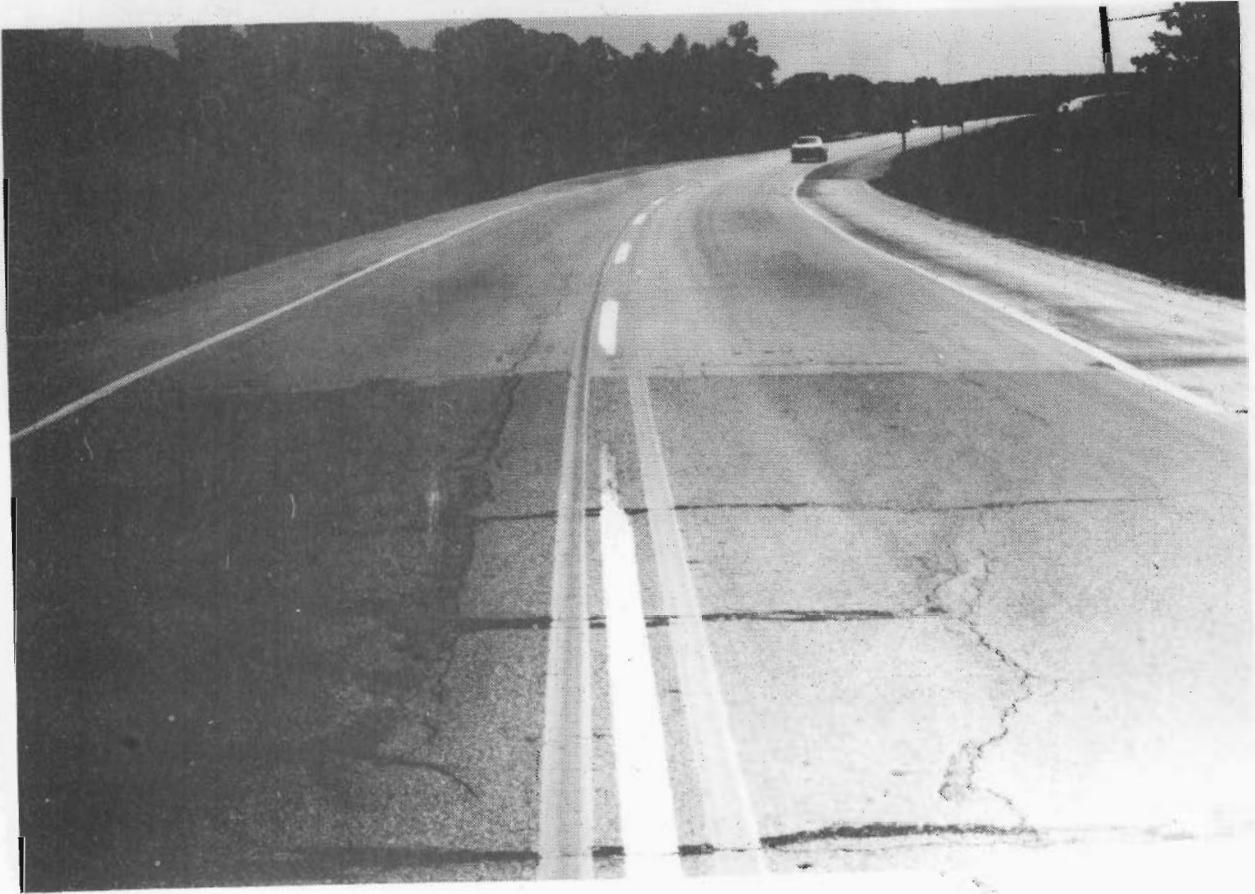
Project F 1116(7)

This photograph shows the transition from a non-reinforced asphaltic concrete overlay to an asphaltic concrete pavement with wire reinforcement.

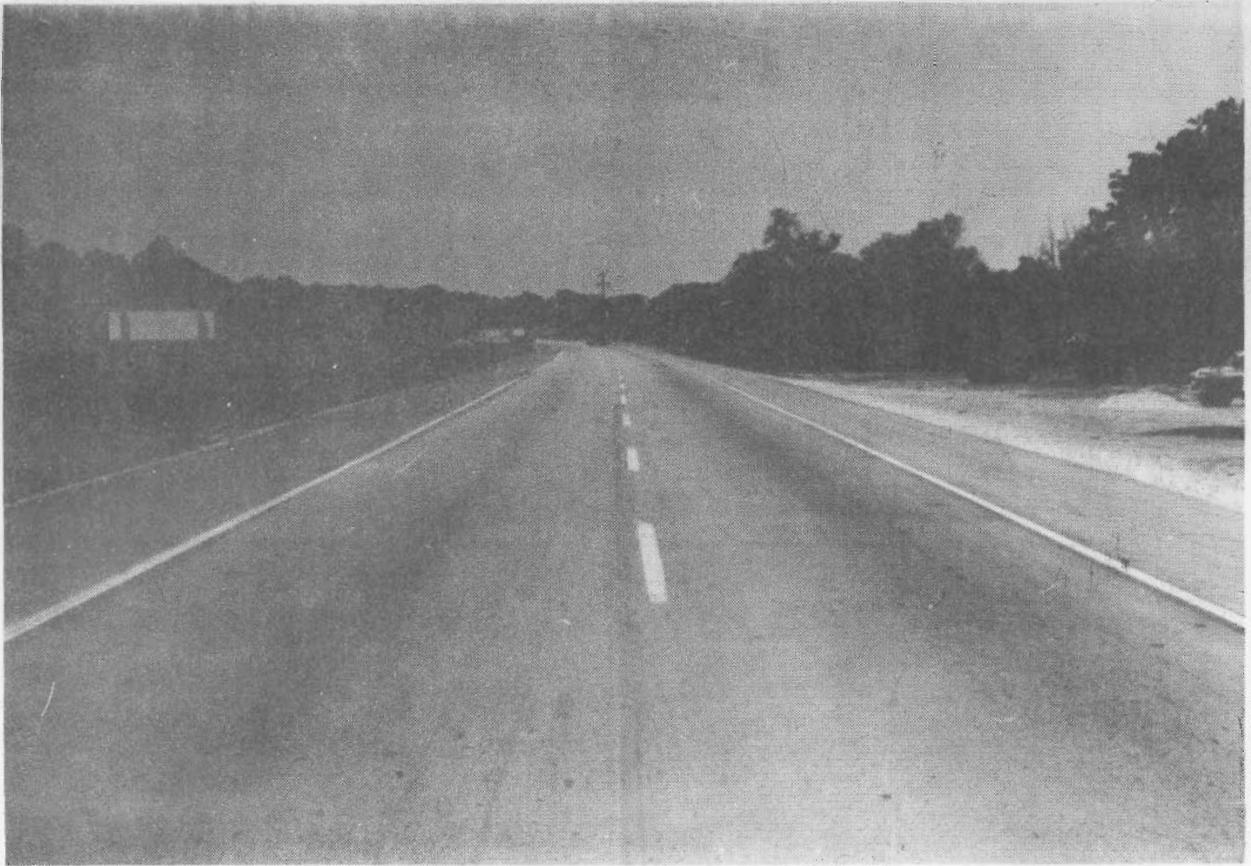
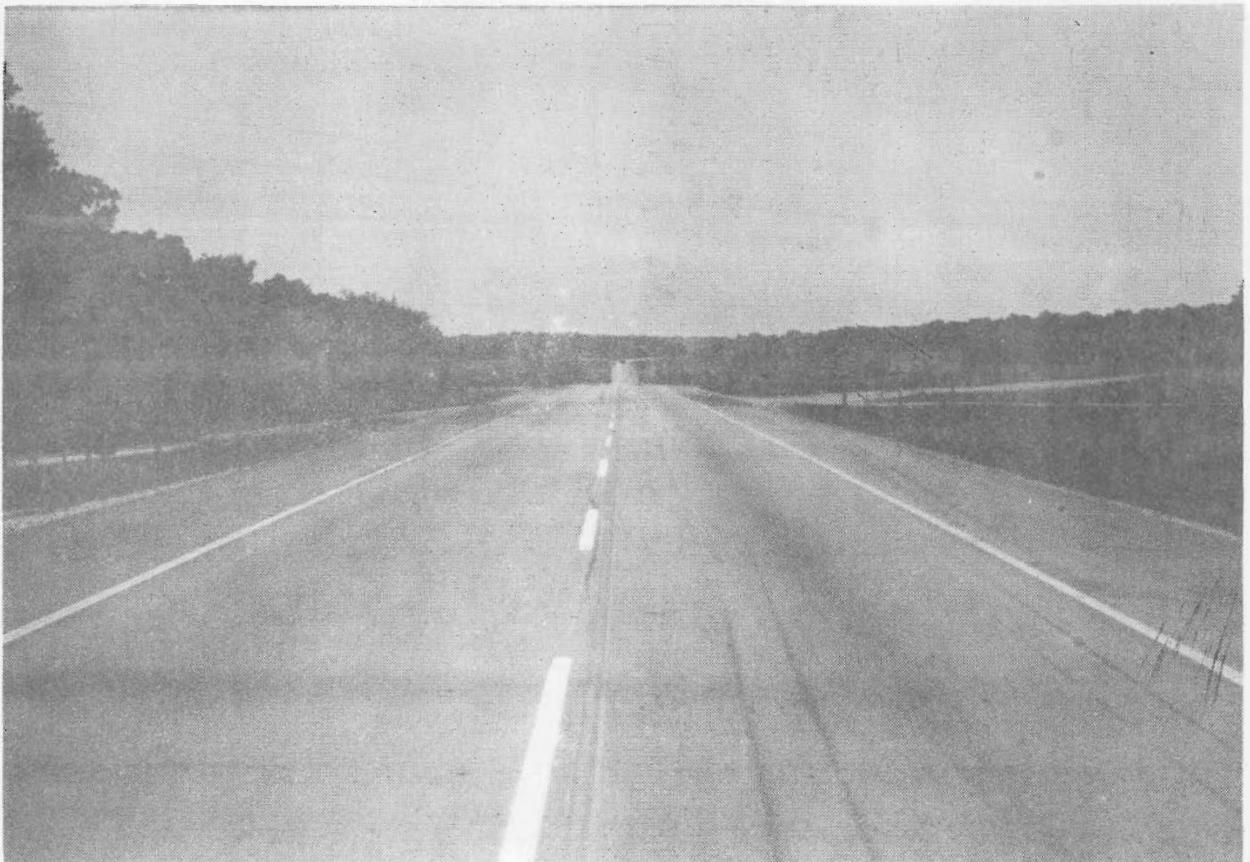
The hair-line cracks appear so infrequently that crack sealing has not been necessary on this project.

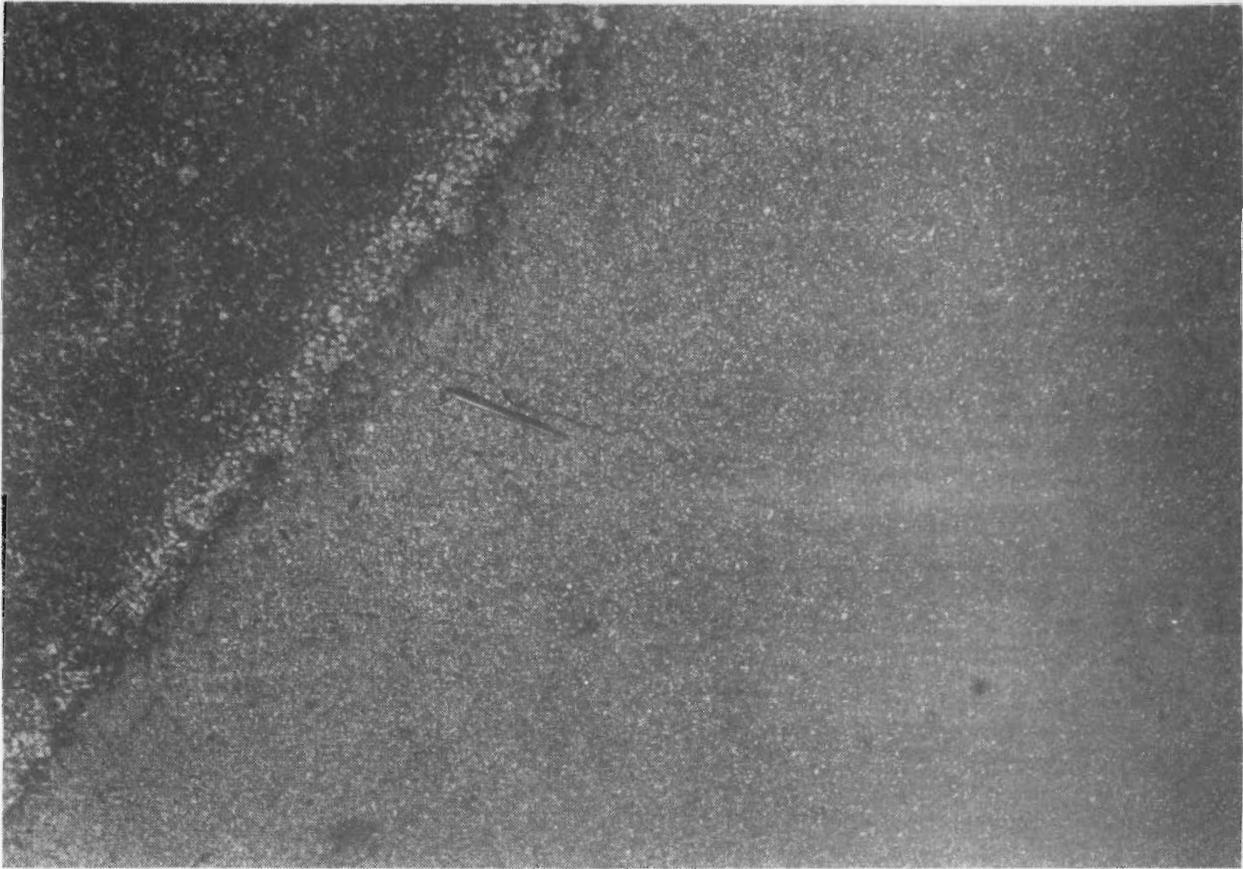
Project F 1116(7)

The typical transverse hair-line crack. These cracks appear approximately every four hundred to six hundred feet.

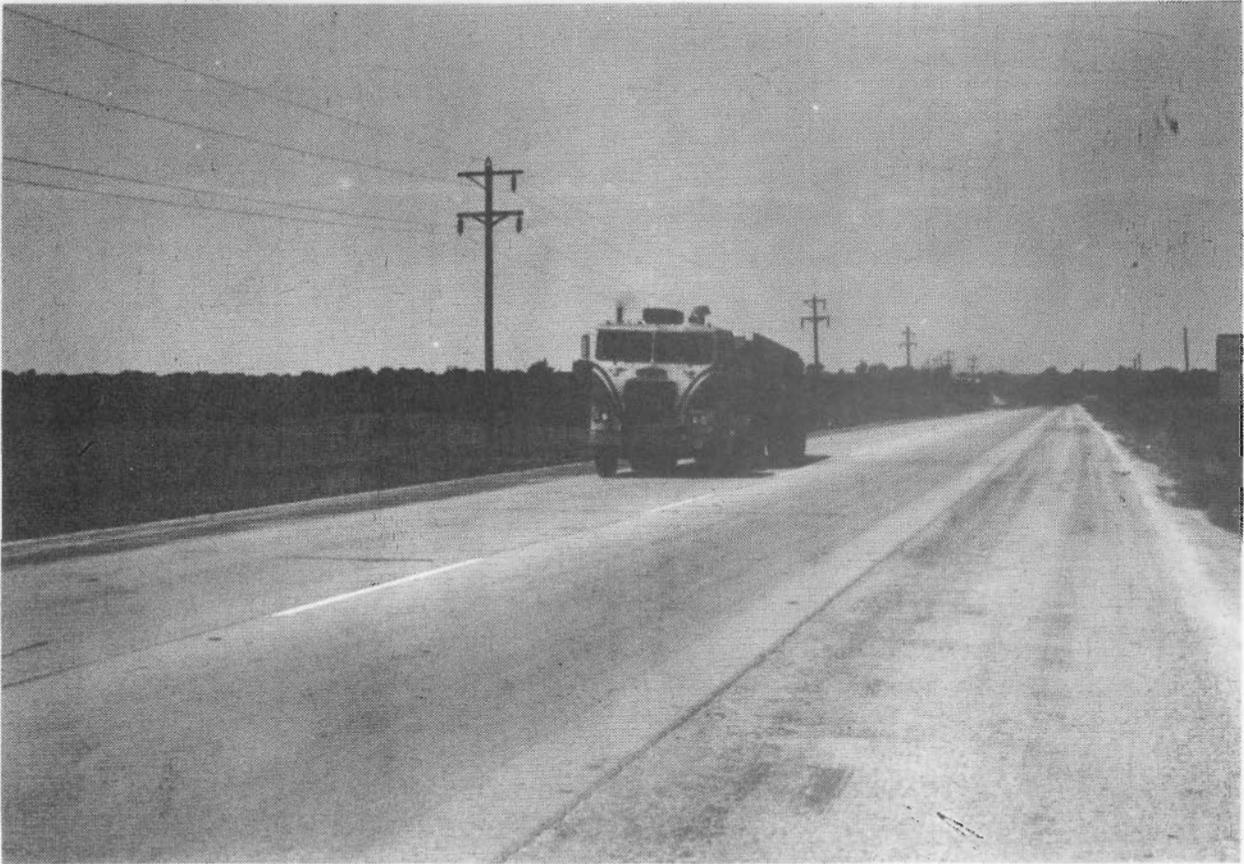
Project F 1116(9)

3,000 trips a day are made by rock trucks ranging in total weight from legal loads up to 110,000 lbs. A few cracks have been sealed in the loaded lane. These cracks are the hair-line type and could have been left unsealed.

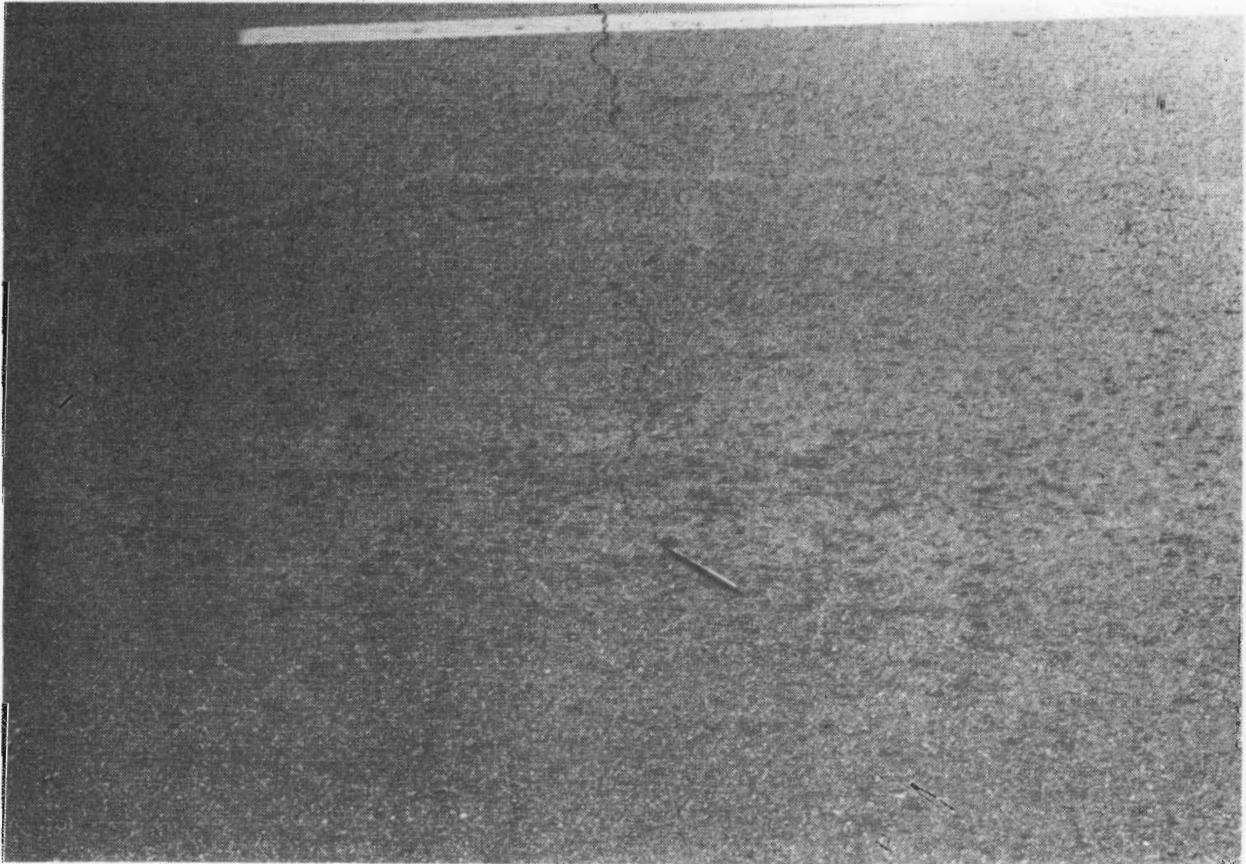
Project F 1116(9)

Typical hair-line crack that has not been sealed.

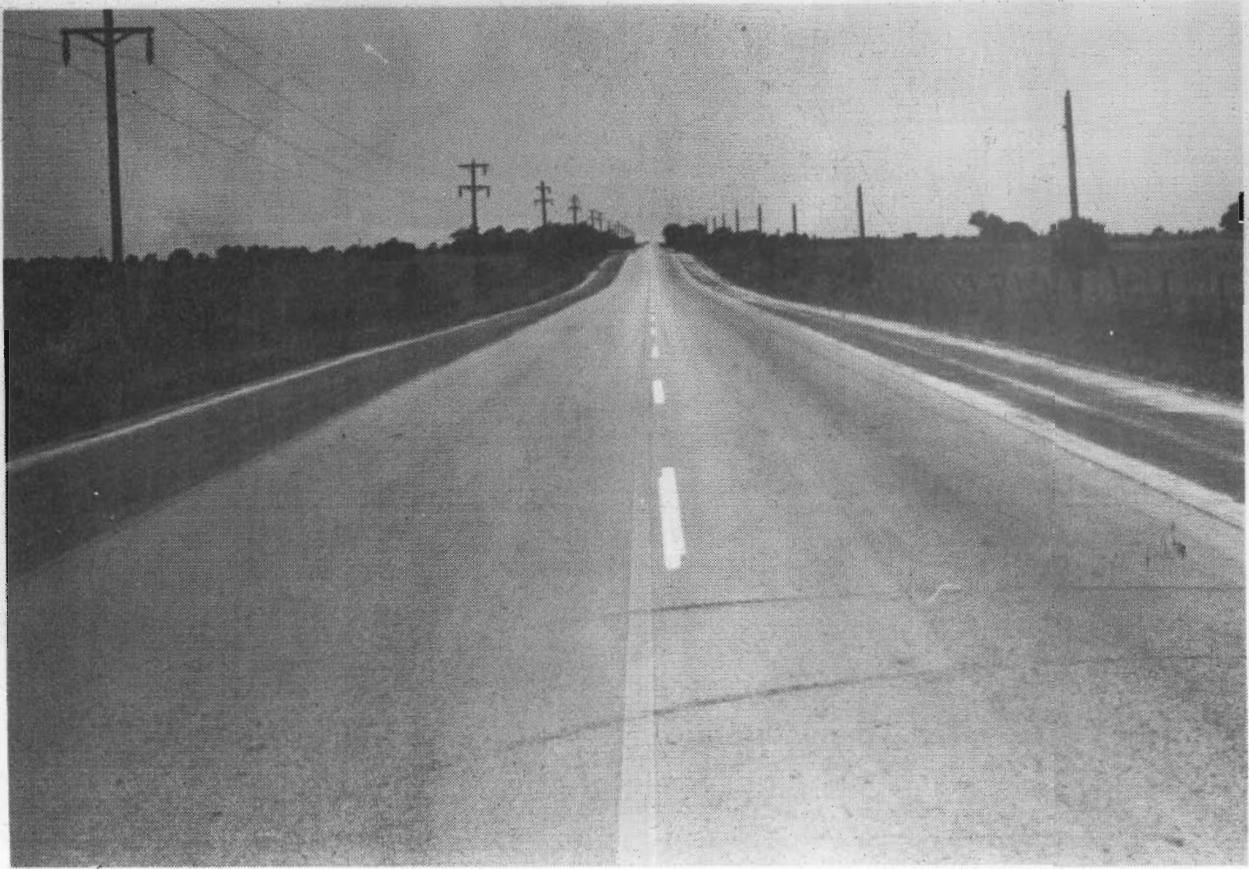
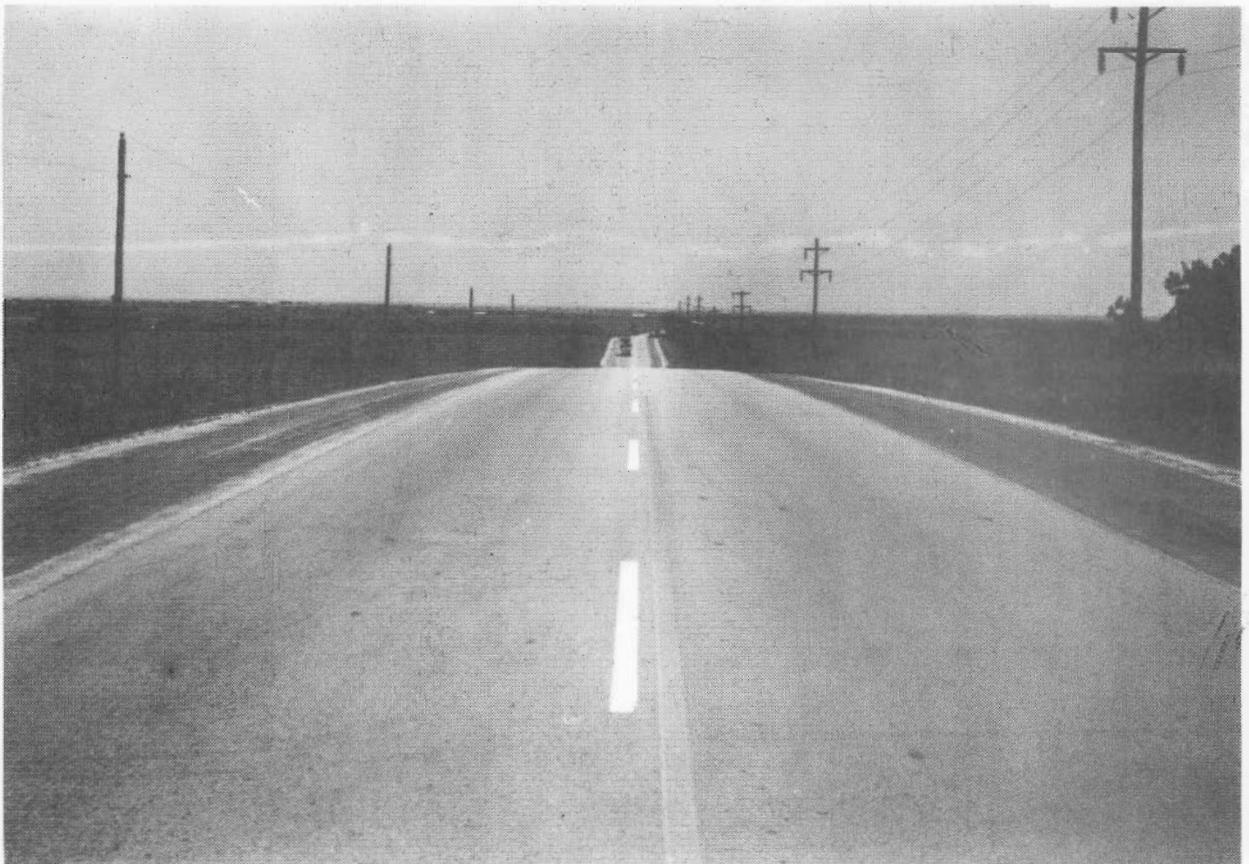
These two photographs represent the remaining portion of the project showing that crack sealing has not been necessary.

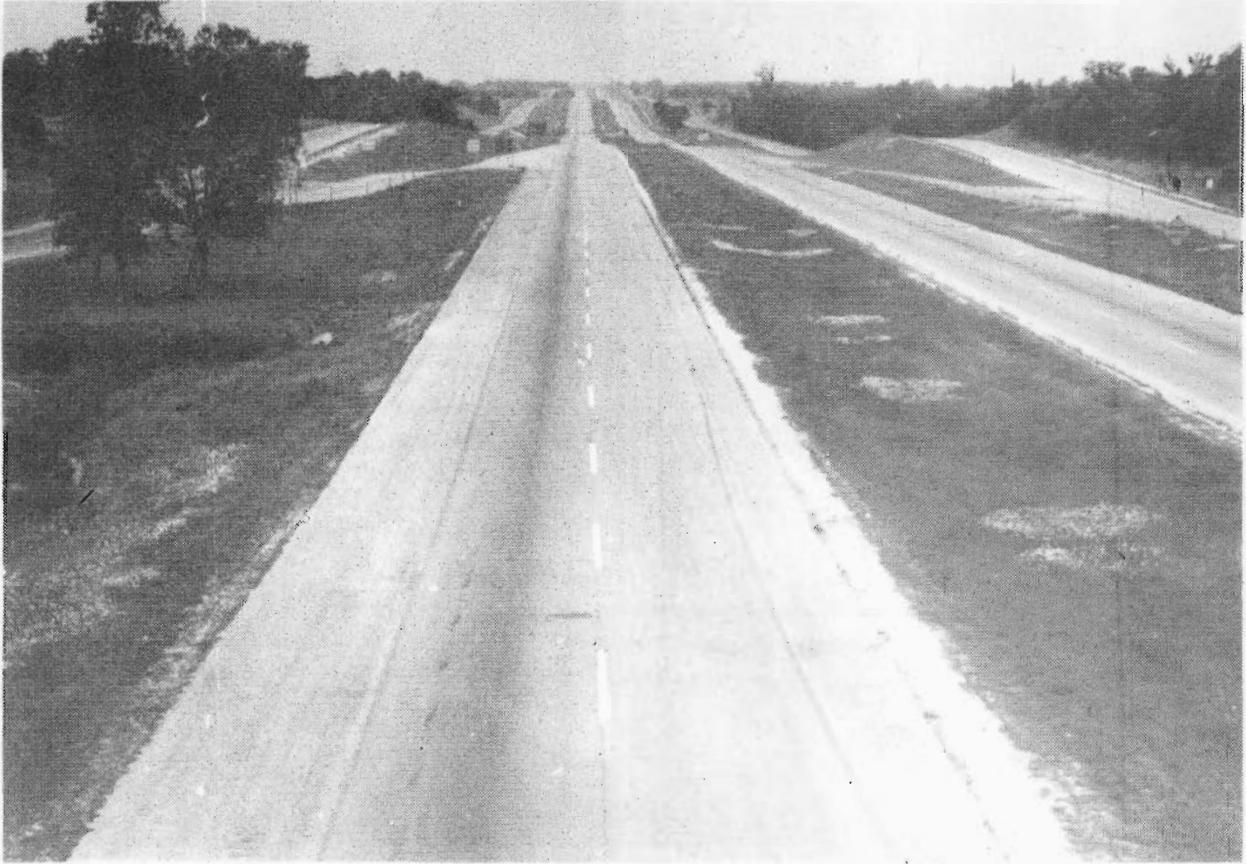
The hair-line cracks have appeared so infrequently that crack sealing has not been necessary on the entire project.

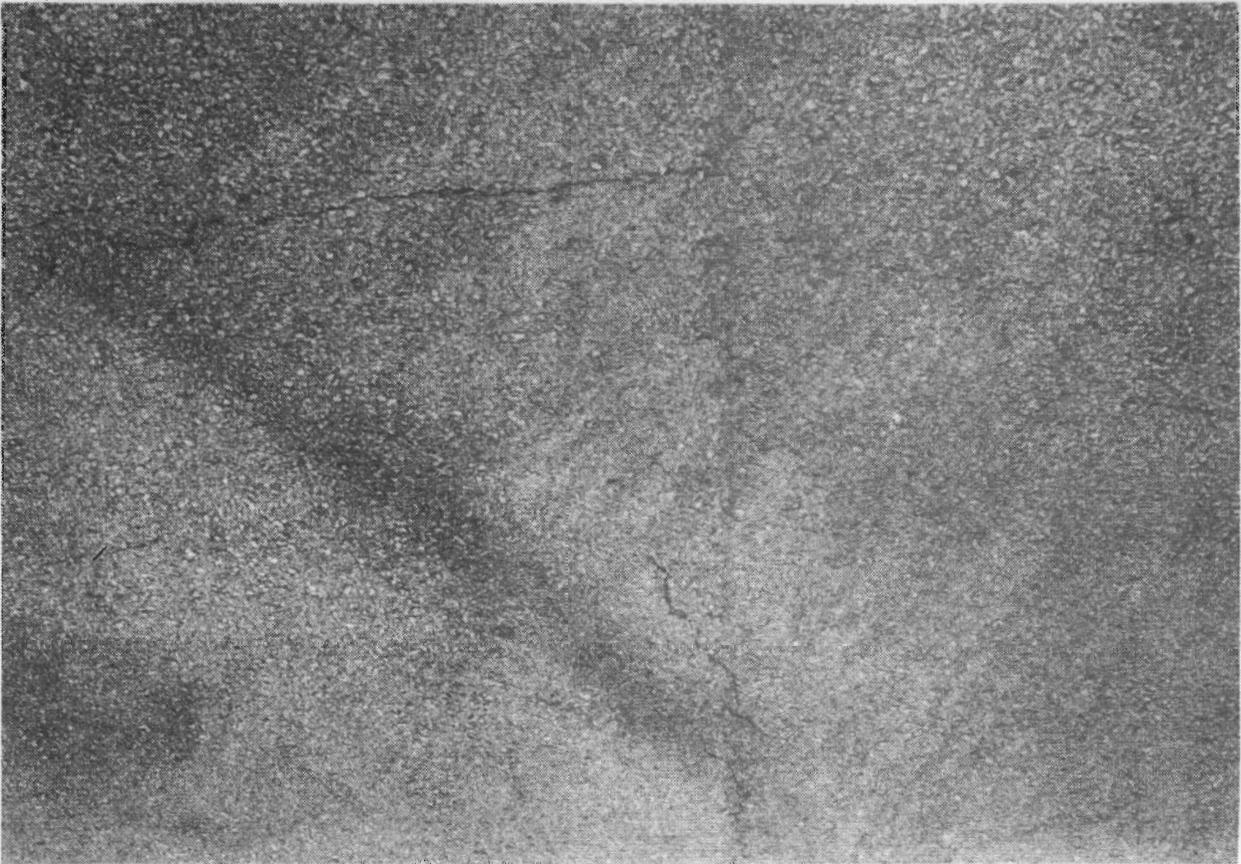
A typical hair-line crack that appears infrequently throughout the project.

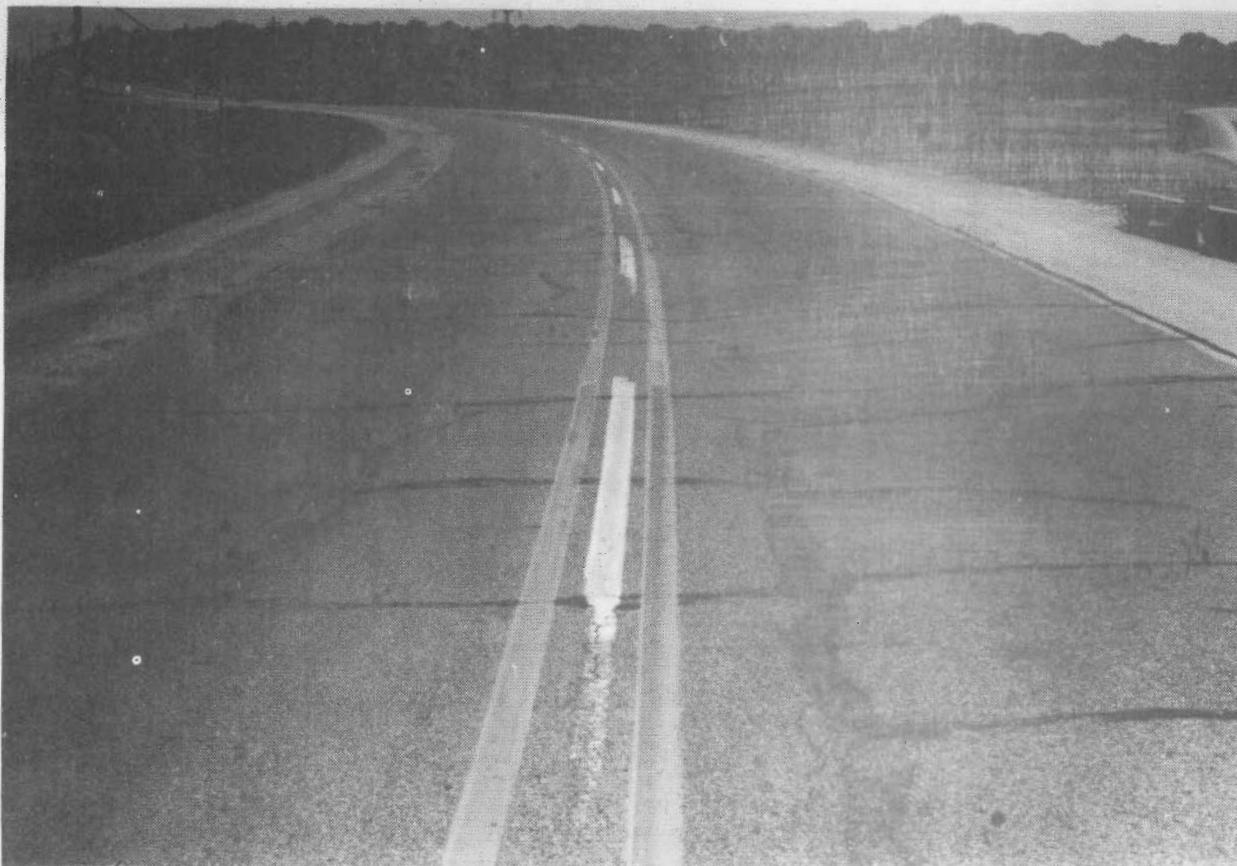
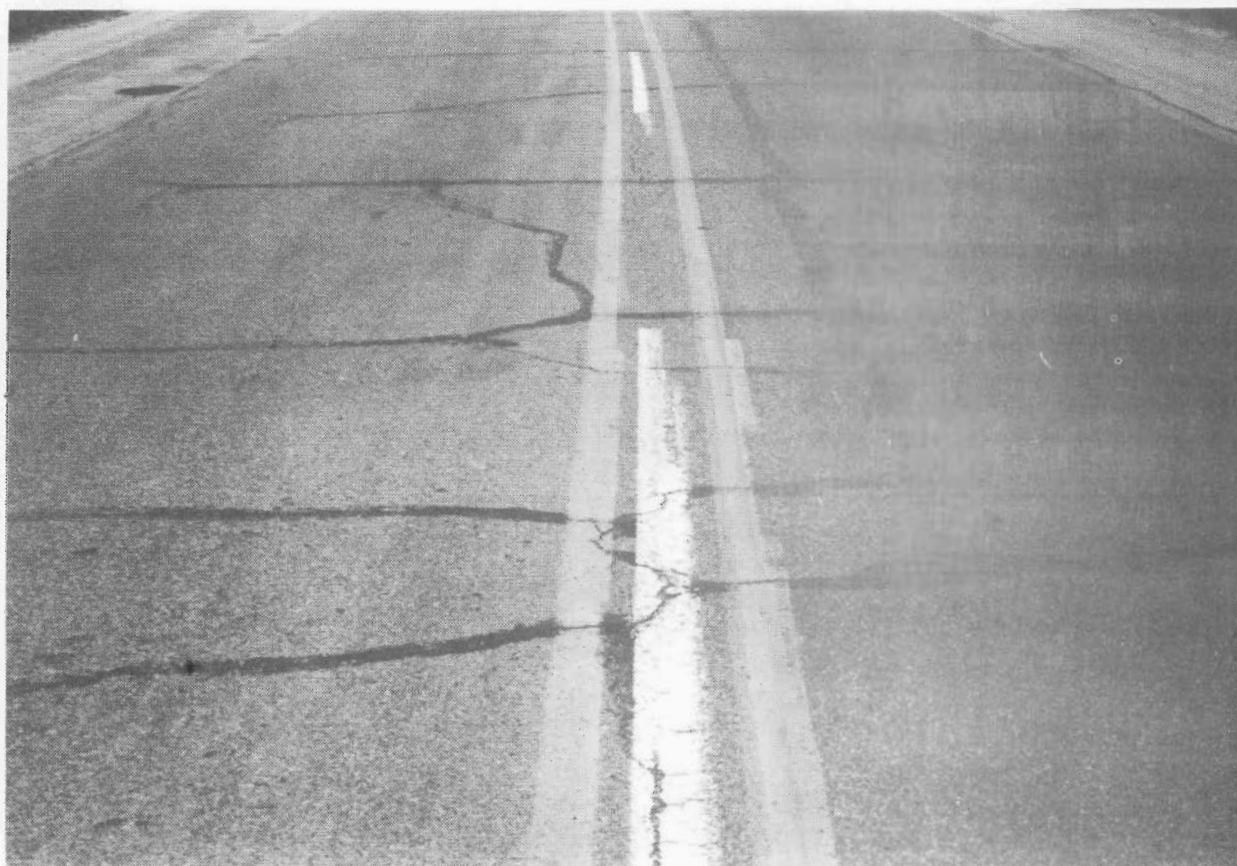
These two photographs show the crack condition of State Highway 114 between Projects F 1116(7) and F 1116(9). The old concrete pavement has been overlaid with non-reinforced hot mix asphaltic concrete.

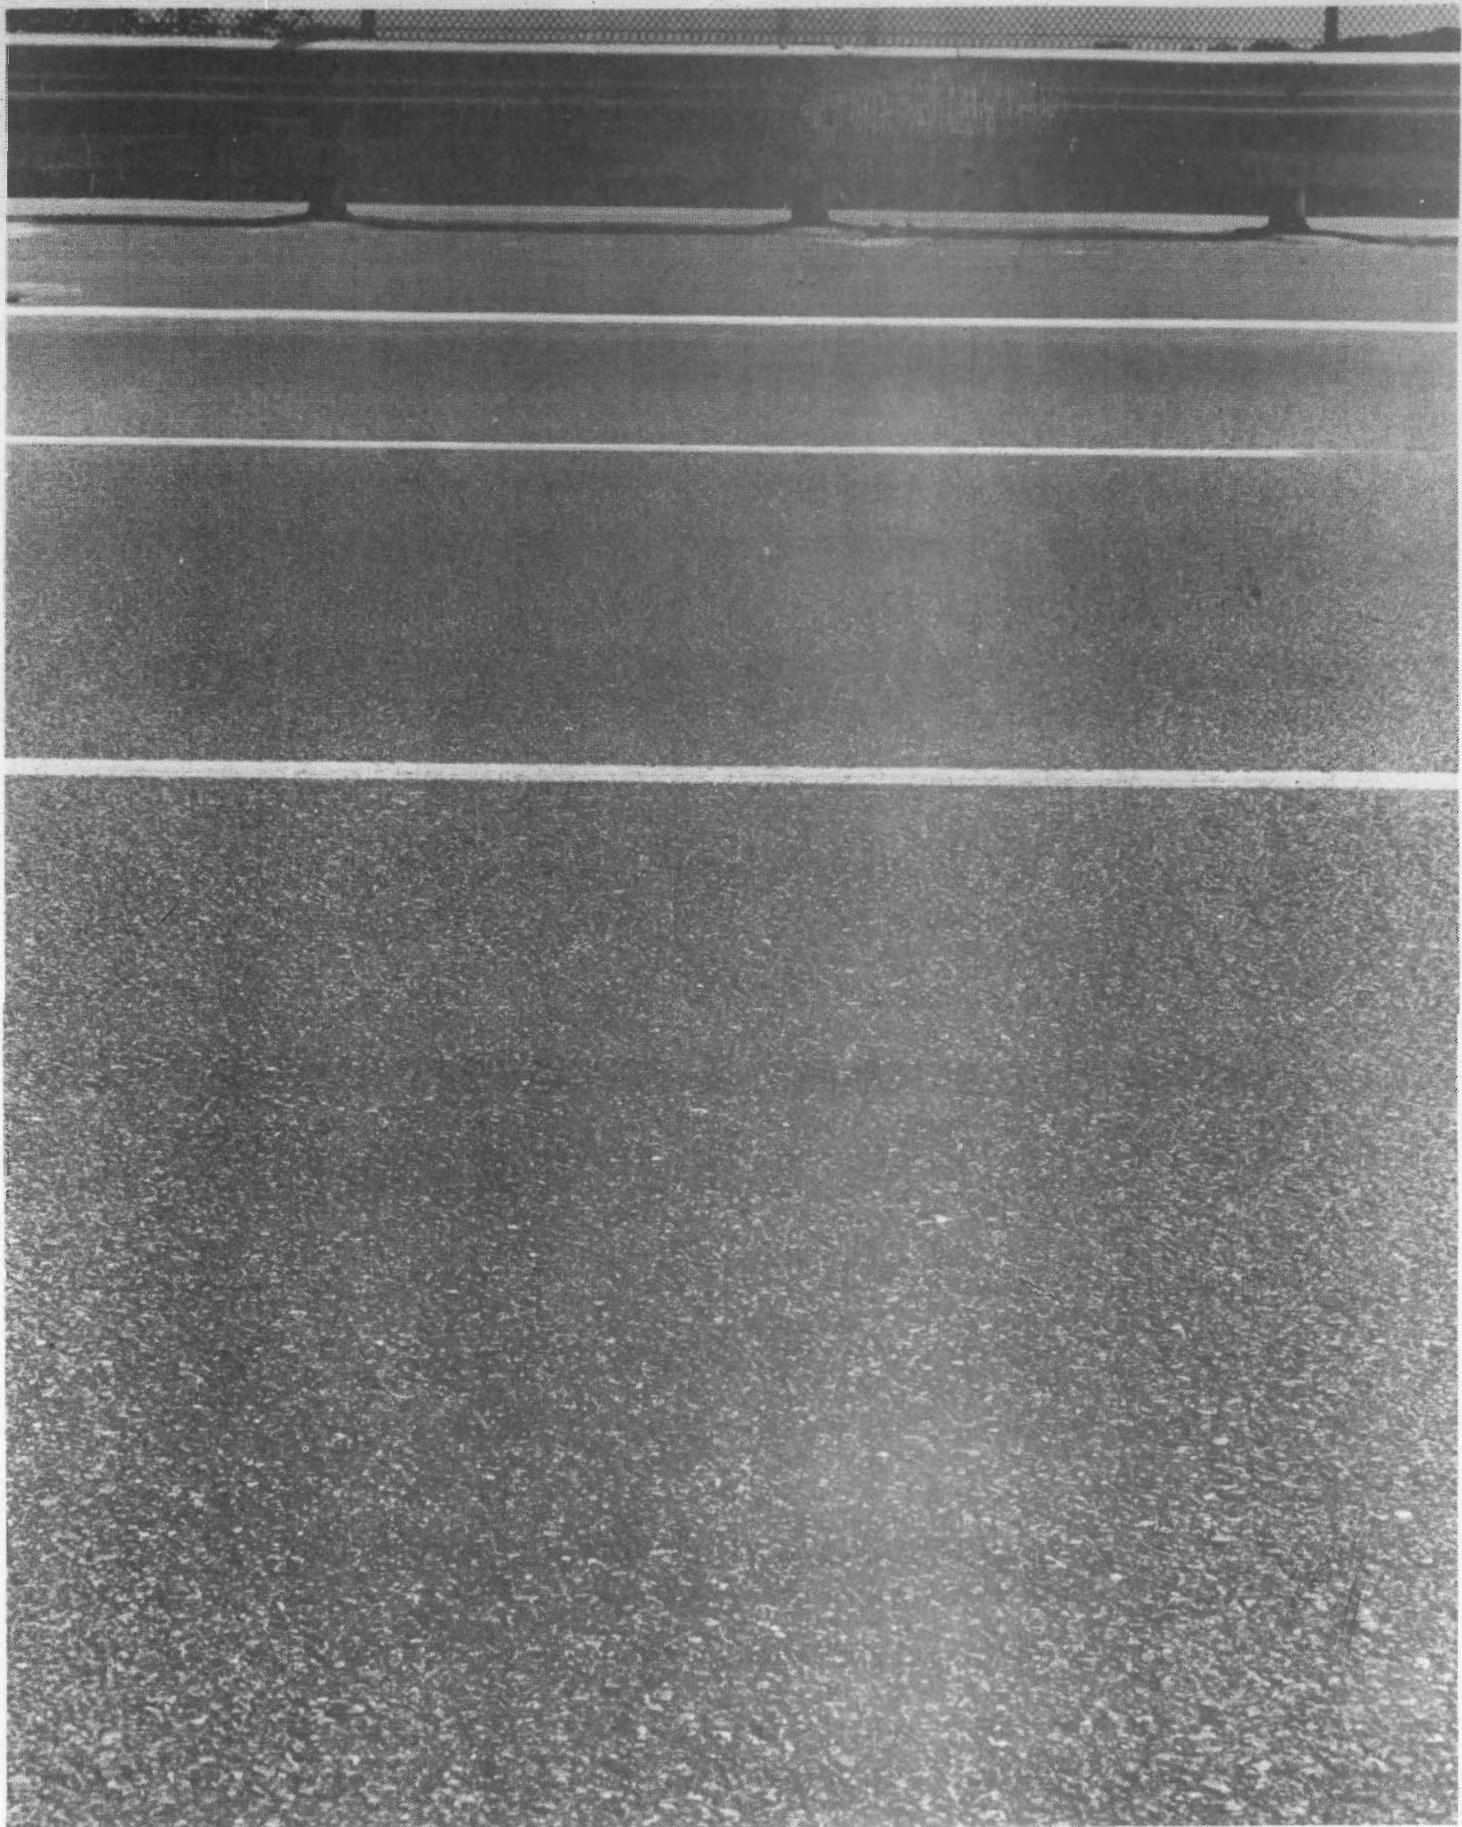
TH 45: AT CLEAR CREEK - No. 1
(with mesh)

- No. 1 & 2: Comparison of transverse joint with mesh and without mesh. These joints are in southbound lane N. of Clear Creek Bridge.
- No. 3 & 4: Northbound lane looking South. Note how crack disappears as we enter mesh section in foreground Knife on pavement. Note both longitudinal and transverse openings.
- No. 5: Transverse joint opening in unreinforced section, North of Clear Creek on southbound lane.

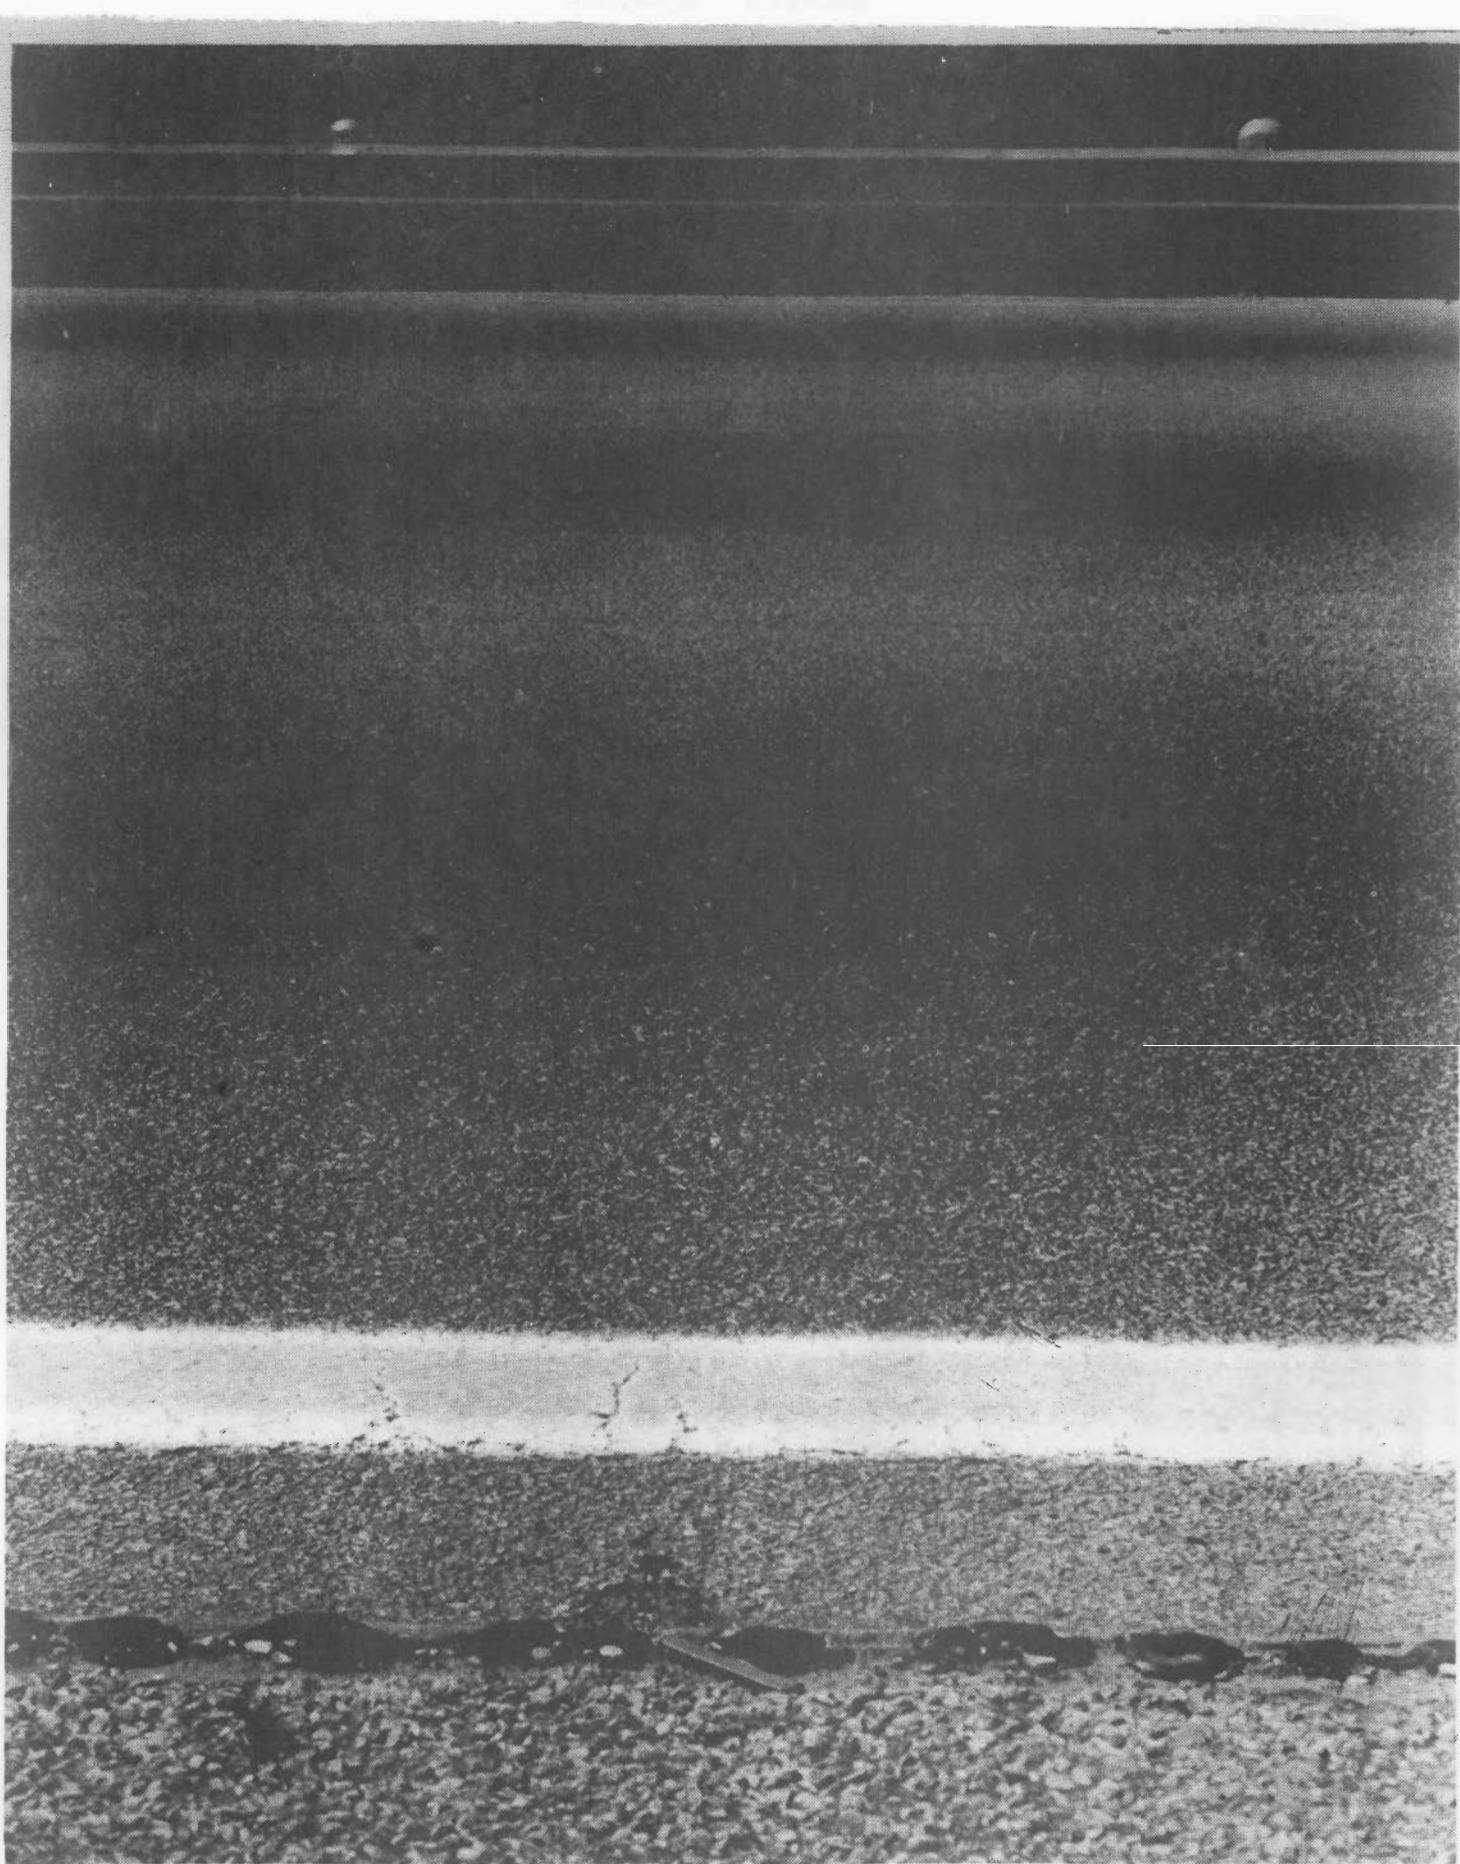
IH. 45: NORTH OF FUQUA SOUTHBOUND LANES - No. 6

- No. 6 & 7 Note slight transverse joint opening at 1" board joint. Knife is at median curb joint line. Longitudinal joints did not come through.

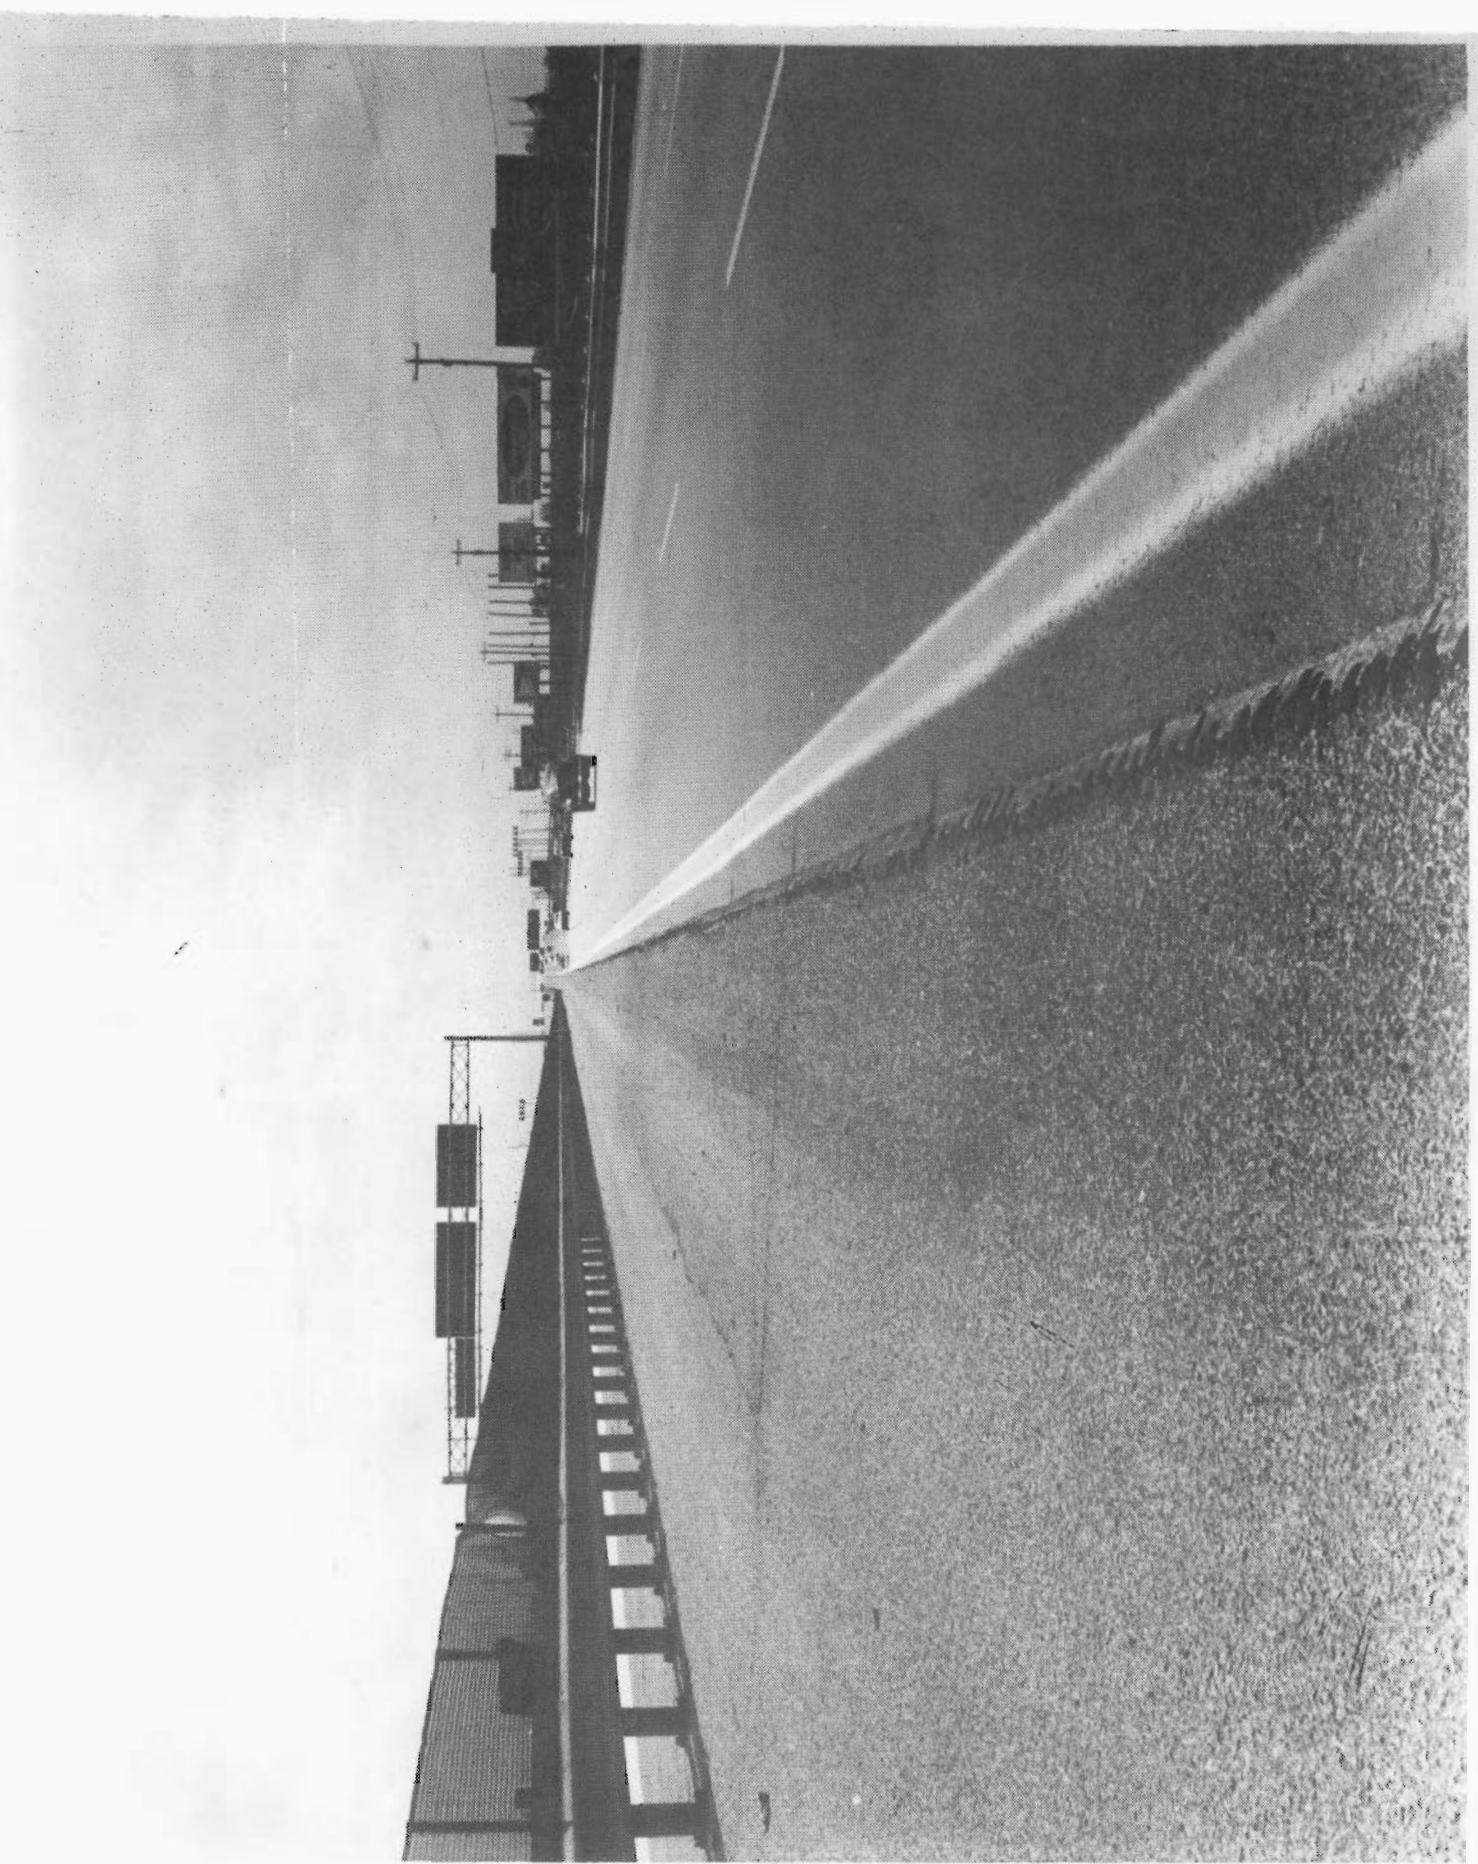
IH 45: SOUTHBOUND LANE TO NORTH OF FUQUA - No. 8

- No. 8 Note no longitudinal joints open under reinforcing mesh area. Transverse joints are only slight openings. Note longitudinal joint in median.
