PERFORMANCE OF
METAL REINFORCED
BITUMINOUS OVERLAYS
IN TEXAS

TEXAS HIGHWAY DEPARTMENT

TEXAS HIGHWAY DEPARTMENT
JUNE 1971

Supplement for District 2 - Fort Worth

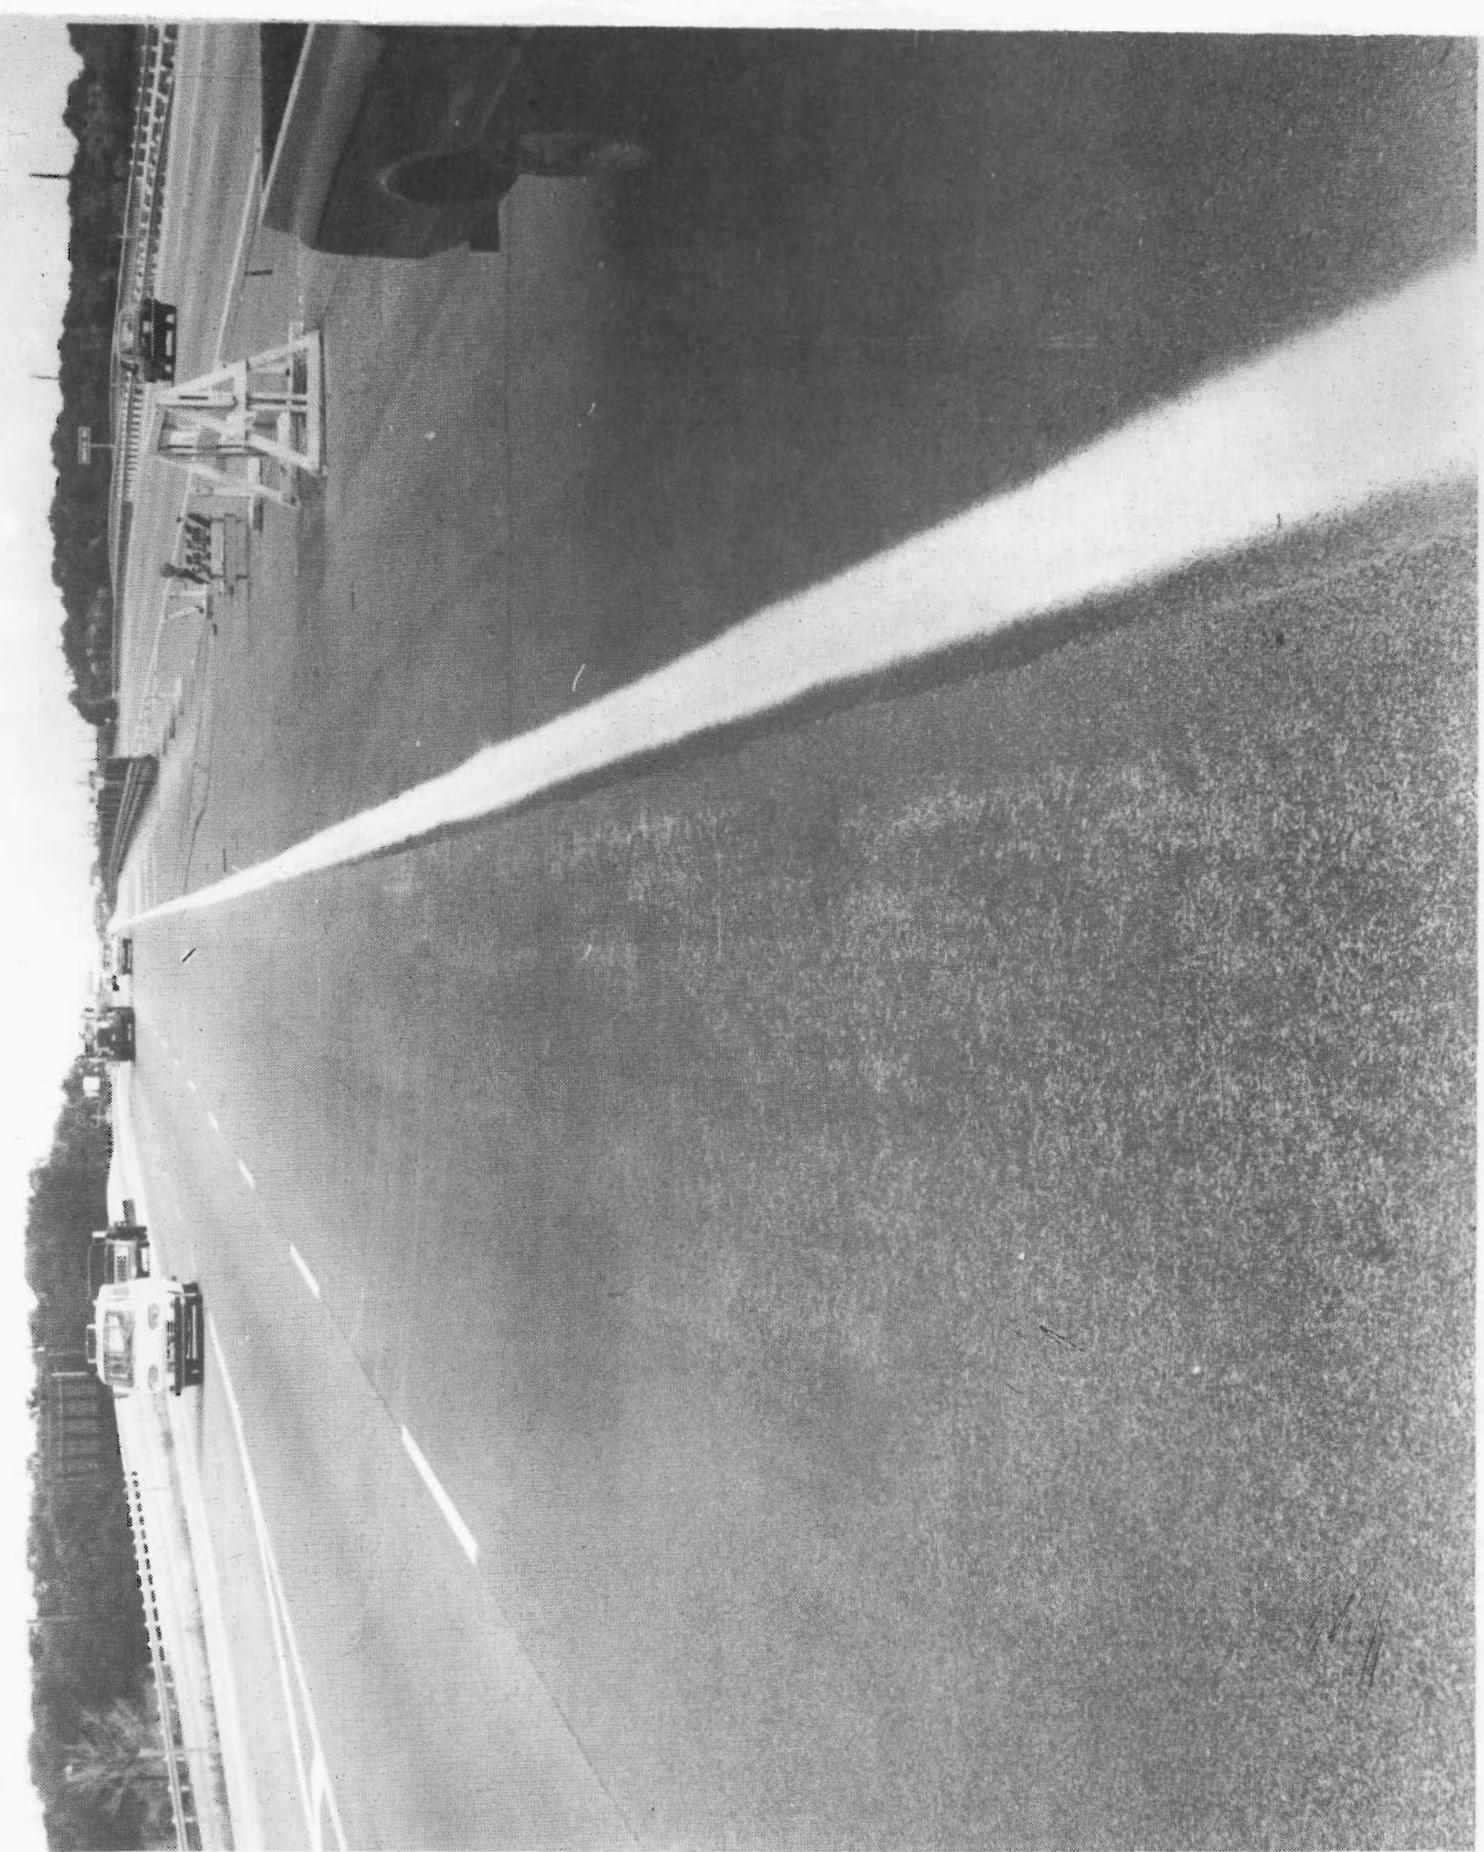
IH 45: BETWEEN CLEAR CREEK AND FM 518 No. 9

- No. 9: Southbound lane looking north. Compare with photo 10 which was taken opposite this picture. (with wire)
- No. 10: Northbound lane looking north, compare with photo 9 which was taken opposite this picture. Note crack pattern which reflects all concrete joints. (without wire)
- No. 11: Northbound lane showing reflection of expansion joint taken opposite photo 12. (without wire)
- No. 12: Southbound lane taken opposite 11. (with wire)
- No. 13: Northbound lane showing reflection of expansion joint. Taken opposite photo 14. (without wire)
- No. 14: Southbound lane taken opposite photo 13. (with wire)
- No. 15: Southbound lane showing reflection of expansion joint in section with wire.

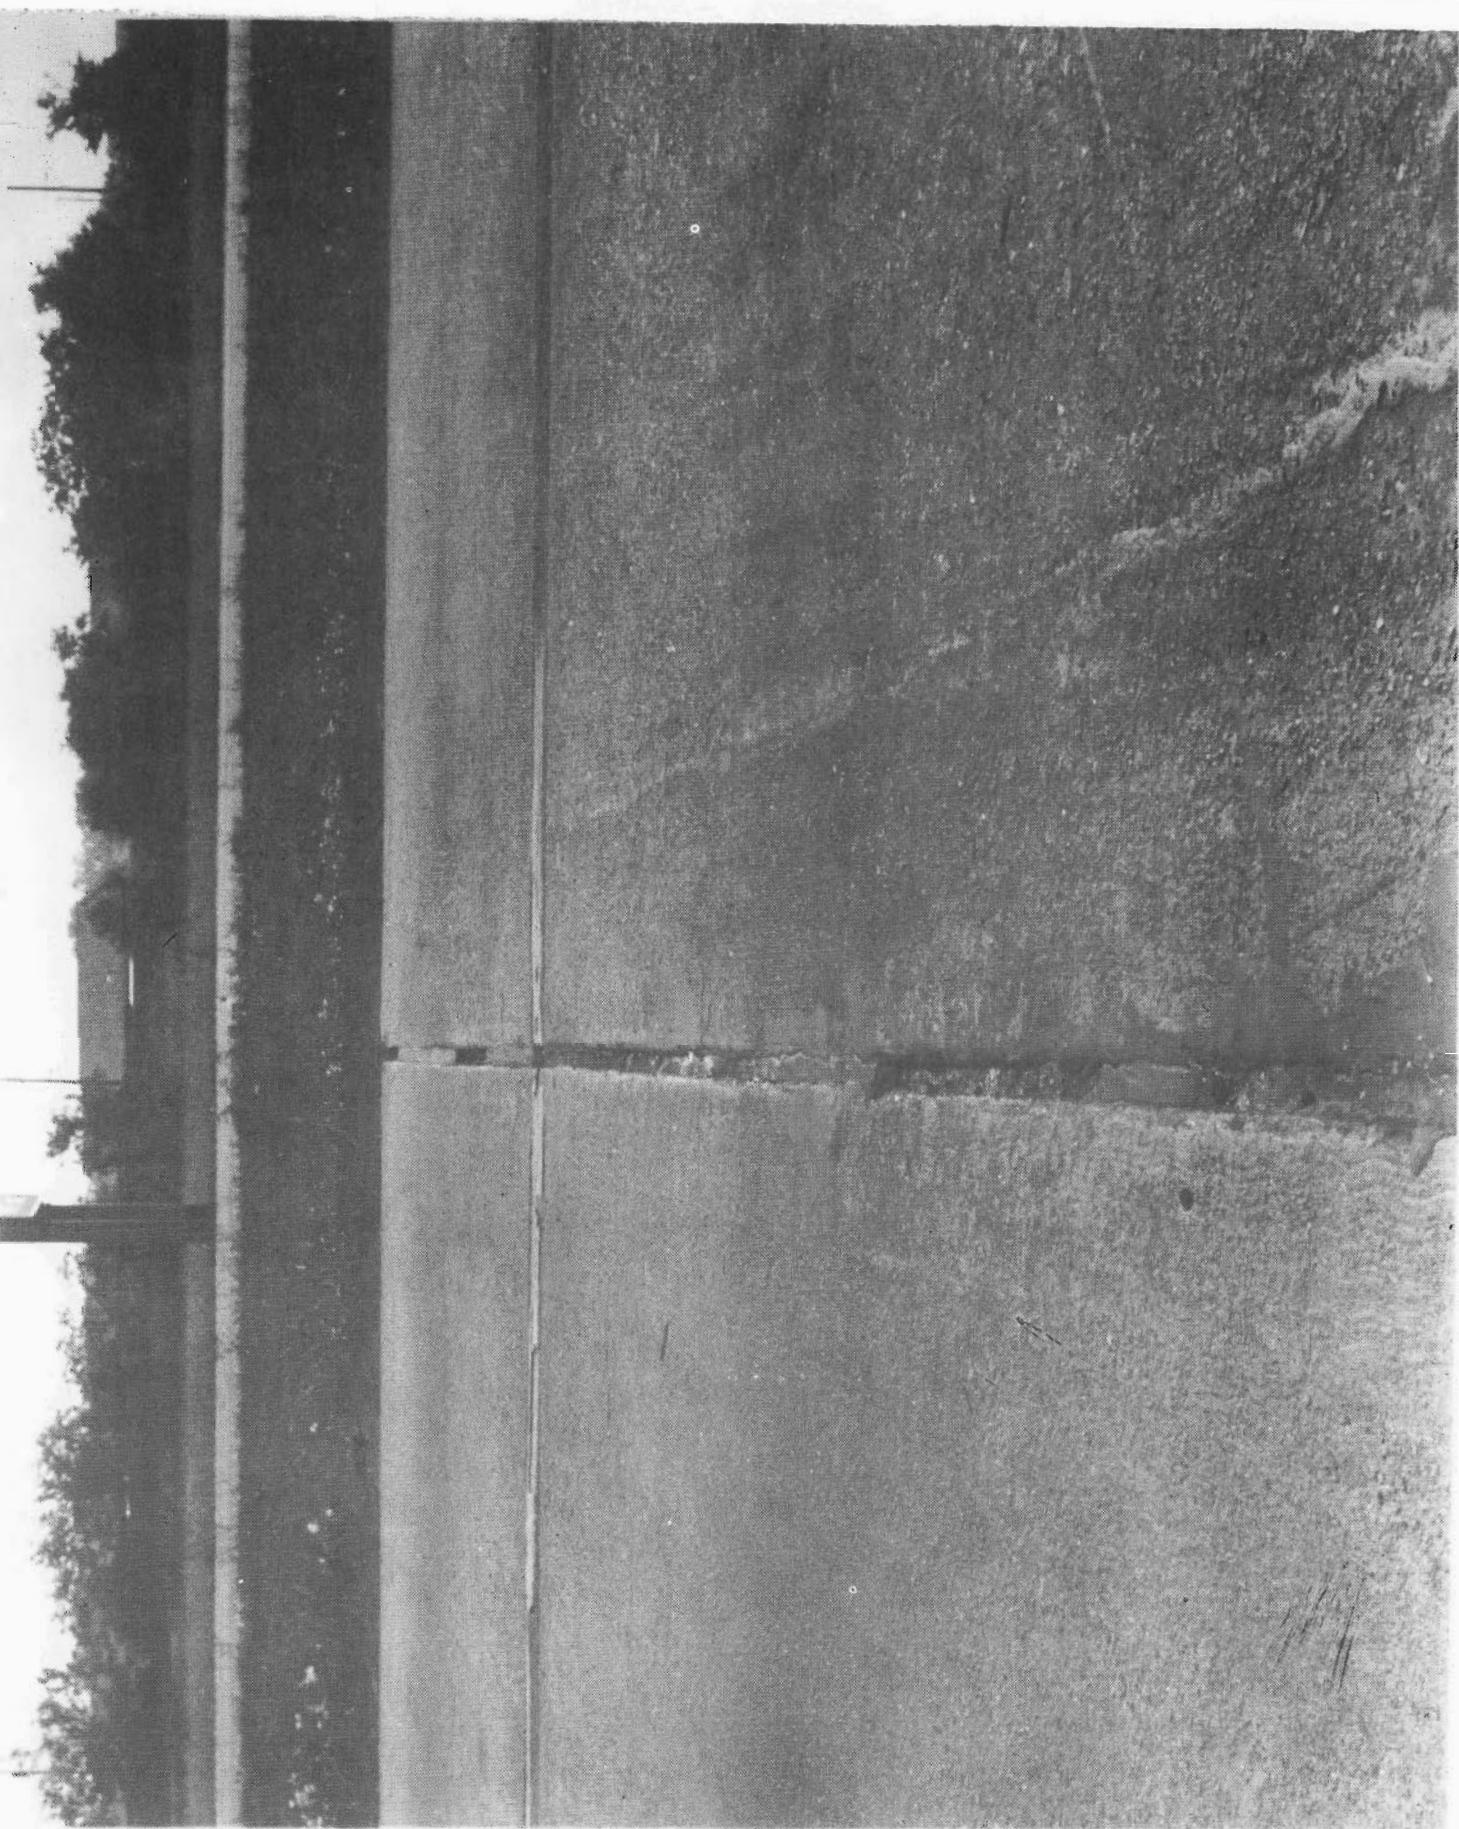
IH 45: SOUTHBOUND LANE - SOUTH OF FM 518 OVERPASS - No. 16

No. 16 & 17: 1" board expansion joint in concrete pavement without overlay. Joint material is spread over pavement in foreground.

This pavement is typical of pavement where wire reinforced overlays have been placed.

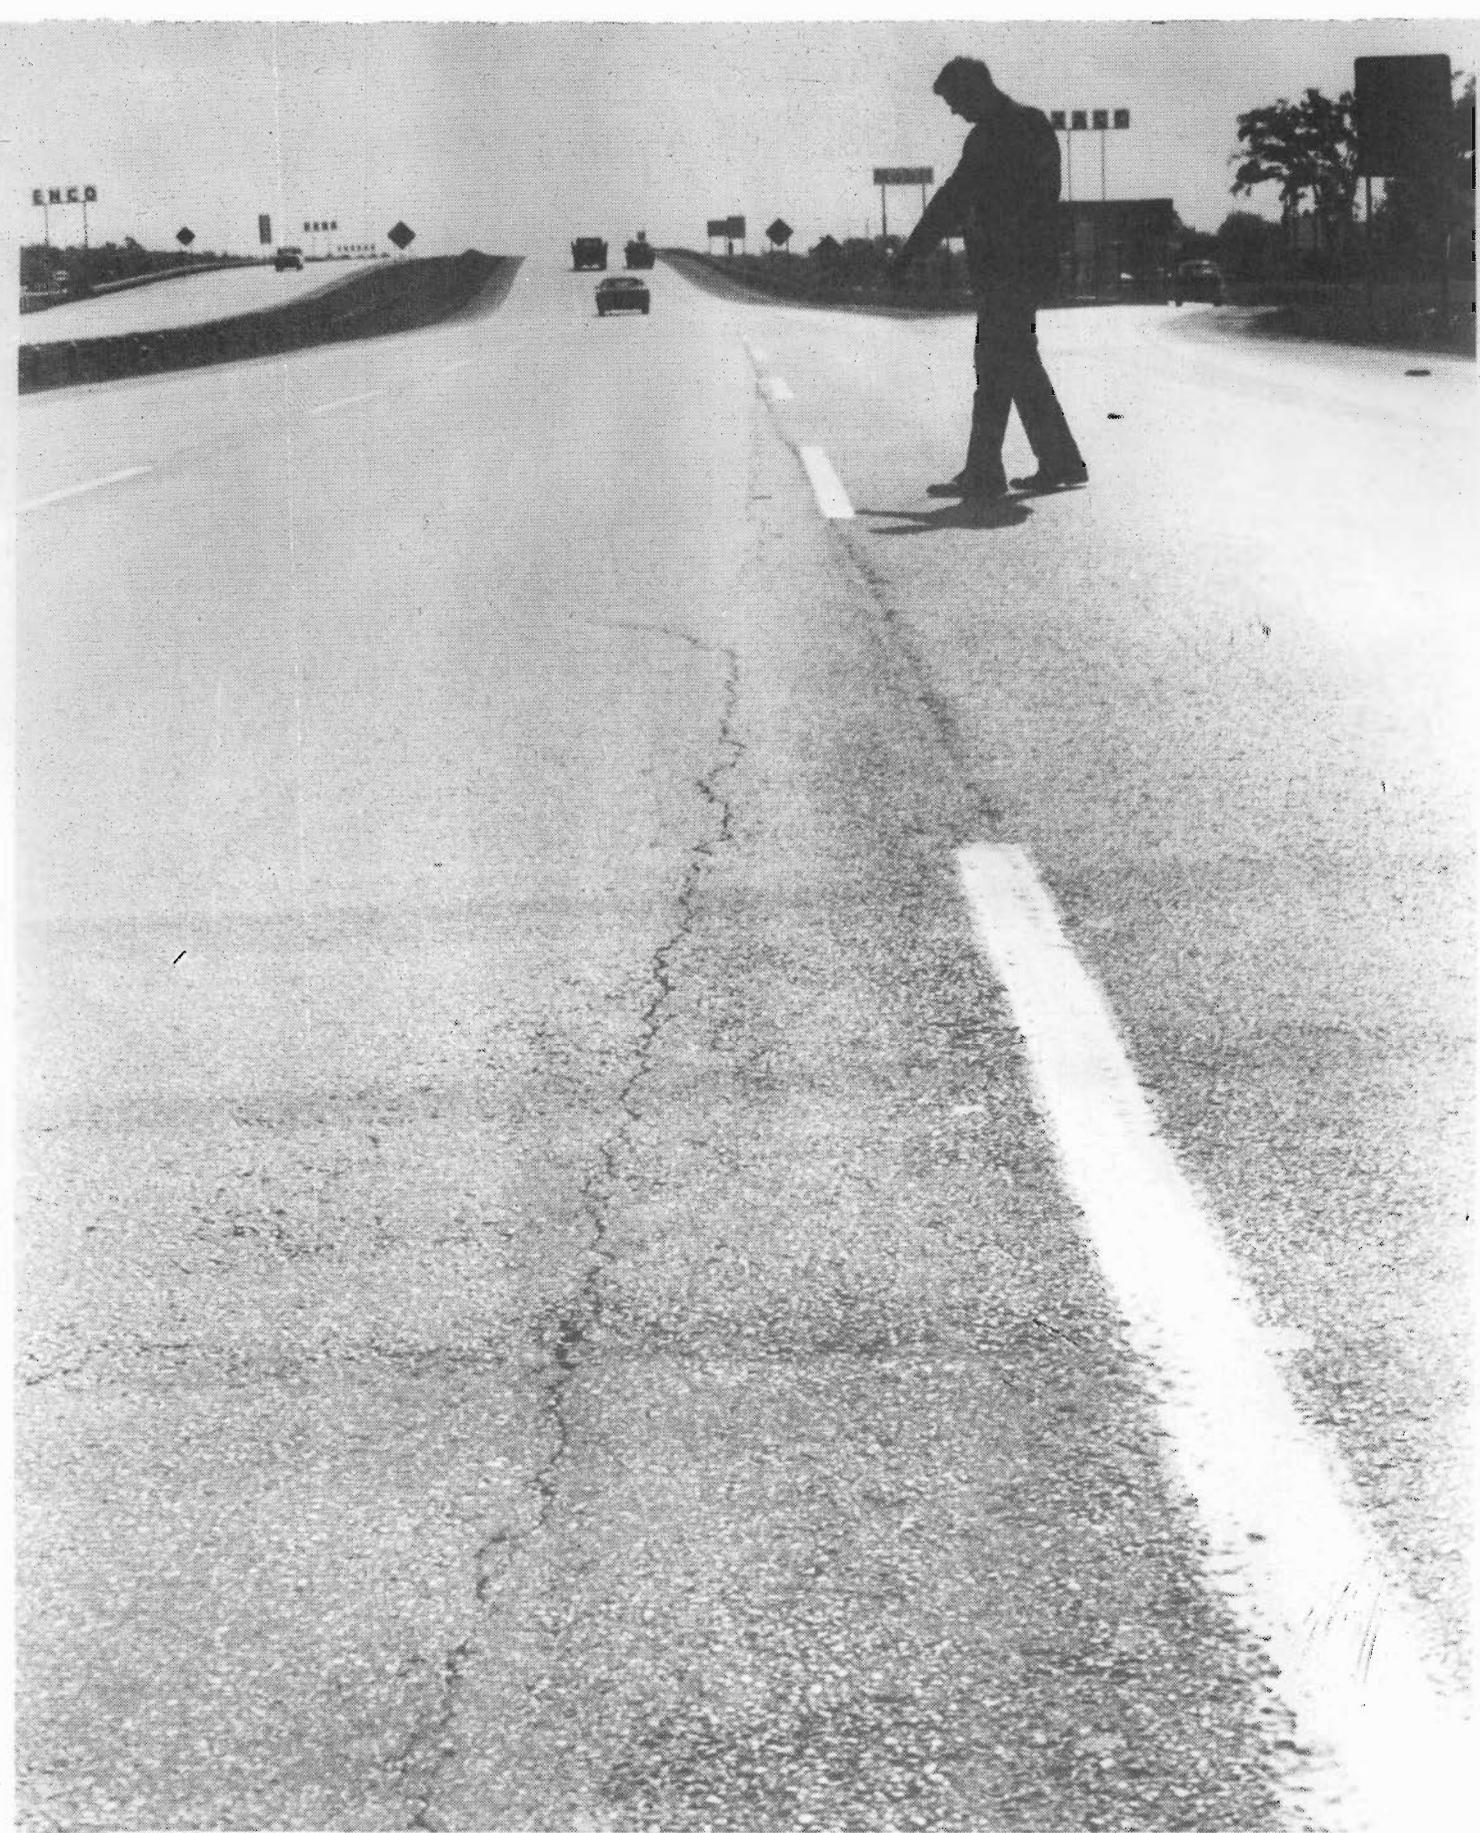
IH 10: EASTBOUND LANE AT OATS LOOKING EAST - No. 18

The above-mentioned photographs taken on I.H. 10 also point out the deterioration of transverse joints in non-reinforced bituminous overlays. This section is in need of widening and additional structure.

No. 18: Note joint where pavement was widened for outside lane. Mercury Drive overpass in background. Knife on pavement.

A wire reinforced bituminous would be desirable for this pavement for the following reasons.

1. The geometrics of the project are such that narrow widenings of five and seven feet would be required for most of the facility. As shown on the attached photographs taken on I.H. 10 within the limits of this project, the widths of the longitudinal joints would be excessive and permit saturation of the non-stabilized subbase under the existing pavement and the heavy clay subgrade predominant throughout the project which would weaken the pavement structure and possibly result in pumping. We would point out that the joints shown in the photographs of I.H. 45 are at 12-foot widenings. We would expect wider joints for the narrower widenings.

4. As shown in all photographs of bituminous overlays without wire, the reflective cracking from the joints cannot be tolerated on a Interstate Highway.

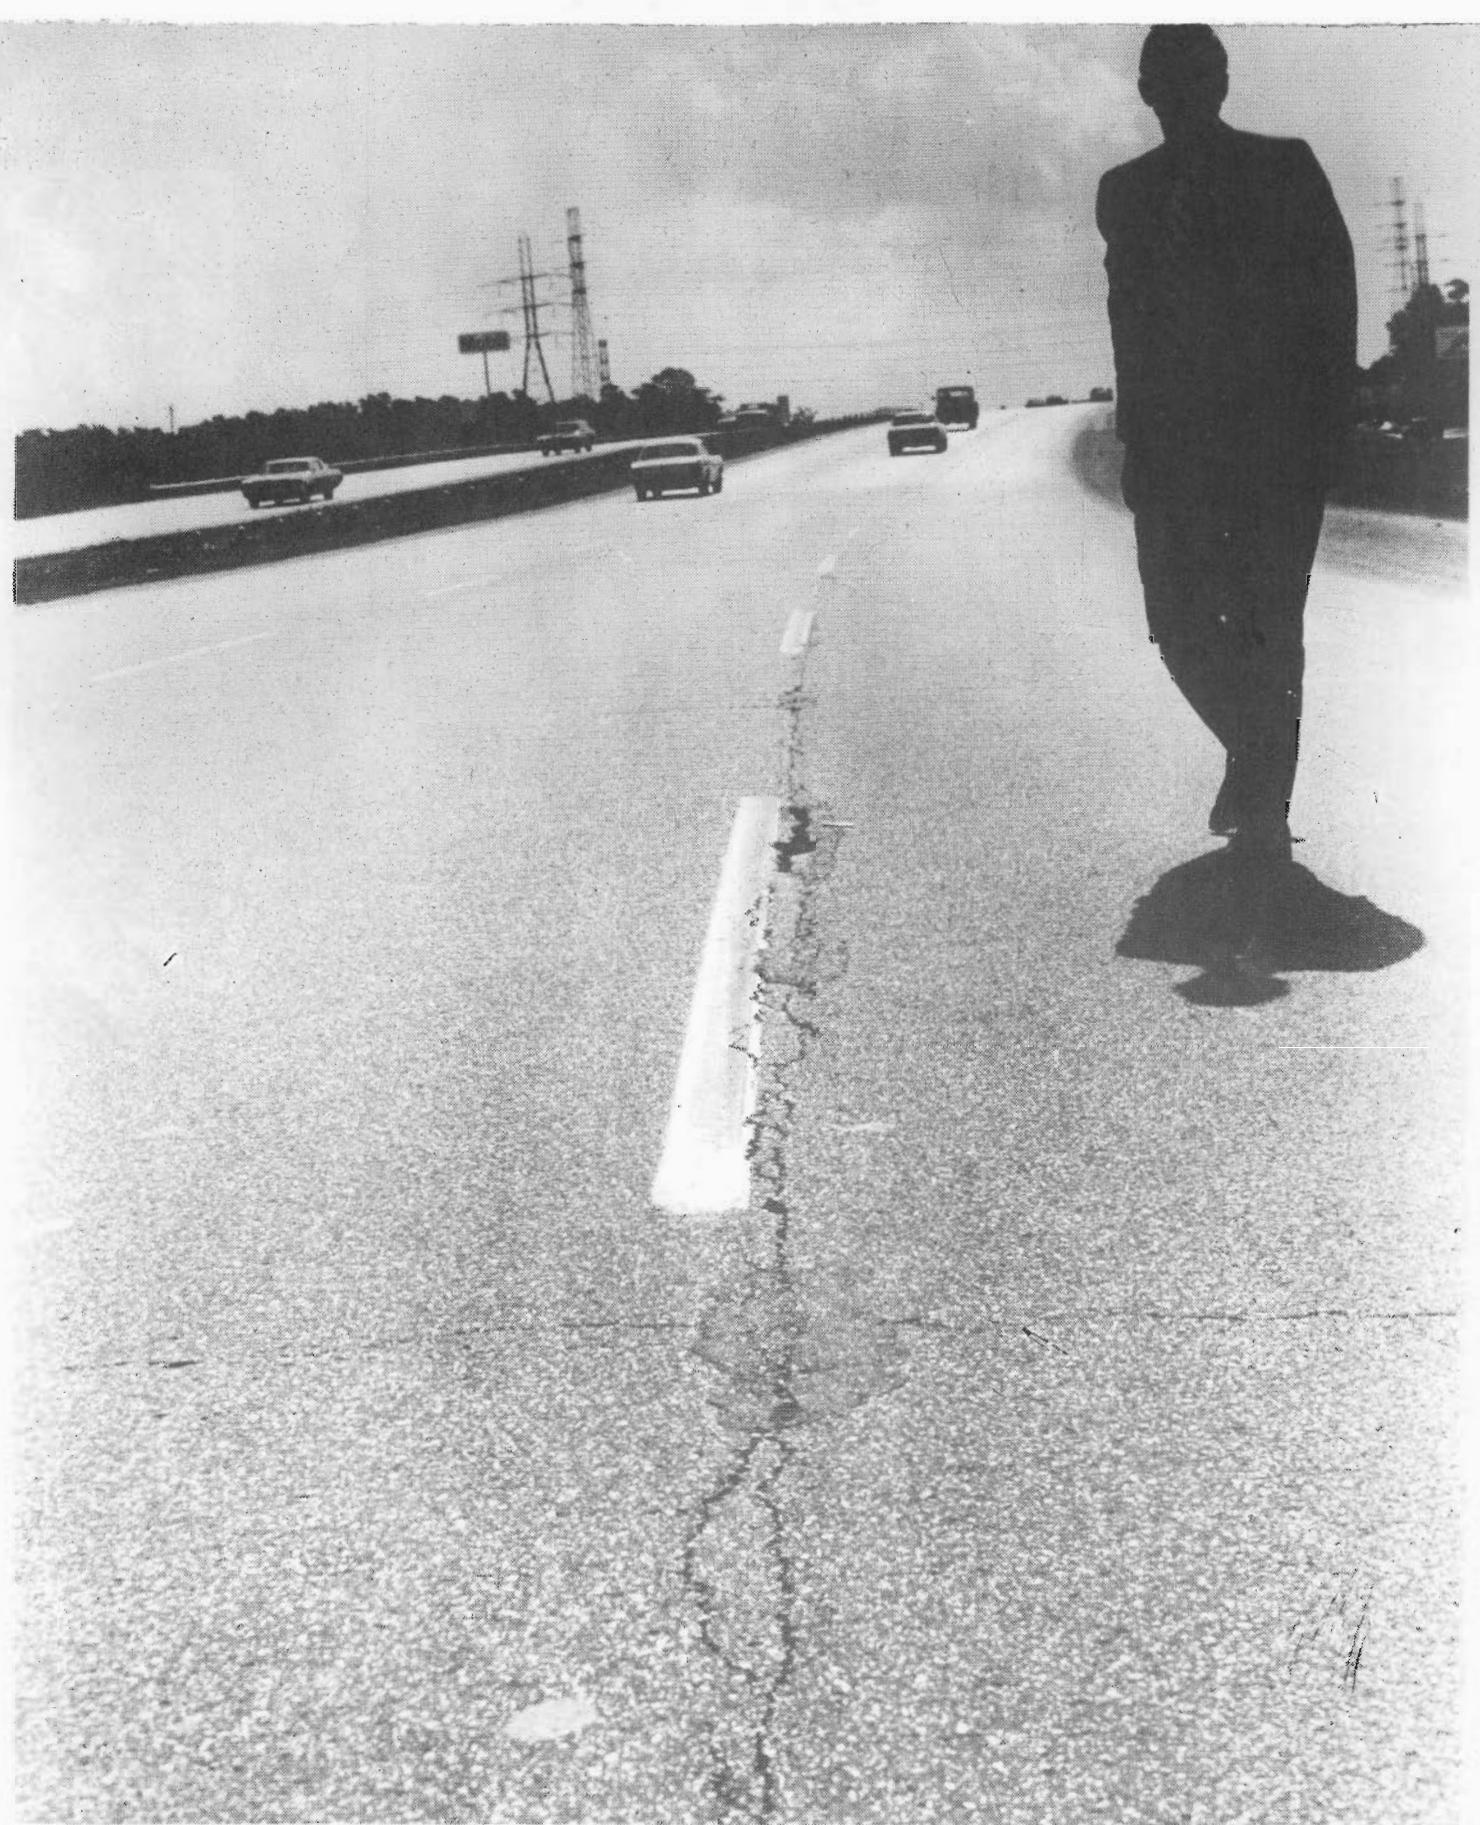
IH 10: EASTBOUND LANE TO WEST OF HOLLAND AVENUE - No. 19

No. 19 & 20: Note spalling of joint where outside lane was added. Transverse joints also opening up.

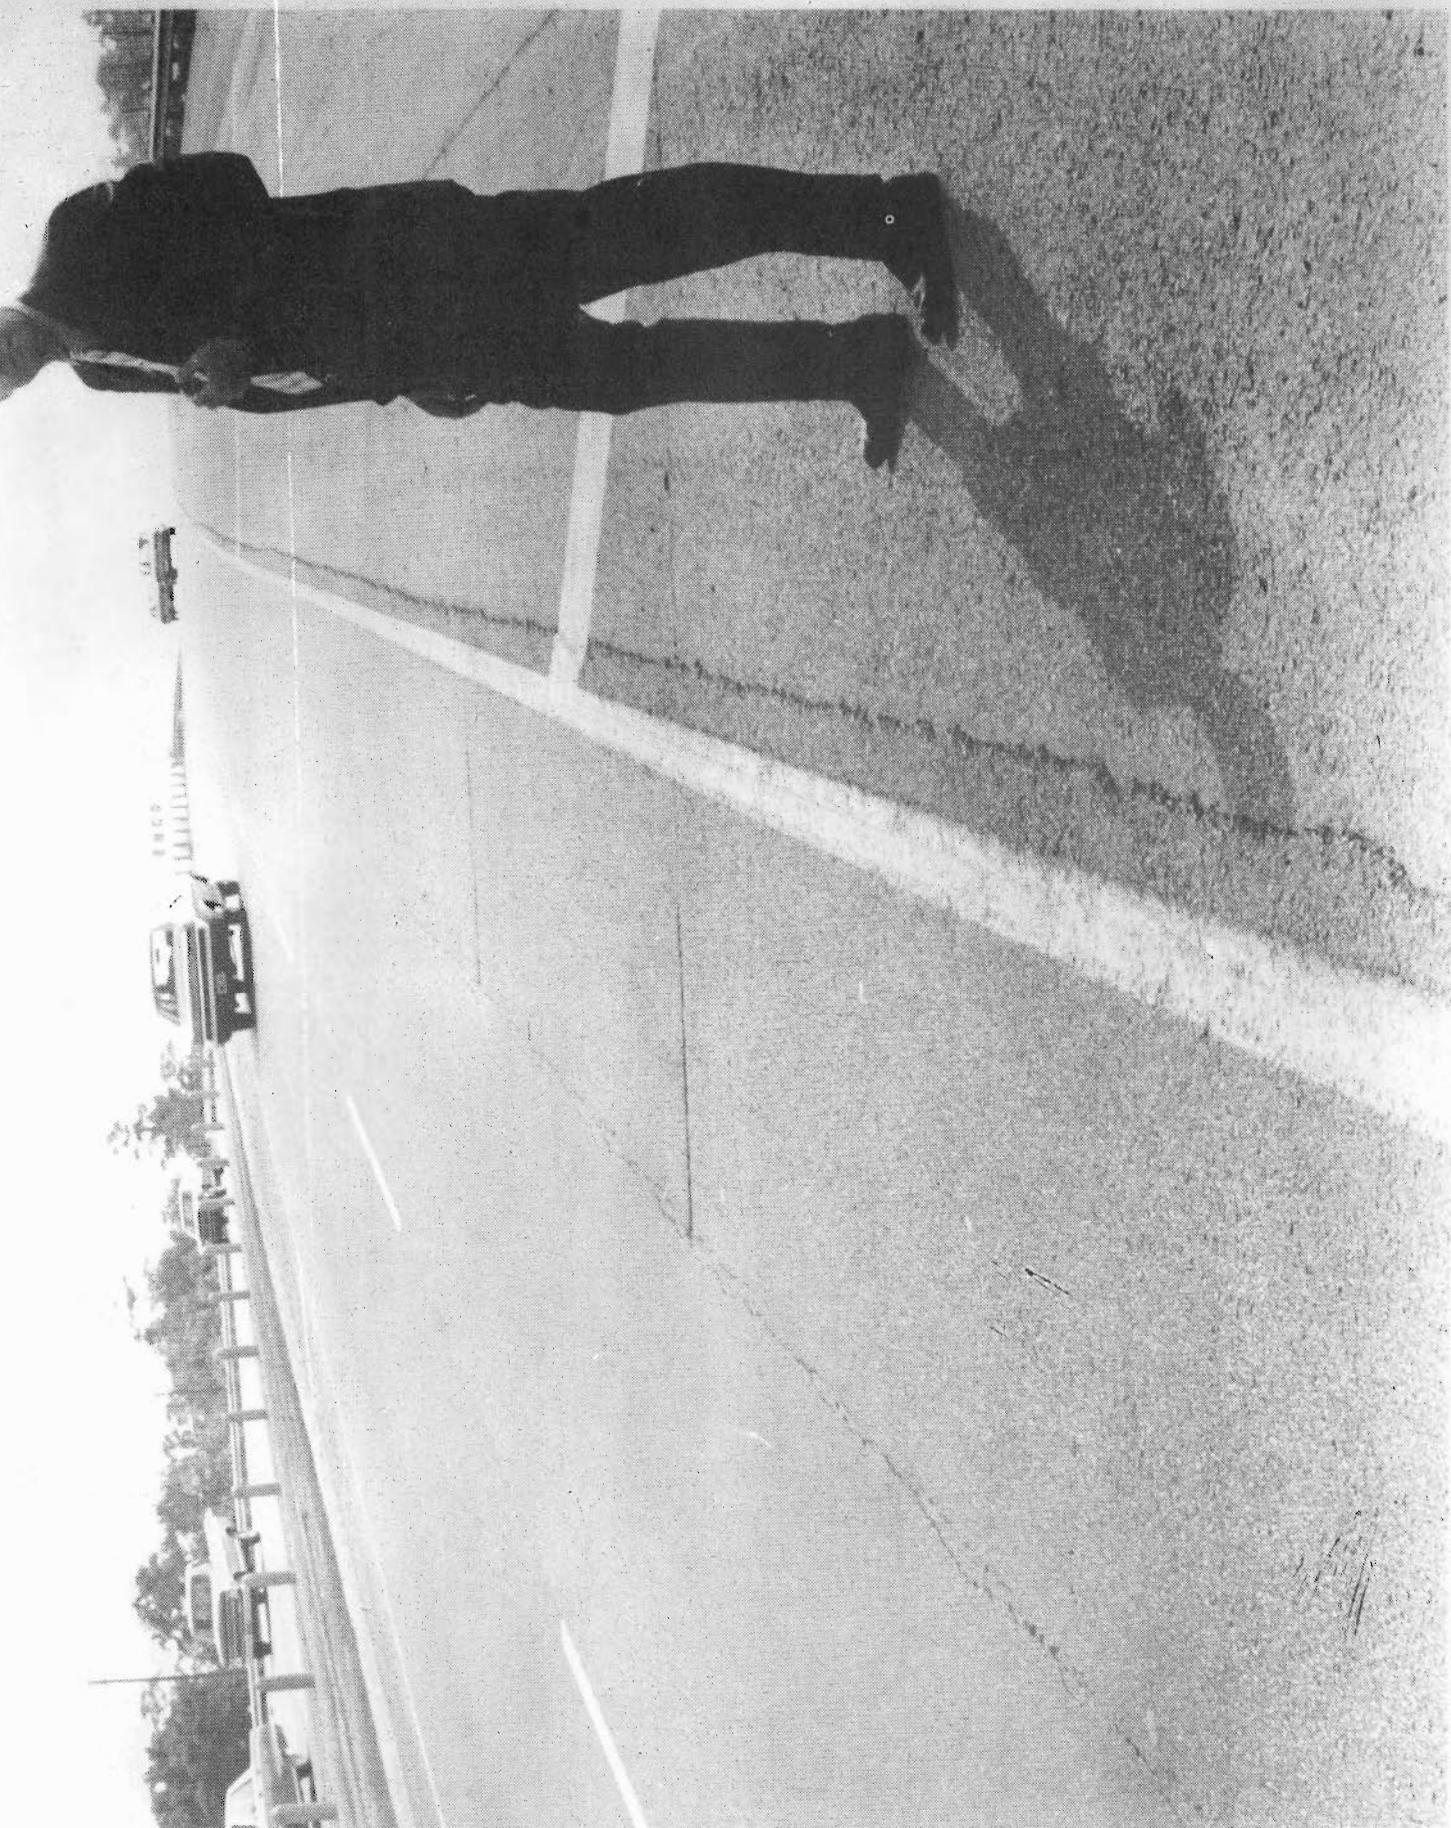
IH 10: EASTBOUND LANE TO WEST OF NORMANDIE OVERPASS - No. 21

No. 21: Note pavement edge widening. Edge of asphalt to right of solid stripe. Note crack in asphalt midway between dashed line and solid line. Note transverse joints. Note cratering of longitudinal joint.

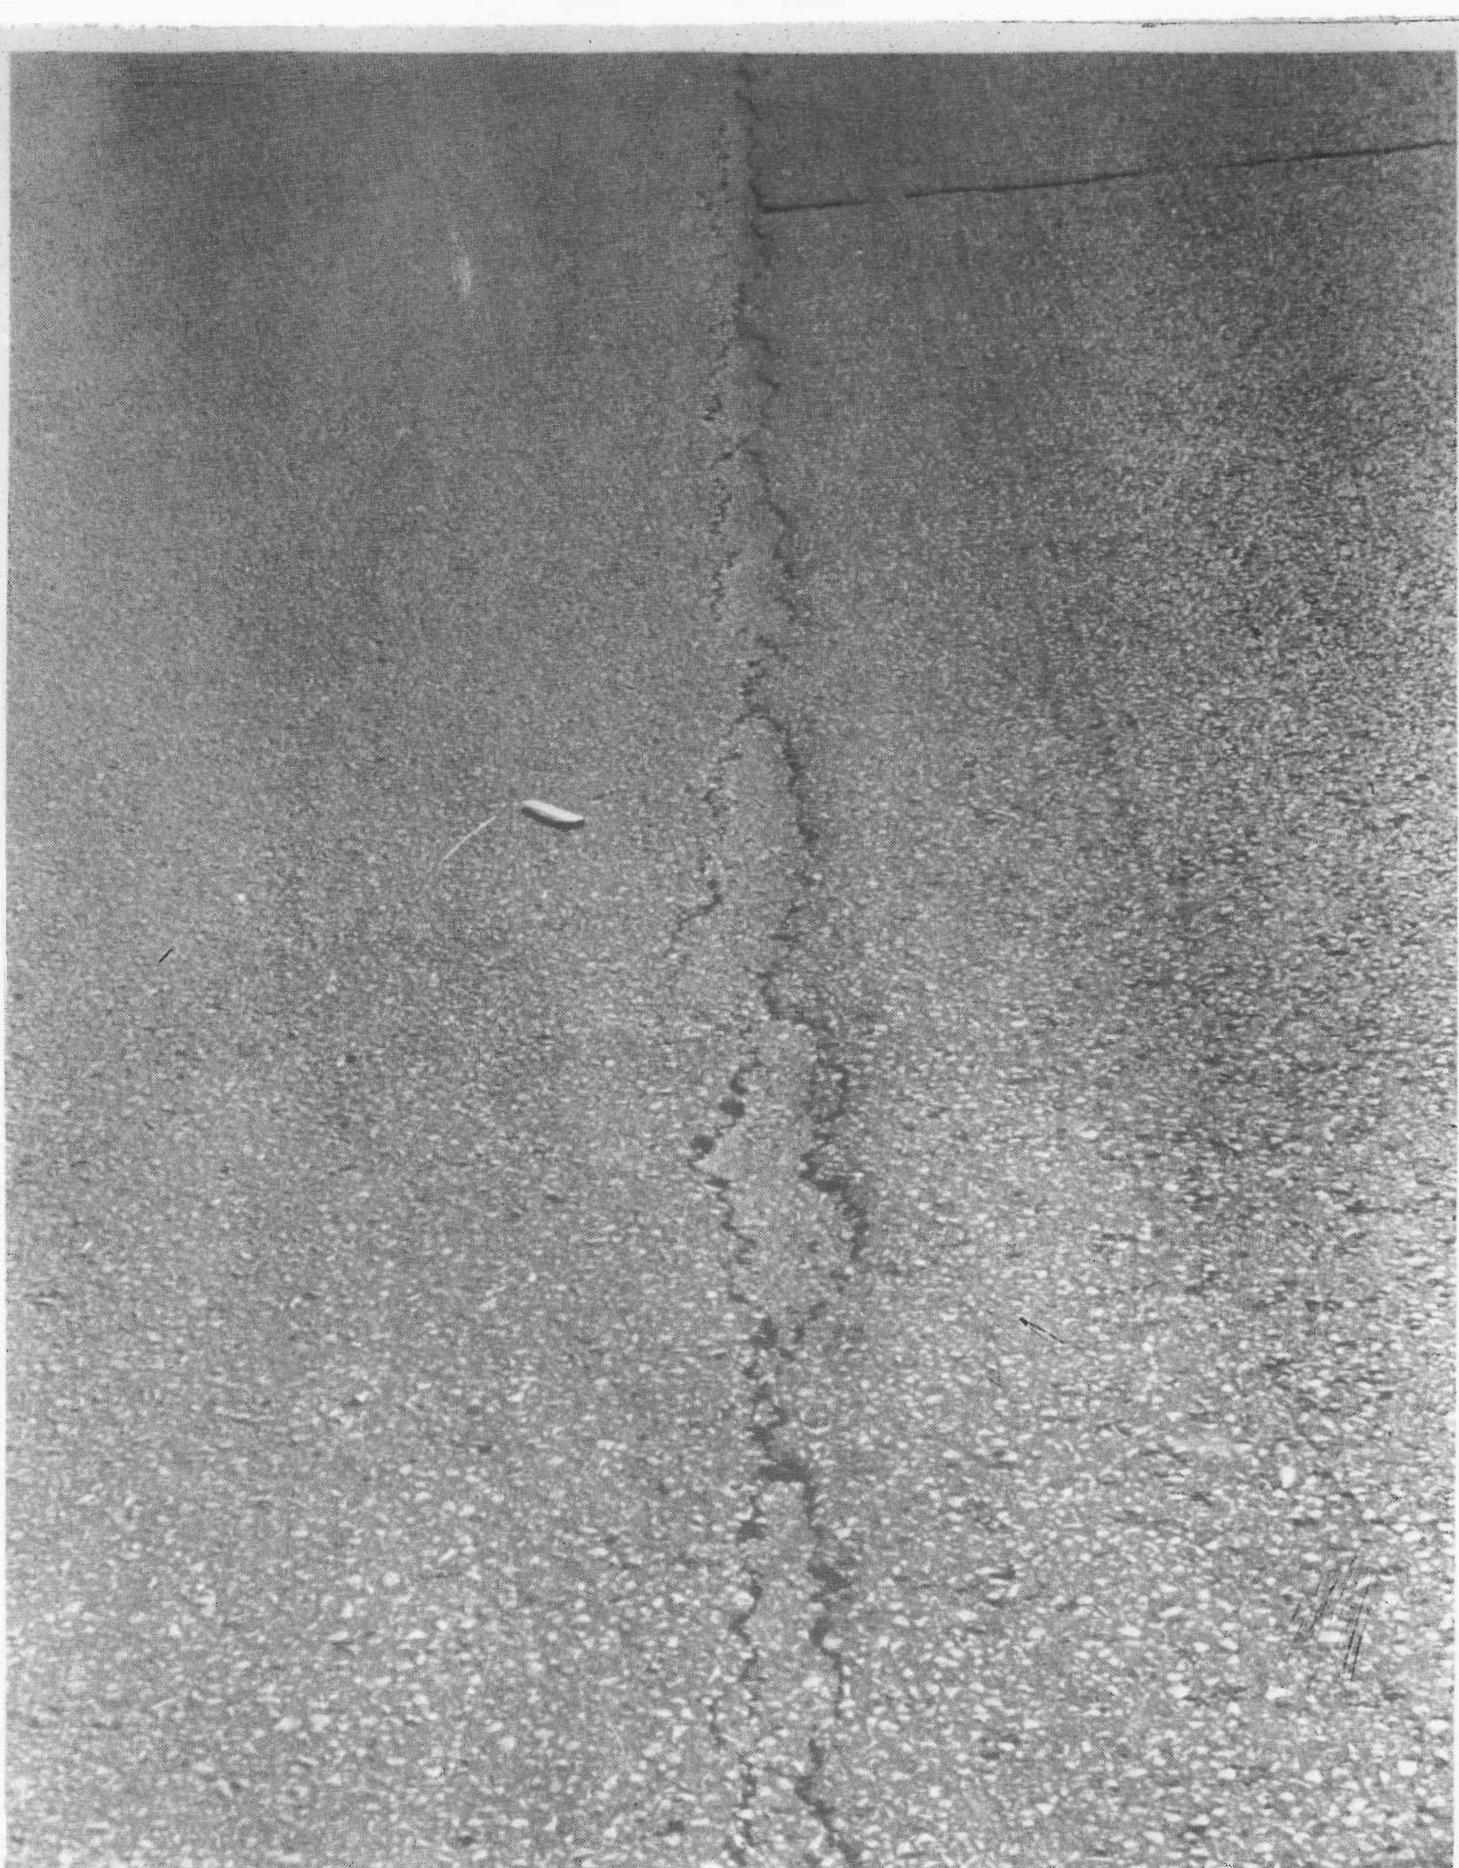
IH 10: EASTBOUND LANE TO WEST OF NORMANDIE OVERPASS - No. 22

No. 22: Closeup of cratering in longitudinal joint.

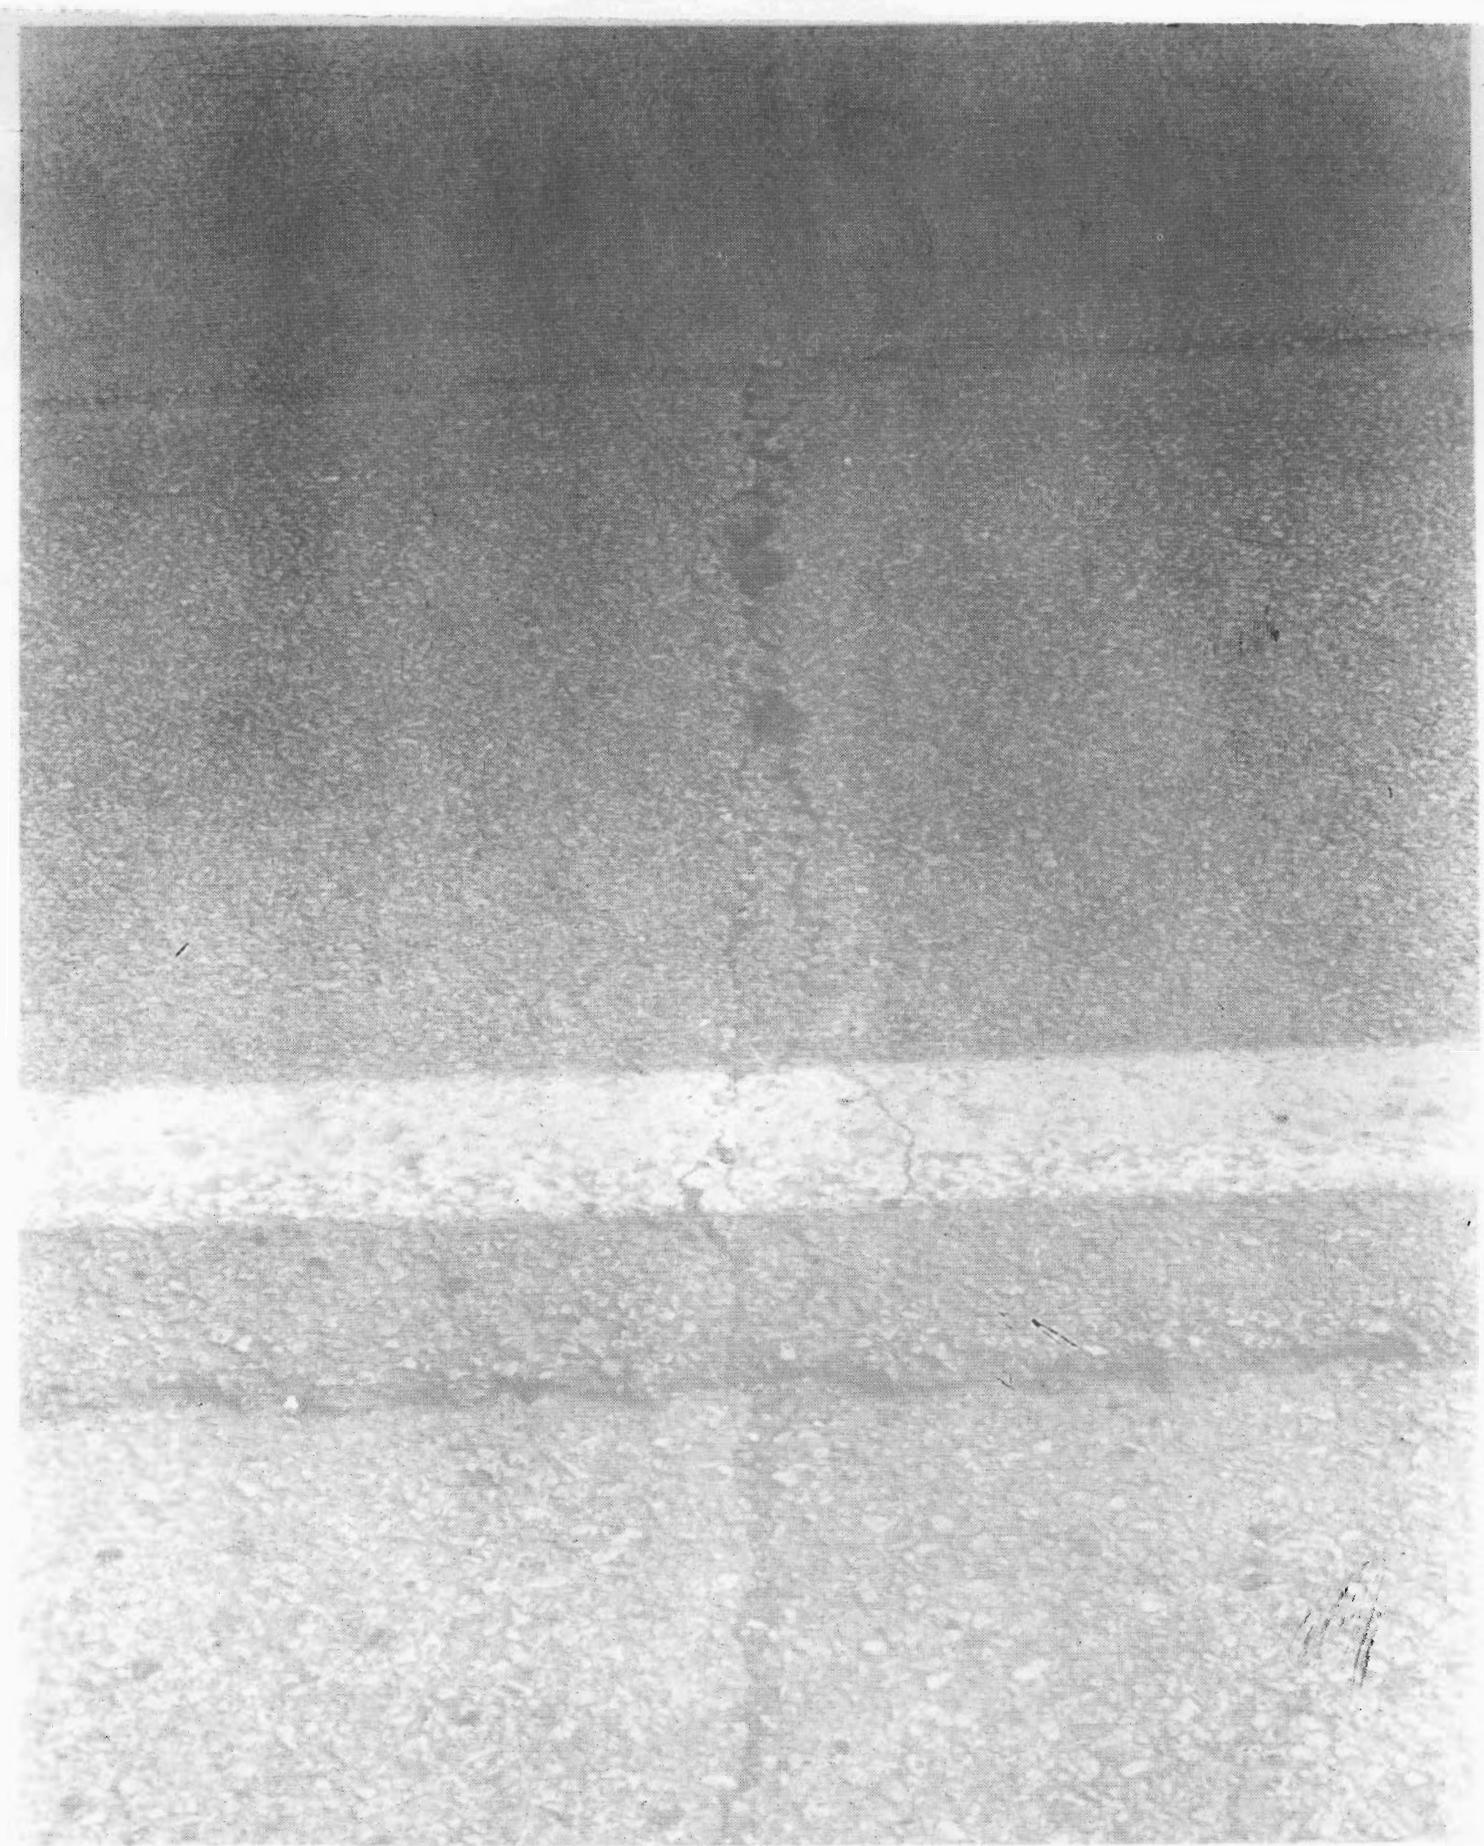
IH 10: EASTBOUND LANE TO WEST OF NORMANDIE OVERPASS - No. 23

No. 23: Note cratering in transverse joint. Note edge of asphalt near edge of stripe. Note joint in shell concrete in foreground.

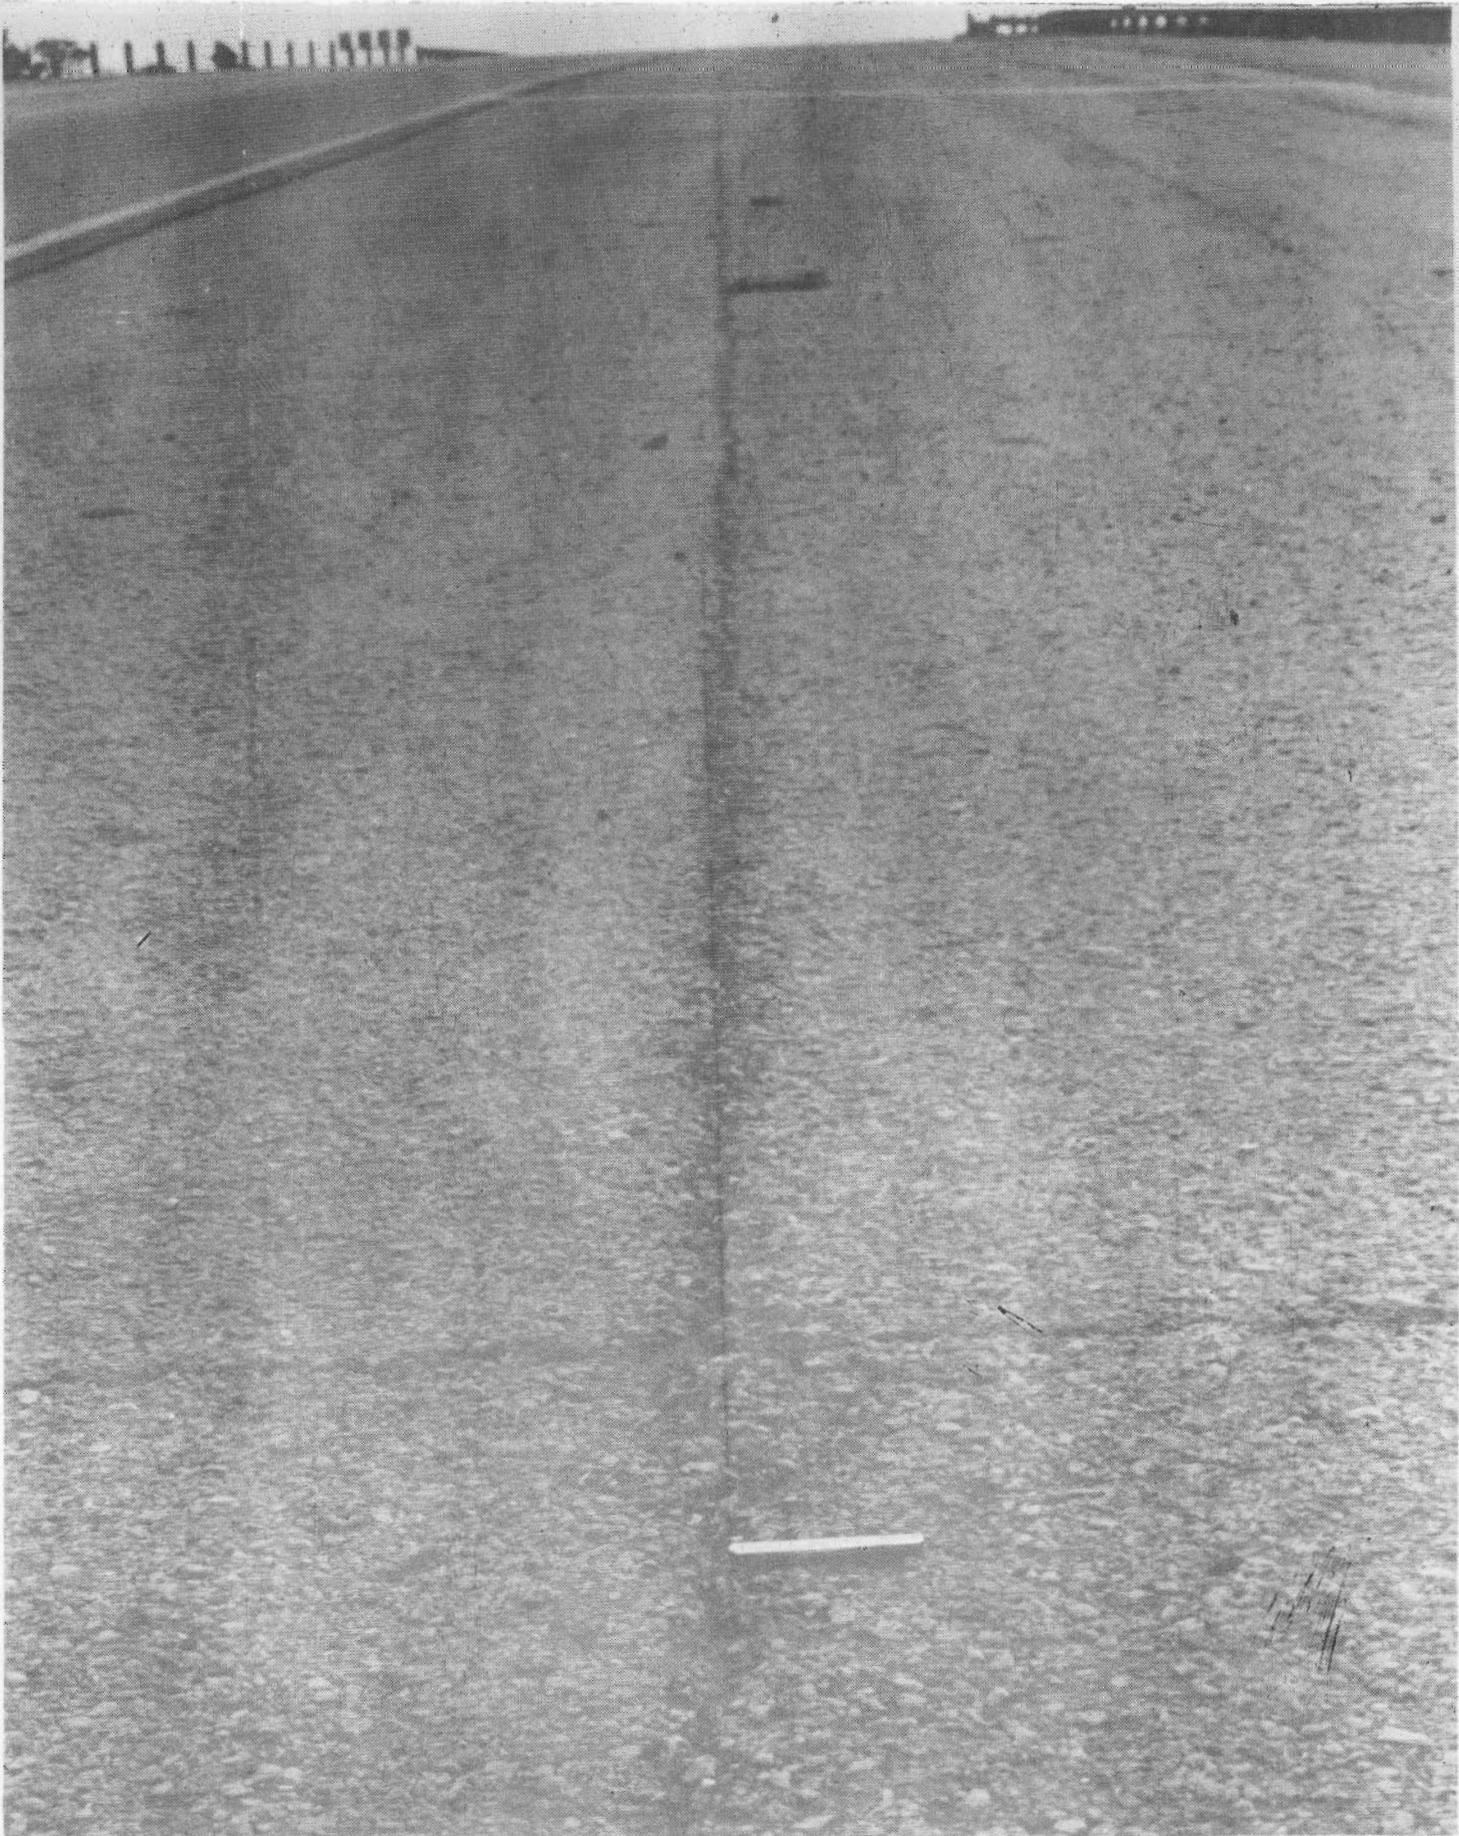
IH 10: EASTBOUND LANE TO WEST OF NORMANDIE OVERPASS - No. 24

No. 24: Joints in Shell Concrete Pavement are not extreme. See knife.
