PERFORMANCE OF
METAL REINFORCED
BITUMINOUS OVERLAYS
IN TEXAS

TEXAS HIGHWAY DEPARTMENT

TEXAS HIGHWAY DEPARTMENT
JUNE 1971

Supplement for District 2 - Fort Worth

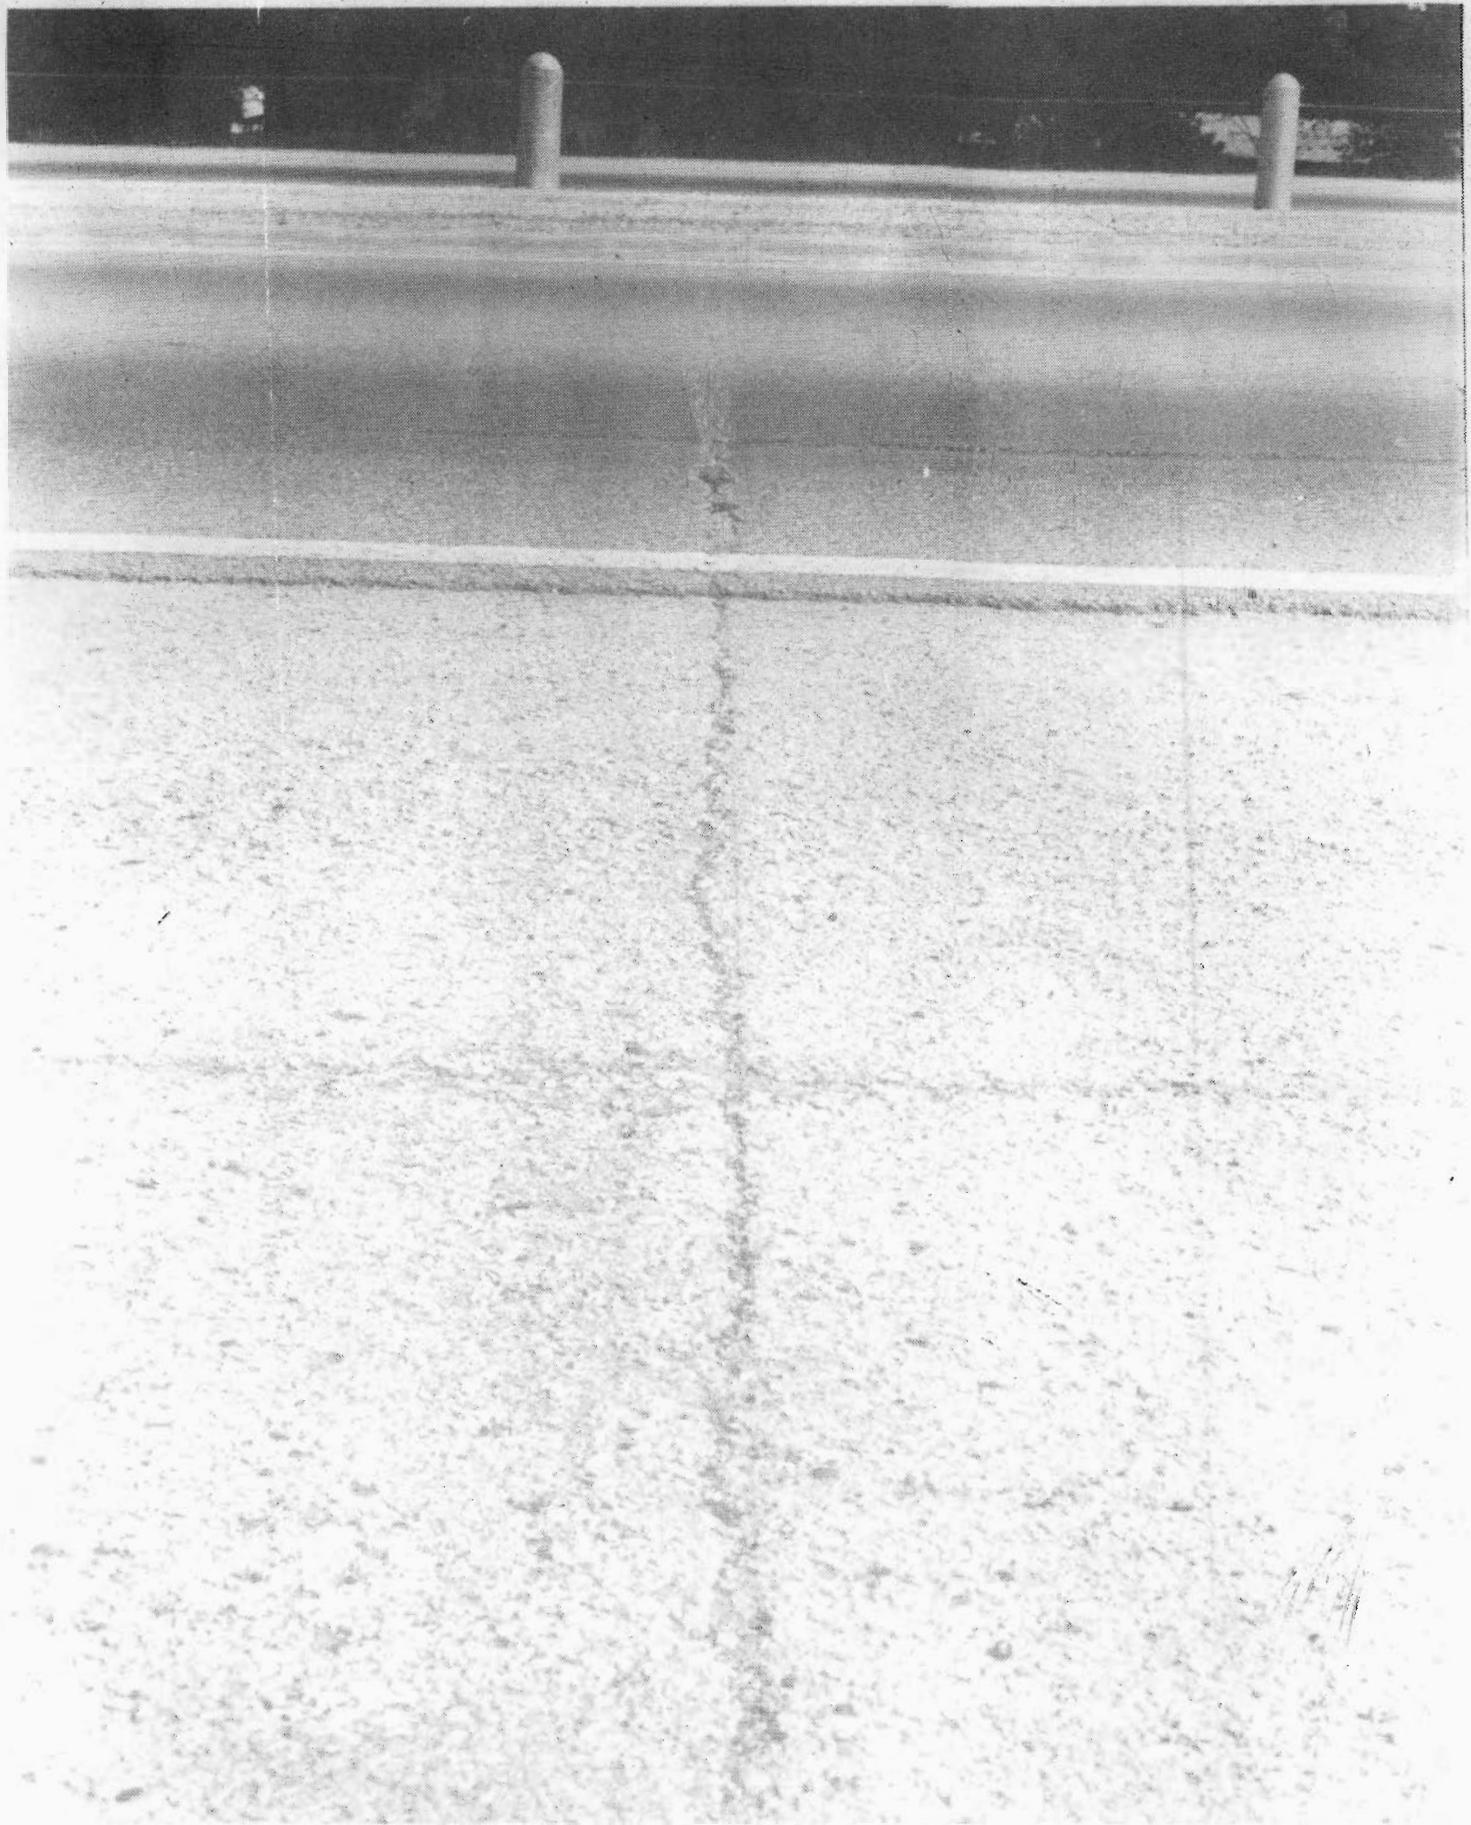
TH 10: EASTBOUND LANE TO WEST OF NORMANDIE OVERPASS - No. 25

No. 25: Compare joints in shell concrete pavement to cratered joint in asphalt overlay in background.

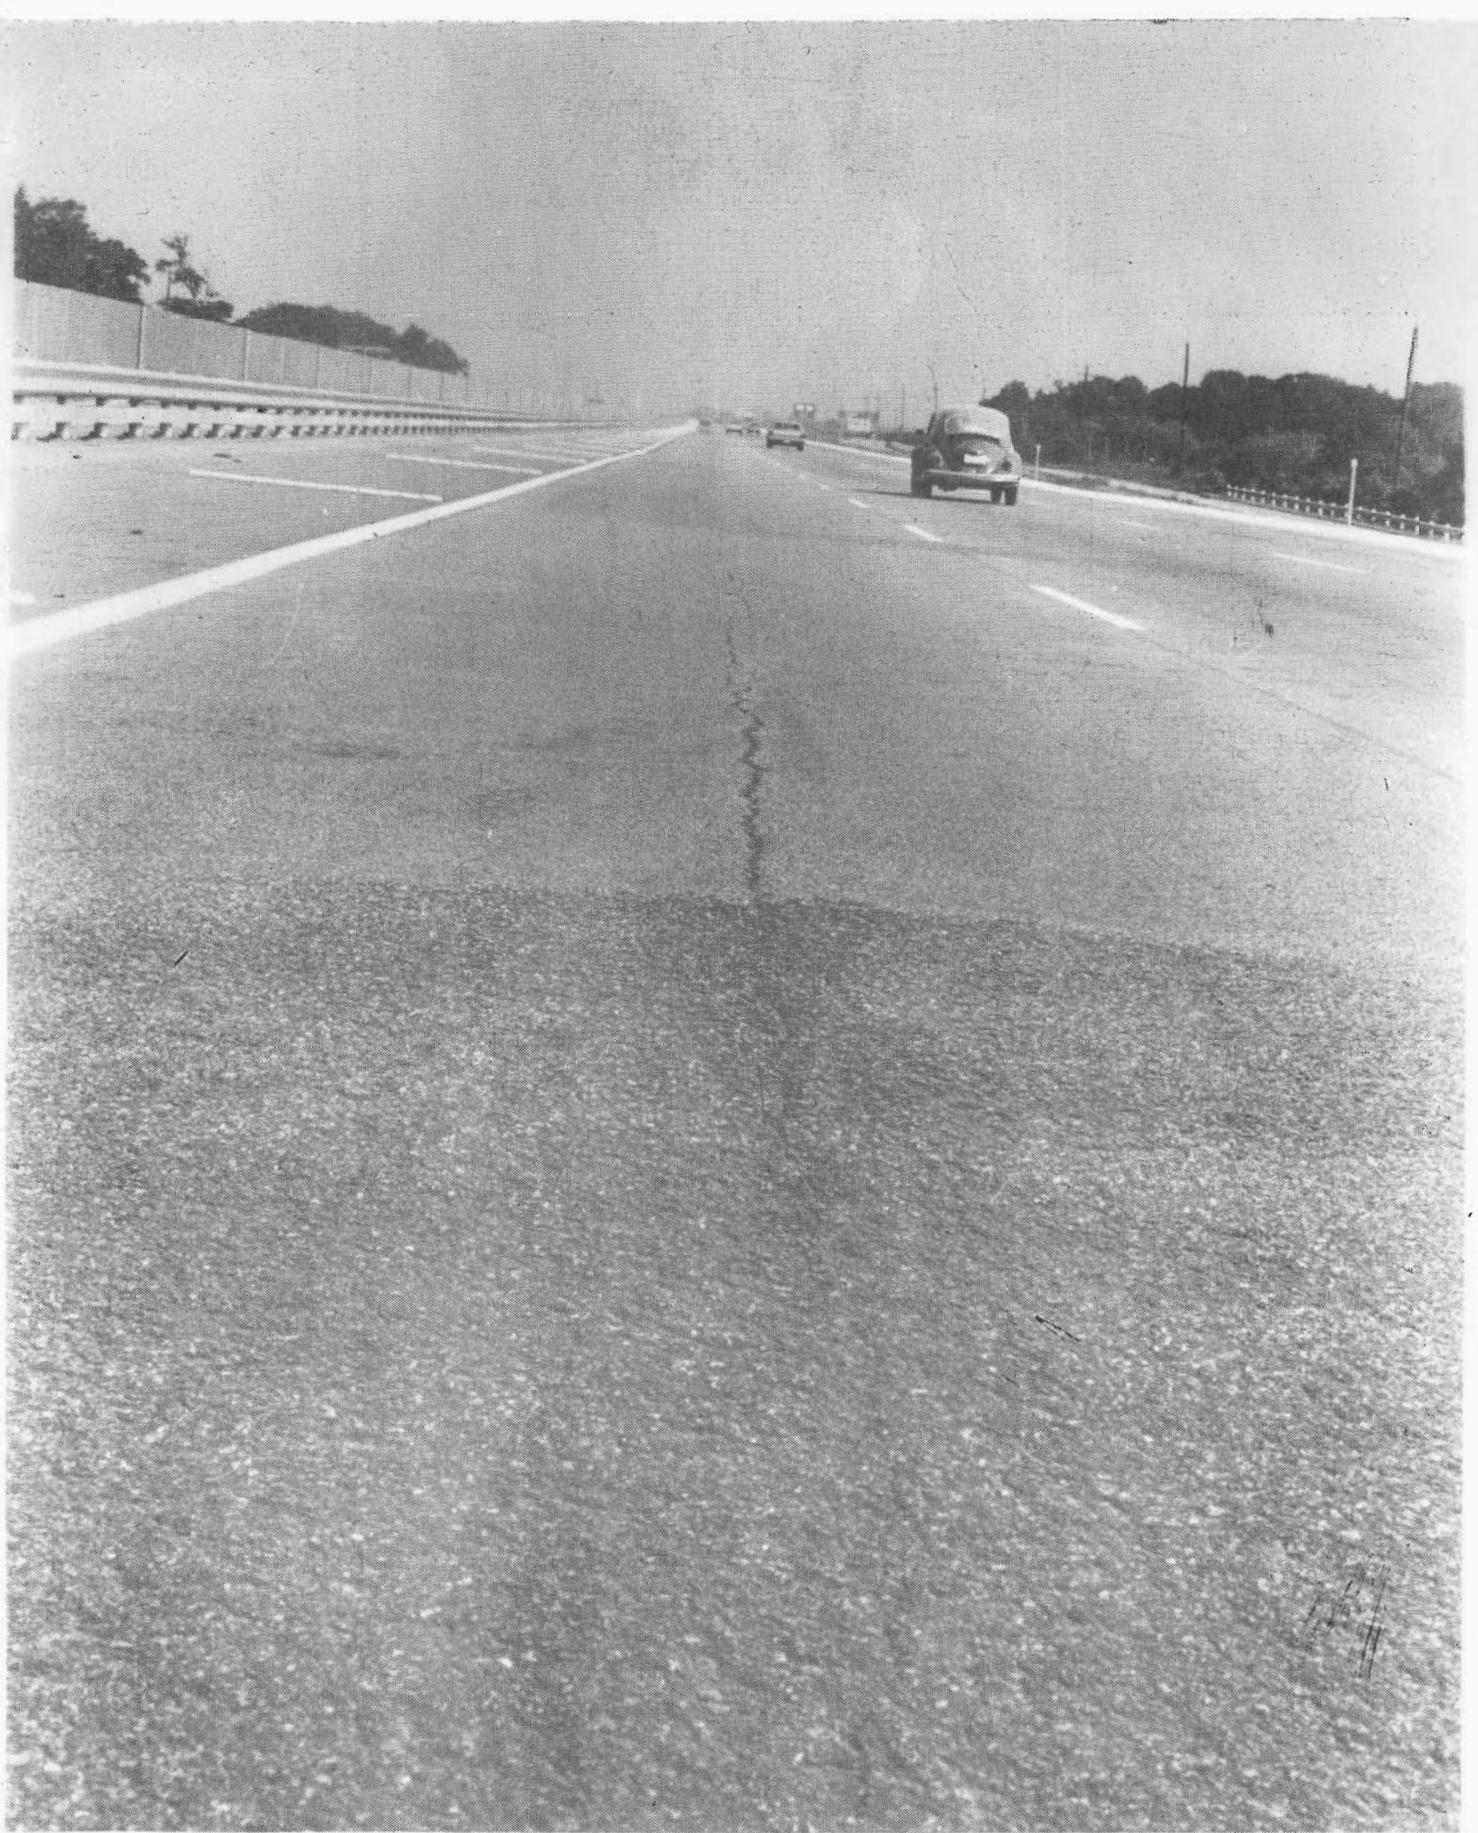
IH 45: NORTHBOUND LANE NORTH OF CLEAR CREEK BRIDGE - No. 26

- No. 26: Asphalt overlay has no mesh reinforcing. Open to traffic 6 months. Longitudinal joint opens up at widening joint. Foreground shows new patch in overlay.
- No. 27: Asphalt overlay has no mesh reinforcing. Open to traffic 6 months. Longitudinal joints open at pavement widening joint.

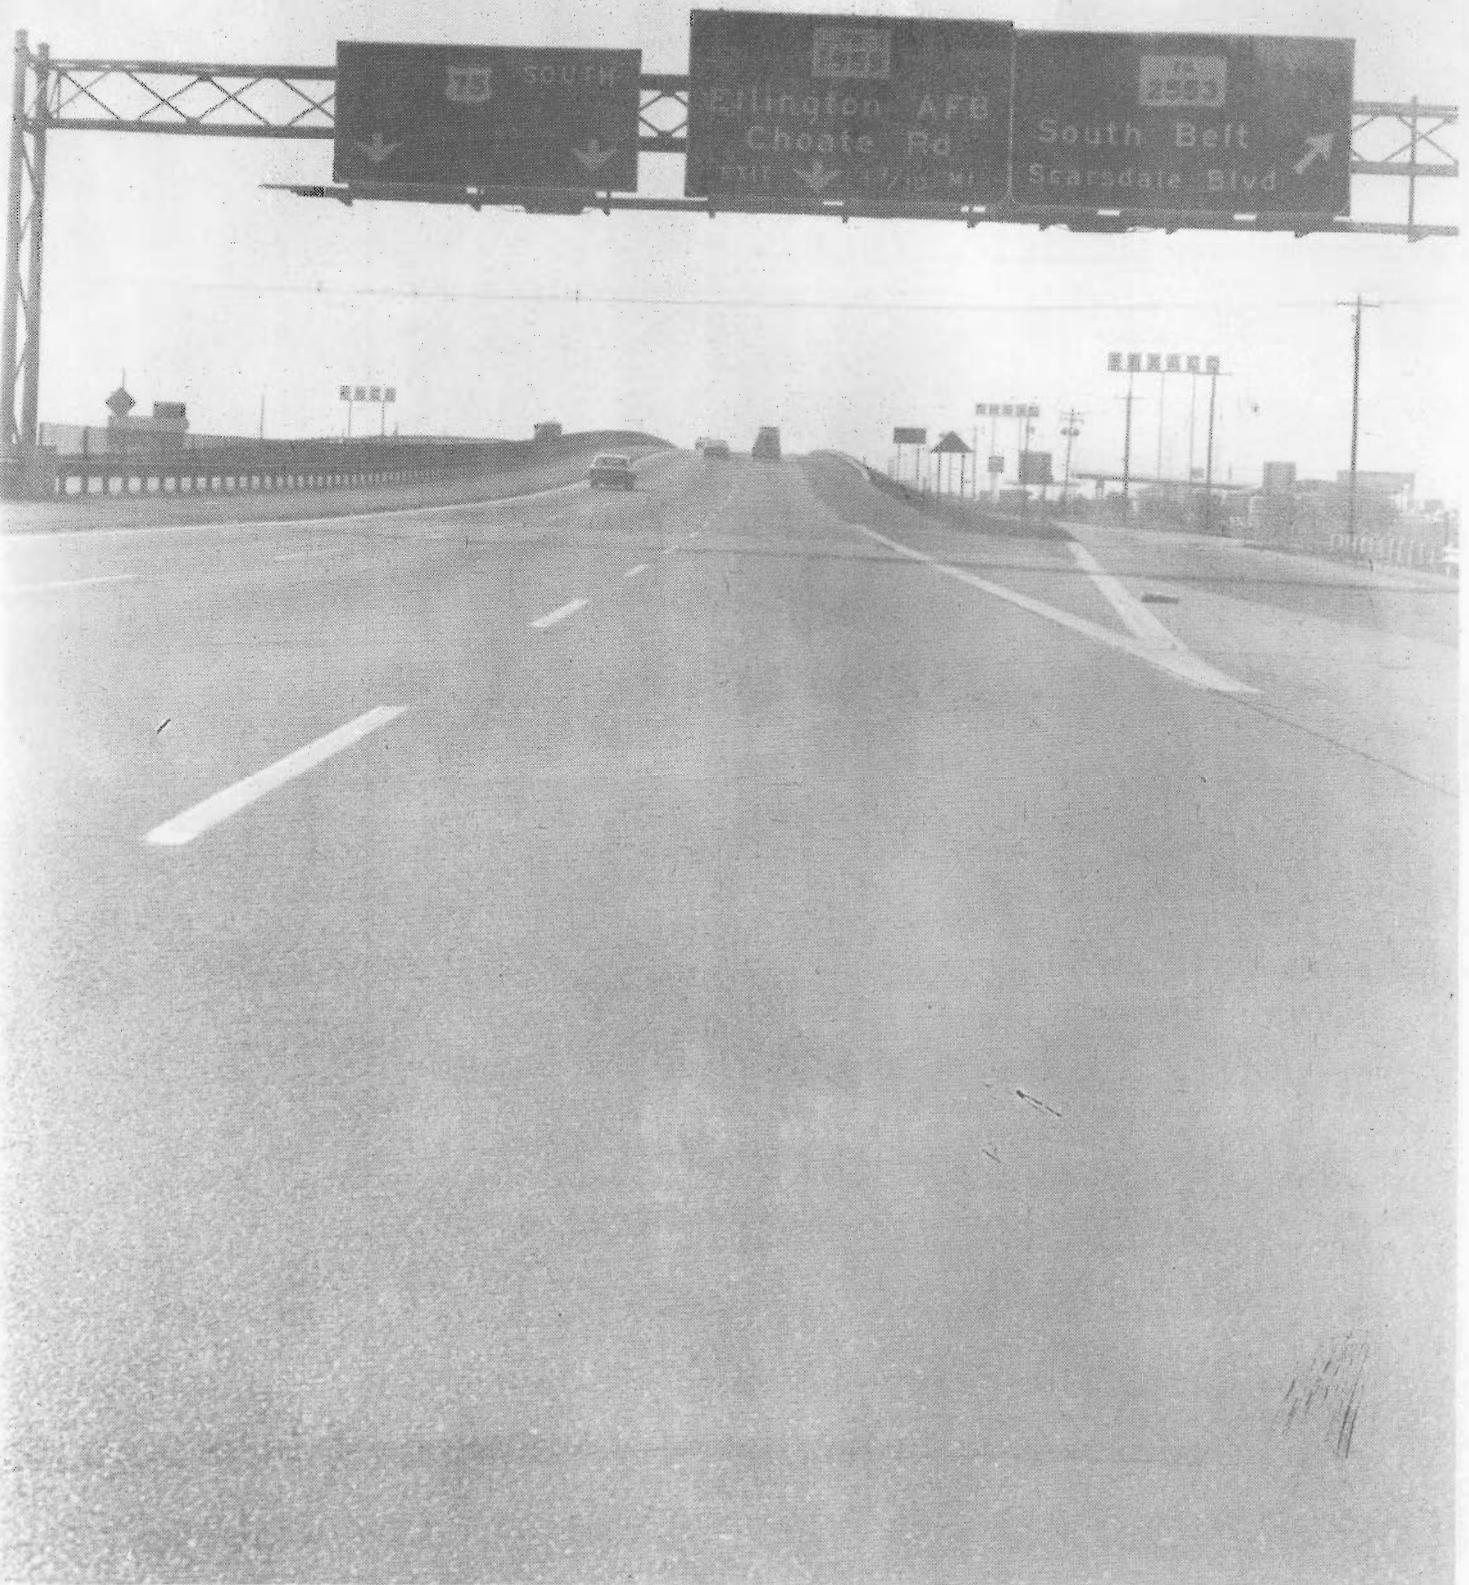
TH 45: PROJECT I45-1(64)031, FROM ALMEDA - GENOA
ROAD TO FM 1959 SOUTHBOUND - NORTH OF SOUTH
BELT INTERCHANGE - No. 28

No. 28 Pavement widened 6' in outside lane in 1965 & over-
laid with hot mix & wire fabric. No evidence of
crack penetration along widening joint. Small crack
in foreground in transverse 1" expansion joint. Note
wide longitudinal joint outside limits of wire mesh.
