PERFORMANCE OF
METAL REINFORCED BITUMINOUS OVERLAYS IN TEXAS

Special Study 9.0

Conducted by
Texas Highway Department
Highway Design Division

August 1968

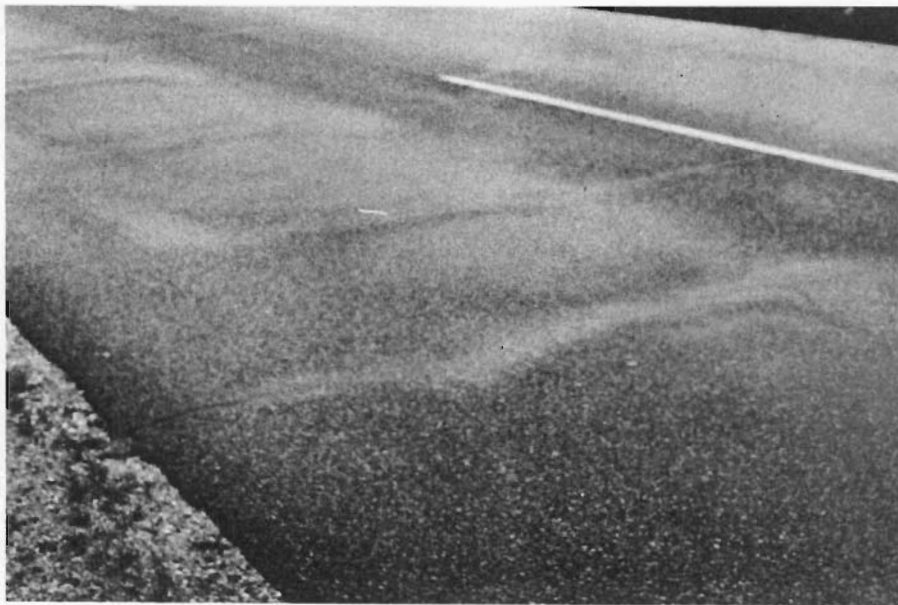
(WITHOUT WIRE)
TYPICAL SECTION A

The cracks in this section were hairline size to about $\frac{1}{4}$ in. in width and had been sealed.

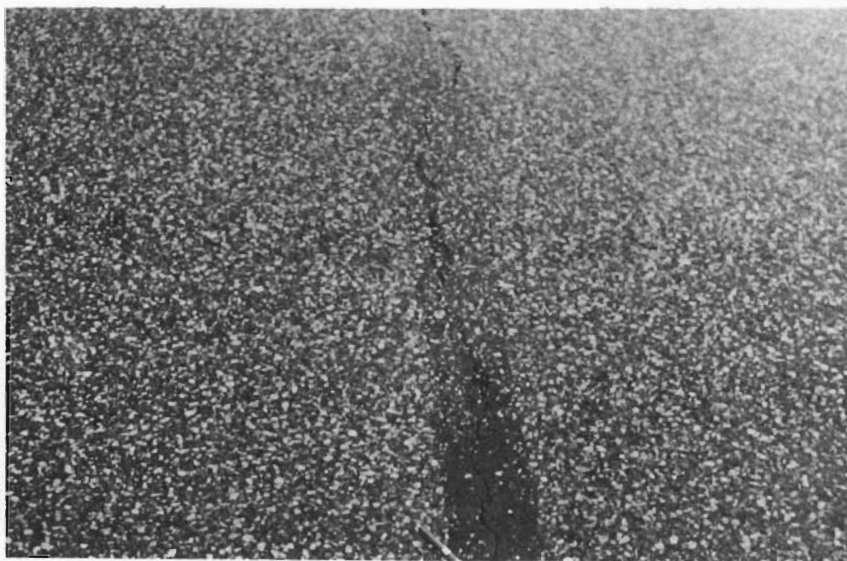
TYPICAL SECTION B

This shows a close up of a transverse crack on a wire reinforced pavement section with cracks varying from hairline to 3/8 in. This section also has longitudinal cracks near the centerline ranging from hairline size to 1/4 in.

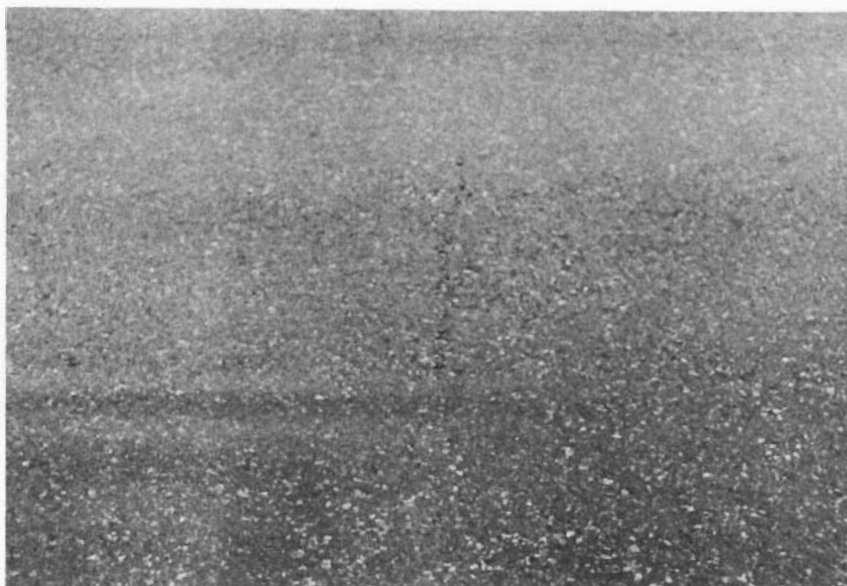
TYPICAL SECTION C

This shows a close up of a hairline transverse crack. This section is in the best shape of the three but its latest overlay was in 1967 and it has had two more overlays than the wire section.

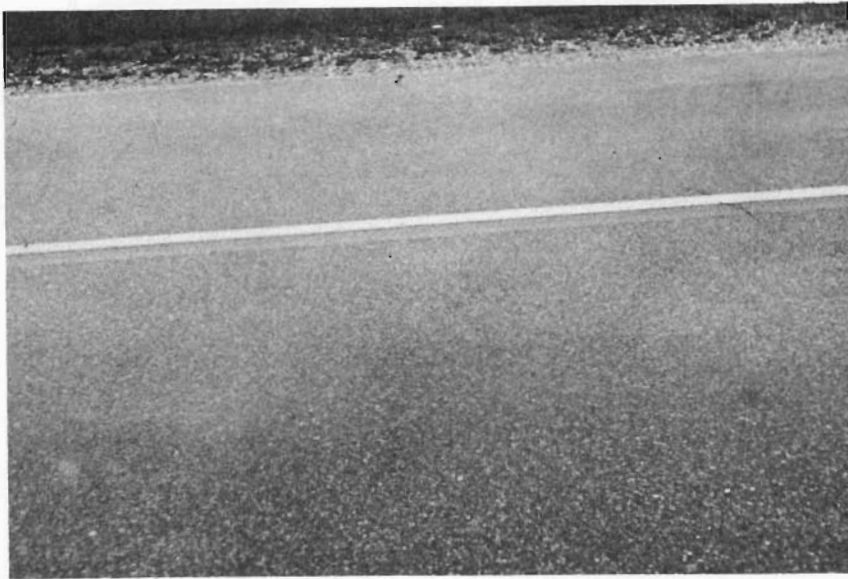
(WITH WIRE)
LIBERTY COUNTY

Shows a transverse crack as viewed from the side of the road.

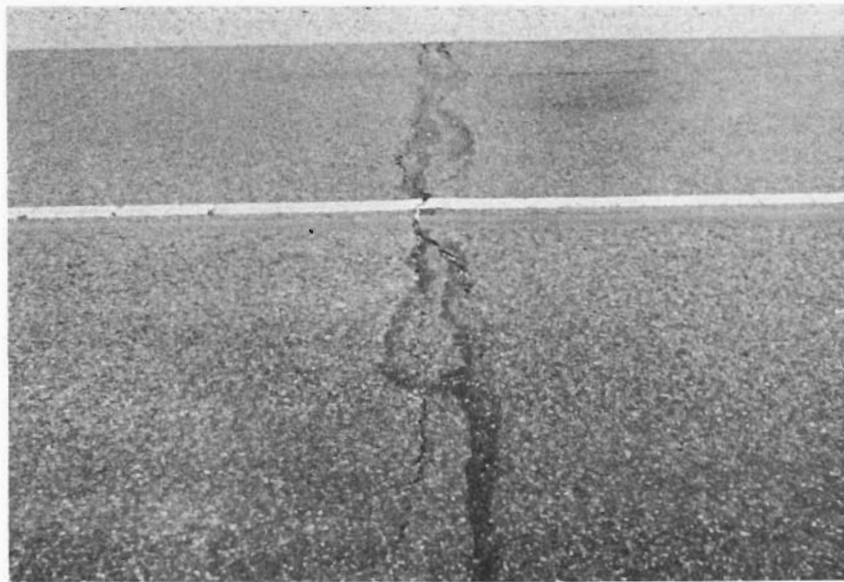
(NO WIRE)
HARRIS COUNTY

Shows a typical transverse crack in the Harris County project. These transverse cracks were located at 80 ft. centers and generally from 1/8 in. to 1 in. across and gave a sharp bump to a 1967 Chevrolet when passing over it at 55 MPH.

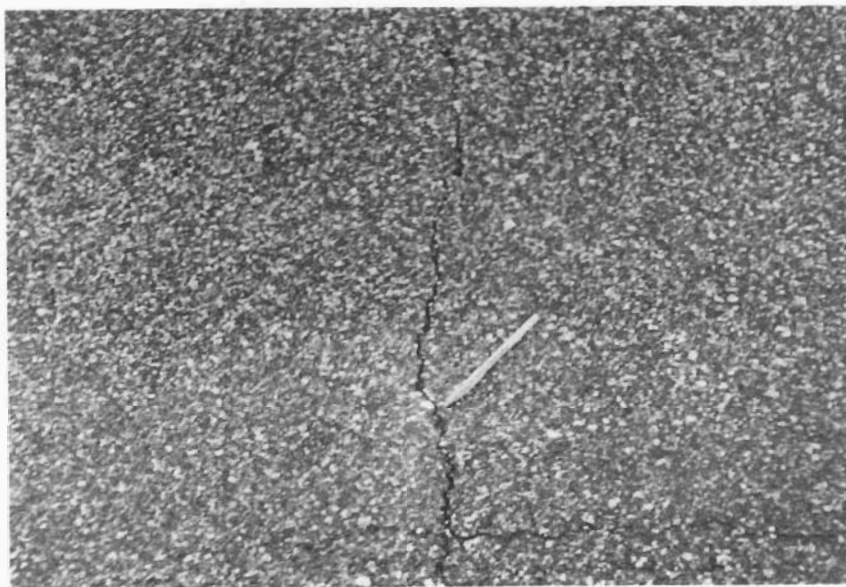
(WITH WIRE)
LIBERTY COUNTY

Shows a closeup of a transverse and longitudinal crack as they occurred in the Liberty County Project. It is noted that this crack gave no bump when passing over it at 55 MPH in a 1967 Chevrolet.

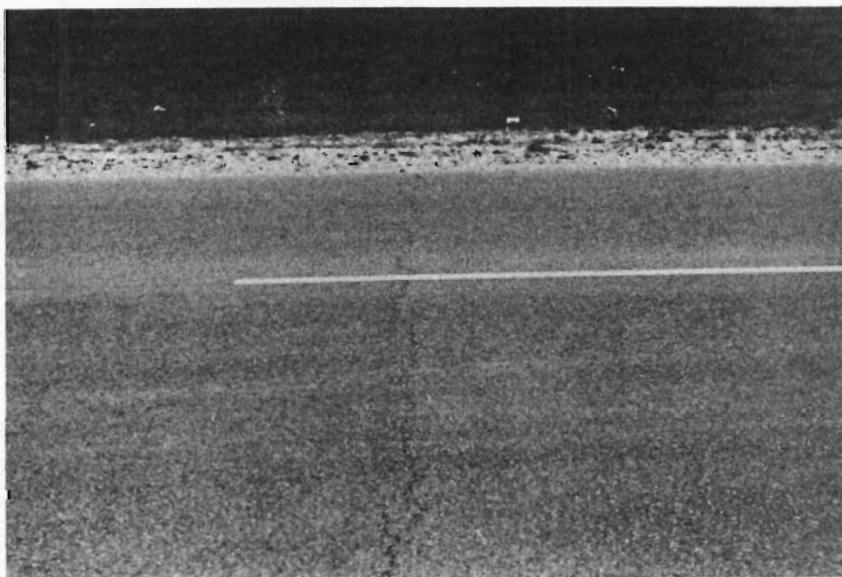
This shows a typical transverse crack with width varying from hairline to 1/8 in. in size and occurring about every 15 ft. This pavement was overlaid with an additional 100 #/SY ACP in 1967. Note that a longitudinal crack has not occurred at the construction joint between the old concrete and the 4 ft. widening.

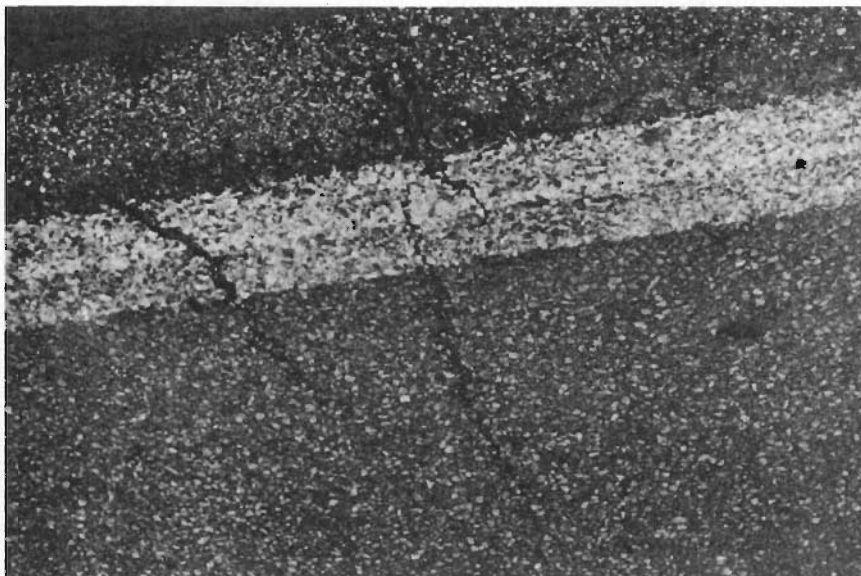
Transverse cracks near median on the above project.

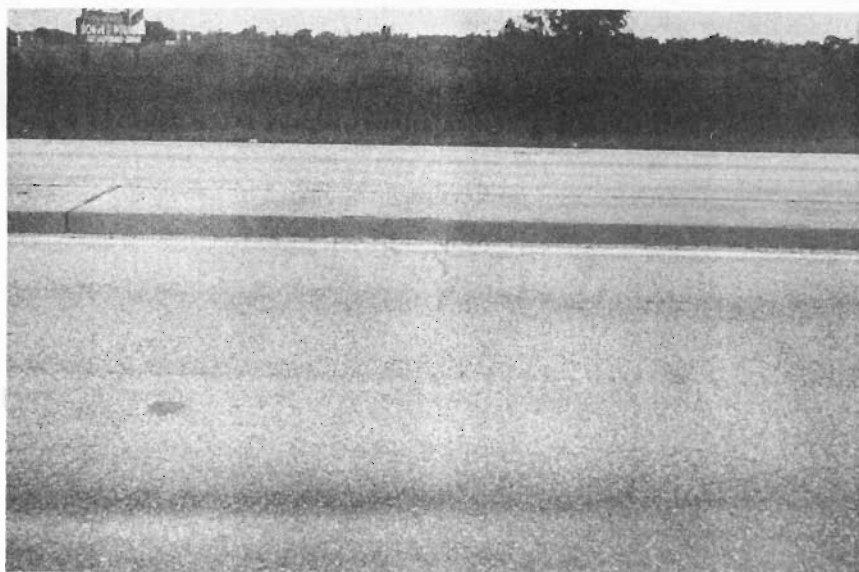
This same pavement crack is shown in both of the above pictures. Transverse cracks in the section varied in width from $1/4$ in. in the median and to hairline size in about 3 ft. There was only one transverse crack about every 100 ft. and no longitudinal cracks apparent between the existing concrete pavement and flexible base widening.

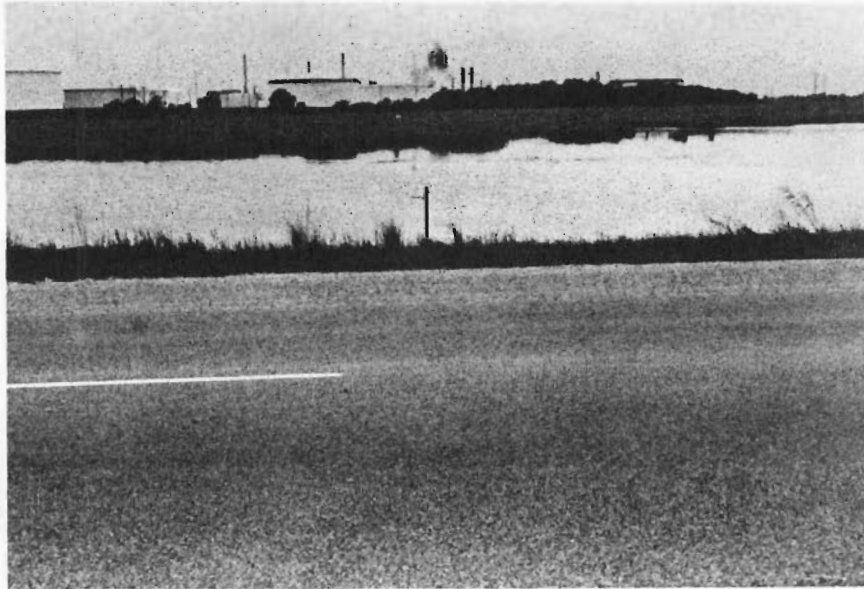
Of the wire reinforced section at which there were no longitudinal or transverse cracks. Wire reinforcements were placed only in a curve section located on the worst subgrade in this marsh land area.

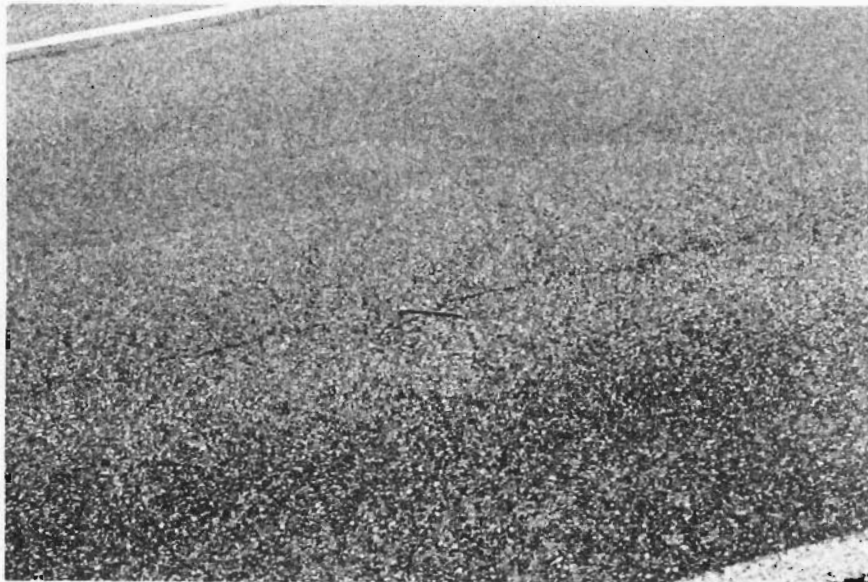
Minor longitudinal cracking appearing in the section without wire which is located adjacent to the wire reinforced section.

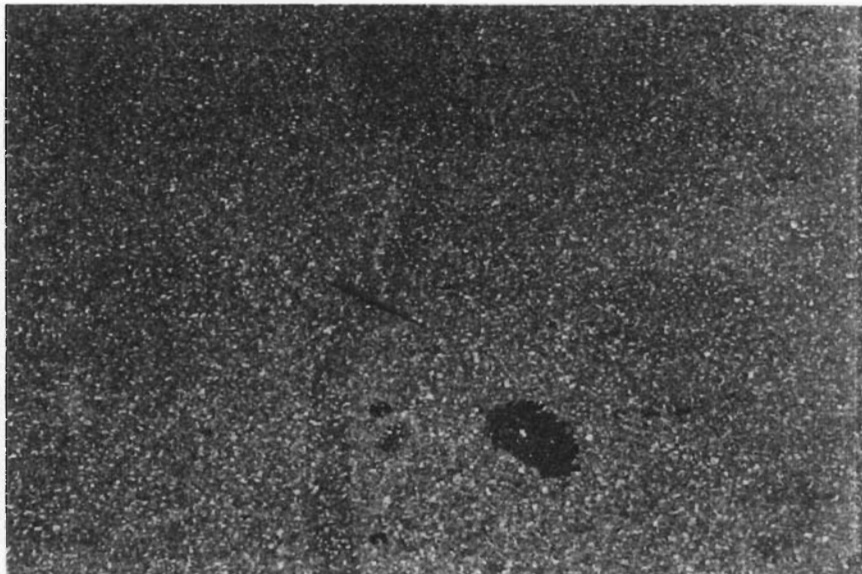
The above transverse crack would be very hard to detect if not for the light seal and is typical of the cracks on this project located near the city limit of Angleton.

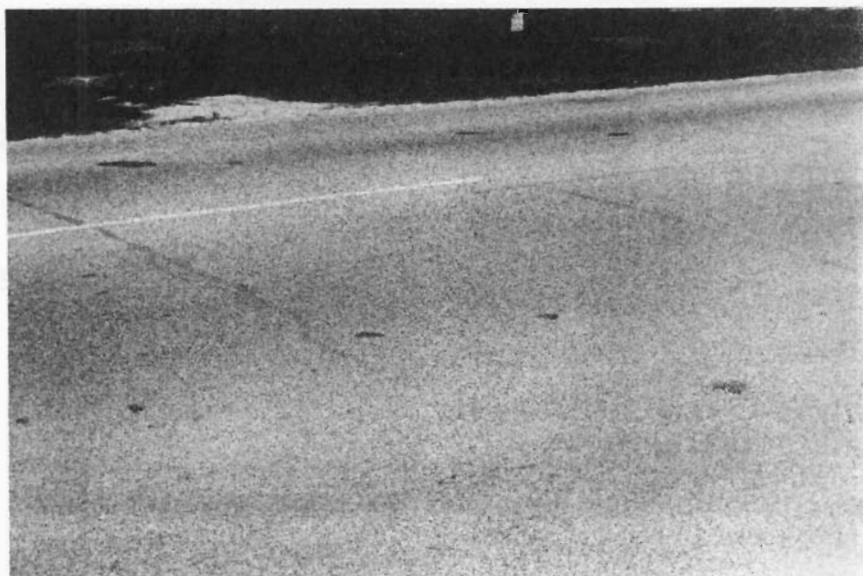
This shows a cross roadway view of the top picture. All cracks in this section near Angleton were hairline in size.

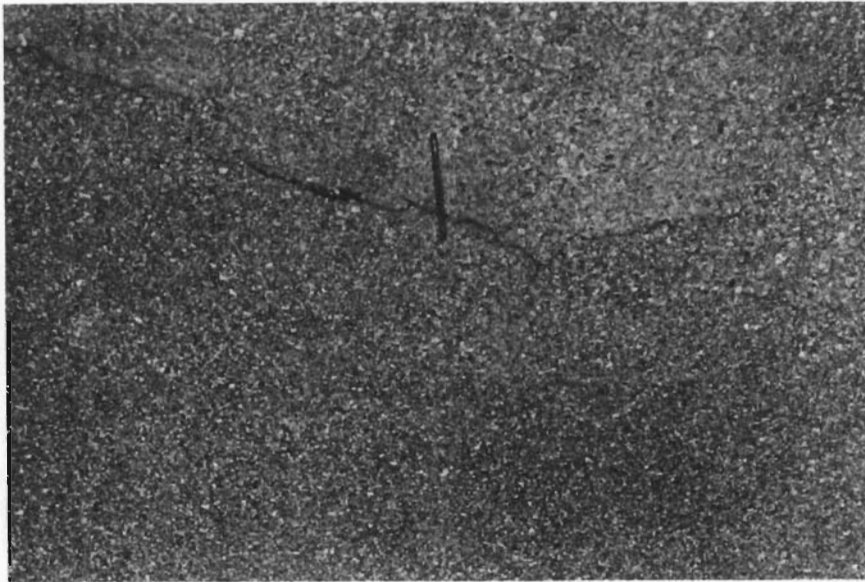
The dark spot is water which appeared after a car rolled at a creeping speed over the shoulder of the road. This roadway is 3.6 miles north of Angleton.

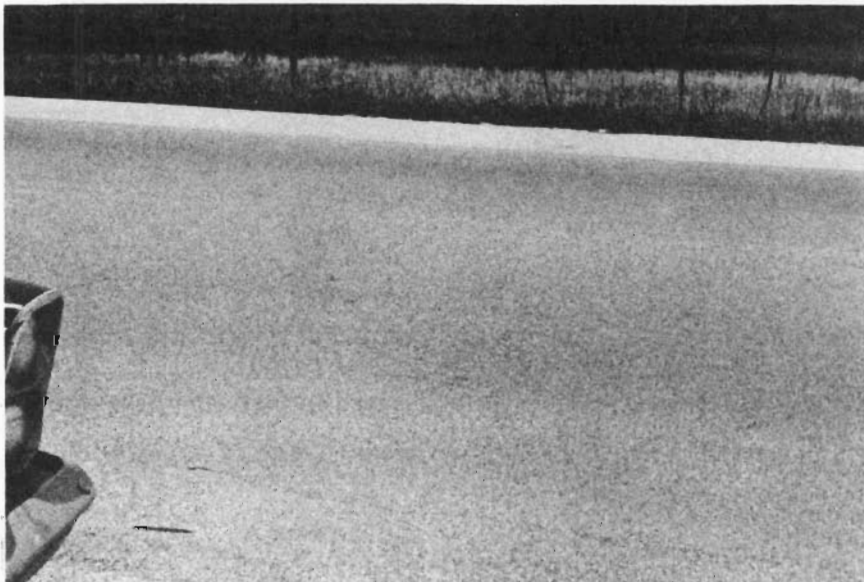
This shows a side view of the same pumping crack. This section of roadway is the only one observed with major pumping occurring on a wire reinforced overlay; however, all cracks are near hairline in size.

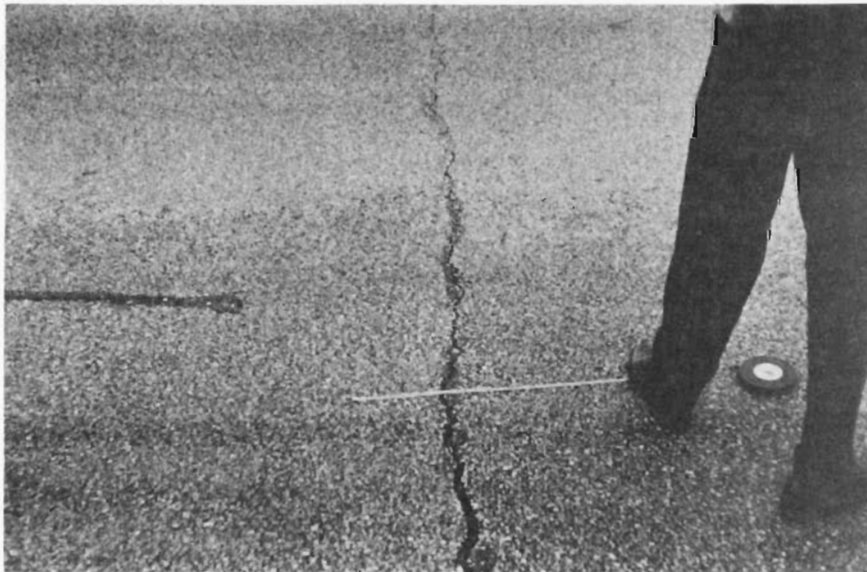
This shows a transverse crack varying from an inch to hairline size. The wide part of the crack occurs over ACP without wire.

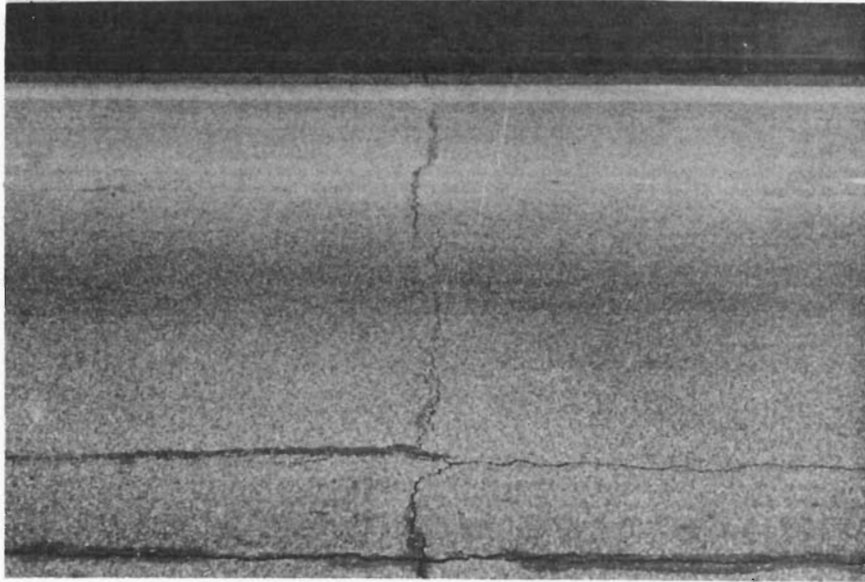
Another transverse crack with two longitudinal cracks appearing at the edge of the parking lane with the inside crack being located at the edge of wire mat. These transverse cracks were spaced at an average of 10' and extended the entire pavement. Where wire was placed (in the travel lane section), the cracks were only 1/16 inch to 1/4 inch in width, while the shoulders had cracks of 1/2 inch to 3/4 inch in width.

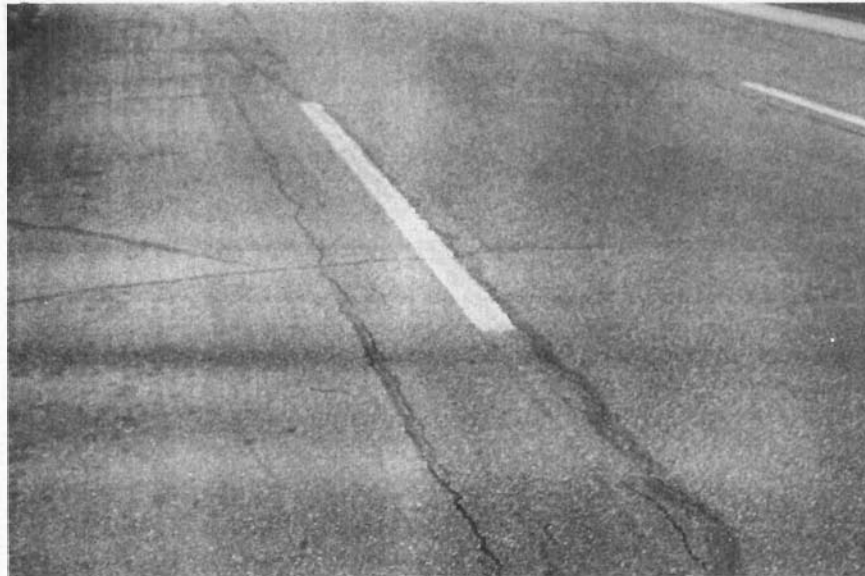
The above shows a view down the roadway on this section showing the general pattern of cracking. Longitudinal cracks were generally about 1/4 inch in width and occurred over about 90 percent of the project.

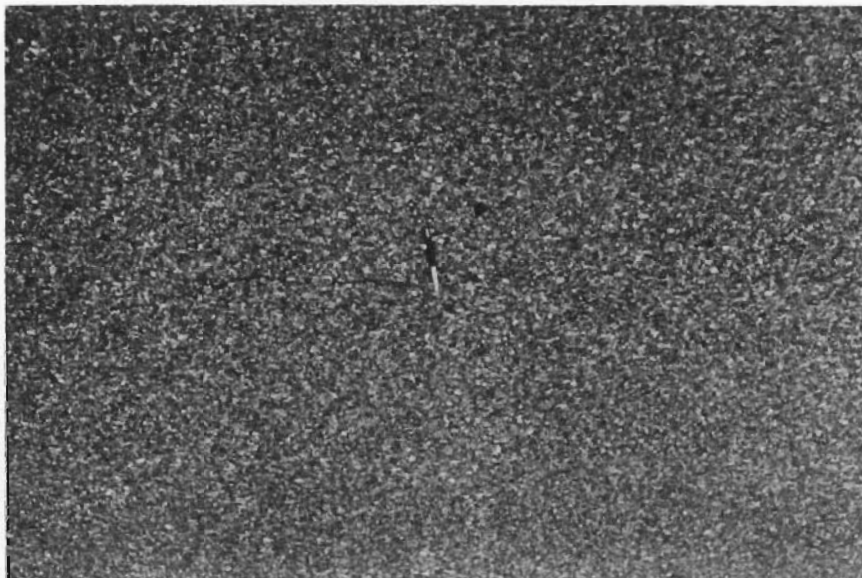
This is a typical transverse crack that has not been sealed.

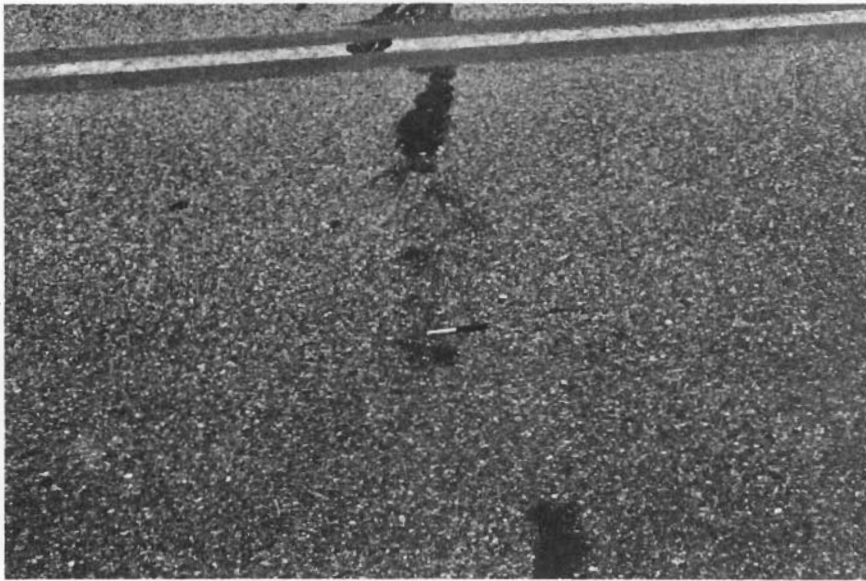
This is a typical transverse crack with spot sealing.

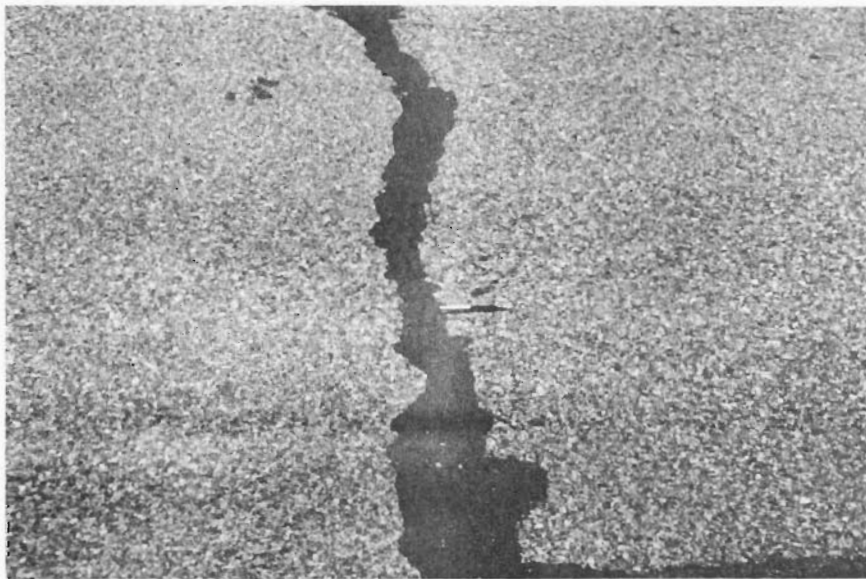
This picture is taken to show a hairline crack with excessive asphalt seal.

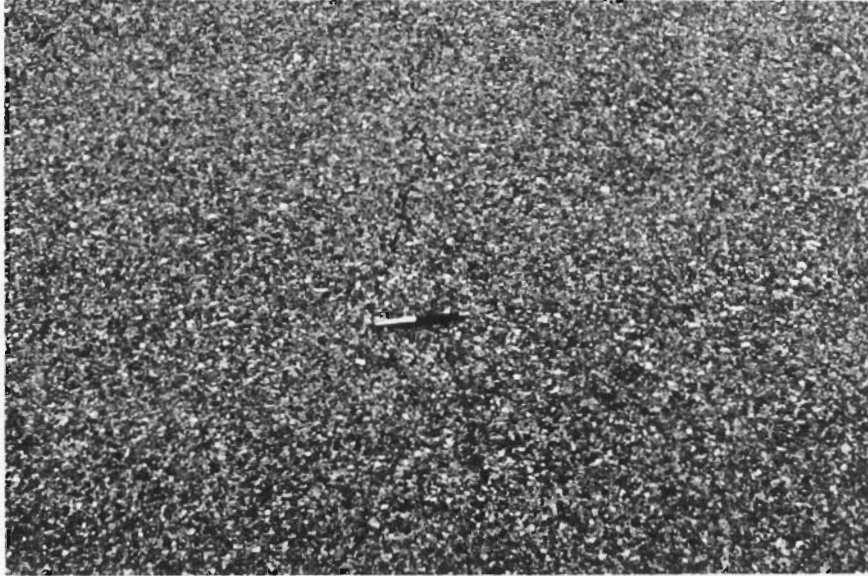
This is one of the most severe transverse cracks observed in this project.

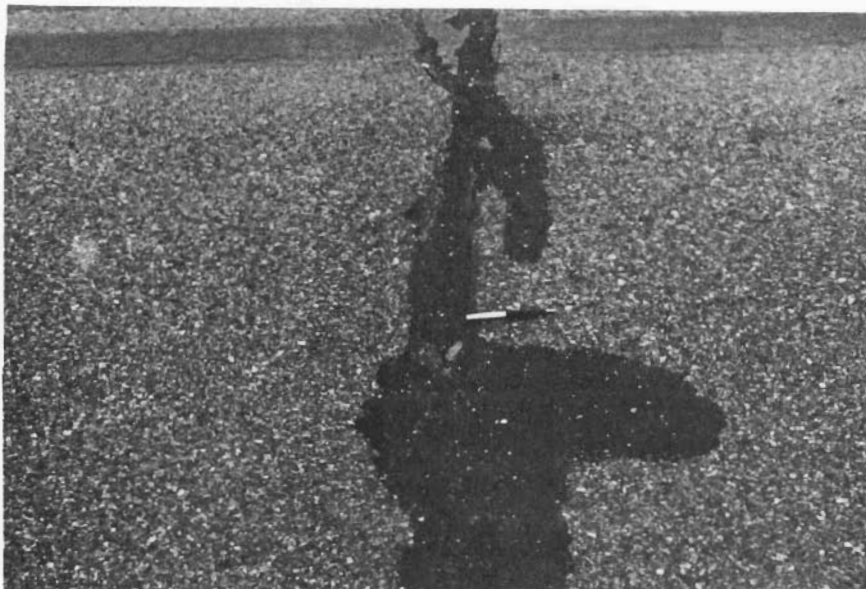
This is an example of a bad crack that occurred when wire reinforcements were not used in an asphaltic concrete overlay.

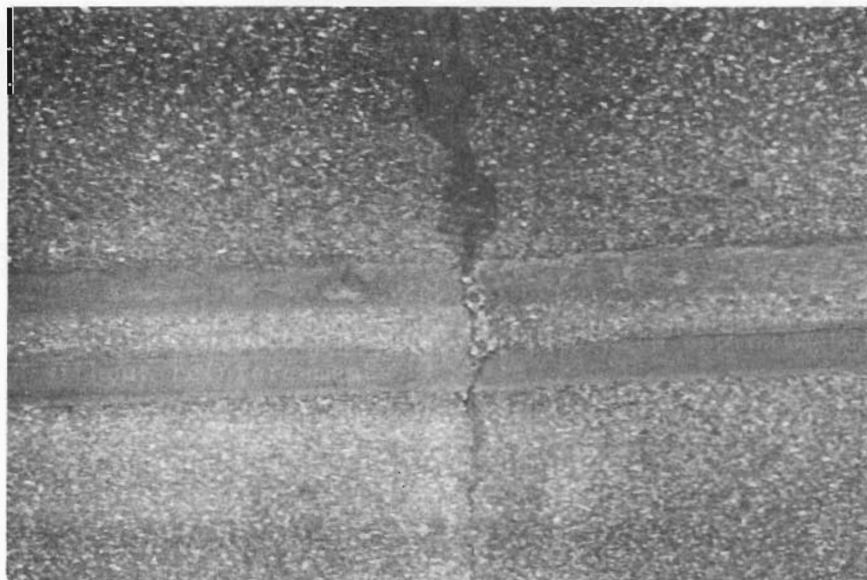
The pavement here at the crack has raised up about one inch.

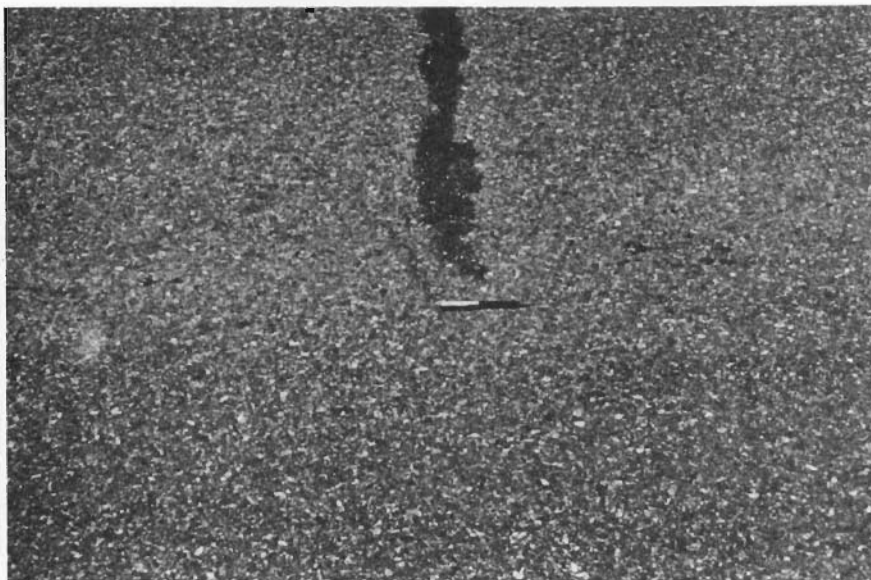
Typical transverse crack which is hairline to 1/8 in. in width and is spaced at about 15 ft. with every other one going across both lanes.

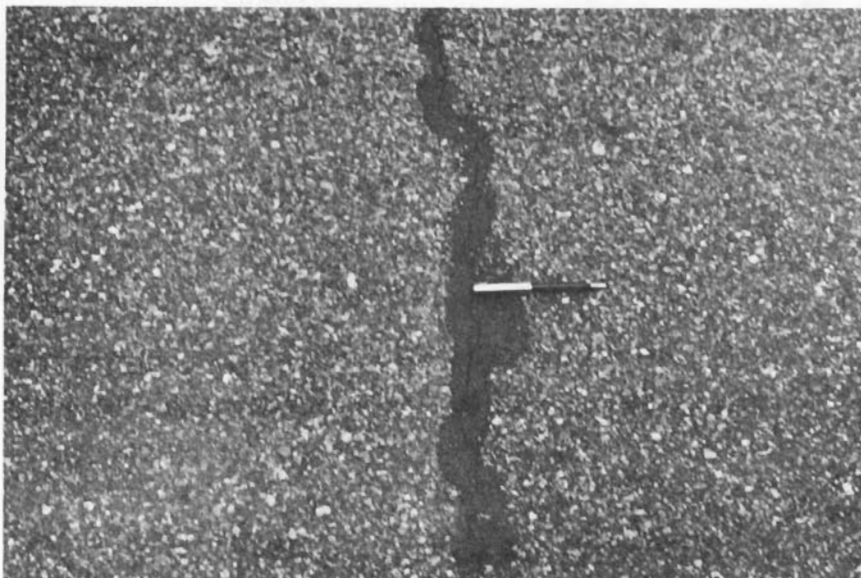
Another transverse crack similar to the above.

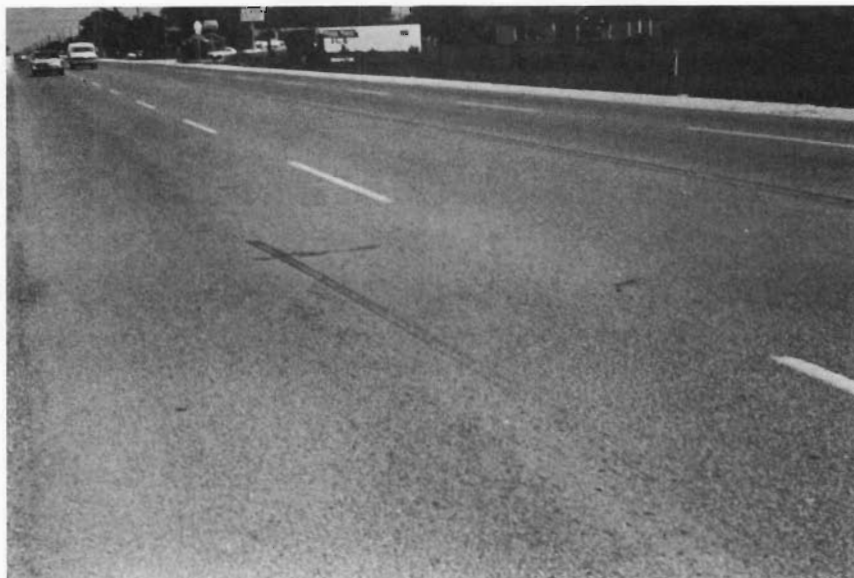
This section has very few longitudinal cracks as shown above. This roadway is located near the north end of this project and is in very good shape. Except for minor transverse cracking appearing in the left center of this picture, it would be hard to determine by sight the location of the old concrete pavement.

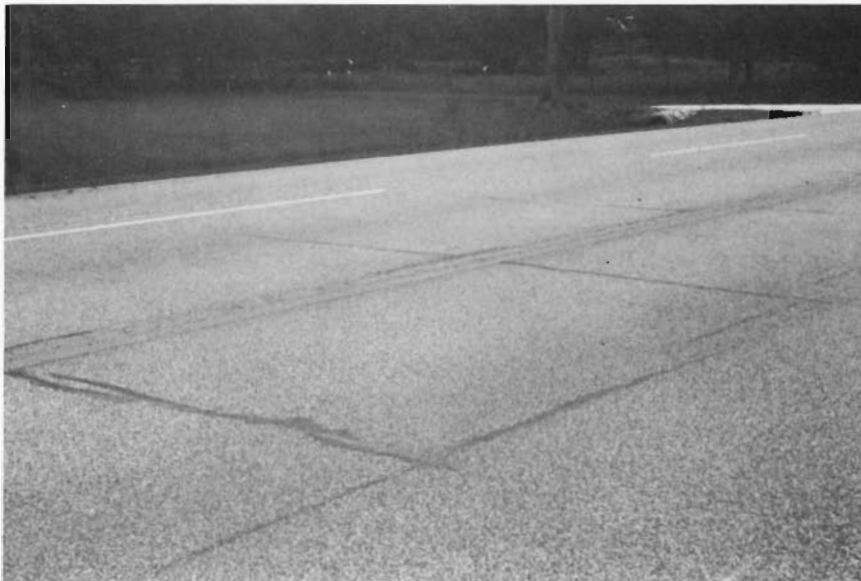
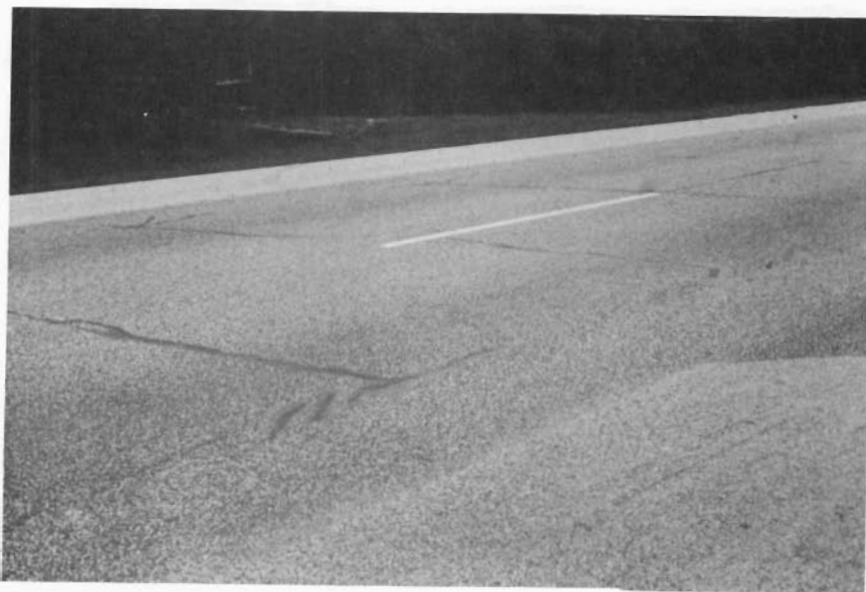
The above two pictures show patterns of longitudinal and transverse cracks on this section. Longitudinal cracks occurring on about 50% of this length of the project. Transverse cracks were spaced at 25' to 30'. Some cracks appearing as close as 15' apart. Both longitudinal and transverse cracks are very small and generally are hairline in size. This section gave a very smooth ride.

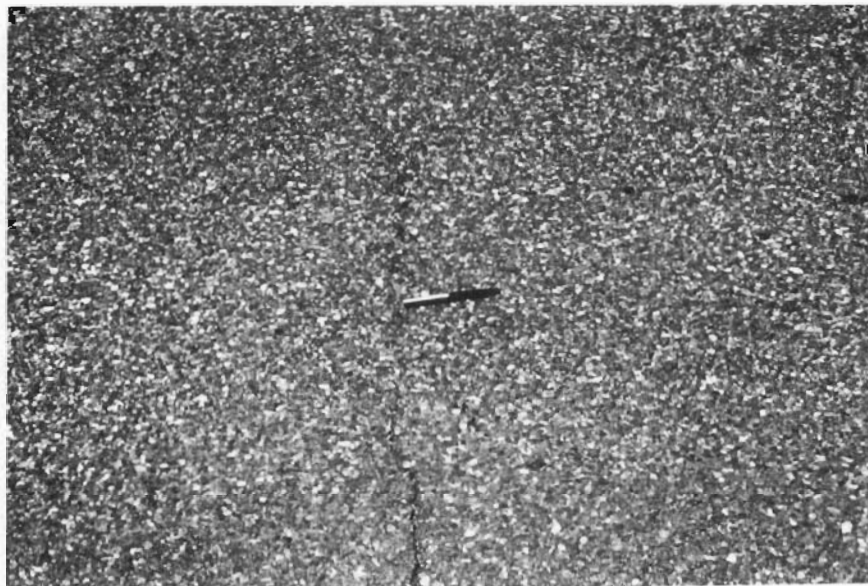
This shows a typical transverse crack on this section. Longitudinal cracks were not appearing in this section.

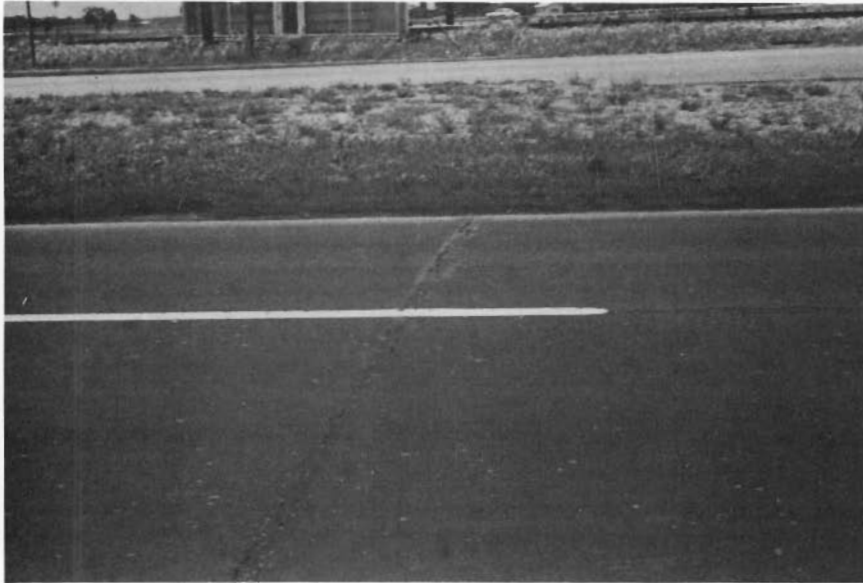
This is the type crack we are guarding against. Picture taken near intersection of SH 6.

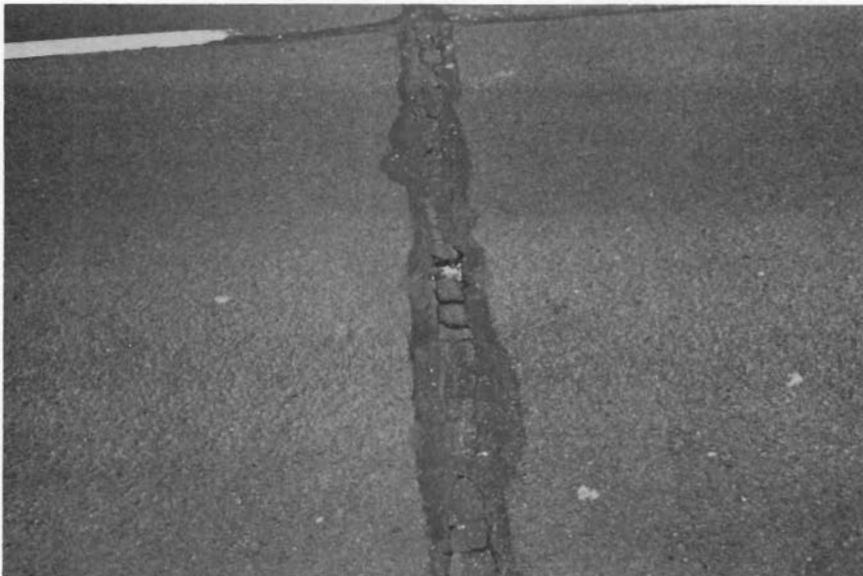
This is another example of a transverse crack on a regular ACP overlay. This is taken near the west city limit of Sugarland.

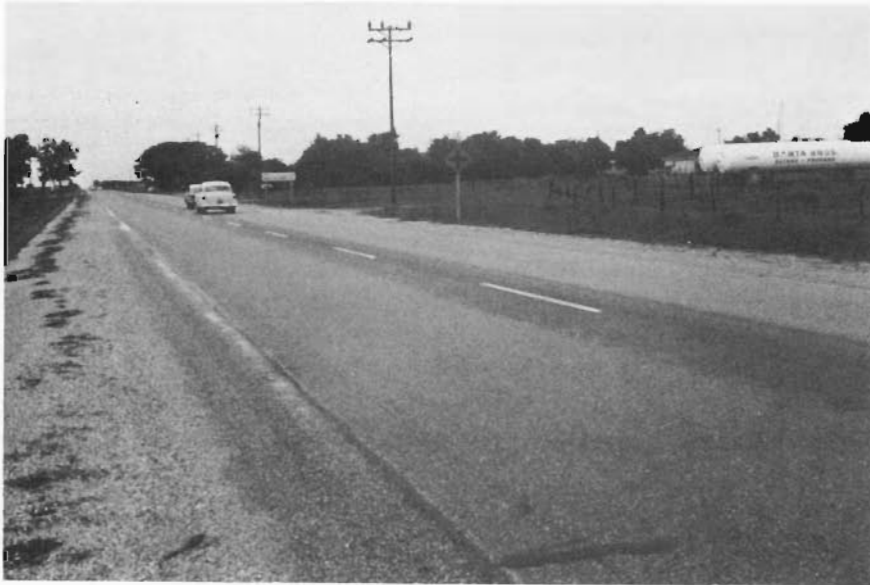
The above roadway is just south of Needville. Note that there is no longitudinal crack at the construction joint between the existing concrete pavement and the 6 ft. widened section.

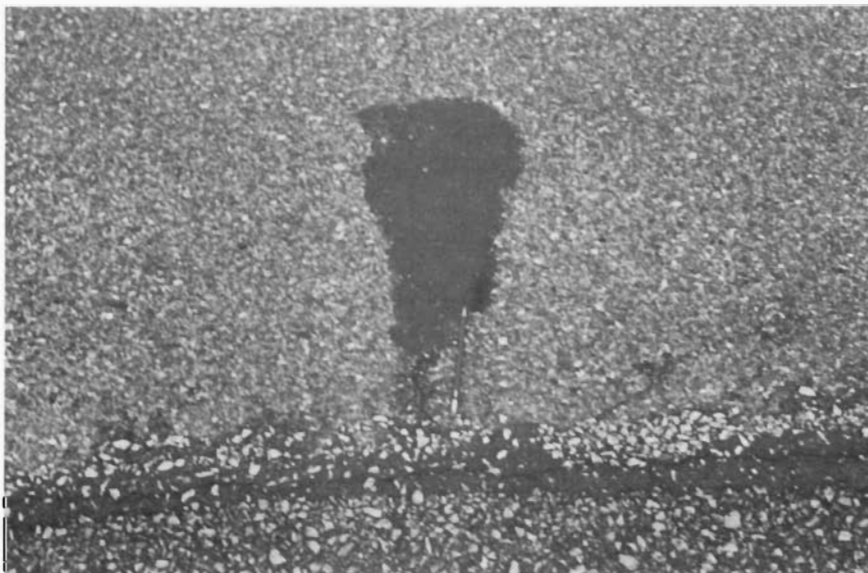
This shows a close up of a transverse crack on the above roadway. These cracks generally started at 1/8 in. in width transitioning to hairline size in about 2 ft.

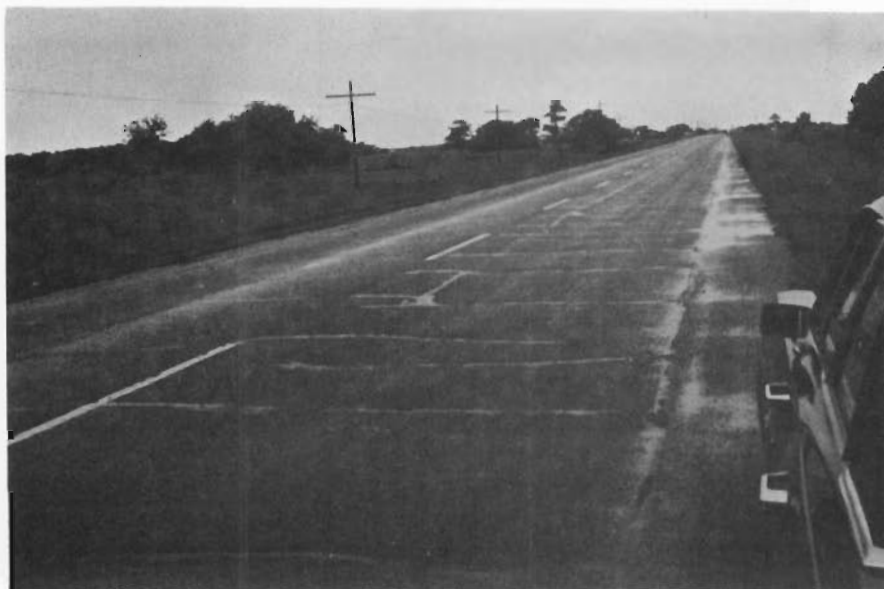
View showing numerous sealed cracks in this section.

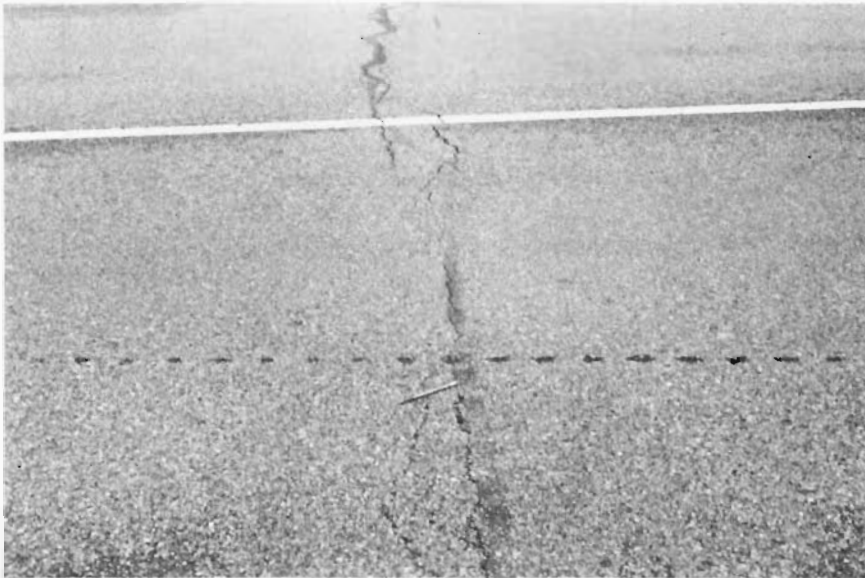
This shows a transverse crack in the wire reinforced section in which the double line crack is forming. This type of crack was very rare in any of the other wire sections that have been observed but was rather common in this project. The double line cracks were still very tight and were generally hairline size to about $1/8$ in. in width.

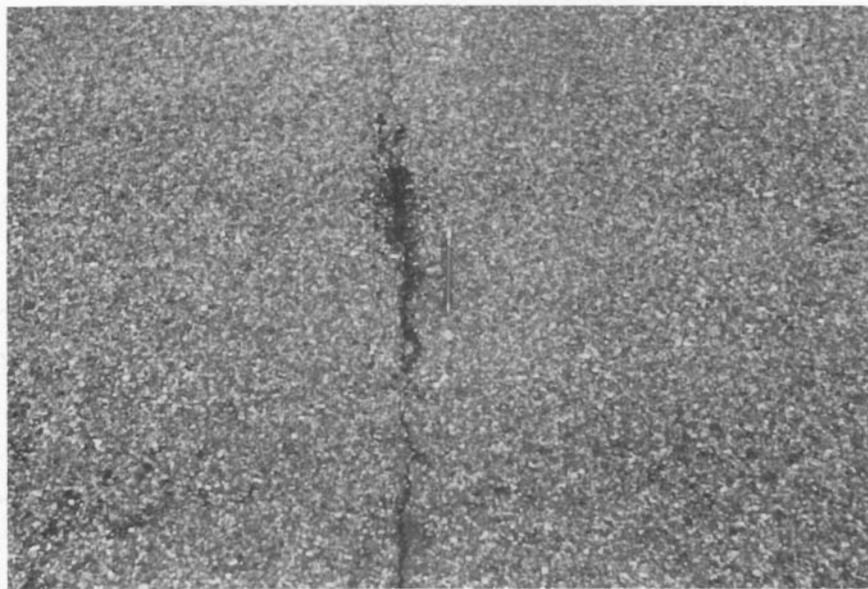
Ravelling is common in this section without wire while it was very uncommon in the section with wire. The ravel near the pencil is about an inch wide and deep.

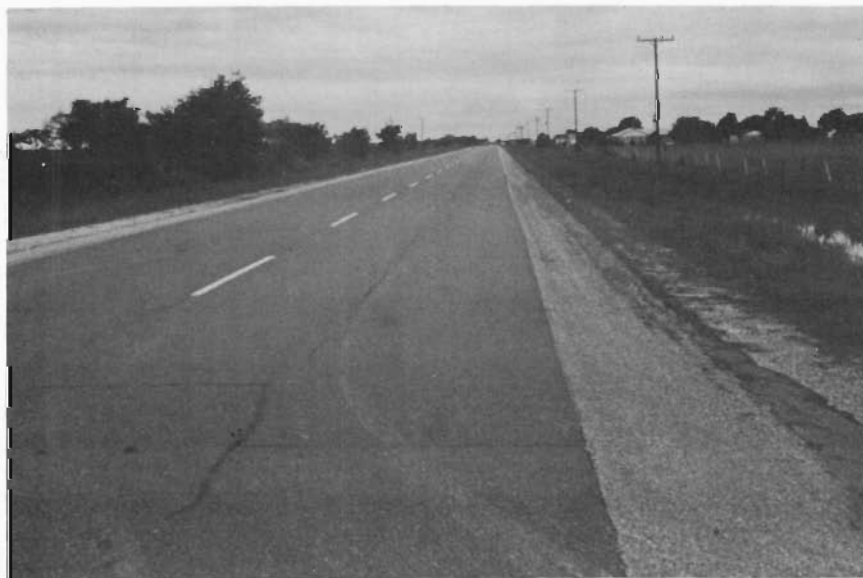
This is just north of Bay City in a section with no wire reinforcements and was taken to show how the longitudinal cracks were forming in this section. These cracks range in widths up to 1/4 in. across.

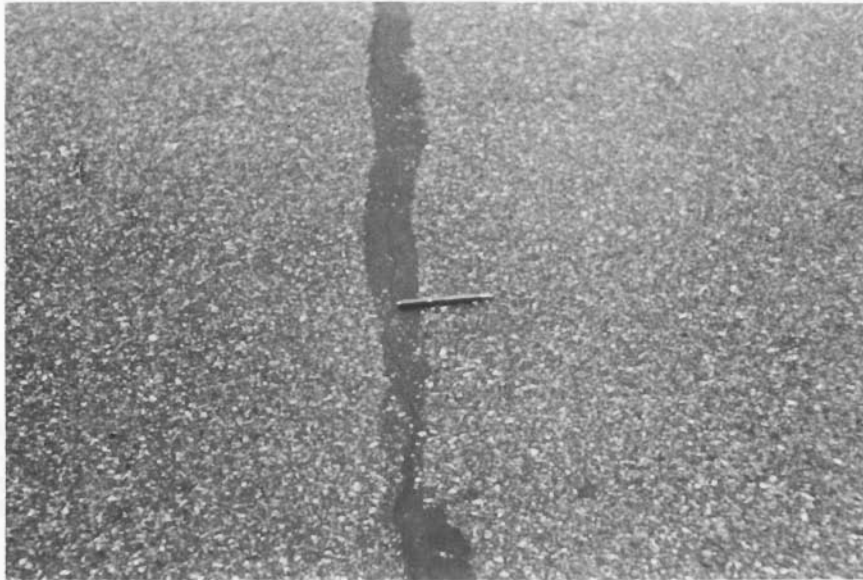
Showing a closeup of a hairline crack which had been sealed.

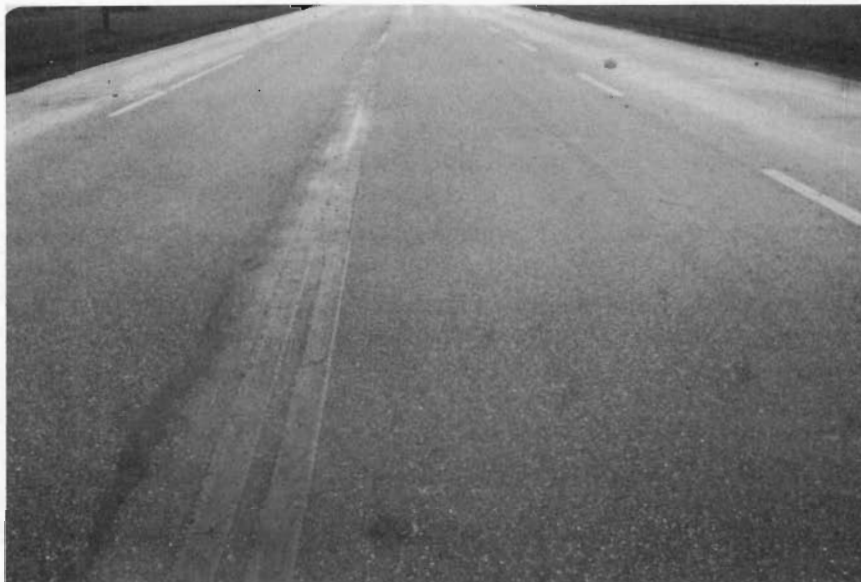
This longitudinal crack was caused by swelling of the base and subgrade beneath the new concrete placed after this section was widened. It is noted that this crack is located near the edge of the wire.

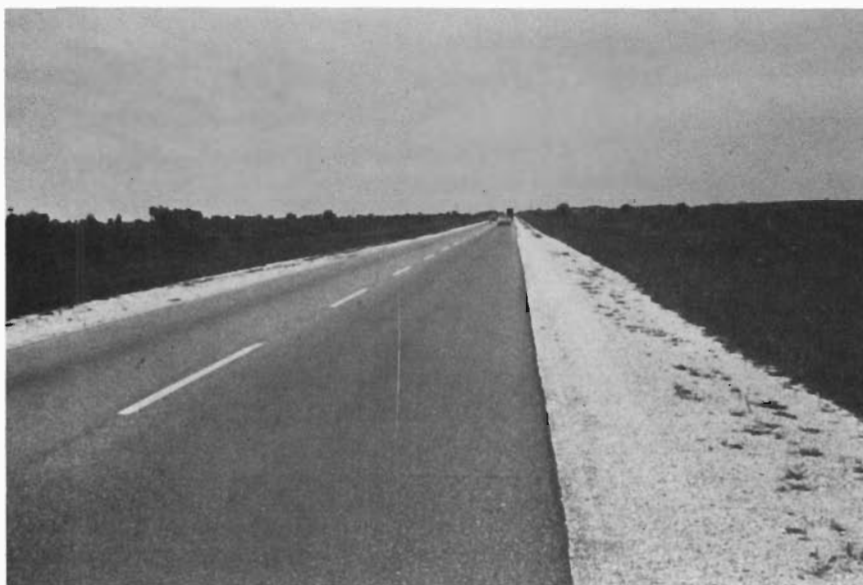
This roadway is about .3 Mile South of FM 521. The cracks were generally hairline in size.

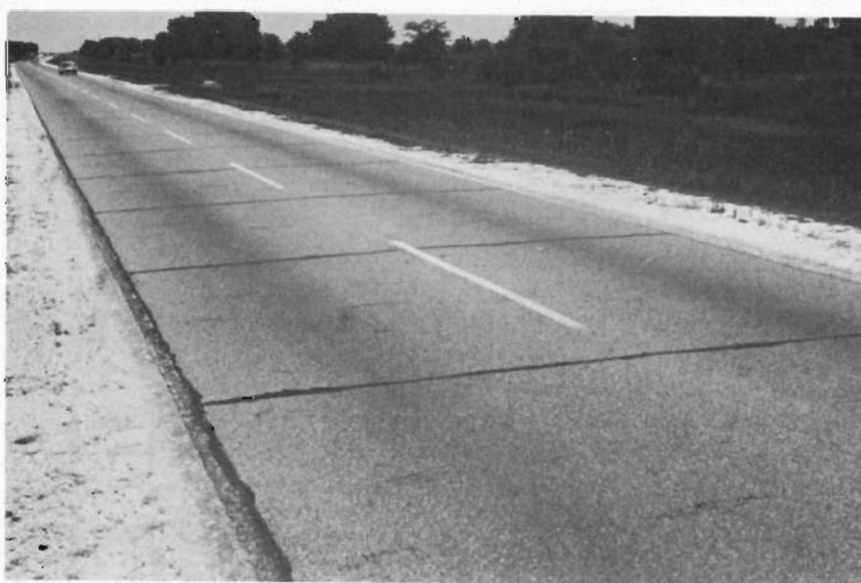
This picture was taken 3.2 Miles South of FM 521. Note the old concrete joint reflecting through.
