PERFORMANCE OF
METAL REINFORCED BITUMINOUS OVERLAYS IN TEXAS

Special Study 9.0

Conducted by
Texas Highway Department
Highway Design Division

August 1968

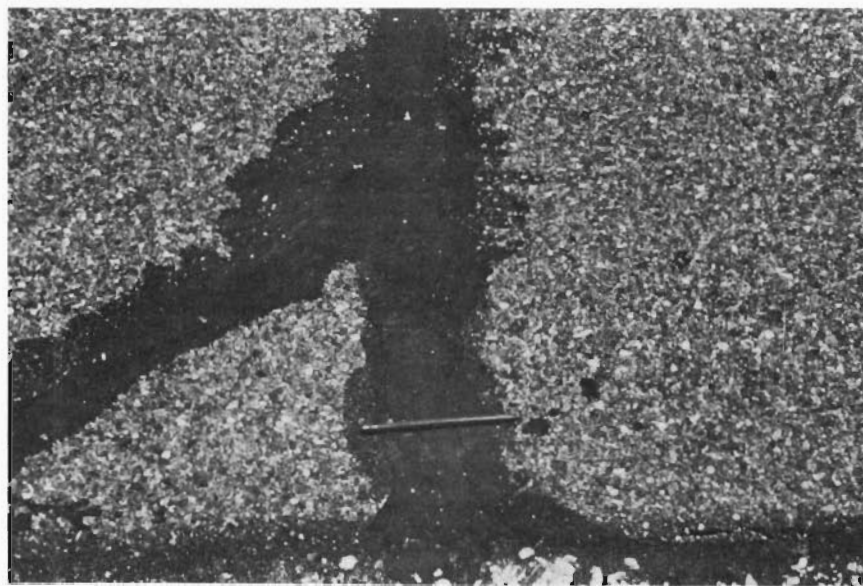
It is noted that asphalt in this seal can be picked up by the heel of a shoe. This closeup was taken at the position the cameraman was standing when taking the view down the roadway on the section without wire above.

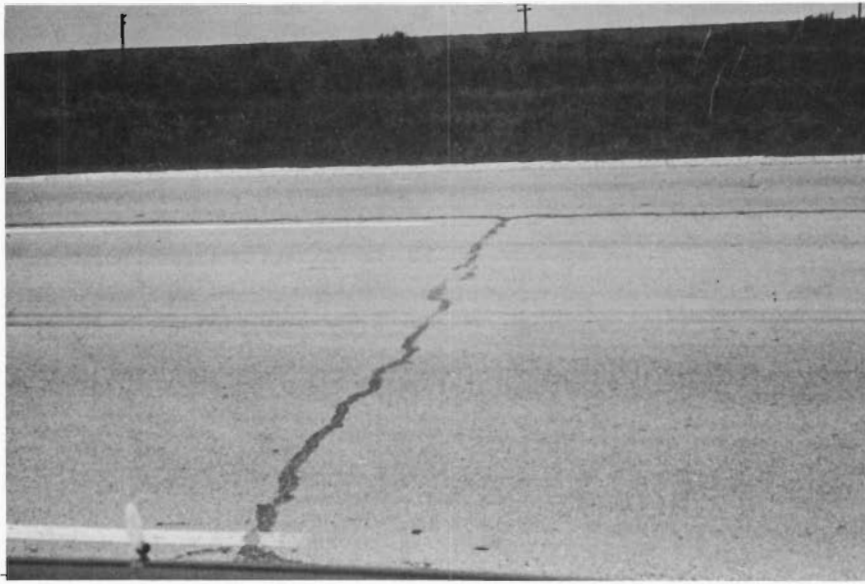
Noted that the longitudinal crack is appearing near the edge of the wire and outside of the construction joint between the concrete and the flexible base

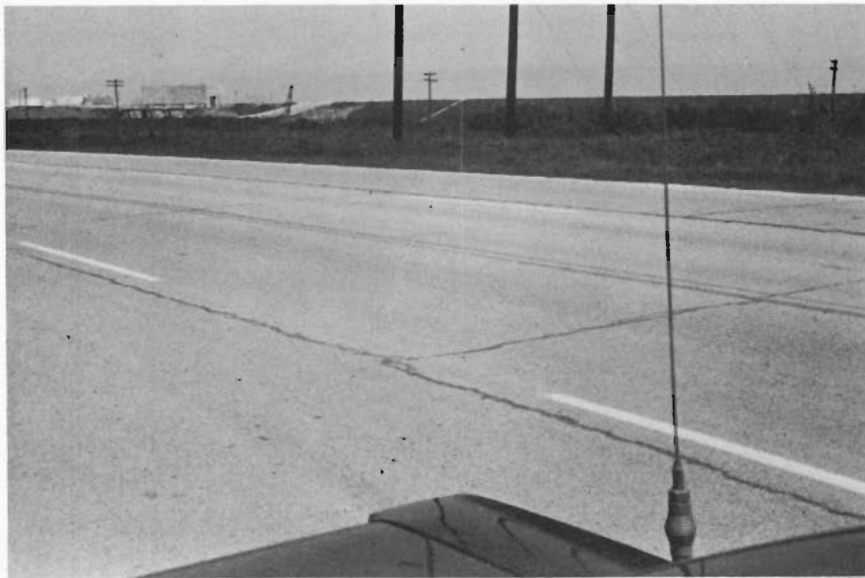
The above two pictures show the general pattern of cracking on this highway. The longitudinal and transverse cracks are about hairline in size with a light seal.

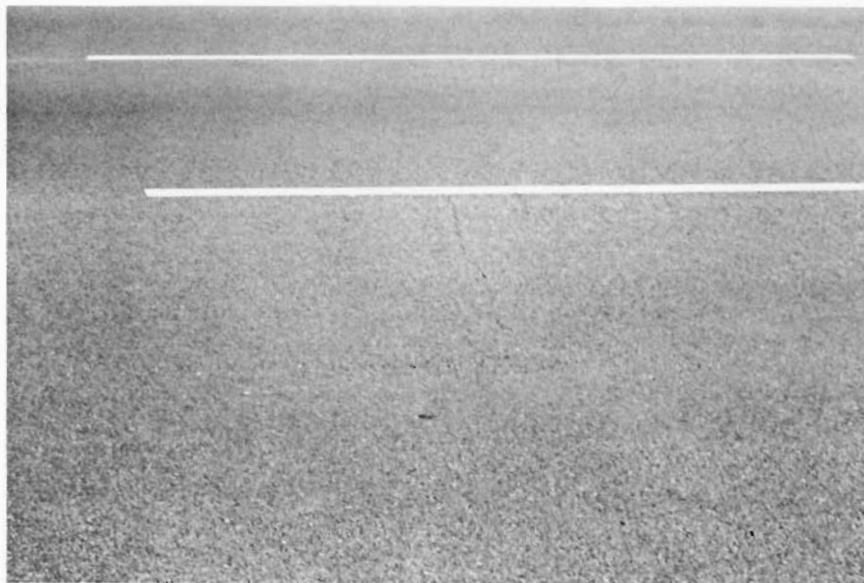
These cracks were about 30 to 40 feet apart.

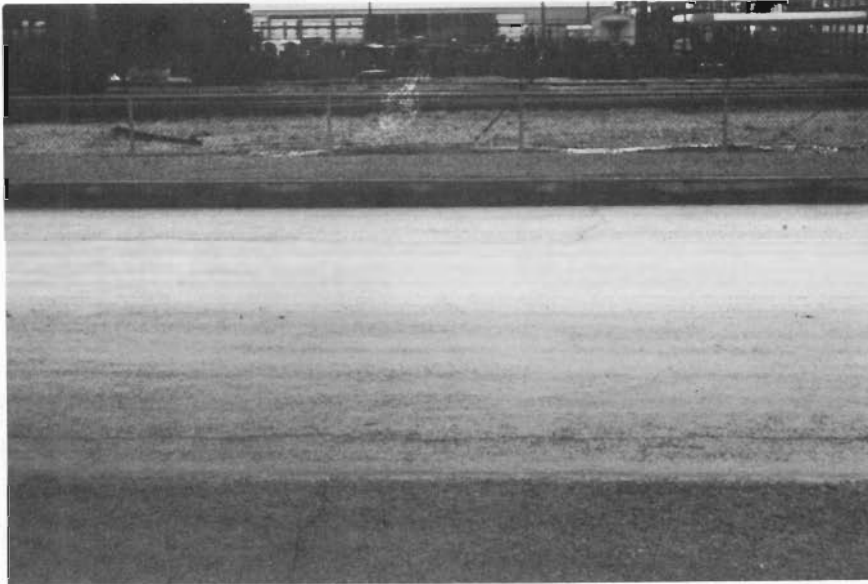
This is the only section that wire was placed directly on a seal coat. This section has hairline to 1/8 in. transverse cracks at about 20 ft. spacings, with slightly larger cracks going across the concrete widening. Longitudinal cracks were hairline to 1/8 in. in width.

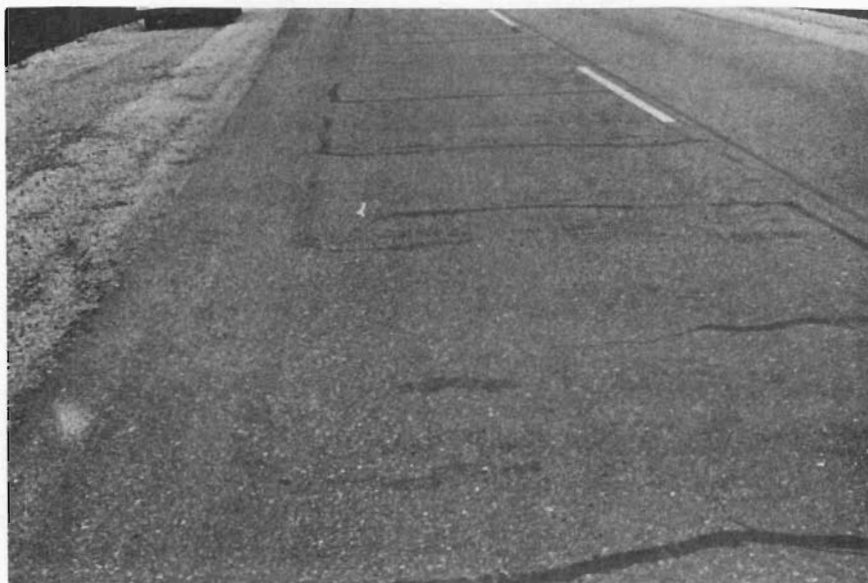
This picture is taken looking north and shows immediate sealing required on an overlay that is not reinforced.
