## SUMMARY REPORT 12-1(S)

# A SURVEY OF DISTRESS AND DEBRIS IN THE JOINTS OF PAN-FORMED CONCRETE BRIDGES

SUMMARY REPORT  
OF  
Research Report Number 12-1  
Study 2-18-73-12

January, 1974

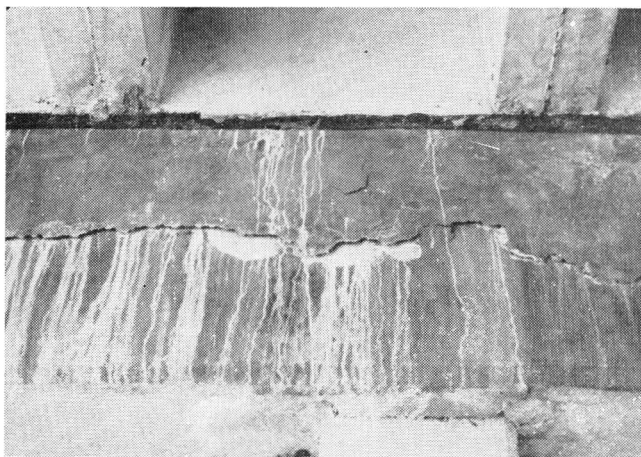
Pier cap distress is frequently found in pan-formed bridges. Such distress results from damaging expansion pressure at debris filled joints.
