SLICK PAVEMENTS

SLICK PAVEMENT

Prepared And Compiled By
District 15

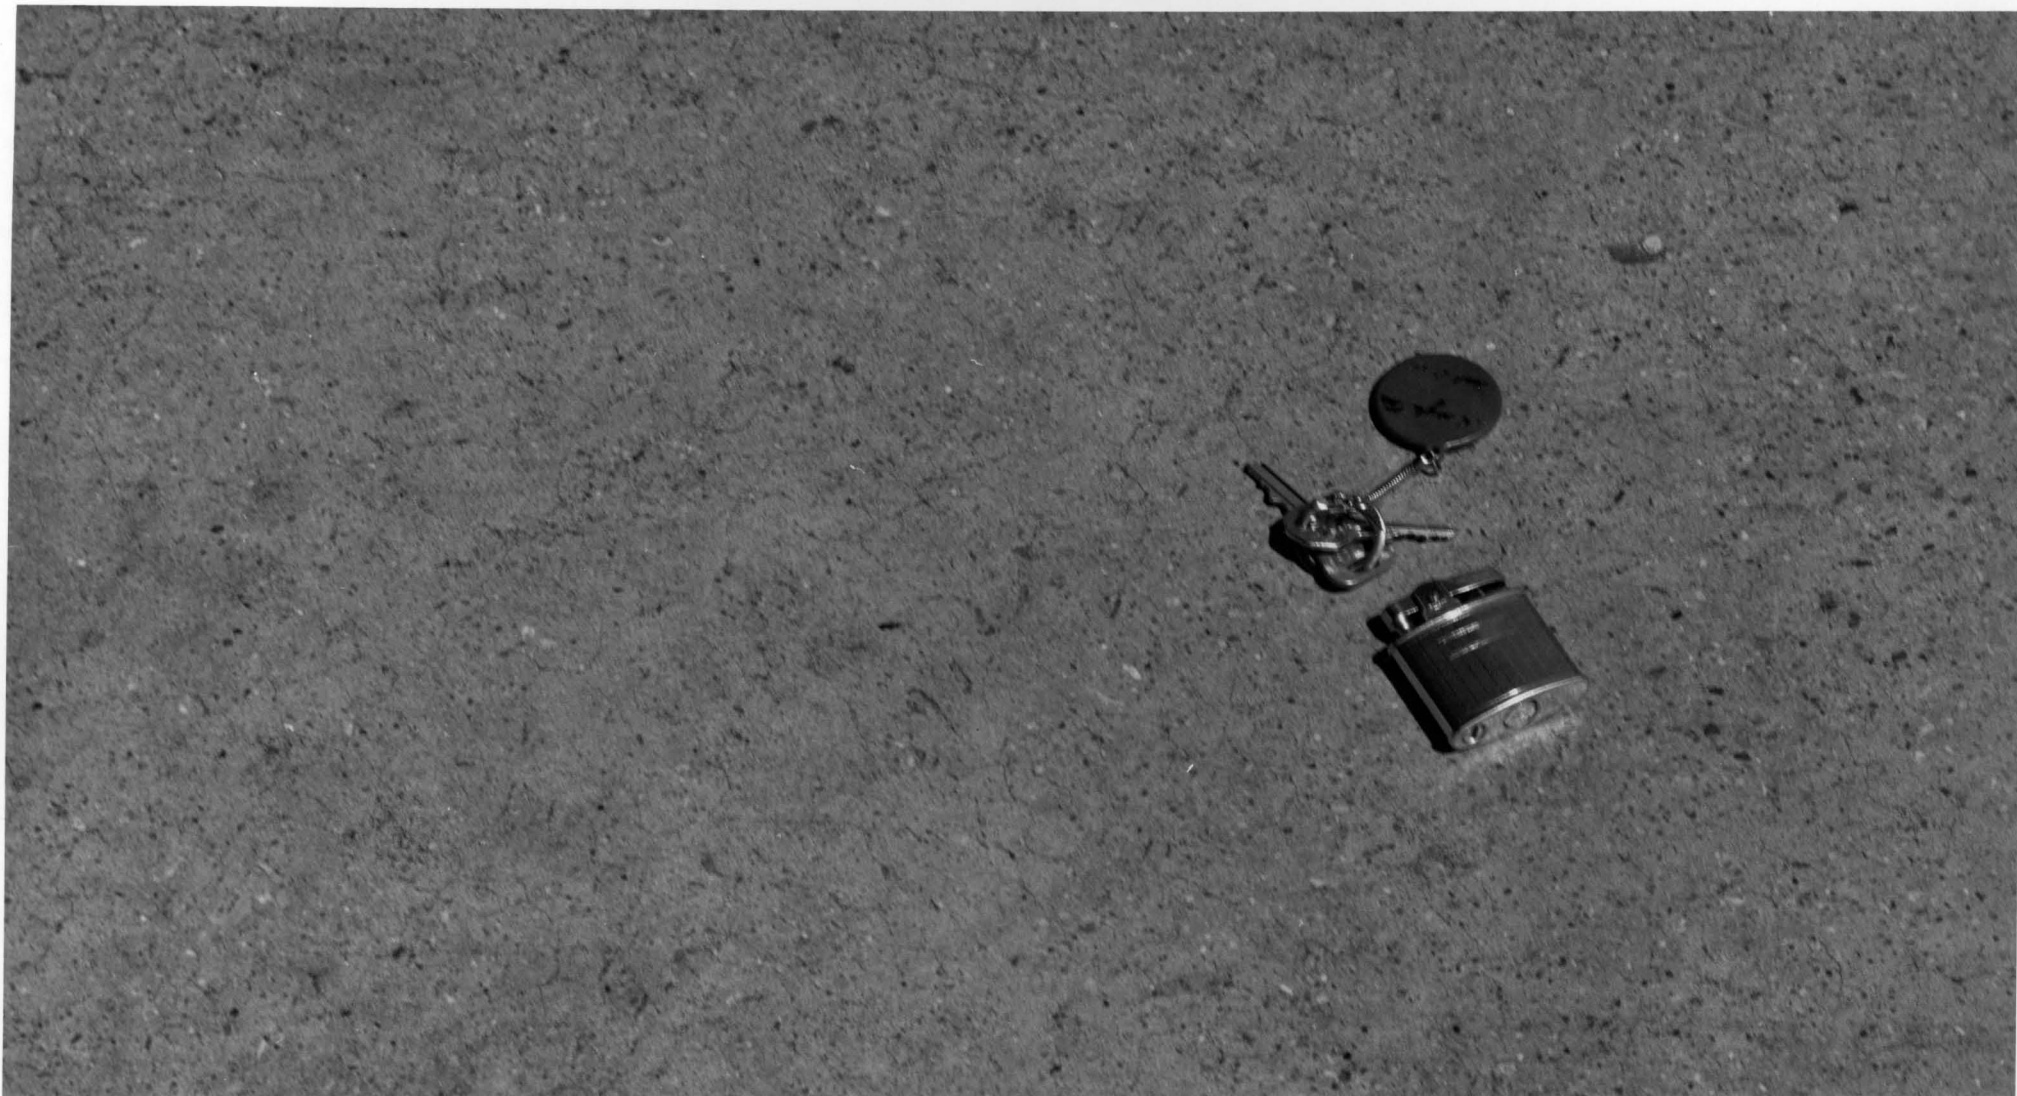
FIGURE NO. 1

The problem in District 15 is considerable mileage of concrete pavement on the Interstate Highway System within San Antonio that has maintained its original smooth riding surface, the pavement is structurally sound, but the riding surface is slick and has the texture of polished marble. See Figure No. 1 showing the surface texture of this pavement. This general condition is on all of the concrete pavement, the only variance being in the degree of smoothness, which seems to be dependent on the length of time the particular section has been open to traffic.

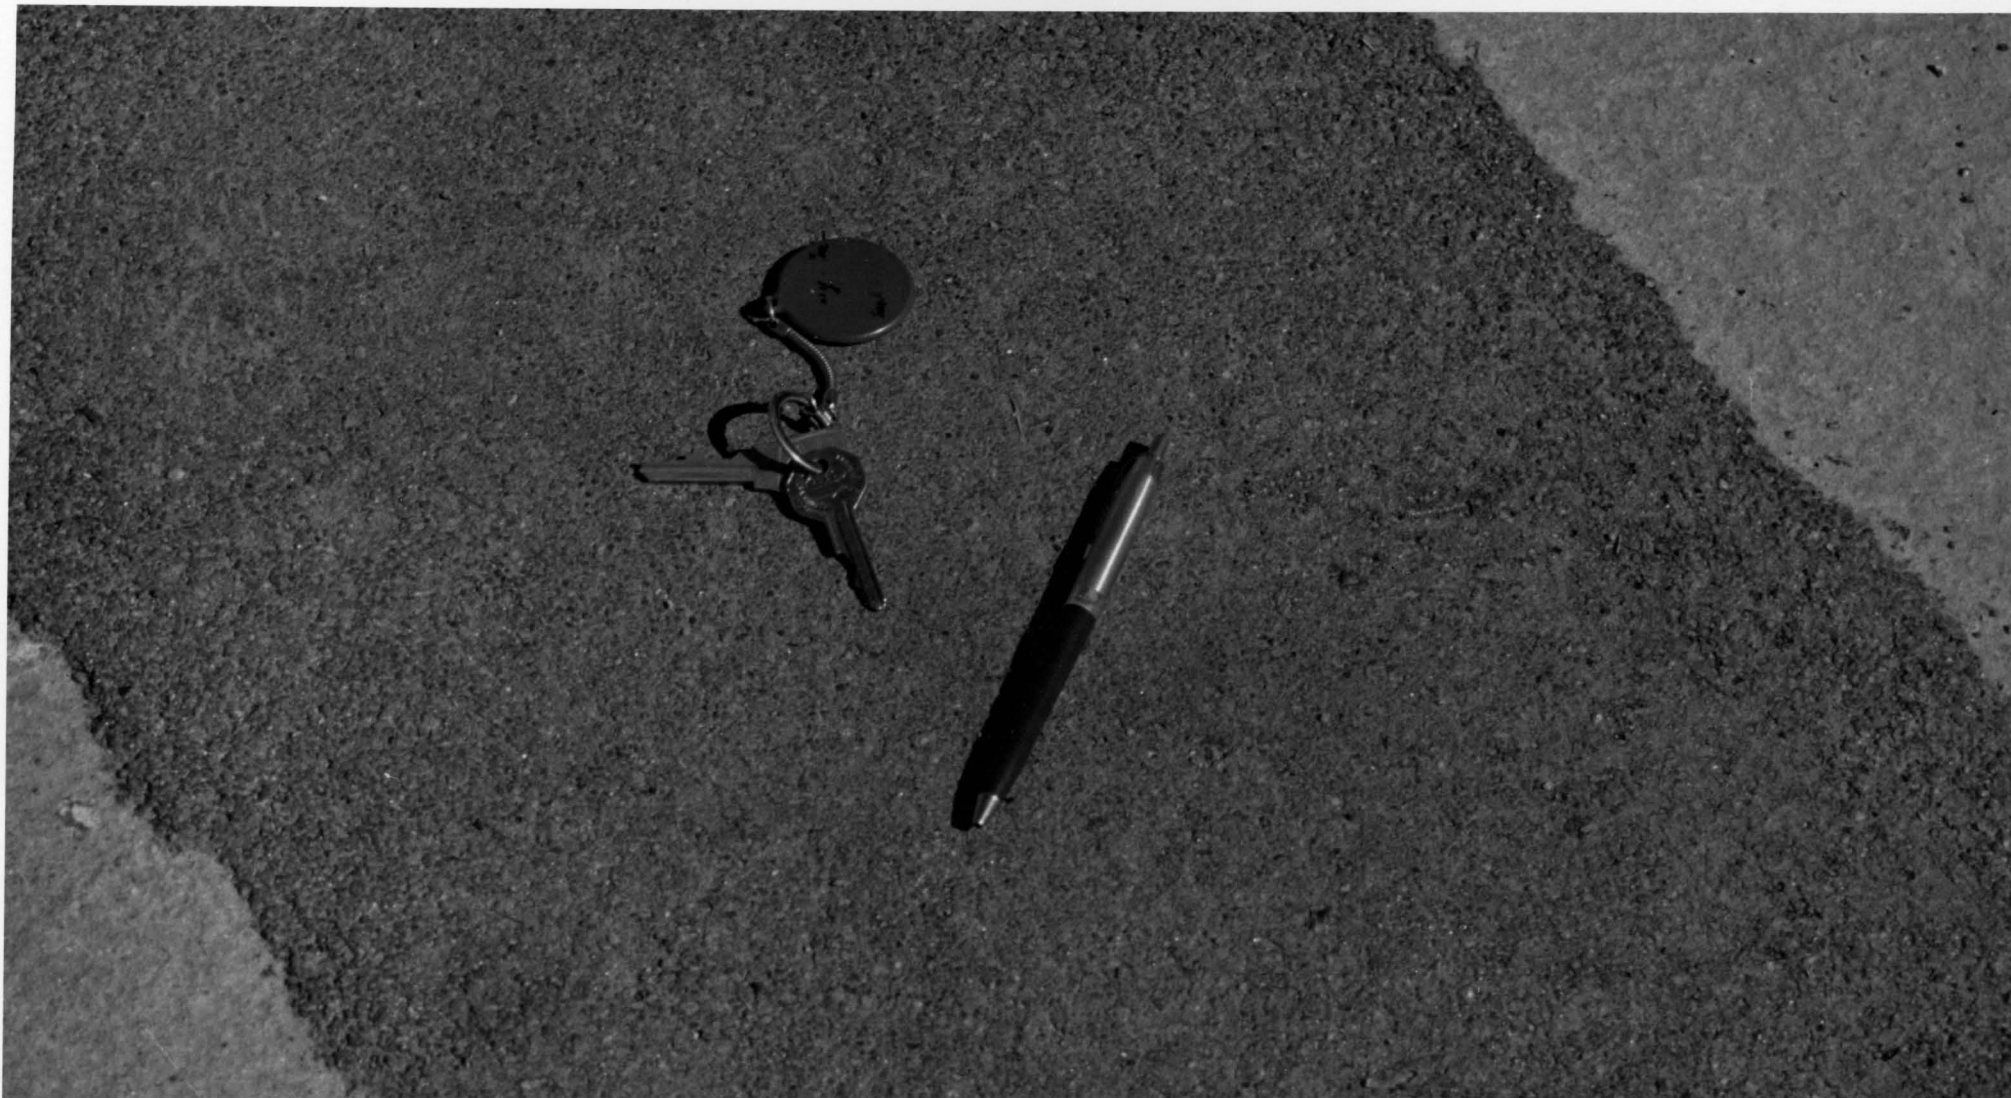
FIGURE NO. 5

The possibility of a slurry seal was investigated, to some extent, as to a skid proofing material to use on concrete pavement. A sample of medium set cationic emulsion was obtained from an asphalt producer and mixed with silica sand. This sand was used due to its hardness and is the only type aggregate available locally, other than limestone sand. The cationic emulsion was used due to its affinity for the concrete pavement, especially where limestone aggregates are used. Various mixes were made with the percent of emulsion varying from 15% to 22%. This mixture was placed on a small section of concrete pavement in the District yard. See Figure 5 for a picture showing the surface texture of this test section.

It is believed that this product will serve very well as a skid proofing method; however, the behavior of heavy, fast traffic to the seal should be thoroughly investigated before it is put to any general use. It was not considered on the District 15 project, since it did not fulfill the requirements for maintaining the original pavement color.

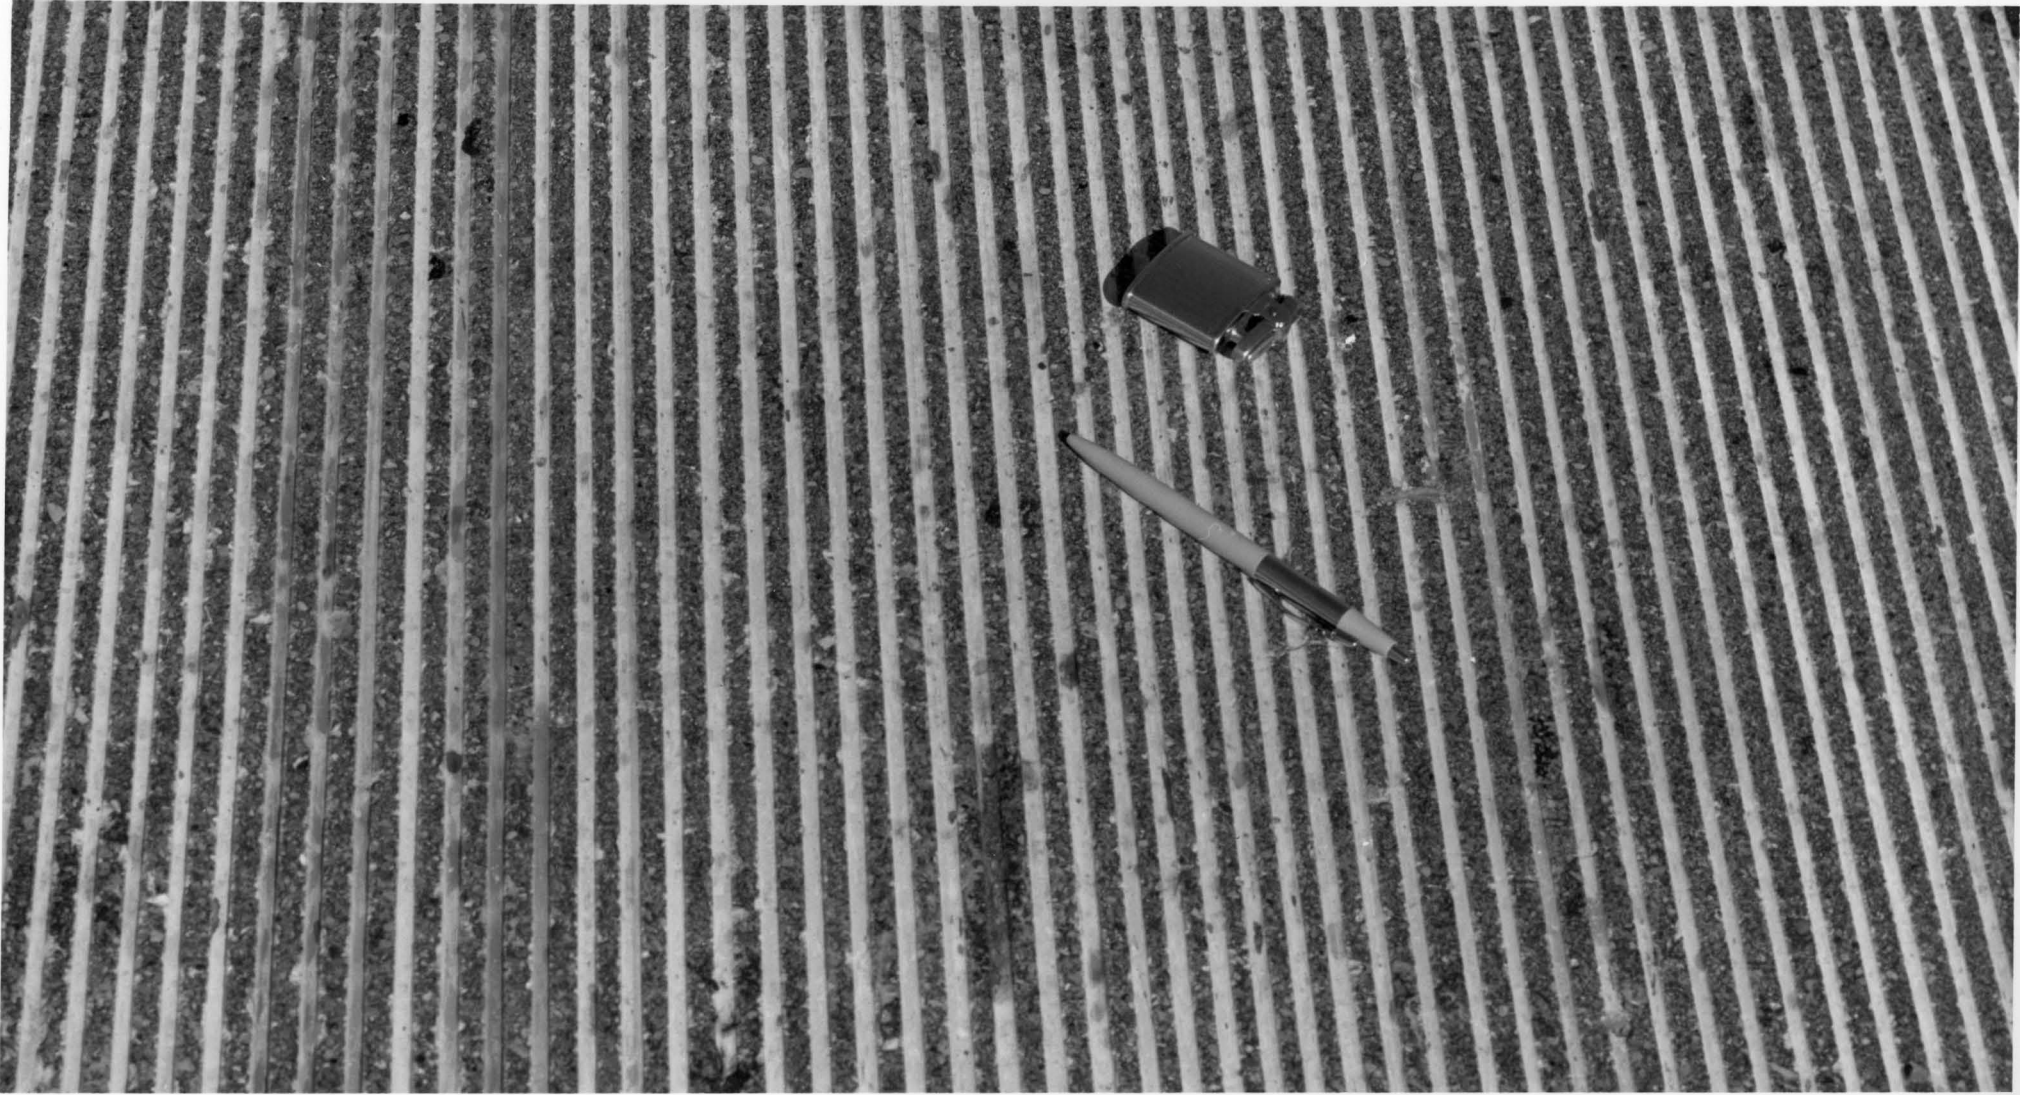
FIGURE NO. 7

Figure No. 7 shows a picture of the finished pavement surface after completion of the longitudinal sawing.

Work was started on this project on July 10, 1962 and was completed on September 14, 1962 with a total of 58 working days used. The working day was, in general, between the hours of 8:30 A.M. to 4:00 P.M., due to the heavy morning and afternoon peak traffic volume. A total of 344,557 sq. ft. of concrete pavement surface was sawed at a total equipment rental cost of \$12,387.50 or a unit cost of \$0.034 per sq. ft. In addition to the above, there was a \$25.00 move-in charge and a maintenance labor and equipment charge of \$2,252.48, which gives a total unit price of \$0.0426 per sq. ft.
