A SURVEY OF EARTH SLOPE FAILURES
AND REMEDIAL MEASURES IN TEXAS

Research Report Number 161-1

Stability of Earth Slopes
Research Project 3-8-71-161

CENTER FOR HIGHWAY RESEARCH
THE UNIVERSITY OF TEXAS AT AUSTIN

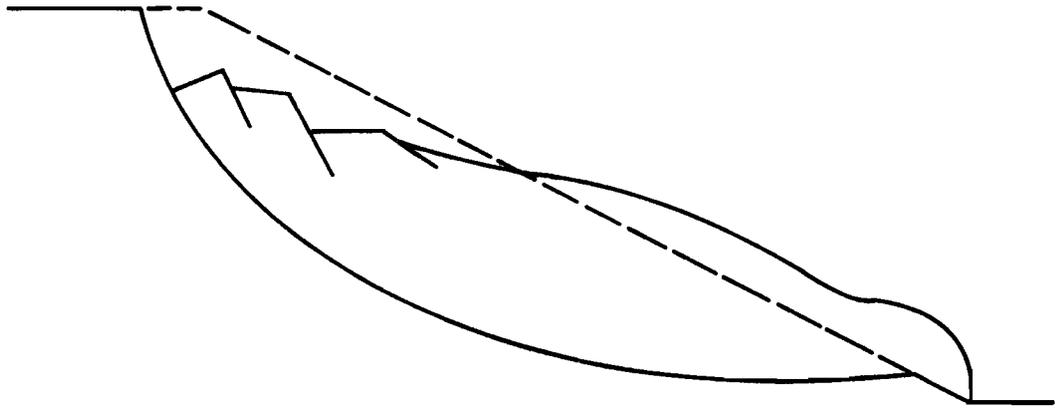
typical cross section in Fig. 2.1. Although there have been several instances of failures during construction of both cut and embankment slopes, failures have generally occurred three to eight years after construction. These long-term failures may have resulted from the gradual reduction in shear strength due to swelling and to the development of positive pore water pressures. Furthermore, in stiff-fissured clays the excavation of a slope may cause some fissures to open; these open fissures, in addition to being surfaces of weakness, provide natural paths for water migration and thereby may lead to the softening of the stiff-fissured clay mass and a reduction in shear strength (Terzaghi and Peck, 1967). The majority of the slides have occurred in five Texas Highway Department Districts: 2 (Fort Worth), 9 (Waco), 14 (Austin), 15 (San Antonio), and 18 (Dallas) (see Fig. 2.2). Some slope failures have occurred in other Districts but with apparently much lower frequency than in the previously mentioned Districts. The five Districts cited encompass some of the most unfavorable geologic and hydrologic conditions for the stability of earth slopes in Texas.

Fig. 2.1. Typical failure which occurs in Texas highway cut and embankment slopes.

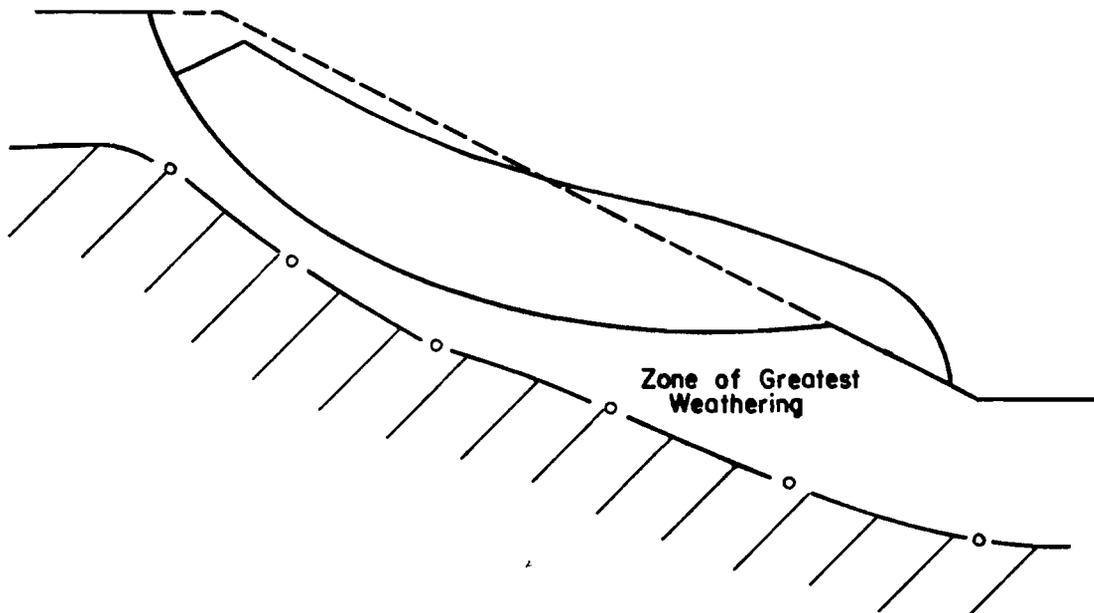
Fig. 2.3. A typical slope failure in a highly weathered zone of an overconsolidated stiff-fissured clay slope.

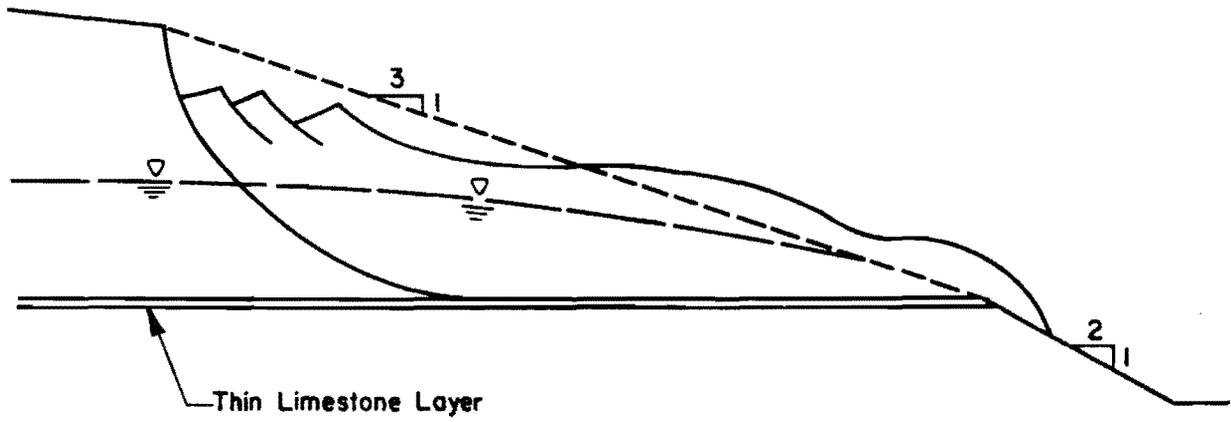
with thin layers of either sandstone or limestone. These thin rock layers tend to control the groundwater conditions and the mode of failure in these layered slopes. Randomly fractured and jointed rock has tended to cause erratic seepage patterns while continuous intact rock has led to the formation of perched water tables. In addition, failure surfaces in these materials tend to be non-circular, as the surface of sliding tends to develop near the base of clay layers adjacent to more resistant rock layers. A typical cross section of such a slide, which occurred north of Evant on U.S. 281, is illustrated in Fig. 2.4.

Fig. 2.4. Cross section of a slide which occurred on U.S. 281 north of Evant.

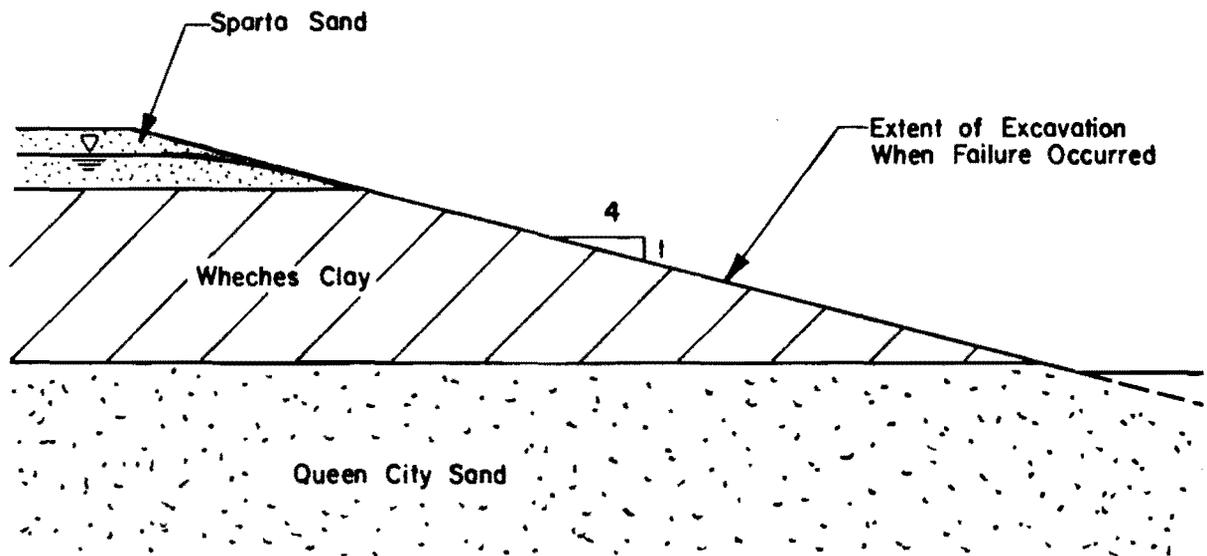
Fig. 2.5. Cross section of slope which failed along I.H. 45 near Centerville.

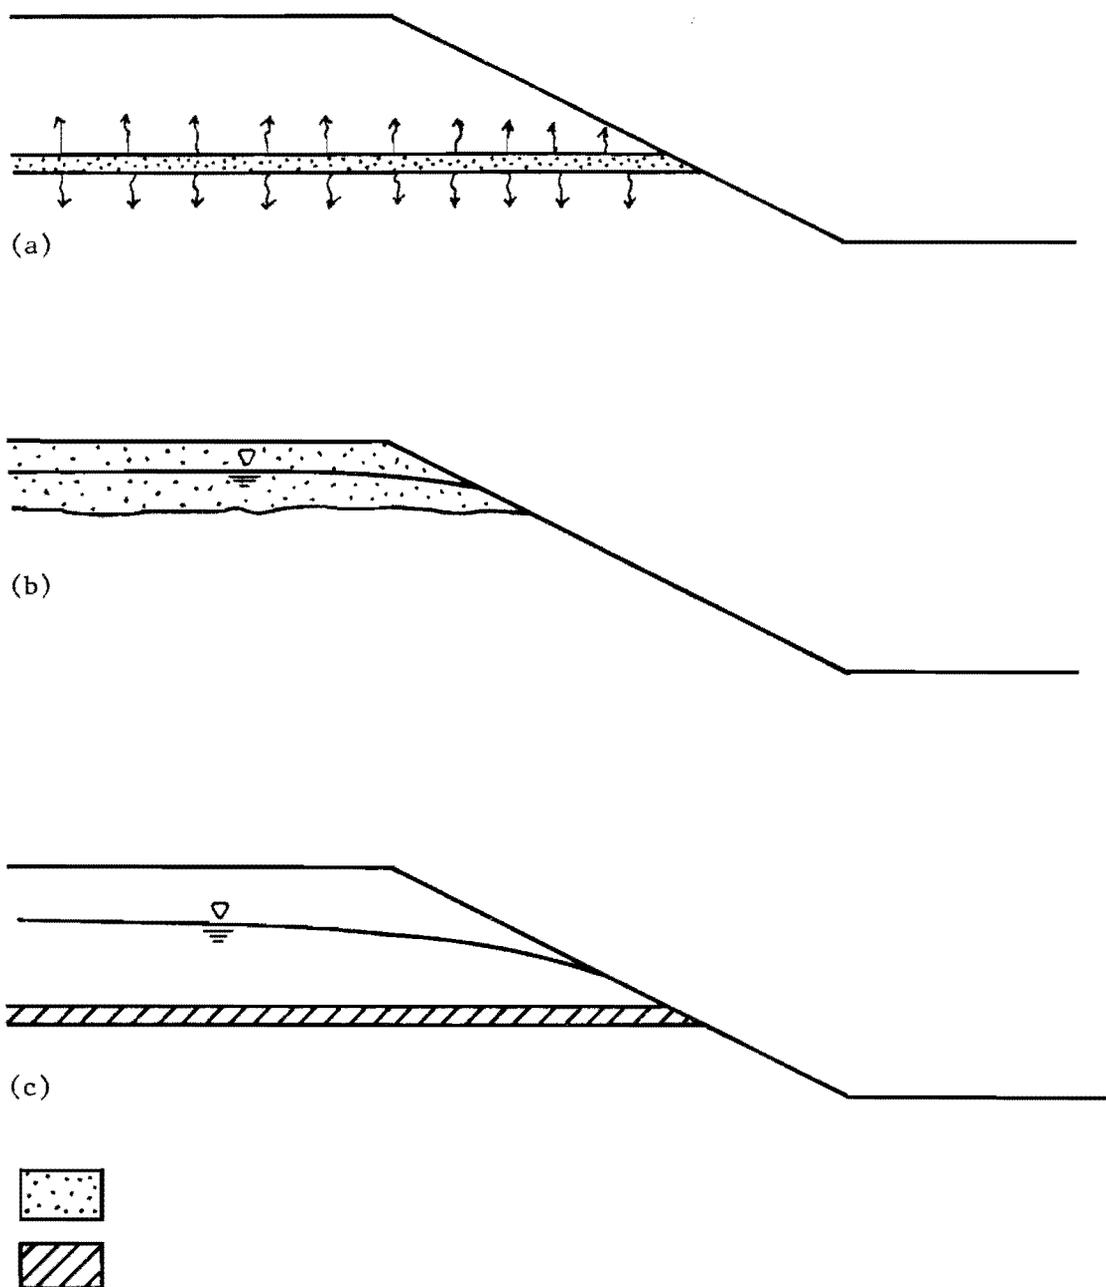
Seepage within relatively pervious zones in a slope such as sand and gravel seams, porous and fractured limestones, sandstones and shell conglomerates, as shown in Fig. 2.6a, may often be a major factor in initiating slope failures. Water from a sandy clay seam is believed to have initiated two slides on a 30-foot, 2 1/2:1 slope along I.H. 35 at Moore Street in San Antonio. The first slide occurred in a section of the slope west of the

Fig. 2.6. Various sequences of pervious and impervious strata in clay slopes.

Water perched in sand, gravel, and pervious rock layers by underlying clays, as illustrated in Fig. 2.6b, may also contribute to slope failures in the clay by reducing its shear strength. This, for example, was the case in the previously discussed Centerville slides. While these slides occurred during construction, a number of years may pass before water from an overlying strata will initiate a landslide. For instance, water seeping from a fractured limestone layer into a 40-foot, 2:1 slope on I.H. 820 near Grove Oak Drive in Fort Worth appears to have contributed to the failure of this side hill cut, several years after the slope had been excavated.

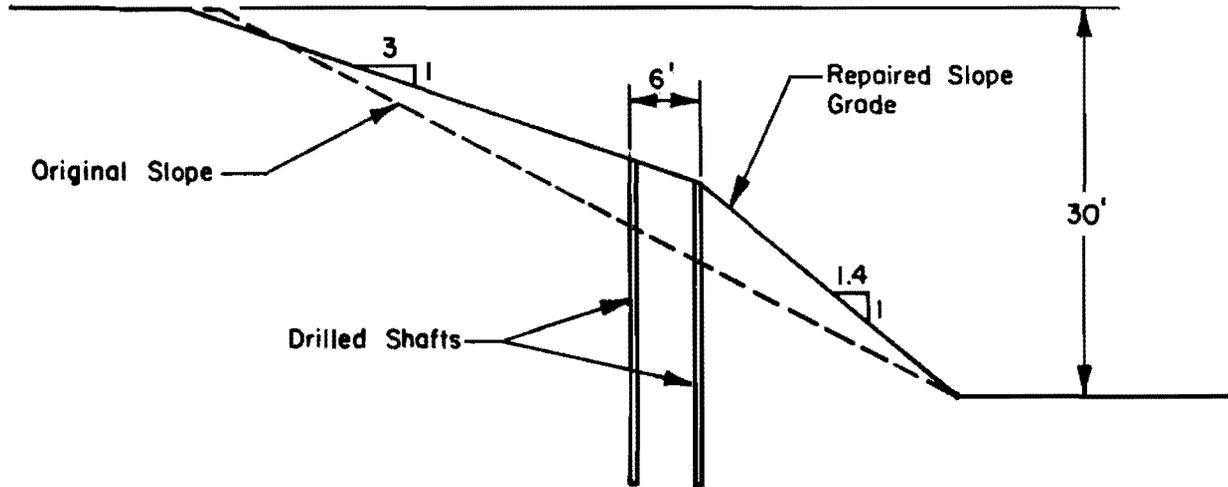
Drilled shafts were also used to correct a slide which developed beneath a highway bridge on U.S. 183 at Boggy Creek in Austin (District 14). The first slide at this location occurred in 1965 along a portion of a 30-foot-high cut slope in highly plastic weathered shale along the bank of Boggy Creek. Fifty, 18-inch-diameter drilled shafts were placed on 6-foot centers in two staggered rows approximately 6 feet apart. The 32-foot-long shafts were located approximately one-third of the way up the original slope. Reinforcement for each shaft consisted of six evenly spaced No. 6 bars and a No. 2 spiral extending the full shaft length. In addition, three No. 9 bars were placed in the lower 20 feet of the shaft, along the upslope side, to provide resistance to bending. In conjunction with the placement of these drilled shafts, the slope was regraded and flattened to 3:1 above the elevation of the line of shafts. However, below this elevation, the slope was steepened to approximately 1.4:1 as illustrated in Fig. 3.1. While the drilled shafts have apparently been successful in halting further slide movements from above, a new slide occurred in the steepened portion of the slope below the drilled shafts during the winter of 1969-1970. This slide, which exposed the upper 6 to 8 feet of the shafts, was repaired with regrading and lime stabilization.

Fig. 3.1. Typical cross section of Boggy Creek near U.S. 183 in southeast Austin.

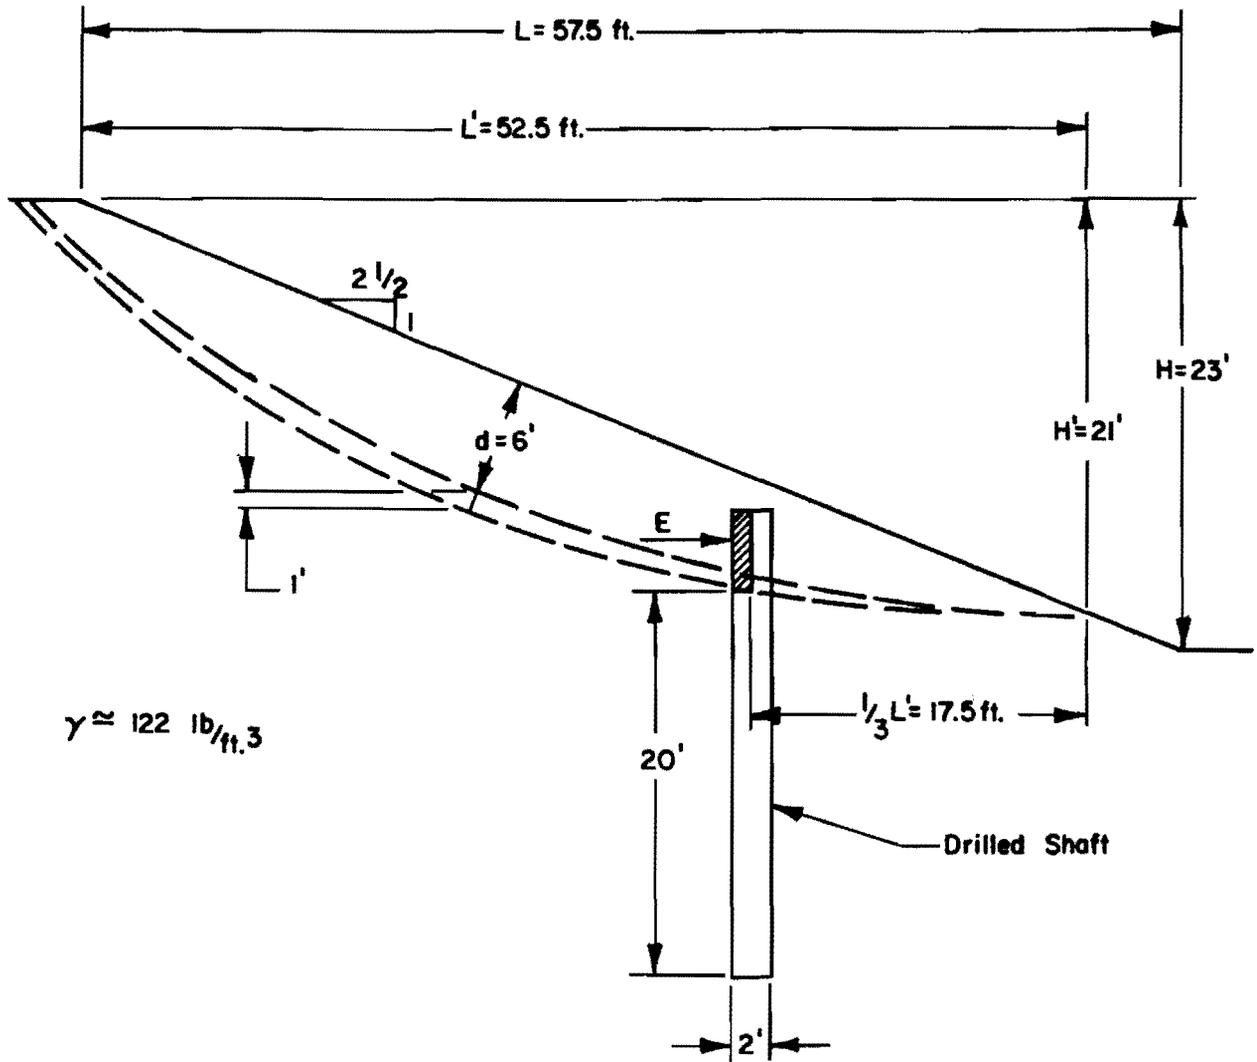
surface, as shown in Fig. 5.1. The use of the charts for this purpose can be illustrated by considering as an example the previously discussed slide which occurred on I.H. 35 beneath the Moore Street crossover bridge. A slide suppressor wall was used at this site to correct the failure which occurred in the 23-foot-high, 2 1/2:1 slope as shown in Fig. 5.16. The average unit weight of the soil at this site was approximately 122 pcf. In this instance an assumption of a circular failure surface appeared to be reasonable, and the maximum depth of this surface, measured normal to the slope face, was estimated to be between 6 and 7 feet.

The units of the earth pressure force are pounds per lineal foot of wall. It is interesting to note that a small change in the depth of the failure surface results in a relatively large increase in the earth pressure force. In this example, a 17 percent increase in the depth of the slip surface resulted in a

Fig. 5.16. Simplified cross section of the slope on I.H. 35 under the Moore Street Bridge.
