Report 26-1

DYNAMIC TEST
OF
P. & S. F. RAILROAD OVERPASS
EL PASO, TEXAS

Final Report
On
Research Project
Part 1 of 2

Research Project 1-5-62-26

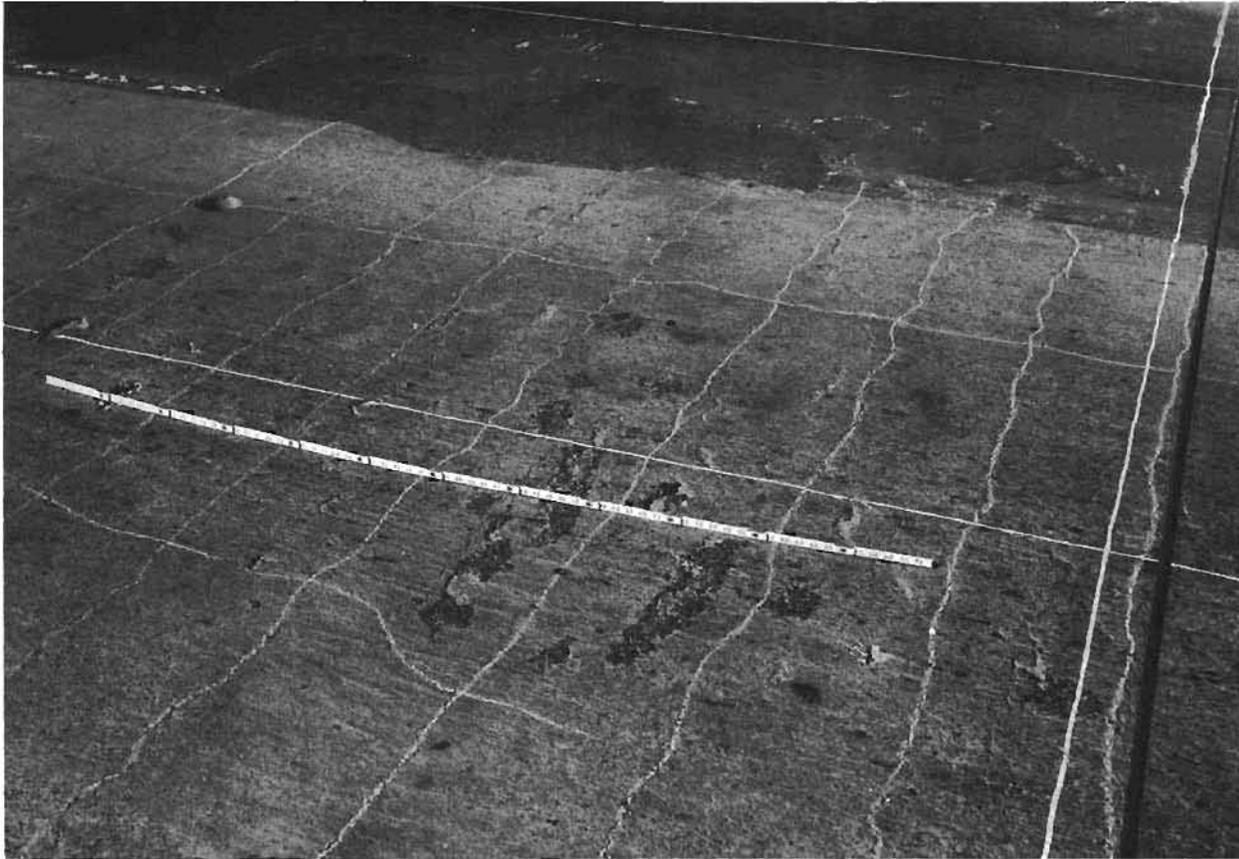
In March and April of 1962 the Texas Highway Department Bridge Division and the Bureau of Public Roads Physical Research Division joined in a bridge testing program on the P & SF Railroad Overpass in El Paso, Texas. The overpass is on U. S. Highway 80 and carries a heavy volume of interstate truck traffic. This 1388 foot bridge is a combination of three, five, and six span steel I-beam units. (Figure 1.) Undue slab distress is evident in the form of longitudinal and transverse cracking, and heavy spalling of the bridge deck is visible down to the top reinforcing steel. (Figure 2 and 3.)

FIGURE 2 LONGITUDIONAL AND TRANSVERSE SLAB CRACKING

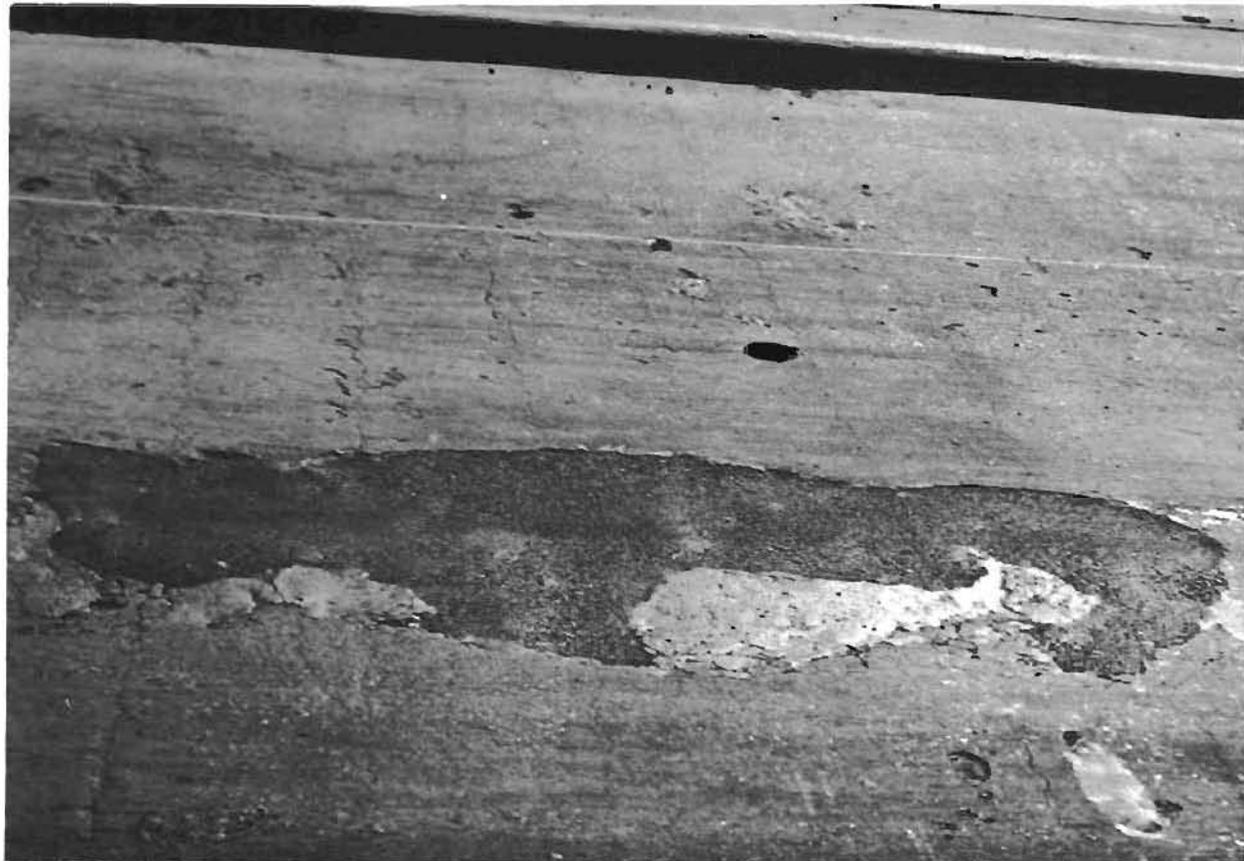
As little interaction or continuity between the beams and slab was evident, it was impossible to calculate actual stresses being obtained in the concrete. The slab itself is heavily cracked and attachment of strain gages to the concrete showed strains only where the wheel of the test truck was over the gage point or very near to it. While the slab seemed to distribute the load to some extent, it was evident that no stress reversals were present as would be expected in a composite unit.

FIGURE 3 CRACKING AND SPALLING OF SLAB
