1. Report No. FHWA/TX-96/1479-2F/1340-1F		2. Government Accession No.		3. Recipient's Catalog No.	
4. Title and Subtitle TESTING NOTCHED ENDS OF PRESTRESSED CONCRETE BOX BEAMS: FINAL LETTER REPORT ON PROJECTS 1479 AND 1340				5. Report Date December 1994

TESTING NOTCHED ENDS OF PRESTRESSED CONCRETE BOX BEAMS

Research Report 1479-2F/1340-1F

FINAL REPORT ON PROJECT 0-1479

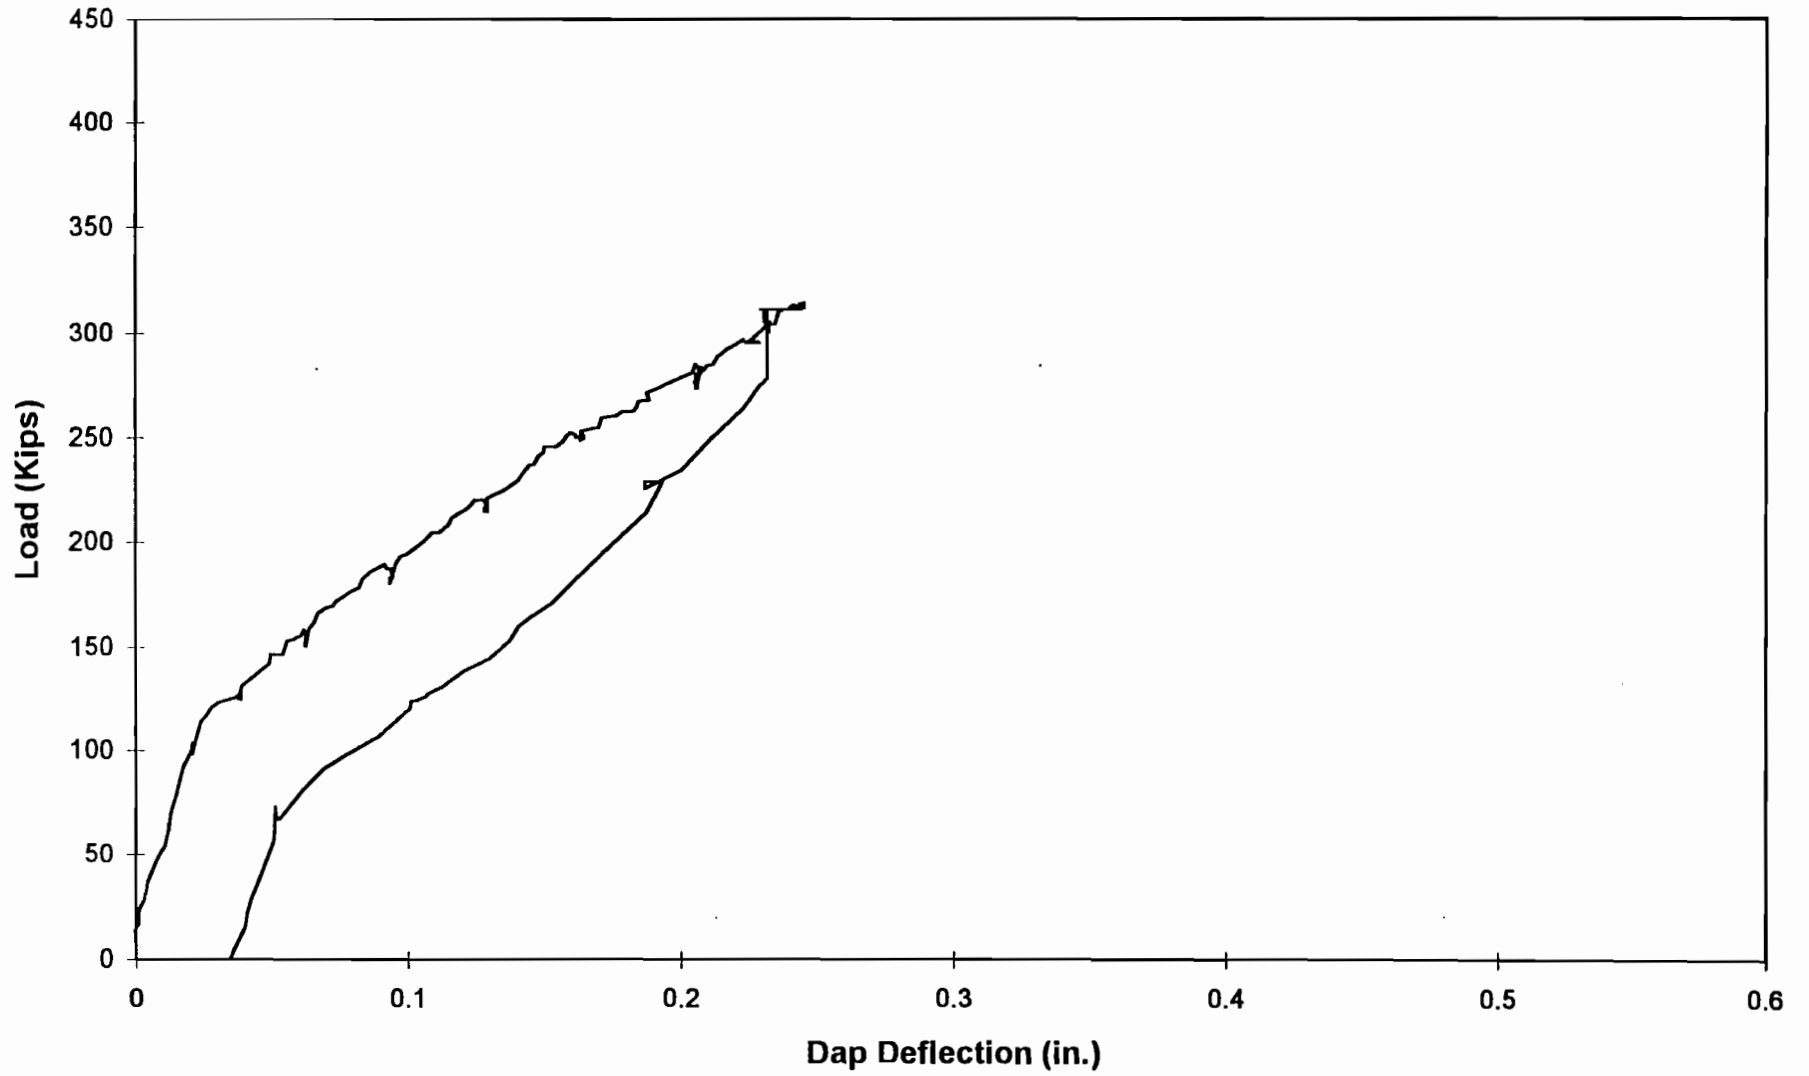
Figure 3 Load vs. Dap Deflection / Factored Load Test

The response of the beam to loading during the two tests is illustrated in Figures 3 and 4 using plots of load versus dap deflection (beam-end deflection minus deflection of the box end adjacent to the dap). Figure 3 clearly indicates stiffness reductions due to cracking and then yielding of reinforcement at approximately 530 kN (120 kips) and 1500 kN (340 kips). Opening of diagonal cracks at the dap/beam interface is illustrated in Figure 5 for the second test. The displacement transducer was unable to precisely record the small crack width at the dap during the factored load test.

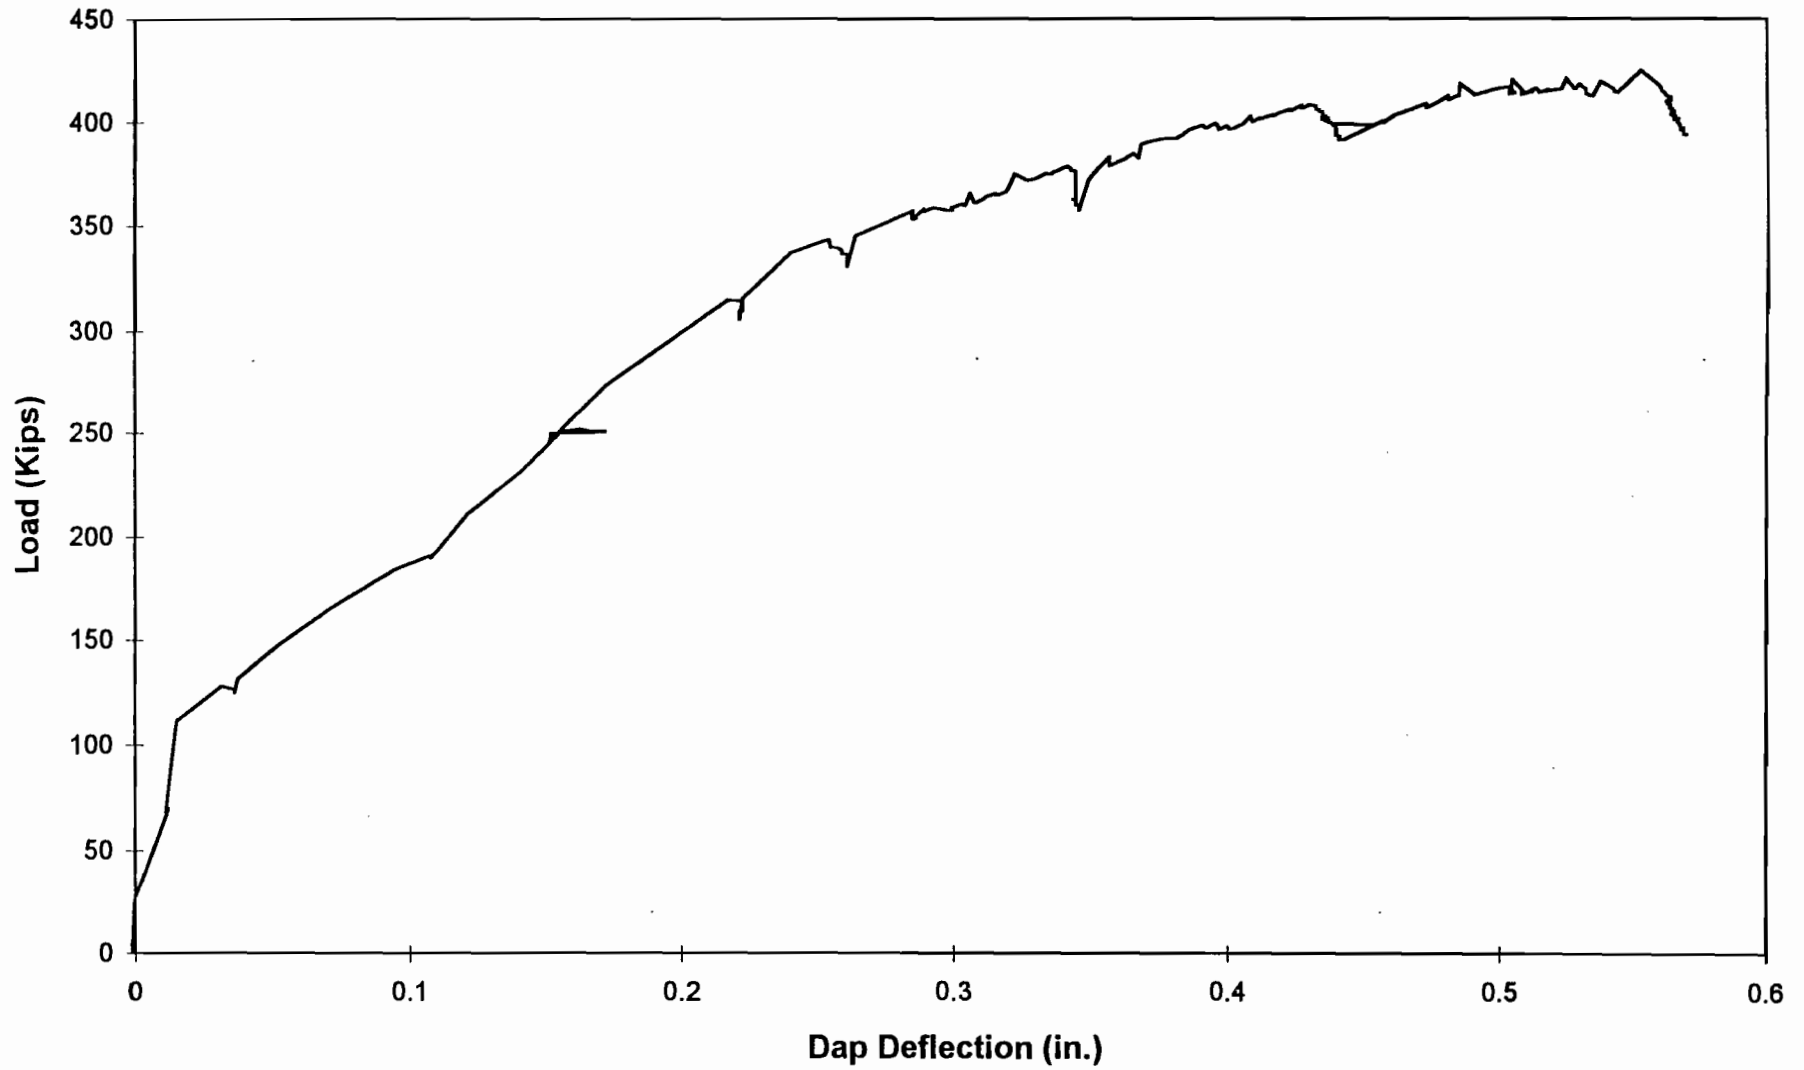
Figure 4 Load vs Dap Deflection / Ultimate Strength Test

Although the diagonal crack in the dapped-end region was the primary concern at the beginning of this investigation, it is interesting that strength of the beam was ultimately controlled by the diagonal cracks that initiated in the beam webs then propagated into and through the bottom flange. These cracks intersected the prestressing strands inside the required development length and resulted in slip of the strands. Initial slip of the strands

was detected at 1600 kN (360 kips). When loading was stopped at a maximum of 1890 kN (425 kips), the top layer of strands had withdrawn approximately 13 mm (0.5 in.) at the end of the beam. At conclusion of the second test, some slip was evident in all four strand layers.

In conclusion, the dapped-end detail performed quite adequately during both tests. The detail was capable of resisting at least 1.4 times the strength required at the support to develop the factored flexural strength of the girder. Failure of the girder was controlled by pullout of the prestressing strands, which was aggravated by diagonal cracks propagating through the development length of the strand.

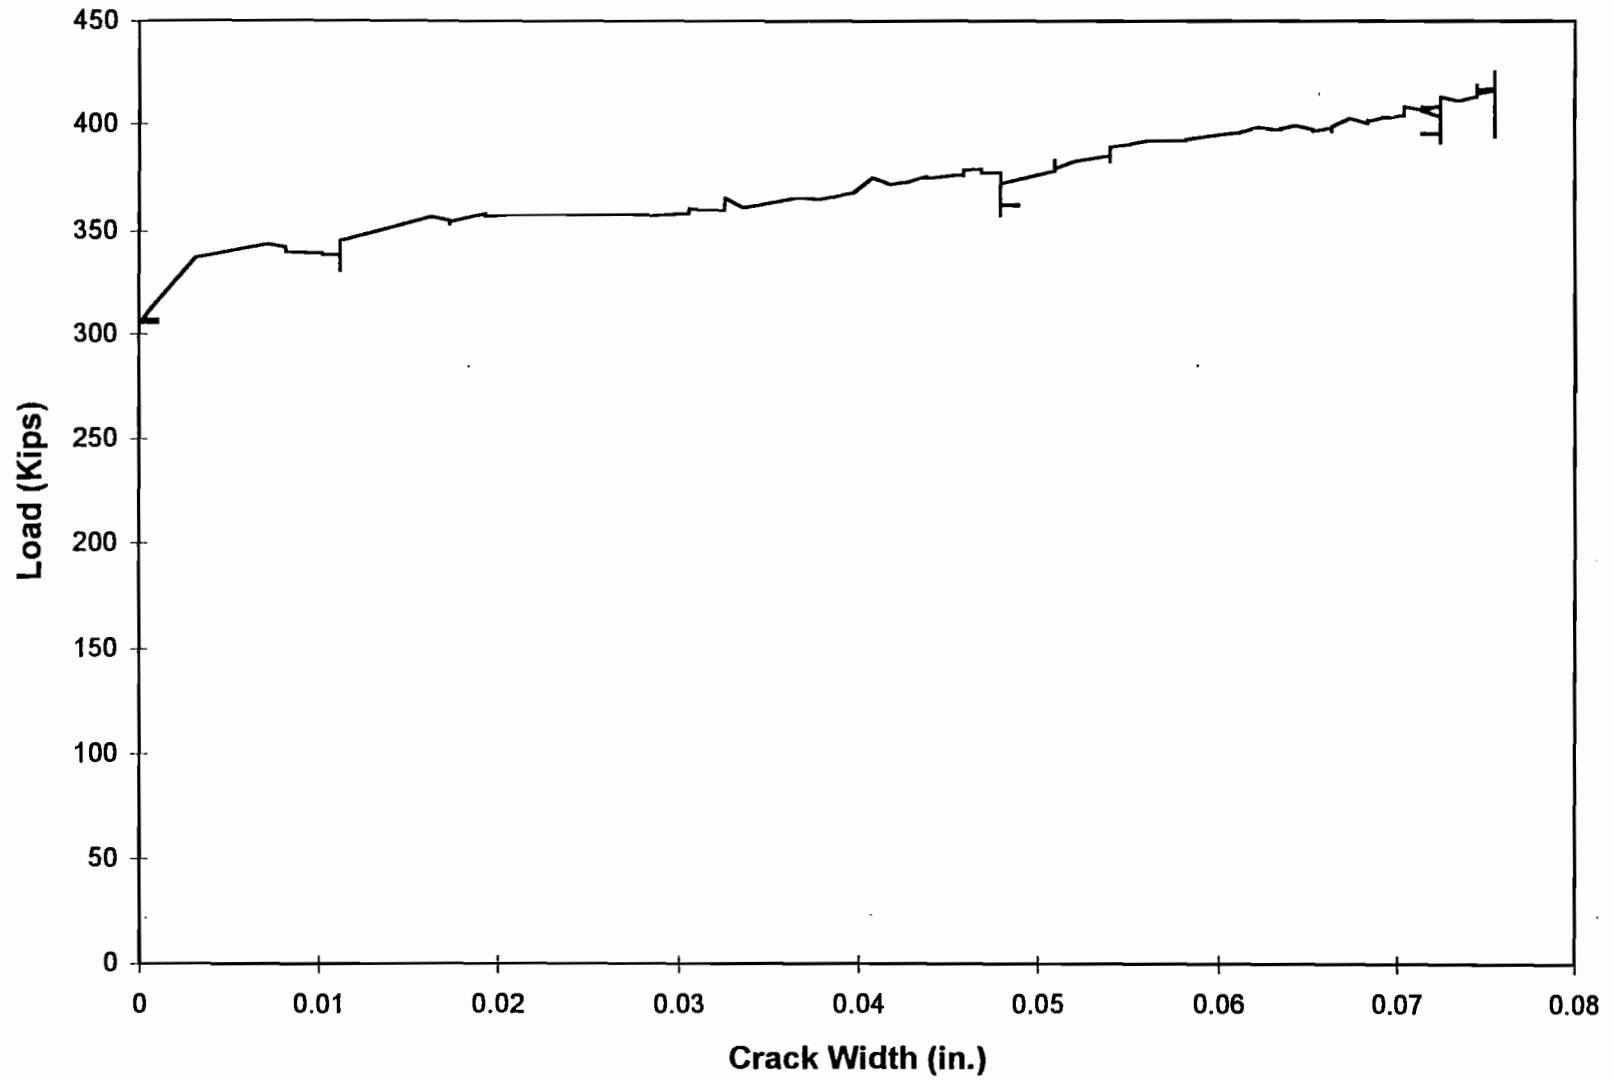
Figure 5 Crack Openings at Beam/Dap Interface for Ultimate Strength Test

At conclusion of the FL test, the largest crack in the dapped end was approximately 0.25 mm (0.01 in.) wide. Diagonal cracks in the webs of the girder developed during the test and were approximately aligned between the steel crosshead and the bottom corner of the beam. The largest of these was approximately 0.05 mm (0.002 in.) wide. During the test to failure, the largest diagonal crack in the dapped end increased to 2.5 mm (0.1 inches) and the largest diagonal cracks in the beam webs increased to 1.4 mm (0.055 in.) in width. Diagonal web cracks extended into the bottom flange of the box girder near conclusion of the FL test. These cracks extended further and ultimately passed completely through the bottom flange during the second test. Note that the measurements presented in Figure 5 do not agree with the dapped-end crack widths presented above because the gage was not oriented perpendicular to the crack where the crack width measurement was made (using a crack width comparator), and also more than one crack is located within the gage length.
