1. Report No. <i>TX-95-1948-1F</i>		2. Government Accession No.		3. Recipient's Catalog No.	
4. Title and Subtitle <i>REPAIR OF FIRE-DAMAGED CONCRETE PAVEMENT ON IH-45 NEAR ANGUS, TEXAS</i>				5. Report Date <i>January 1995</i>

**REPAIR OF FIRE-DAMAGED
CONCRETE PAVEMENT
ON IH-45 NEAR ANGUS, TEXAS**

Research Report Number 1948-1F

Repair of Fire-Damaged Concrete Pavement on I-45 (Evaluation Near Corsicana, Texas)

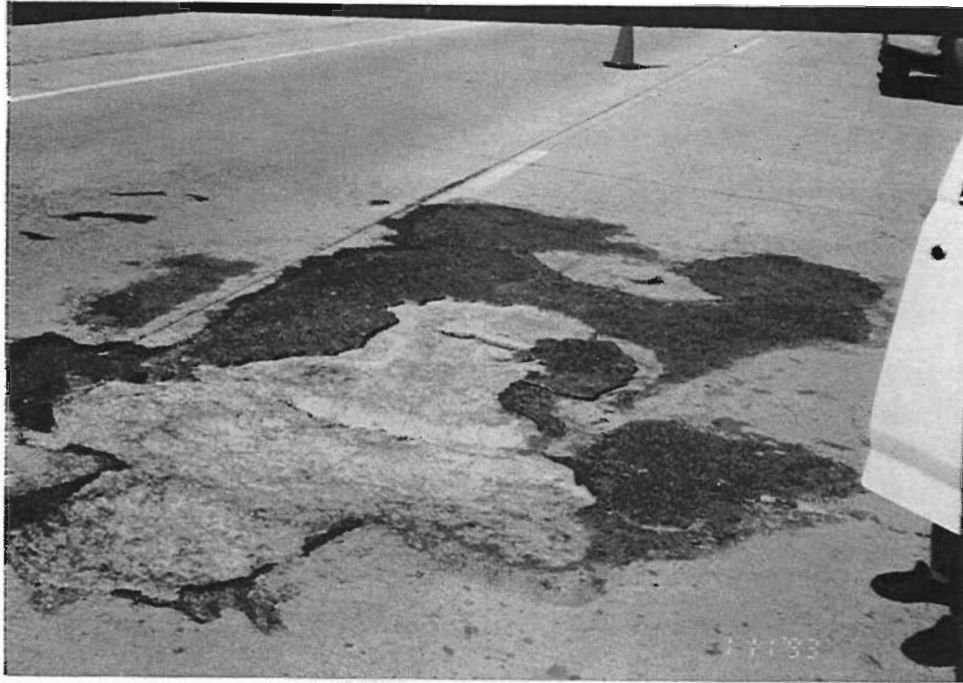
As early as late November 1993, TxDOT maintenance forces began reporting some failed portions of the repaired areas. By January 1994, extensive damage to the first repair area, slabs 11 and 12, was apparent at the region where underlying substrate pavement joints intersected. This area was where the Transpo T-230 had failed to polymerize and had to be shoveled out and replaced with the PUP system. Also, the PUP mortar had been allowed to bridge over the joints and apparently cracked and spalled as the substrate joints moved differentially (Figures 2 and 3).

Figure 2. Repair area 1, consisting of the repairs to slabs 11 and 12, shows large areas of delaminated and broken chunks of PUP material.

The distressed area was almost exclusively badly cracked PUP which had debonded and broken into large chunks. This debonded repair material together with any adjacent unsound concrete was cleaned, sandblasted, and then repaired with a user-formulated methyl methacrylate-based (MMA) polymer concrete (Figure 8). This material was used because its formula can be easily adjusted by the user in the field to give desired working and curing times even at cold temperatures, and January temperatures in North Texas can be very unpredictable. This adjustability is more difficult with polyester systems and is not possible with epoxies. The general formula for this binder system is shown below.

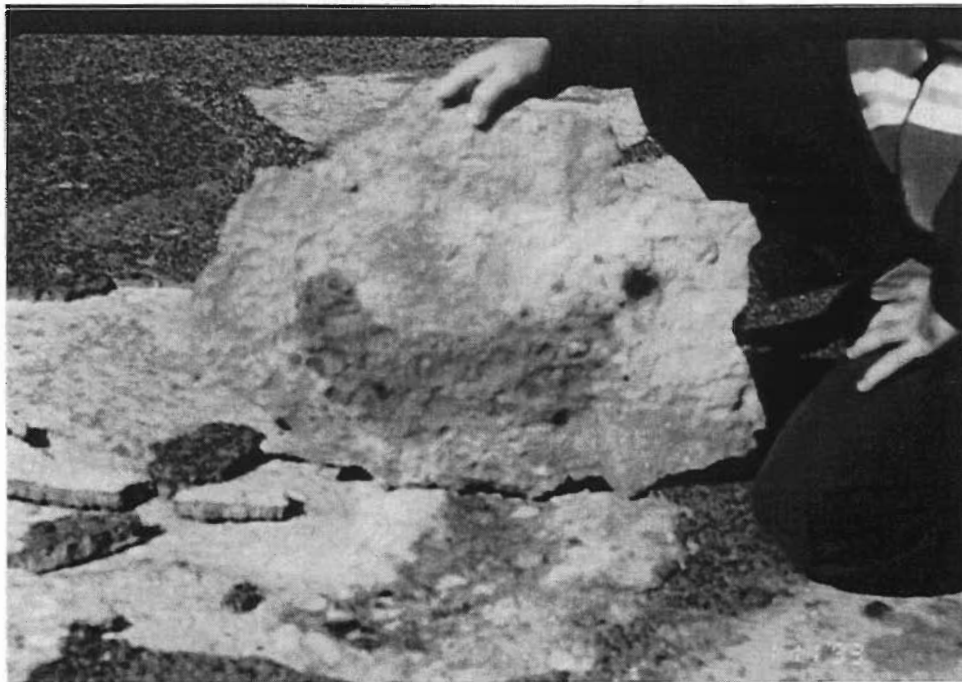
Figure 3. Large piece of debonded PUP mortar shows large dark area where material never bonded to the substrate.

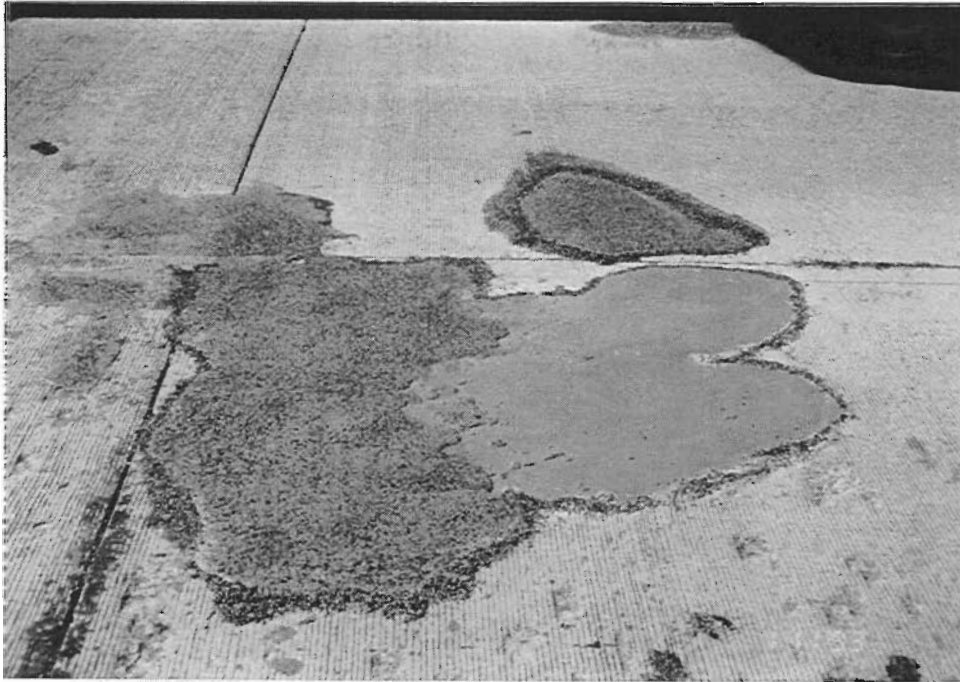
Figure 4. Area 2, consisting of slabs 14 and 15, still appears to be in good condition.

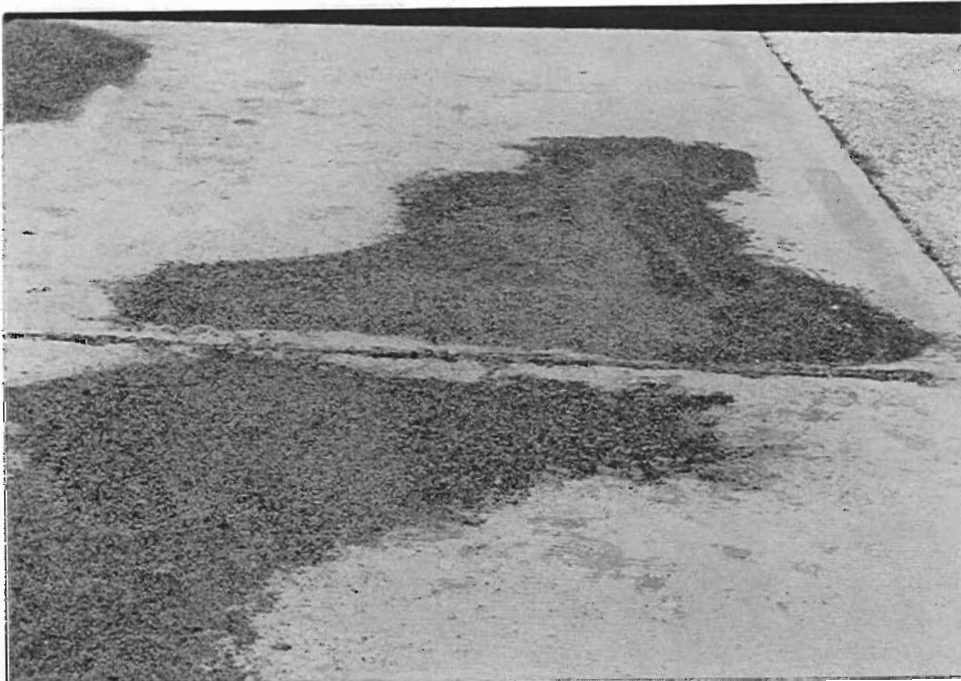
Figure 5. Area 3, consisting of slabs 18 and 19, still appears to be in good condition.

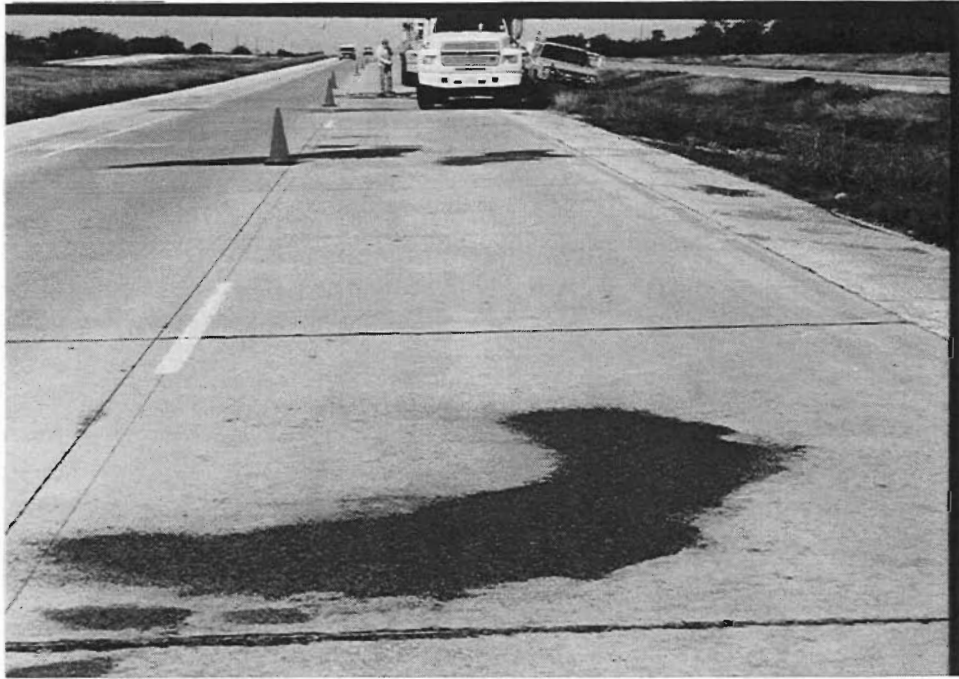
Figure 6. Area 4, consisting of slabs 22 and 23, shows no deterioration.

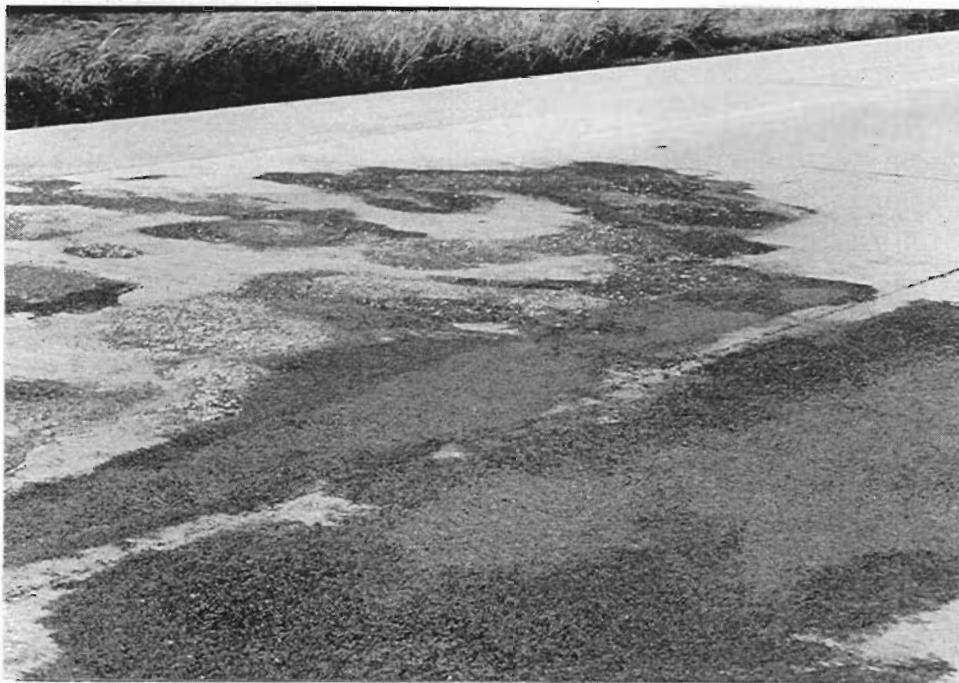
Figure 7. Area 5, consisting of slabs 41 and 42, shows that repairs were made of different materials. No significant deterioration has occurred.

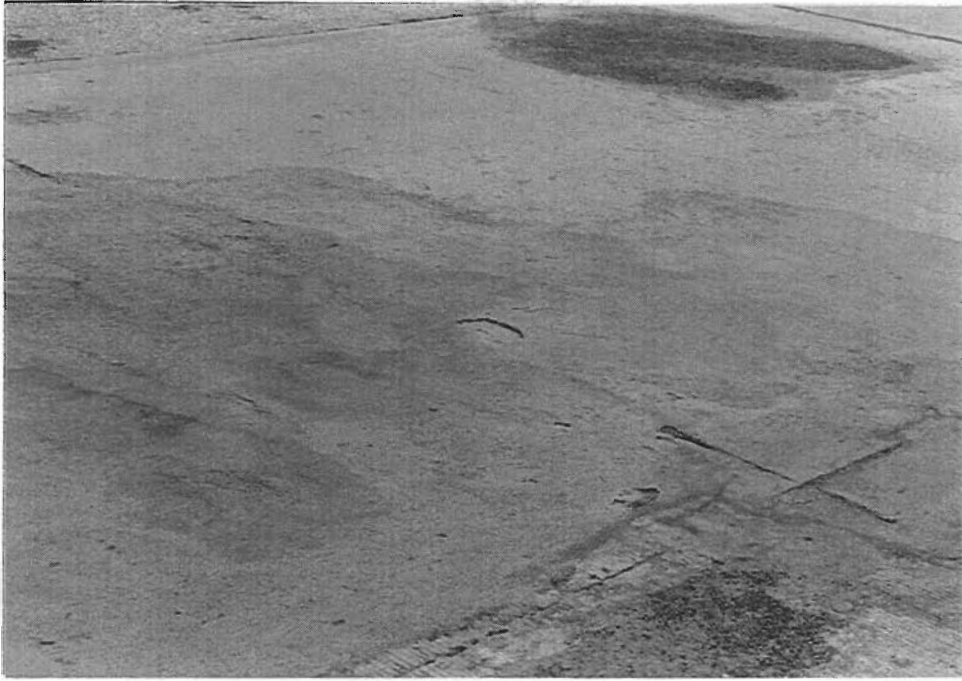
Figure 9. MMA repairs to area 2 are in good condition after six months.

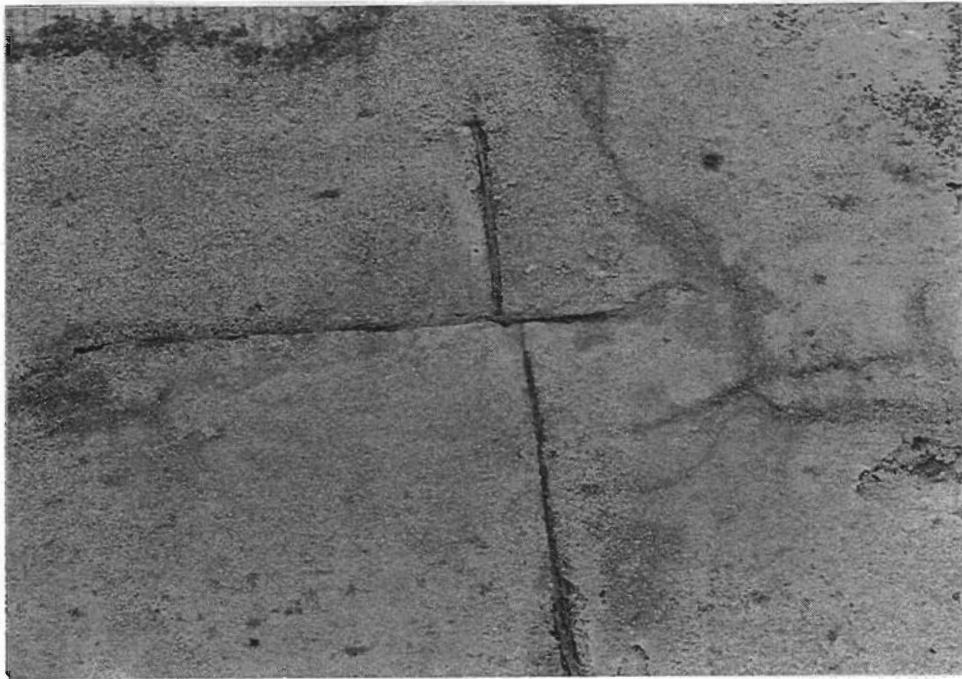
Figure 10. Detail of cardboard inclusions in MMA mortar for stress relief over substrate joints shows little deterioration.

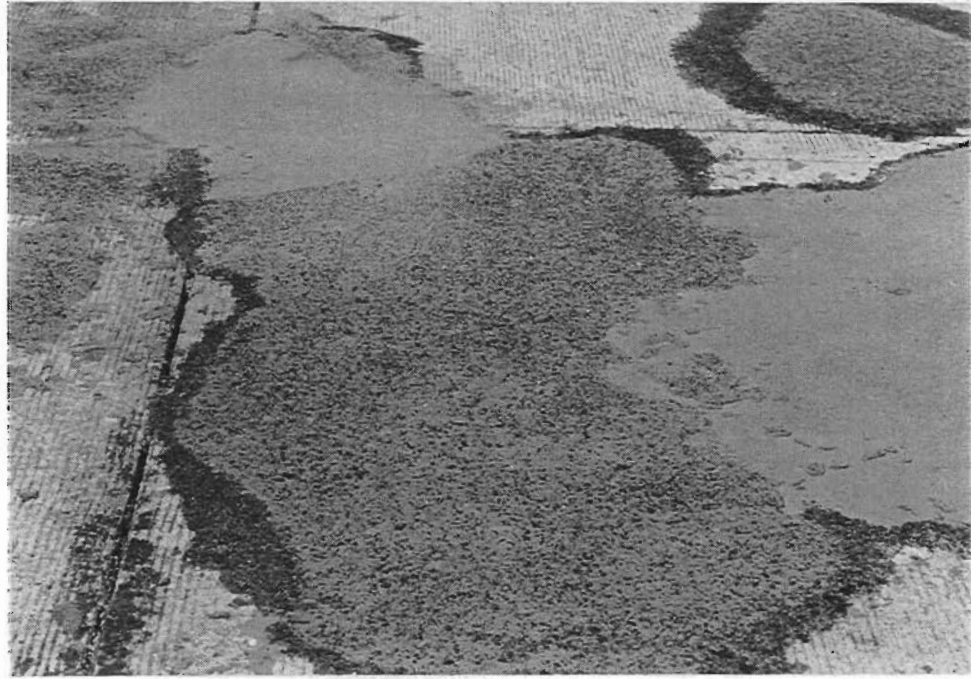
Figure 11. PUP mortar in repair area 2 (slabs 14 and 15) is still in good condition after one year.

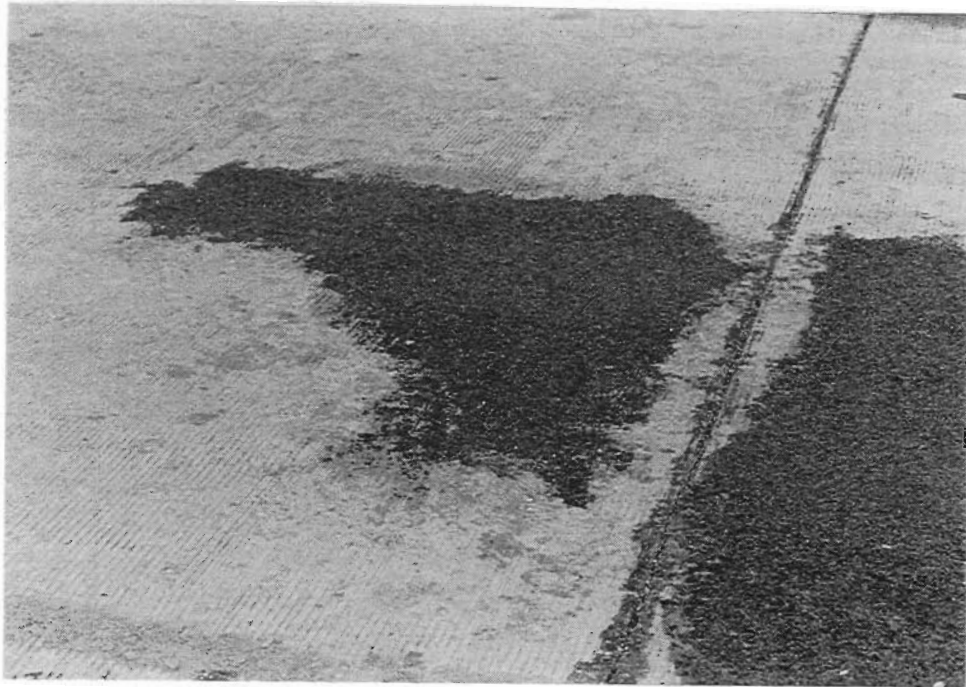
Figure 12. After one year, epoxy system in repair area 3 (slabs 18 and 19) shows no sign of deterioration.

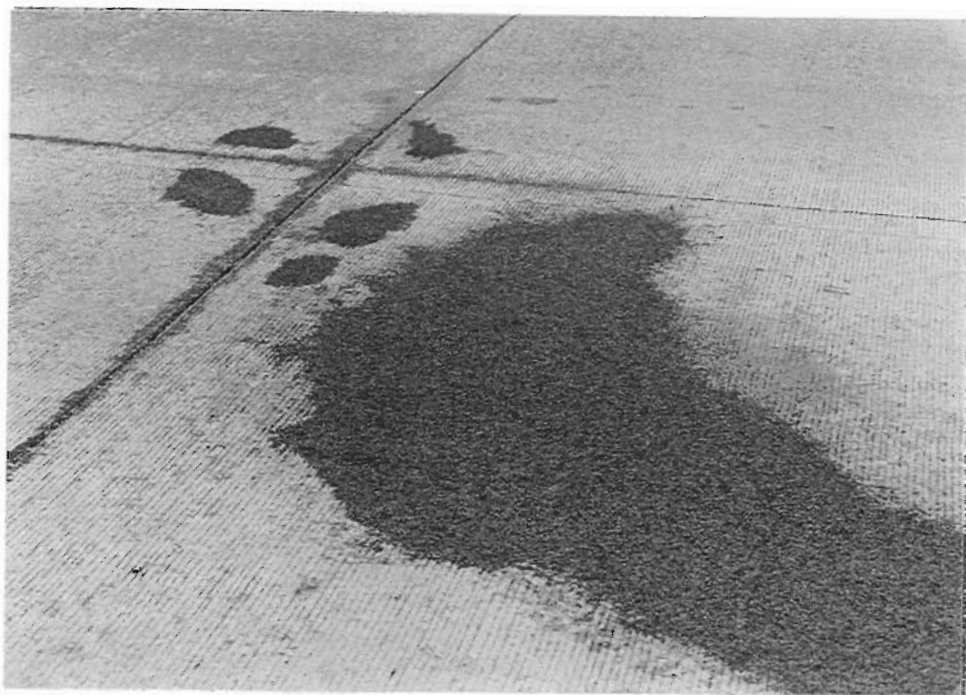
Figure 13. After one year, epoxy system in repair area 4 (slabs 22 and 23) shows no sign of deterioration.

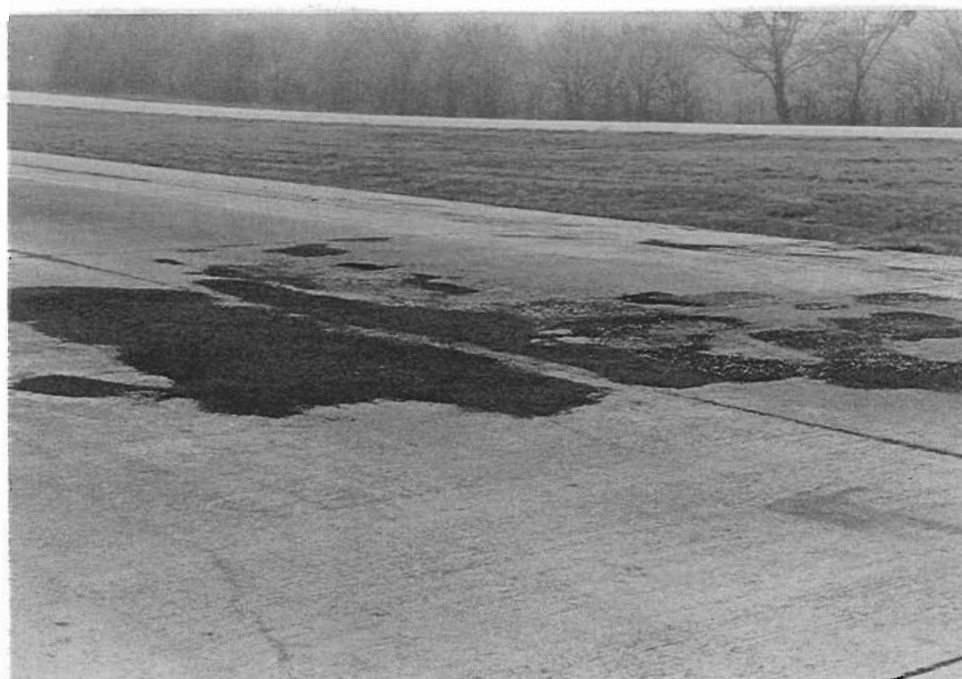
Figure 14. Overall condition of repair area 5 (slabs 41 and 42) is good.

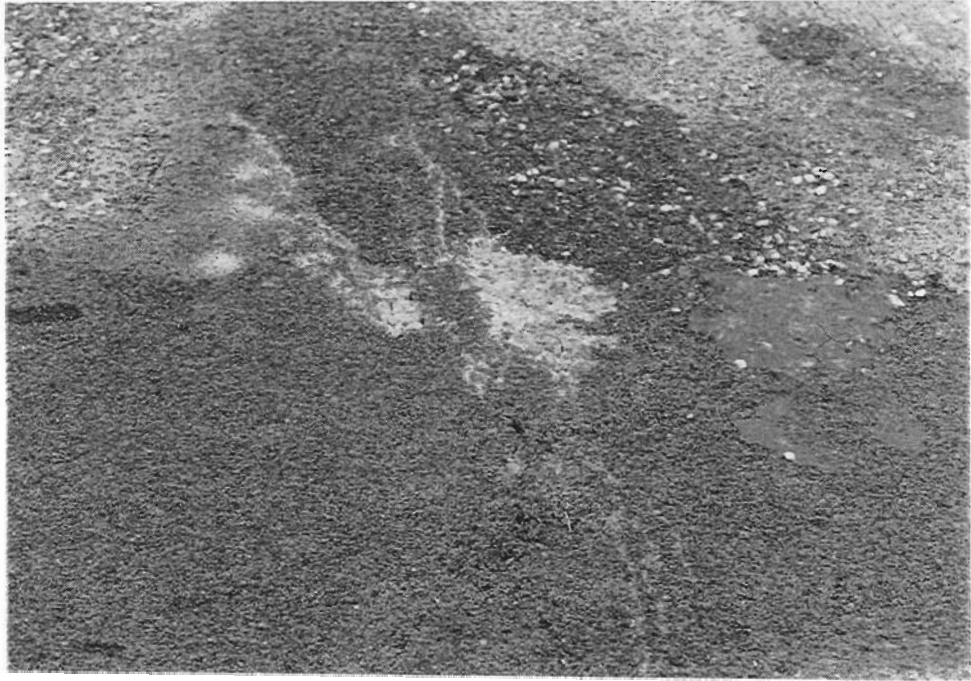
Figure 15. Some reflective cracking from substrate through epoxy mortar has occurred at one year.

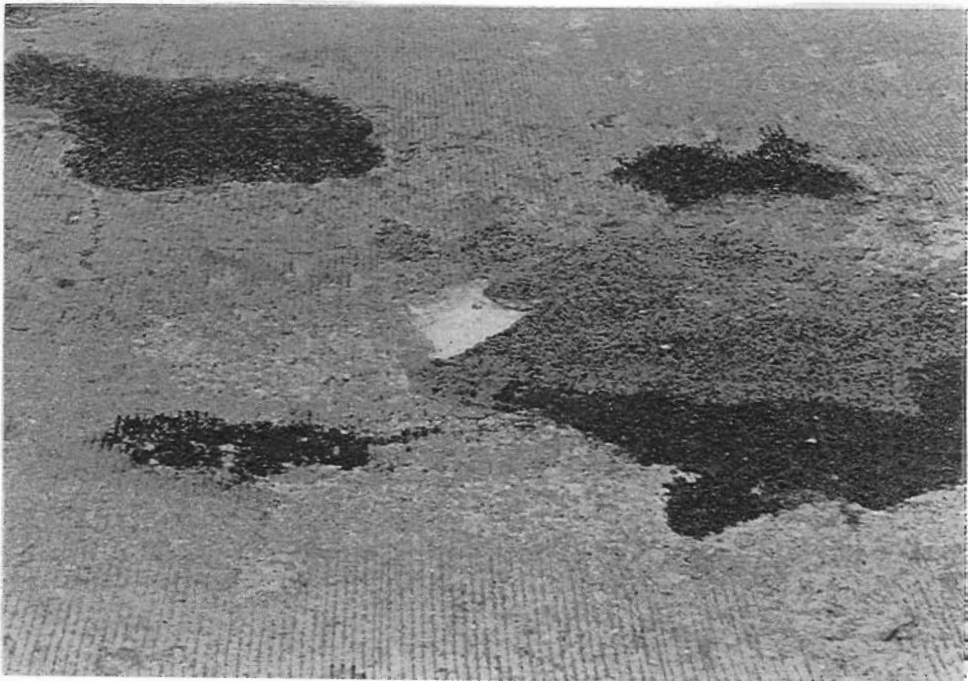
Figure 16. After one year, a few small pieces of concrete covered by PUP mortar have spalled out over intersecting substrate cracks in repair area 5.

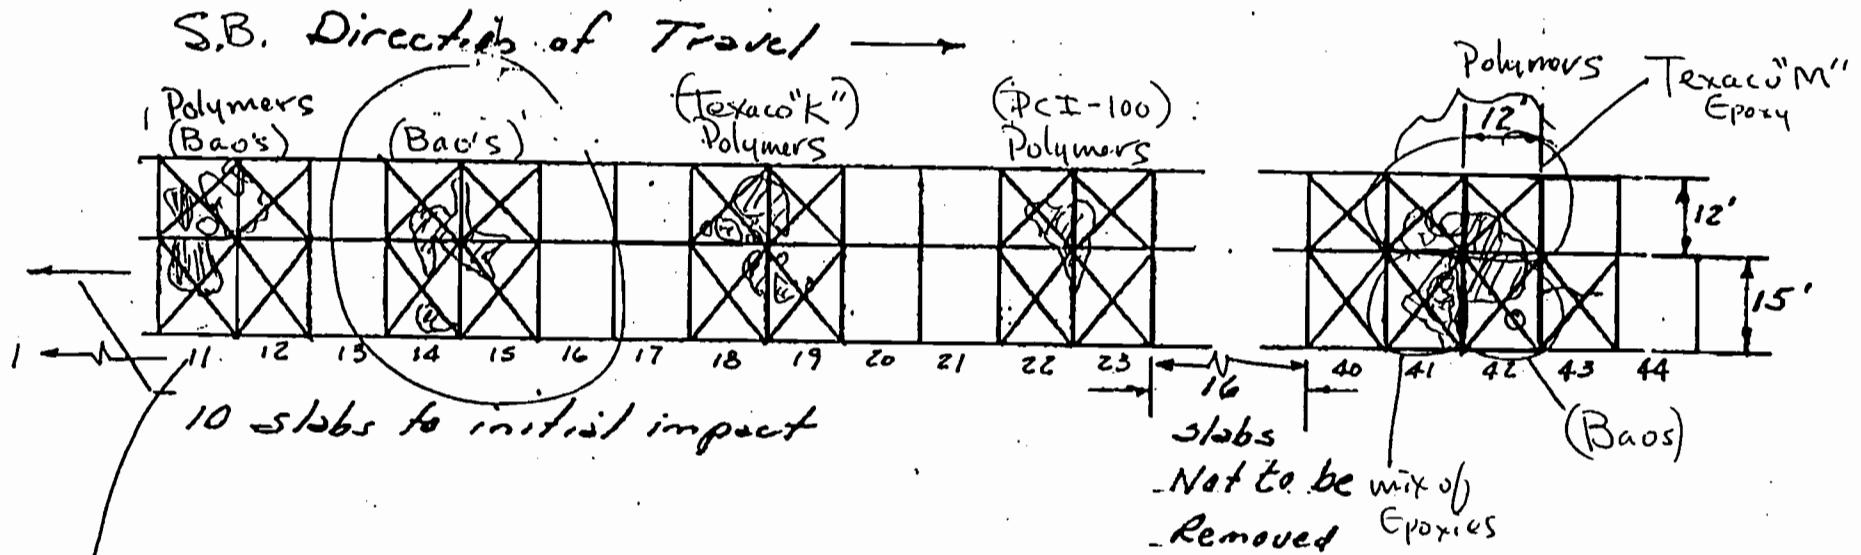
Figure A-1. Field sketch showing relative positions and sizes of spall damage. Actual repair material placements are also indicated.

Repaired first with Transpo, but it did not cure. We cleaned out the holes again and repaired them with Ms. Baos' mortar.

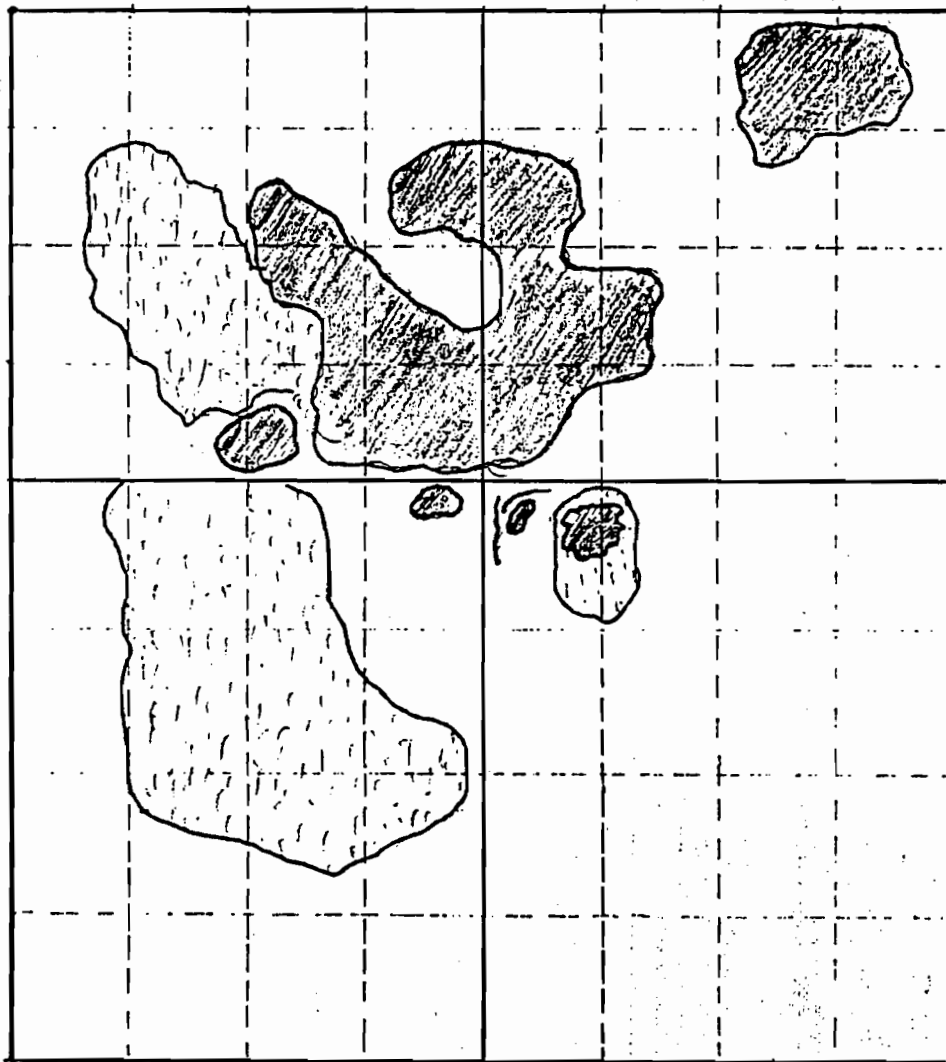
Figure A-2. Schematic of damage to slabs 11 and 12. The repair area for slab 11 is 35.5 sq ft, requiring 8.9 cu ft of material. The repair area for slab 12 is 41.5 sq ft, requiring 10.4 cu ft of material.

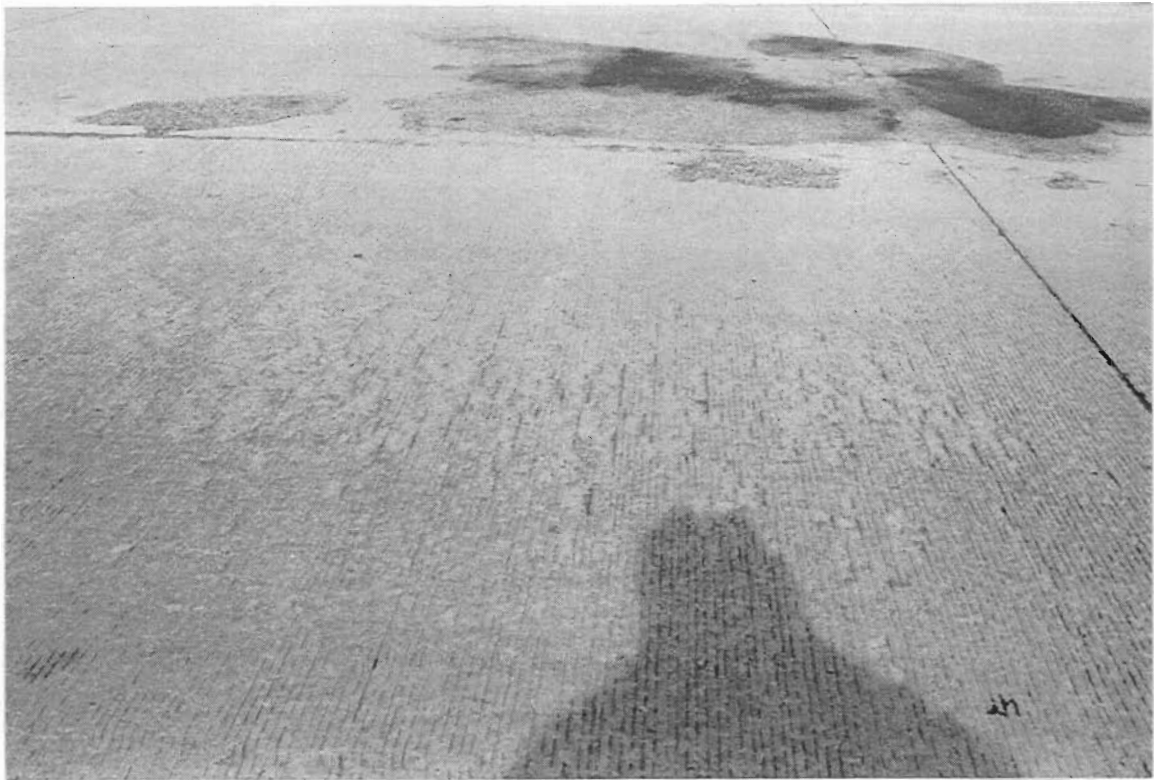
Figure A-3. Slab 11 shows light surface spalling in the foreground and asphalt filling the deeper spalls in the background.

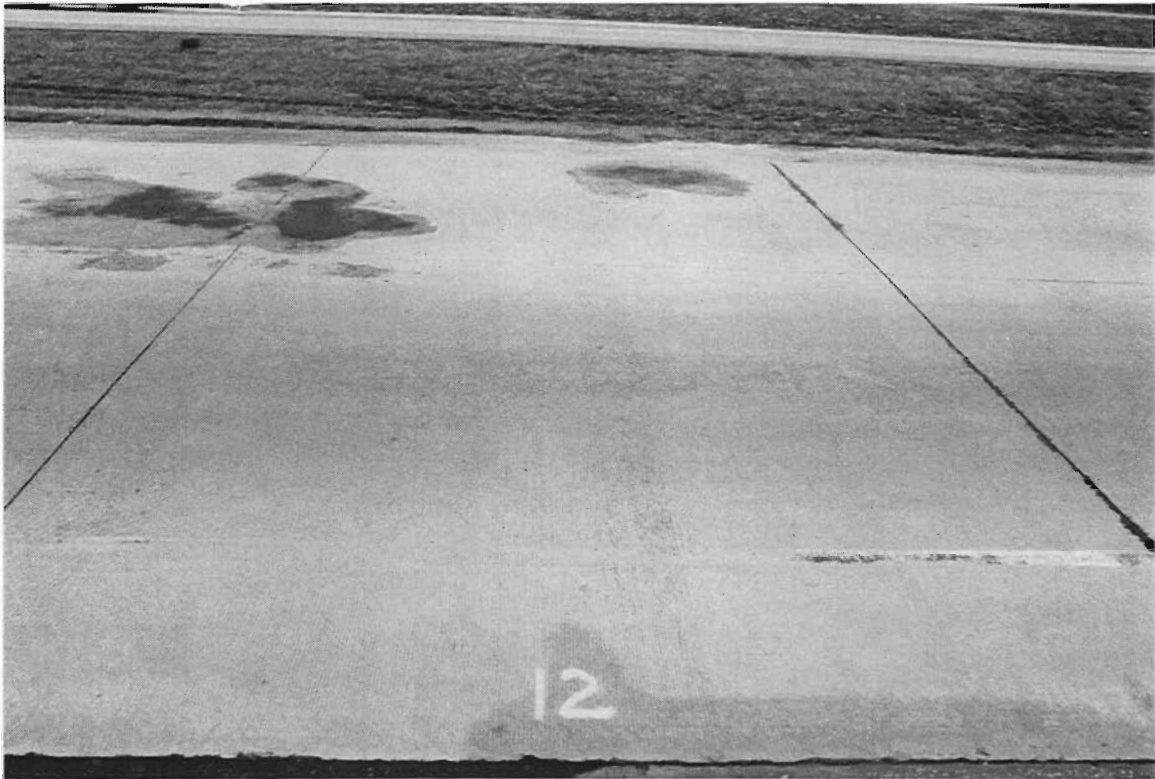
Figure A-4. Slab 12 shows mostly deeper spalling on the interior lanes.

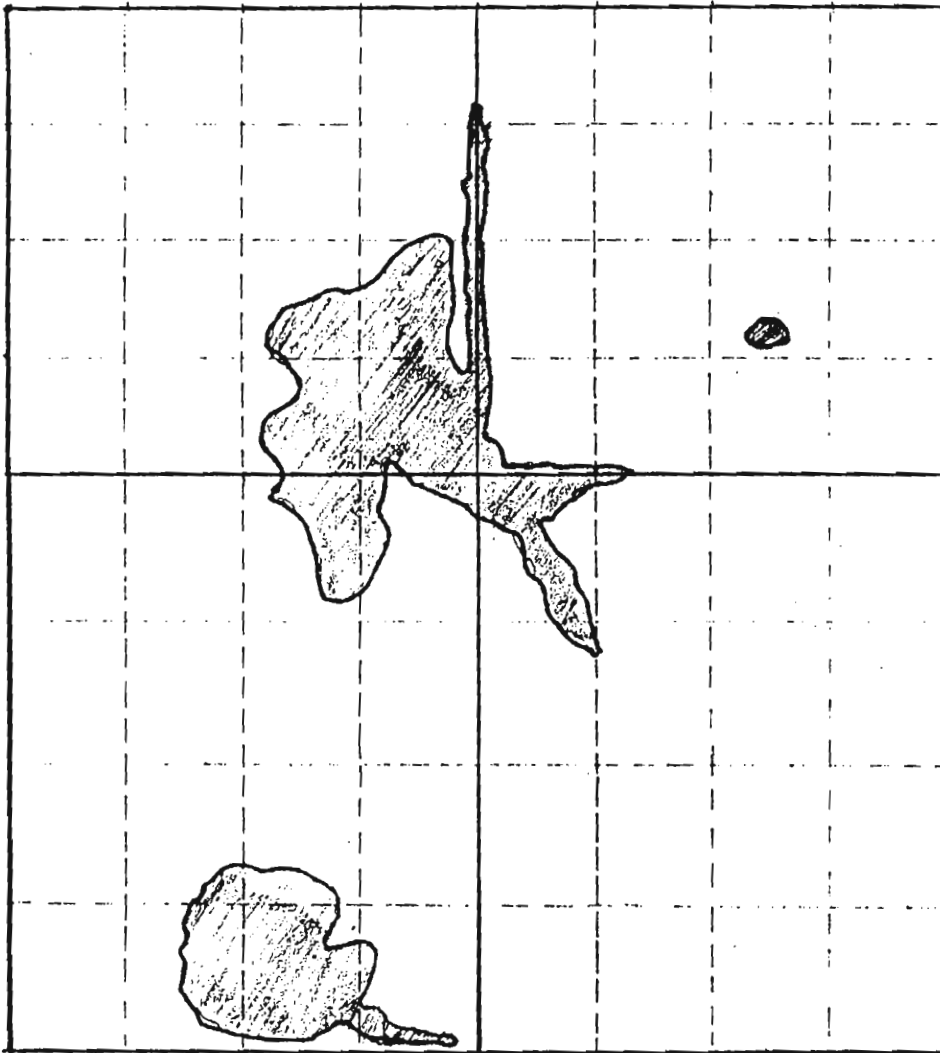
Figure A-5. Schematic of damage to slabs 14 and 15. The repair area for slab 14 is 39.8 sq ft, requiring 9.9 cu ft of material. Slab 15's repair area is 11.05 sq ft, requiring 2.9 cu ft of material.

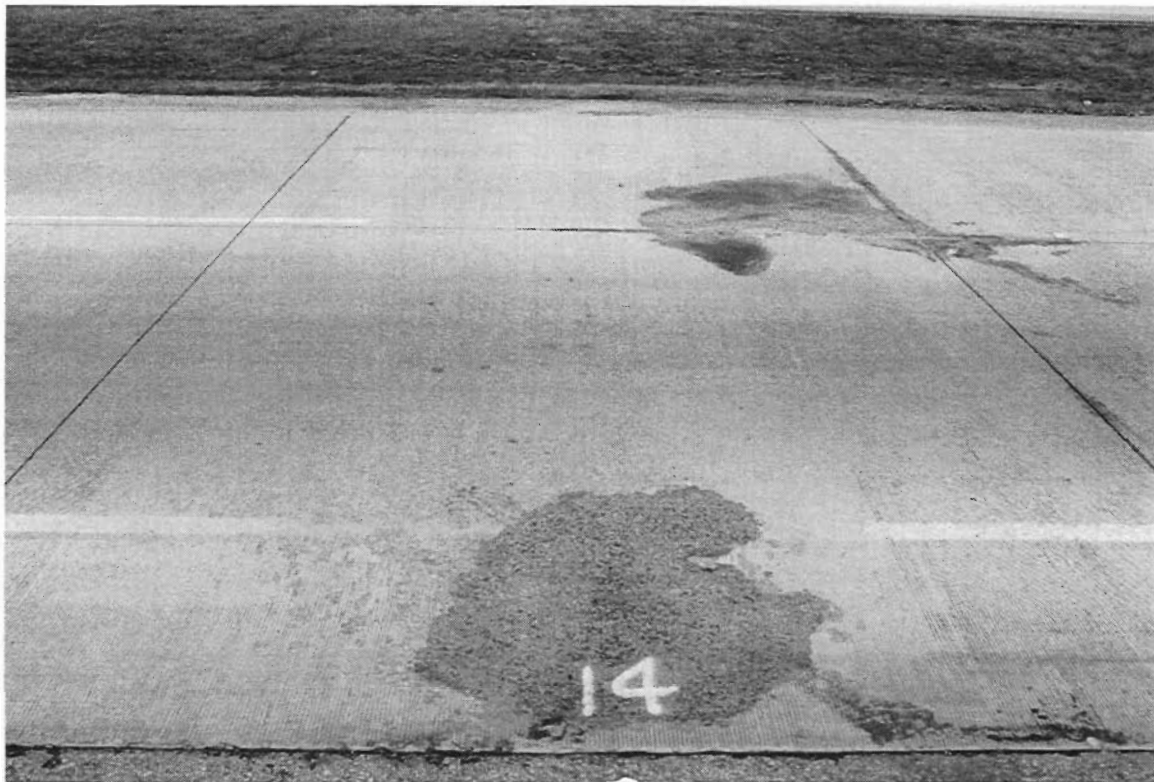
Figure A-6. Slab 14 shows asphalt-filled spalls in both outside and inside lanes.

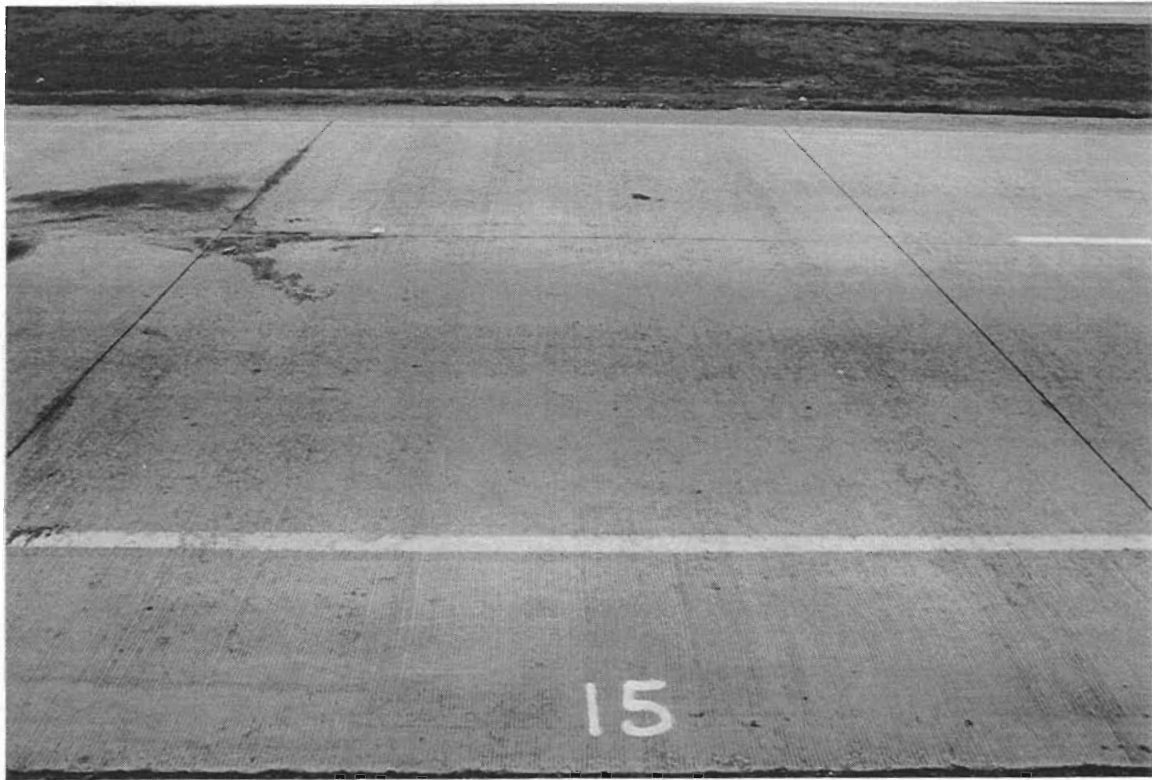
Figure A-7. Slab 15 has incurred damage mostly adjacent to the longitudinal and transverse joints where spilled chemicals collected and then burned.

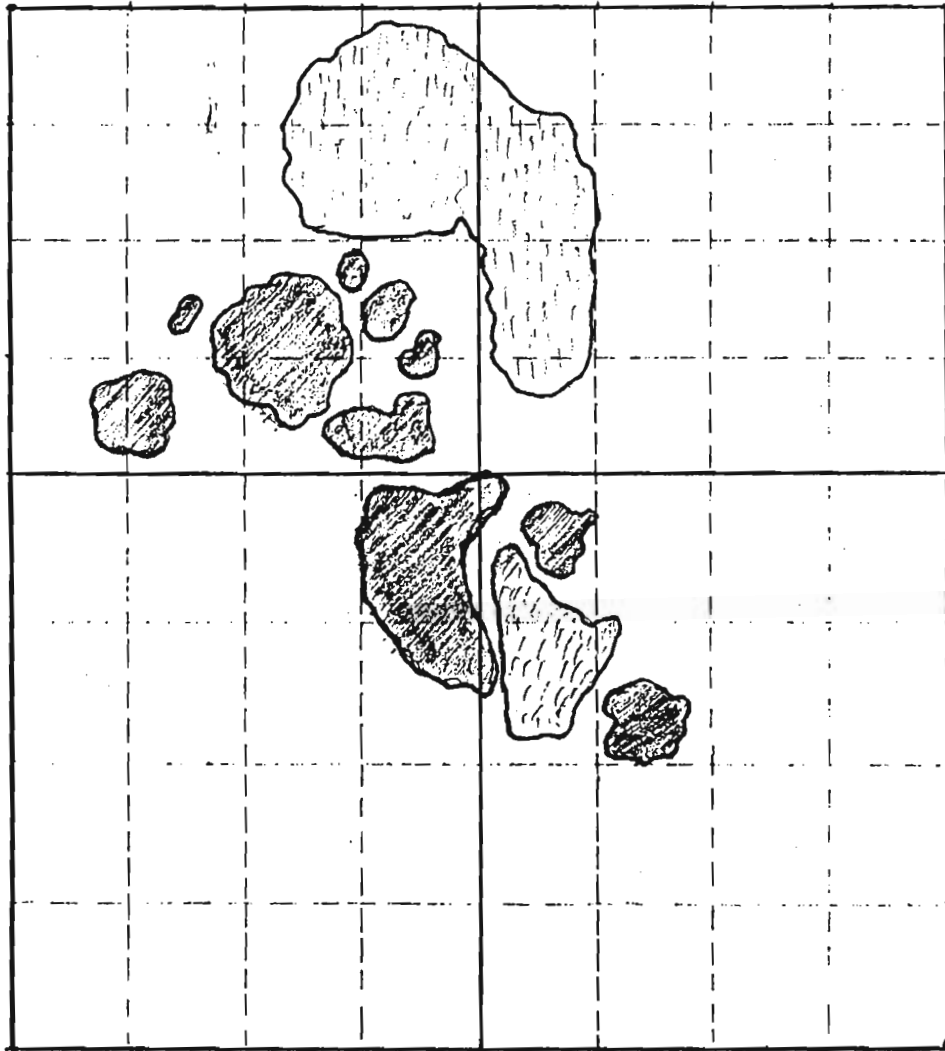
Figure A-8. Schematic of damage to slabs 18 and 19. Slab 18 repair area is 38.2 sq ft, requiring 9.6 cu ft of material. Slab 19 repair area is 6 sq ft, requiring 1.5 cu ft of material.

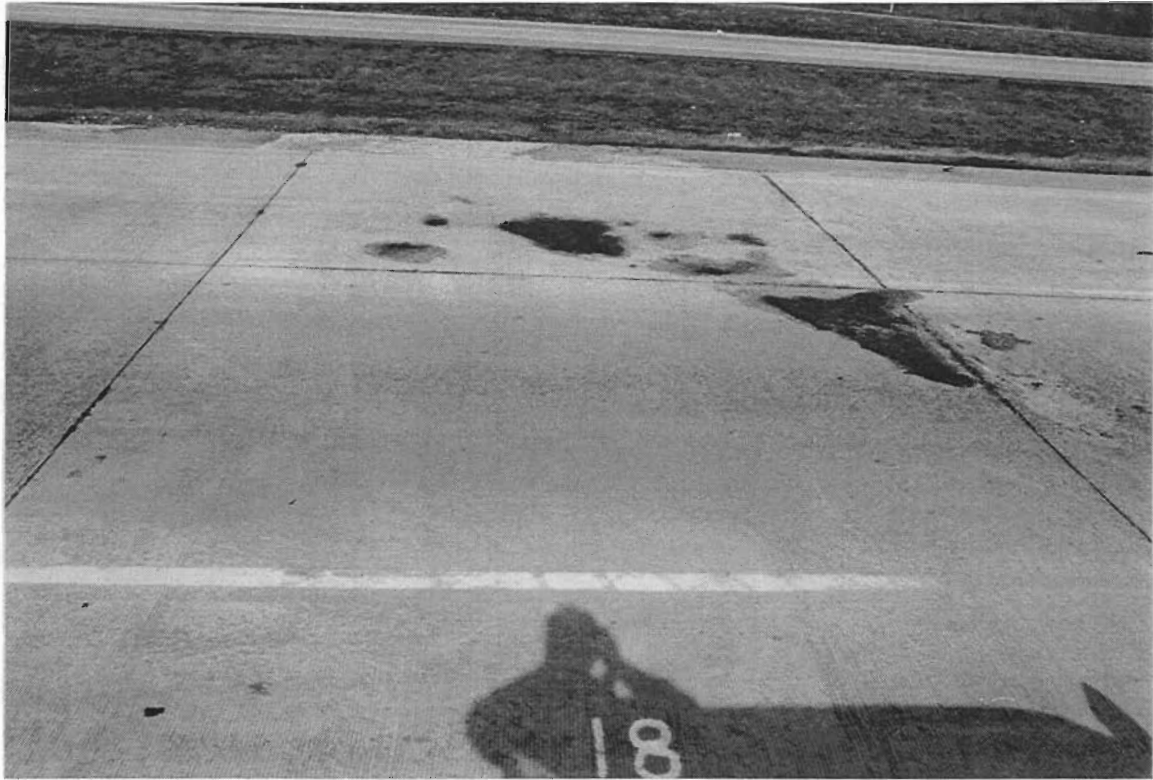
Figure A-9. Slab 18 shows asphalt patches indicative of deeper spalling.

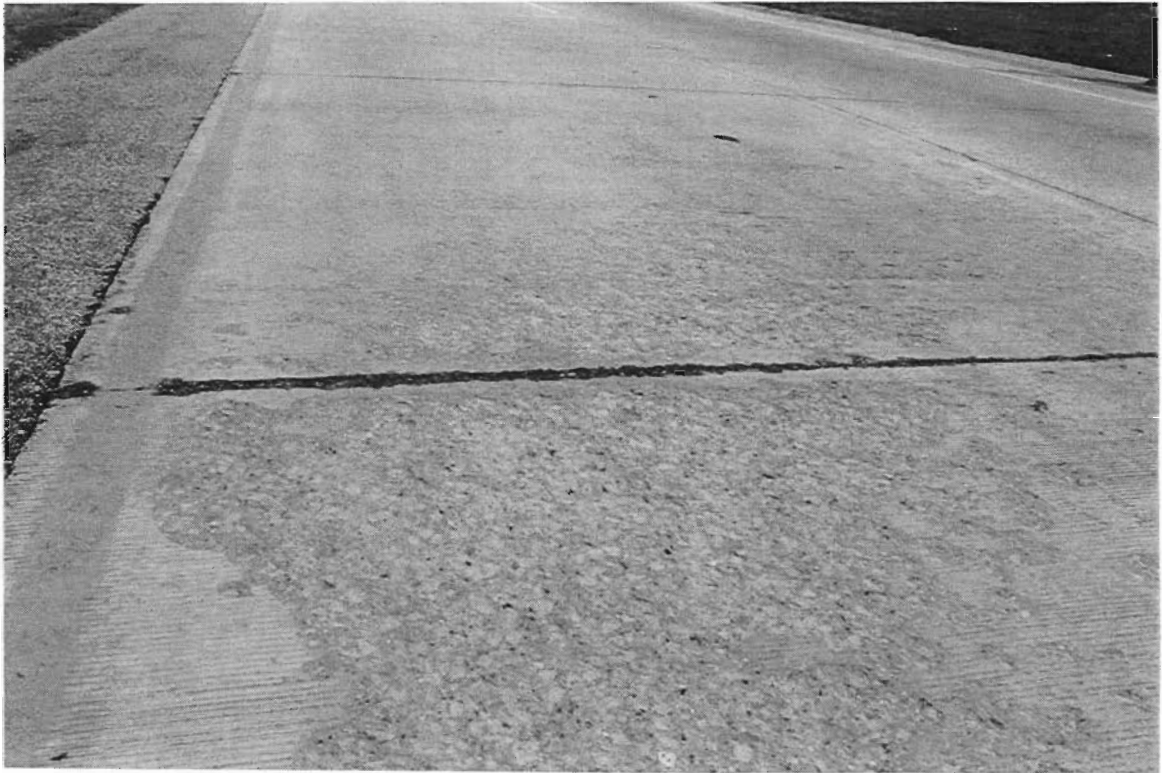
Figure A-10. An area of light spalling is also apparent on the inside lanes of slab 18.

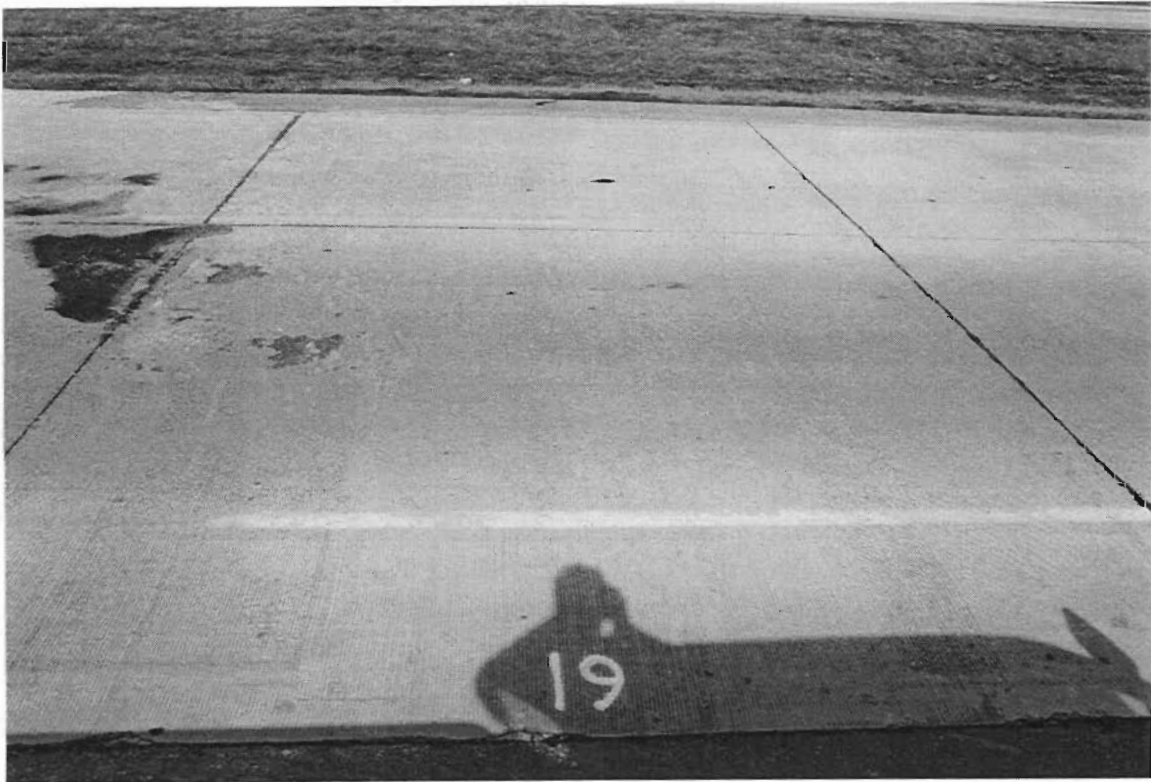
Figure A-11. Slab 19, like slab 18, has deeper spalls in the outside lanes and an area of light spalling on the inside lanes.

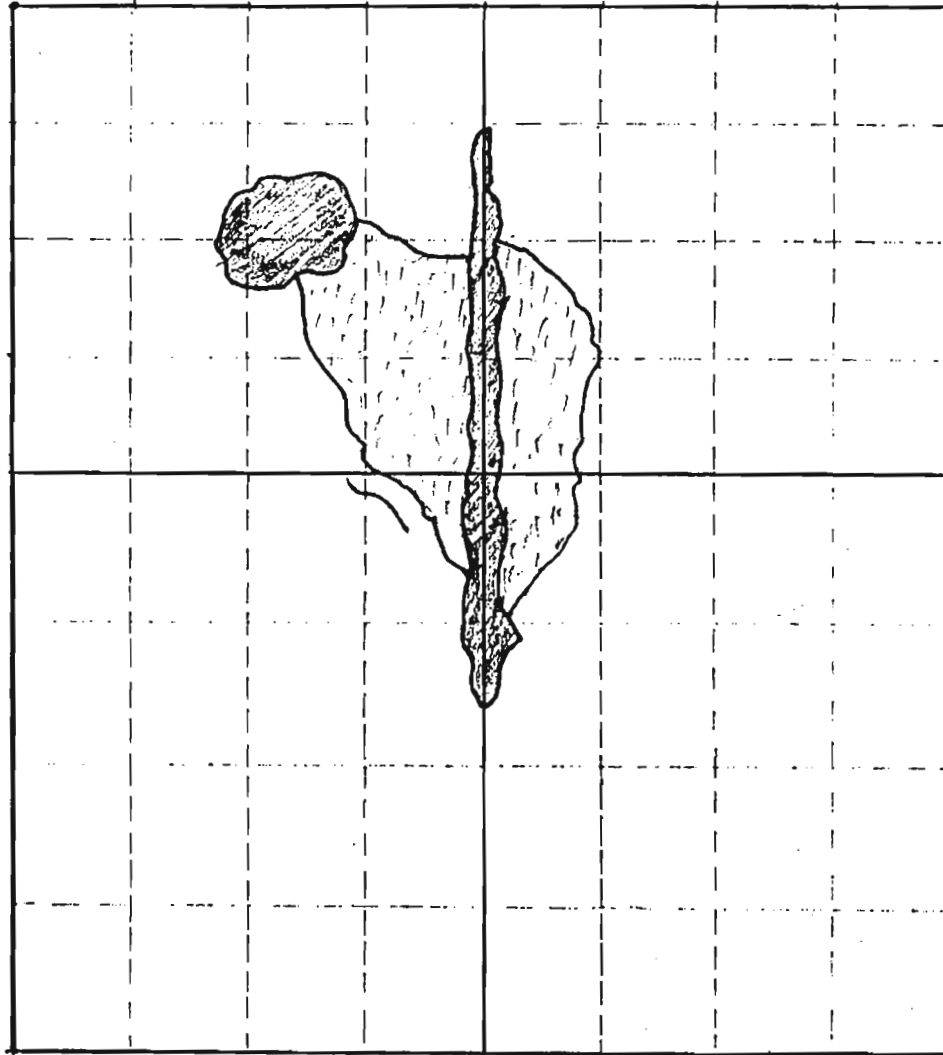
Figure A-12. Schematic of damage to slabs 22 and 23. Slab 22 repair area is 15 sq ft, requiring 3.75 cu ft of material. Slab 23 repair area is 8.2 sq ft, requiring 2.1 cu ft of material.

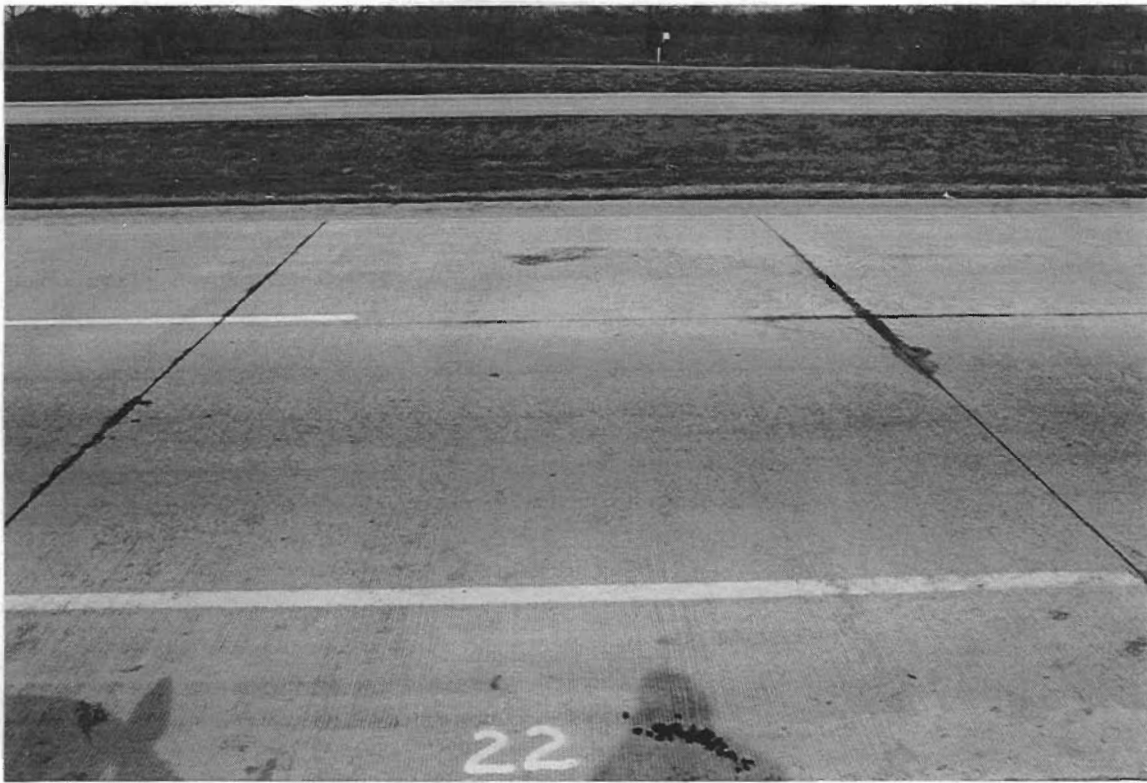
Figure A-13. Slab 22 shows one deeper spall in the middle of the inside lanes and another along the transverse joint with an area of light spalling between the two.
