1. Report No. <i>TX-95-1948-1F</i>		2. Government Accession No.		3. Recipient's Catalog No.	
4. Title and Subtitle <i>REPAIR OF FIRE-DAMAGED CONCRETE PAVEMENT ON IH-45 NEAR ANGUS, TEXAS</i>				5. Report Date <i>January 1995</i>

**REPAIR OF FIRE-DAMAGED
CONCRETE PAVEMENT
ON IH-45 NEAR ANGUS, TEXAS**

Research Report Number 1948-1F

Repair of Fire-Damaged Concrete Pavement on I-45 (Evaluation Near Corsicana, Texas)

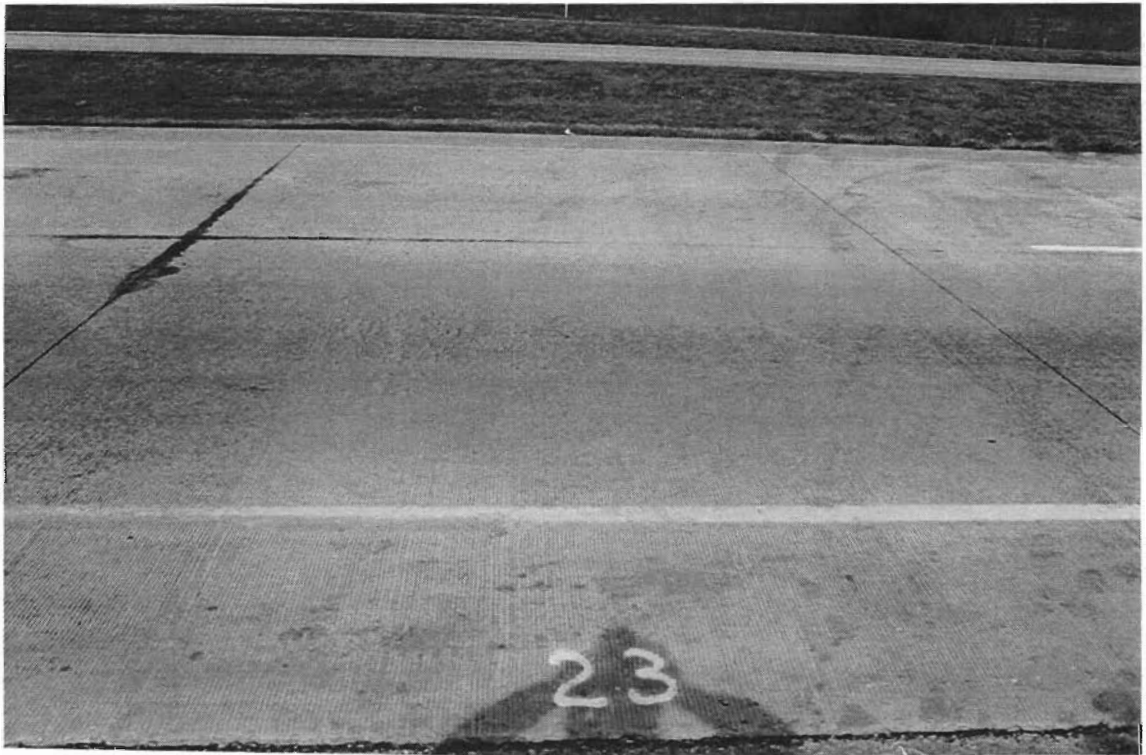
Figure A-14. Slab 23 has a small area of light spalling adjacent to the deeper spalling at the transverse joint.

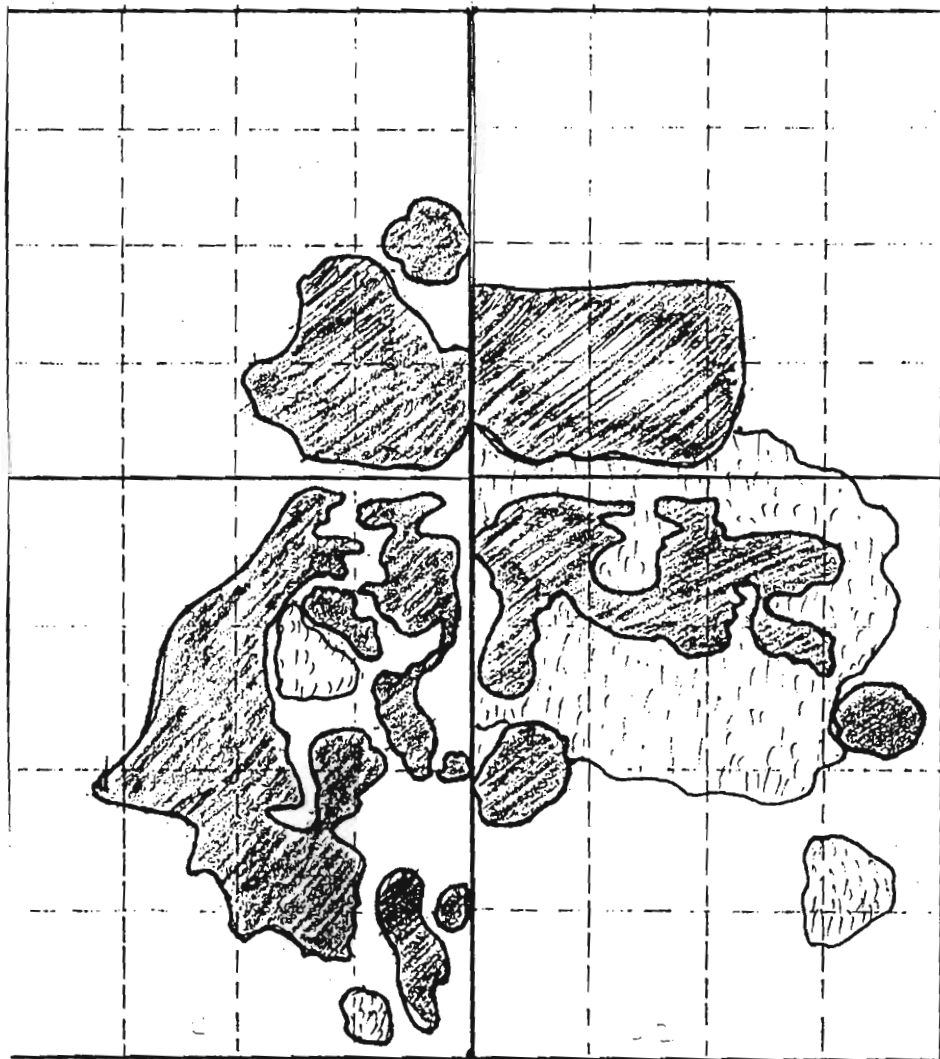
Figure A-15. Schematic of damage to slabs 41 and 42. Slab 41 repair area is over 77 sq ft, requiring more than 19 cu ft of material. Slab 42 repair area is almost 64 sq ft, requiring 16 cu ft of material.

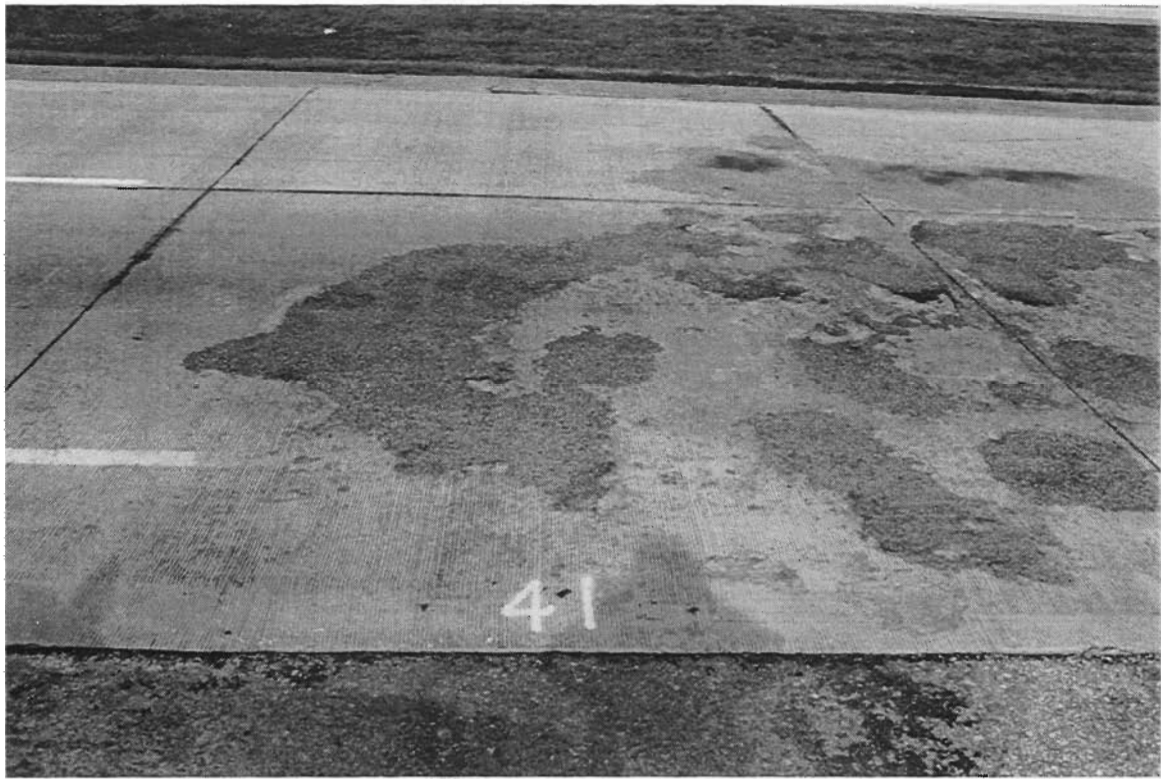
Figure A-16. Slab 41 shows several large areas of deeper spalling.

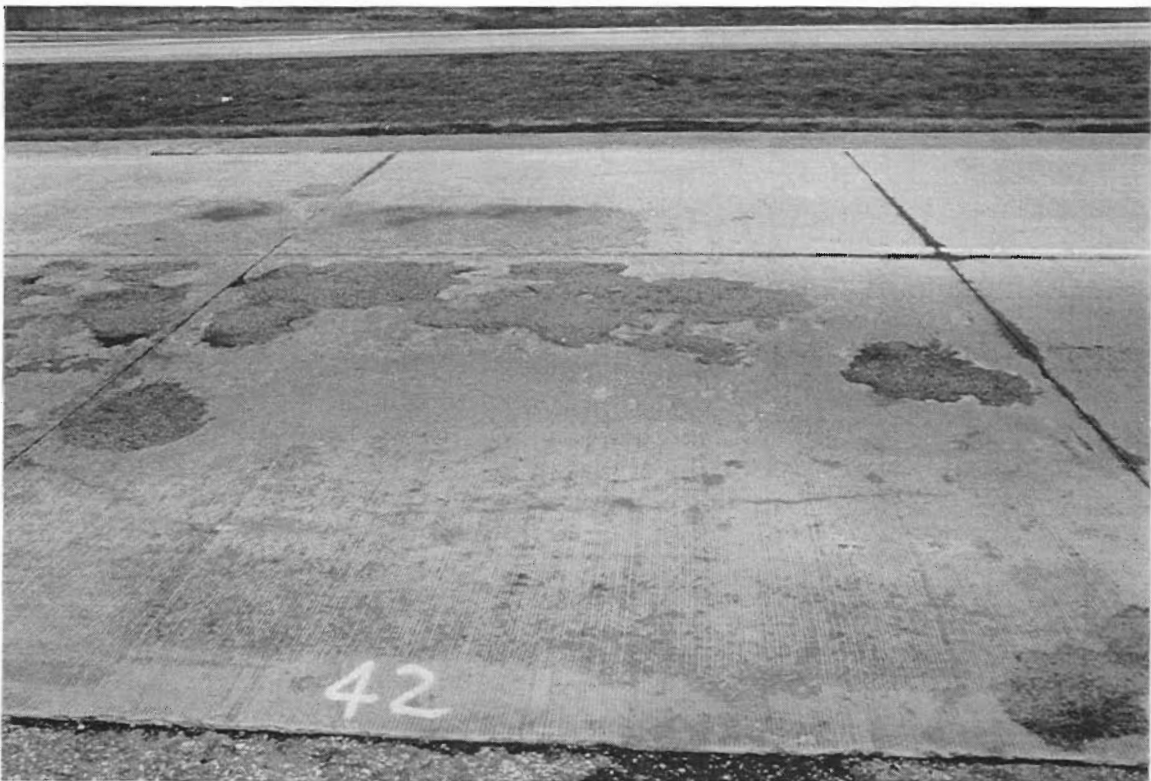
Figure A-17. Slab 42 shows a few areas of deeper spalling surrounded by a large area of light surface spalls.
