1. Report No. FHWA/TX-86/06+353-3F		2. Government Accession No.	
4. Title and Subtitle AN EXAMINATION OF EARTH SLOPE FAILURES IN TEXAS		5. Report Date November 1984

AN EXAMINATION OF EARTH SLOPE
FAILURES IN TEXAS

Research Report 353-3F

Stability Evaluation for Earth Slopes
Research Project 3-8-83-353

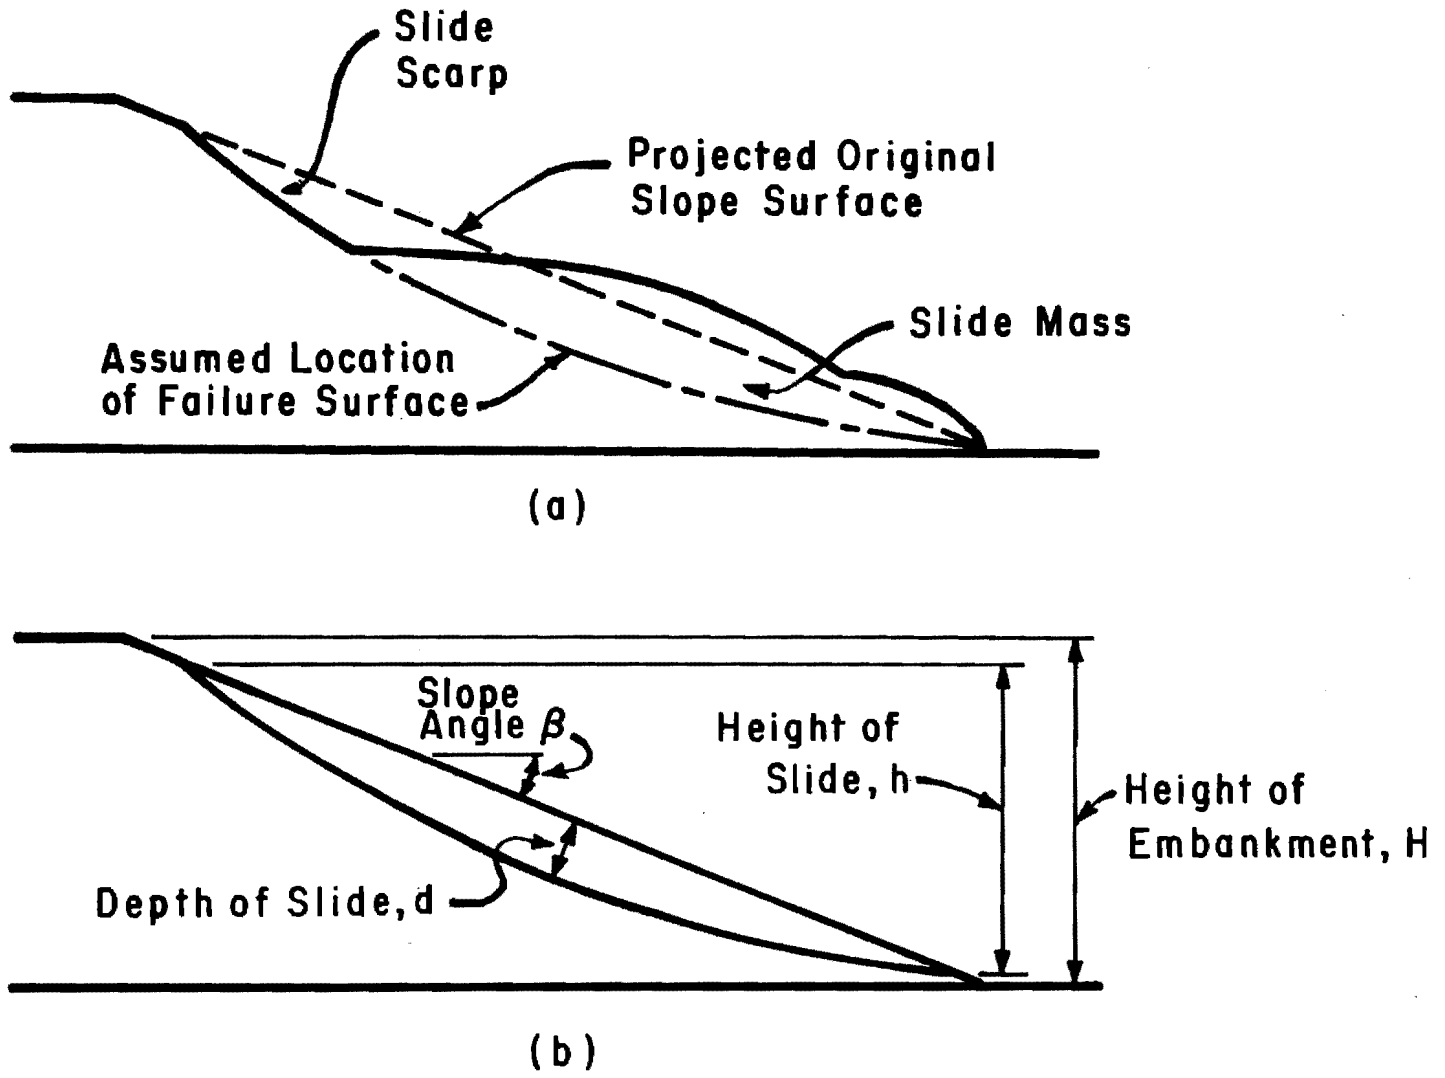
A typical cross-section of an embankment where failure has occurred is shown in Fig. 2.2. This cross-section represents an actual embankment slope failure which occurred at the northeast quadrant of the intersection of IH 610 and Scott Street in Houston. The cross-section as viewed in the field is shown in Fig. 2.2a, which shows how the slope and slide appeared at the time of the field inspection. The position of the failure surface was estimated from an examination of the slope and the slide mass geometry. The idealized cross-section is shown in Fig. 2.2b, which illustrates what was estimated to be the original embankment slope

Fig. 2.2. Cross-sections of embankment slope failure at IH 610 and Scott Street, District 12: (a) cross-section as viewed in field; (b) idealized cross-section and parameters used to define slope and slide geometry.

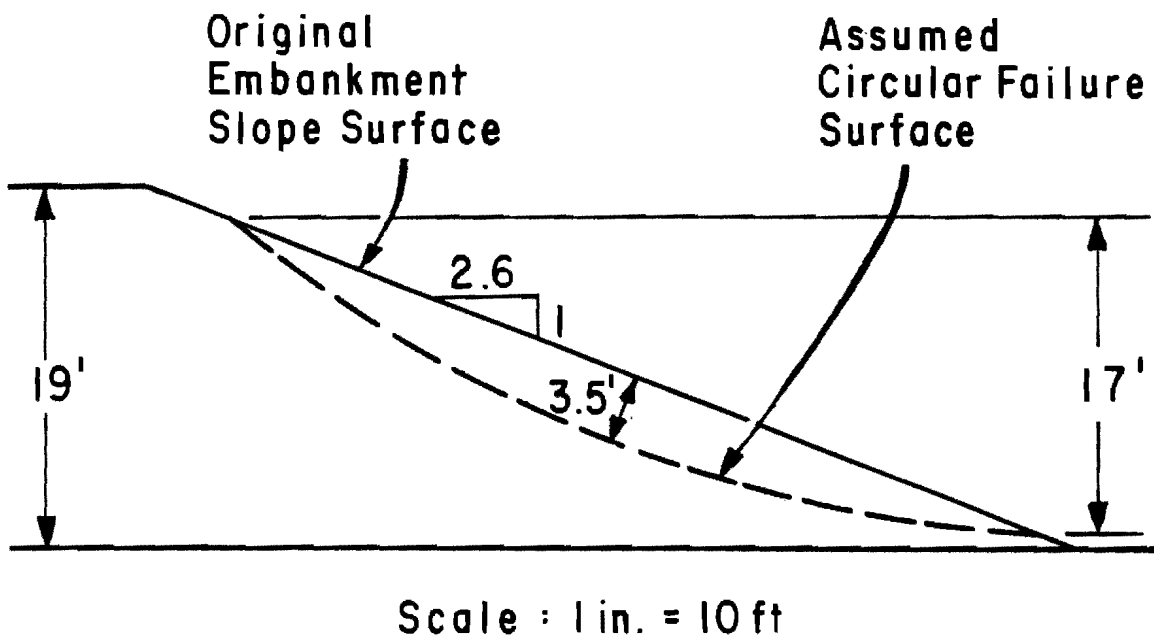
Fig. 5.3. Slope geometry and slide dimensions for the embankment slide at IH 610 and Scott Street (NE quadrant).

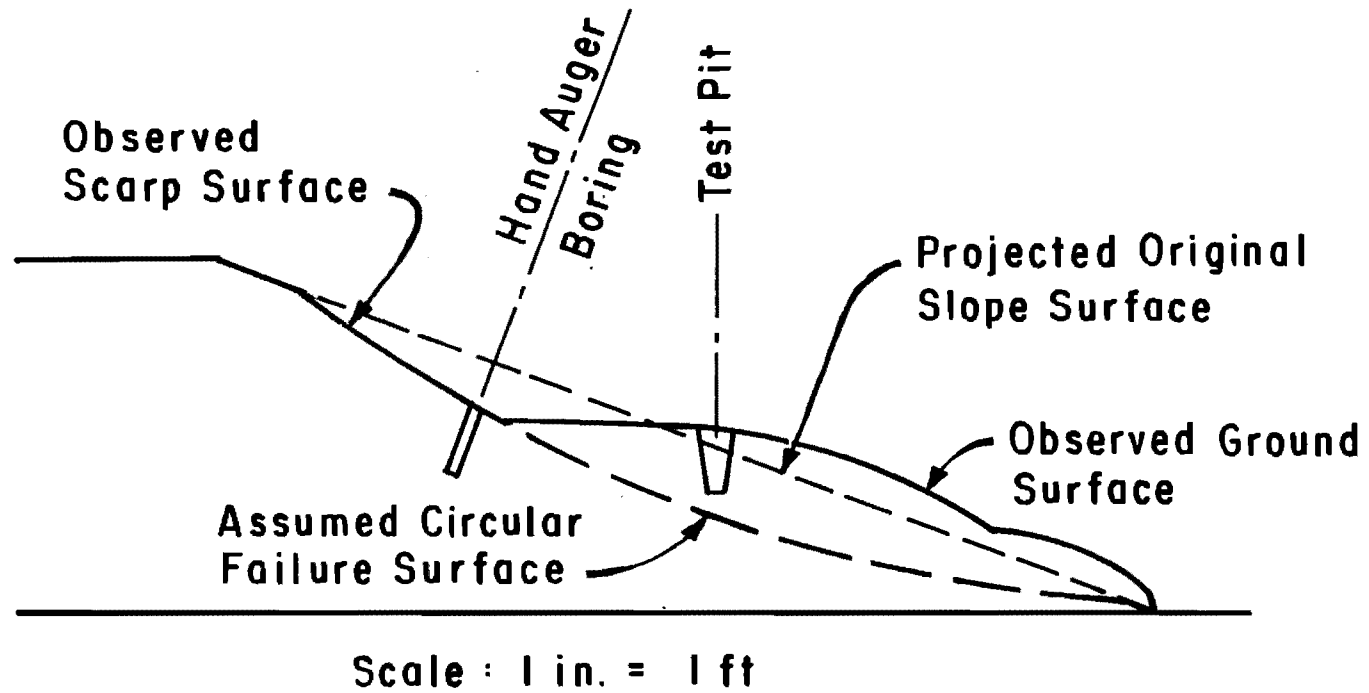
Fig. 5.5. Cross-section of embankment slide at IH 610 and Scott Street (NE quadrant) showing approximate locations of hand-augered borehole and test pit.

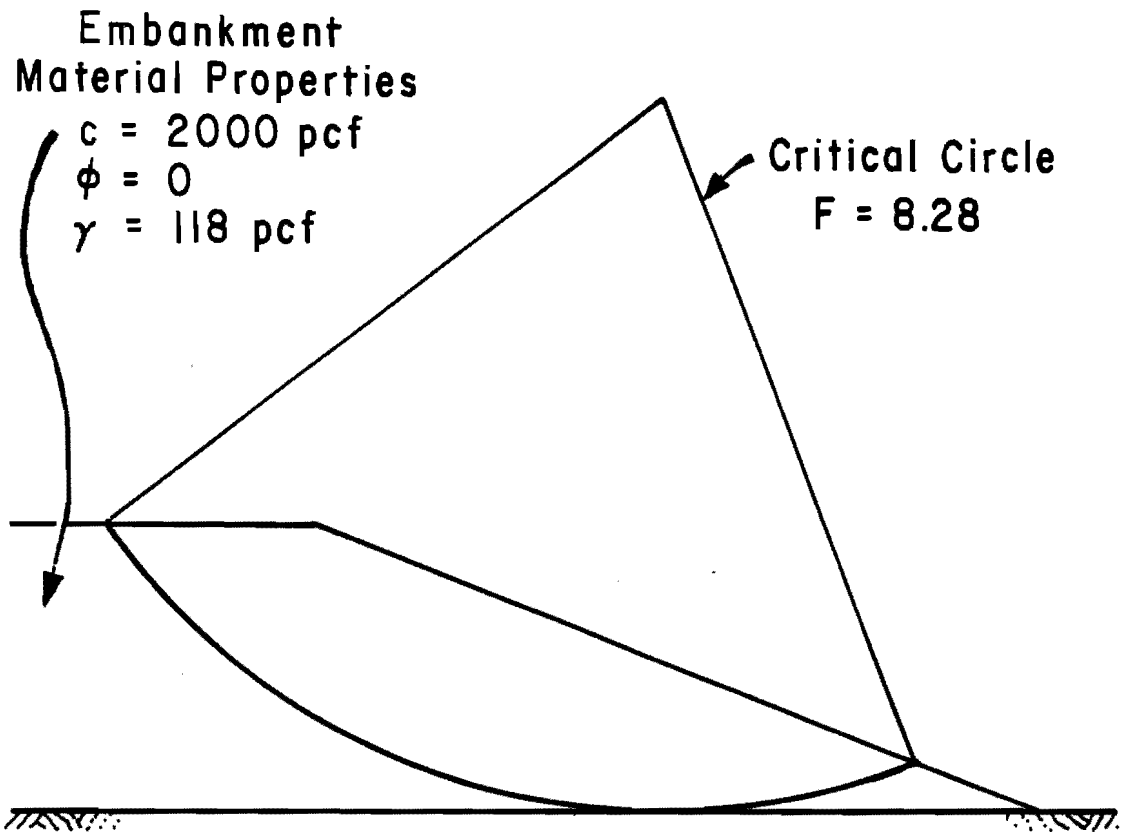
Fig. 5.10. Critical circle for embankment at IH 610 and Scott Street based on "short-term" stability calculations with shear strengths obtained from laboratory unconfined compression tests.

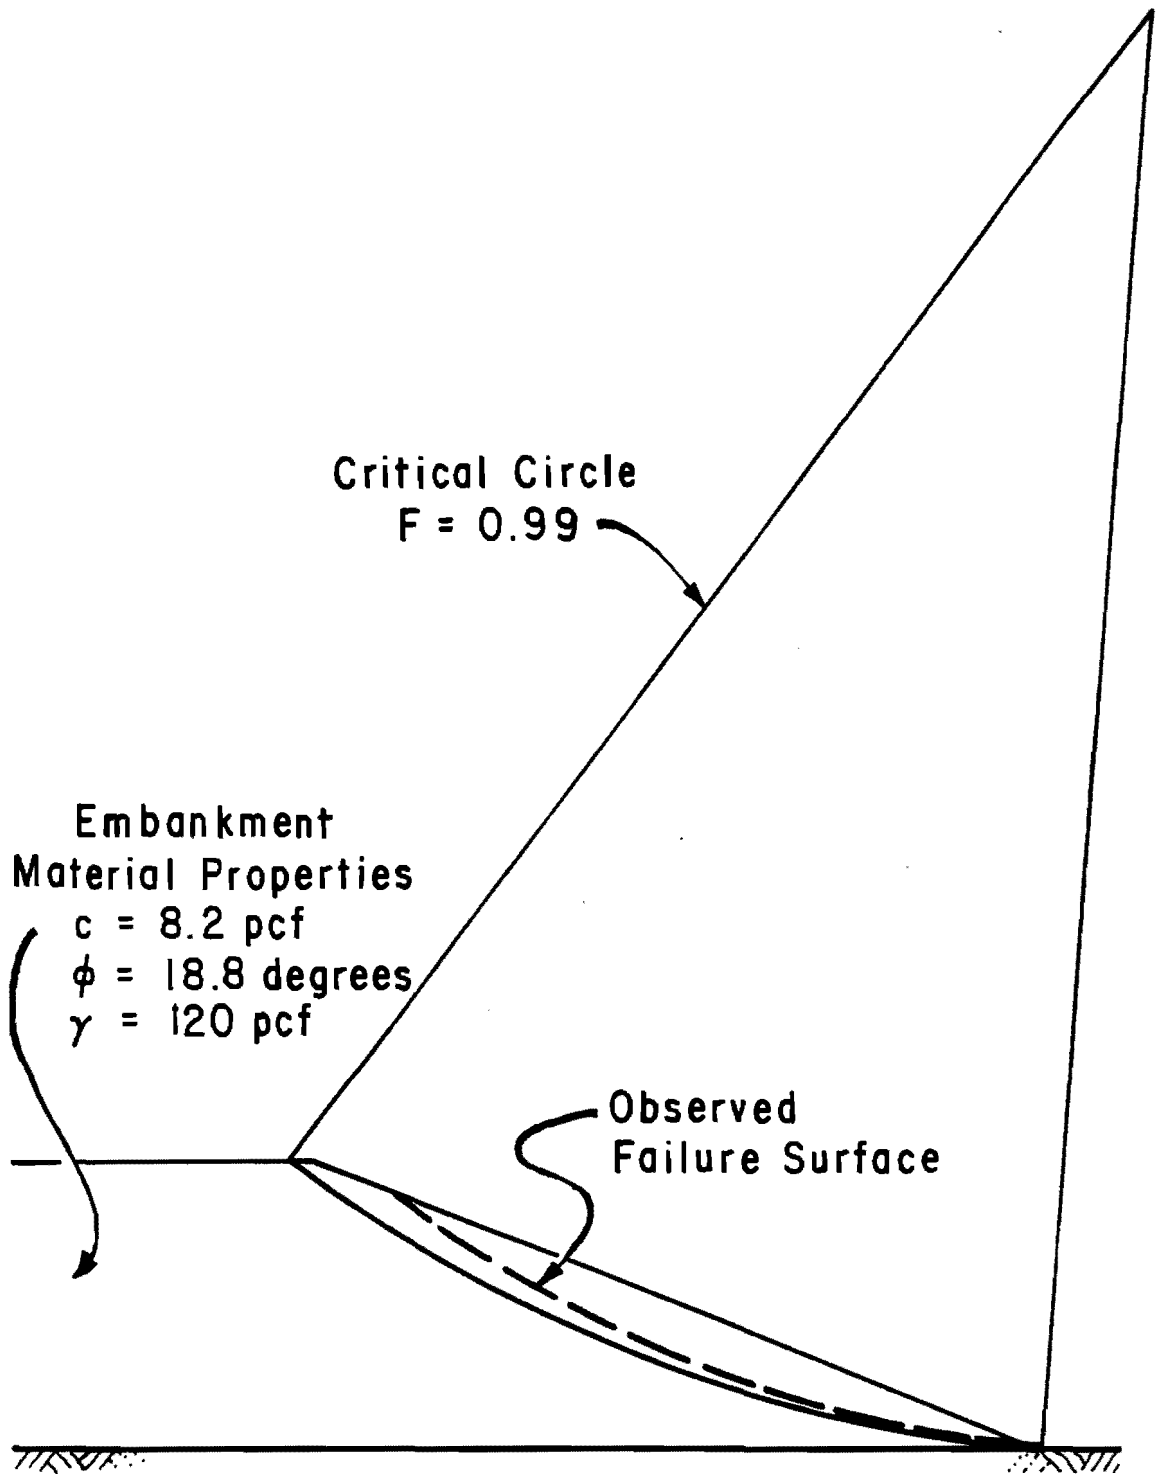
Fig. 5.11. Critical circle for embankment at IH 610 and Scott Street based on "long-term" stability calculations with back-calculated shear strength parameters - no pore water pressures.

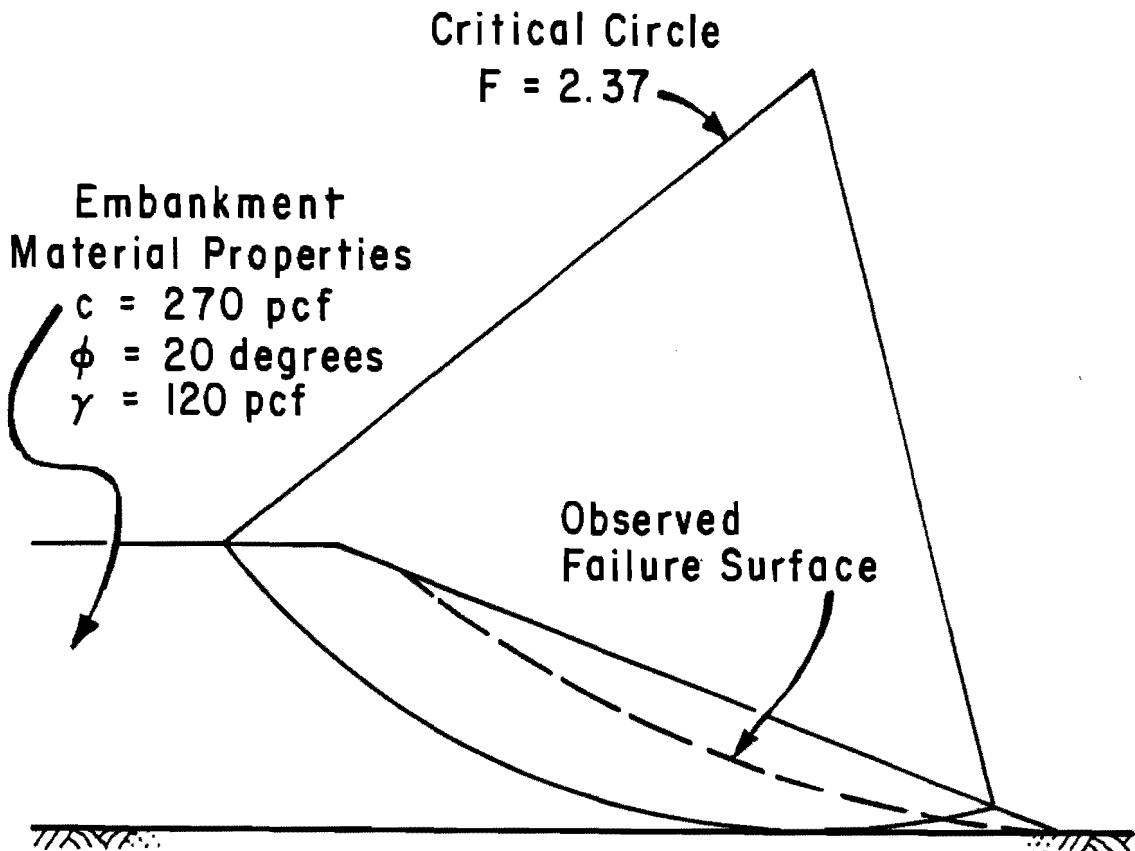
Fig. 5.12. Critical circle for embankment at IH 610 and Scott Street based on "long-term" stability calculations with shear strength parameters measured in the laboratory - no pore water pressures.

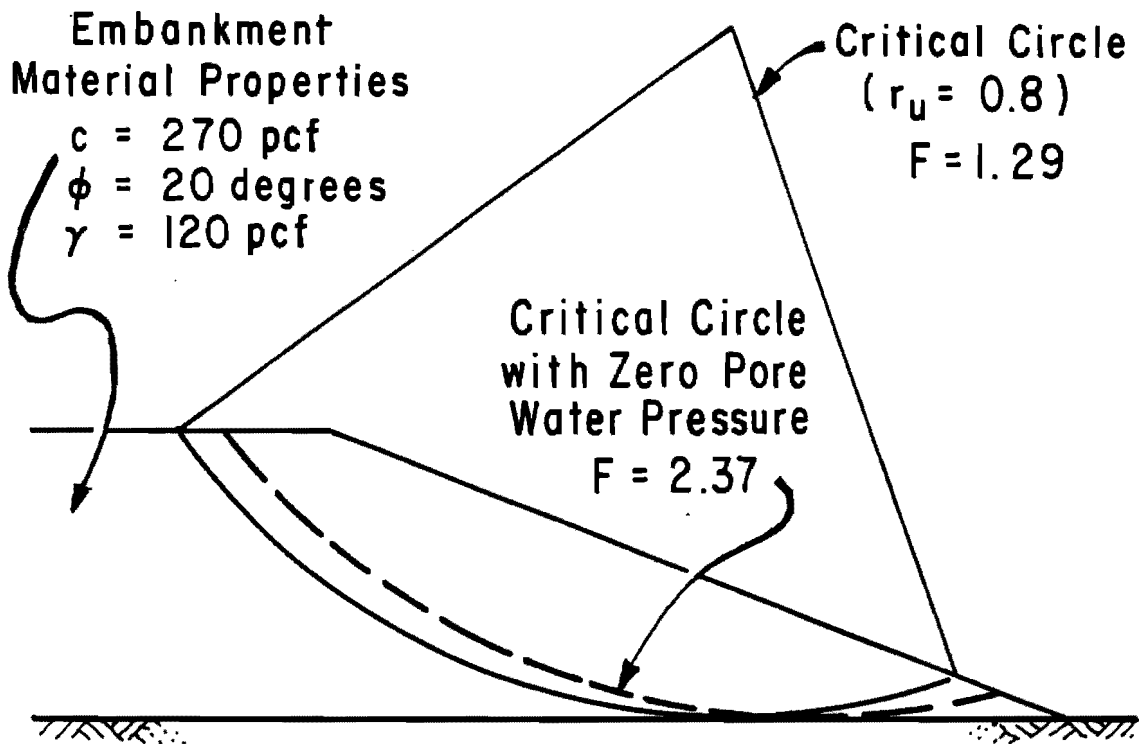
Fig. 5.13. Critical circle for embankment at IH 610 and Scott Street based on "long-term" stability calculations with shear strength parameters measured in the laboratory - pore water pressure ratio, $r_u = 0.8$.

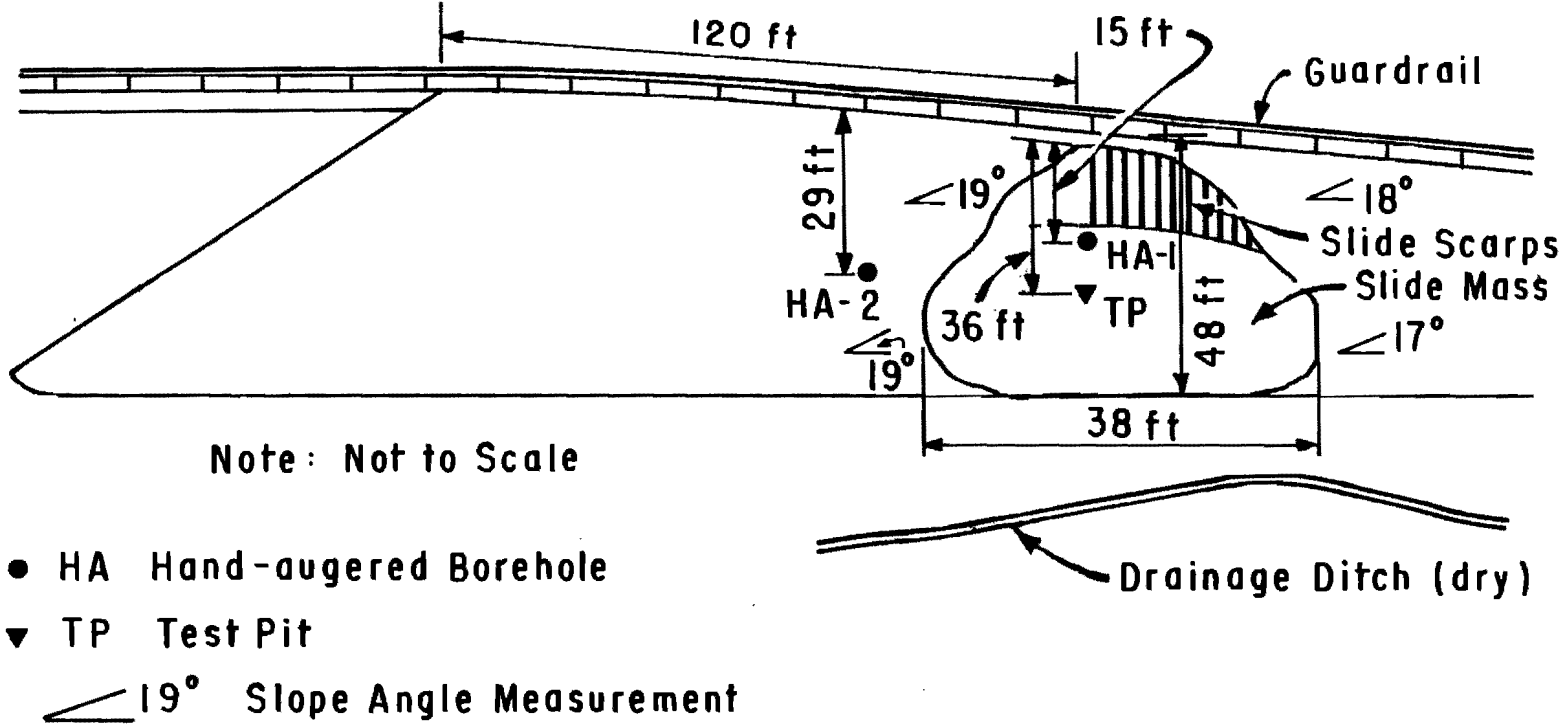
Fig. 5.14. Sketch of embankment at SH 225 and SH 146 (SW quadrant) showing extent of slope movement and sampling locations (redrawn from field sketch, 15 March 1983).

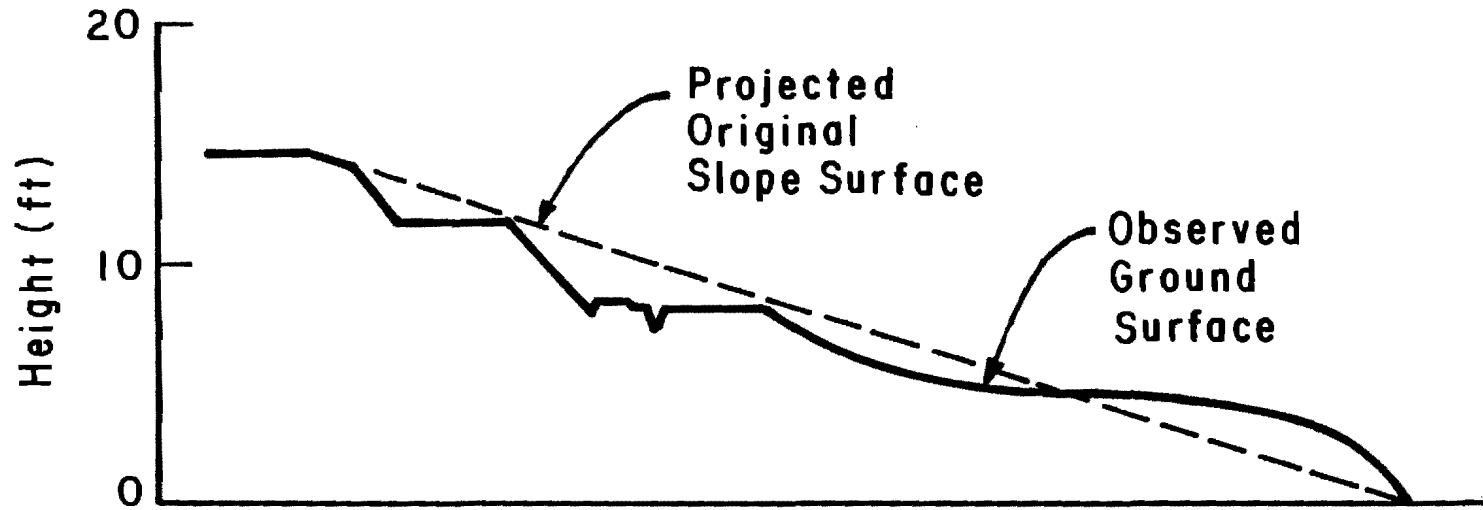
Fig. 5.15. Cross-section of embankment slide at SH 225 and SH 146 (SW quadrant).

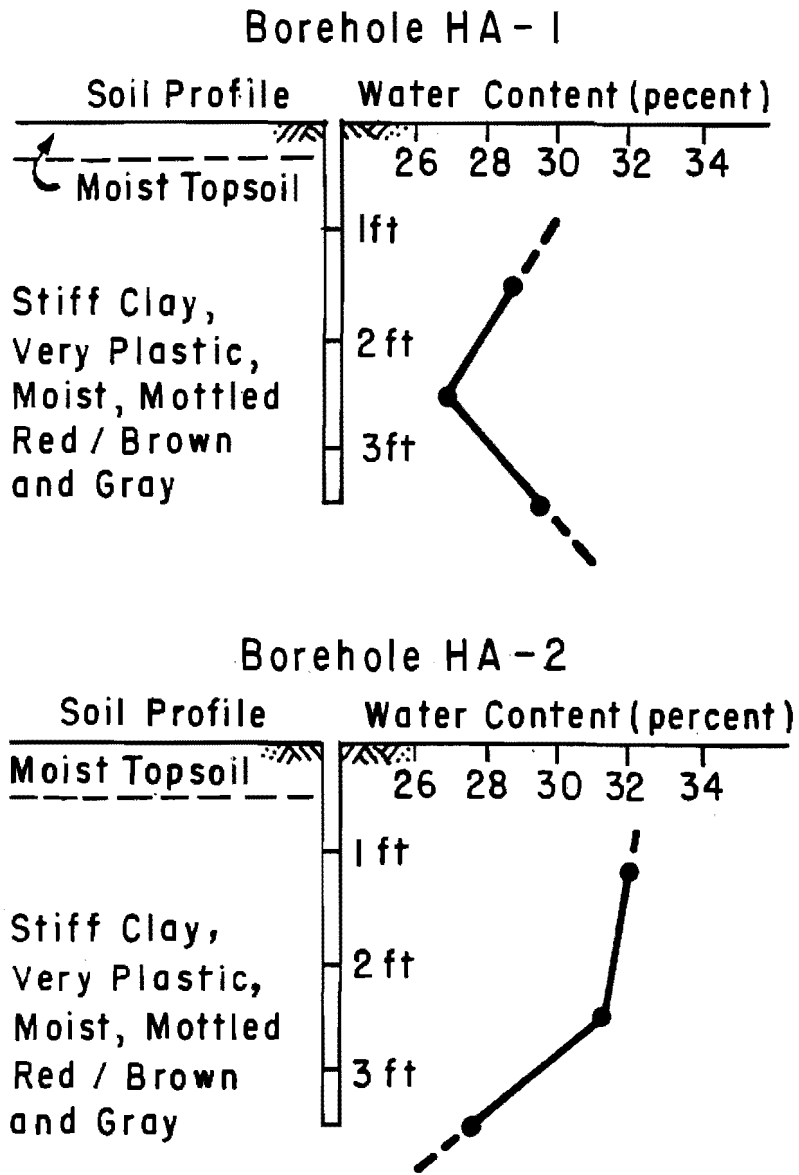
Fig. 5.16. Soil and water content profiles for two hand-augered boreholes at SH 225 and SH 146 (SW quadrant).

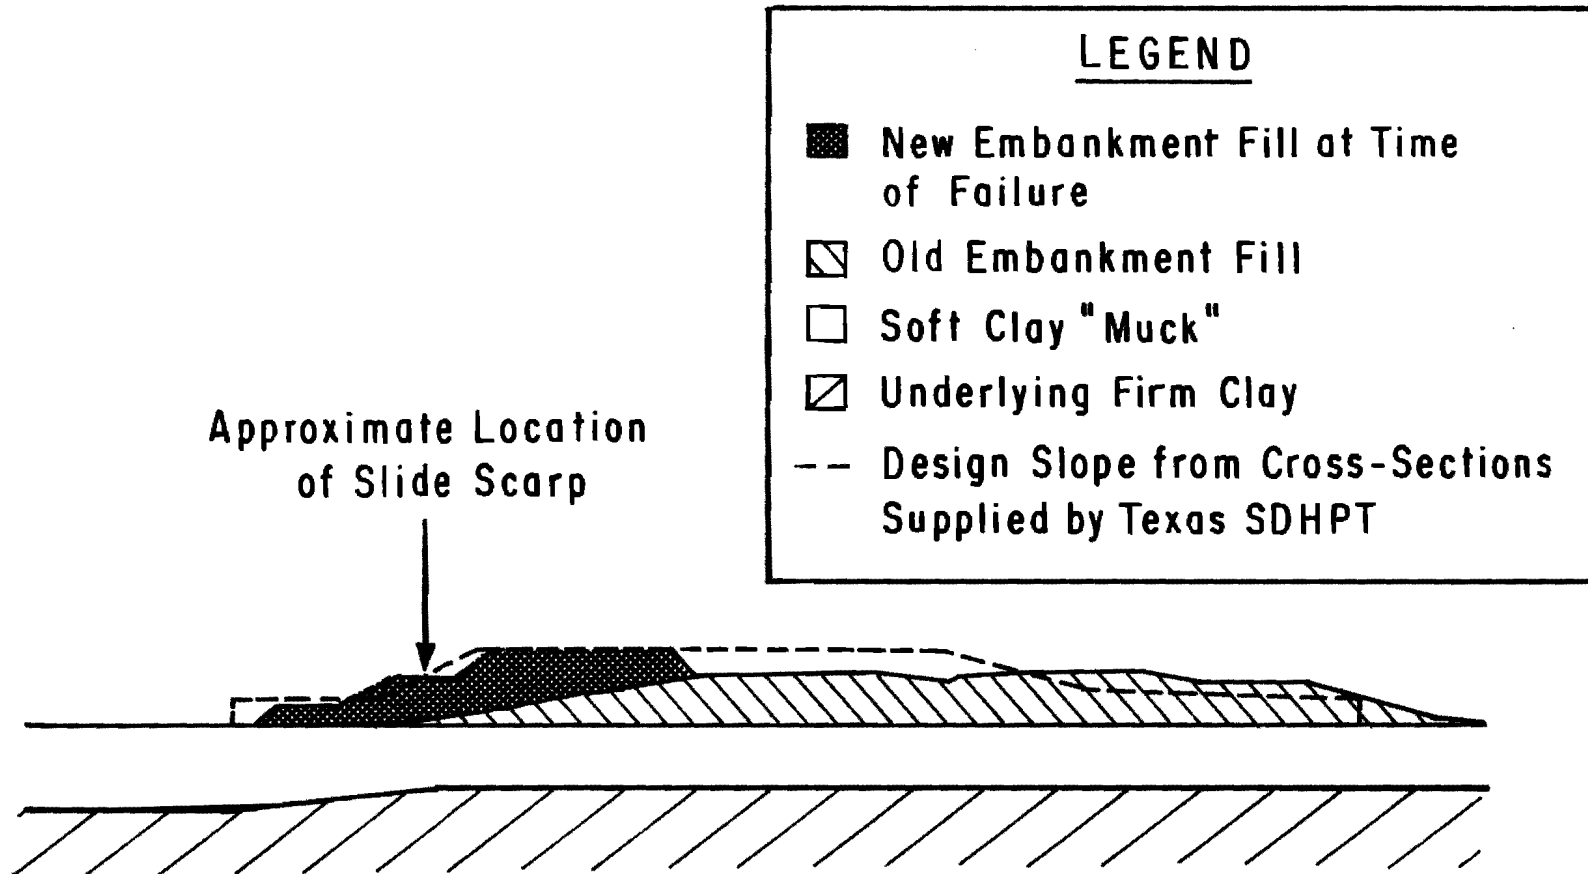
Fig. 7.1. Cross-section of SH 358 embankment near Oso Bay at Station 160 + 00 near the location of the failure.

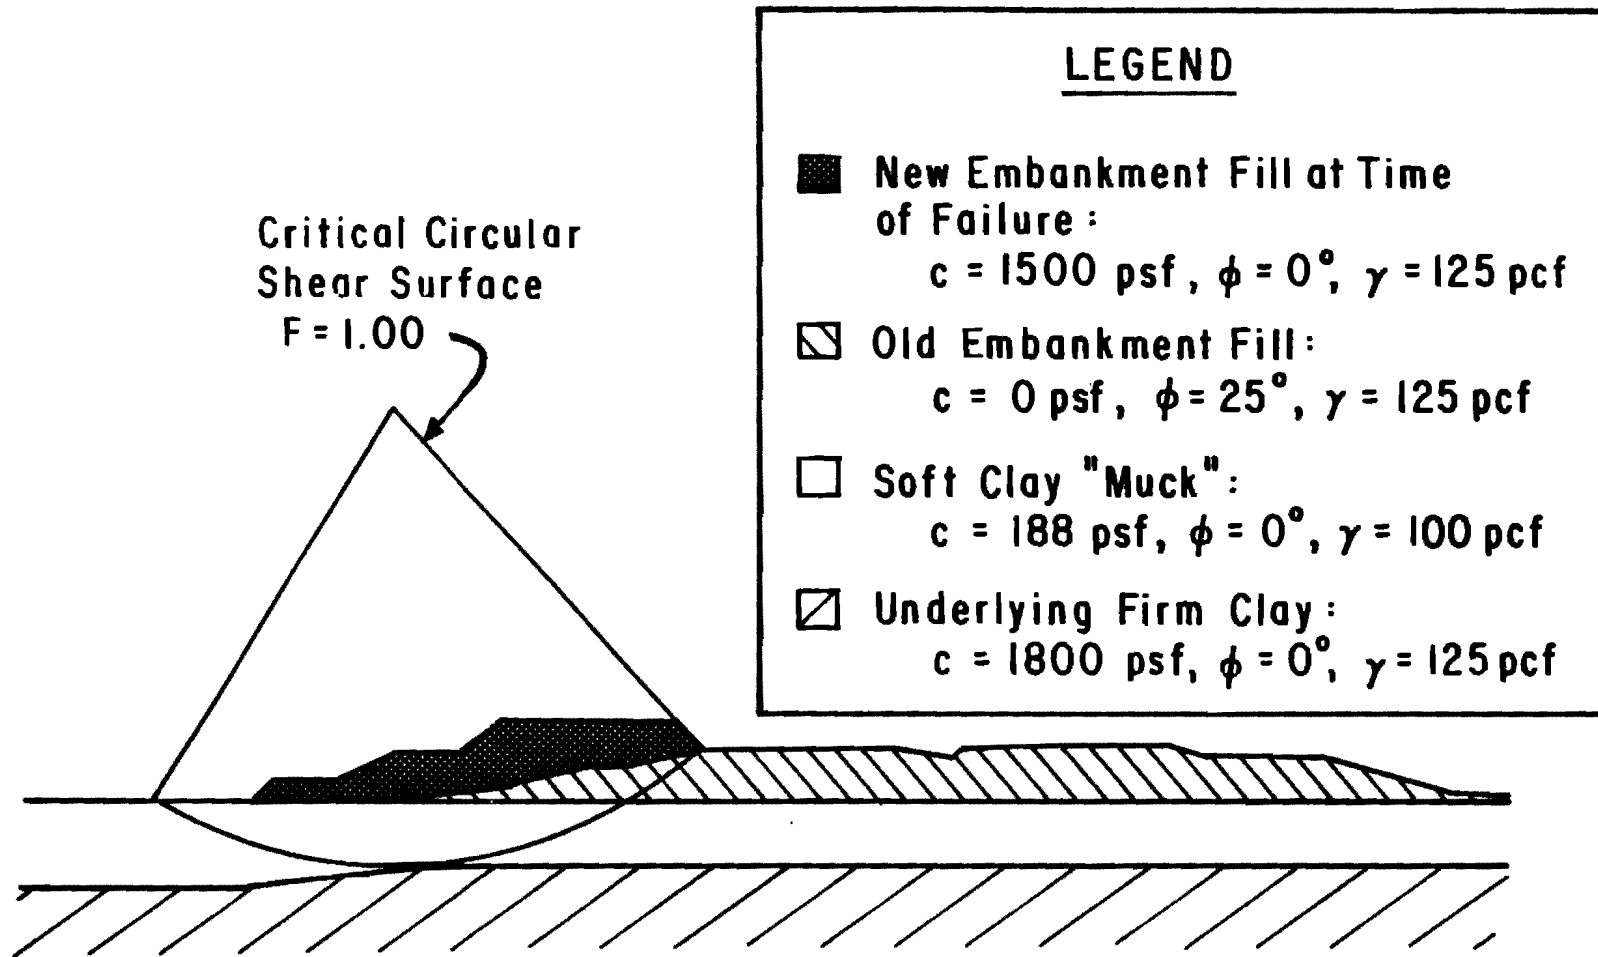
Fig. 7.5. Critical circle for Oso Bay embankment based on stability calculations for conditions at the time of failure with the new embankment characterized as a purely "cohesive" ($\phi = 0$) material.

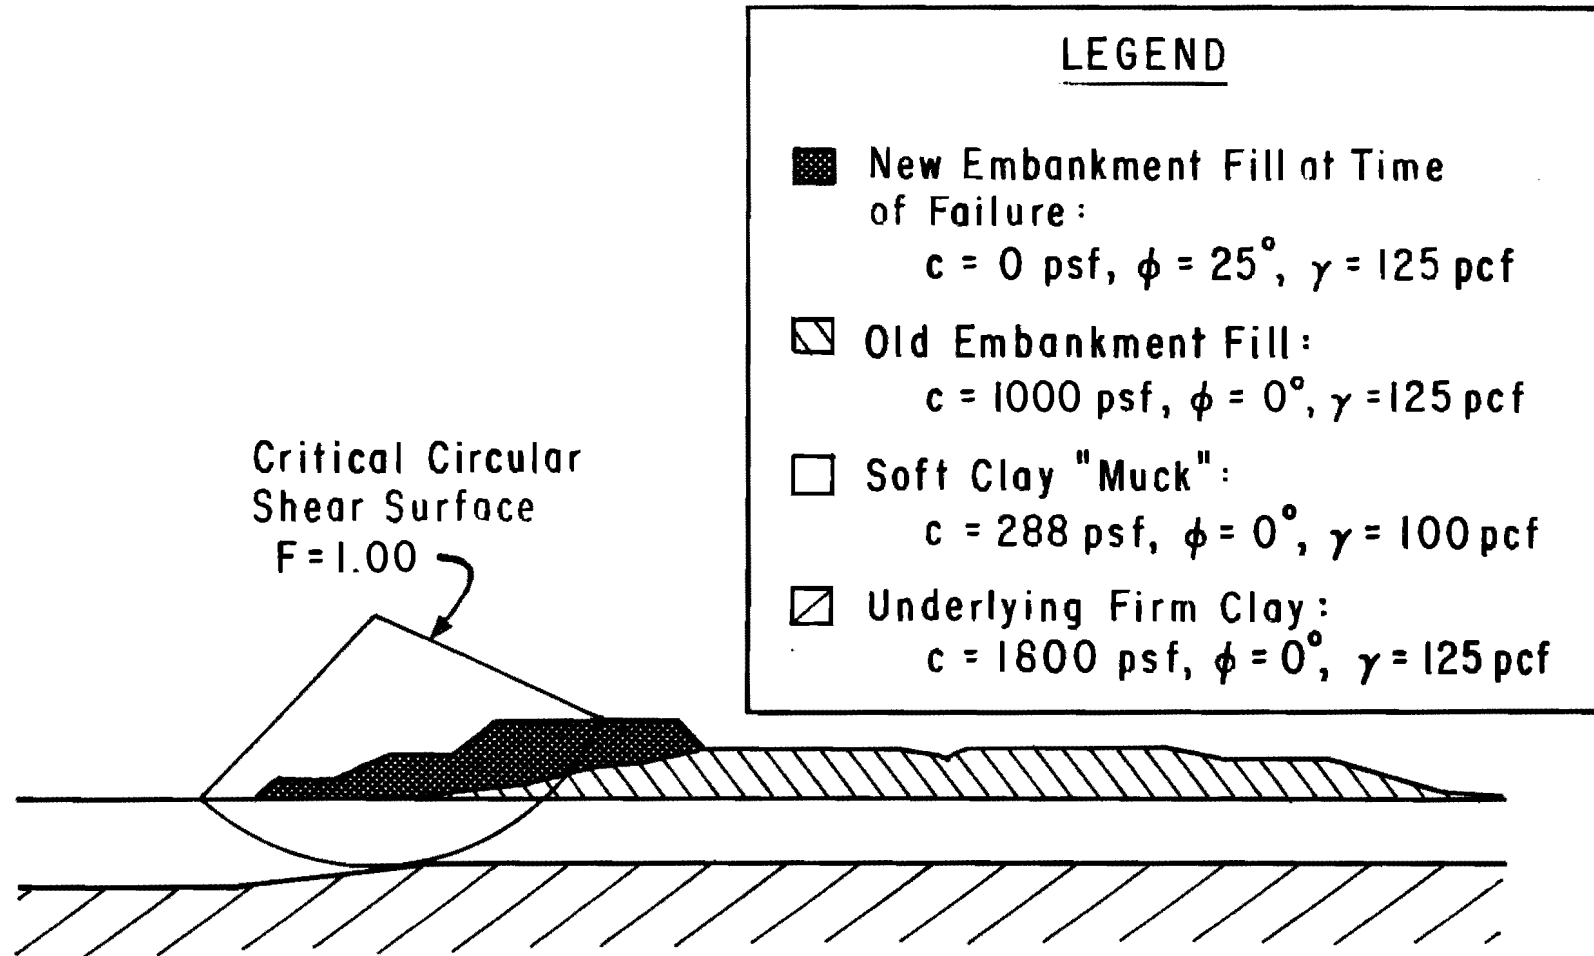
Fig. 7.6. Critical circle for Oso Bay embankment based on stability calculations for conditions at the time of failure with the new embankment characterized as a cohesionless ($c = 0$) material.

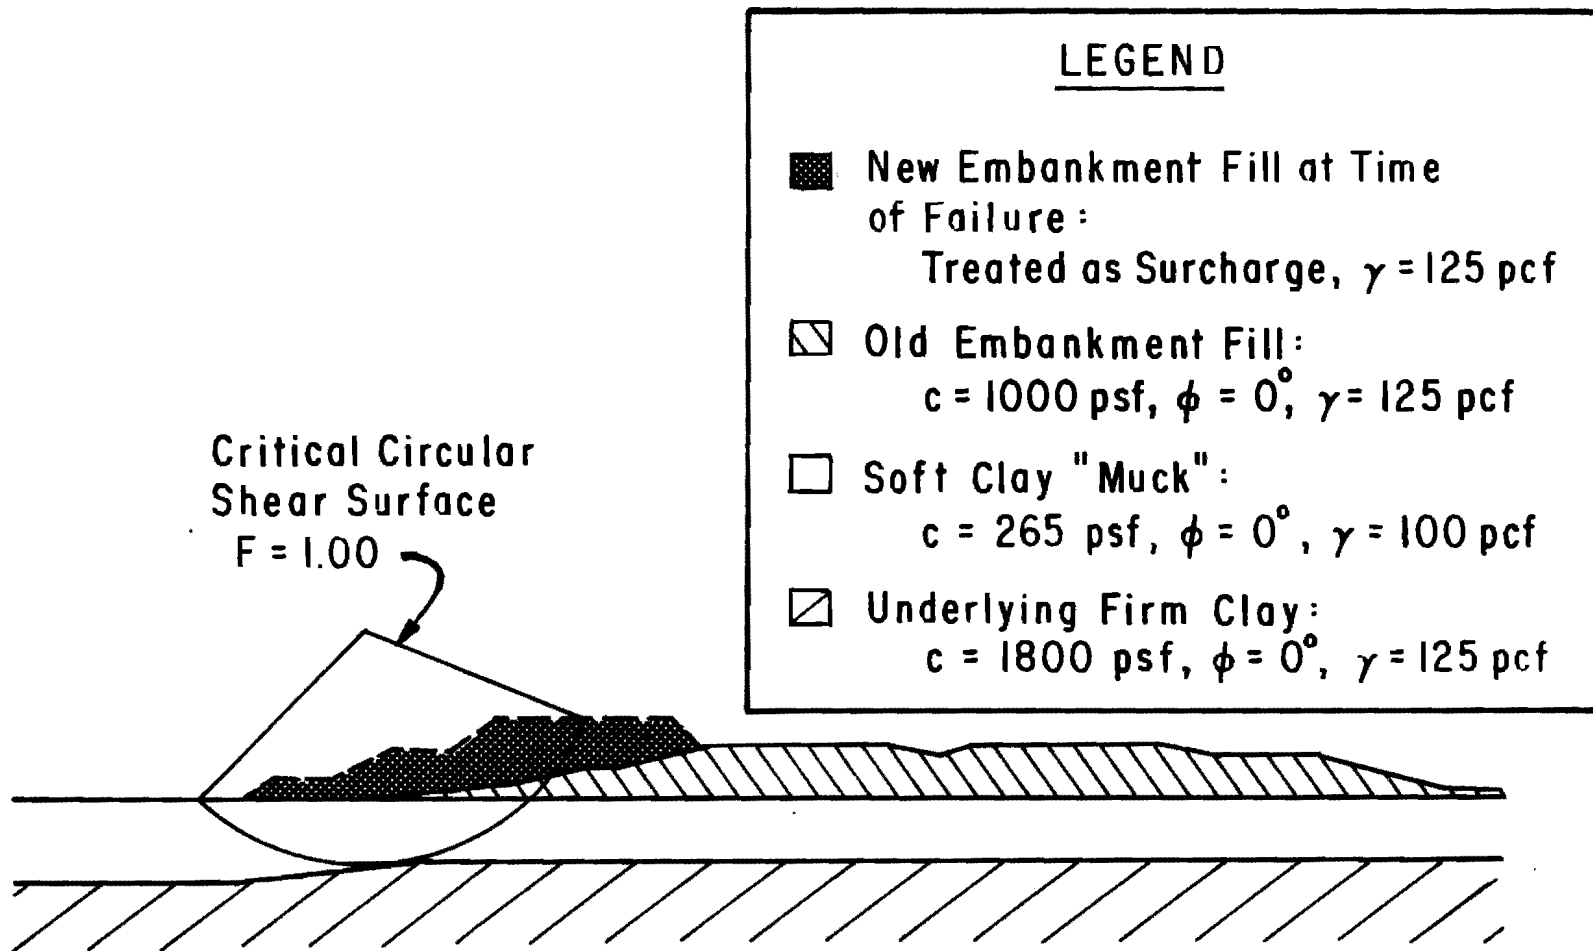
Fig. 7.7. Critical circle for Oso Bay embankment based on stability calculations for conditions at the time of failure with the new embankment characterized as a surcharge.
