# INVESTIGATION OF CONCRETE COATING PROBLEMS

**Research Report 451-1F**

Research Project 3-9-86-451  
Concrete Coating Problems

Texas State Department of Highways  
and Public Transportation

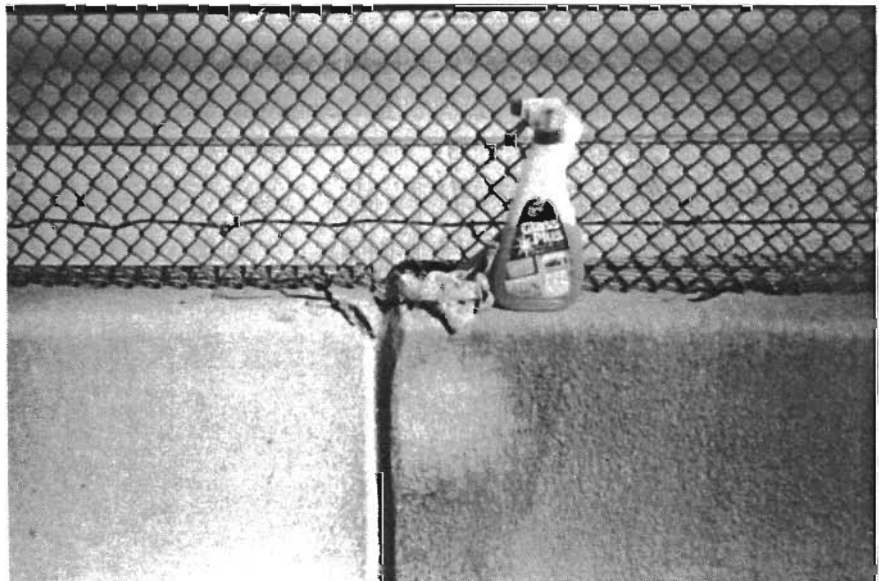
**3.2.1.1 Findings of Field Surveys.** Several miles of median barriers on the McAllister Freeway (US 281) and at the Fratt Interchange (IH 410 and IH 35) were inspected in San Antonio. The Fratt barrier coating had been applied in 1983. The coating was light tan in color and was said to be a product of Preston Pacific. The barrier displayed significant discoloration of the coating (Fig 3.1) on surfaces with rough texture. Throughout other locations in the district, severe peeling and discoloration of coatings were observed. Often, a "zebra-stripe" effect was evident on median barriers; that is, a repeating vertical pattern of darkened and lighter areas occurred at short irregular intervals, thus creating the appearance of zebra stripes. District personnel contacted felt that this could be due to the spray pattern in these areas and that the coating was either too thick or too thin in the darkened stripes.

Fig 3.1. Discoloration on median barrier at the Fratt Interchange.

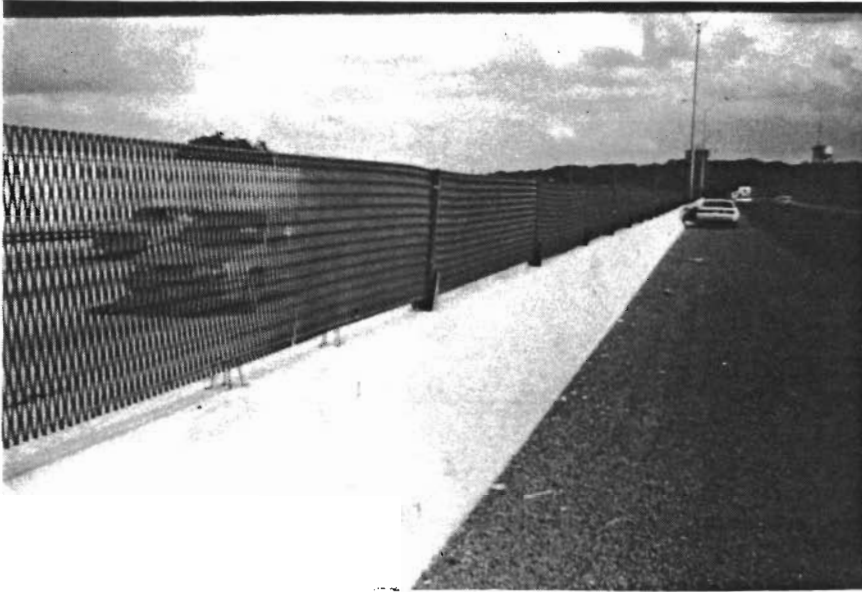
In particular the McAllister Freeway median barrier exhibited significant peeling about one or two years after being painted with Prestonshield®. The barrier was cleaned with high pressure (9000 psi) water and repainted. However, it again began peeling (Fig 3.2).

Fig 3.2. Peeling on median barrier on McAllister Freeway in San Antonio.

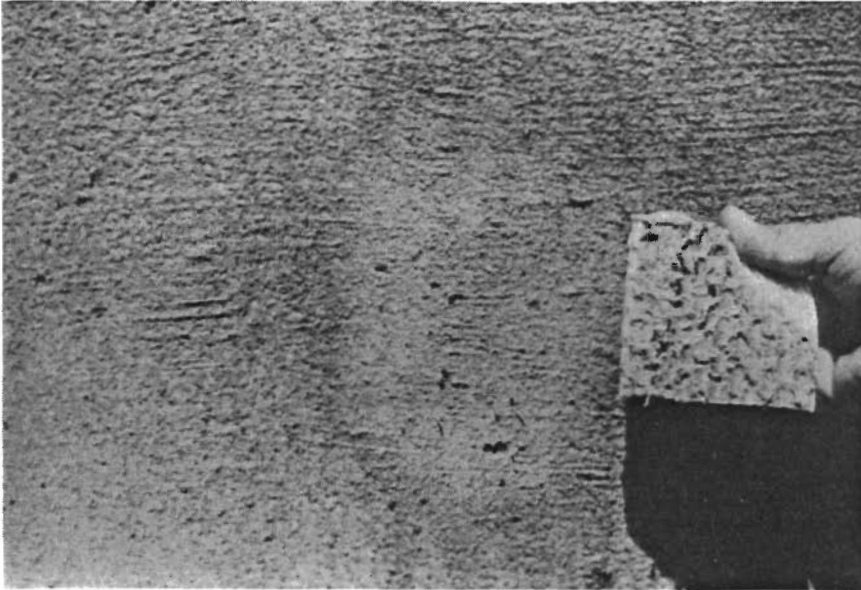
**Fig 3.3. Pier after cleaning with 409® cleaner (SH 35).**

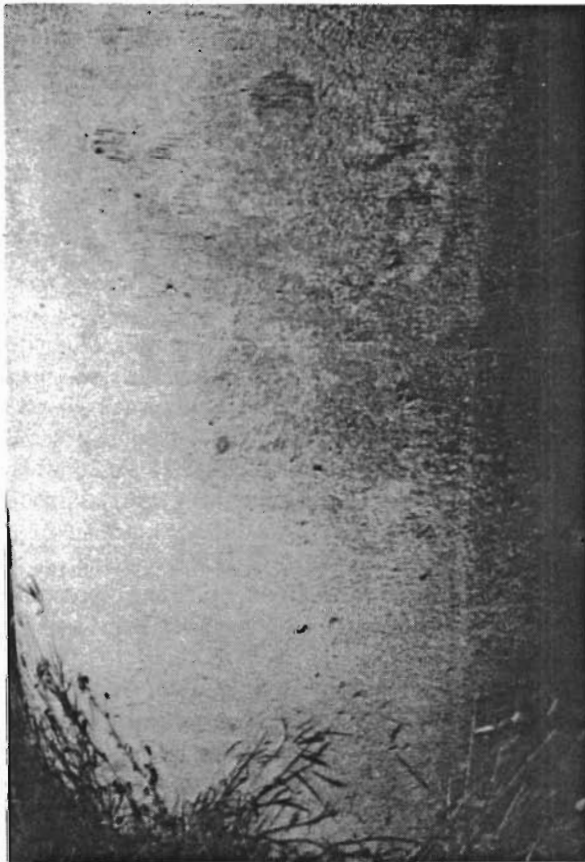
Note the contrast between smooth surface (lower left) and rough texture

**Fig 3.4. Pier on bridge on SH 35.**

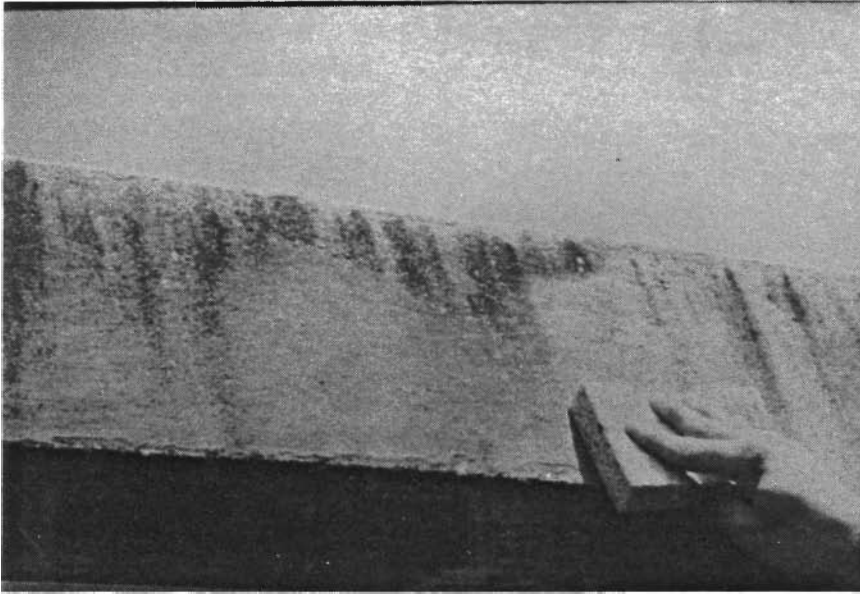
**Fig 3.5. Discoloration cleaned off Tulosa Underpass.**

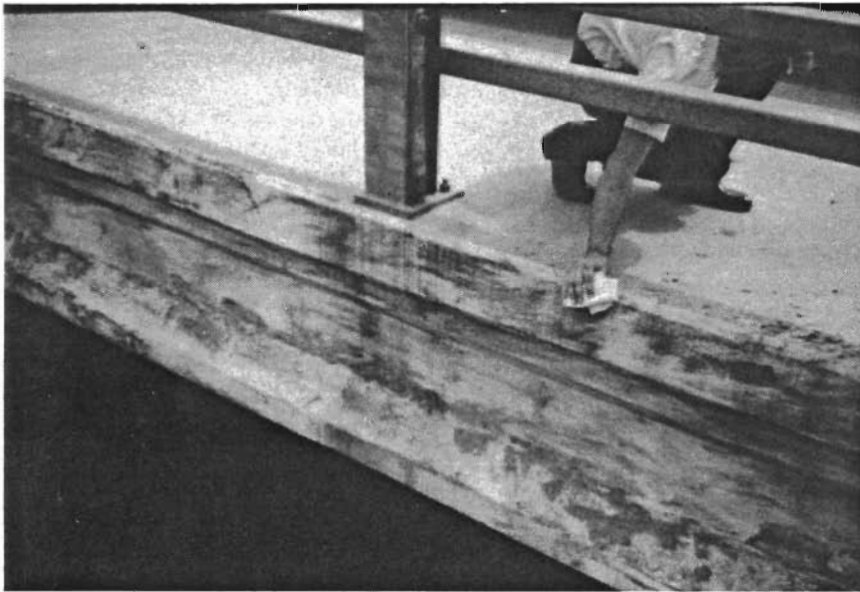
surface texture increased. Darkened material could be removed from the surface with either wet or dry rags (Fig 3.6). In addition, darkened areas appeared much too random to be caused by a spray pattern. The painting contractor was consulted and indicated that the coating may have been subject to freezing temperature and/or had aged excessively.

**Fig 3.6. Discoloration removed from Ripy Overpass.**

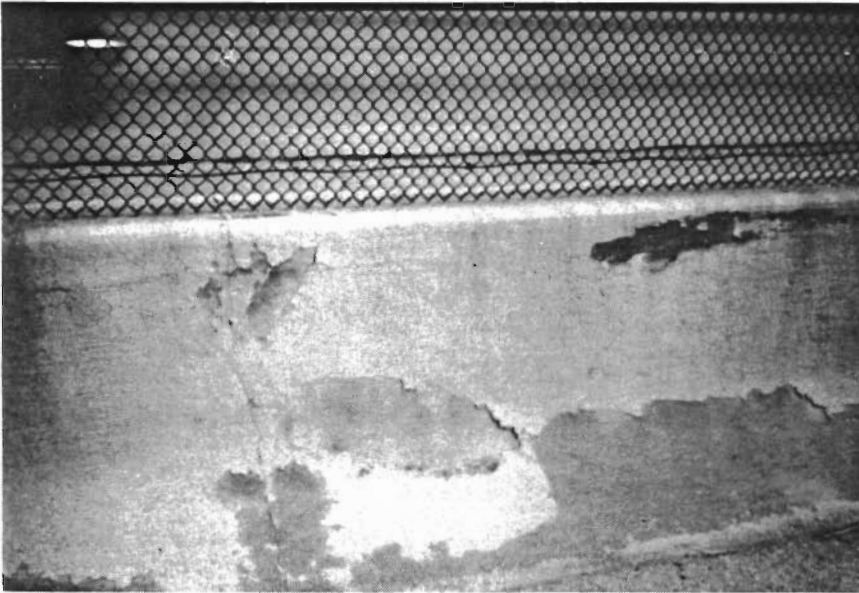
Fig 3.7. Peeling on median barrier on I 35W south of Fort Worth.

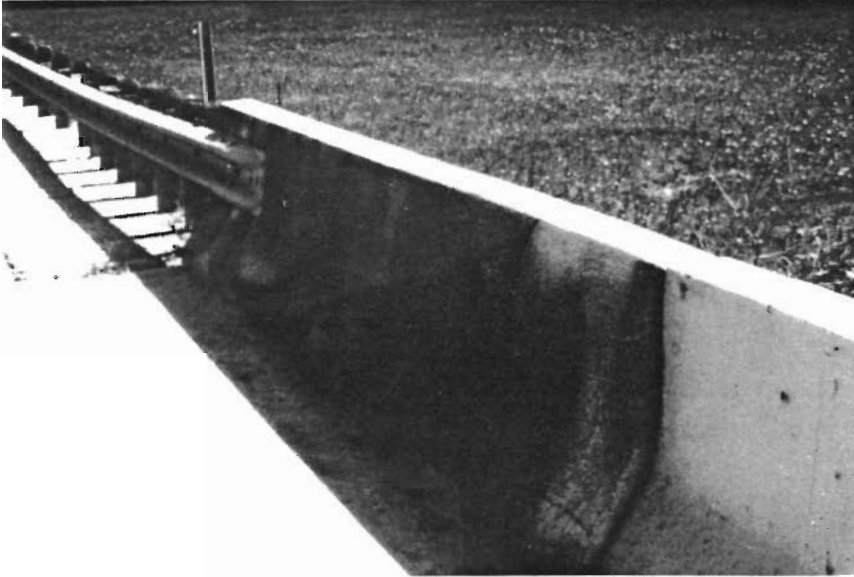
(a) Discoloration on north end of west side of barriers with textured coating (SH 288 in Houston).

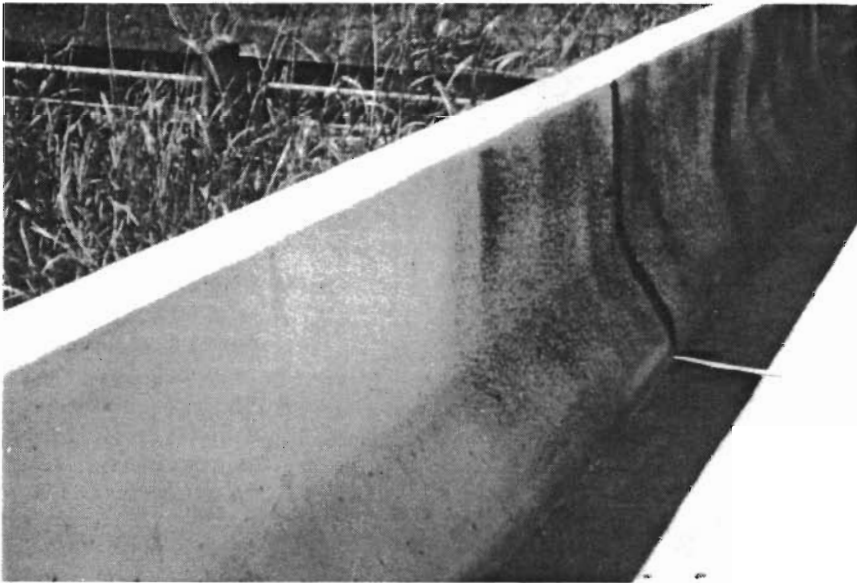
(b) Discoloration on south end of west side of barriers with textured coating (SH 288 in Houston).

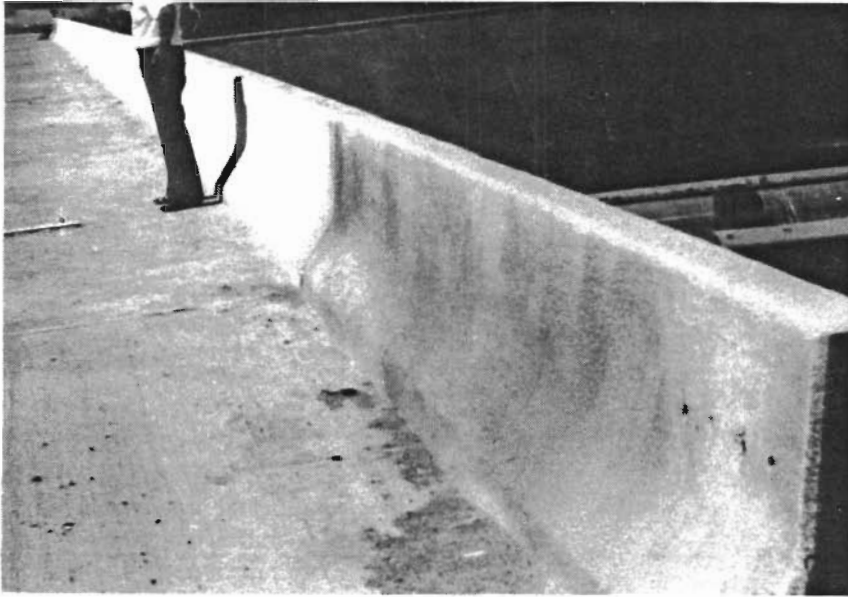
(c) Discoloration on north end of east side of barriers with textured coating (SH 288 in Houston).

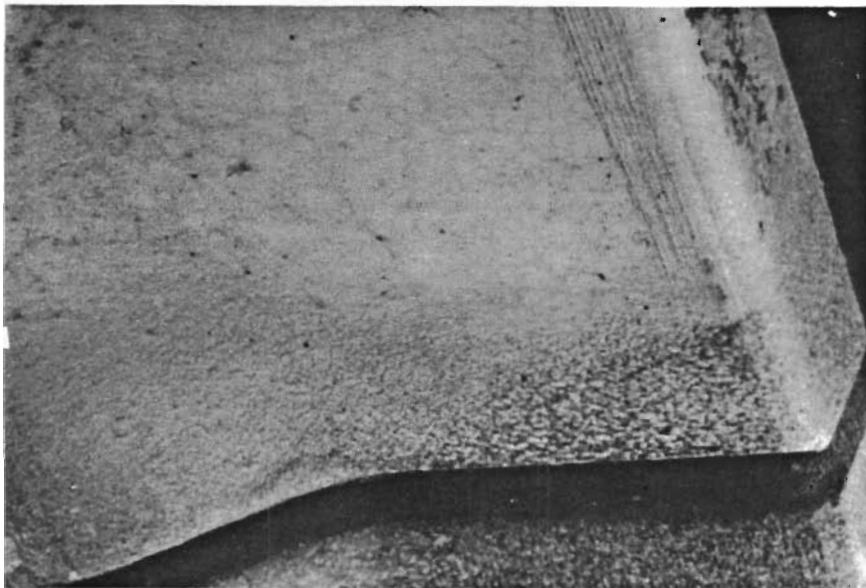
roughness of coating surface and darkness of discoloration. The darkened area extended only to the point where the rough texture terminated; the smooth, nontextured surface exhibited no darkening (Fig 3.8). A close-up view of the intersections of smooth and textured surfaces is shown in Fig 3.9. (The painting contractor indicated that the ends had a rougher texture because they were repainted.) It was found that the darkened areas could be easily cleaned with 409® cleaner and a sponge (Fig 3.10).

Fig 3.9. Close-up of intersection of smooth and textured surfaces.

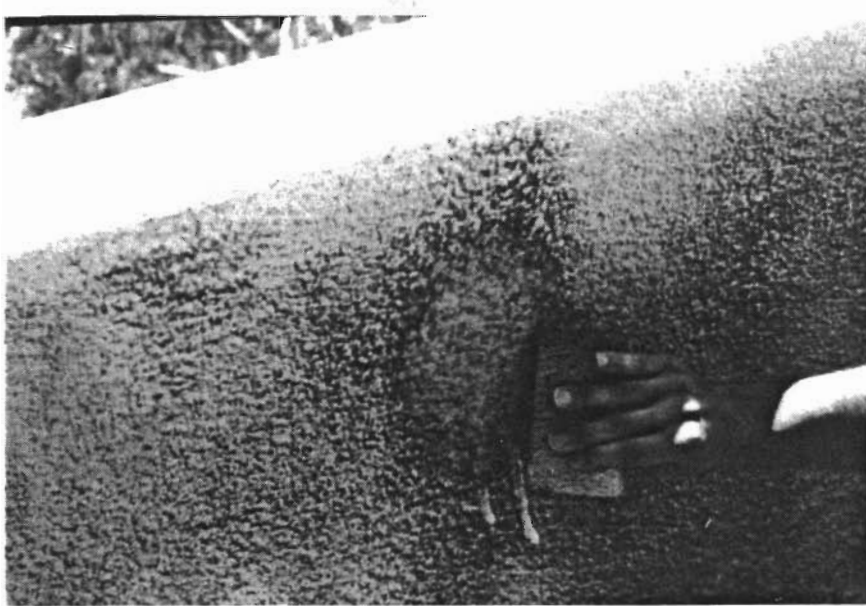
**Fig 3.10. Cleaning discolored areas on SH 288.**

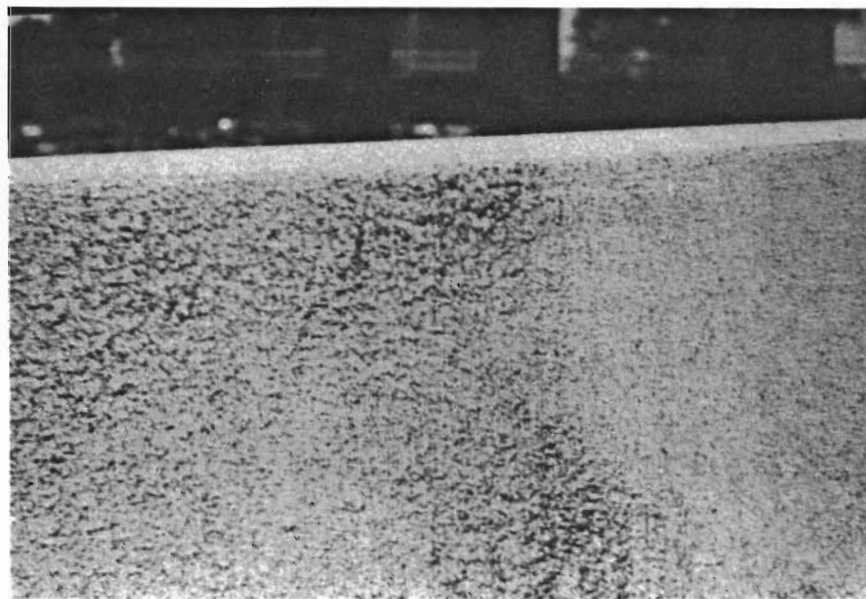
At the intersection of Dallas-Pierce Avenue and the SH 288, the coating of the median barriers on the left side of the northbound lanes was found to have a generalized "zebra-stripe" effect (Fig 3.11). The darkened areas appeared to correspond to the heavier texture, apparently caused by overlapping applications of coating during spraying. Throughout other locations, darkened coatings, especially those with smooth texture, were reported to have become lighter with time. It is believed that rain has washed some of the darkened material off these surfaces.

**Fig 3.11. Zebra-stripe effect on barrier on SH 288.**

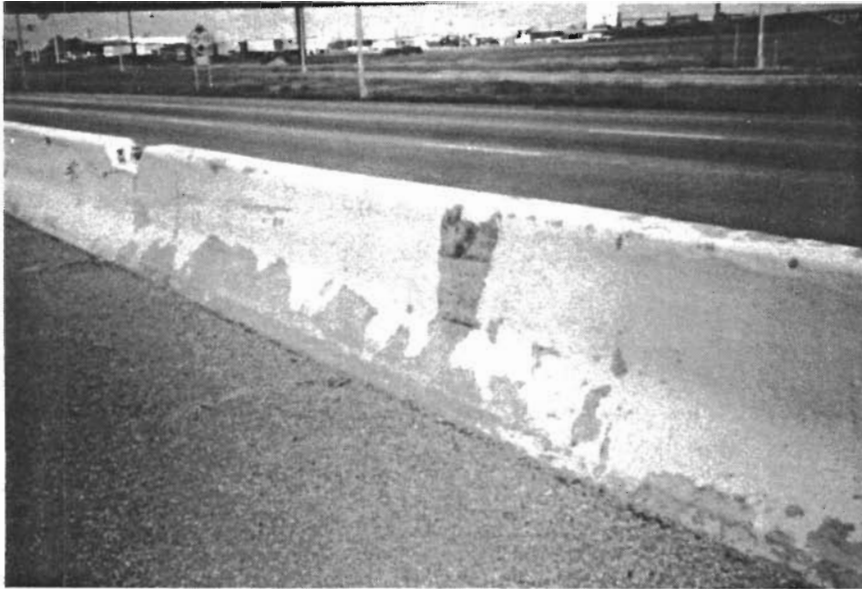
peeling of the coating was found to be a major problem (Fig 3.12). Peeling had occurred only in those concrete structures where curing compound was used. It was reported that generally the curing compound was applied the same day the concrete was placed and that no provision was made to remove the compound before the coating was applied. It was also reported that all median barriers in the Amarillo area are slip-formed with no form oil used; still, barriers with and without peeling were found. Particular observations were made at each site visited, as follows.

**Fig 3.12. Peeling on median barrier in Amarillo.**

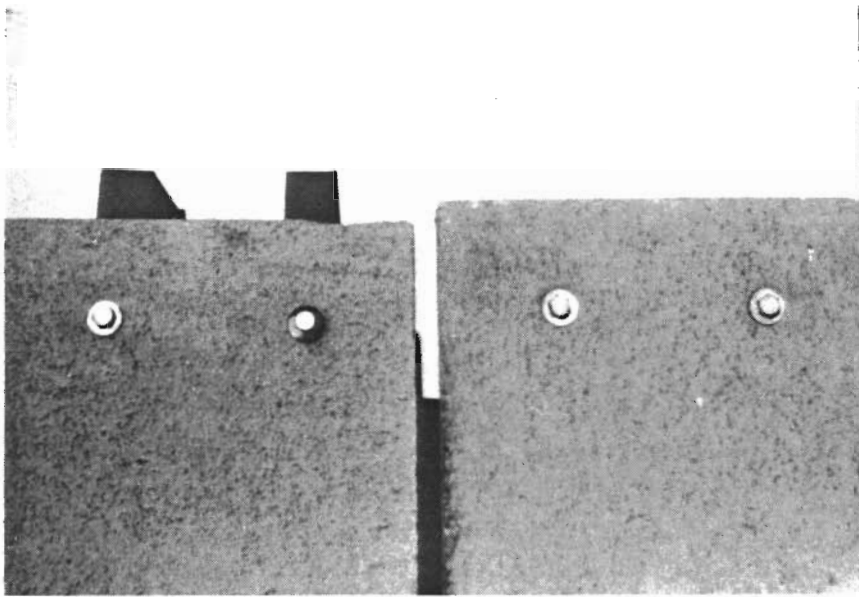
**Fig 5.8. Panels No. 4 and No. 22 which had a rough coating texture (Secoat W®) showing significant darkening.**

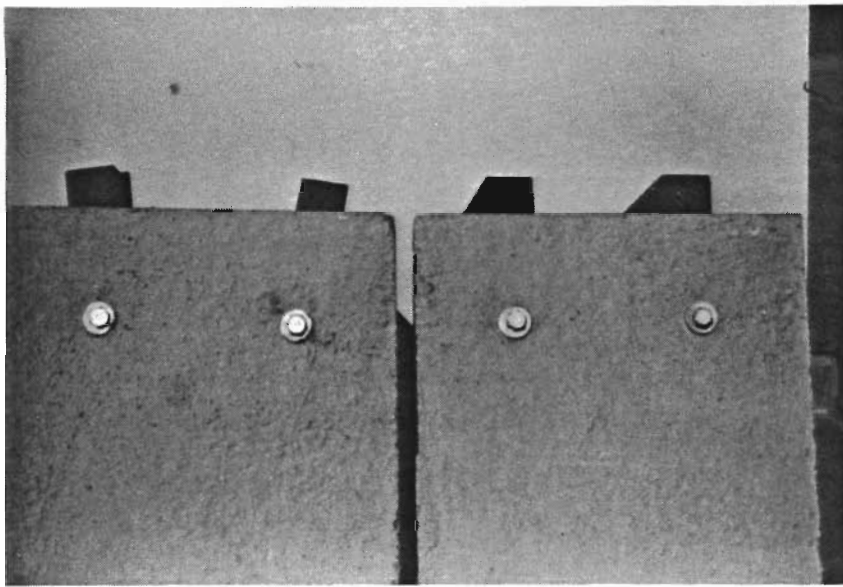
**Fig 5.9. Panels No. 24 and No. 16 which had a smooth coating (Secoat W®) showing no significant indication of darkening.**

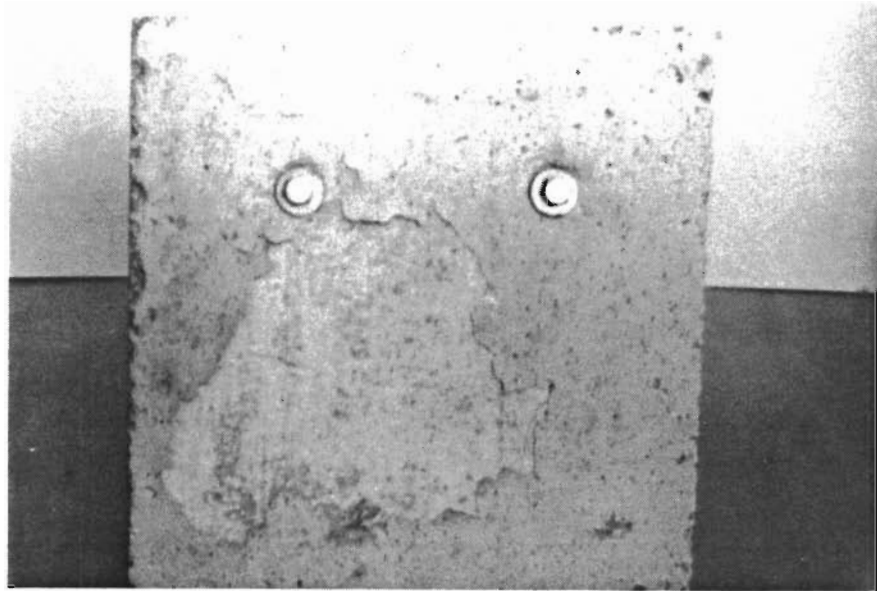
Fig 5.10 . Severe peeling of the Prestonsshield® coating on a slipformed, flat surface.

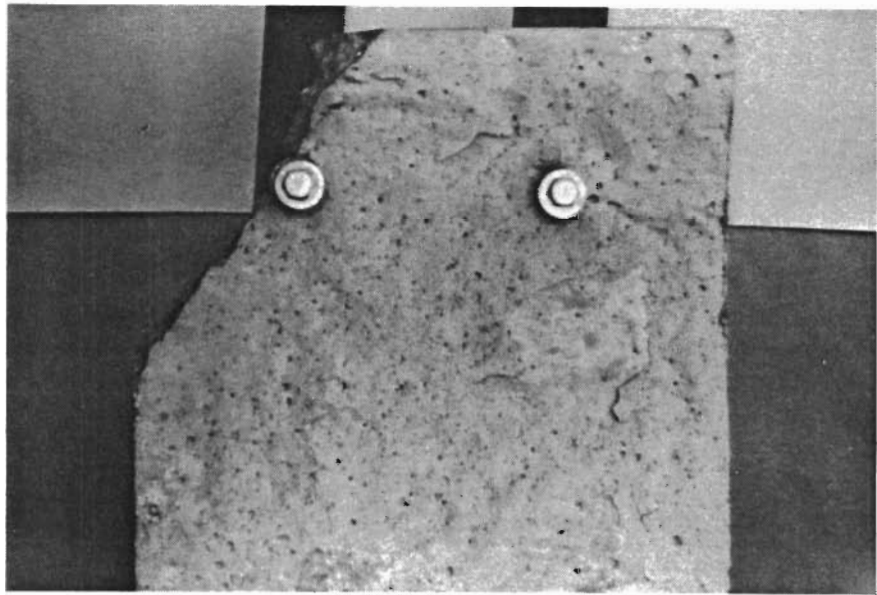
Fig 5.11. Severe peeling of the Prestonsshield® coating on the slipformed, concave surface.

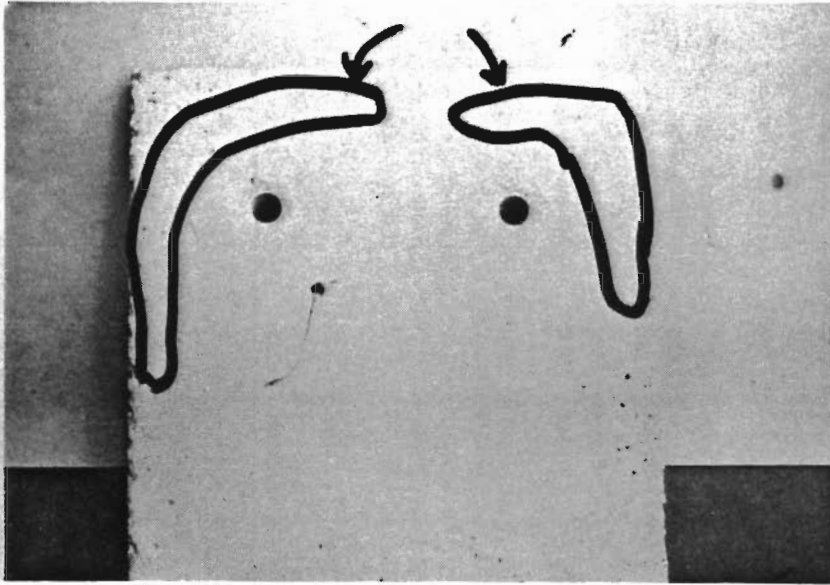
Fig 5.12 . Blistering of the Secoat W® coating on the slipformed panel No. 56.

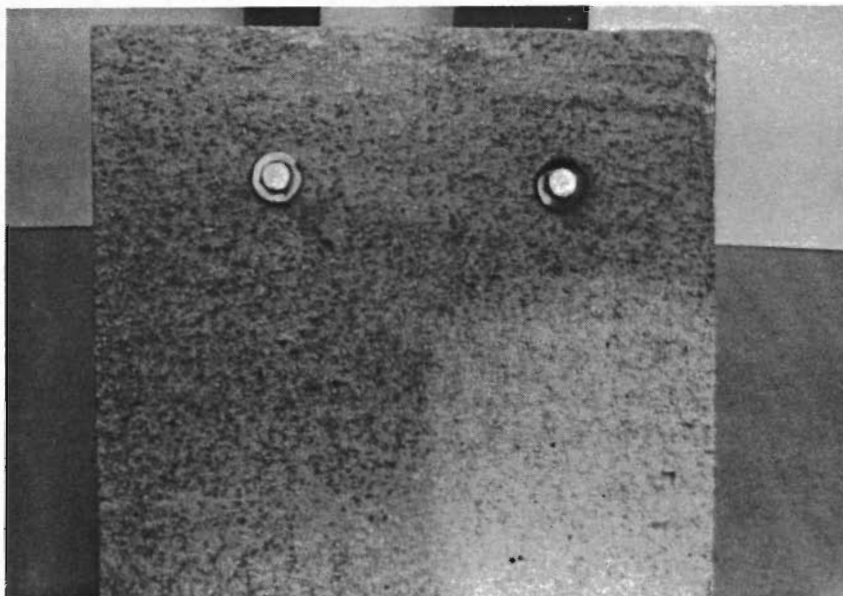
**Fig 5.13.** Rough-textured panel (No. 22) washed with Clorox® using a sponge ( $\Delta Y = 11.6$ ).

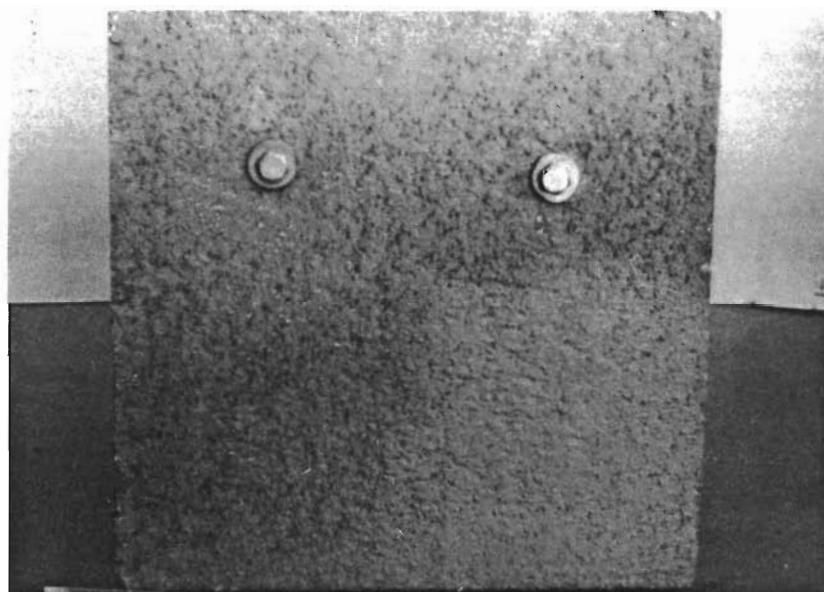
**Fig 5.14.** Rough-textured panel (No. 10) washed with 409® by spraying ( $\Delta Y = 10.0$ ).

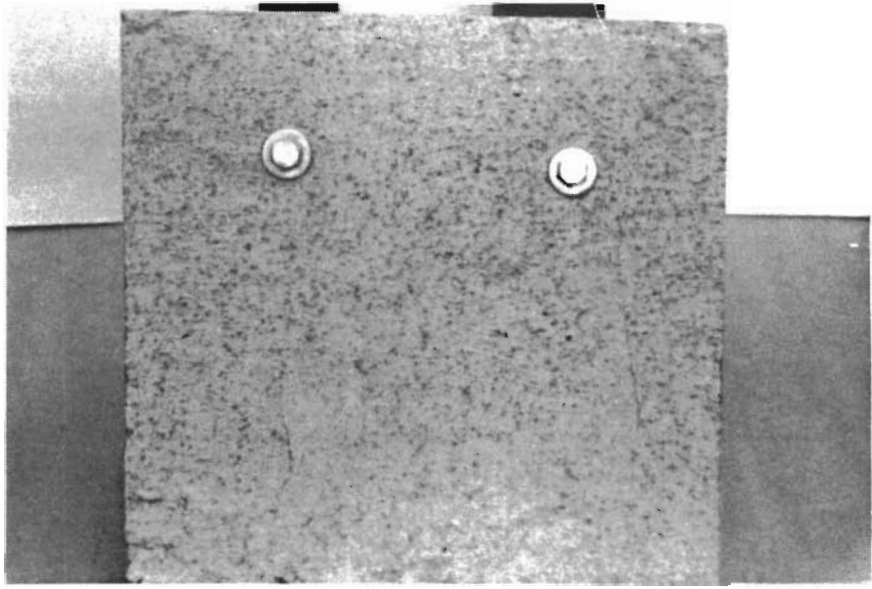
**Fig 5.15. Rough-textured panel (No. 36) washed with water under pressure ( $\Delta Y = 1.4$ ).**
