EFFECTS OF TEMPERATURE CHANGE ON PLASTIC CRASH CUSHIONS

Research Report Number 514-1F

Research Project 3-10-76-514

CENTER FOR HIGHWAY RESEARCH
THE UNIVERSITY OF TEXAS AT AUSTIN

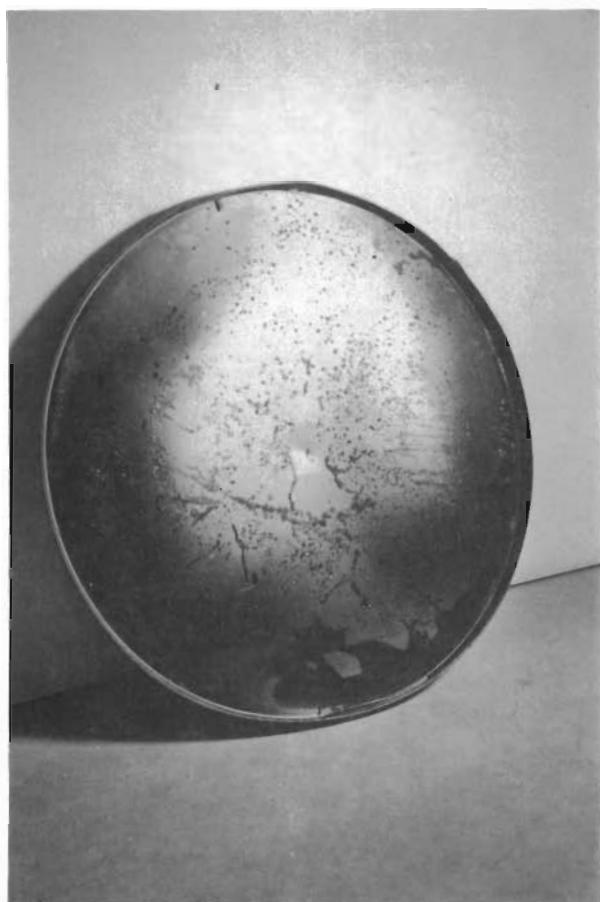
Fig 11.

of 5 percent. At the conclusion of three complete hot-cold cycles, the top cover of unit F-1 was replaced with a new cover furnished by the manufacturer. When the original cover was removed, an ice crystal formation was noted on the inside cover surface (Fig 11). It is estimated that one to two ounces of water were contained in this formation. Additionally it was noted that some thawing had occurred before the cover was removed, as evidenced by wet spots on the sand surface (Fig 12). These conditions appeared to indicate considerable moisture movement within the sand mass and suggested that evaporation probably took place. Also visible (Fig 12) were cracks in the sand up to 5/16 inch wide and more than 1/2 inch deep. The exact cause of these cracks is unknown since the covers remained in place throughout the test except as noted above.

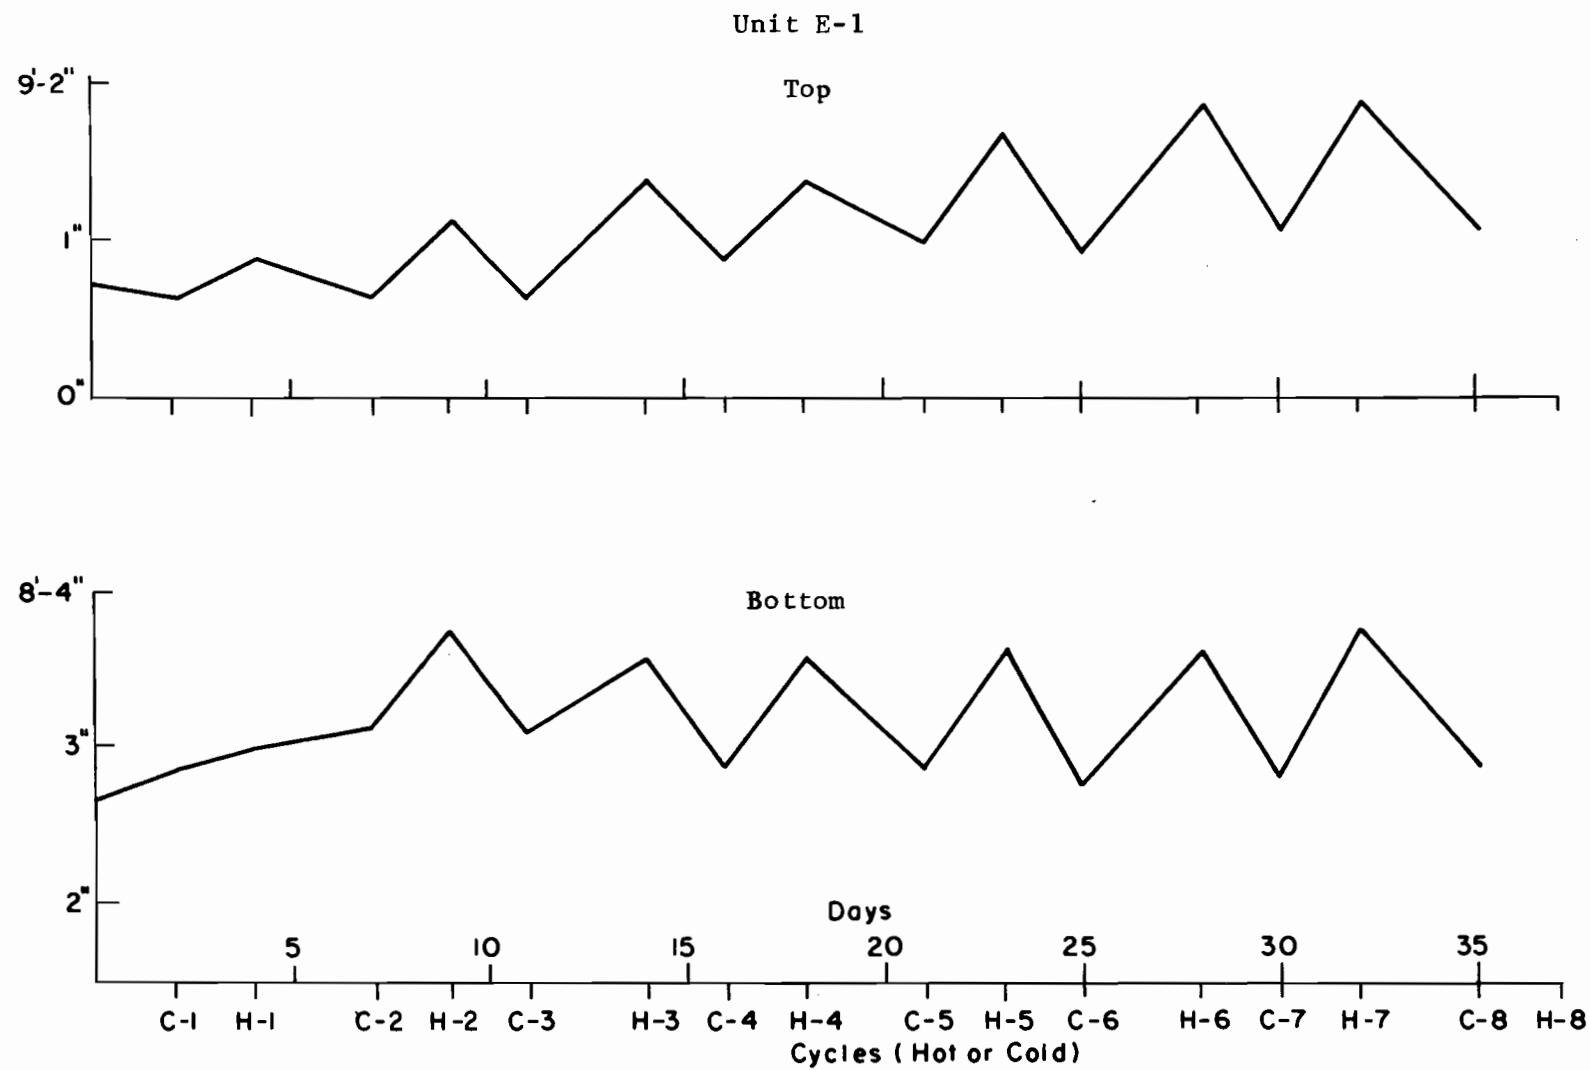
Circumference changes with time and temperature changes for the Energite units are depicted in Figs 16 and 17. The E-2 measurements shown in Fig 17, except for an unexplained lack of cyclic initial movement at the bottom, experienced no unusual circumference changes. The E-1 unit, Fig 16, however, began reacting quite early in the test. As the plot indicates, a very definite circumference increase occurred at the top both initially and throughout the test period. By the end of the test, the top circumference had enlarged more than an inch. At the conclusion of the second cold cycle a visible deformation had occurred at the unit's bottom, as shown in Fig 18. Also noted at this time was the unit's partially sagging lid, Fig 19.

Fig 16. Circumference measurements with time and temperature.

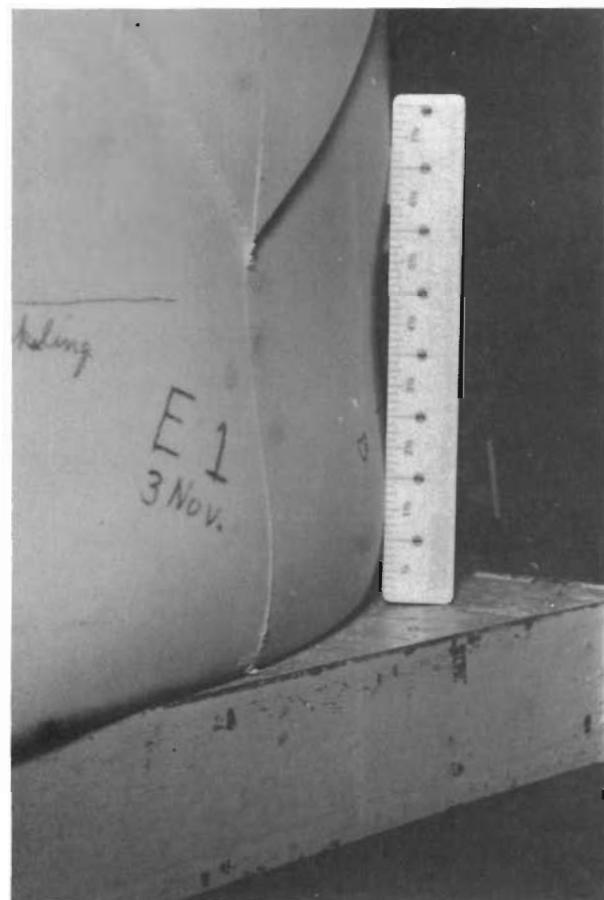
were in evidence at each notch around the unit's bottom and coincided with the original bulge shown in Fig 18. Further inspection of this unit showed (Fig 22) that the sand had settled at least two inches in the inner container and that this container had slipped off the upper supporting edge of the outer shell and moved about one inch downward. These movements probably caused both the dimensional changes and the subsequent cracks in the outer shell of this unit. A detailed physical inspection of E-2, the newer Energite model, showed no indication of a similar phenomenon, as is evident in Fig 23. There was, however, some settlement of the sand in this unit during the testing period.

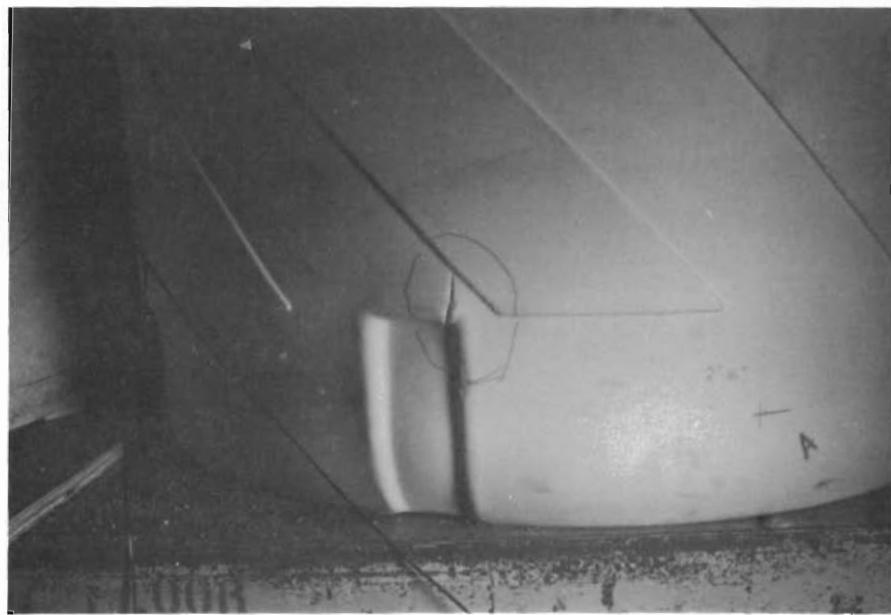
After eight complete hot-cold cycles the cyclic temperature tests were terminated. All units were, however, maintained at 130° F for an additional seven days, at which time a physical inspection revealed that the E-1 unit had developed cracks throughout the outer shell, as shown in Fig 21. These cracks

Distortion and subsequent cracking in the outer shell of the old model Energite specimen occurred after the sand had settled in the white plastic inner liner and the liner had slipped downward off the upper supporting edge of the outer unit. Stresses in the plastic containers resulted from the weight of the sand plus the temperature-induced volume changes in the container and in the sand. Sequential expansion, contraction, and settlement of the sand along with creep distortion and softening of the plastic containers apparently caused the destructive downward movement of the inner shell that produced the damage to this unit. The new model Energite specimen, which incorporated five support pedestals in the black plastic inner liner, exhibited no external evidence of distress during the cyclical temperature tests, but several significant cracks were found in the liner after the sand had been removed.

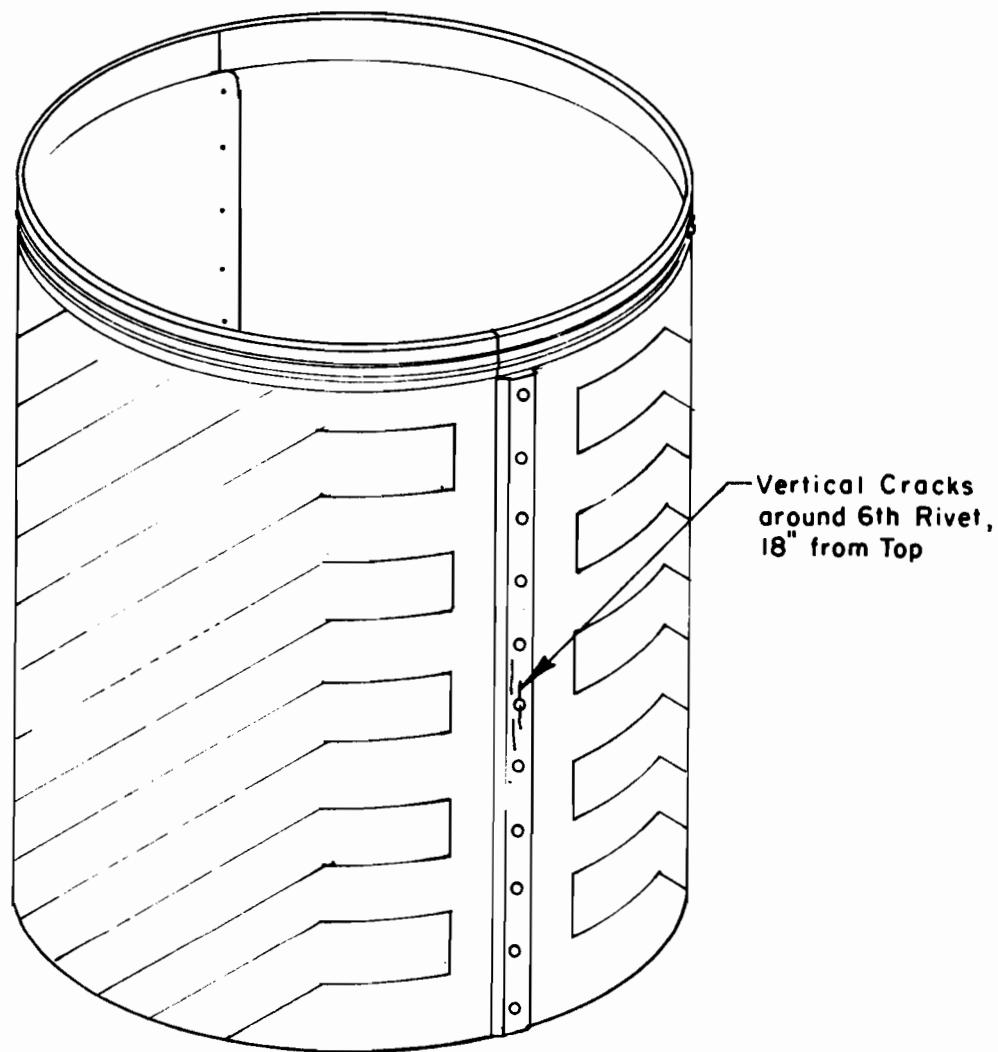
The final inspection of all test units that was conducted immediately after the sand had been removed revealed that the F-1 unit had developed three fine vertical cracks at and adjacent to the sixth rivet hole on one side (Fig 24). These cracks were not evident during the test period and no significant dimensional changes occurred in this area of the F-1 unit during the cyclic temperature test.

Fig 24. Location of vertical cracks in Fitch unit after cyclic temperature tests.

Vertical hairline cracks around a rivet hole in one of the Fitch specimens (F-1) were detected at the end of the tests. Deformation measurements that were made throughout the program did not indicate significant circumferential changes in the vicinity of the cracks. There is no obvious explanation for these cracks appearing around the sixth rivet hole from the top of the specimen on one side only. There was no apparent damage to the F-2 unit.

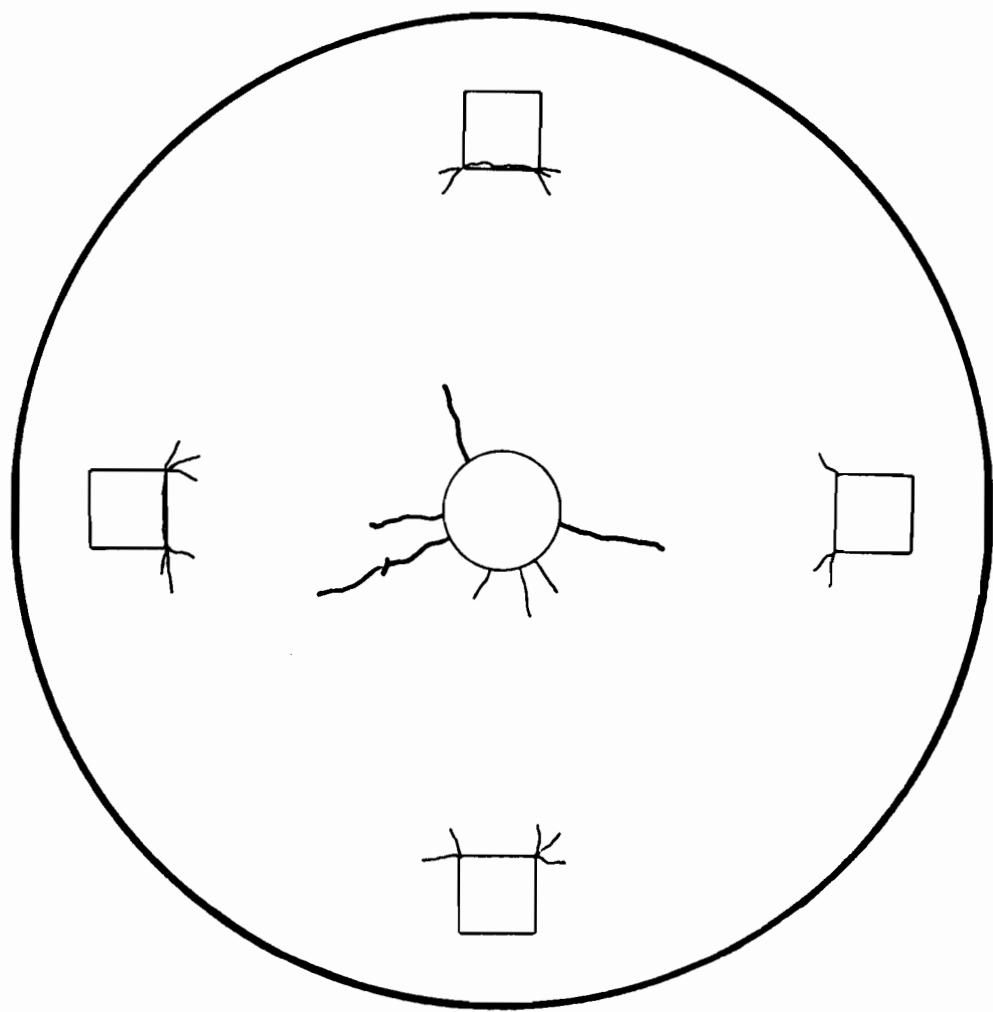
After the sand had been unloaded from the Energite specimens (December 29, 1975), three radial cracks were found in the bottom ribs of the white plastic liner of E-1. Several easily visible cracks were also discovered in the E-2 black plastic inner liner unit after the sand had been removed at this time. These cracks opened widest toward the inside of the liner and generally radiated into the horizontal bottom surface from the support pedestals (see Fig 25). Cracks were found in the bottom of several of the radial ribs between the pedestals. Two of these cracks extended through the full thickness of the liner, and light could be seen through the hairline openings on the outer surface. While no direct observation was made of the crack development, the fact that all the crack openings were wider on the inside surface than on the outside indicates that higher tensile stress concentrations were present on the inner surface. Stressing of the plastic liner by the sand load and the temperature cycling obviously caused permanent deformation in the material that resulted in tensile failure. There is no way of knowing the exact mechanism of crack formation, but these cracks evidence several points of serious stress concentration in the new model Energite unit.

Fig 25. Inside view of the bottom of new model Energite liner showing crack locations after unloading.
