**AN EVALUATION OF REPAIR TECHNIQUES USED FOR  
UNCONTROLLED LONGITUDINAL CRACKING AND  
FAILED LONGITUDINAL JOINTS**

**Research Report Number 920-4**

Evaluation of Thin-Bonded Concrete Overlay in Houston

January 1991

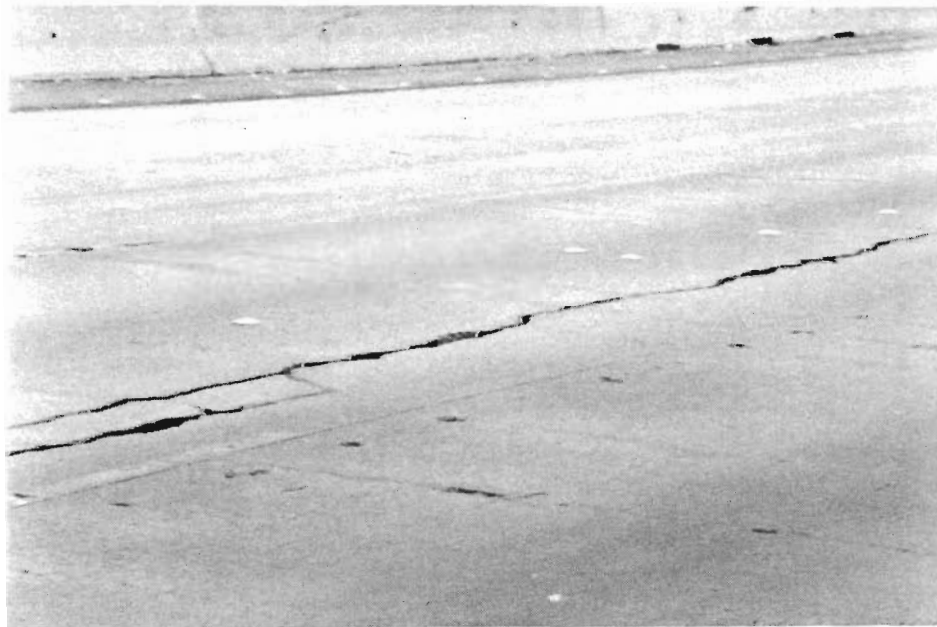
**Fig 1.1. Uncontrolled longitudinal cracking.**

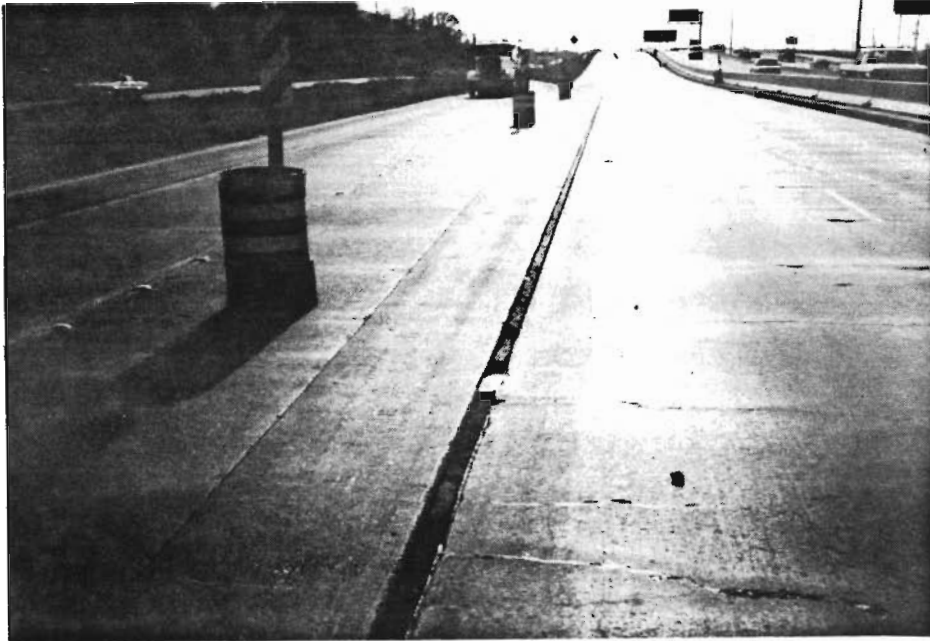
**Fig 1.2. Failed longitudinal joint.**

In 1989, District 12 performed repairs on failed longitudinal joints on IH-610 in Houston. An example of this type of distress is given in Fig 1.2 in Chapter 1. The objective of the repair was to reestablish load transfer across failed longitudinal joints and cracks and to prevent further widening.

Load transfer was reestablished by “stitching” the two sides of the crack together. In this context, stitching refers to cutting 1-inch-wide slots at 12-inch centers perpendicular to the joint. These slots were cut to a depth of approximately 2 inches and an overall length of 54 inches, centered on the joint or crack. After the slot was cleaned, a #5 tiebar was epoxied in the slot. A drawing of the repair is shown in Fig 3.1. Normal surface preparation followed the specified curing time. Photos of the repair process are shown in Figs 3.2 and 3.3.

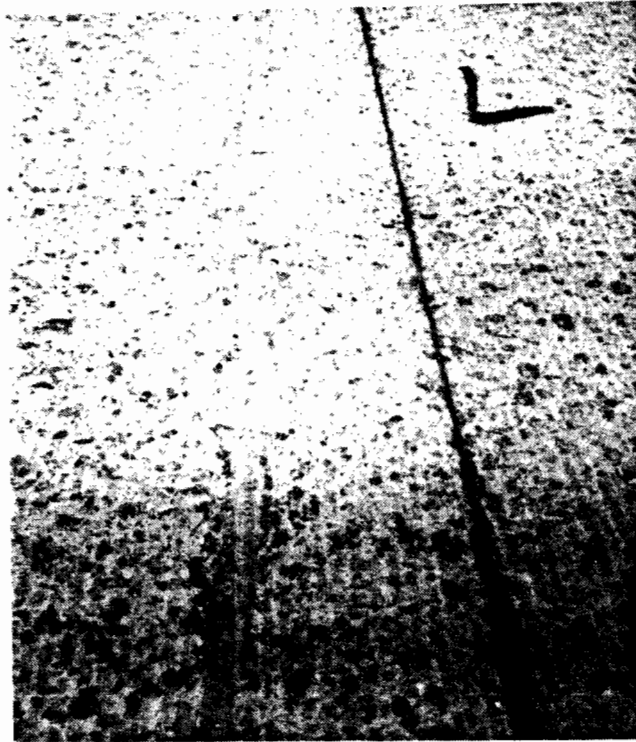
portland cement concrete overlays, many of the repaired cracks could easily be observed. In nearly every case, the repairs appeared to be very sound, with the bond to each face of the concrete still intact (Fig 2.7).

**Fig 2.7. Repair after milling.**

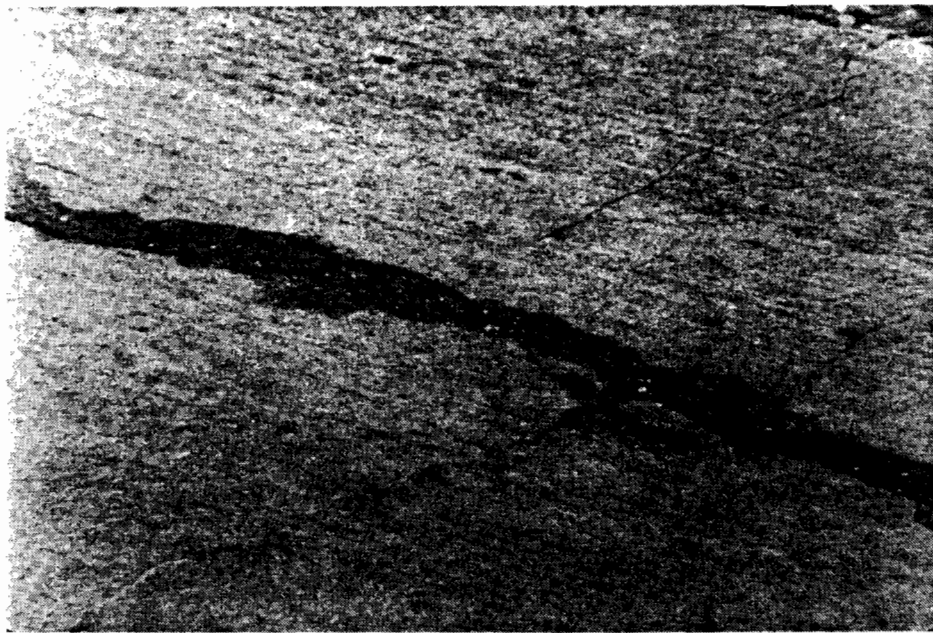
The repairs were again evaluated as being in good, fair, or poor condition. A rating of "good" required that the crack be completely filled and sealed with the repair material. A rating of "fair" required that the majority of the repair material be in place; the crack could be slightly reopened, and small, infrequent cracks could be evident in the material. A rating of "poor" required that all of the repair material had spalled. Photos representing each rating condition are shown as Figs 2.8, 2.9, and 2.10.

**Fig 2.8. Good.**

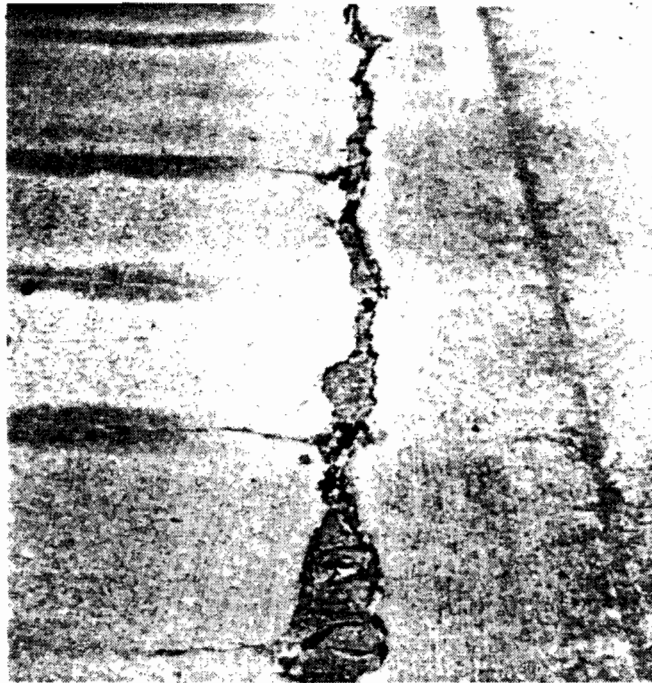
**Fig 2.9. Fair.**

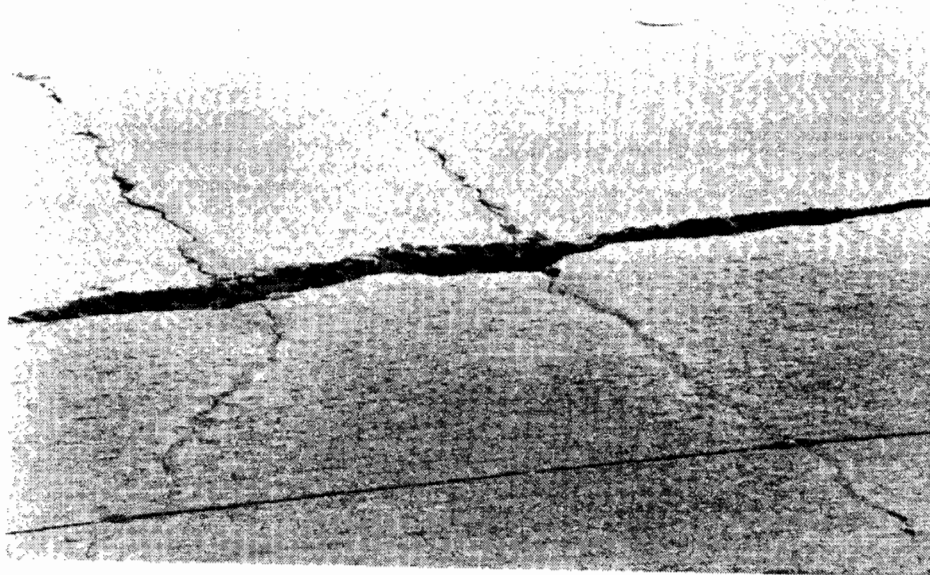
The repairs rated fair or poor generally showed evidence of wear or erosion on the surface, apparently due to evaporation of monomer from the surface or depletion of the monomer caused by leakage through the bottom of the crack. When a portion of the South Loop (IH-610S) was scarified in preparation for placement of bonded

**Fig 2.10. Poor.**
