Bridge Repairs Project
El Paso County

Bridge Deck Repairs

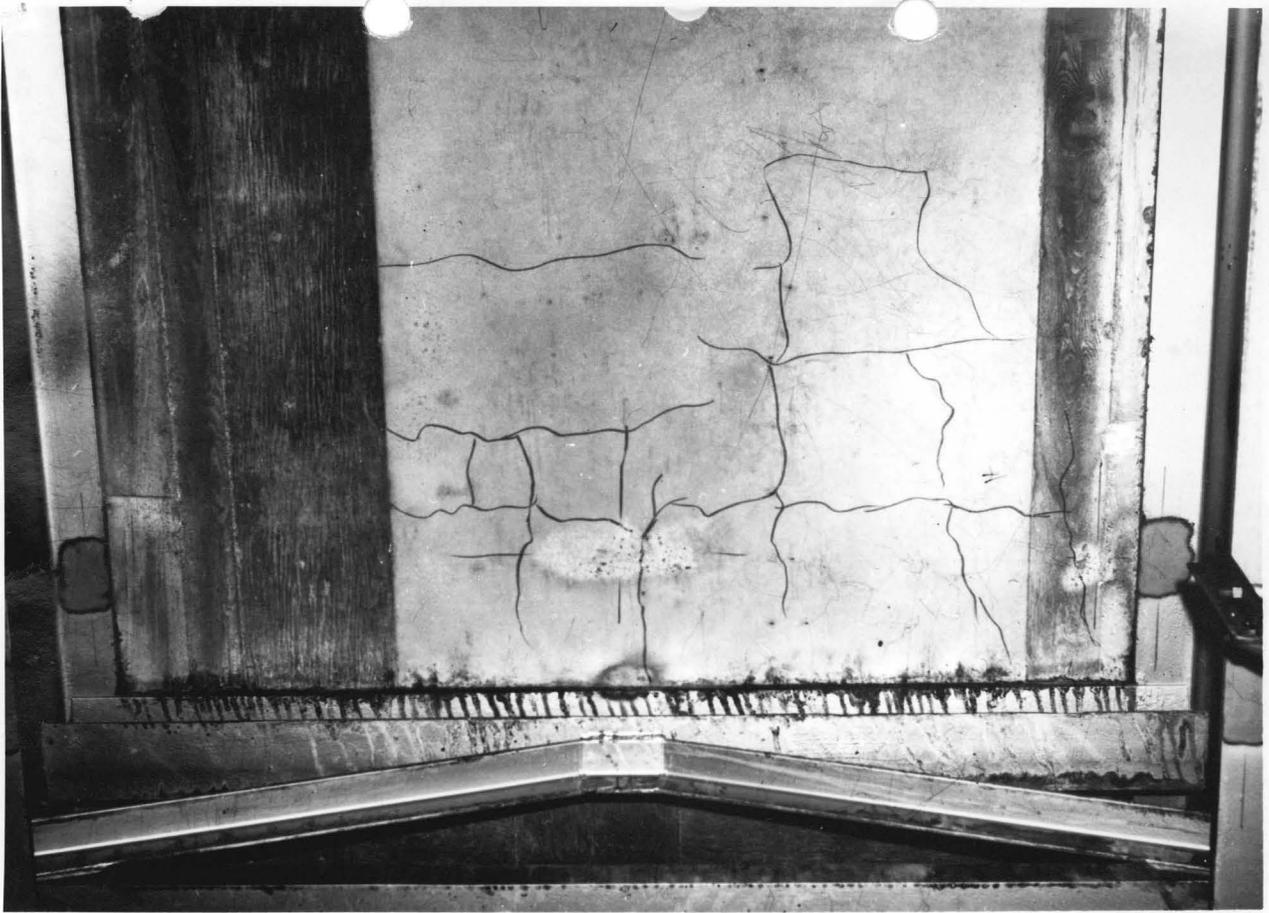
Typical View of Underside of Deck with Cracks Marked

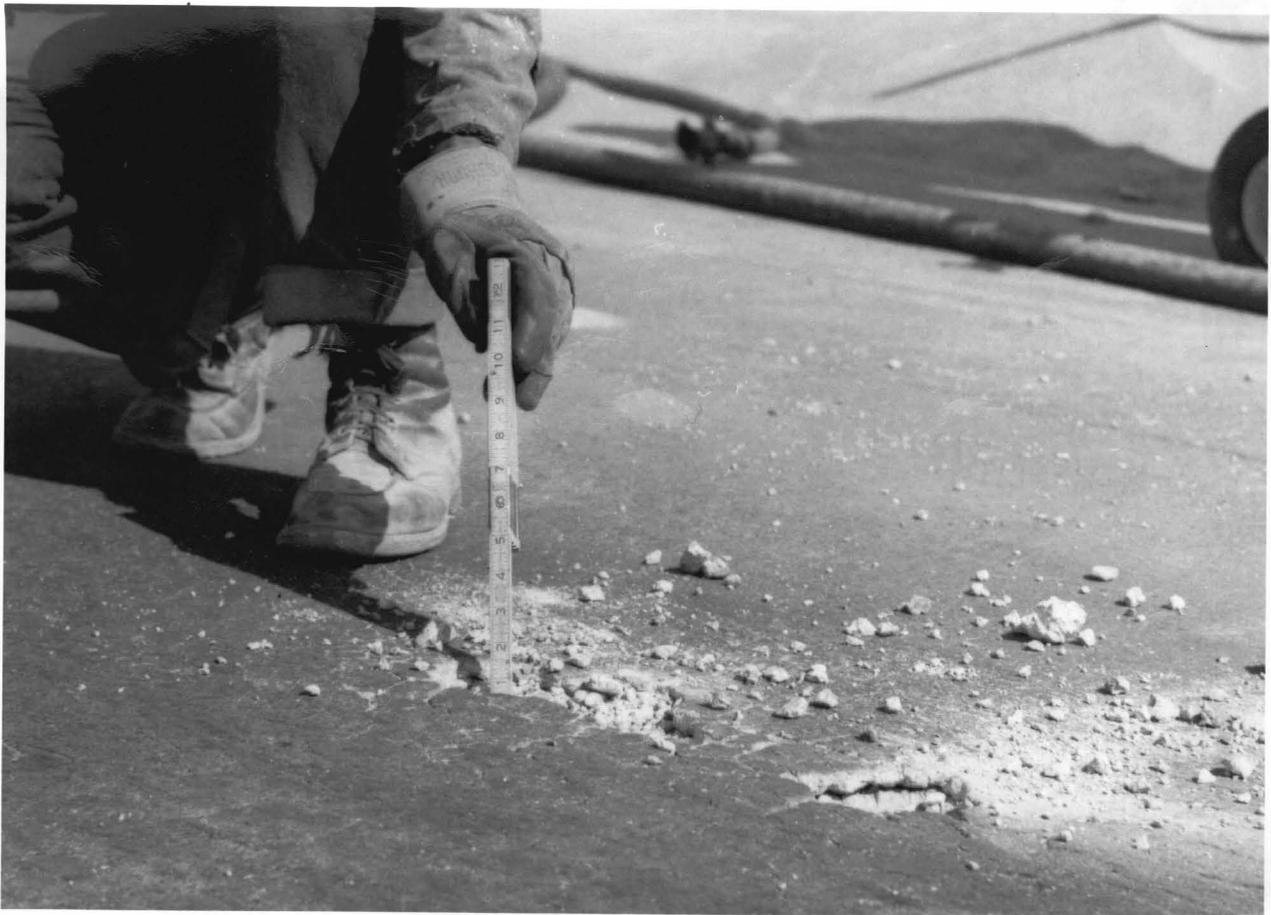
The first problem with this structure was noted by our maintenance crews. Concrete was spalling out to the top steel. These "pot holes" started developing shortly after the legal load limit on Texas highways was raised to 72,000 lbs. Maintenance crews patched these holes with premix, but they continued to grow and new holes developed.

Typical View of Pothole Development

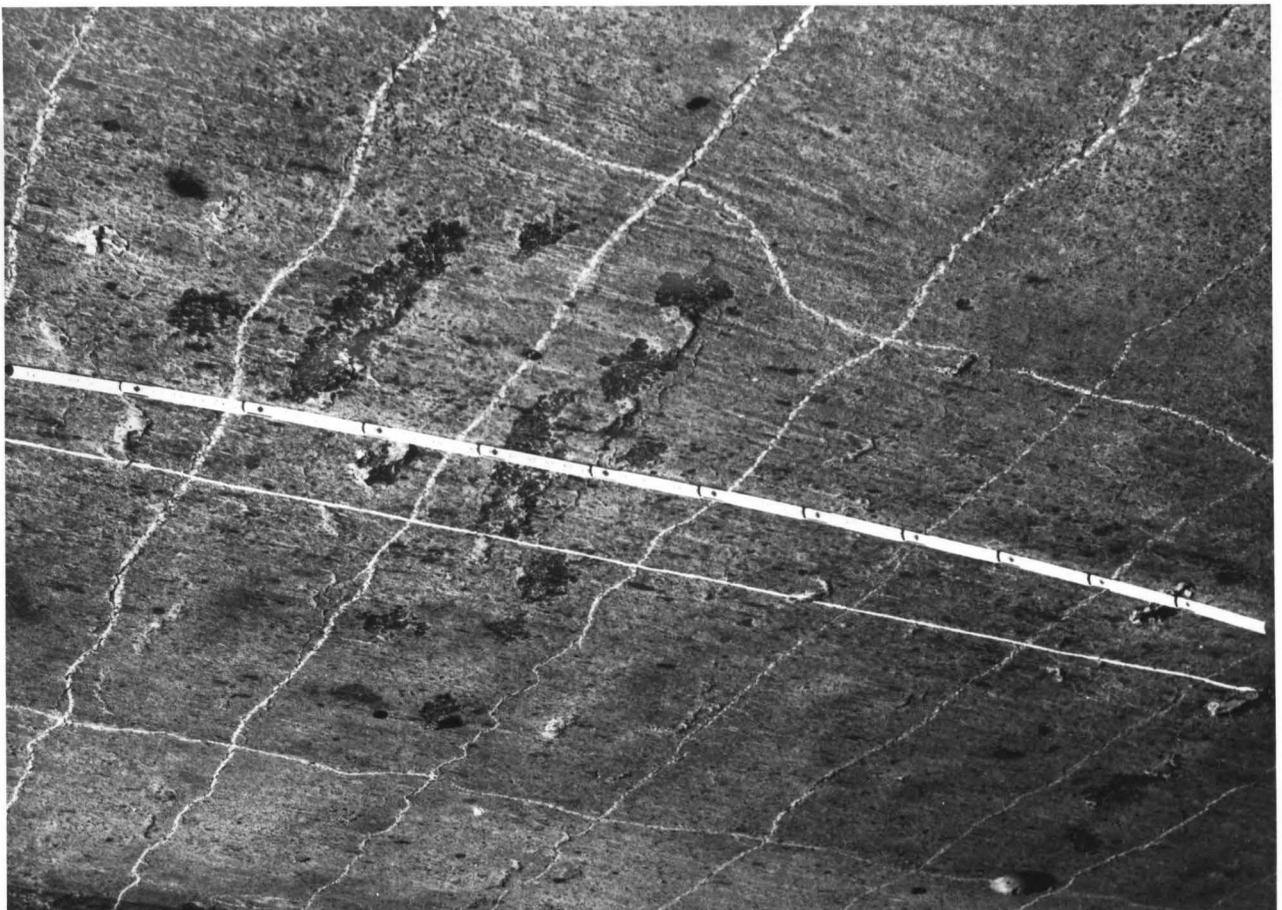
Typical View of Deck with Major Cracks Marked with Chalk

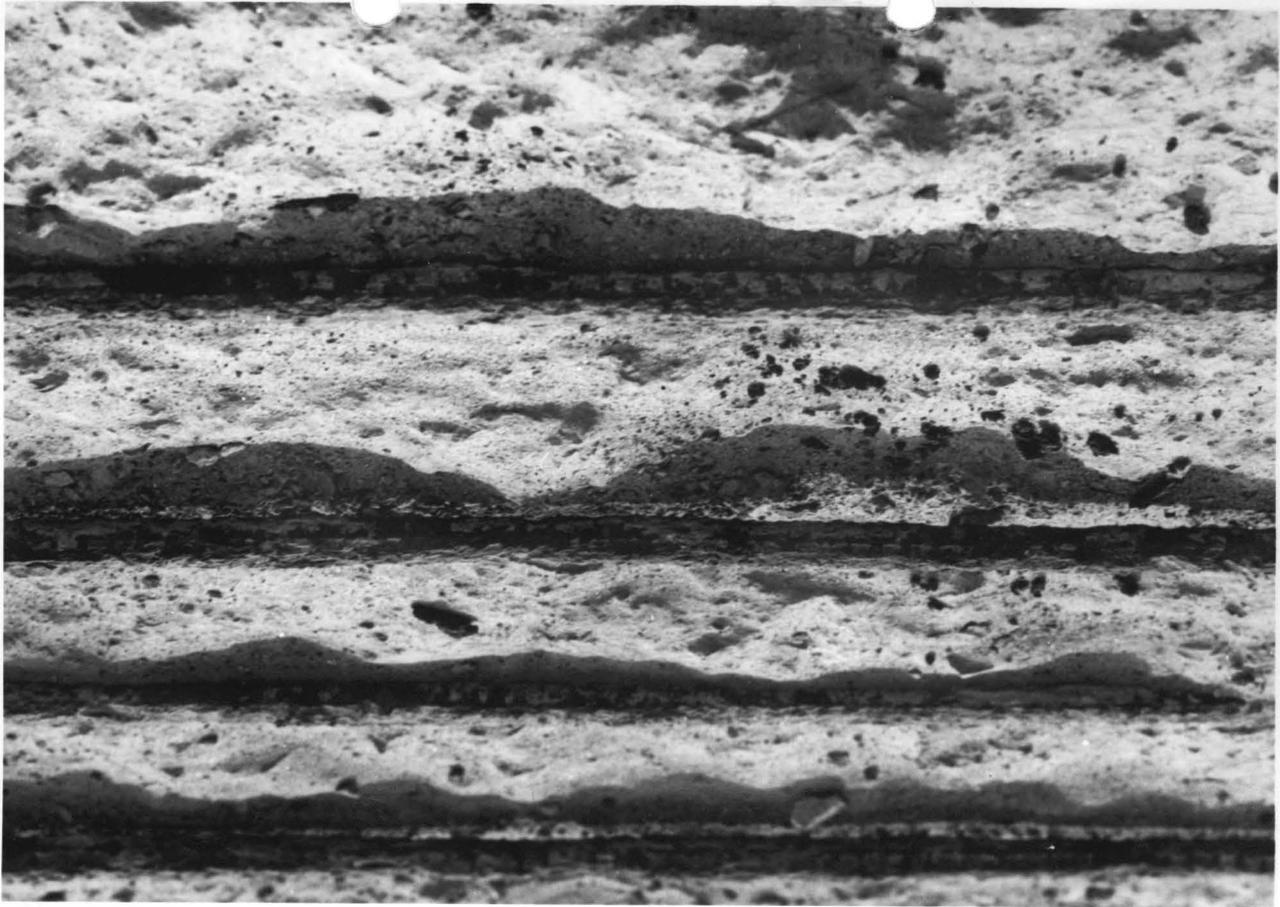
The deck was "sounded out" by tapping with a hammer. All hollow sounding areas were marked. An air hammer crew followed breaking out the unsound concrete which extended to the top layer of steel. Three small holes were opened through the bridge deck in areas where vibration had been inadequate during construction. This was followed by a sand blast of the area to remove the rust from the reinforcing steel.

Typical of deterioration of reinforcing steel

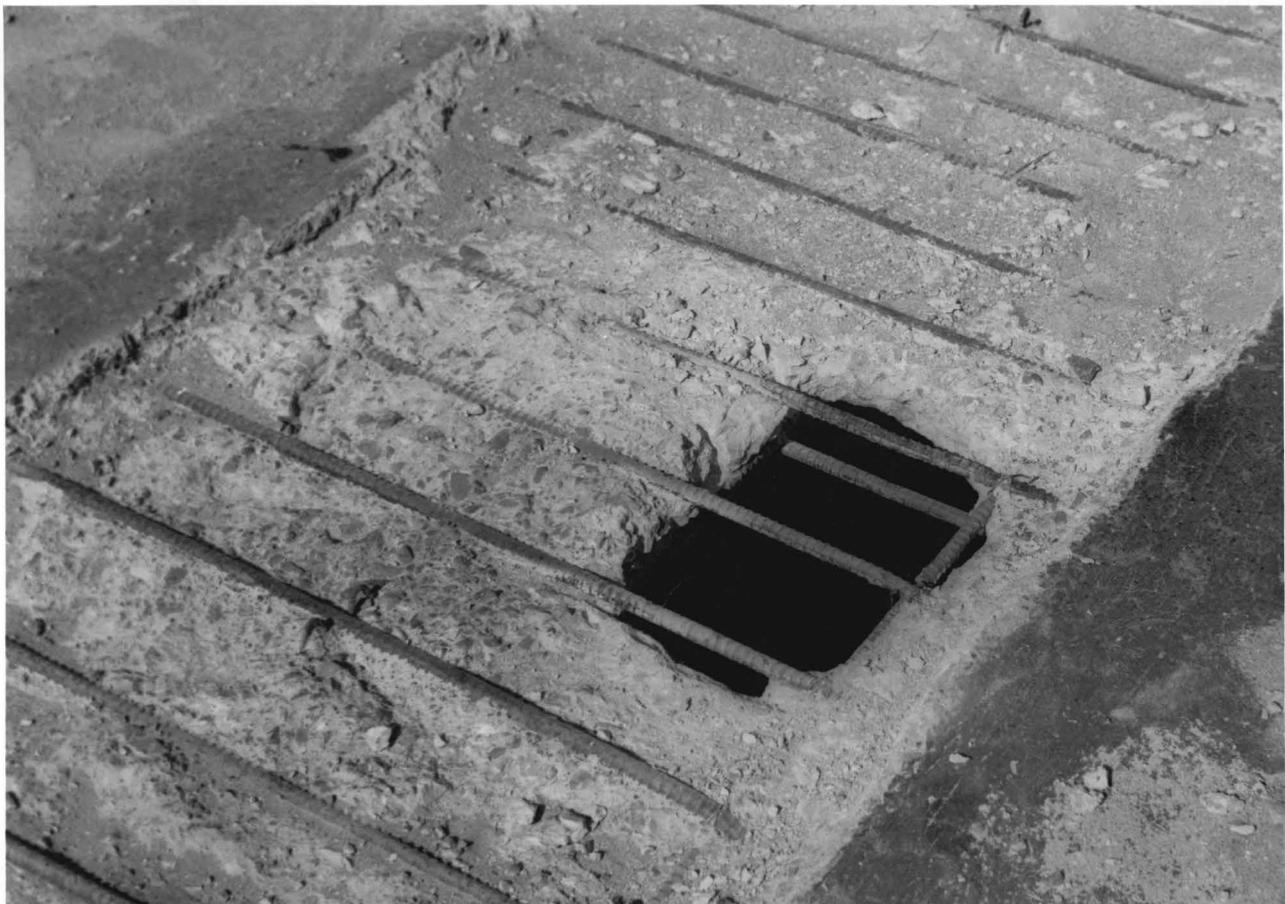
One of three holes opened in deck during operation
