1. Report No. TTI-2-18-74-164-1	2. Government Accession No.	3.	
4. Title and Subtitle Structural and Geometric Characteristics of Highway-Railroad Grade Crossings		5. Report Date August 1975

STRUCTURAL AND GEOMETRIC CHARACTERISTICS
OF
HIGHWAY-RAILROAD GRADE CROSSINGS

Research Report Number 164-1

Structural and Geometric Design of
Highway-Railroad Grade Crossings

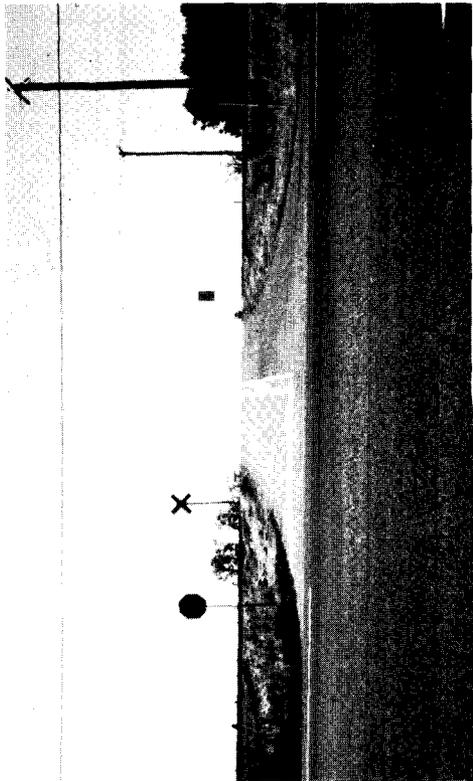
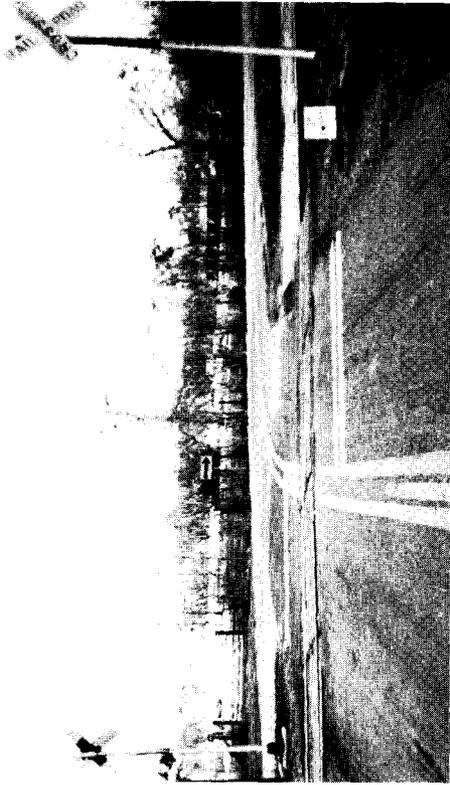
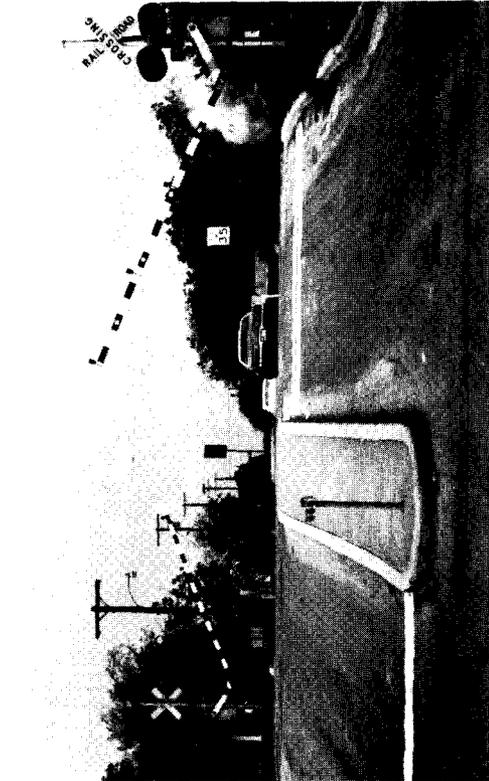
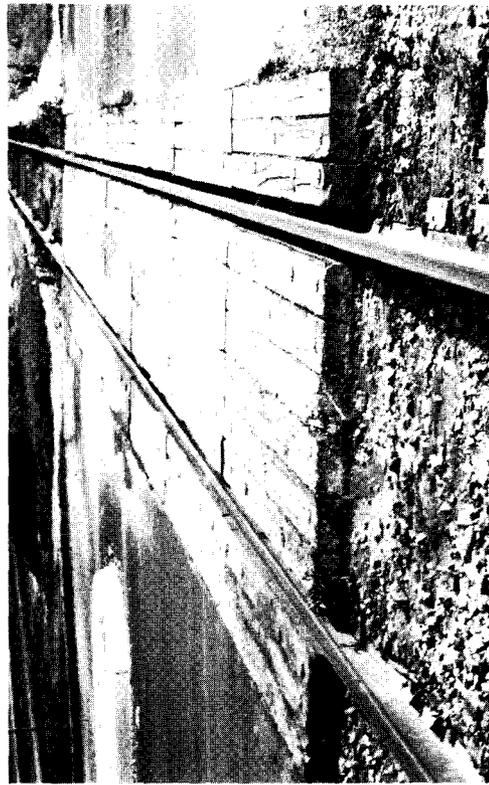
FIGURE I-6 - TYPICAL CONDITIONS AT HIGHWAY RAILROAD GRADE CROSSINGS

1. The railroad is frequently higher than the roadway, thus requiring vertical curves at the approaches to the railroad.
2. A highway is frequently located parallel and adjacent to the railroad property, and a highway intersection is required near the grade crossing. Approximately 65 percent of the sites inspected had a highway intersection within 200 feet of the railroad crossing. Table 1-2 contains a summary of these conditions.
3. Horizontal alignment in approaches to crossings often includes curves having radii less than 1000 feet. In most cases, the highway alignment is tangential at the crossing, as is the railroad alignment.

Geometric conditions at or near crossings are shown in Figures 1-6 and 1-7.

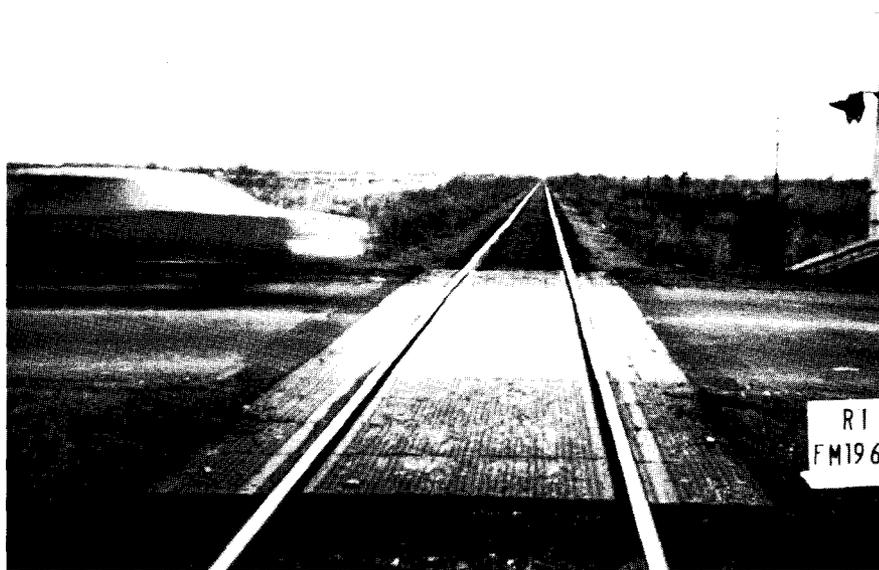
FIGURE 2-2 - RUBBER PANEL CROSSING INSTALLATION AT FM HIGHWAY 1960 AND ROCK ISLAND RAILROAD

FM Highway 1960 carries an average daily traffic of 8680 vehicles. The Rock Island has 7 trains per day. This is considered to be low traffic volume for railroads; however, heavily loaded freight cars are carried over the crossing. The highway traffic volume is classified as high by the State Department of Highwaya and Public Transportation Highway Design Division Operation and Procedures Manual, Part IV (4). This crossing was installed in July, 1971 (5). It was examined on January 26, 1975, and appears to be one of the smoother crossings observed during the studies made to date.

Figure 2-2 shows the excellent conditions at this crossing. Observed highway traffic did not slow noticeably for the crossing. Rail traffic did not traverse the crossing during the inspection. A typical cross-section of a rubber panel crossing is reproduced in Figure 2-3.

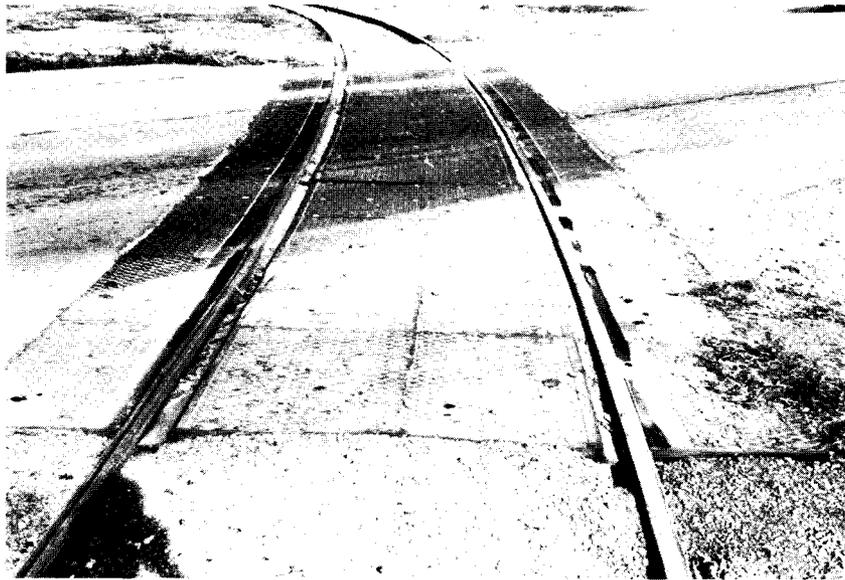
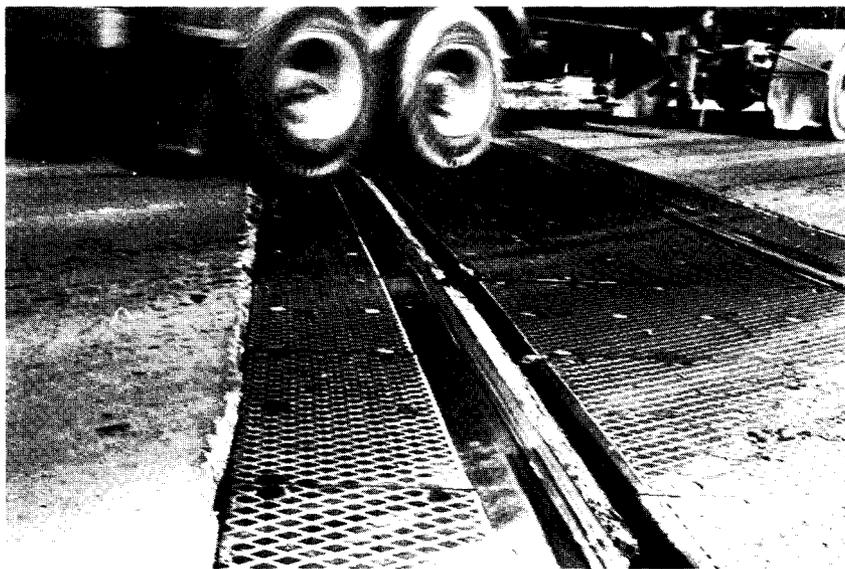
FIGURE 2-4-RUBBER PANEL CROSSING IN HOUSTON
(PHOTOGRAPH FURNISHED BY DISTRICT 12,
STATE DEPARTMENT OF HIGHWAYS AND
PUBLIC TRANSPORTATION)

The frontage roads of State Highway 225 cross the Southern Pacific industry spur which serves the Goodyear plant in Houston. Rubber covered metal planking was installed at these crossings in 1964. The climate and soil conditions are similar to the FM 1960 crossing. A detailed inspection by District personnel revealed that the crossings were in good condition in December, 1969. Photographs taken at that time are shown in Figure 2-4. The crossings were revisited in January, 1974, at which time one of the crossings had been damaged by a derailed railroad car.

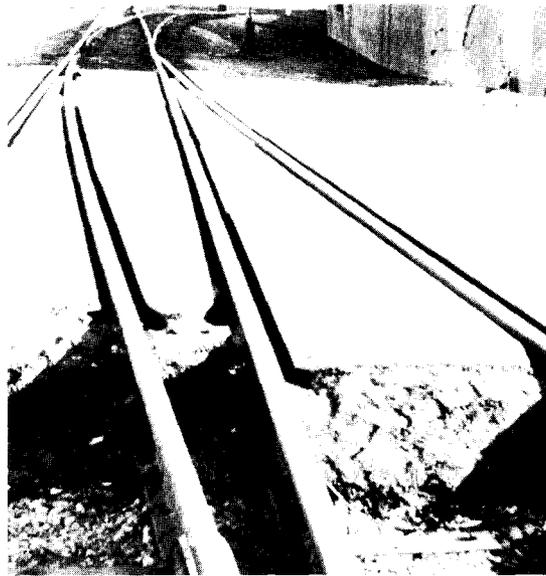
**FIGURE 2-9- A COMPLETED FAB-RA-CAST CROSSING WITH A
TURNOUT**

An inspection at the crossing site in March, 1975, revealed that one of the special panels shown in Figure 2-9 had displaced in such a manner that one edge of the panel was two to three inches above the surrounding surface. Another panel in the highway traffic lane has fractured and the traveled lane is very rough.

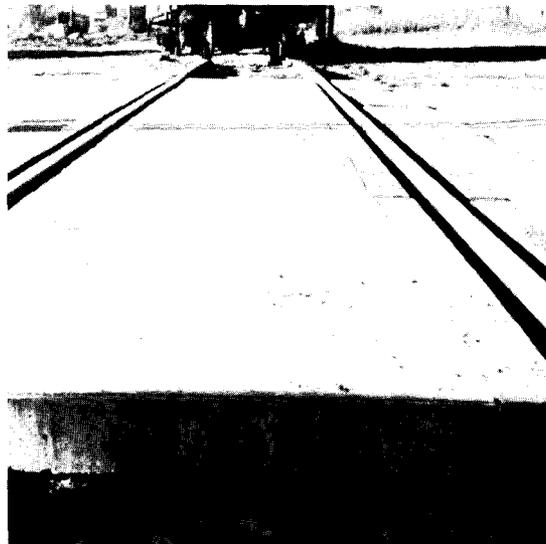
**FIGURE 2-10- A COMPLETED FAB-RA-CAST CROSSING ON
TANGENT TRACK**

Initially, the panels appear to be adequate and durable. Figure 2-10 shows the smooth riding surface of the mainline crossing after the completion of the installation, and the asphalt placed at the ends of the panels to protect them from dragging equipment.

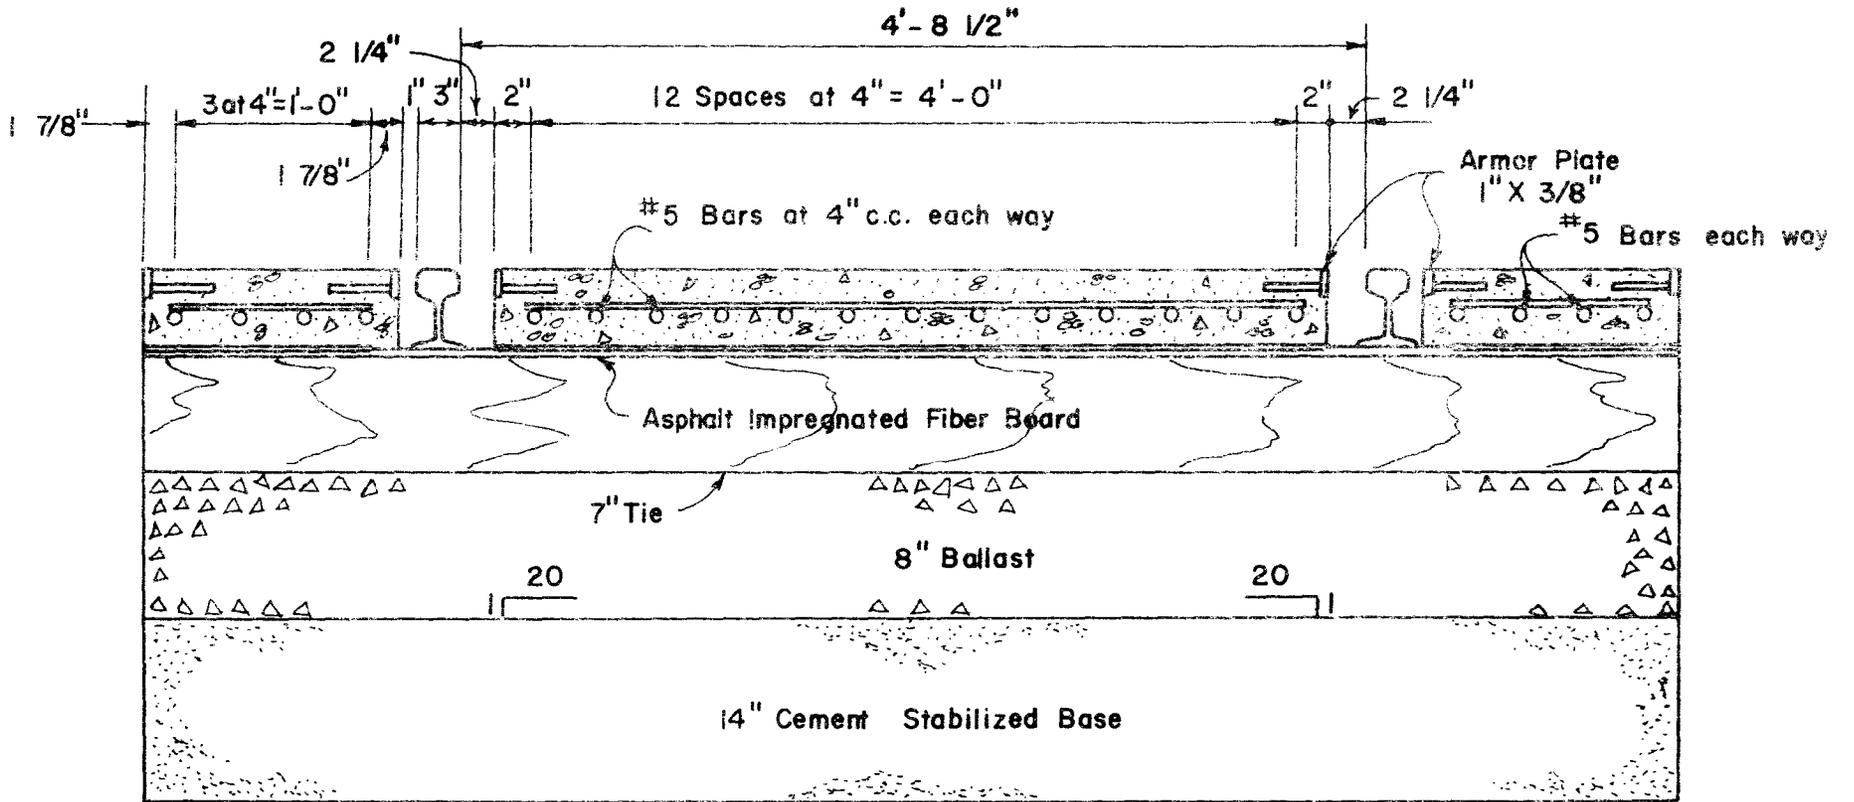
FIGURE 2-II - REINFORCED CONCRETE CROSSING AT WACO, TEXAS

The crossing was constructed in 1975, and remains in good condition. The rideability is excellent at the posted speed of 35 miles per hour. The installed cost was \$41.72 per track foot.

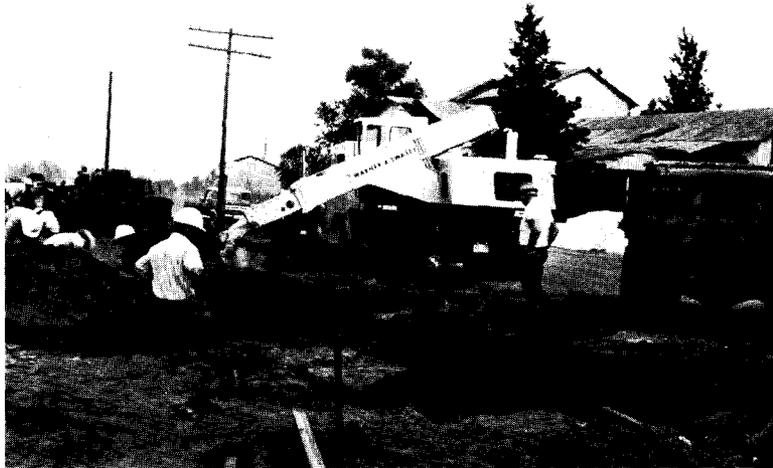
FIGURE 3-1 - BACKHOE LEVELING BASE MATERIAL

removed the old crossing surface, rails, and ties. State forces excavated the fouled ballast and subgrade material. Figure 3-1 shows a backhoe beginning to level the base material dumped into the excavation. After the base material was finished to the proper configuration, the strings of perforated pipe were installed on each lower edge of the base surface (see Figure 3-2). These strings had been pre-assembled while the excavation was being prepared. These perforated pipes were connected to others as shown in Figure 3-3, which permitted positive outfall to a drainage ditch.

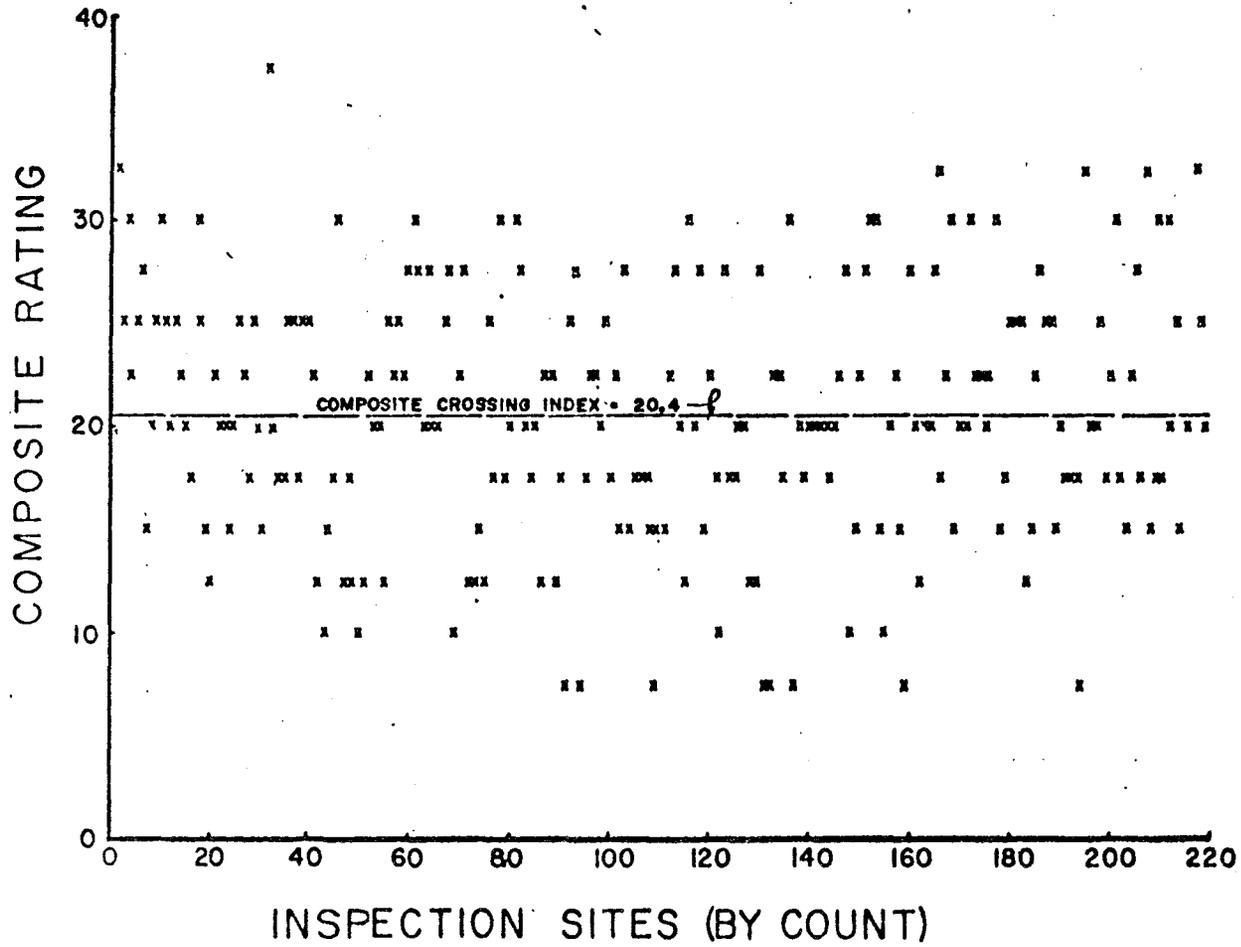
FIGURE 4-2 - COMPOSITE RATINGS OF 219 INDIVIDUAL CROSSINGS

above the index line. Individual crossings below the index line are rated as being adequate by the proposed method. However, special attention should be given to the maintenance of any individual element having a rating of 5.
