TEXAS
TRANSPORTATION
INSTITUTE

**CRASH TESTS AND EVALUATION
OF SINGLE POST
HIGHWAY SIGNS**

**RESEARCH REPORT 146-11
STUDY 2-10-68-146
ADAPTATION OF ATTENUATION SYSTEMS**

August, 1973

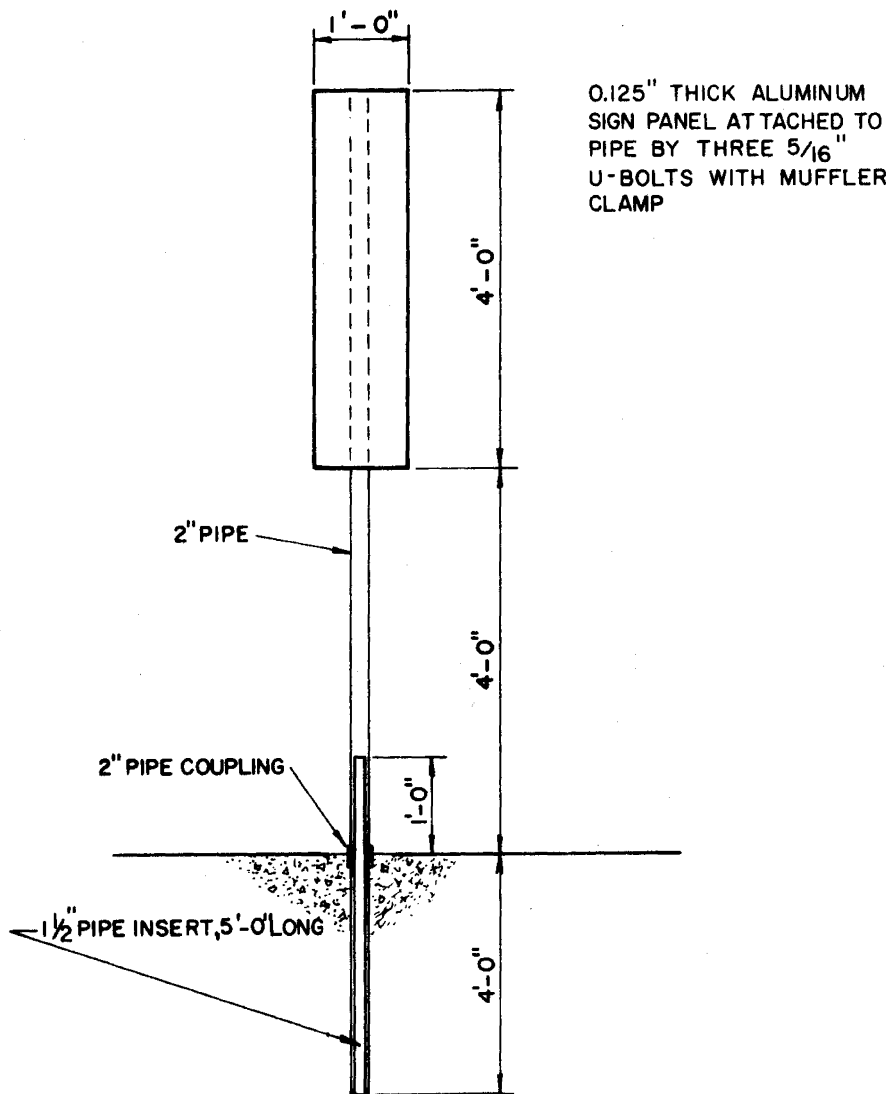
Figures 2 and 3 show a similar Mile Post Marker design with a 1.5 in. diam. pipe insert placed inside the 2 in. pipe. The function of the pipe insert was to delay the rotation of the sign post after "breakaway" on impact to avoid a secondary impact of the sign post into the windshield area. The 3970 lb vehicle impacted the sign head-on at 47.5 mph and sustained a speed change of 2.6 mph. The sign behaved as intended. The pipe hooked on the car hood after "breakaway" rode with the car and no secondary collision occurred. The impact force and damage to the vehicle front end (see Figure 5) was more severe than that obtained from other designs tested.

Figure 2. Mile Post Marker with pipe insert.
Test S-7, 47.5 mph, $\Delta V = 2.6$ mph.

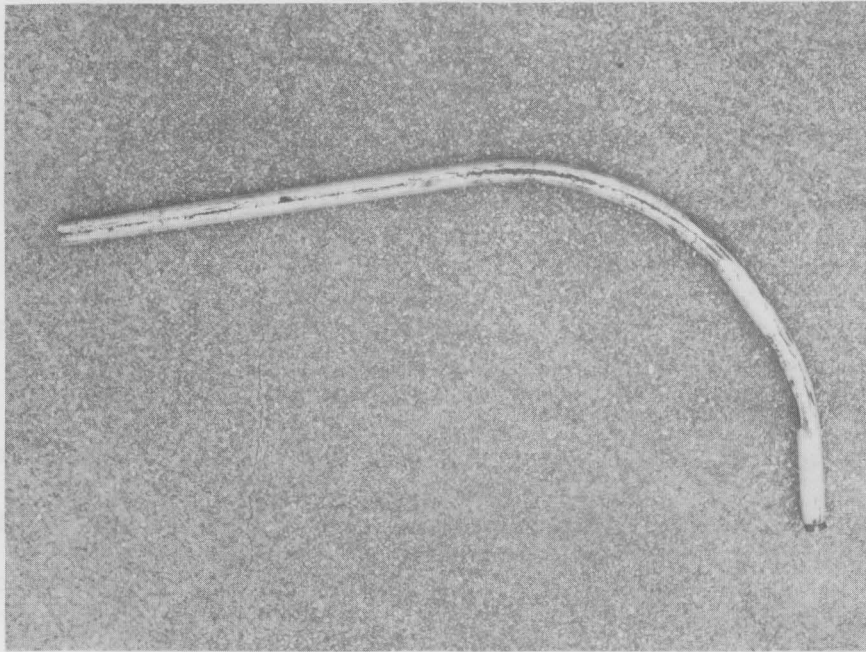
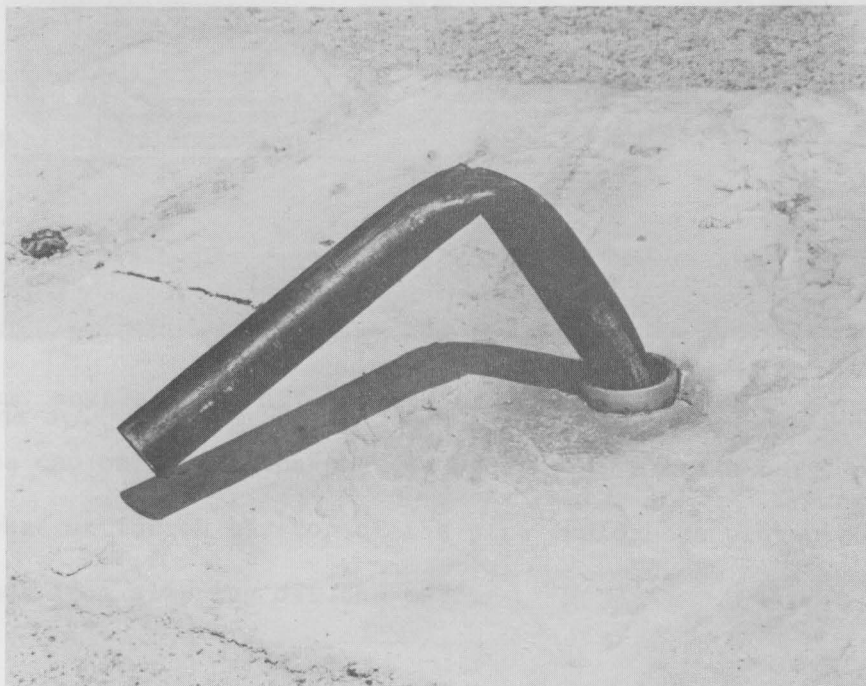
Figure 4. 2" pipe post and 1.5" pipe insert after crash.
Test S-7, 47.5 mph, $\Delta V = 2.6$ mph.

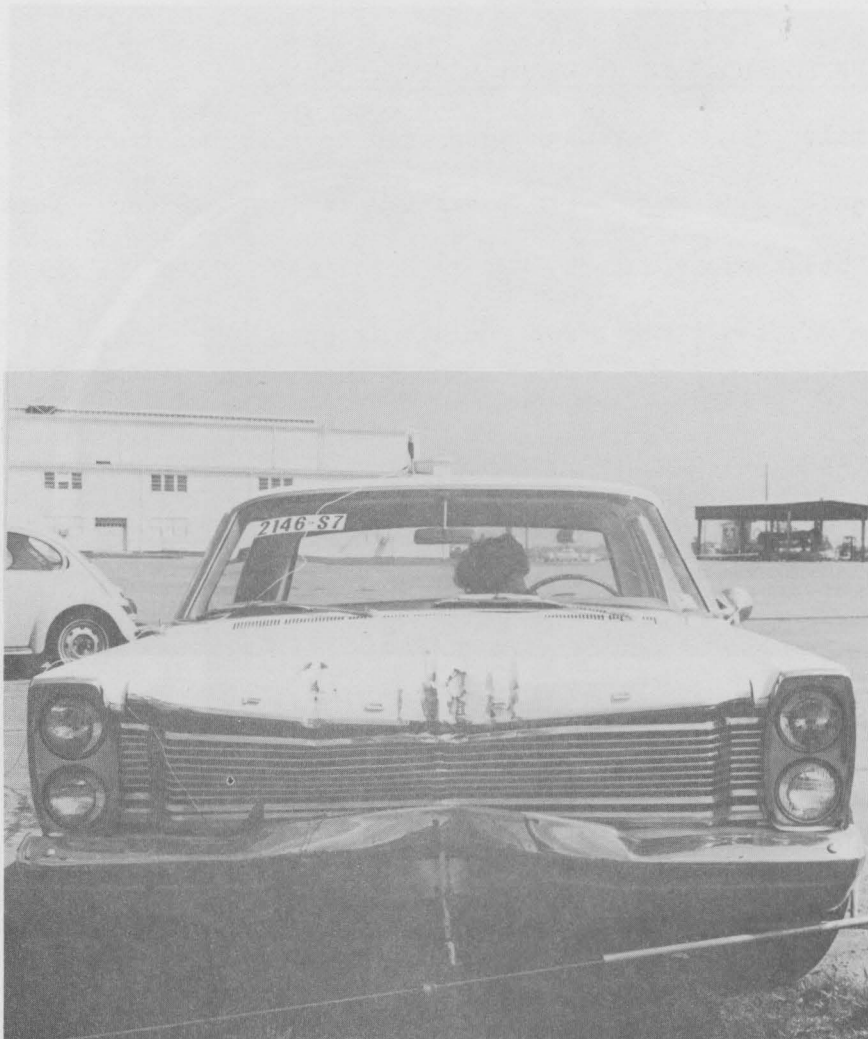
Figure 5. Vehicle after Test S-7, 47.5 mph, $\Delta V = 2.6$ mph.

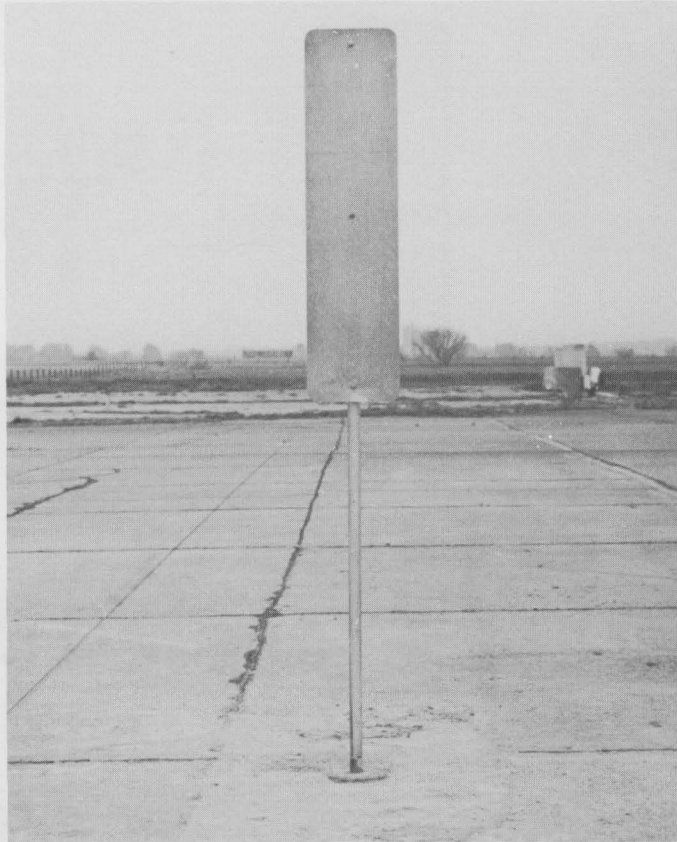
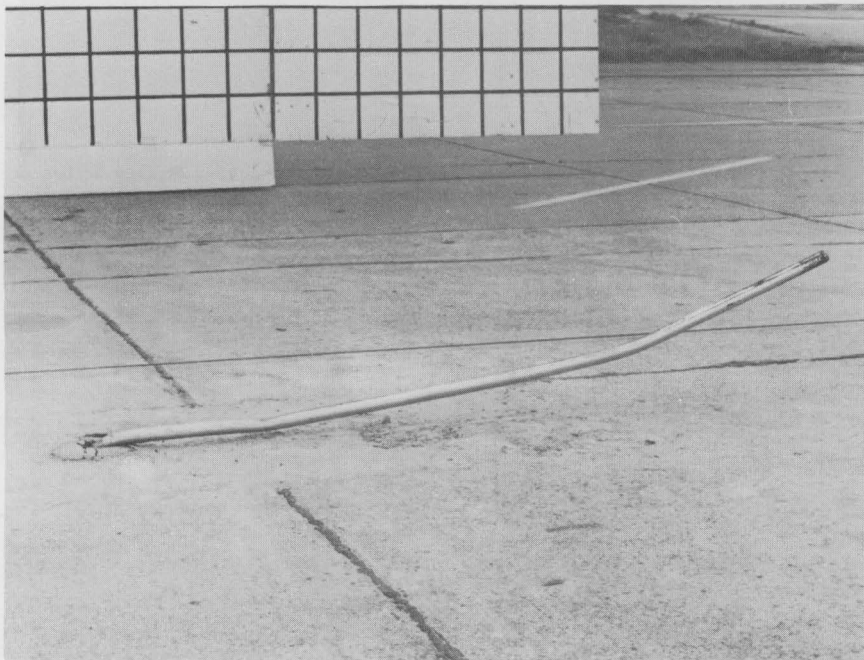
In Test S-2, this sign was impacted head-on at 38.2 mph. The post bent down as intended and the panel was stripped from the post by the undercarriage of the vehicle as shown by Figure 7. The velocity change of the vehicle was 1.3 mph and little damage was sustained (see Figure 8).

Figure 7. "Before" and "After" photographs of Mile Post Marker mounted on 1.25" pipe embedded in 8" diam. concrete shaft. Test S-2, 38.2 mph, $\Delta V \approx 1.3$ mph.

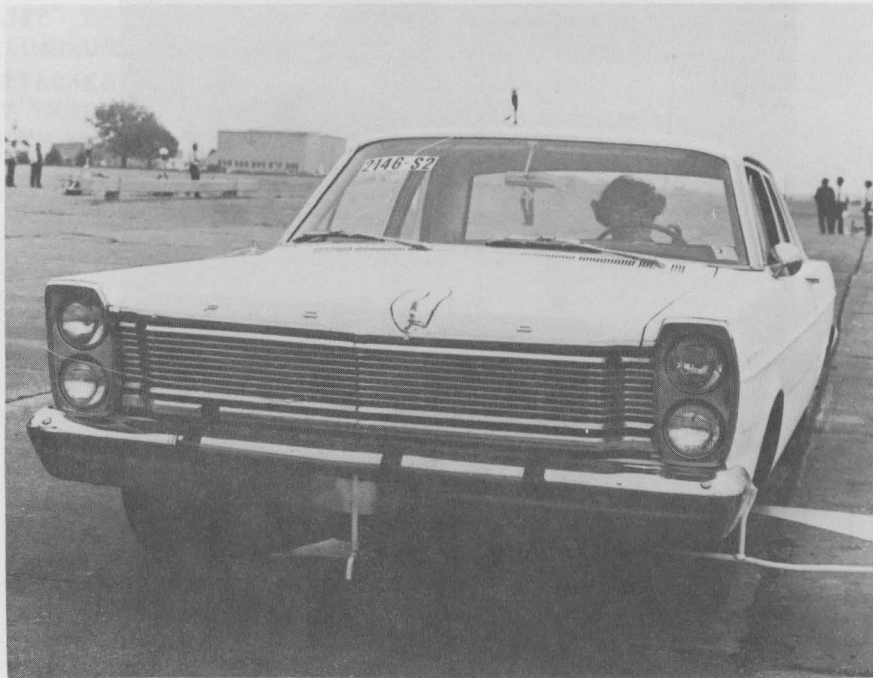
Figure 8. Vehicle after Test S-2, 38.2 mph, $\Delta V = 1.3$ mph.

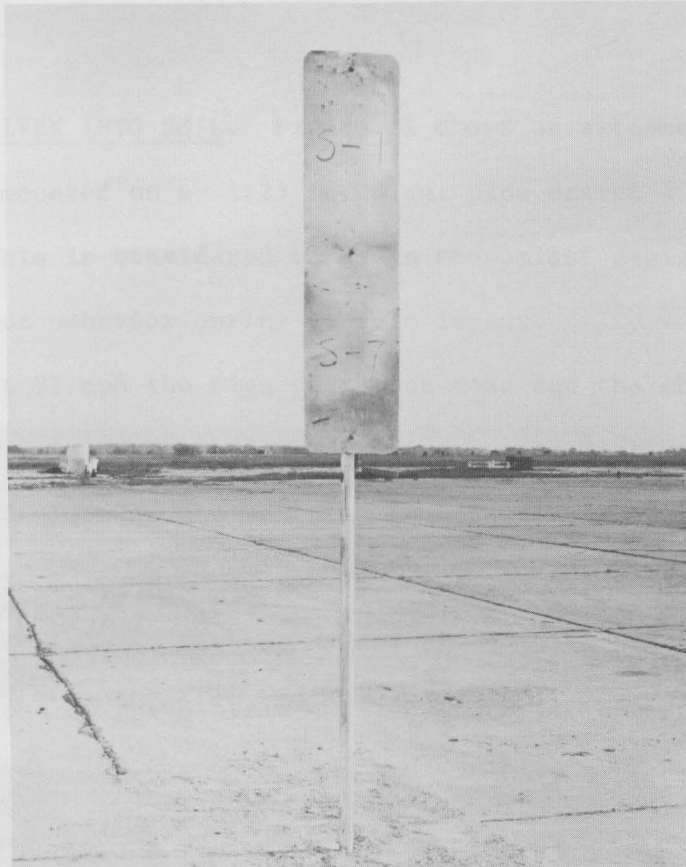
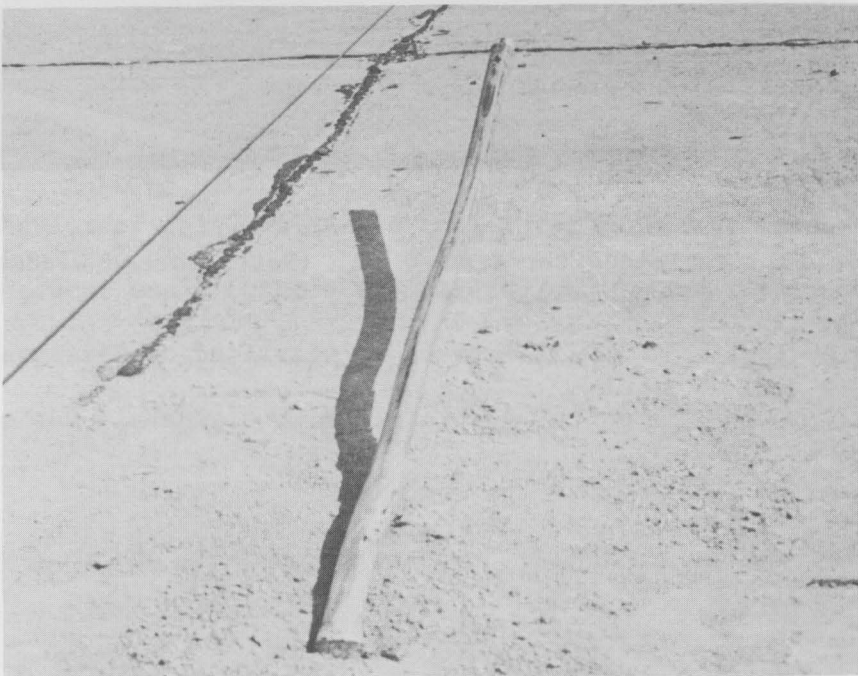
In Test S-12, the sign was impacted head-on at 56.9 mph. The post bent down as intended, however, the sign panel came off the post and hit the windshield of the vehicle (see Figures 9 and 10). The velocity change of the vehicle was 0.9 mph and it sustained a cracked windshield.

The U-bolts holding the 0.125 in. thick aluminum sign panel to the 1.25 in. diam. post slipped off the end of the pipe during impact. A threaded pipe cap on top of the post, a spot weld, a cross bolt or some other obstruction on the top of the pipe could have prevented the sign panel from slipping off the post.

Figure 9. "Before" and "After" photographs of Mile Post Marker mounted on 1.25" pipe embedded in 8" diam. concrete shaft. Test S-12, 56.9 mph.

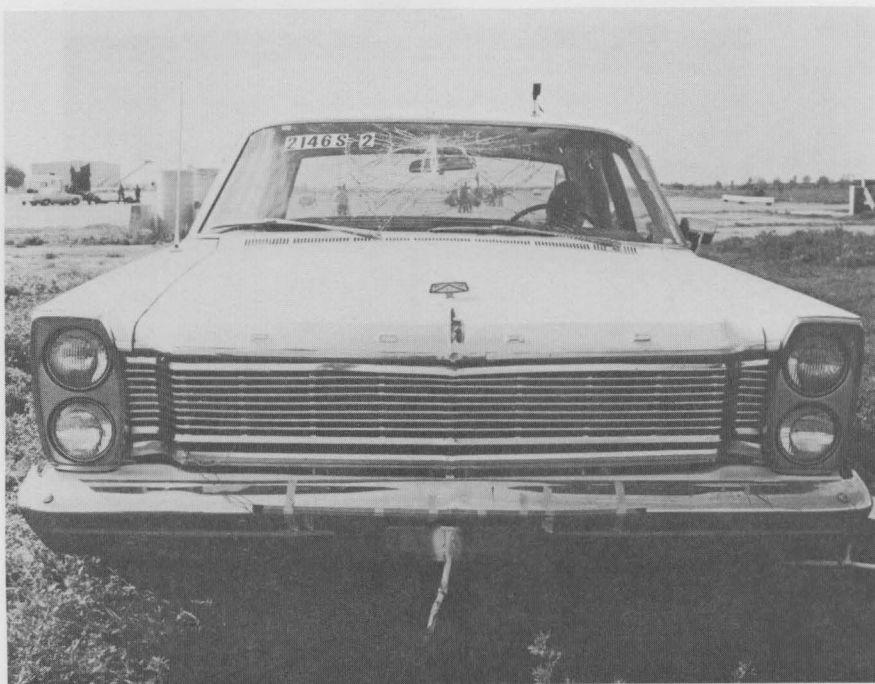
Figure 10. Vehicle after Test S-12. (Note cracked windshield)
56.9 mph, $\Delta V = 0.9$ mph.

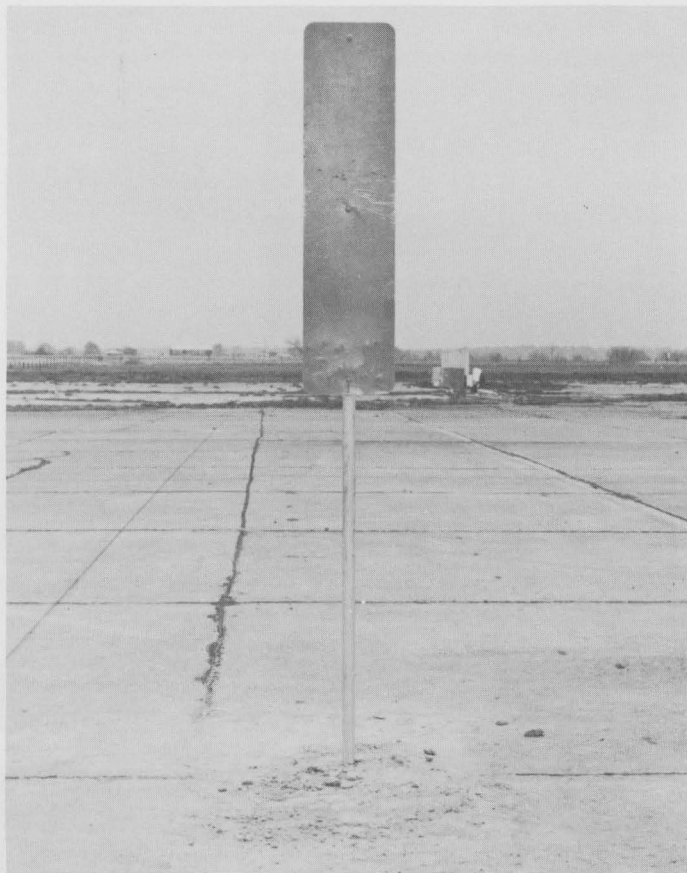
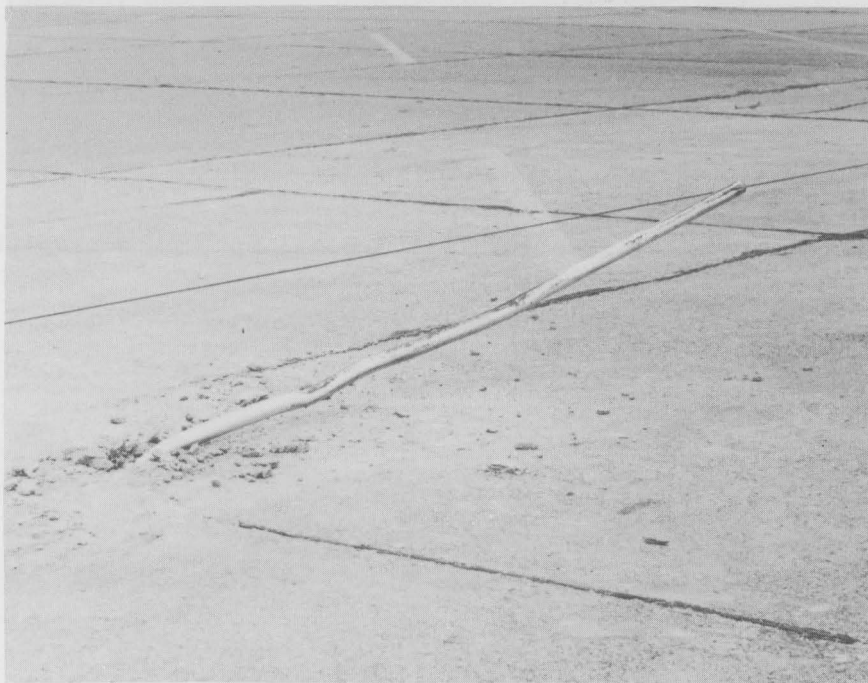
In Test S-3 at 31 mph the sign post bent down and the change in vehicle speed was 1.4 mph (see Figure 12). The sign panel was stripped off by the undercarriage of the vehicle. No damage was sustained by the vehicle (see Figure 13).

Figure 12. "Before" and "After" photographs of Mile Post Marker mounted on 1.25" pipe driven into soil. Test S-3, 31 mph, $\Delta V = 1.4$ mph.

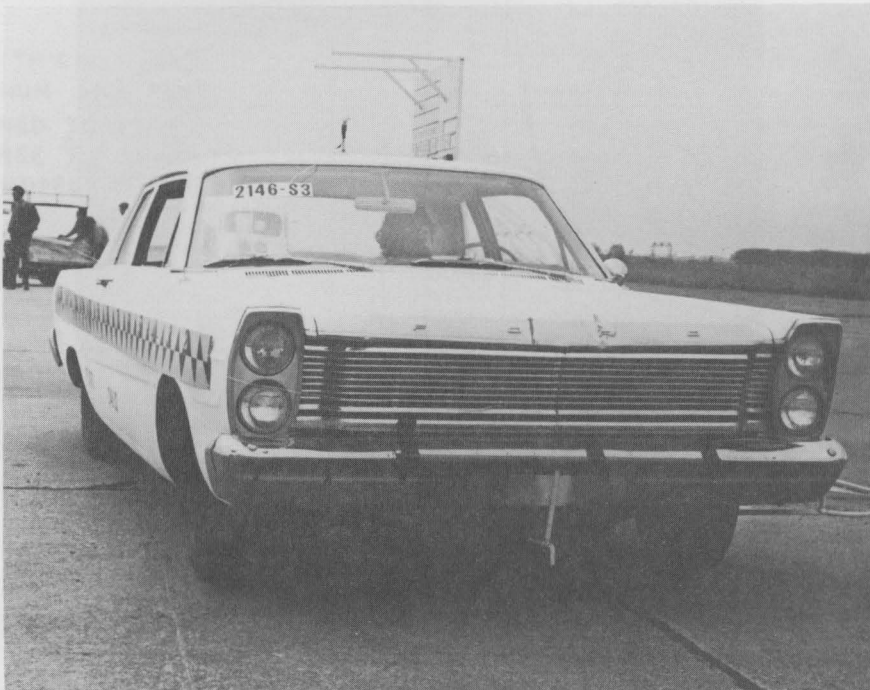
Figure 13. Vehicle after Test S-3, 31 mph, $\Delta V = 1.4$ mph.

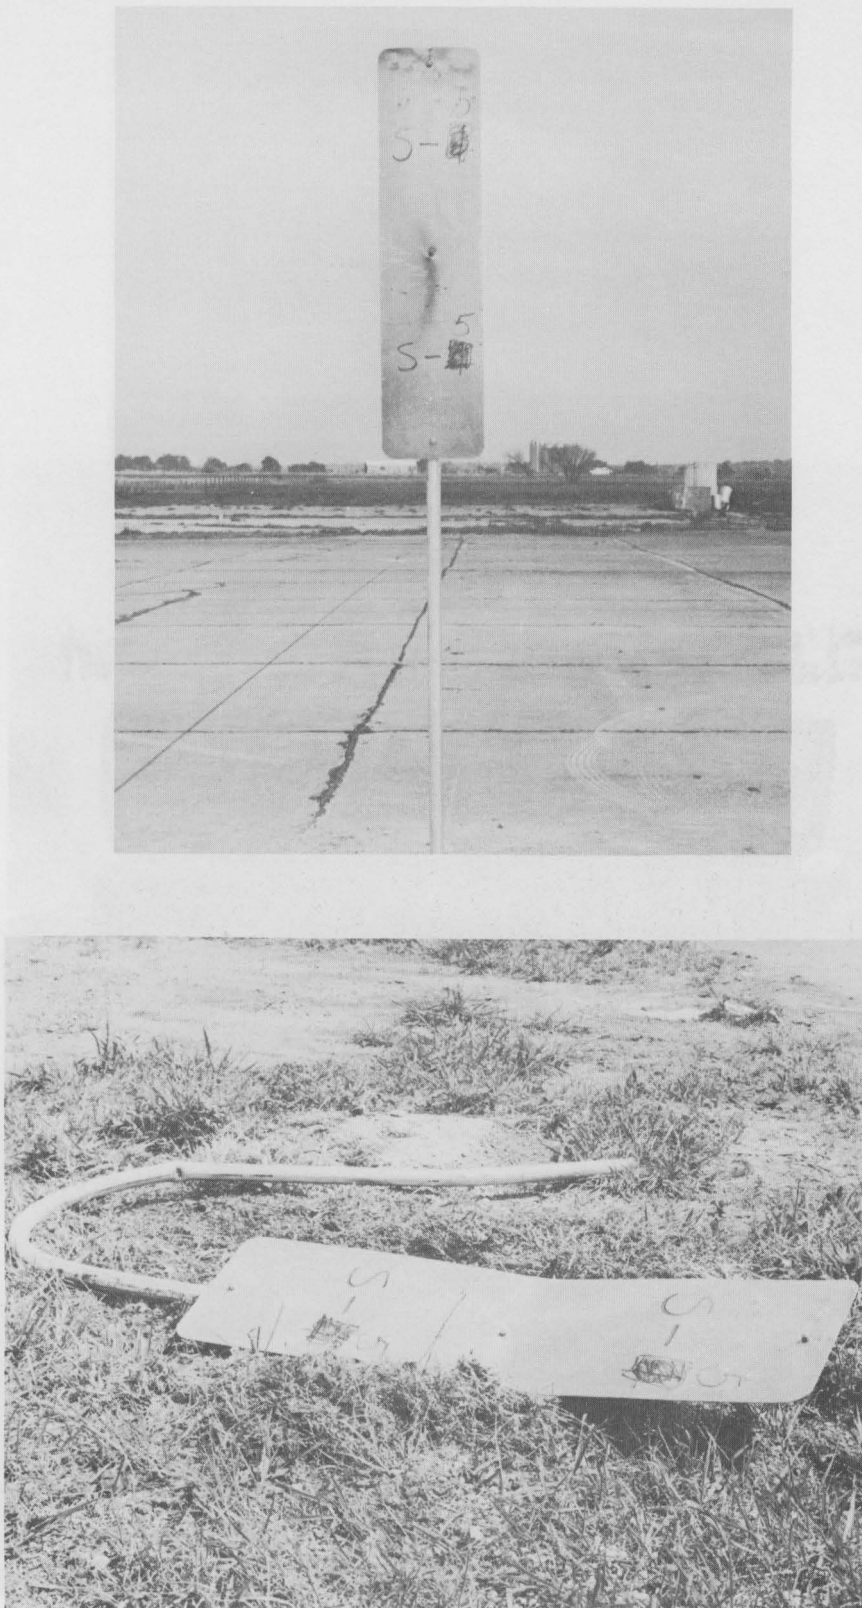
In Test S-5 at 44.9 mph the sign post pulled out of the soil and hooked over the hood of the vehicle and rode with it (see Figure 14). The change in vehicle speed was 0.8 mph and little damage was sustained (see Figure 15).

Figure 14. "Before" and "After" photographs of Mile Post Marker mounted on 1.25" pipe driven into soil. Test S-5, 44.9 mph, $\Delta V = 0.8$ mph.

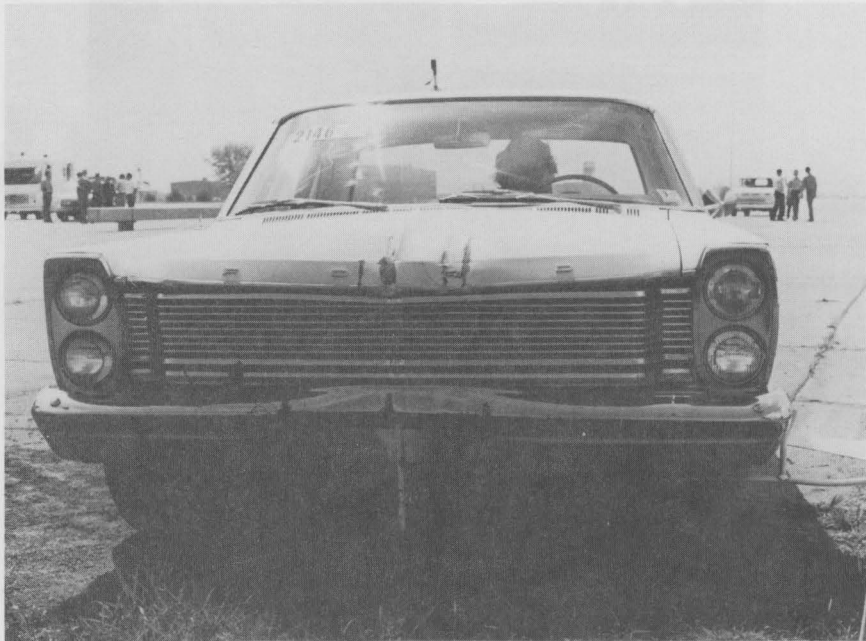
Figure 15. Vehicle after Test S-5, 44.9 mph, $\Delta V = 0.8$ mph.

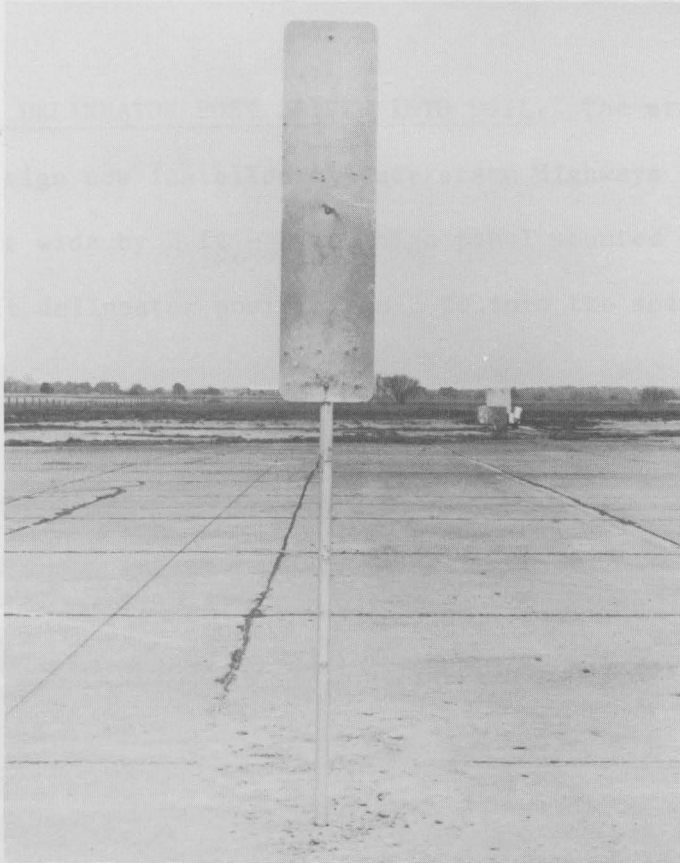
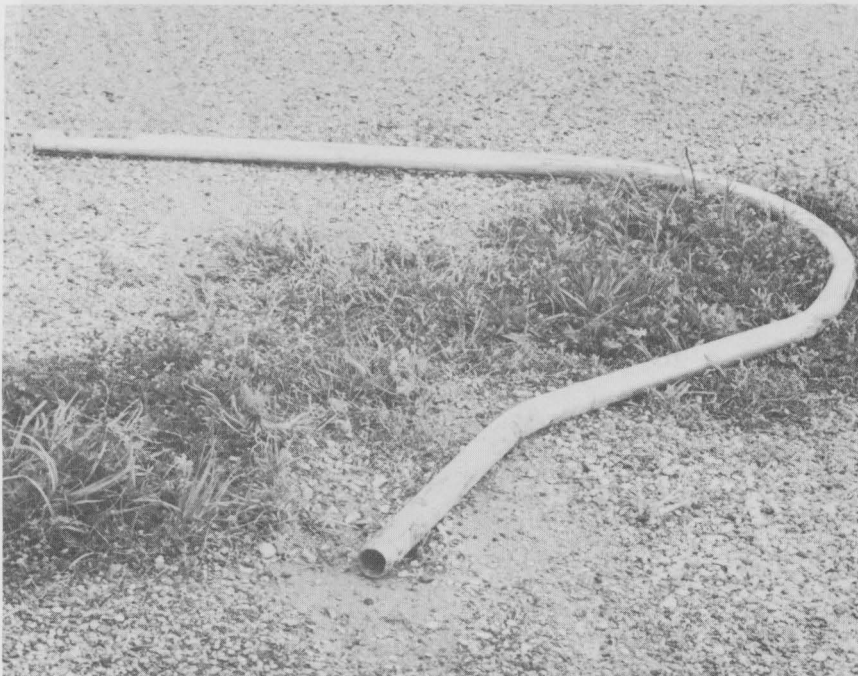
In Test S-4 at 59.4 mph the sign post pulled out of the soil and hooked over the hood of the vehicle and rode with it (see Figure 16). The change in vehicle speed was 0.5 mph and little damage was sustained (see Figure 17).

Figure 16. "Before" and "After" photographs of Mile Post Marker mounted on 1.25" pipe driven into soil. Test S-4, 59.4 mph, $\Delta V = 0.5$ mph.

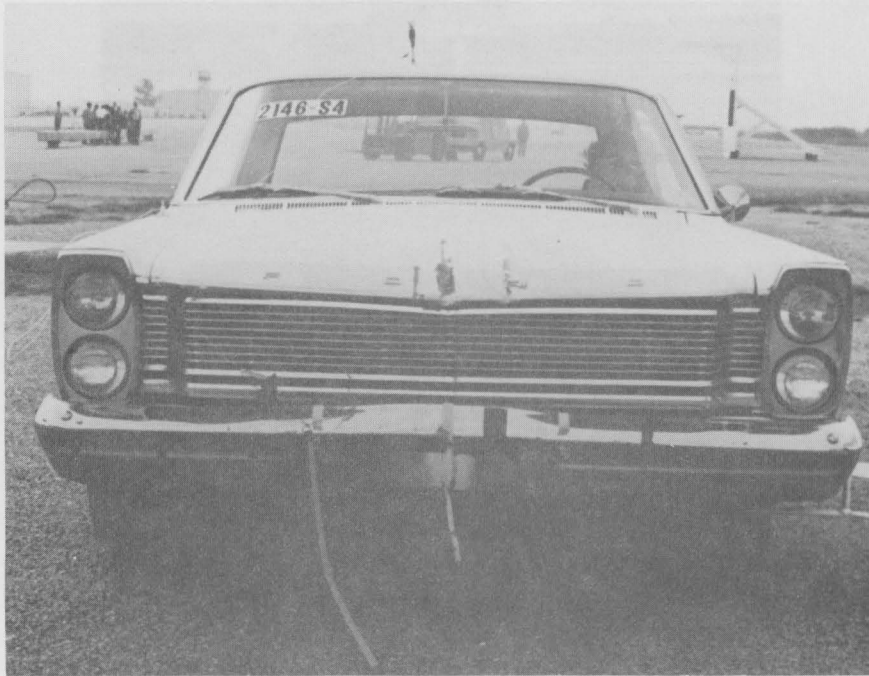
Figure 17. Vehicle after Test S-4, 59.4 mph, $\Delta V = 0.5$ mph.

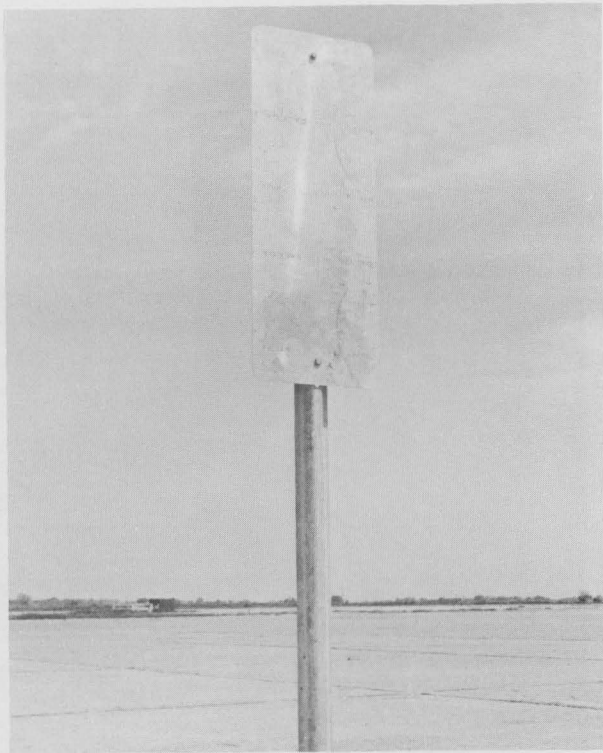
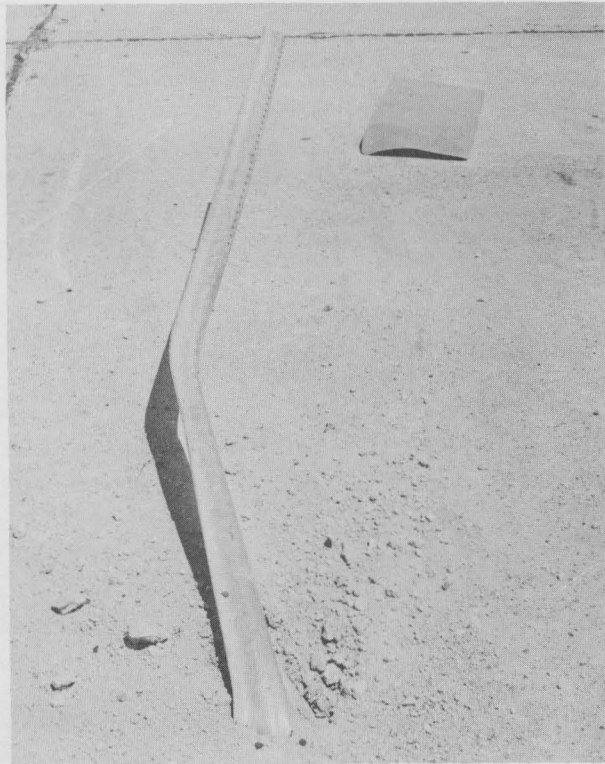
In Test S-15 the sign was impacted head-on at 28.1 mph and it bent down as intended by the design (see Figure 19). The speed change of the vehicle was 0.5 mph and the vehicle sustained little damage.

Figure 19. "Before" and "After" photographs of Texas Mile Post Marker mounted on delineator post driven into soil. Test S-15, 28.1 mph, $\Delta V = 0.5$ mph.

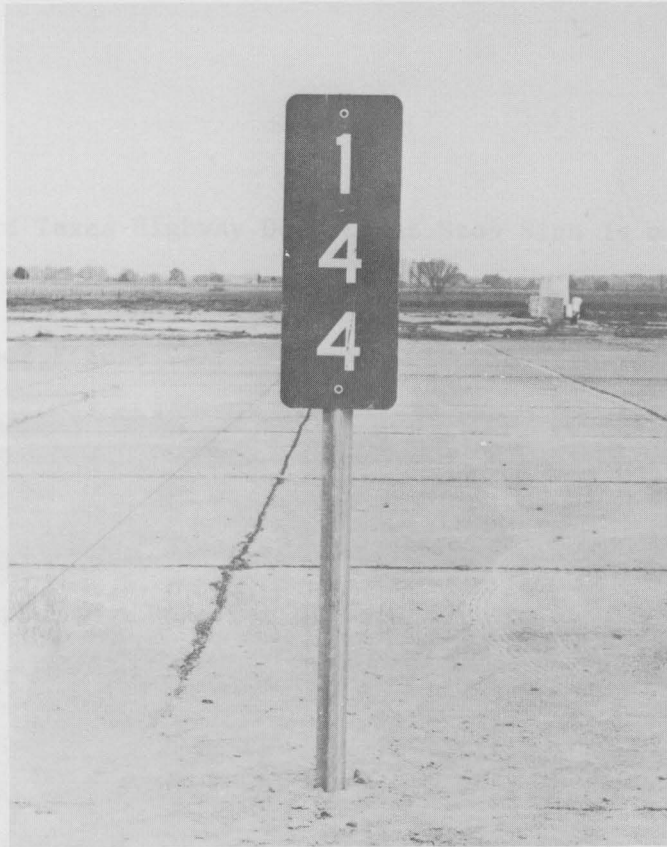
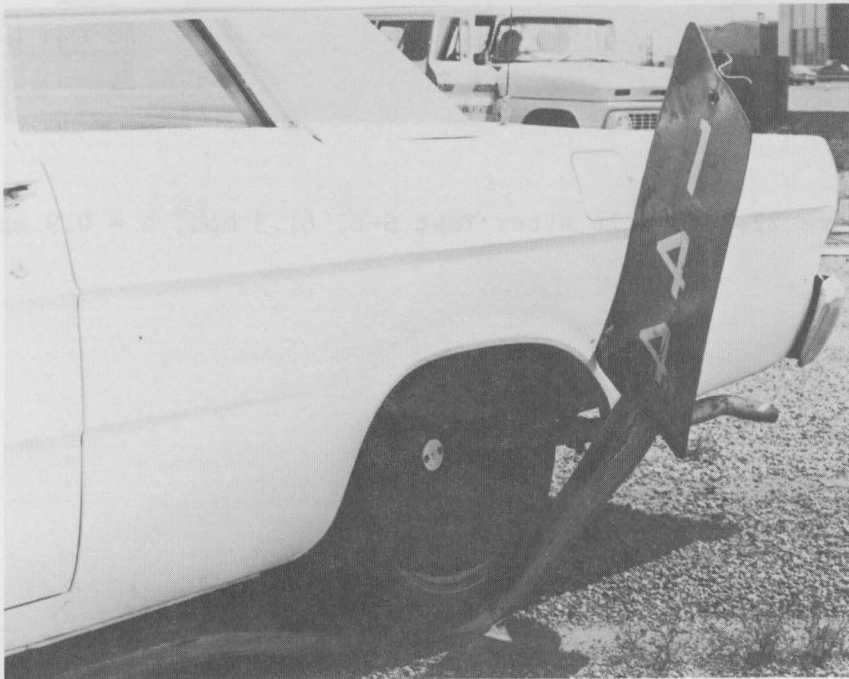
In Test S-6 the vehicle impacted the sign at 61.3 mph and the sign post pulled out of the soil and hooked over the hood of the vehicle and rode with it (see Figure 21). The speed change of the vehicle was 0.9 mph. The slight damage to the vehicle after all three tests is shown by Figure 22.

Figure 21. "Before" and "After" photographs of Texas Mile Post Marker mounted on delineator post driven into soil.
Test S-6, 61.3 mph, $\Delta V = 0.9$ mph.

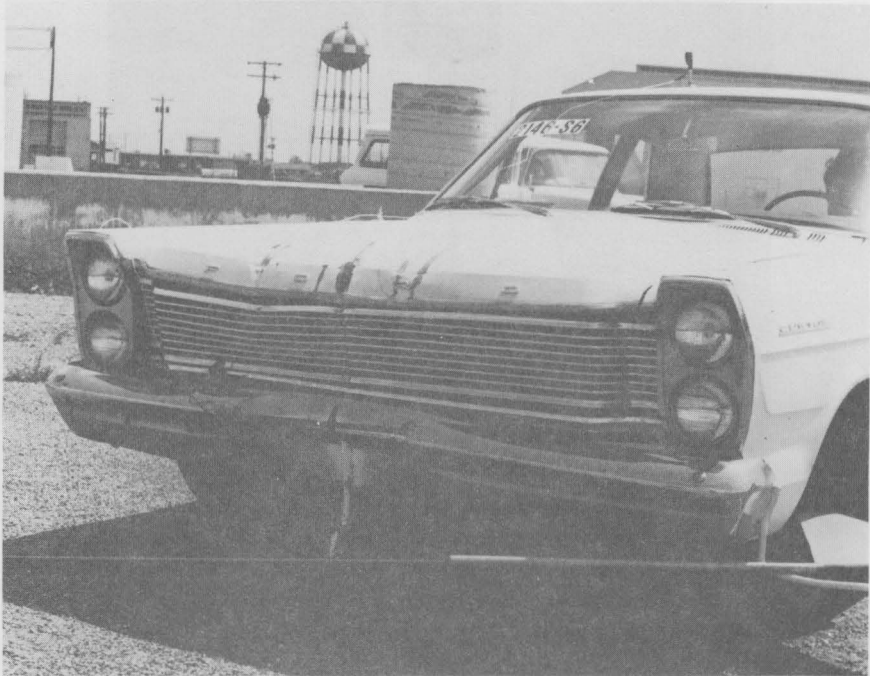
Figure 22. Vehicle after Test S-6, 61.3 mph, $\Delta = 0.9$ mph.

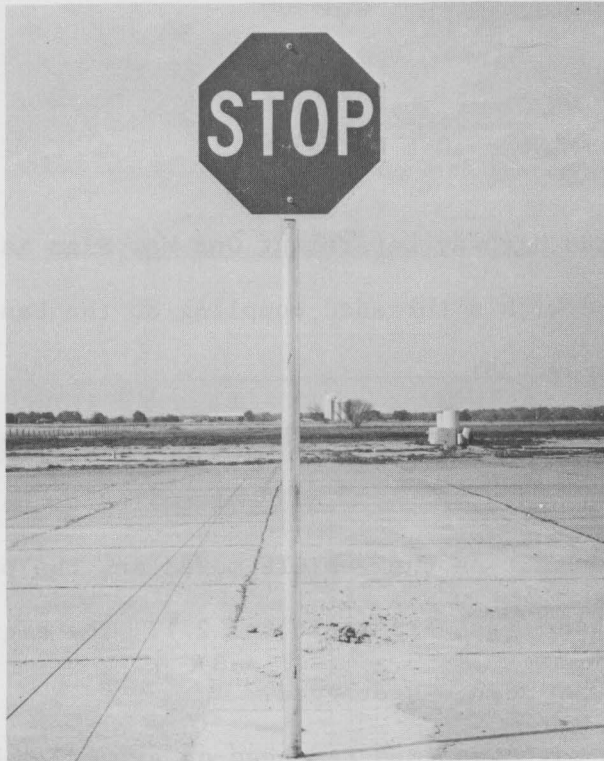
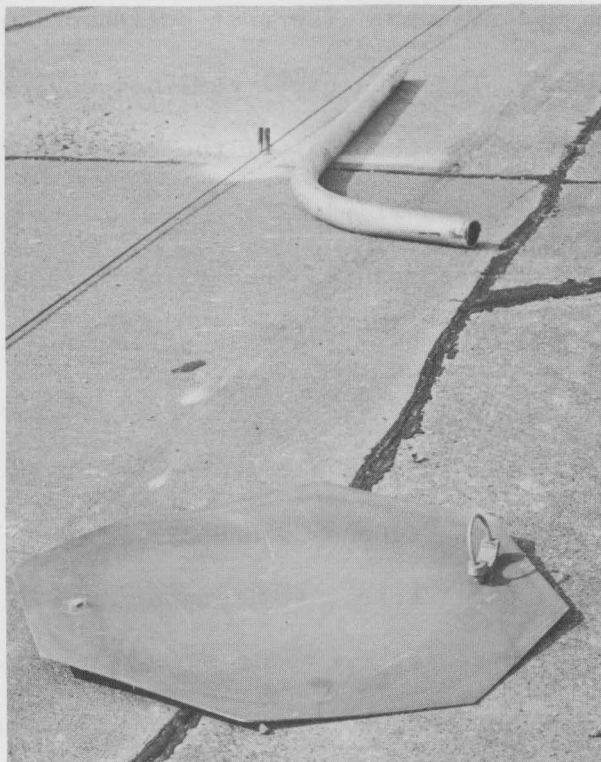
Figure 24. "Before" and "After" photographs of Stop Sign mounted on 2.5" pipe with threaded coupling as breakaway feature. Test S-10, 45.5 mph, $\Delta V = 1.7$ mph.

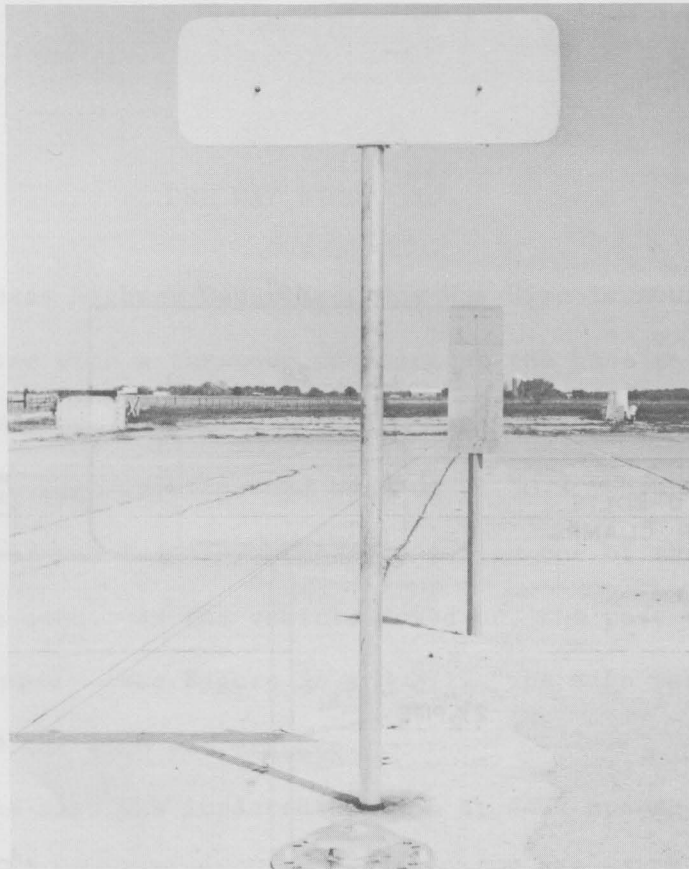
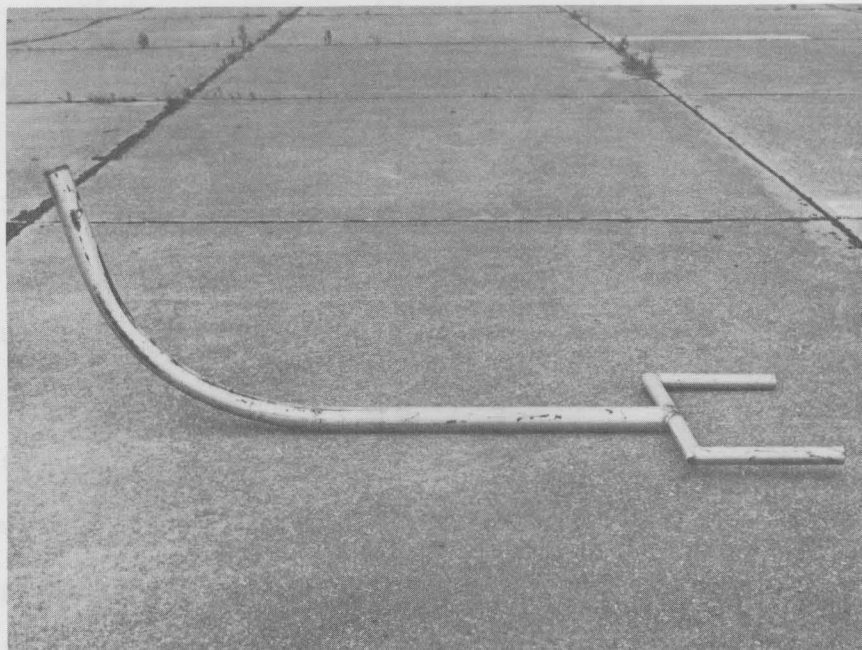
Figure 26. "Before" and "After" photographs of One Way Sign mounted on 2.5" pipe with threaded coupling as breakaway feature. Test S-14, 30.2 mph, $\Delta V = 2.3$ mph.

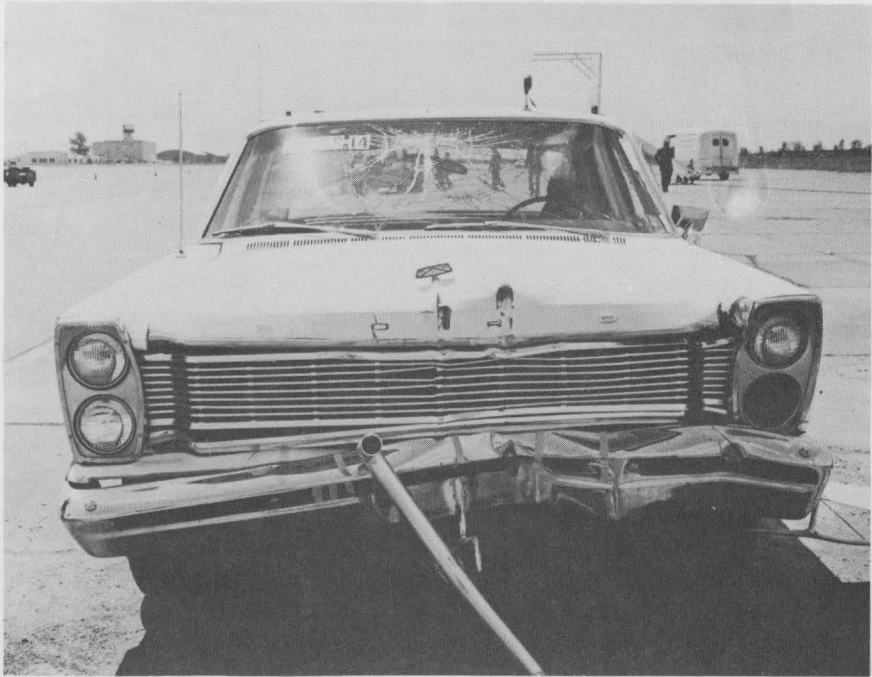
Figure 27. Vehicle after Tests S-14.
Windshield was cracked in Test S-12.

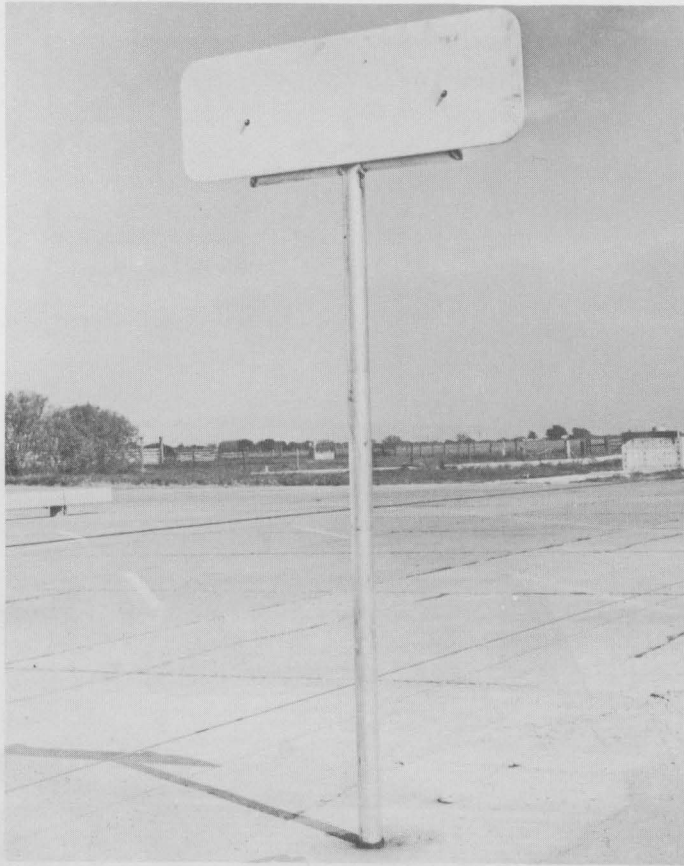
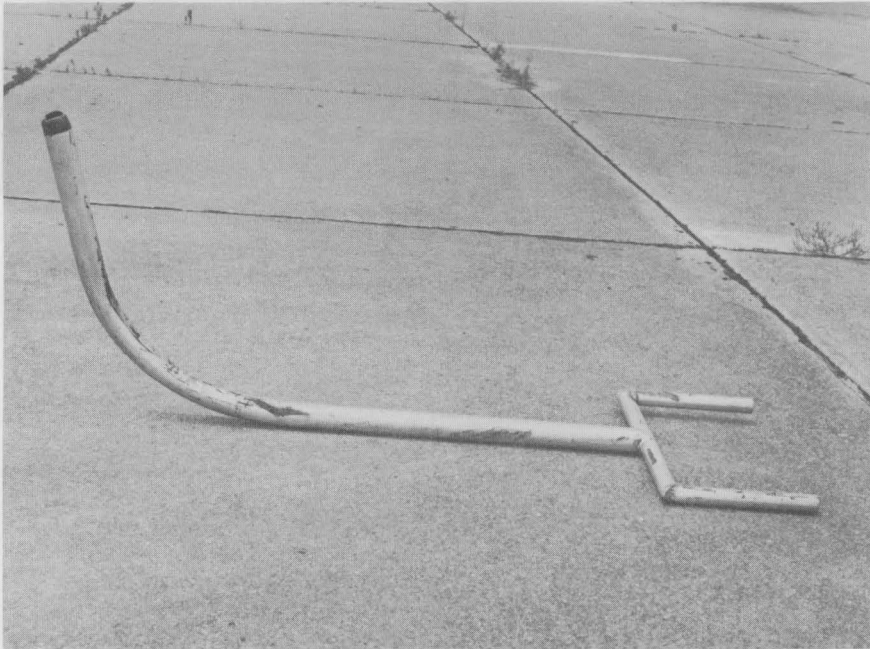
In Test S-13 the sign was impacted head-on at 44.2 mph and the vehicle change in speed was 1.5 mph. The post pulled out of the coupling and hooked over the hood. The sign panel came off during impact and passed over and lightly struck the roof of the car (see Figures 28 and 29). Damage to the vehicle was slight.

Figure 28. "Before" and "After" photographs of One Way Sign mounted on 2.5" pipe with threaded coupling as breakaway feature. Test S-13, 44.2 mph, $\Delta V = 1.5$ mph.

As a result of these three tests, it is apparent that the connection of the sign panel to the pipe support needs strengthening. The two 5/16 in. U-bolts should be increased to four. In addition, threaded caps or some other stop device should be placed on top of the pipe to prevent the U-bolts from slipping off. Overall the One Way Sign behaved in an adequate manner.

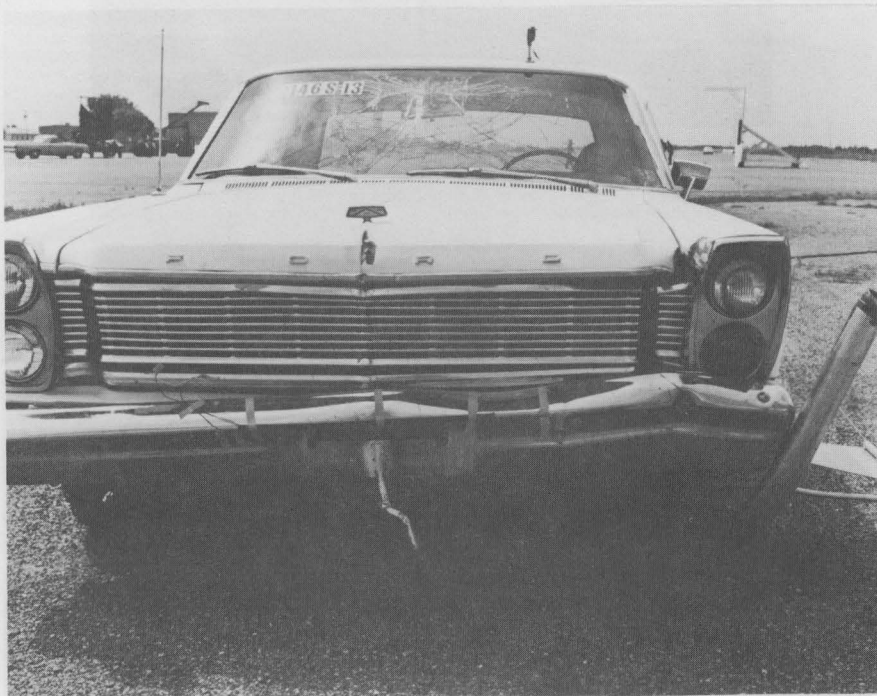
Figure 29.. Vehicle after Test S-13.
Windshield was cracked in Test S-12.

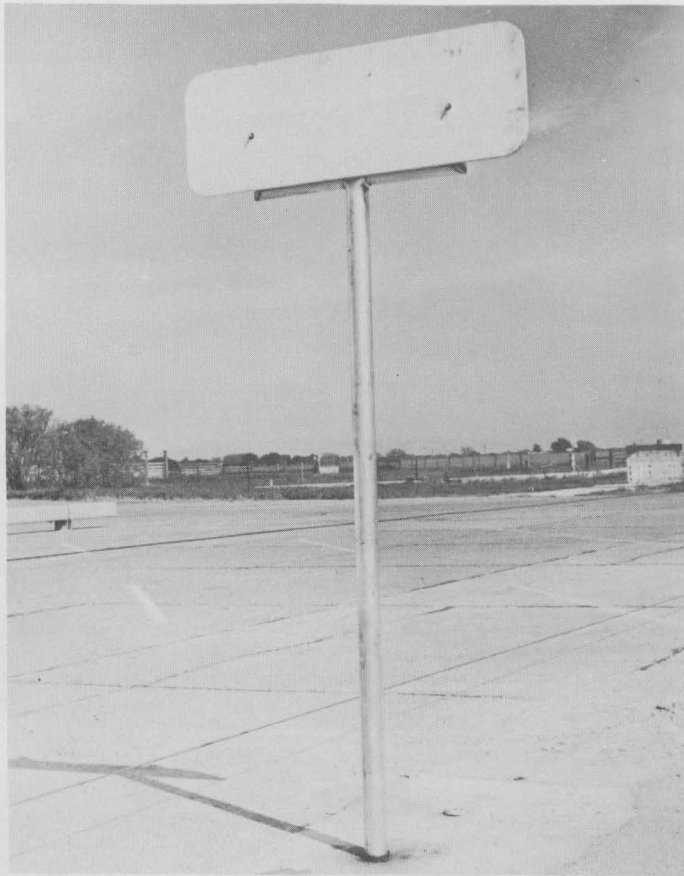
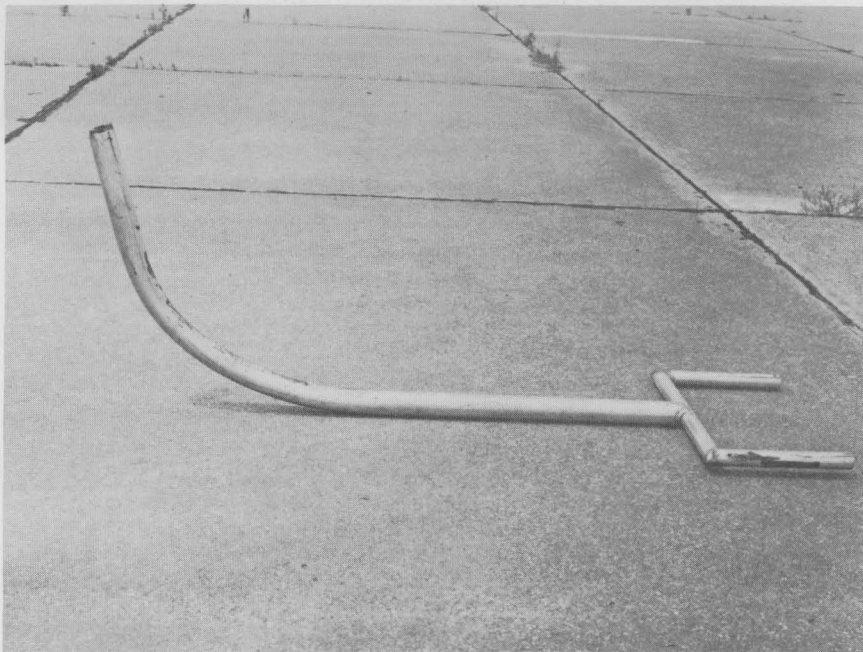
Figure 30. "Before" and "After" photographs for One Way Sign, mounted on 2.5" pipe with threaded coupling as breakaway feature. Test S-16, 58.4 mph, $\Delta = 1.3$ mph.

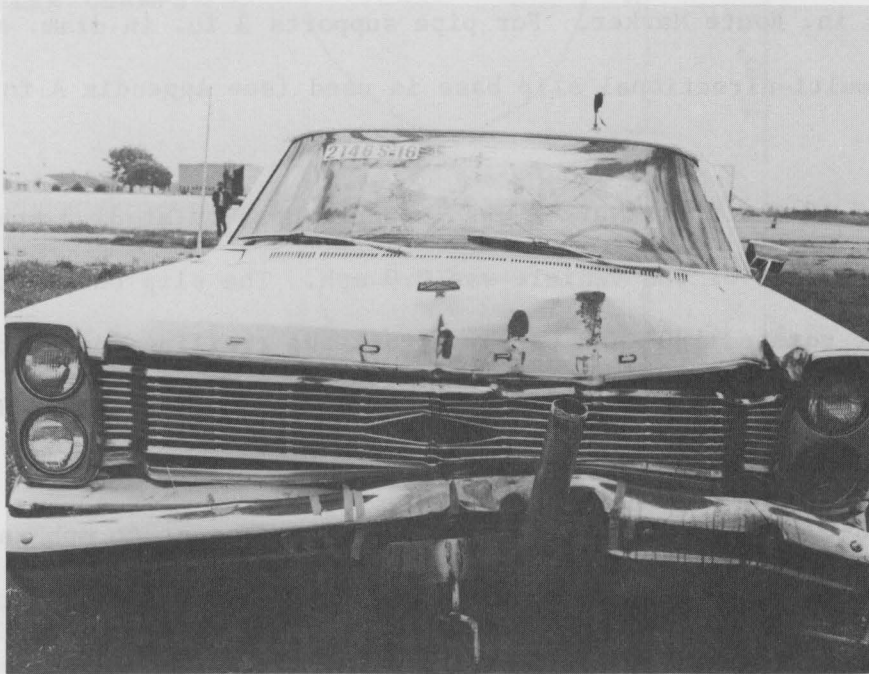
Figure 31. Vehicle after Test S-16.
Windshield was cracked in Test S-12.
