TEXAS
TRANSPORTATION
INSTITUTE

**CRASH TESTS AND EVALUATION
OF SINGLE POST
HIGHWAY SIGNS**

**RESEARCH REPORT 146-11
STUDY 2-10-68-146
ADAPTATION OF ATTENUATION SYSTEMS**

August, 1973

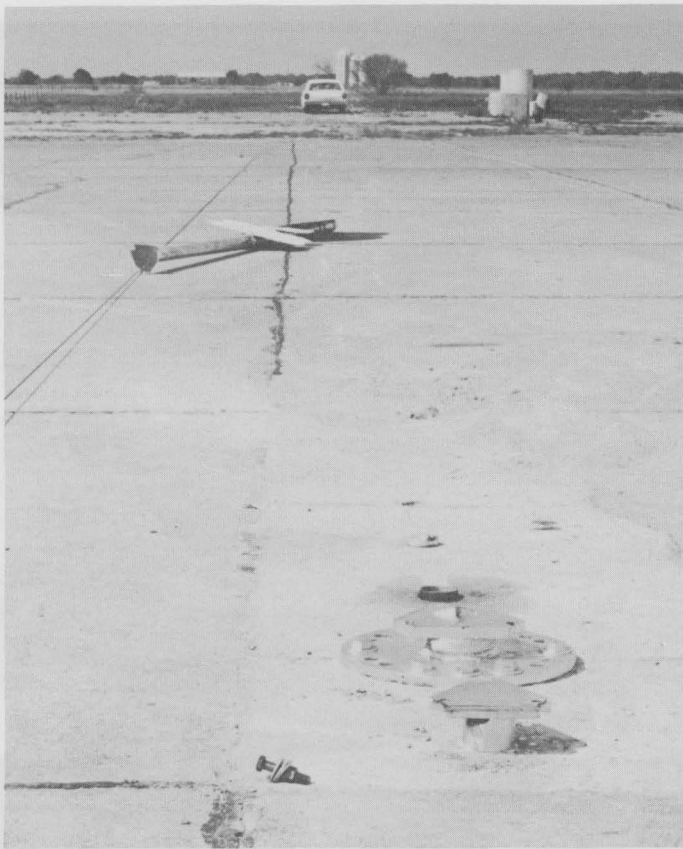
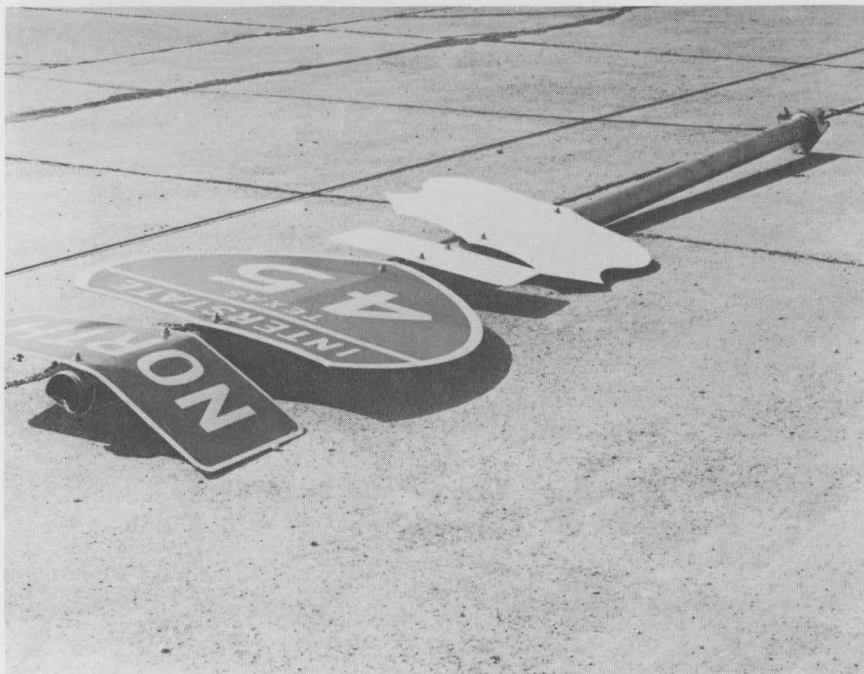
Figure 34. Route Marker after crash.
Test S-18, 31.3 mph, $\Delta V = 0.9$ mph.

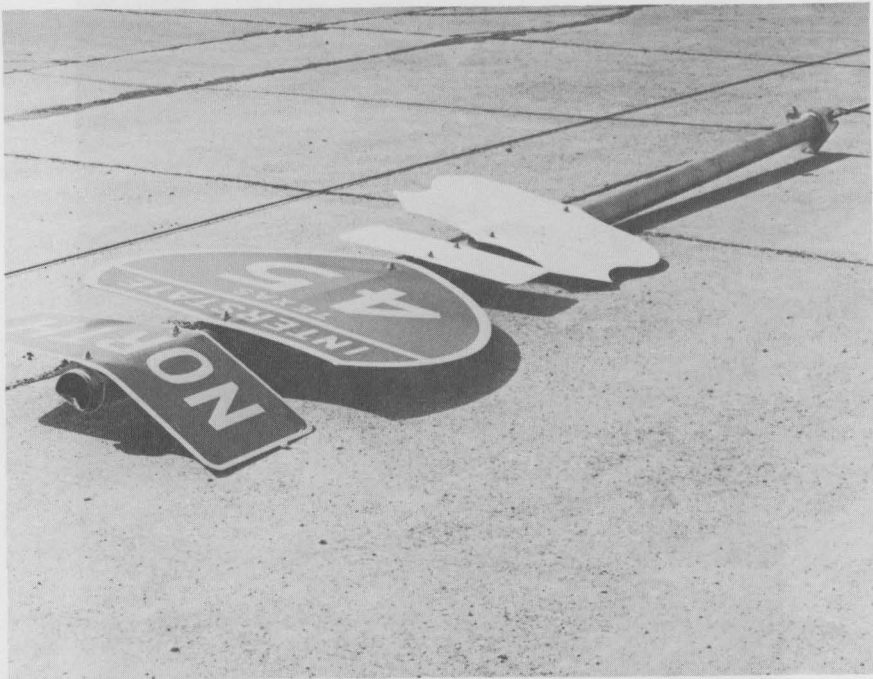
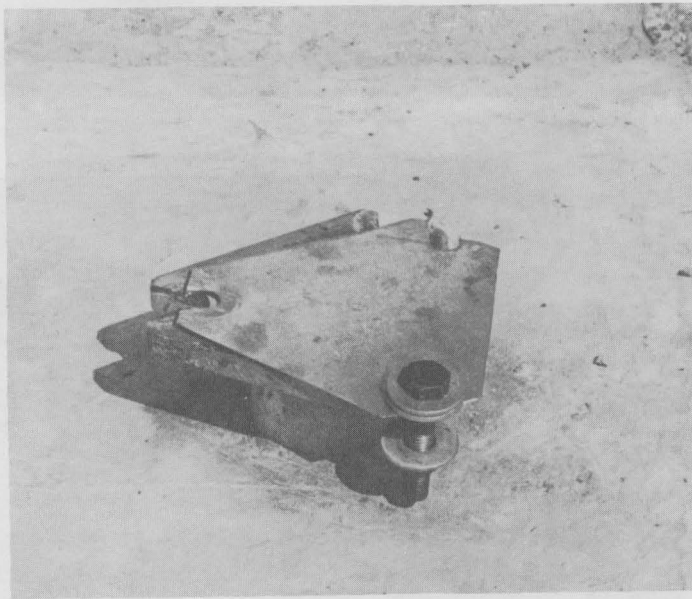
Figure 35. Route Marker and base after crash.
Test S-8, 46 mph, $\Delta V = 0.8$ mph.

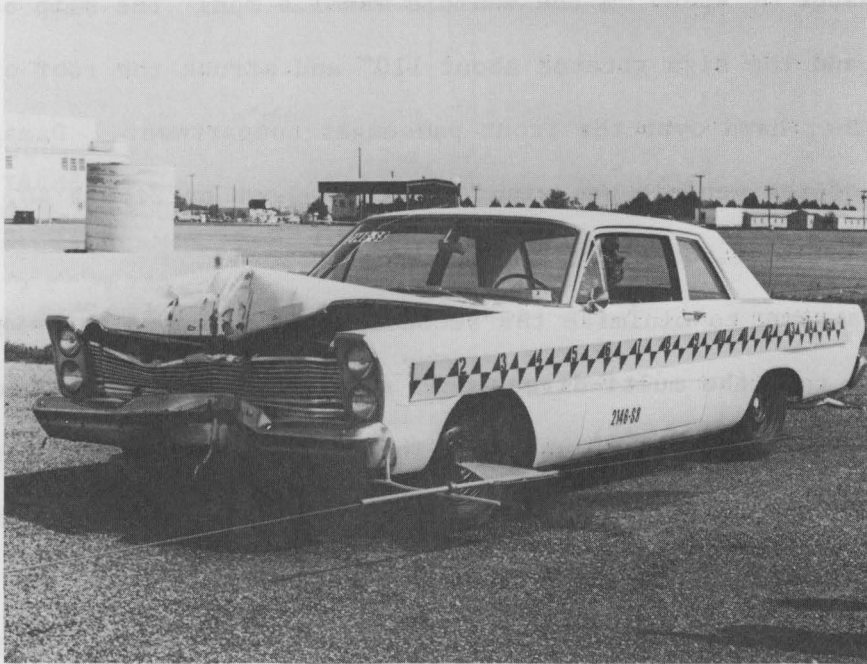
Figure 36. Vehicle after crash.
Test S-8.

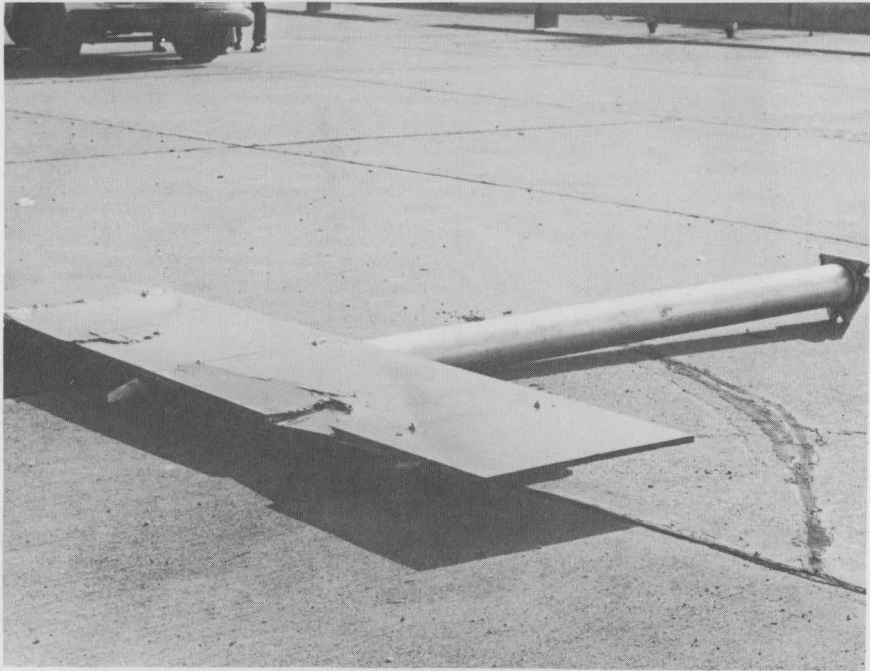
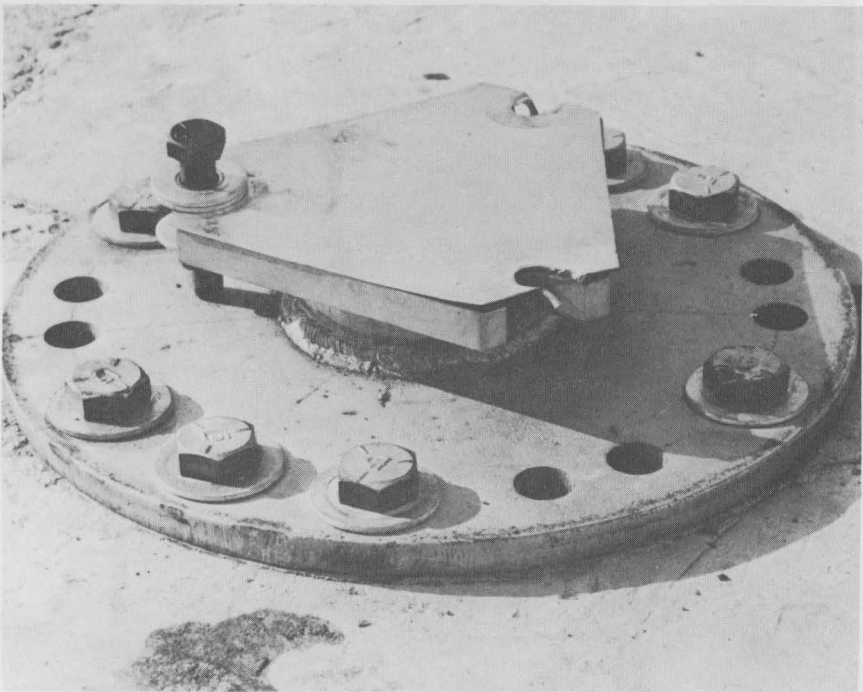
In Test S-11 the sign was impacted head-on at a speed of 44.5 mph and the change in speed of the vehicle was 1.4 mph. The slip base activated and the sign rotated about 110° and struck the roof of the vehicle rather hard over the front passenger compartment. Damage to the front of the vehicle was significant as shown by Figure 40. Figure 39 shows the final position of the sign structure.

Figure 39. Destinations Sign and base after crash.
Test S-11, 44.5 mph, $\Delta V = 1.4$ mph.

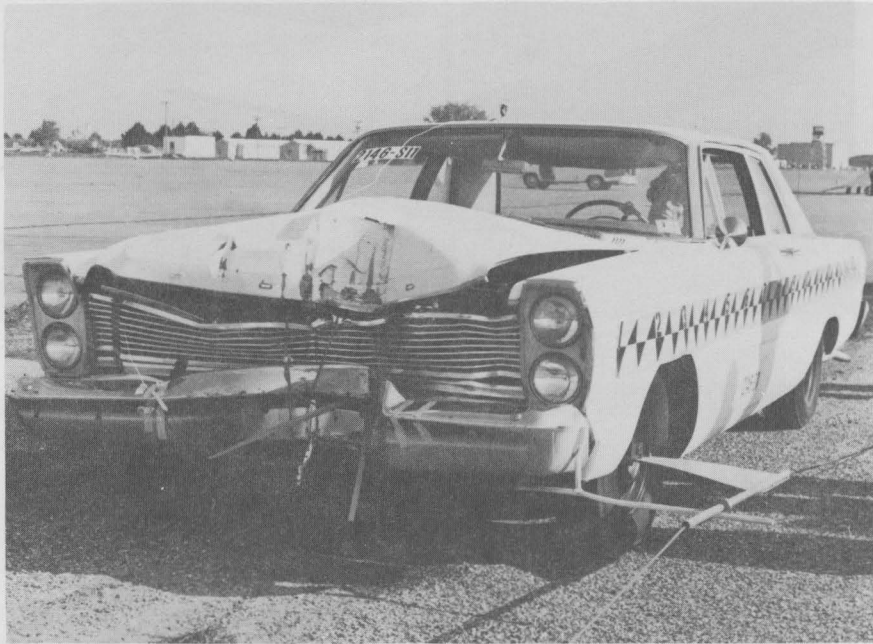
Figure 40. Vehicle after Test S-11.

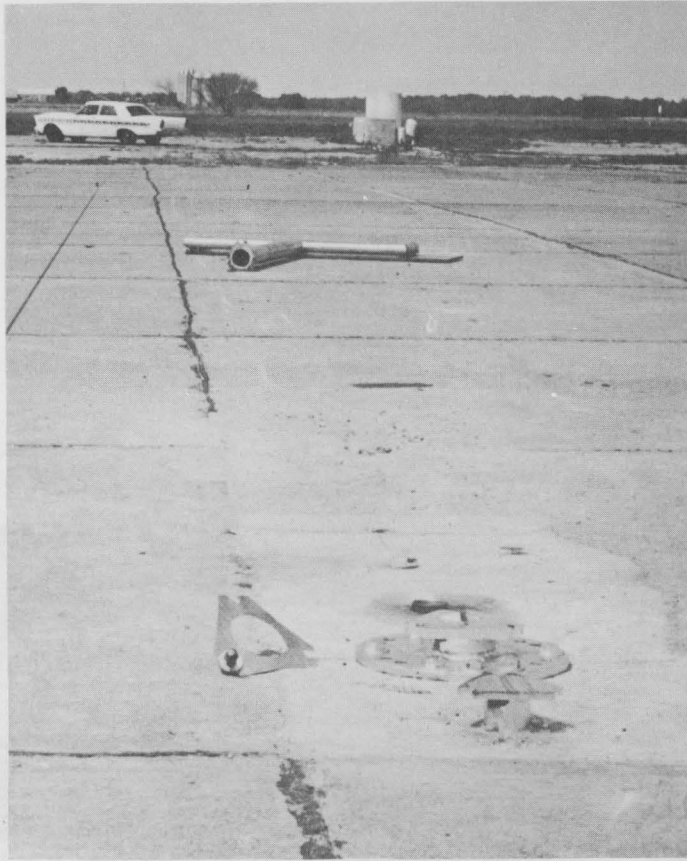
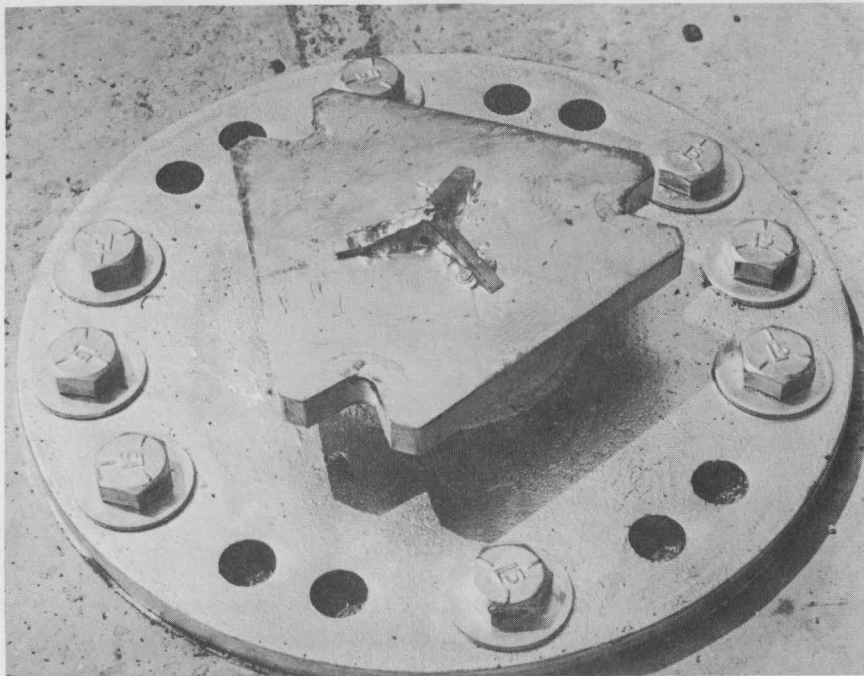
In Test S-17 the sign was impacted head-on at a speed of 45.5 mph and the change in speed of the vehicle was 1.7 mph. The slip base activated and the sign rotated about 120° and struck the roof of the vehicle over the rear passenger compartment. The sign raised about 2 ft higher into the air than in Test S-11, however, the secondary collision still occurred. Figures 43 and 44 show the sign and vehicle, respectively, after the test.

The modified slip base with riser shown in Figure 43 was considered partially successful. The recommended slip base with riser shown in Figure 45 is believed to be a better design which will impart a higher upward velocity to the sign post.

Figure 43. Destination Sign and base after testing, note modification on base for raising sign post during impact. Test S-17, 45.5 mph, $\Delta V = 1.7$ mph.

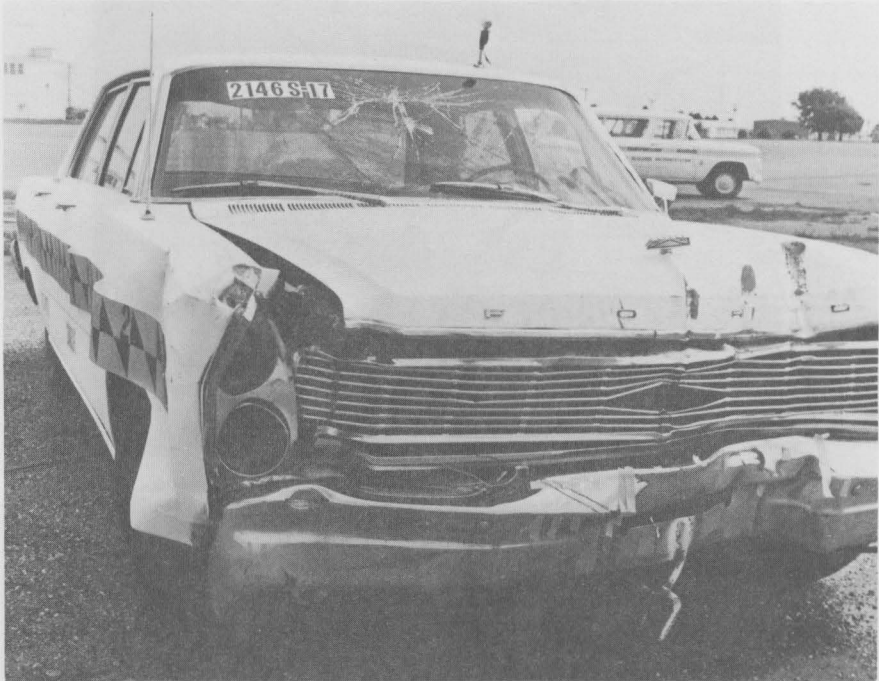
Figure 44. Vehicle after Test S-17.

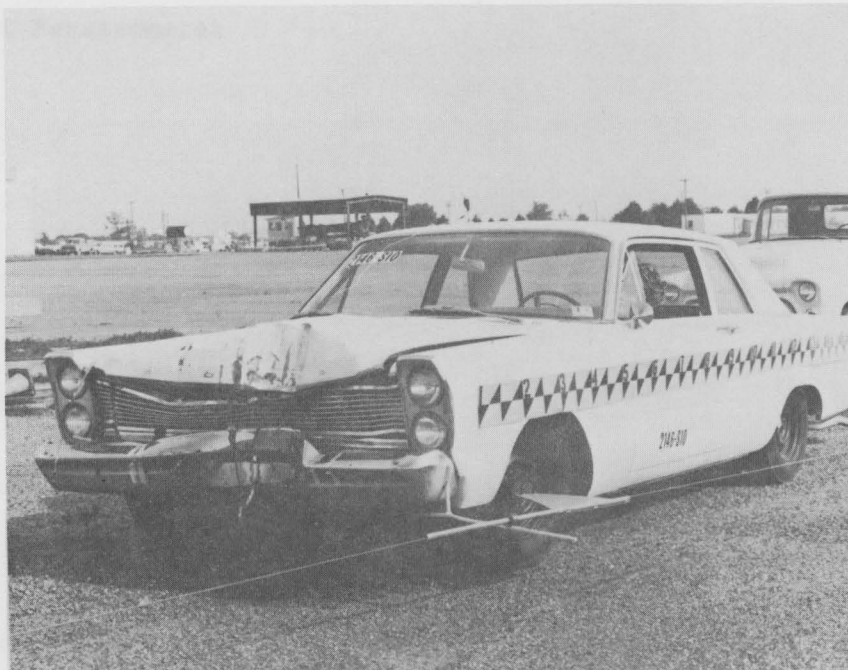
Figure B2. Vehicle after Test S-10.

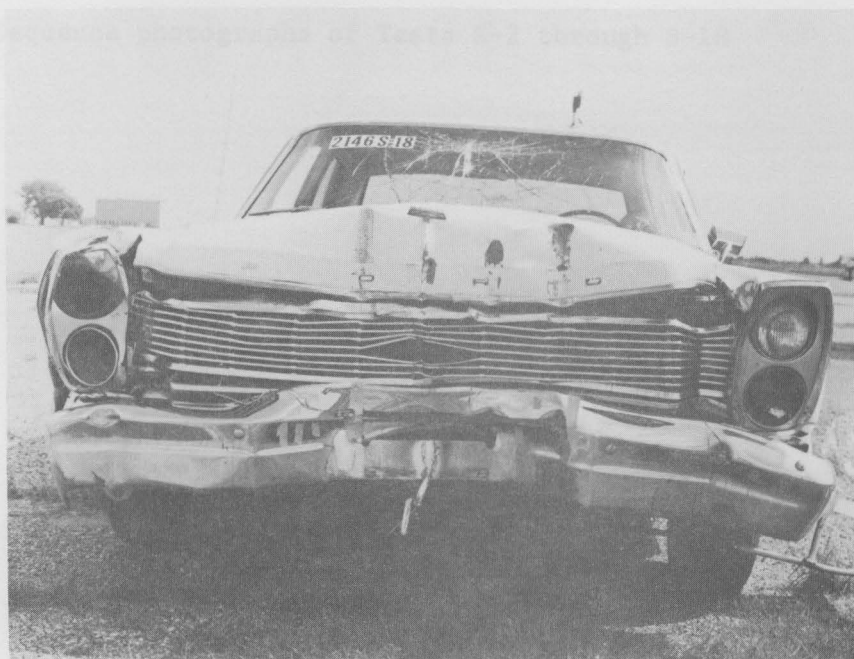
Figure B4. Vehicle after Test S-18.
