**A REPORT  
ON  
CONTINUITY  
BETWEEN REINFORCED  
CONCRETE PAVEMENT  
AND A CONTINUOUS  
SLAB BRIDGE**

Research Report 39-3

Evaluation of Terminal Anchorage Installations  
Research Project 1-8-63-39

August, 1966

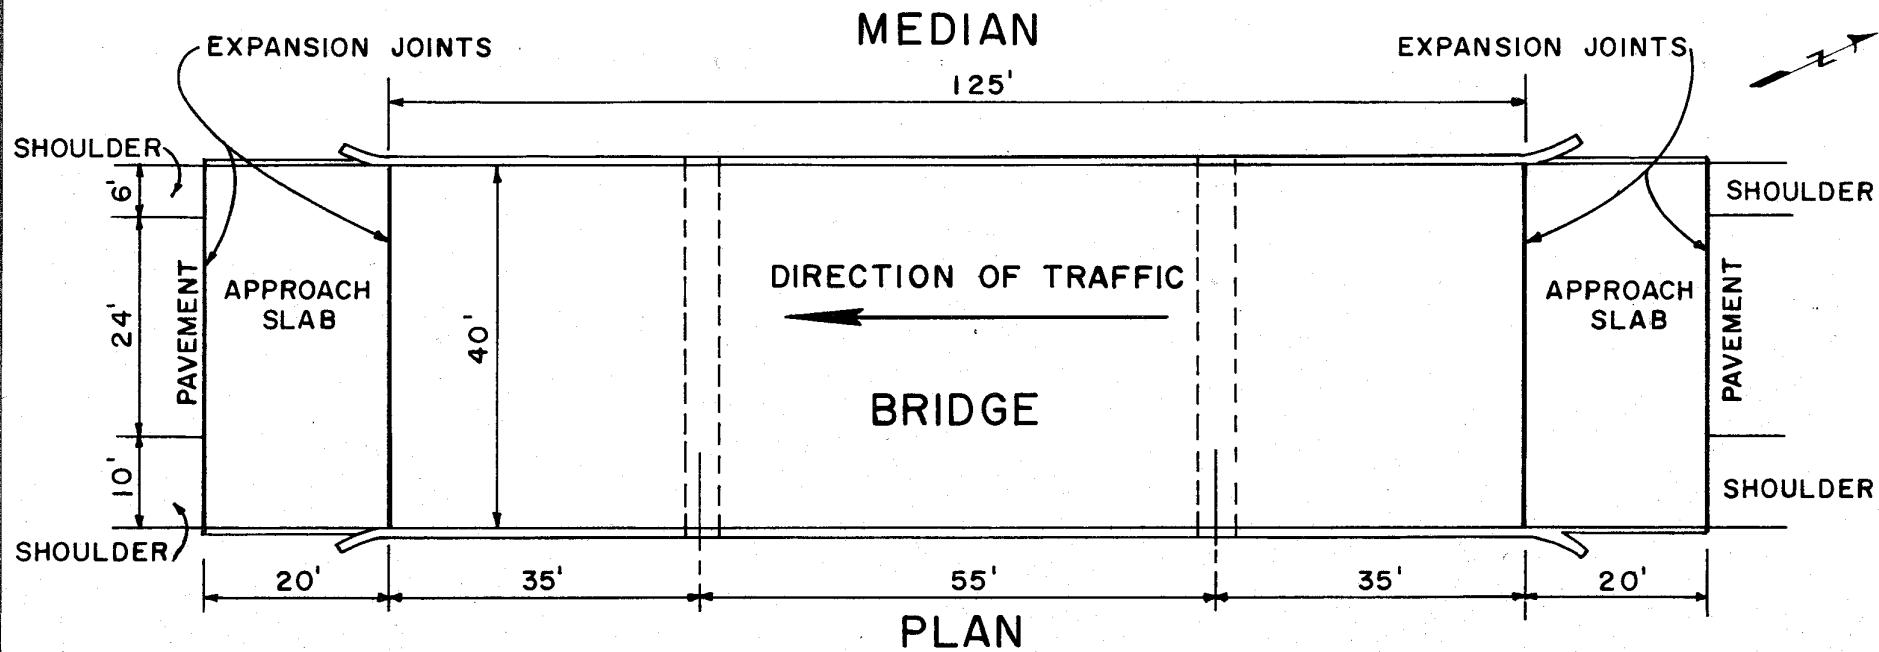
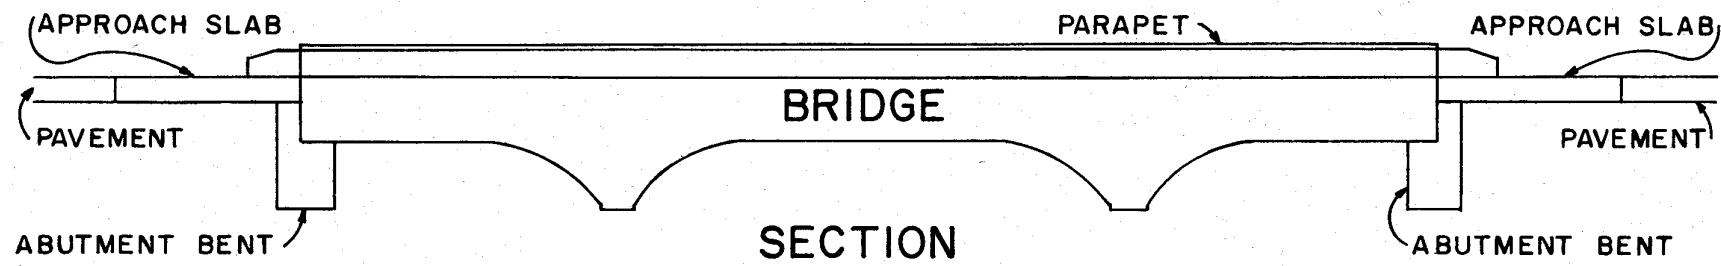
**FIGURE 2**

The southbound structure was constructed in the usual manner with a five lug terminal anchorage system to anchor the pavement slab and a crown width structure approach slab at each end of the structure (Figure 2). The approach slabs were separated from the structure by one inch expansion joints and from the pavement slabs by 1-1/2 inch expansion joints. Every feature of the southbound unit followed typical design and construction procedures, thus it serves as the control unit in evaluating the performance of the experimental aspects of the northbound unit.

The pavement at each end had very tight cracks which started about 20 feet from the approach slabs, placing the first crack between the first and second anchor lugs. The pavement south of the structure had an average crack spacing of 13.63 feet, while that to the north had an average crack spacing of 8.57 feet. On the initial run, cracks near the

structure measured 0.004 - 0.010 inch in width while those located about 100 feet from the structure measured 0.012 - 0.014 inch.\* Cracks measured during the second major inspection revealed cracks near the south end of the structure averaged about 0.006 inch in width while those north of the structure were somewhat wider, averaging about 0.016 inch.

The initial inspection revealed that both 40 foot (crown width) approach slabs had cracked longitudinally near their centers and no other cracks were visible in either slab. No changes in these slabs were noted throughout the inspection period.

All four seals had water and sand encapsulated in bubbles throughout their lengths and some spalling was occurring along the faces of the joints.

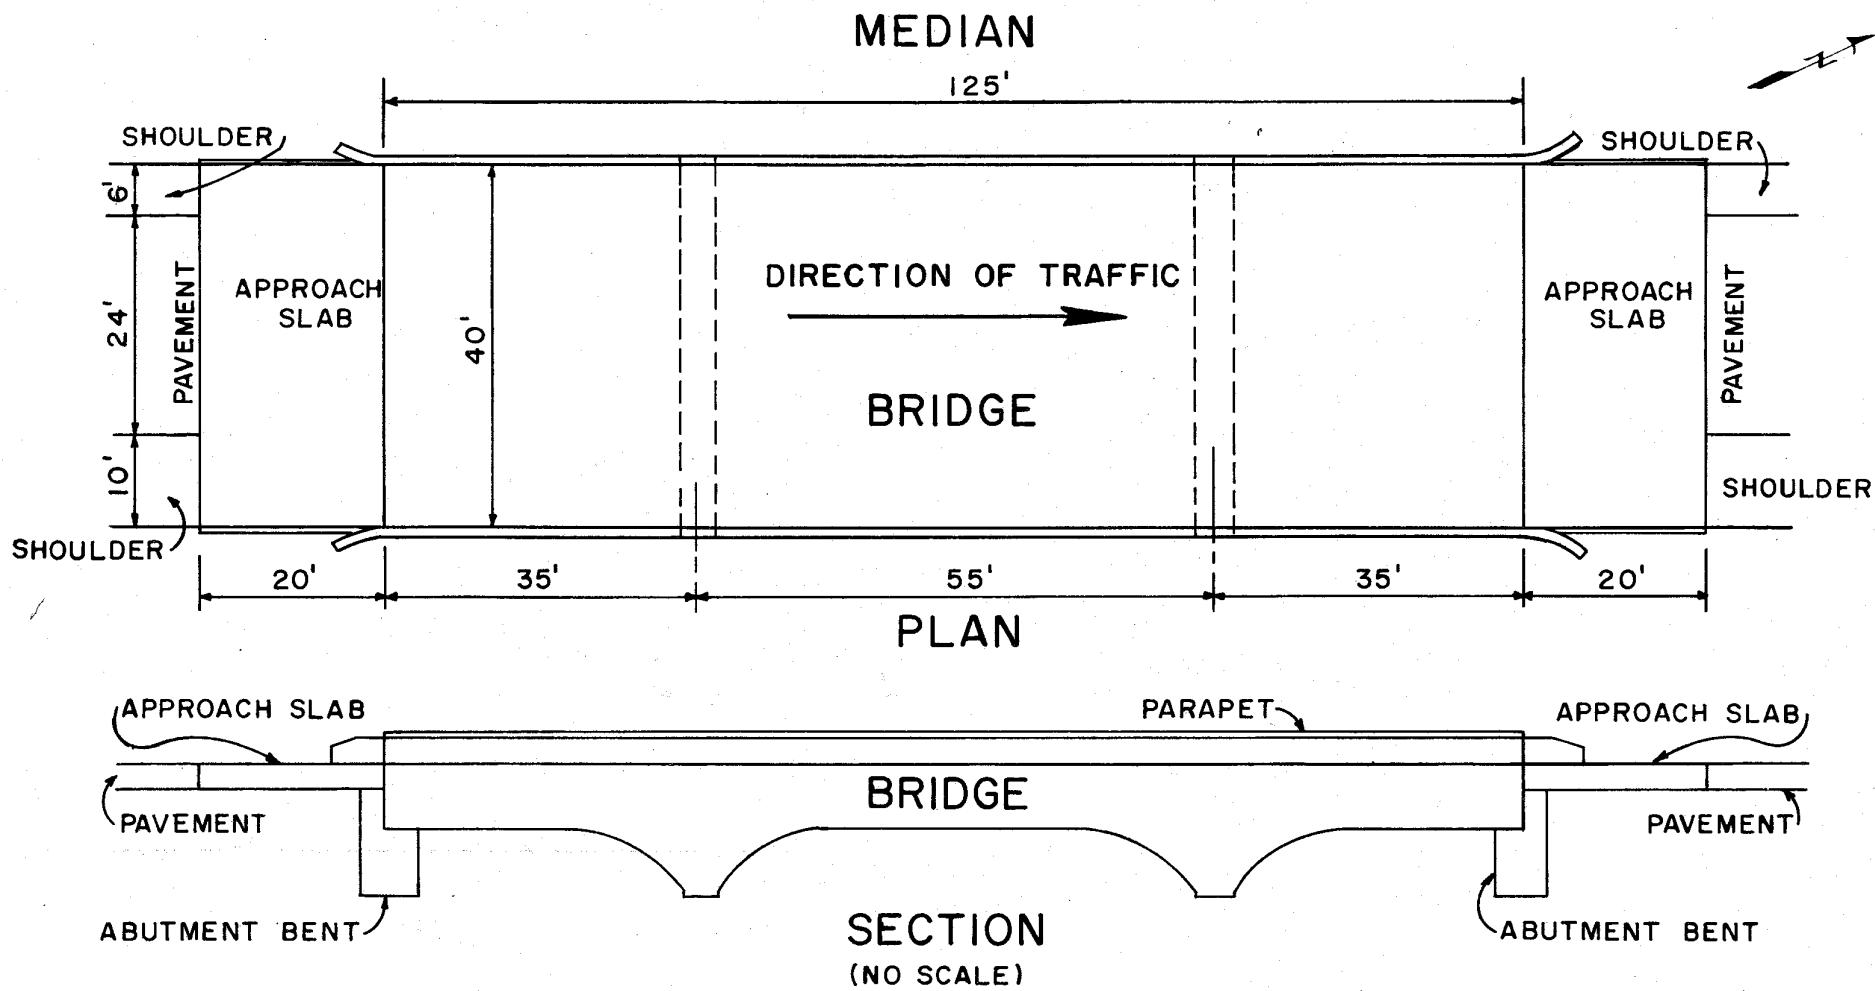
FIGURE 3

The northbound unit differs from the southbound unit in that in the attempt to maintain roadway continuity, the terminal anchorage system was eliminated and the pavement, approach slabs and structure were all tied together (Figure 3). Transverse

construction joints were used in lieu of the expansion joints employed in the control unit. The regular longitudinal pavement steel extended into the approach slab so that one-half of this steel was terminated three feet and the other half four feet past the construction joint. The longitudinal paving steel consisted of thirty-nine number five bars with a center to center spacing of 7-1/2 inches. This arrangement gives a longitudinal steel percentage of 0.52 percent for the pavement.

The approach slab steel parallel to the highway centerline consisted of eighty-one number five bars with a center to center spacing of six inches giving a steel percentage in this direction of 0.654 percent. The increased number of bars is due to both a smaller spacing and a greater width. The approach slab tapered from a thickness of eight inches at the pavement joint to nine inches at the bridge connection. The approach slab was tied to the abutment bent by twenty-eight number four ties. Each tie was embedded and hooked into the approach slab twice, thus the equivalent area of fifty-six number four bars was furnished to tie the approach slab to the bent. Forty number five tie bars spaced twelve inches on center extended two feet into the approach slab from the bridge to tie these slabs together. The complete steel layout is shown in Figure 5. Other than the aforementioned treatment at the joints, the pavement, approach slab, and structure were of typical design.

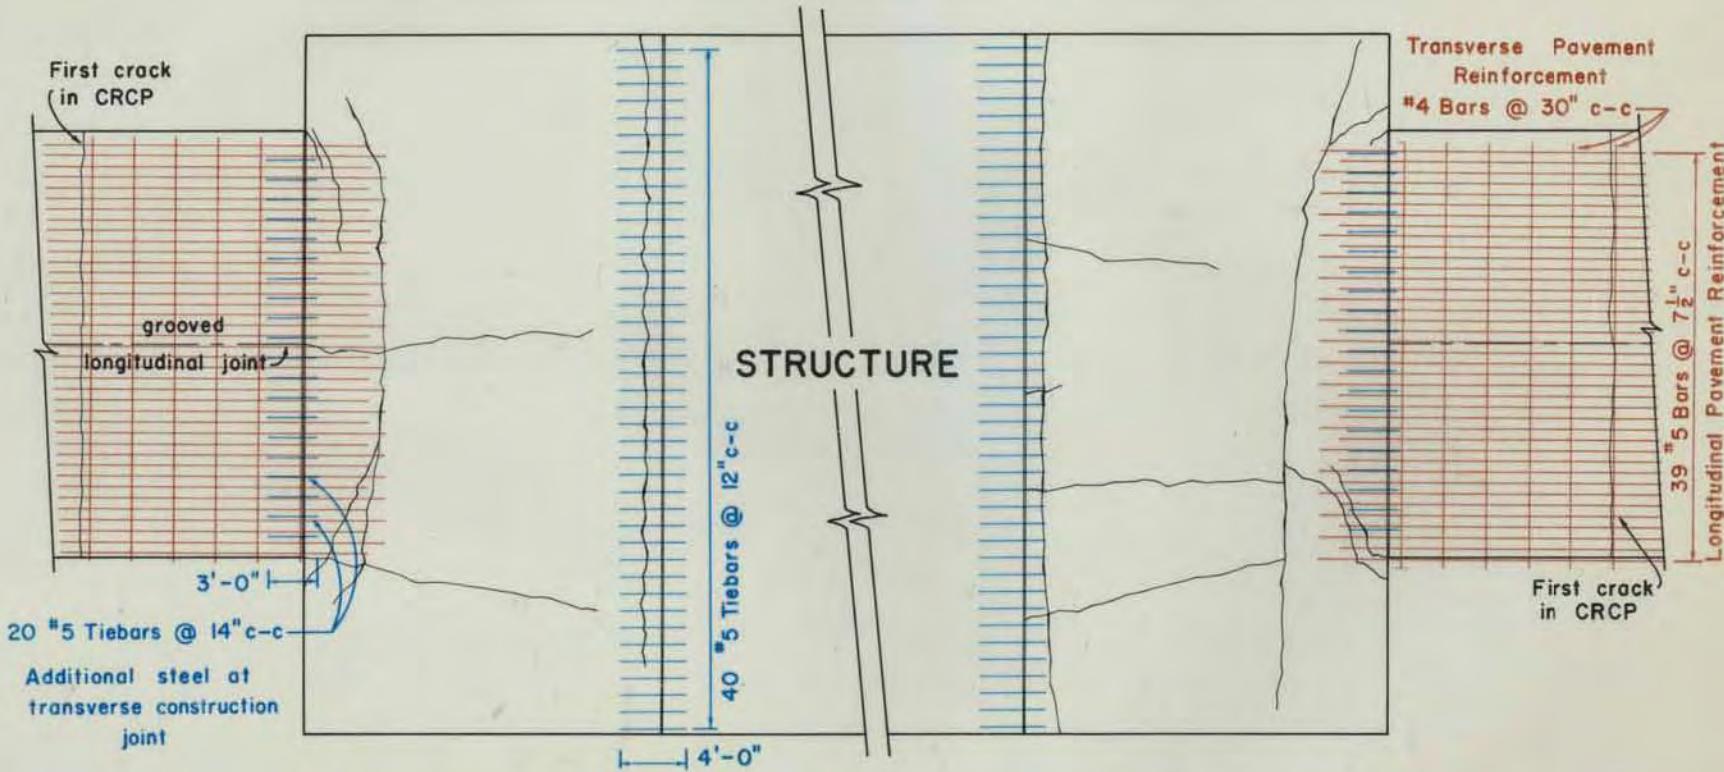
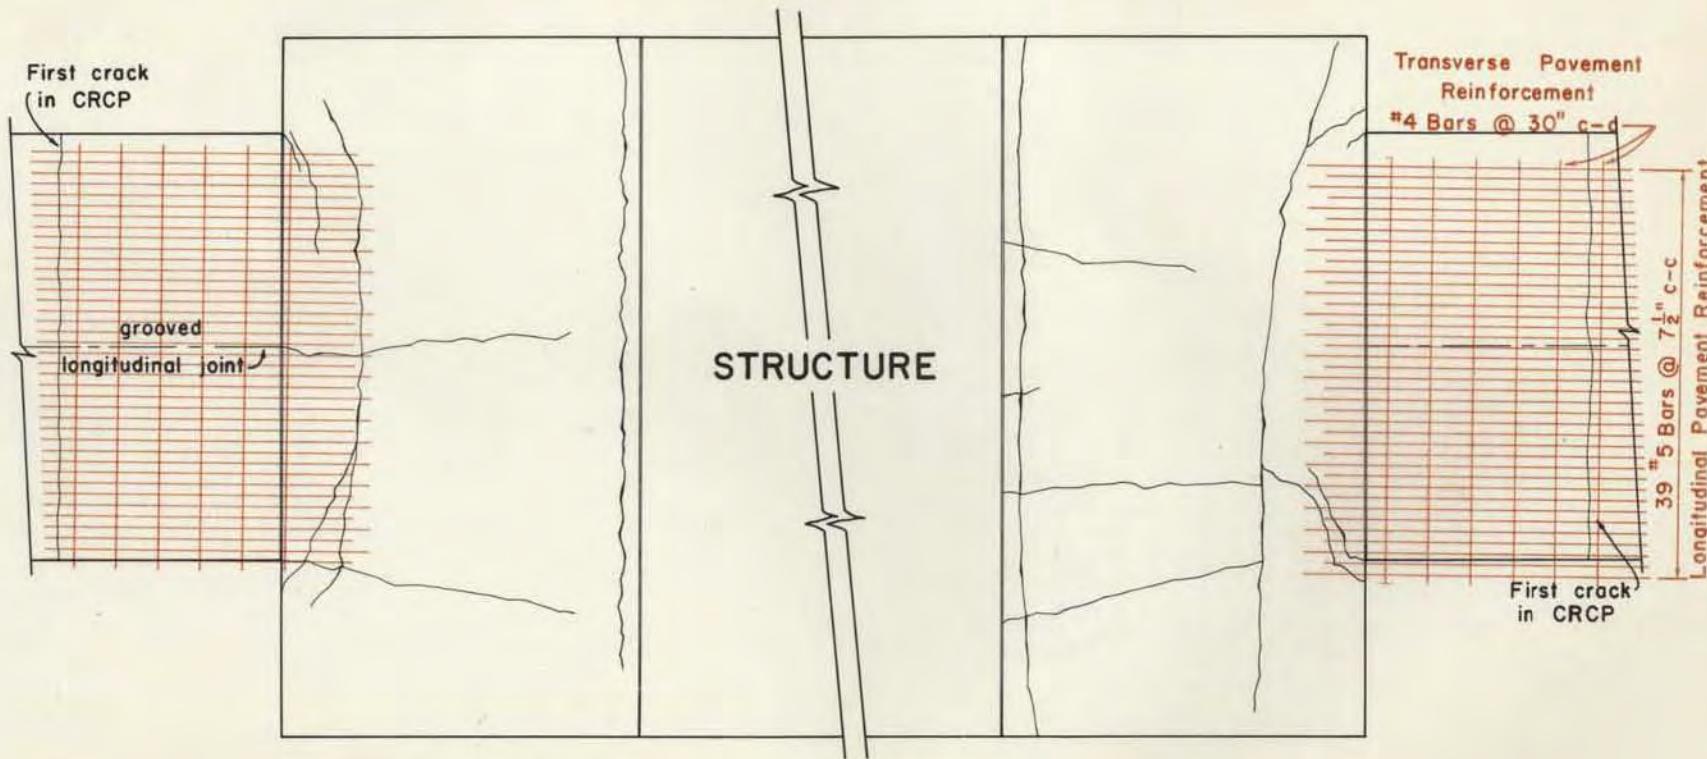
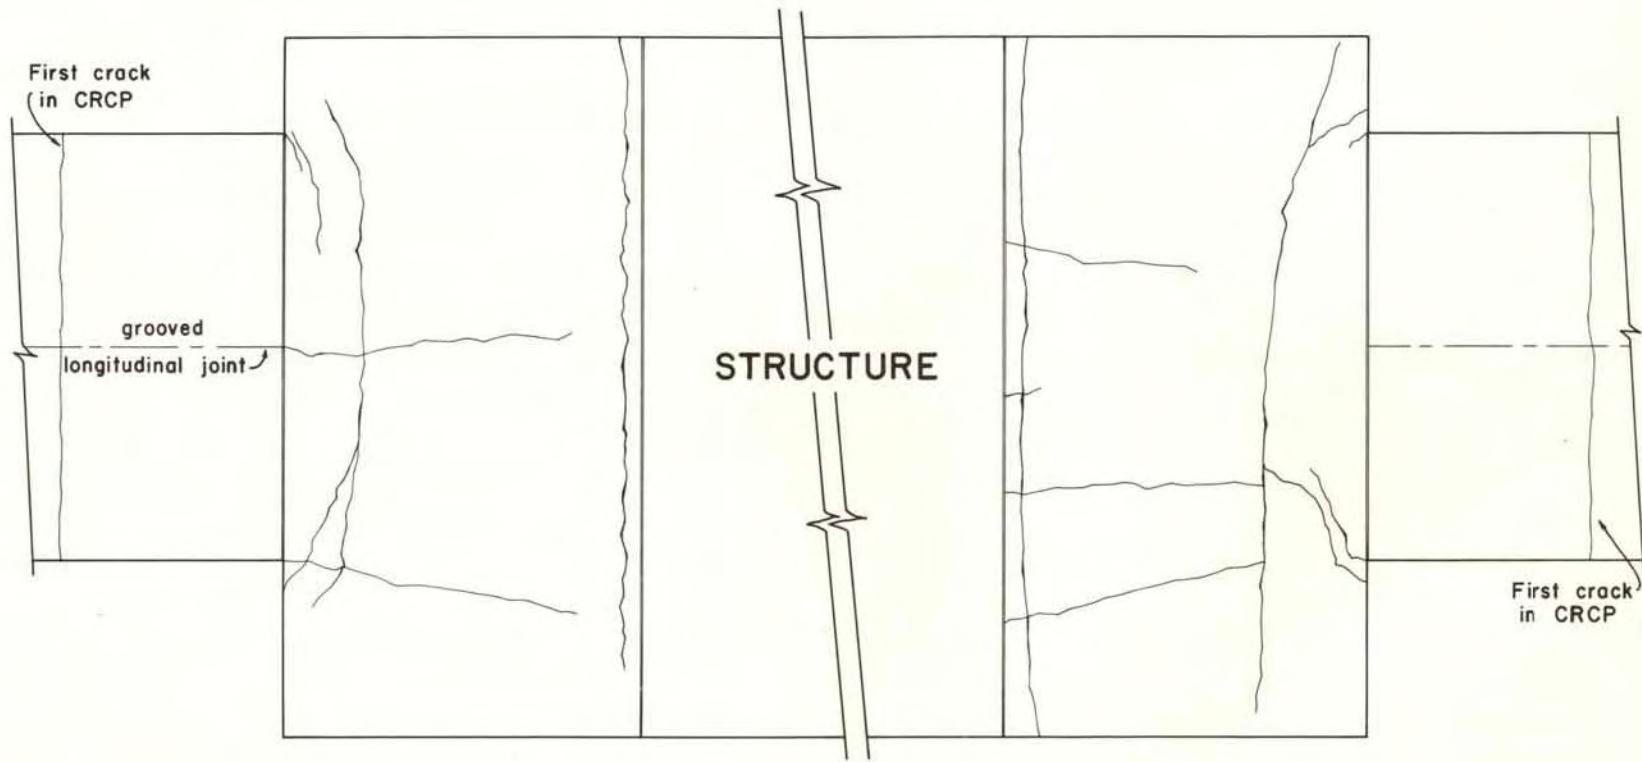
CRACK PATTERN OF EXPERIMENTAL UNIT  
FIGURE 4

The approach slabs of the experimental unit showed signs of distress that were not present in the Control Unit. Each slab contained a transverse crack near the structure and a transverse crack running somewhat parabolically from the point where the pavement joined the approach slab to a maximum distance of about five feet from the joint separating the pavement from the approach slab. Each approach slab also contained three minor cracks running in a direction approximately parallel to the longitudinal direction of the pavement. All of the cracks located are shown on the crack layout, Figure 4. The parabolic cracks were rather wide; crack widths in excess of 0.100 inch were measured.

The latest inspection revealed only one additional crack. This crack was located in the approach slab at the north end of the structure. This was a very minor crack running in the direction of the pavement which was actually a short extension of an earlier crack. All of the cracks running longitudinally in the direction of the pavement were barely visible. This was true at both ends of the structure. The average crack width for the parabolic crack in the north approach slab was 0.057 inch and in the south approach slab was 0.041 inch. The average crack width for the transverse cracks near the structure was 0.026 inch and 0.014 inch respectively in the north and south approach slabs. These widths were about the same as the year before.

Examination of the steel placement pattern reveals that the regular longitudinal reinforcement of the CRCP did not continue through the approach slab, but was cut off within the approach slab. To obtain adequate load transfer, the additional steel required at all normal transverse construction joints (twenty-four #5 bars, three feet long) were also used across the pavement-approach slab joint. One-half of the longitudinal steel was extended three feet and the other half was extended four feet into the approach slab. The major portion of the parabolic crack occurred at the point of termination of the longitudinal steel (see Figure 4).

Examination of the concrete placement dates reveals what is probably the predominate cause of the unusual crack pattern in the approach slabs. The structure was placed on October 21 and 22, 1963; the pavement was placed on January 9, 1964; and the approach slabs were not placed until January 27, 1964,

thus a situation similar to that found at other "leave outs" was created.<sup>(2)</sup> The pavement and structure slabs were well on their way toward achieving full strength when the approach slab was poured and the "green" approach slab was unable to absorb the tensile forces generated by the contraction of the adjoining slabs.

1. The approach slab should be eliminated. The approach slab proved to be the weak link in the Irving Lee design due to its late construction. The pavement slab should be continued all the way to the bridge and anchored into the abutment bent. If crown width is desired, the pavement could be extended to crown width by means of normal longitudinal construction joints.
2. The dowels tieing the bridge to the pavement should be eliminated. Due to several factors, the bridge should be left free to move.

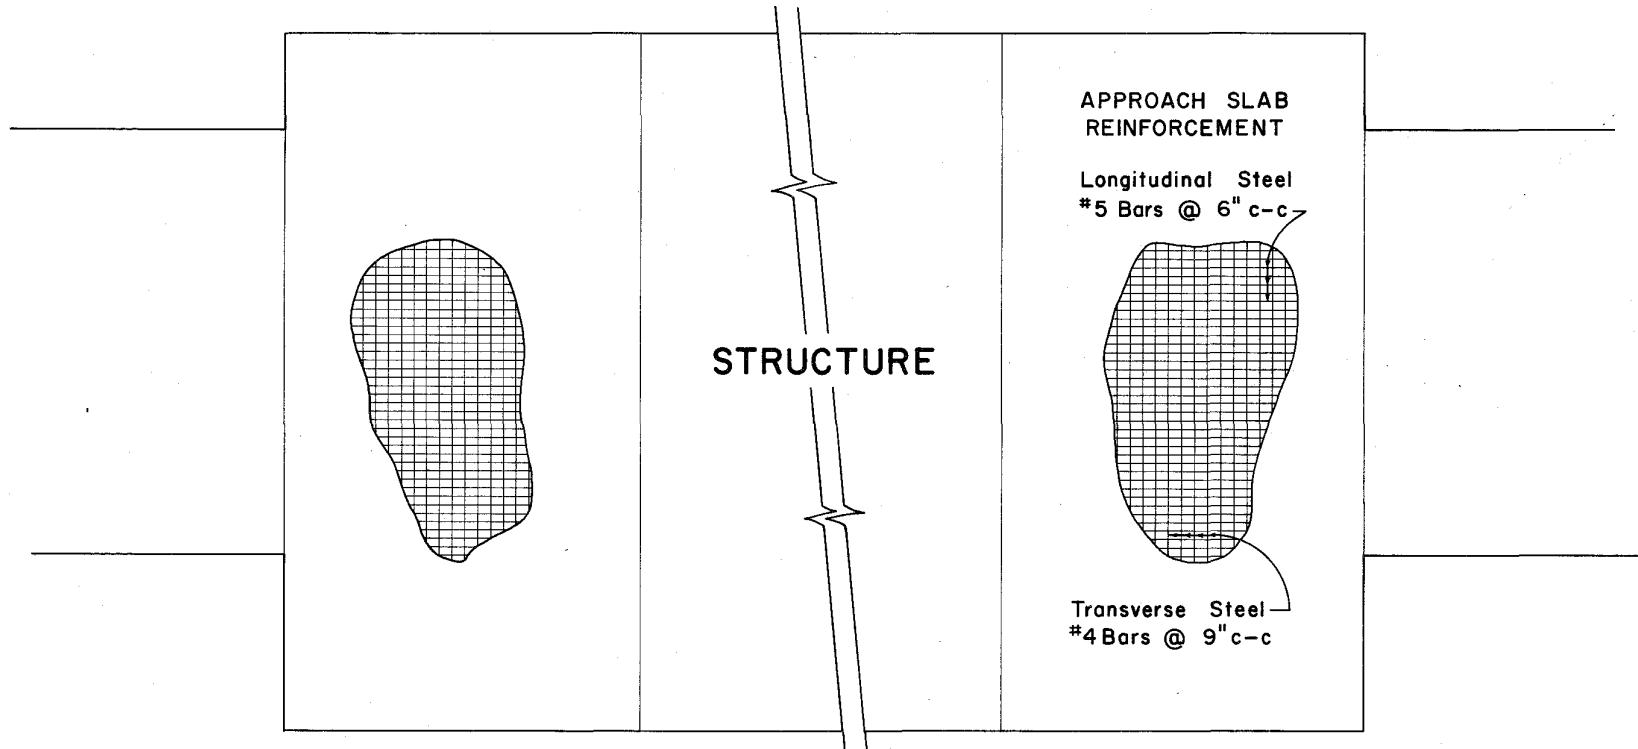
LAYOUT OF STEEL IN EXPERIMENTAL UNIT  
FIGURE 5

The approach slab was tied to the abutment bent with fifty-six #4 bars, embedded in the bent and hooked into the slab. The bridge and approach slab were tied together by forty #5 bars, four feet long. The transverse crack near the structure occurred at the point of termination of this steel.
