EXPERIMENTAL SEAL COAT CONSTRUCTION
INCLUDING OVERFLEX

Report Number: 526-1

Demonstration Project 1-10-76-526
Evaluation of Overflex Pavement Test Sections

STATE DEPARTMENT OF HIGHWAYS
AND PUBLIC TRANSPORTATION
and
U.S. DEPARTMENT OF TRANSPORTATION
FEDERAL HIGHWAY ADMINISTRATION

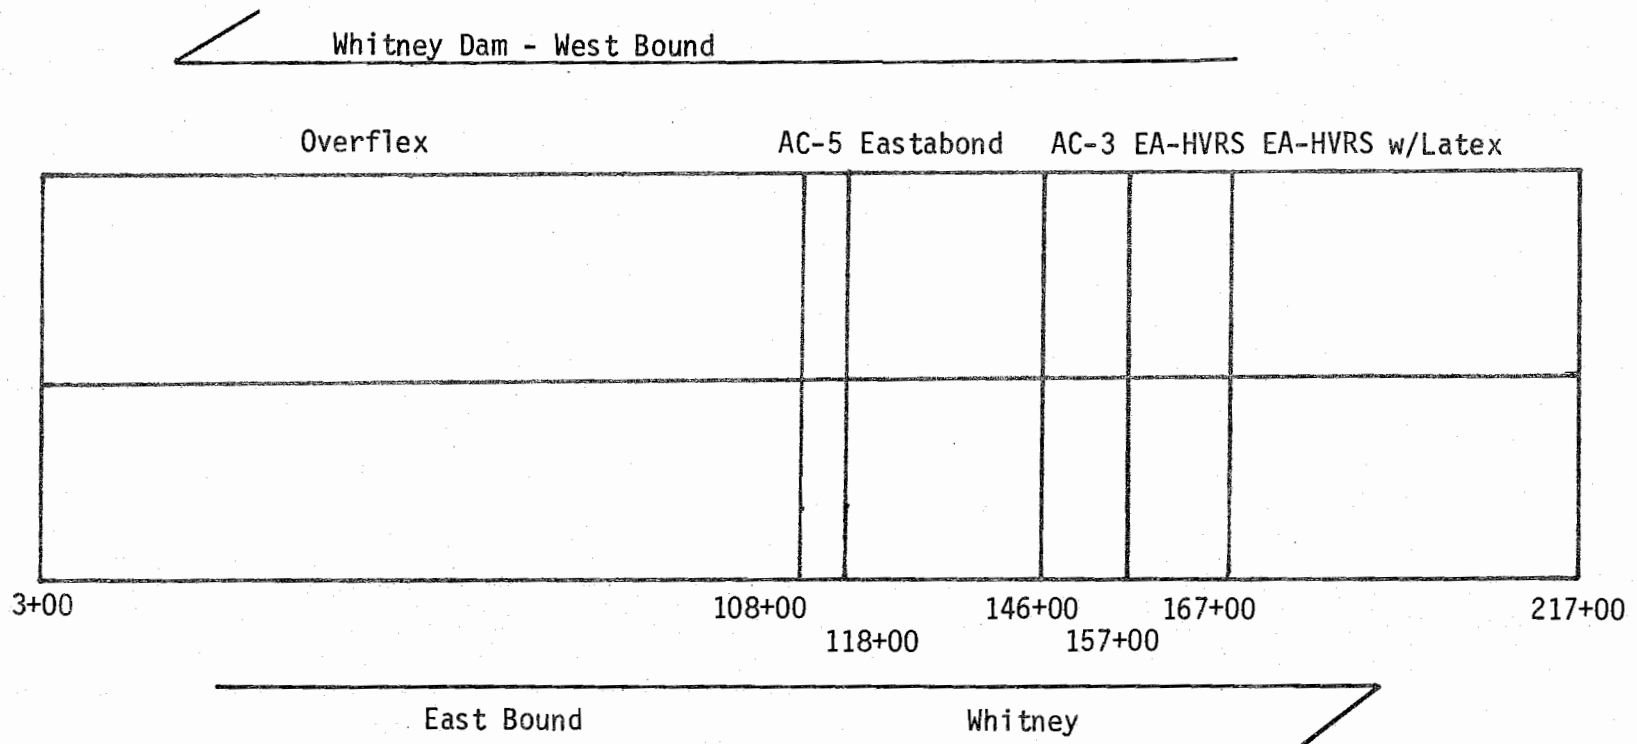
FIGURE 3
 SCHEMATIC OF EXPERIMENTAL SECTIONS
 ON SH - 43 IN DISTRICT 19

SH-43 in Dist. 19 was badly alligator cracked, especially in the wheel paths. The distance between cracks was about three to four inches. In some areas patching occurred where small blocks of pavement had been dislodged by traffic.

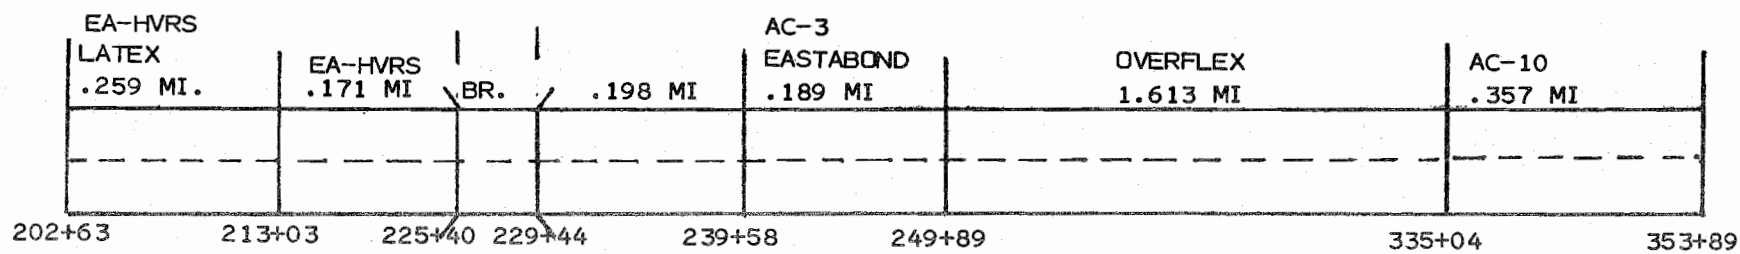
FIGURE 4
 SCHEMATIC OF EXPERIMENTAL SECTIONS
 ON US - 80 IN DISTRICT 19

The outside lane of US-80 in Dist. 19 was alligator cracked with some transverse and longitudinal cracks. The distance between cracks was about four to five feet. The inside lane was alligator cracked with longitudinal and transverse cracks but was in much better shape in comparison to the outside lane.

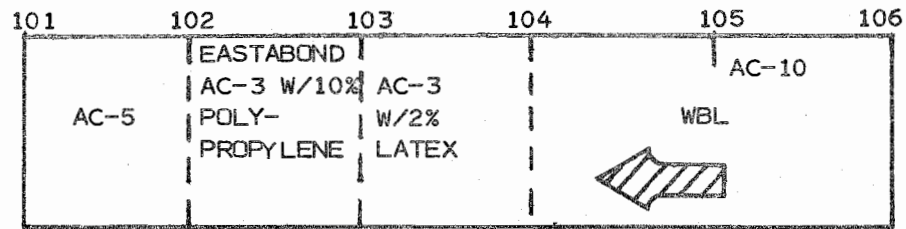
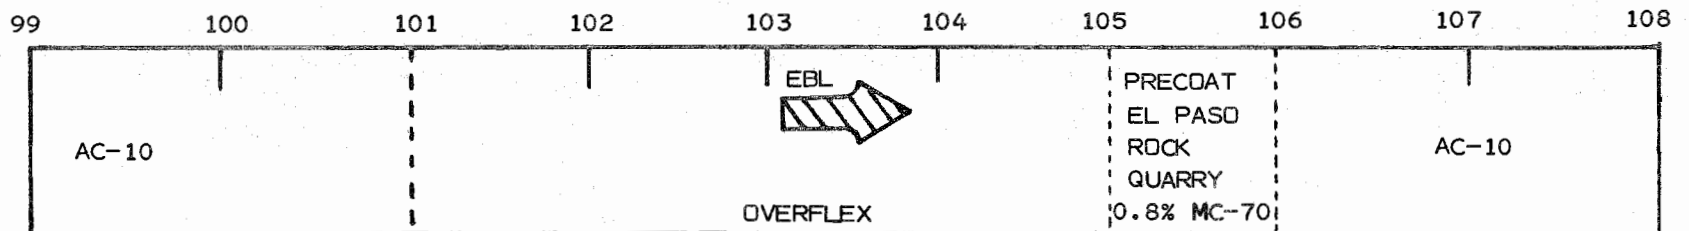
FIGURE 5
 SCHEMATIC OF EXPERIMENTAL SECTIONS
 ON IH - 10 IN DISTRICT 24

Both the outside and inside lanes of IH-10 in Dist. 24 were alligator cracked with some longitudinal and transverse cracking. Again the inside lane was in much better shape in comparison to the outside lane. The lanes had been cracked-sealed, except the area which received the Overflex.
