EVALUATION OF SURFACE-SEALING SYSTEMS UTILIZING SEAL COATS AND POLY-FAB UNDERSEALS

Report Number 606-4
SUPPLEMENT NO. 5

FINAL REPORT
FOR EVALUATION OF EXPERIMENTAL
CONSTRUCTION PROJECT

INTERSTATE HIGHWAY 40
OLDHAM AND POTTER COUNTIES
TEXAS

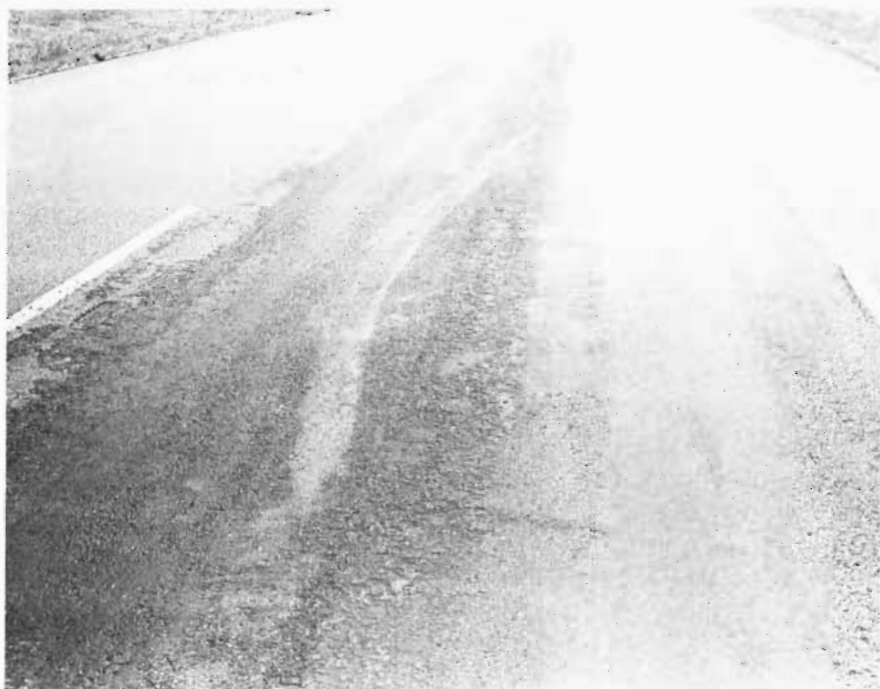
In a portion of System IV, blading has been done to reduce the rutting condition in the outside lane in the eastbound direction (Picture 1). The other test systems have not rutted as much as System IV. The cause may be subgrade and/or excessive densification of the asphalt base and surface by the high volume of heavily loaded vehicles.

Bladed Hump in System IV

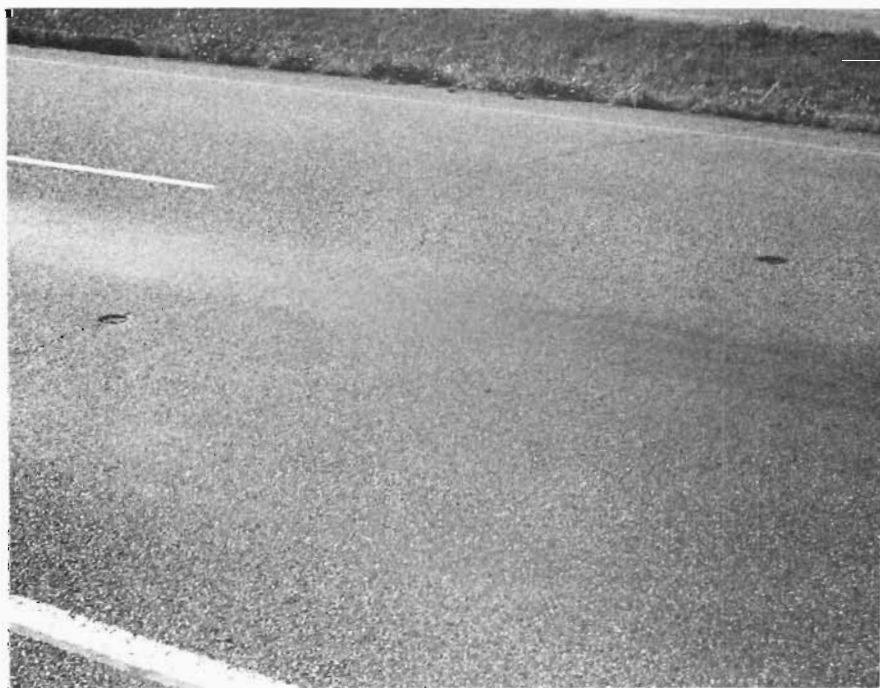
Punch outs occurred in System III (Pictures 2 and 3) and System IV. The punch outs probably were caused by the asphaltic concrete pavement being placed at a depth of less than 1 1/2 in. The location of the Petromat within the section does not appear to influence the punch out effect. In System III the Petromat is located on the old pavement. In System IV the Petromat is between the black base and Type D hot mix.

Punch Out in System III

The location of the Petromat within the design section does not appear to change the effectiveness. The same serviceability can be expected with any placement of the Petromat. It should be noted that a minimum depth of the riding surface course should be greater than 1 1/2 in.

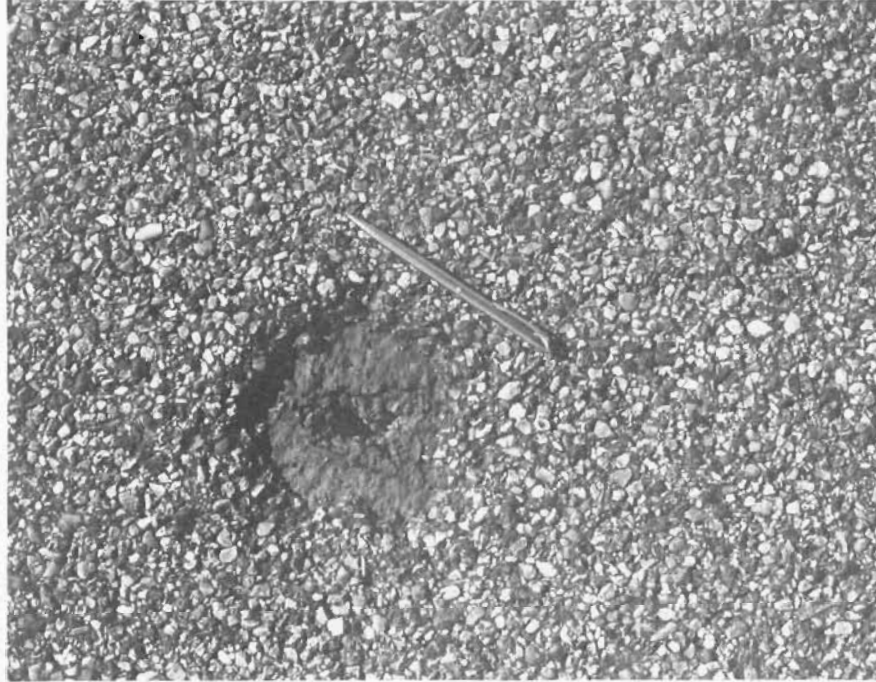
Close Up of Punch Out in System III

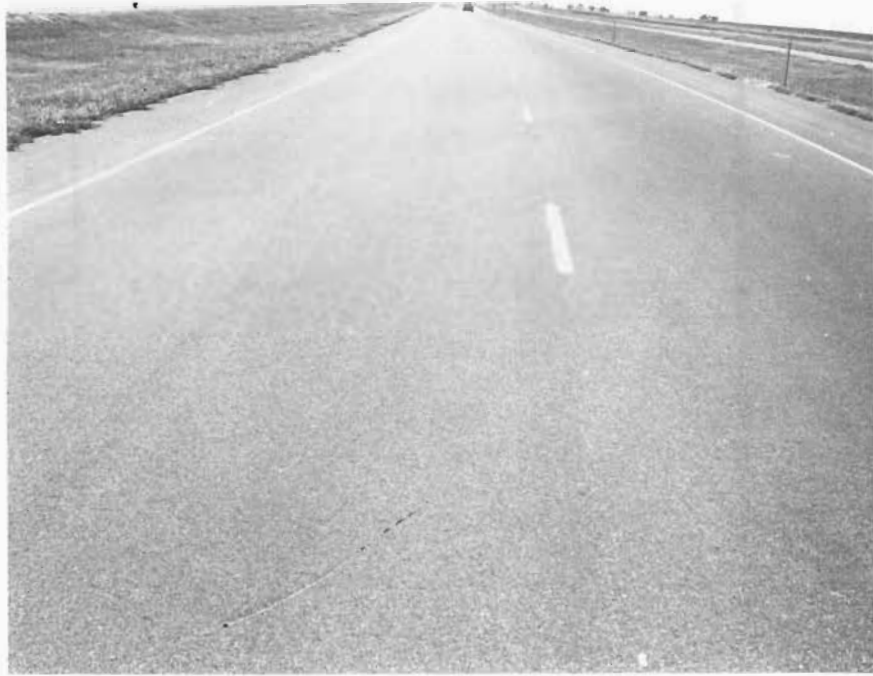
System I - 1978

Some cracks have appeared in all test section. It has not been established if these cracks are reflective. They have required no maintenance. There are more cracks in the System I section (no poly-fab) than in the other three sections which contain poly-fab.

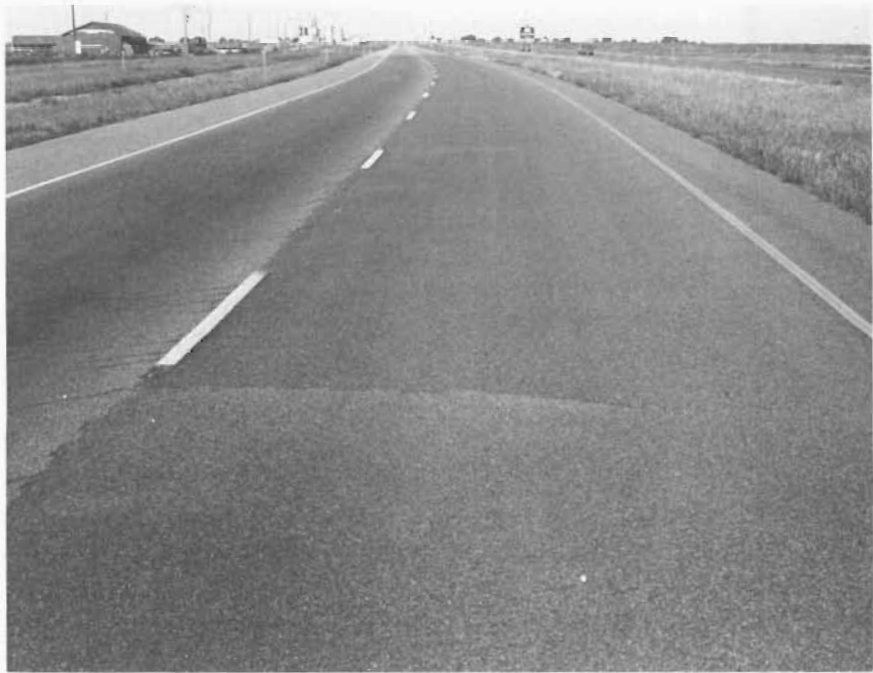
System I - 1982

The longitudinal cracks are more nearly continuous in System I than in the other systems. There are approximately three times as many linear feet of longitudinal cracks in System I. It is evident that the cracks are wider and deeper in System I than in the other test sections. The longitudinal cracks were about $1/2$ in. in width and 1 in. deep in System I. The cracks in the other test sections were about $1/4$ in. wide and $1/2$ in. deep.

The differences between System I and the other systems are more evident than during the previous report periods. There has been some crack pouring done on System I. It appears at this time major maintenance on this portion will be required 3 to 4 years before the other test sections. This is in regard to the cracks that have appeared on the riding surface.
