EVALUATION OF SURFACE - SEALING SYSTEMS UTILIZING SEAL COATS AND POLY-FAB UNDERSEAL

Report Number: 606-4

Initial Report
for
Evaluation of Experimental
Construction Project

Interstate Highway 40
Oldham and Potter Counties
Texas

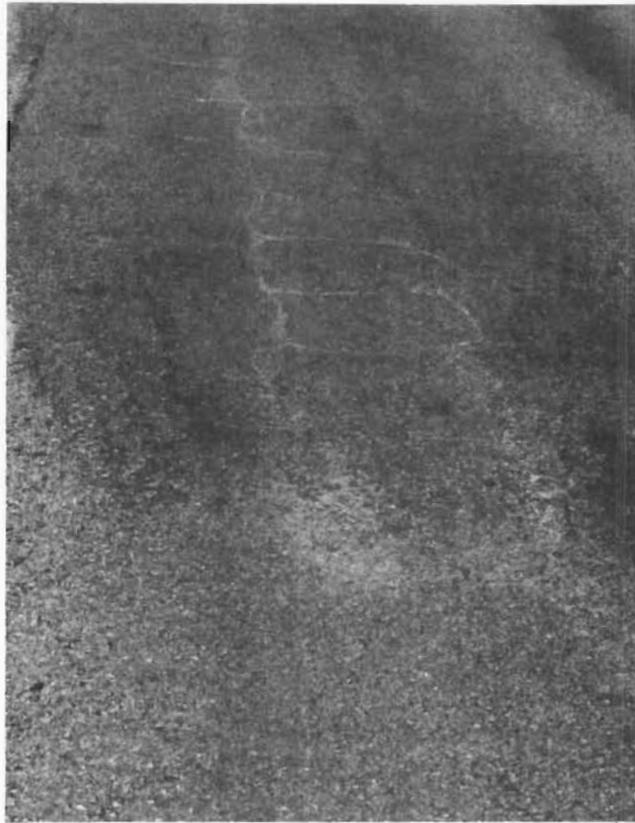
Picture 1

Approximately one year after the completion of the emergency construction, cracks began to appear in the surface of the roadway. With the 1/8" per 1' slope, water did not drain off the roadway, especially in the wheel paths. With the cracking and standing of the moisture during wet periods, pumping and increasing deterioration of the pavement resulted. (See Picture, 1, 2, 3 & 4)

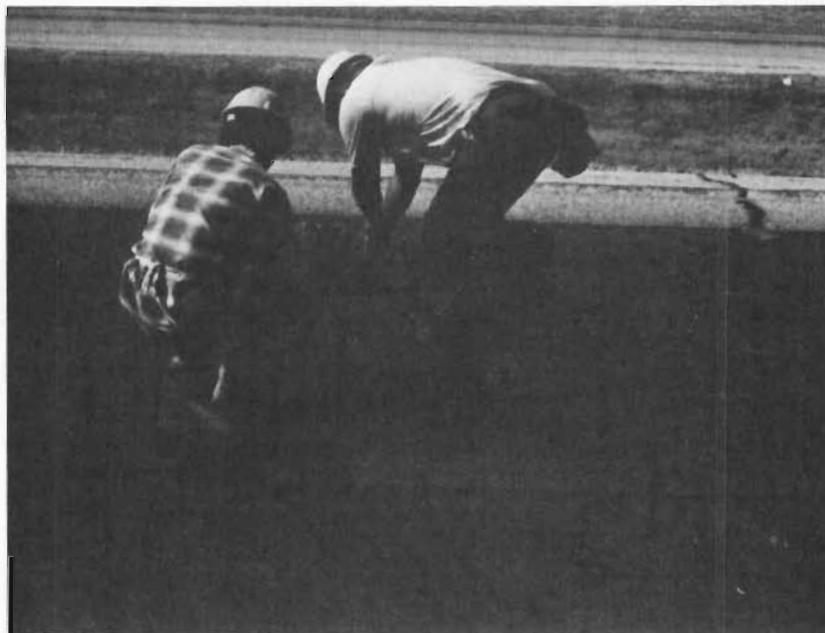
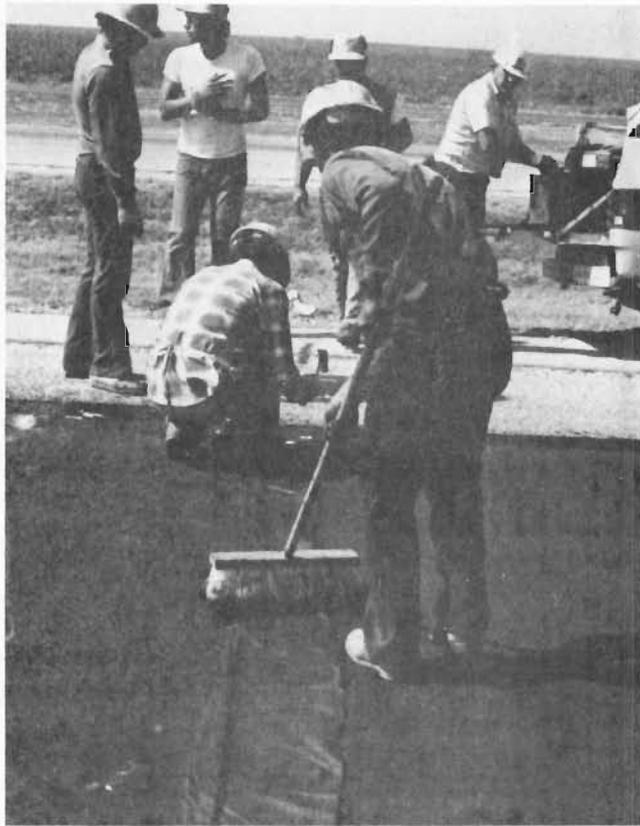
The transverse joints were lapped 6 to 14 inches and additional asphalt was applied, then the joints were nailed down for protection from damage by the traffic. The joints were lapped with the traffic to lessen damage and wear (See Pictures 6 and 7).

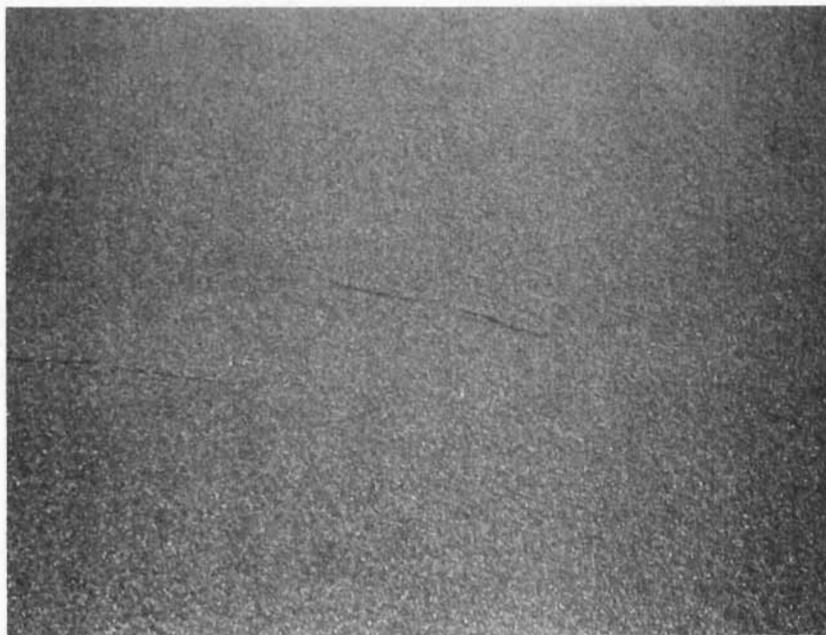
Picture 8

The section (Section II) receiving the seal coat on the Petromat developed more wrinkles than the other sections. The material expanded when the hot asphalt was applied (See Picture 8). There were some wrinkles present in all sections (See Picture 9). There has been no apparent ill-effect in the succeeding layers of material placed above these wrinkles, as of this report.
