POLYMER CONCRETE DECK REPAIR

Report Number: 614-2

Donald R. Mosier
Resident Engineer
District 16

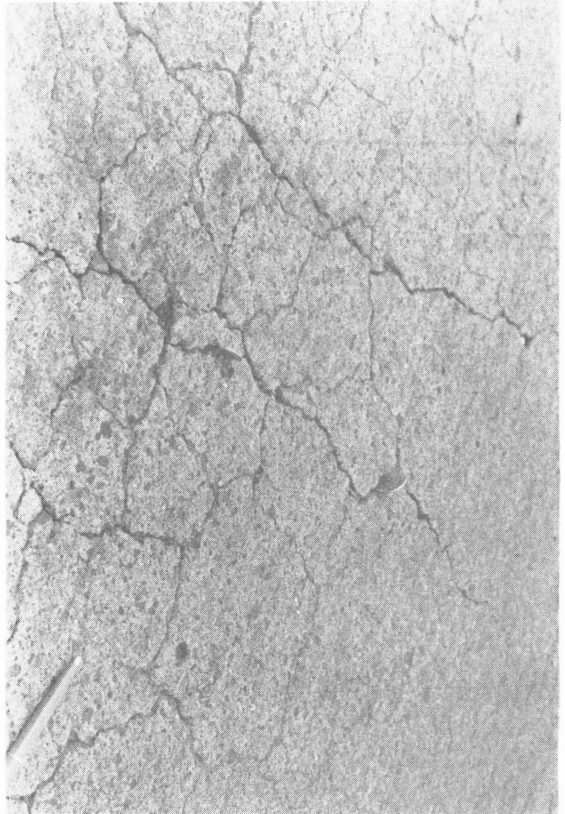
Figure 1 - Cracks Being Repaired Individually (Area No. 1)

The deck consists of light weight concrete over steel girders and truss sections, and regular concrete over the prestressed beam sections. The light weight sections have deteriorated badly in the last four years. The progression of cracking started in the outside lanes with slight transverse cracking turning into severe transverse cracking with alligator cracking breaking into spalled areas and delaminations.

a) Prior to Treatment

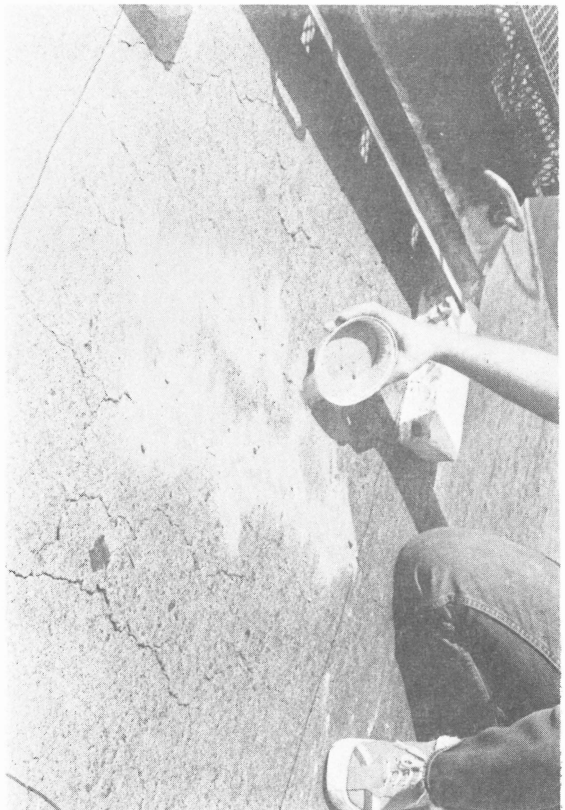
b) Applying Sand

After completing the drying time for area #1, the heater was moved to area #2. Fine sand was then spread over area #1 and brushed into the cracks. Mix #1 was applied to the area by hand and involved pouring small amounts of monomer over the area and working the sand and monomer into the cracks with a trowel. The cracks were kept moist by application of more monomer as the monomer already applied soaked into the cracks or was evaporated at the surface. After 15 minutes, a total of 600 grams of monomer had been applied to the area. The area was then covered with polyethylene to minimize evaporation at the surface. After 10 minutes, the film was removed and an additional 200 grams of monomer was applied, especially where cracks were noticeably dry.

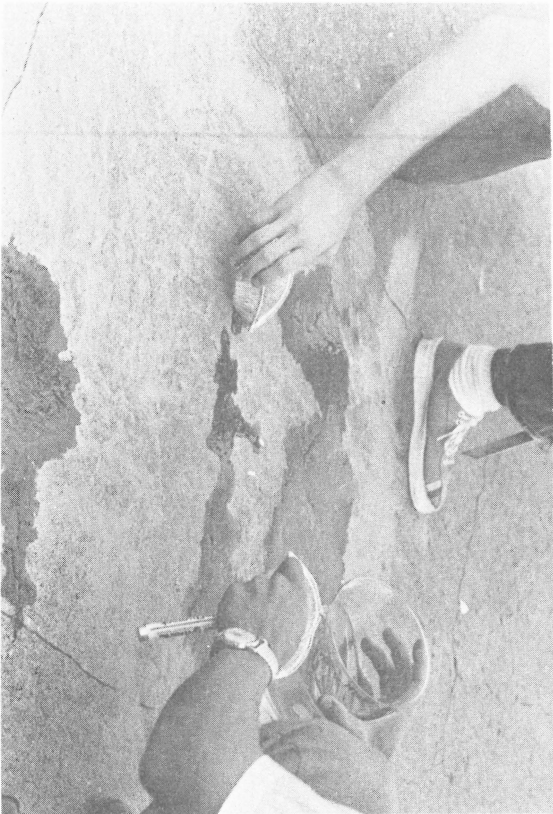
c) Applying Monomer

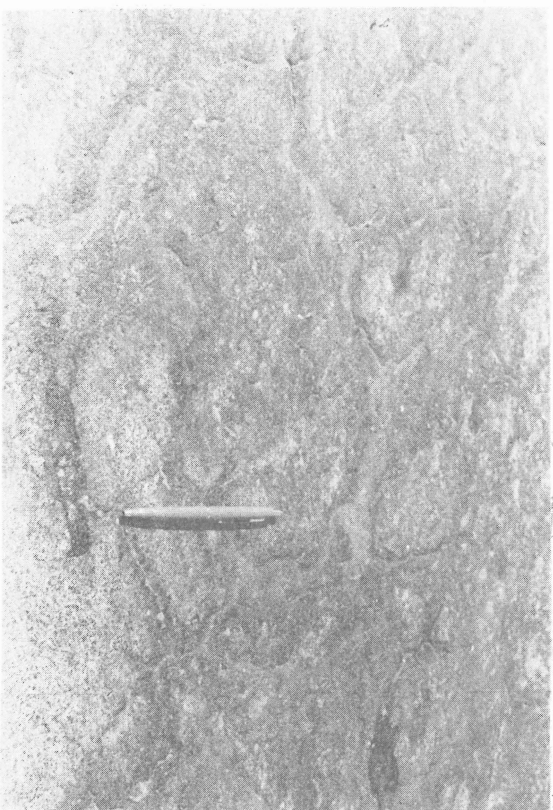
Areas #1 and #3, which were repaired with mix #1, showed very little retention of the patch material. What little material was left was in the lower portion of the cracks. Mix #1 definitely was not an acceptable mix.

d) Repaired Cracks

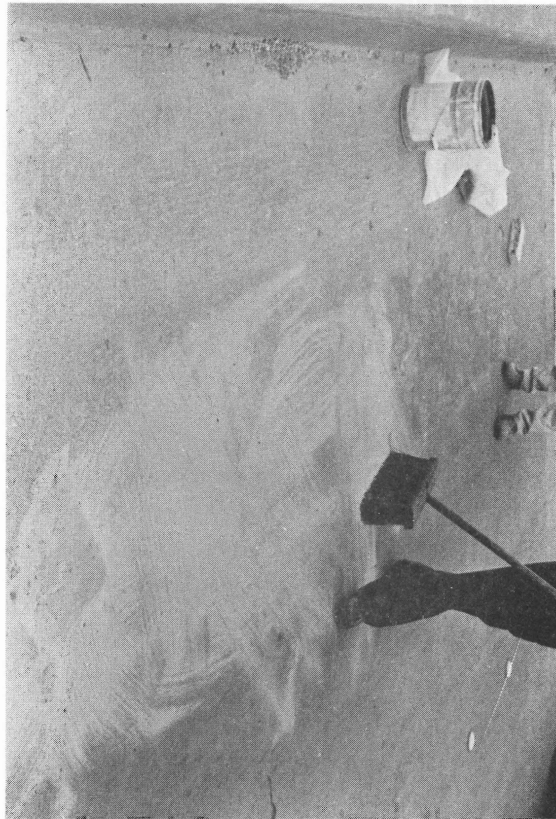
Figure 2 - Cracks Repaired by Brooming (Area No. 5)

a) Brooming on Monomer - Wetted Sand

Area #5 was dried with the heater for 10 minutes. A small pile of sand was wetted with the monomer and brushed over the area with a stiff floor broom until the cracks were thoroughly filled. Additional monomer was applied to the sand which dried rapidly. The monomer became fairly hard in 35 minutes.

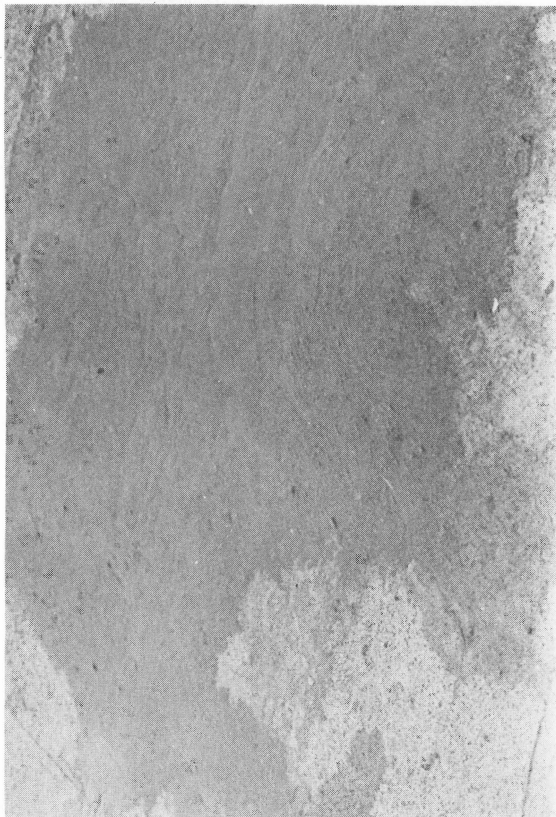
Area #5 repaired with mix #3 showed practically no patching material remaining. Also, the spalled area #6, patched with the same mix, failed.

b) After Application of Monomer

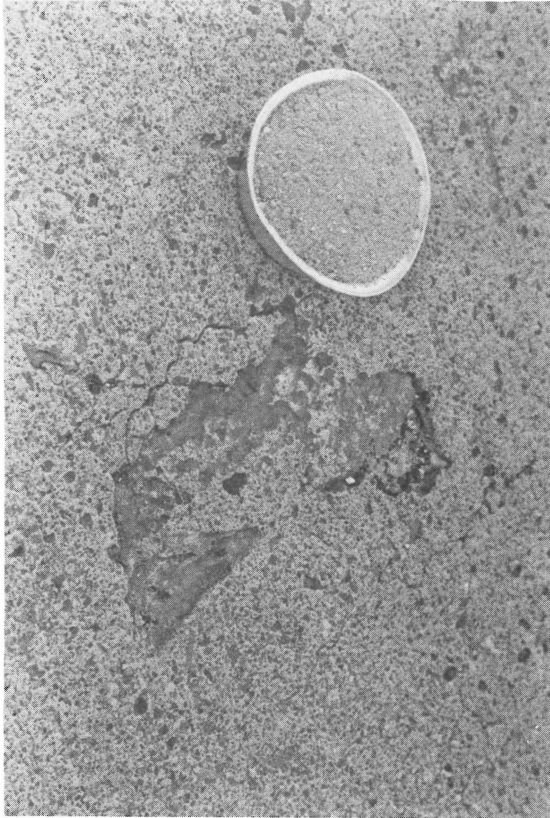
Figure 3 - Repair of 0.5 to 0.75 in. Deep Spalled Area

Area #6 was a spalled area at the north end of the test area. The spalled area, which was about 6 inches long by 3 inches wide and 1/2 to 3/4 inches deep, was dried for 20 minutes and allowed to cool. Then it was filled with sand and saturated with monomer mix #3. As the sand dried out, more monomer was applied until polymerization occurred.

a) Before Patching

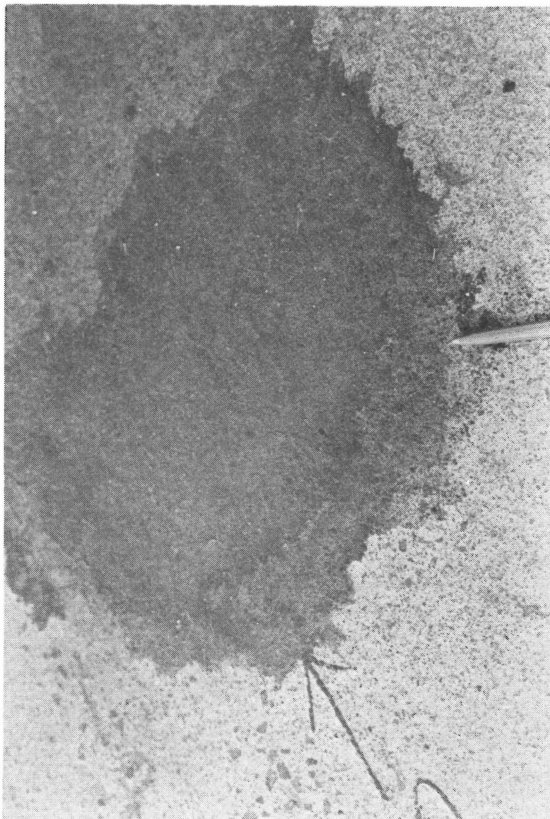
b) After Repair
