**FOURTH YEAR PROGRESS
REPORT
ON EXPERIMENTAL C R C P
IN WALKER COUNTY**

by
M. D. Shelby
and
B. F. Mc Cullough
**RETURN TO FILE D-10
TEXAS HIGHWAY DEPT.**

TEXAS HIGHWAY DEPARTMENT

March, 1965

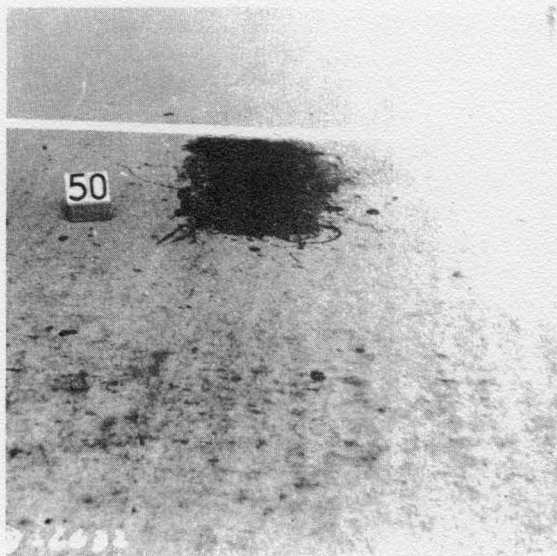
Figure A-1. Repair Area
with Cold Mix. SBL Station
560+

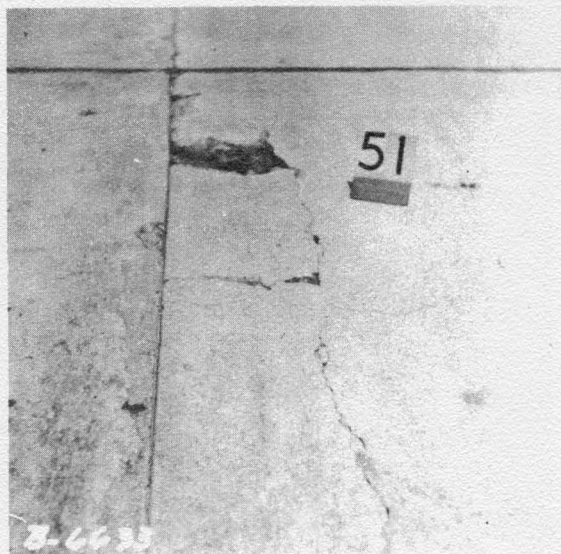
Figure A-2. Failure at Con-
struction Joint SBL Station
530+

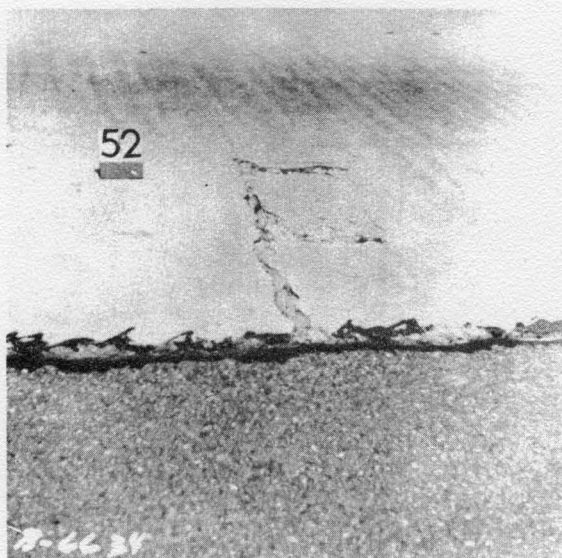
Figure A-3. Failure SBL
Station 524+

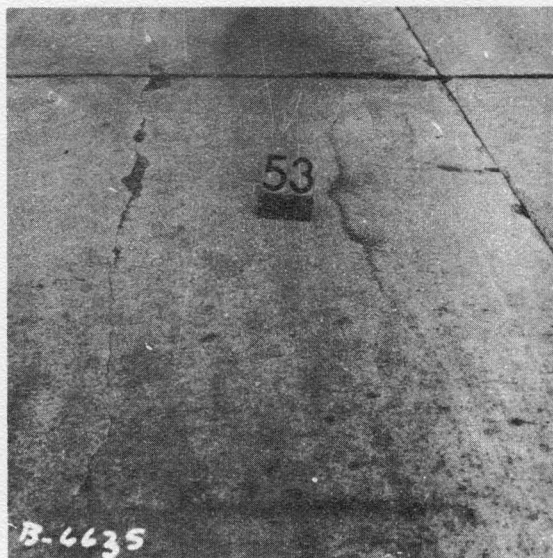
Figure A-4. Failure Near
Construction Joint. SBL
Station 511+

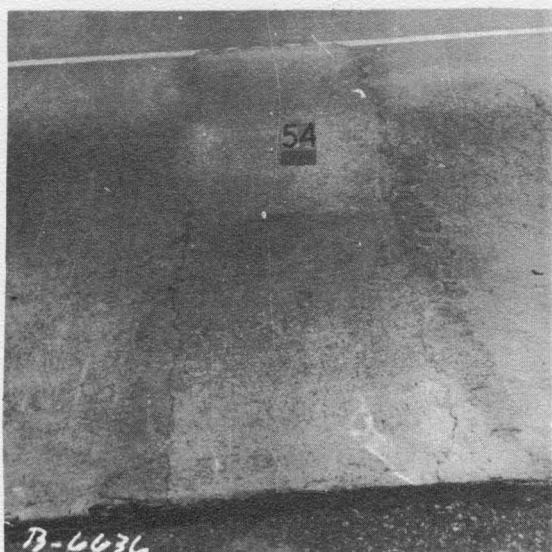
Figure A-5. Repair Area. SBL Station 508+

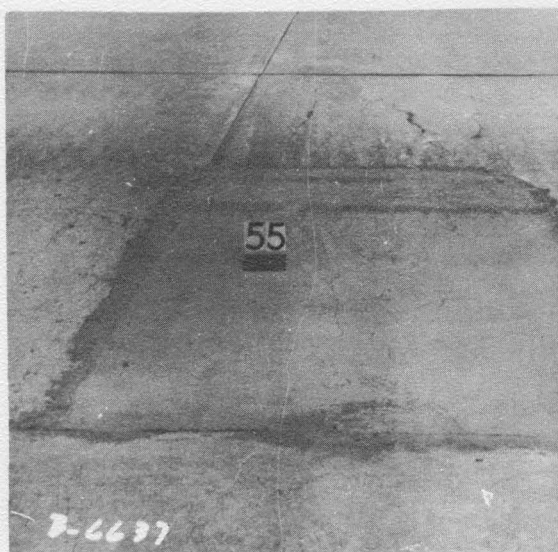
Figure A-6. Repair at Construction Joint. SBL Station 495+

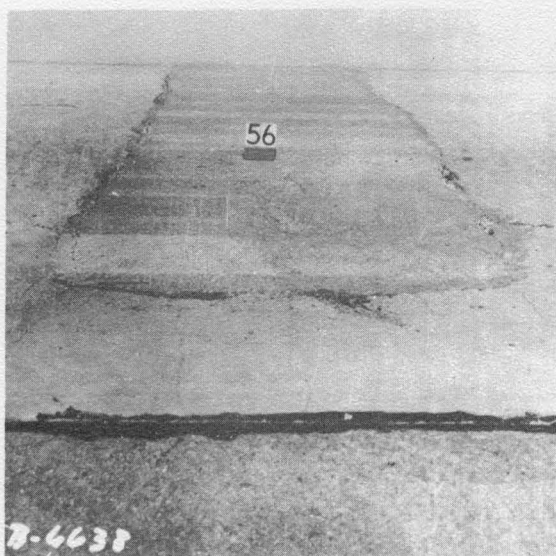
Figure A-7. Repair Area Deteriorating. SBL Station 485+

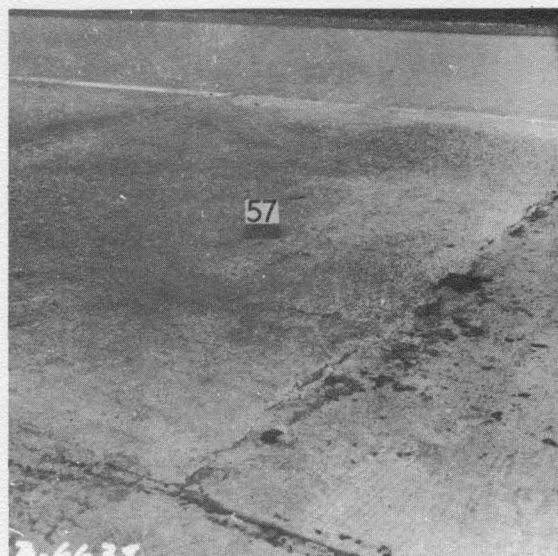
Figure A-8 Repair Area. SBL Station 445+

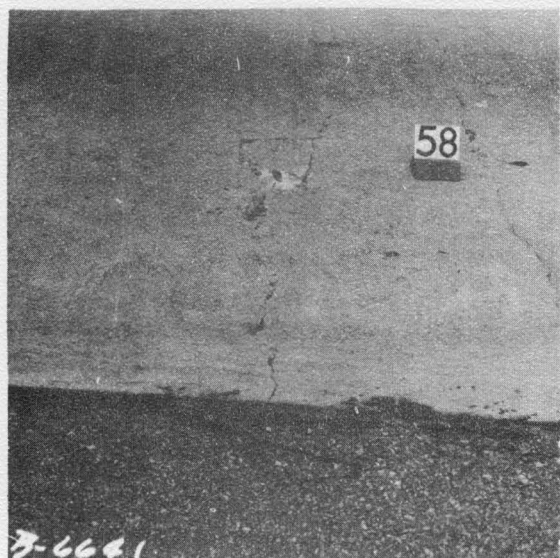
Figure A-9. Failure. SBL Station 441+

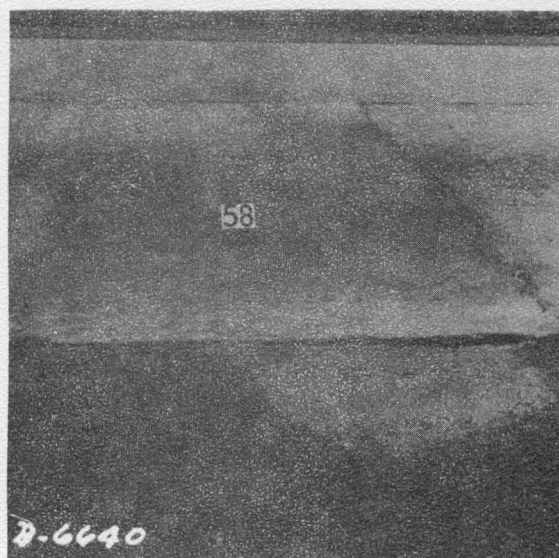
Figure A-10. Repair Area. SBL Station 441+

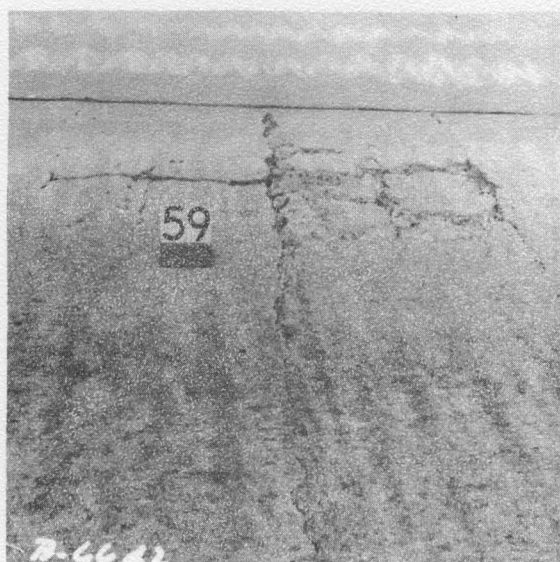
Figure A-11. Failure Near Longitudinal Joint. SBL Station 438+

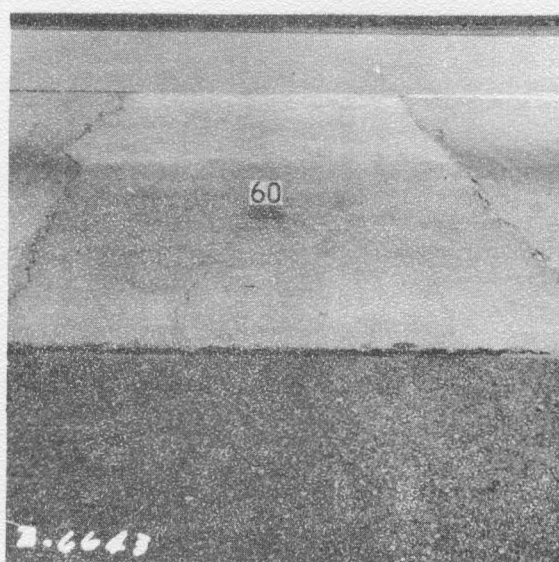
Figure A-12. Repair Area. SBL Station 405+

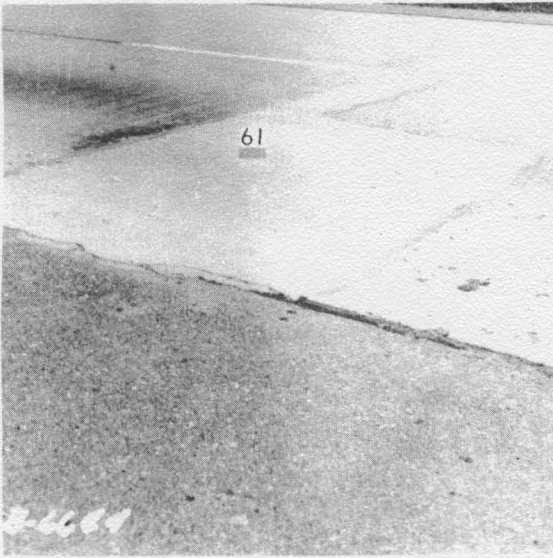
Figure A-13. Repair Area.
SBL Station 387+

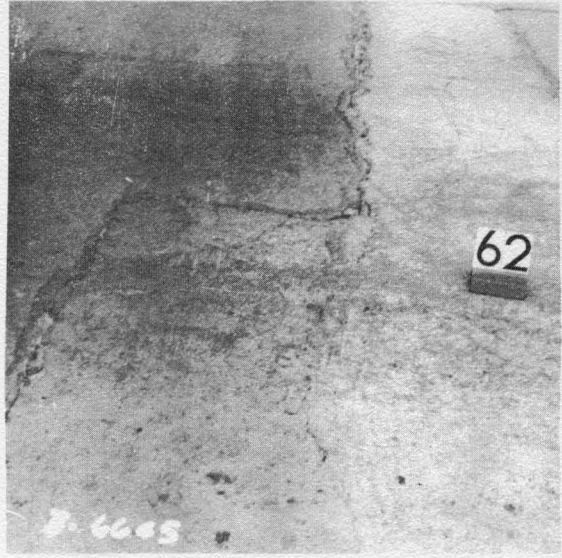
Figure A-14. Repair Area.
SBL Station 331+

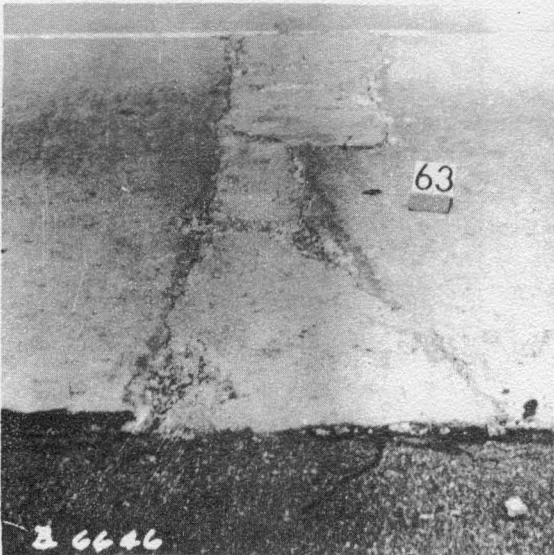
Figure A-15. Repair Area
Deteriorating. SBL Station
206+

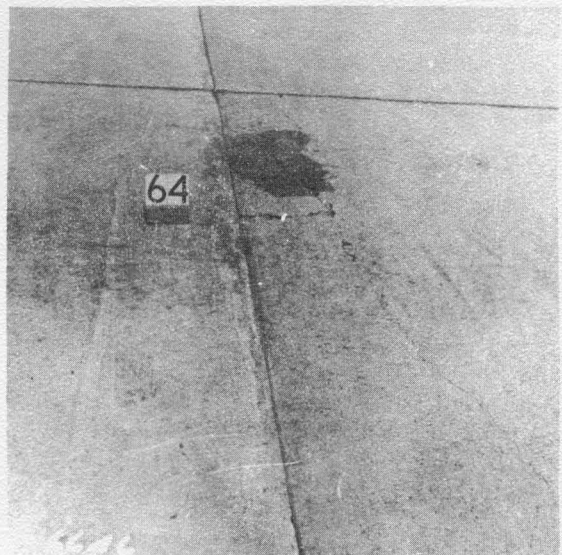
Figure A-16. Repair Area
with Cold Mix Construction
Joint SBL Station 98+

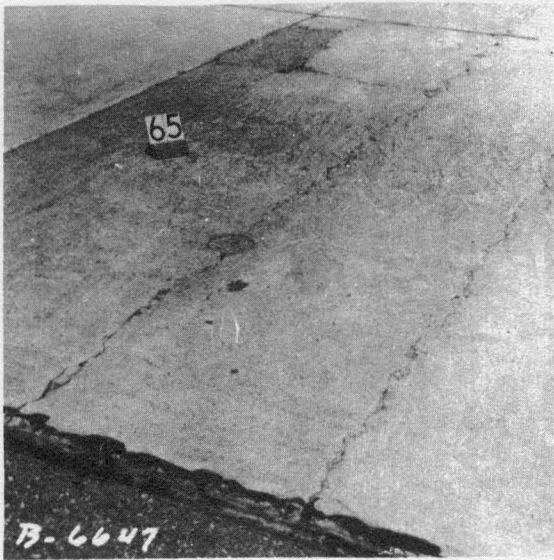
Figure A-17. Repair Area at Construction Joint. SBL Station 88+

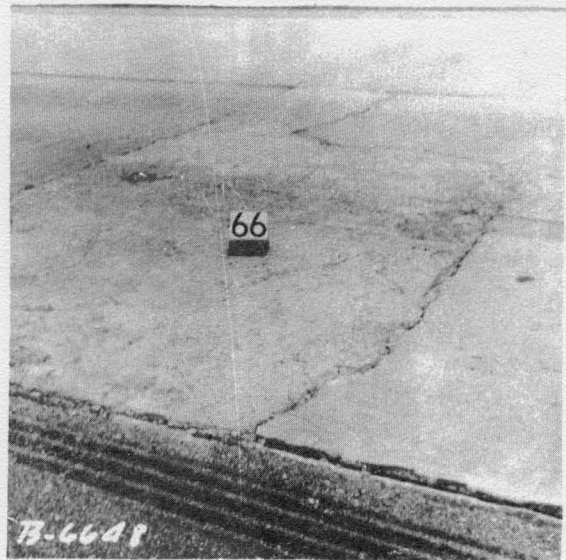
Figure A-18. Repair. NBL Station 138+

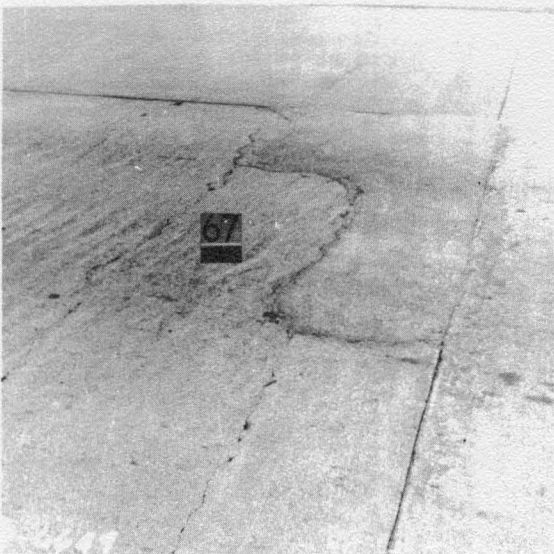
Figure A-19. Repair Area at Construction Joint. NBL Station 310+

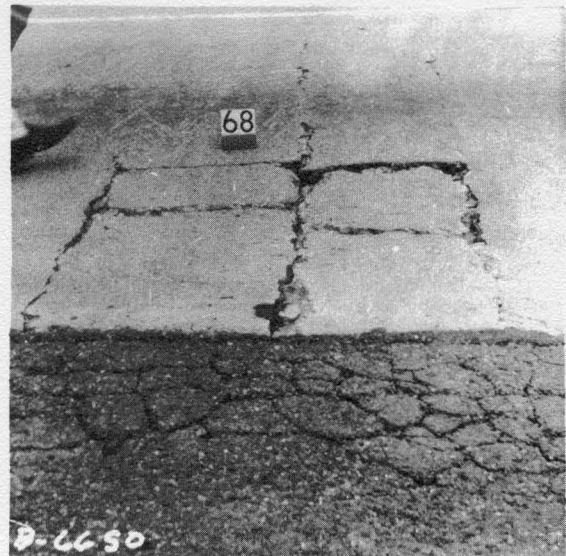
Figure A-20. Failure. NBL Station 351+

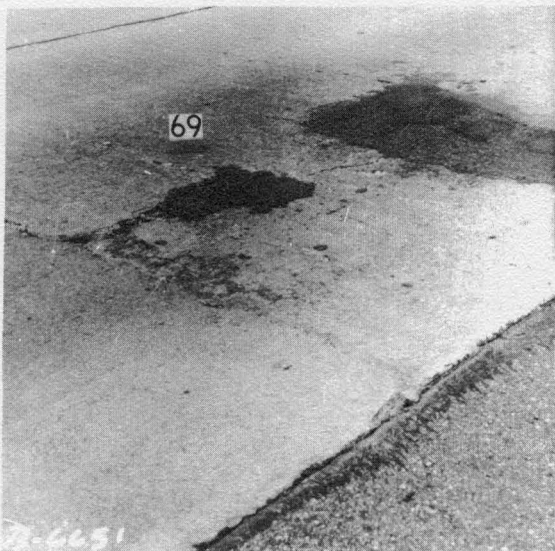
Figure A-21. Repair Area
with Cold Mix and Concrete.
NBL Station 353+

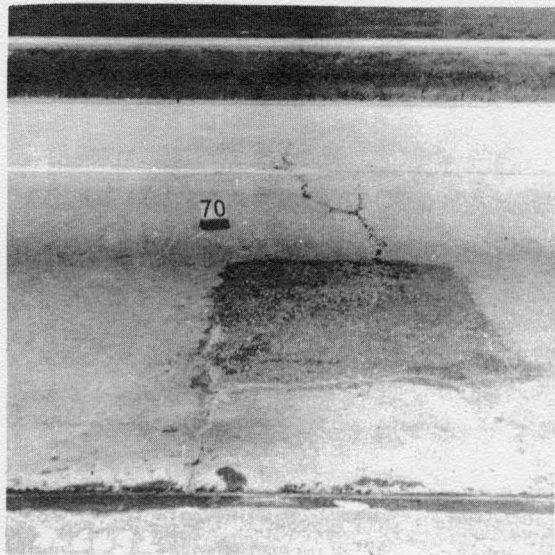
Figure A-22. Repair Area
with Cold Mix and Failure.
NBL Station 377+

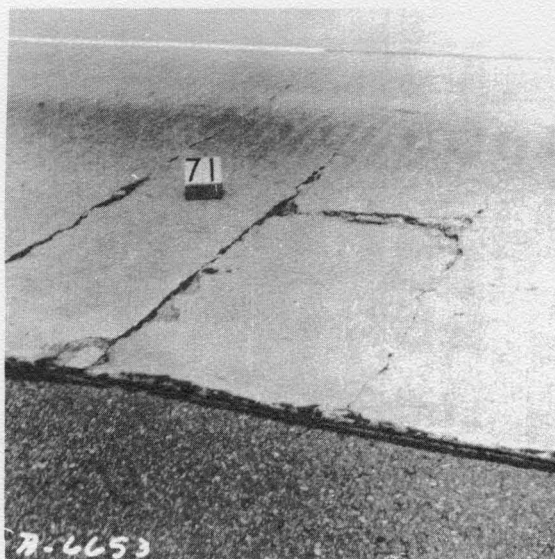
Figure A-23. Failure. NBL
Station 419+

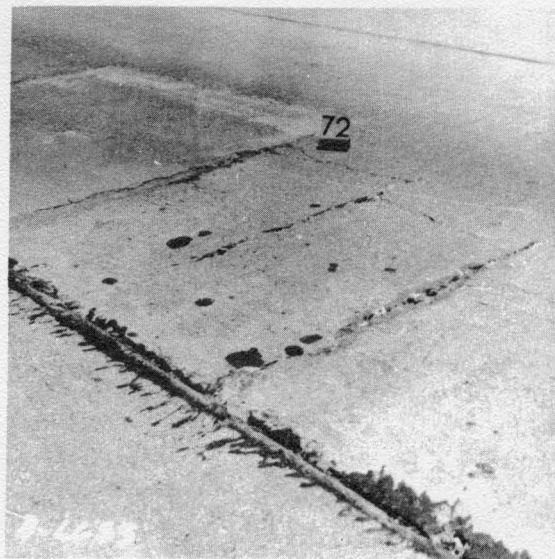
Figure A-24. Repair Area and
Failure due to Honeycombing.
NBL Station 425+

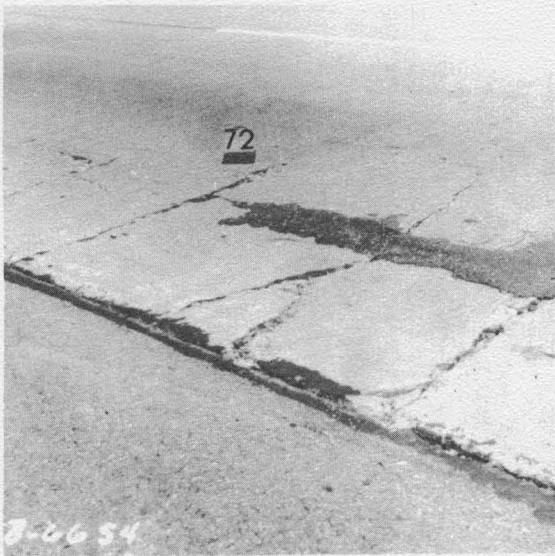
Figure A-25. Repair Area and Failure due to Honey-combing. NBL Station 425+

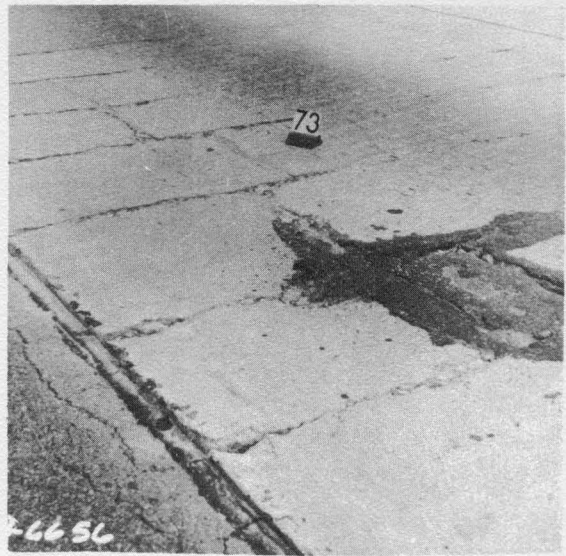
Figure A-26. Repair Area and Failure due to Honey-combing. NBL Station 520+

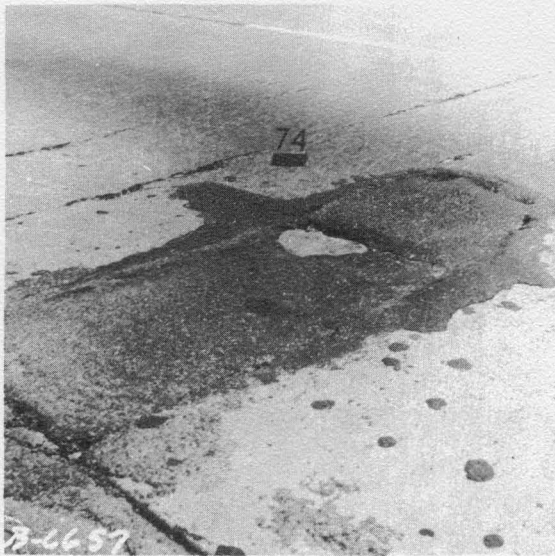
Figure A-27. Repair Area and Failure due to Honey-combing. NBL Station 521+

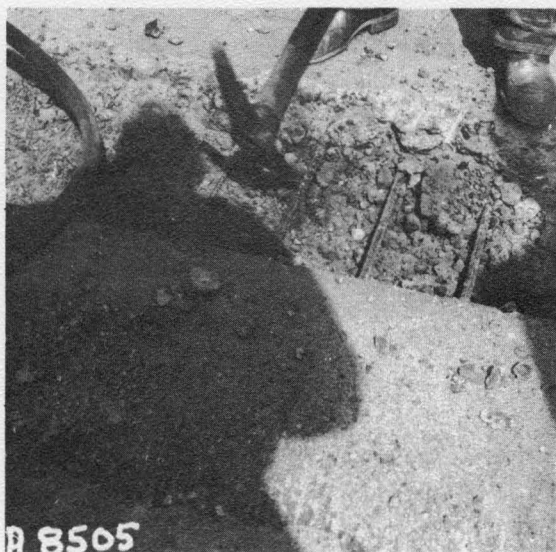
Upon removing the upper four inches of concrete to expose the steel around the perimeter of the area to be removed, it was observed that a dry, sandy batch had been placed in the area immediately adjacent to the construction joint (Figure B-3). The material in the area of the dry batch crumbled under a light blow with a pick as shown in the picture. It was also noted that the transverse cracks in the failure area had formed directly above the transverse bars as shown in Figure B-4.

FIGURE B-3
Dry, Sandy Batch of Concrete
Below Steel

Several possibilities exist which might explain the dry batch of concrete. One theory is that the first batch mixed each day is lean as a result of cement adhering to the sides of the mixer. Other sources feel that the Type III Cement used on this project caused "sand balls", i.e., sand surrounded by cement, to form.

The special provision to Item 360 should eliminate the possibility of lean batches or sand "balling up" in the mix. However, it may be desirable to add cement to the first batch each day in order that the resultant mix contain sufficient cement after coating the mixer surfaces. Since this is a construction problem it is felt that this should be left to the discretion of the project engineer.

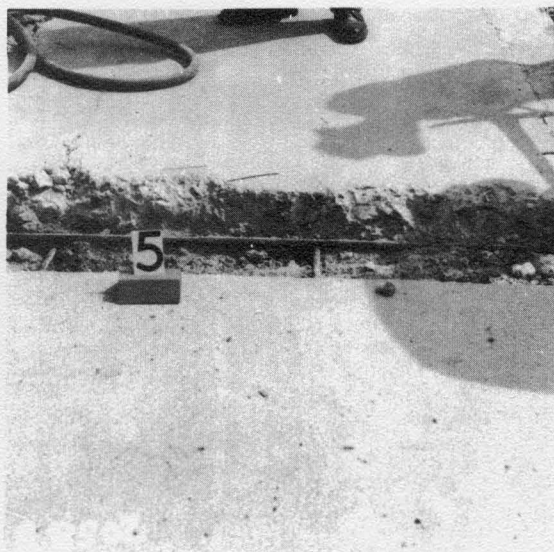
FIGURE B-4
Transverse cracks above
Transverse Steel

The transverse bars acted as support for the thin slab of sound concrete and the longitudinal bars. The slab, unable to support the applied loads, failed above the supports resulting in the transverse deflection cracks shown in Figure B-4. The "banging" sound detected during previous investigations can be attributed to the thin slab hitting against the steel mat.

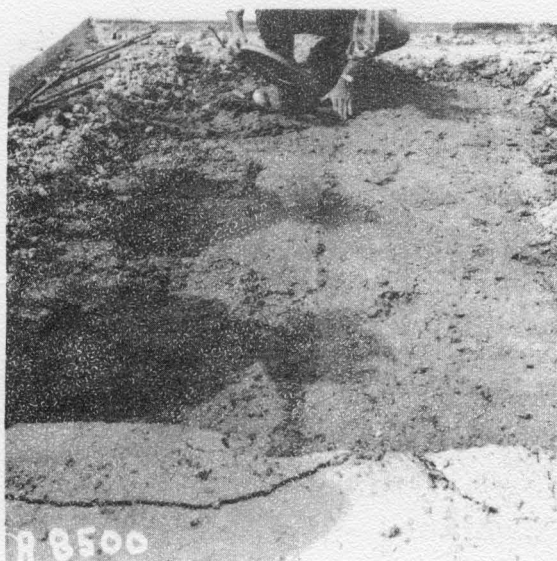
After the slab had been lifted from the location, the subbase material was inspected. The upper 1 to 2 inches of the crushed sandstone base was wet, with some free water present on the surface as shown in Figure B-5. The lime stabilized subgrade appeared to be very dense although the upper portion was damp relative to the lower portion.

FIGURE B-5
Base Immediately after Re-
moving Slab

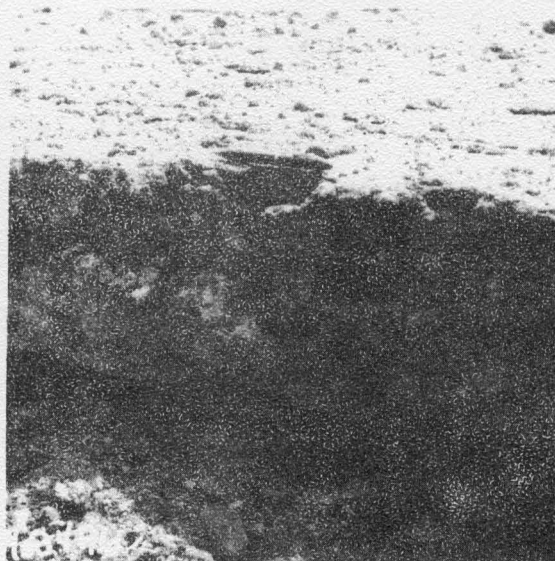
Figure B-6 shows the slab (upside down) after removal. It appears that some of the mortar from the fresh concrete combined with a thin layer of the crushed sandstone had adhered to the bottom of the slab. This figure also reflects the composition of the slab. The upper part of the slab (lower portion in figure) is sound while the bottom 3 to 4 inches of the slab is sandy and honeycombed.

FIGURE B-6
Slab Removed from Pavement

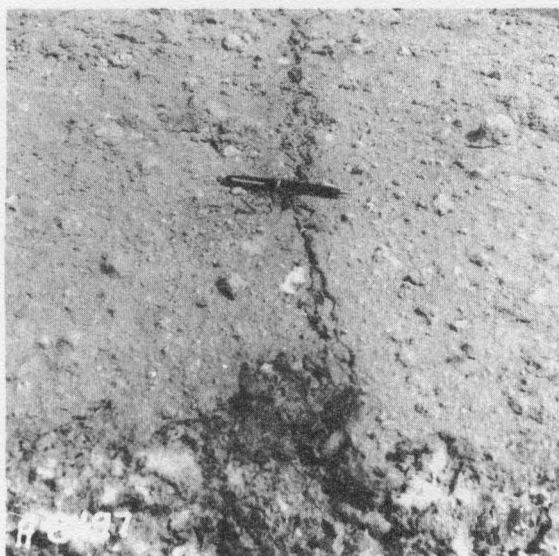
Poor bond between the concrete and steel or complete absence in some cases resulted in wide crack openings as shown in Figure B-7. The steel removed in the vicinity of these open cracks also show rusty spots as a result of the water filtering through the crack.

FIGURE B-7
Crack in Bottom of Slab
