TEXAS TECH UNIVERSITY

Project Level Performance Database for Rigid Pavements in Texas, II

Sung Woo Ryu, Sureel Saraf, Moon C. Won

Report #: 0-6274-1
www.techmrt.ttu.edu/reports.php

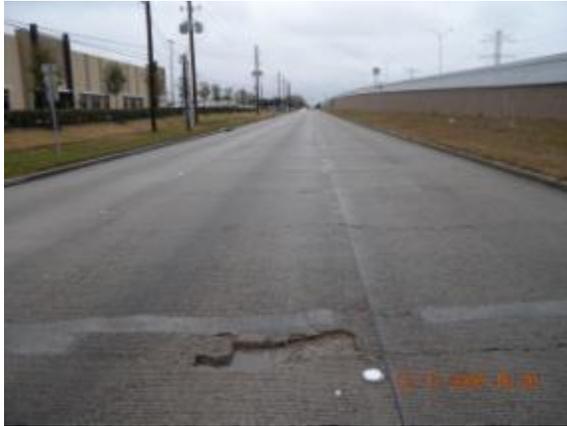
There was a large difference in the surface defects between sections containing SRG and those containing LS. There was no distress, either punchout or spalling, in sections with LS coarse aggregate. On the other hand, there were numerous spalling and spalling repairs in the SRG sections. Figure 2.8 shows deep spalling in the SRG section. Figure 2.9 shows a close-up view of spall repairs. The number of spalling and spall repairs are: 17 in Section A, 22 in Section B, 34 in Section C, and 19 in Section D. Section A had the highest steel percentage, and Section C had the lowest steel percentage among SRG sections. This finding strongly indicates that there is a good correlation between steel percentage and spalling potential in concrete with spalling-susceptible coarse aggregate.

Figure 2.8 Deep Spalling in SRG Section

It appears that a larger amount of steel restrains concrete movement at transverse cracks, thus reducing spalling occurrence. On the other hand, a lower steel amount does not restrain concrete volume changes well, and larger concrete displacements at cracks eventually lead to spalling. This finding is supported by the fact that spalling in this section did not take place at early ages; it took a long while before deep spalling took place. It appears that large concrete displacements at cracks in sections with a low steel percentage accumulate fatigue damage due to temperature and moisture variations, and eventually with traffic wheel loading applications, resulting in spalling. Observation of spalling in this section indicates the problem has been getting worse over the years. This section will be monitored periodically to document the spalling progress. The finding in this section suggests that a larger amount of steel may be needed for concrete with SRG as a coarse aggregate type. One of the distinctive properties of concrete containing SRG in the Houston area is a high coefficient of thermal expansion (CoTE). The potential issue would be that, with a larger steel percentage for concrete with high CoTE, there will be more transverse cracks. From a theoretical standpoint, short crack spacing shouldn't be a problem. This finding does not indicate that concrete with a high CoTE can be used safely with a larger steel amount. There were 17 spall repairs or spalls in Section A, where a high steel percentage was used. There was no spalling in LS section. As for the performance in terms of punchouts, there was no punchout in either SRG or LS sections after more than 20 years.

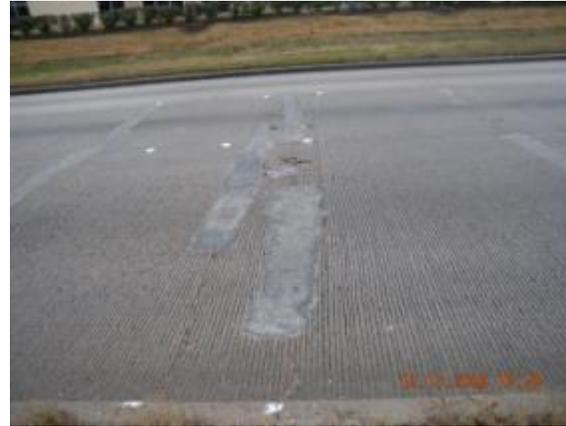
Figure 2.9 Close-Up View of Spall Repairs

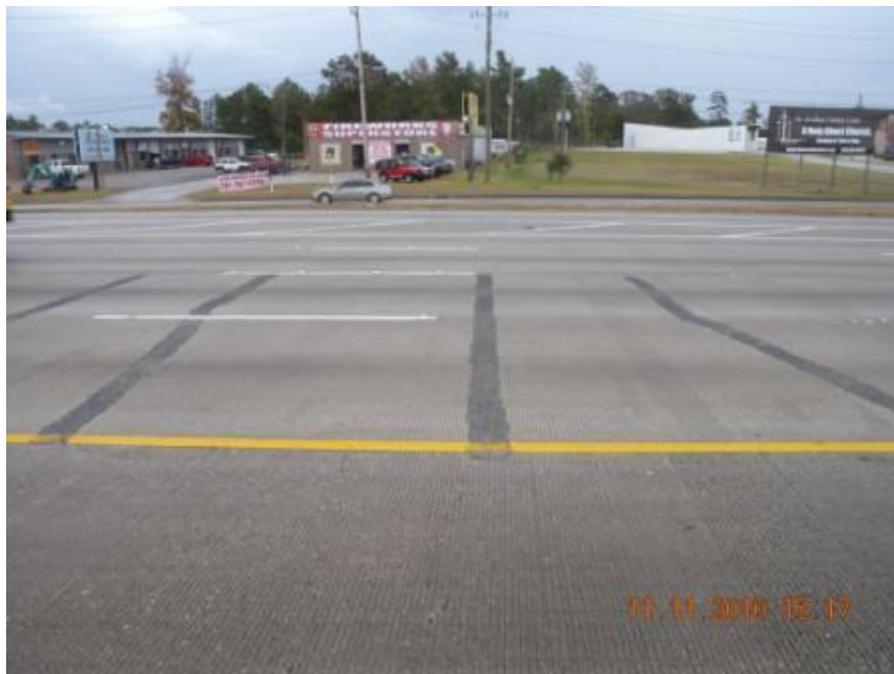
There was no punchout in the sections studied. The only distress observed was spalling in the SRG sections. There was no spalling observed in this section until 2004, when the director of construction at the Houston District first observed spalling 14 years after construction. Since then, more spalling occurred and spalling conditions worsened. Figure 2.13 shows the spalling repairs. The spalling in the SRG sections is solely due to a materials issue, or possibly contributed by construction quality. However, since the same construction crew built both the LS and SRG test sections and there is no spalling in the LS sections, it is most likely that the spalling is due to coarse aggregate used in the SRG section. As shown in Figure 2.12, deflections are small, and the spalling is not due to excessive deflections. Crack spacing is relatively small, as shown in Figure 2.11, and the spalling is not due to large crack spacing. The number of spalling at sections with various steel percentages was not quantified, even though it appeared that spalling was uniformly distributed throughout the sections. The information will be collected in the next round of field evaluations and included in the final report.

Figure 2.13 Repaired Spalls in SRG Section

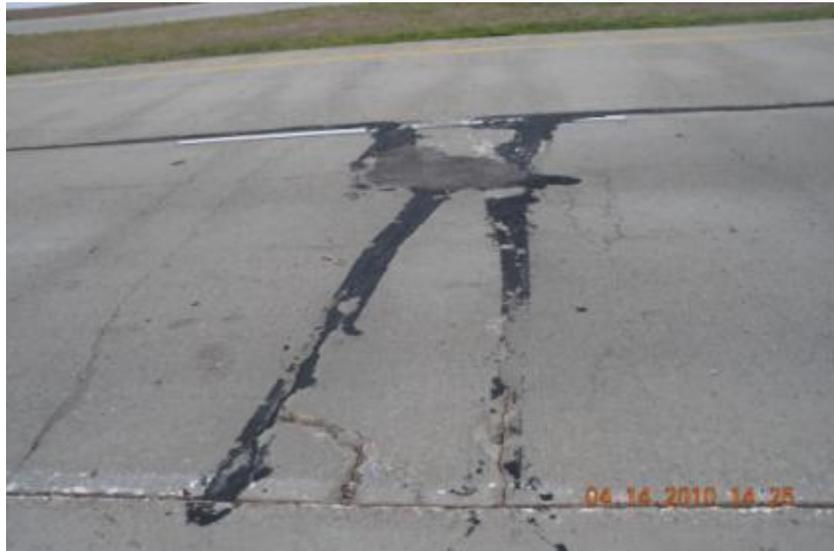
Figure 3.1 Distress on IH 40 in Amarillo District

Figure 3.1 shows a typical distress type observed in the CRCP section. In areas where punchouts occurred, faulting was observed at longitudinal joints. Faulting varied from almost negligible to a half inch. Lane separations were also observed at longitudinal joints, whether there were longitudinal construction joints or warping joints. Most of the distresses observed were located along longitudinal joints where lane separations and/or faulting were observed. From visual observations, it was clear that poor load transfer at longitudinal joints and poor subbase support were related to the distresses.

Distresses were observed in several locations and the area office staff repaired the distresses. The distress shown in Figure 3.1 was repaired on May 4, 2010. Repair work was performed by the area office staff and forensic evaluations were conducted during the repair. Before the repair work began, deflection testing using falling weight deflectometer (FWD) was conducted. Figure 3.2 shows the locations of FWD testing. IL stands for inside lane, OL for outside lane and OS for outside shoulder. L1 through L5 indicate longitudinal line number for FWD testing. Most of the testing was done in the outside lane, with four locations in the outside shoulder.

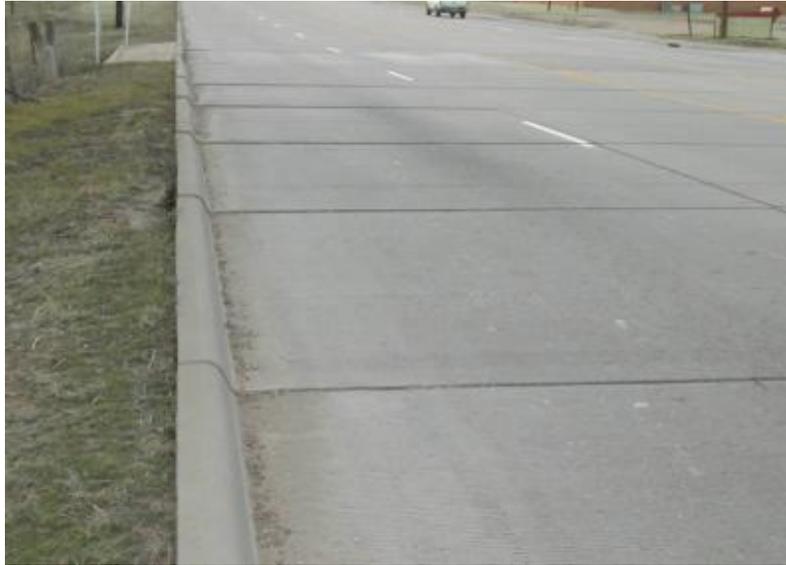
Figure 3.5 Severe Faulting Observed on US 287 in Quanah

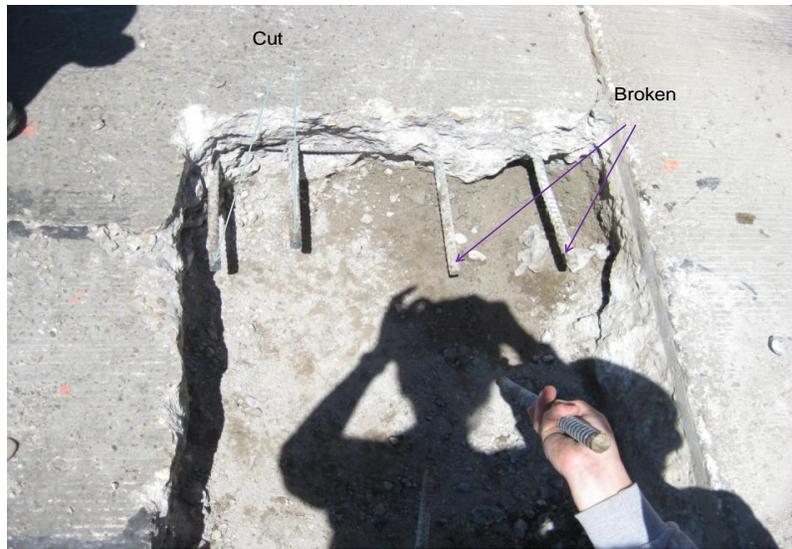
Figure 3.6 Fractured Longitudinal Steel at Punchout Location

Concrete was removed and it was observed that both longitudinal and transverse steel were fractured as shown in Figure 3.6. Figure 3.6 shows that the warping joint did not crack under the joint saw-cut; however, it appears that at the loading location #16, full-depth crack occurred at the warping joint. Water was observed in the leave side of the joint. Since the concrete was removed by a jackhammer and manually, not by saw-cutting, no water was used in the concrete removal operation. The water observed had apparently been there for a while, since weather information shows that it had not rained for several months prior to the pavement repair. Due to the way concrete was removed, it was not possible to observe whether there was a void under the slab. Based on the FWD deflections and the faulting mechanism in JCP, it was concluded that there was a void in loading location #16 or the support condition was much weaker. Westergaard equation for corner condition shows that the deflection for 9-in. slab with modulus of subgrade reaction of 300 psi/in would be 25.5 mils. Since the deflection was 30 mils at loading location #16, the support condition was much weaker or there was a void under the slab. Also, according to Westergaard equation for edge loading condition, the deflection for 9-in. slab with 300 psi/in modulus of subgrade reaction would be 10.7 mils. The deflection at location #15 was 10.2 mils, which is quite close to Westergaard prediction at edge condition with 300 psi/in modulus of subgrade reaction. It implies that, even though longitudinal steel was fractured at this location, the support provided by tied concrete shoulder (with joint not cracked), put the slab in the edge condition. Dynamic cone penetration (DCP) testing was conducted after the concrete removal. Visual observation showed that there was no cohesiveness in the asphalt materials, and the stiffness of the asphalt material was quite low. It appeared that stripping occurred in the asphalt stabilized materials. DCP testing results indicate that the average of the estimated modulus values for asphalt layer was about 40,000 psi, which is very low. The average estimated modulus of subgrade material from DCP testing was 17,500 psi, which is larger than the modulus of subgrade material in many parts of Texas. It appears that the water in the asphalt base degraded asphalt materials and support conditions.

was observed at the loading locations #15 and #16 (See Figures 3.1 and 3.2). It is noted in Figure 3.6 that two longitudinal steel bars near the longitudinal warping joint were ruptured. The ruptured longitudinal steel, as shown in Figure 3.7, shows that the failure was primarily due to shear, not longitudinal stress. Quite limited corrosion was also observed. Evidence of necking and corrosion were noted in transverse steel. Figure 3.7 shows that the ruptured shape of the longitudinal steel, minimum corrosion and little evidence of necking indicate that shear played a major role, with tensile force playing a minor role. Even though horizontal cracking was observed at loading location #2, as shown in Figure 3.8, due to the way the concrete was removed it was not feasible to determine whether the horizontal cracking was pre-existing or it was caused by concrete removal operations. It is postulated that high deflections due to poor subbase support condition resulted in high deflections due to wheel loading applications at loading location #16, which caused the rupture of longitudinal steel without causing longitudinal cracking.

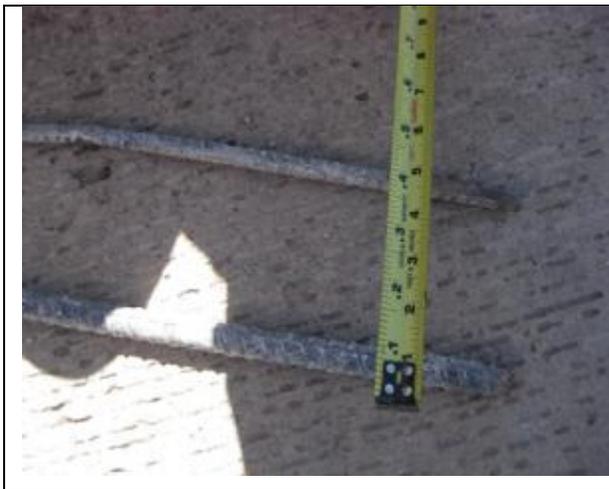
Figure 3.7 Ruptured Longitudinal and Transverse Steel

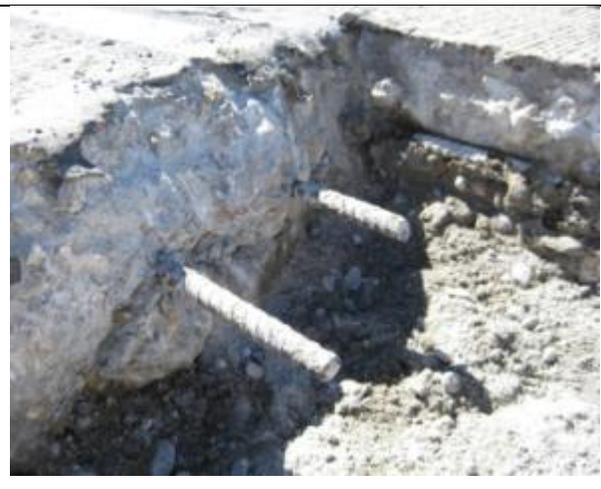
Figure 3.8 Distressed Slab Showing Horizontal Cracking at the Mid-Depth of Slab
