TEXAS TECH UNIVERSITY

Improvements of Full Depth Repair Practices for CRCP Distresses

Report #: 0-6611-1
www.techmrt.ttu.edu/reports.php

September 2013

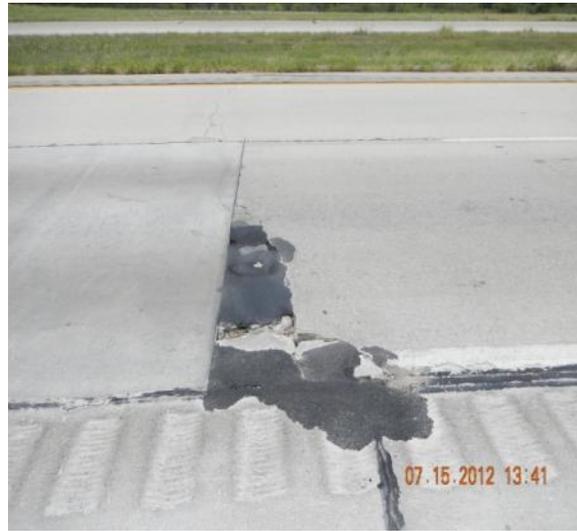
Continuously reinforced concrete pavement (CRCP) is the most widely used rigid pavement type by the Texas Department of Transportation (TxDOT) primarily due to its excellent performance. As of 2010, TxDOT had 12,345 lane miles of CRCP, with some as old as 50 years still in service ⁽¹⁾. Having served much longer than intended, some sections are showing distresses. Over the years, various methods of full-depth repair (FDR) have been used to restore structural condition of the pavement. Until the early 1990s, the primary method used in Texas consisted of full-depth cuts at 2 ft away from transverse repair joints and partial-depth cuts at repair joints, with removal of the concrete in between by jack-hammering to expose 2 ft of longitudinal steel. Longitudinal steel was brought in and tied with 2 ft of exposed steel. A primary disadvantage of this FDR method was the time and manpower required to complete the repairs. Figure 1.1-(a) illustrates the manpower utilized in this method. Other disadvantages include the difficulty to rework the base below the exposed steel area and potential damage to existing concrete by jack-hammering below the longitudinal steel at transverse repair joints. The performance of FDR done this way varied, with some repairs showing good performance while some required additional repairs due to distresses at repair joints, as shown in Figure 1.1-(b).

Figure 1.1- (b) Distress on existing CRCP at repair joint

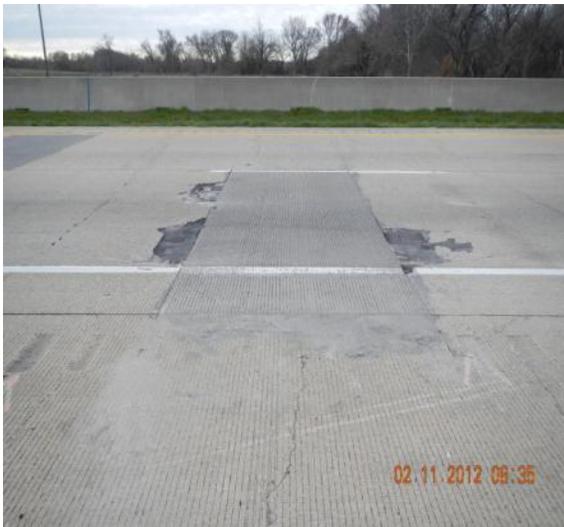
The effectiveness of this method also varied. A substantial portion of the repairs done with this method resulted in further distresses and needed further repairs within a few years. Figure 1.2-(a) shows the distress of the repairs done in this method. Figure 1.2-(b) shows a gap between Tie bars used for previous repairs and surrounding concrete. Since the full-depth cut face of concrete at repair boundaries is smooth, the load transfer efficiency (LTE) at repair joints is achieved primarily by Tie bars and base support. If bonding between Tie bar and surrounding concrete is not fully achieved, the Tie bar might become loose and shear mode failure or reduction in load transfer could occur due to repetitive traffic and environmental loading. Accordingly, it is imperative that Tie bars are fully bonded to existing concrete.

Figure 1.2- (a) Distress at FDR

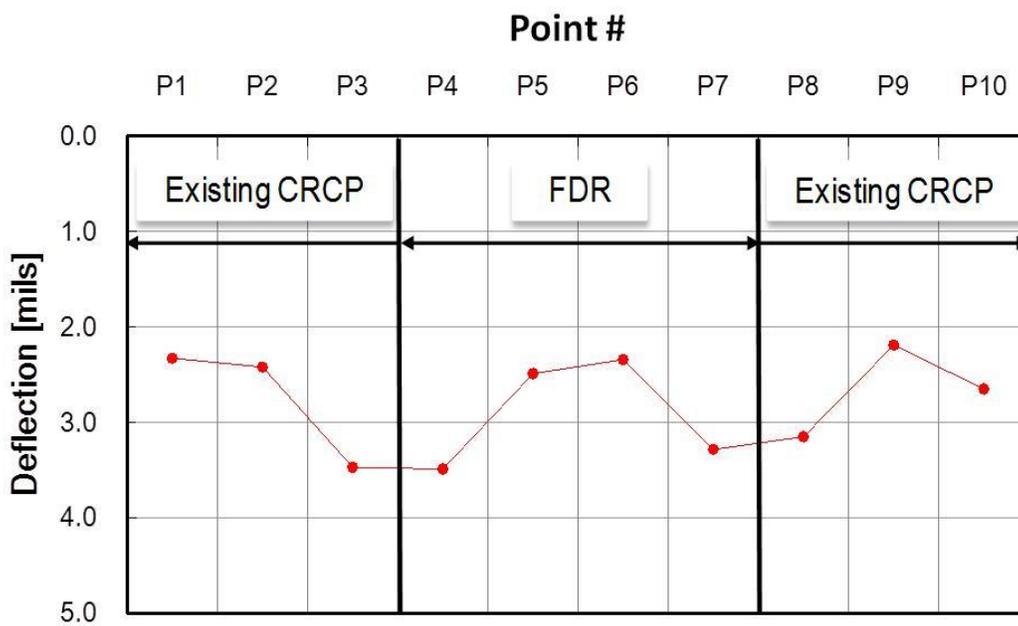
Figure 3.1- (b) shows typical deflection variations along the FDR area. It is observed that deflections at repair joints are larger than those at the other locations. This trend holds true for almost all FDRs evaluated. The major difference between good and performing FDRs was the magnitude of the increase in deflections at repair joints. In good performing FDRs, such as

The reason for the larger deflections at repair joints even in good performing FDRs is that, in the FDR method, the concrete surface after the cut is smooth, and no aggregate interlock is present at repair joints. All the load transfer is achieved by tie bars and base support. It appears that if tie bars are adequately installed and/or base condition is restored to an acceptable level during repairs, FDRs with FDC method can perform well. On the other hand, if tie bars are not properly installed and base condition is not adequately restored, the performance of FDR with FDC method could be poor. Performance evaluations of FDRs with FDC method clearly indicated the need for improving repair practices at transverse joint areas. Since loose base materials are removed during FDRs, as evidenced by deflections in the repair slabs comparable to those in the existing slabs, the primary cause for large deflections at repair joints is the inability of tie bars to provide adequate shear load transfer and slab continuity.

Figure 3.1- (b) FWD test result [good condition]

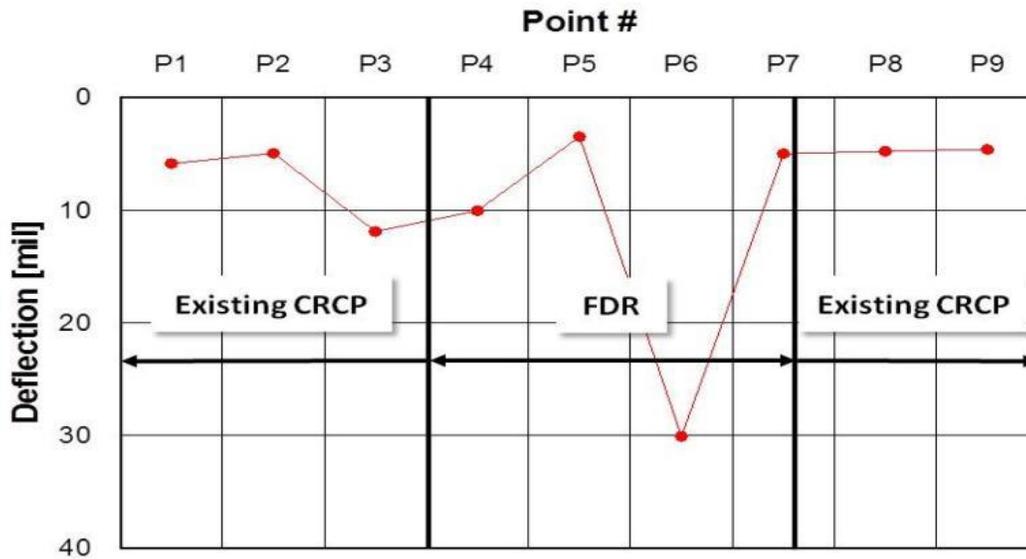
shown in Figure 3.1-(b), the increase was minimal, while in poorly performing FDRs, as shown in Figure 3.1-(c), the increase was substantial. In Figure 3.1-(c), the increase of deflections at a repair joint is about 6 times higher than those at other locations, which clearly indicates the potential for future deterioration at this repair joint. All FWD test and visual survey results are included in Appendix A.

Figure 3.1- (c) FWD test result [poor condition]

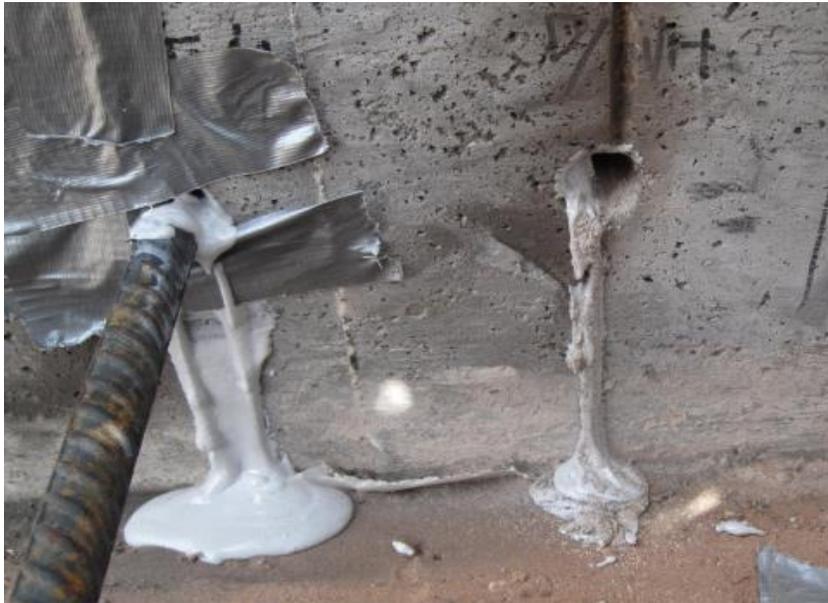
Current Item 361 does not require hole cleaning before epoxy injection. Drilling operations generate large quantities of dust and, unless cleaned out, this dust will stay inside the holes and might reduce the bond strength. Figure 3.7-(a) shows the condition of drilled holes that were cleaned (left) and not cleaned (right) observed after pull-out testing. The effect of cleanness of the holes on the bond strength was evaluated, and Figure 3.7-(b) shows that, even though leaving dust in the holes before epoxy injection does not appear to adversely affect ultimate bond strength, the pull-out displacements are larger compared with those in clean holes due to larger shear strains at the interface between epoxy and dust. Epoxy injection without cleaning holes might result in widening of repair joint widths, reducing load transfer efficiency and leading to poor performance.

Figure 3.7- (a) Clean condition hole (left) and dirty condition hole (right)

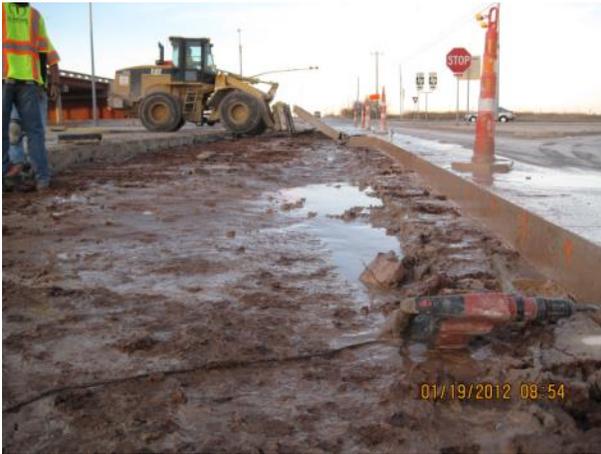
Figure 3.11-(a) shows base condition before the concrete placement. It shows loose base as well as water in the base from the saw cutting operations of repair joints. The original CRCP tie bars were not installed at the same spacing as that of longitudinal bars, which is not compliant with Item 361 requirements. Figure 3.12 shows the layout of the rebars at a transverse repair joint and three steel strain gages (SSGs) installed on tie bars. As discussed, tie bar spacing was double the longitudinal bar spacing.

Figure 3.11-(a) Condition of base

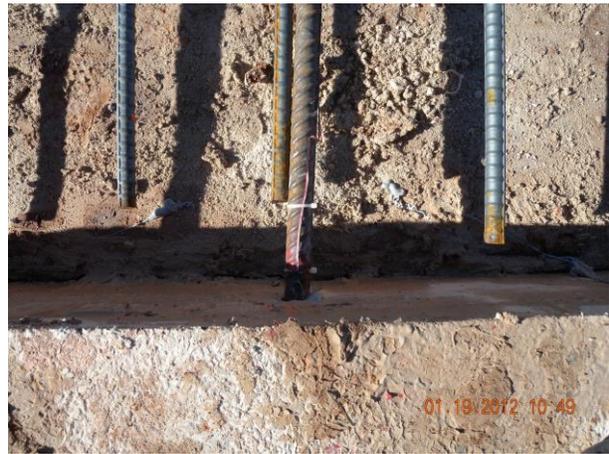
Figure 3.11-(b) Insufficient tie bars

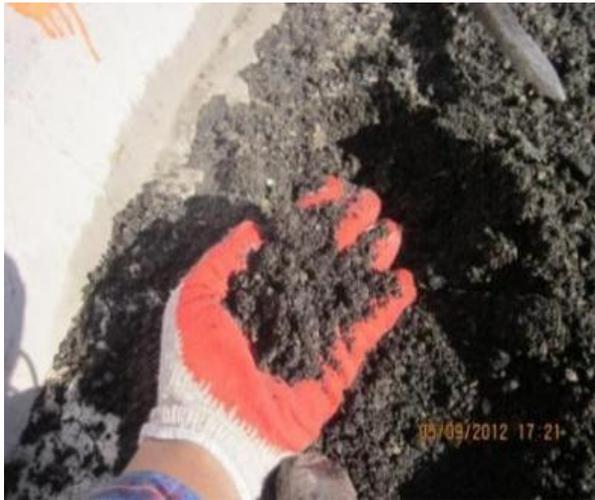
Since loose materials in the base course were observed in the distressed areas, further investigation was conducted to evaluate the base condition of the CRCP section in this area. A CRCP section in good condition was selected, and dynamic cone penetrometer (DCP) testing was conducted in the FDR area as well as in the CRCP section in good condition. Figure 3.16-(a) shows the DCP testing locations in the FDR area and CRCP section in good condition. Figure 3.17 shows resilient modulus values in each layer at both the FDR and CRCP section in good condition. In general, there was no significant difference in modulus values between two sections, and the modulus values were quite low. During the DCP test, it was confirmed that soil was saturated at both the FDR and CRCP section in good condition as shown in Figure 3.16-(c). It appears that moisture in the soil degraded soil stiffness and strength, and potentially caused stripping of asphalt base material, which resulted in larger deflections and subsequent distresses.

Figure 3.15- (a) Loose asphalt base

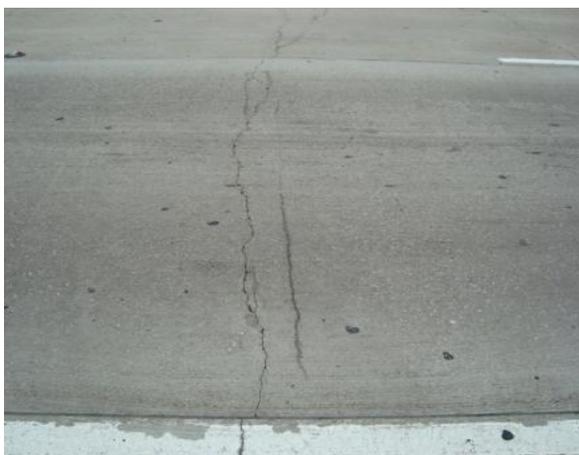
CRCP. First, this crack is much straighter than normal cracks in CRCP that occur at early ages due to environmental loading. Second, this crack is quite close to the existing transverse crack. Normal transverse cracks caused by environmental loading will occur somewhere in the middle of two adjacent transverse cracks, because concrete stresses due to environmental loading are zero at transverse cracks, and increase with the distance from transverse cracks. Accordingly, the crack on the right in Figure 4.2-(a) was not caused by environmental loading alone. Figure 4.2-(b) shows cracks with similar characteristics. This section is located in southbound main lanes on IH 35 in the Waco District between mileposts 362 and 363. This 14-in CRCP was completed in 1999, and horizontal cracking was observed at the depth of longitudinal steel in November 1999, before this section was open to traffic. This picture was taken in August, 2009, and the pavement was 10 years old when this picture was taken. The crack on the left is a normal crack due to environmental loading that occurred at early ages. On the other hand, the crack on the right has the same characteristics as the one on the right in Figure 4.2-(a). Based on the similarities between the two projects, it is concluded that the crack on IH 35 in the Laredo District was caused by a horizontal crack at the depth of the longitudinal steel.

Figure 4.2-(a) Cracks on IH 35 in Laredo

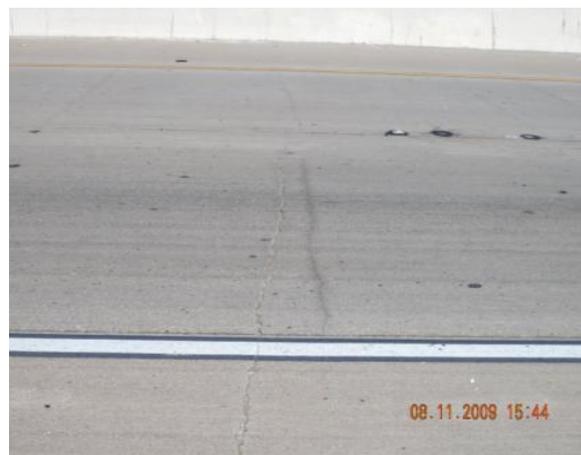
Figure 4.2-(b) Cracks on IH 35 in Waco

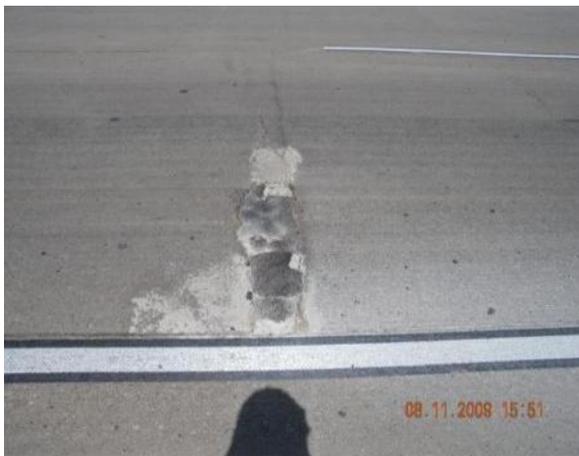
observed that the crack on the left is a normal early-age crack, while the one on the right has the same characteristics of the cracks on the right in Figures 4.2-(a) and 4.2-(b). The slab segment between two close transverse cracks deteriorated primarily due to wheel loading applications, and it appears that multiple applications of various materials were made to repair this distress. It took 10 years for horizontal cracks at the depth of longitudinal steel to develop into a distress. Distress shown in Figure 4.3-(b) is on IH 35 in the Laredo District. Three transverse cracks occurred right next to each other, and distresses developed near wheel paths. There are similarities between the distresses shown in Figures 4.3-(a) and 4.3-(b). These distresses are not full-depth punchouts. In the past, these were misdiagnosed as full-depth punchouts, and researchers tried to hypothesize their mechanisms, theorizing that slab segments with short crack spacing behave like a cantilever beam and, with wheel load stress in the transverse direction becoming large due to wheel loading applications, longitudinal cracks will develop, resulting in punchouts. Obviously, this theory is not technically correct. TxDOT recognized the deficiency in this theory and initiated a research study on horizontal cracking, 0-5549. Efforts made in that study identified the mechanism of horizontal cracking and subsequent distress.

Figure 4.3-(a) Distress due to horizontal cracking on IH 35 in Waco

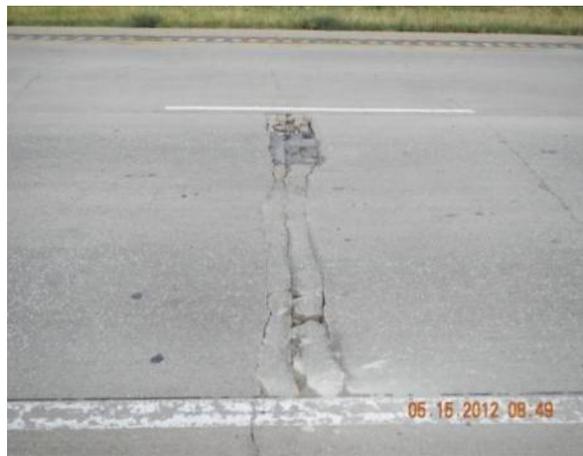
Figure 4.3-(b) Distress due to horizontal cracking on IH 35 in Laredo

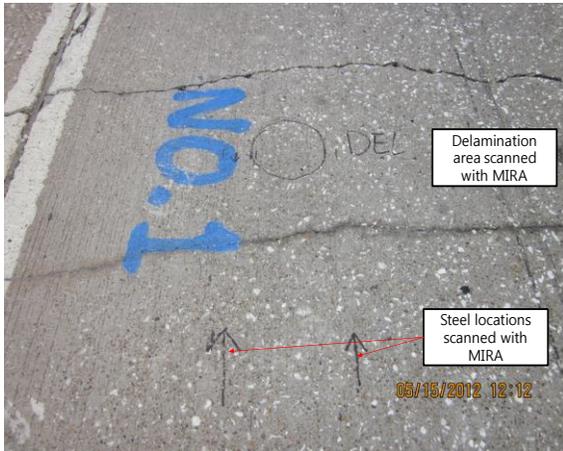
cracking were identified and selected for testing. Figure 4.4-(a) shows two cracks – the one on the top is a natural CRCP crack, while the one in the middle is due to horizontal cracking. Figure 4.4-(b) shows the MIRA analysis and image, illustrating the existence of horizontal cracking. The red color illustrates voids or gap in the concrete. To confirm MIRA analysis results, coring was made and horizontal cracking was observed, as shown in Figure 4.4-(c) and (d).

Figure 4.4-(a) Condition of section 1

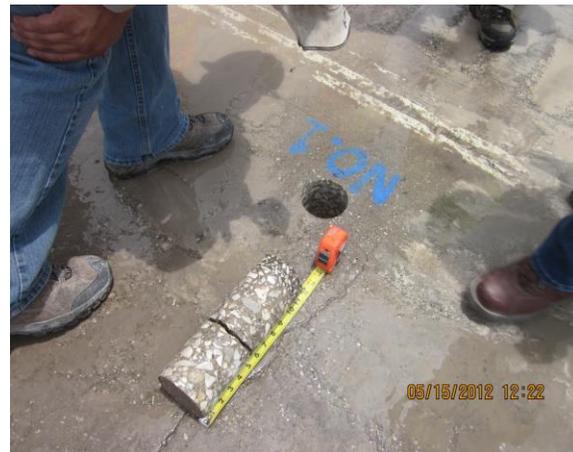
Figure 4.4-(d) Horizontal crack

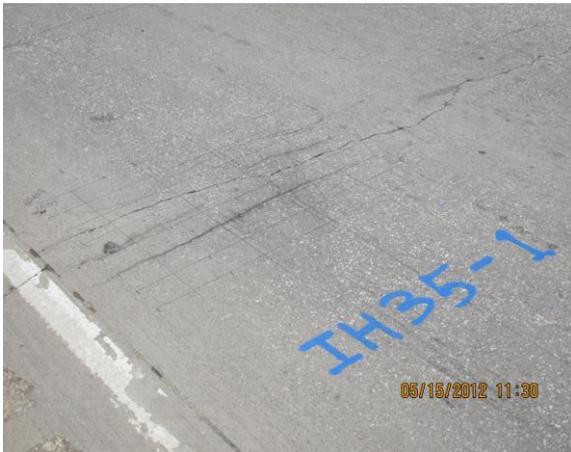
concrete inside the pavement was evaluated with MIRA. Figure 4.5-(b) illustrates 3-D analysis result from MIRA testing. Horizontal crack was detected at mid-depth, along with longitudinal steel. Figure 4.5-(c) shows the plan view of the MIRA analysis results. The extent of horizontal cracking and longitudinal steel is illustrated.

Figure 4.5-(a) Condition of section 2

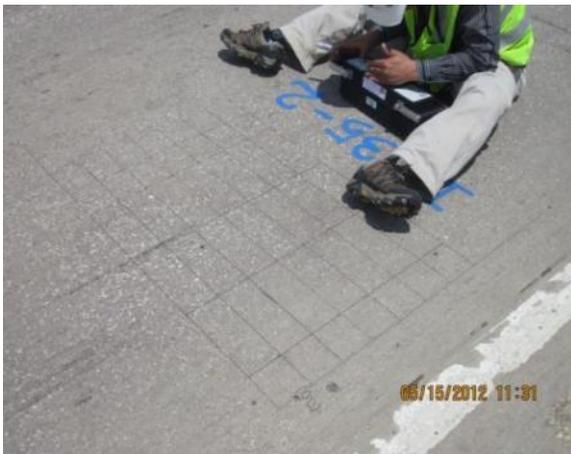
Figure 4.6-(a) Condition of section 2

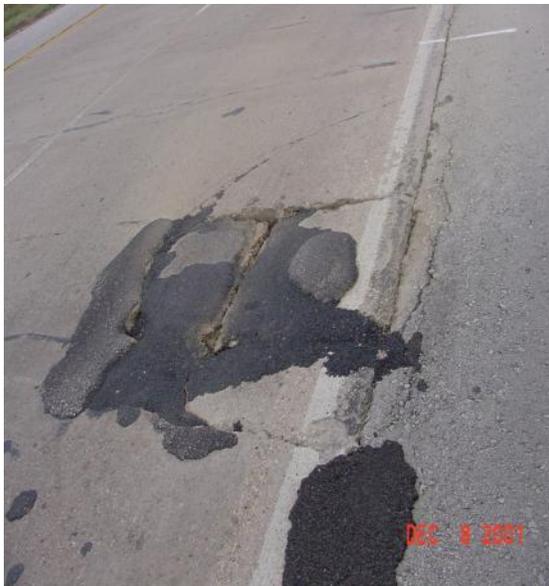
1. Distresses are located at the edge of the outside lane with asphalt shoulder.
2. Distresses are not necessarily confined to adjacent two transverse cracks whose spacing is small, as some documents on CRCP describe. In general, distresses take the shape of a half-moon, as shown in Figure 1, where evidence of minor pumping and depression of asphalt material at the pavement edge exist.
3. Near the distressed area, evidence of pumping, either significant or minor, is normally observed, as shown in Figure 2. Punchouts in this area were repaired.

Figure 1 Typical full-depth punchout

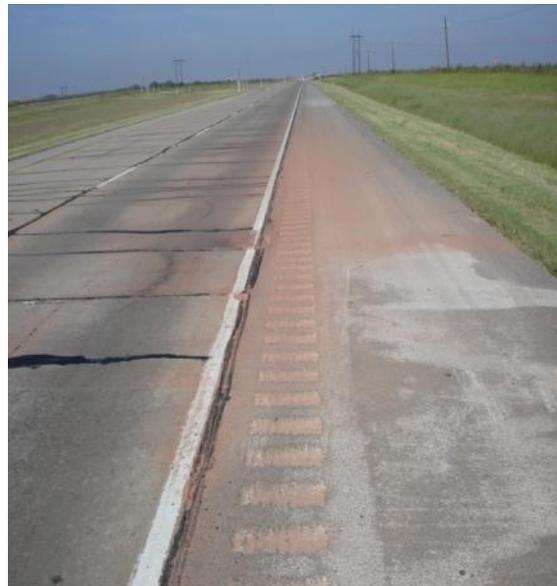
Figure 2 Evidence of severe pumping

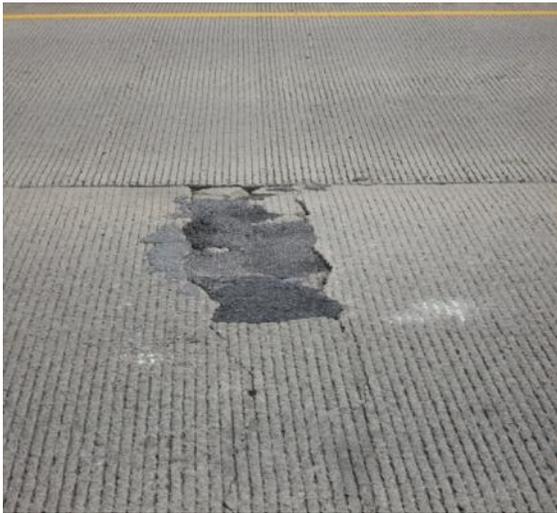
On the other hand, distresses that occurred near longitudinal joints, either construction or warping joints, where tied-concrete shoulder was used, are probably not full depth failures. Also, if distresses are under wheel path, and two or more transverse cracks are close to each other with quite small spacing, chances are that these distresses are not full depth failures. Figures 3 through 8 illustrate examples of distresses that are not full-depth failures caused by structural deficiencies. These distresses are confined to the top half of the slab and should be restored with partial-depth repair (PDR) method. For the detailed information on PDR, refer to the guidelines in the Appendix # of this report.

Figure 3 – Partial depth distress near longitudinal construction joint

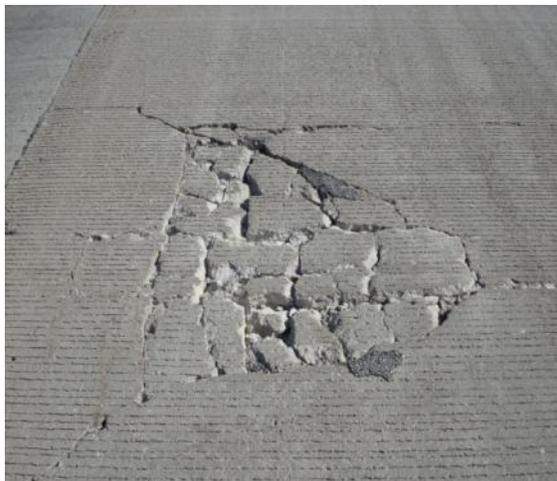
Figure 5 – Partial depth distress under wheel path with fractured concrete

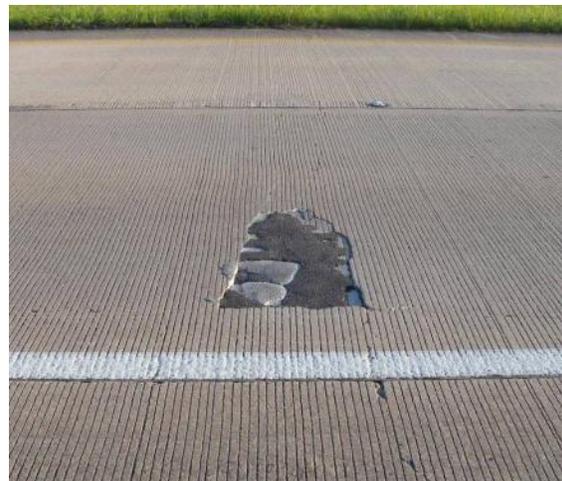
Figure 6 – Partial depth distress under wheel path

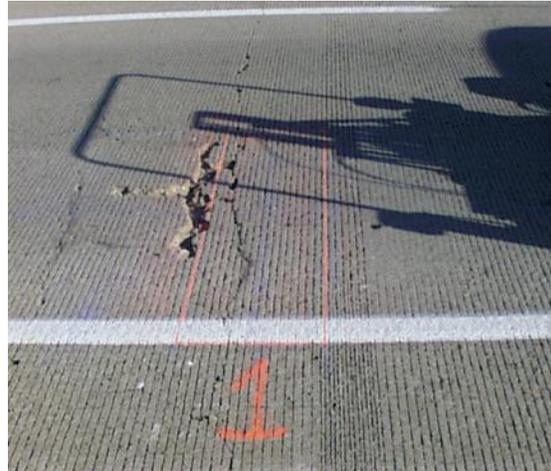
Figure 8 – Partial depth distress under wheel path

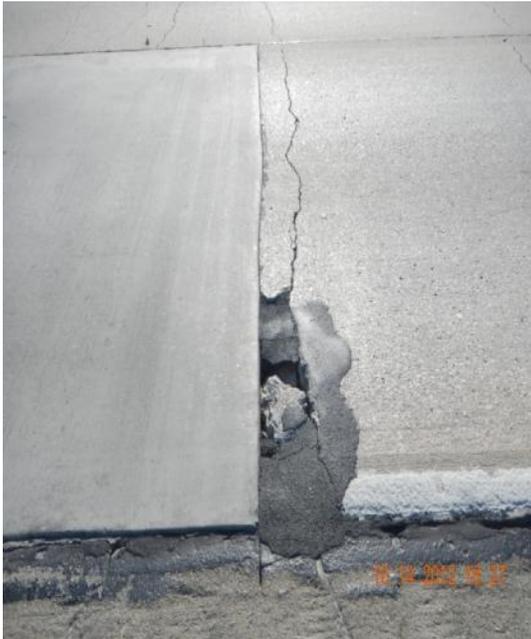
The determination of repair boundaries for FDR is quite straightforward. The repair area should include all the distressed areas. When determining the locations of transverse repair boundaries, they should not be located close to existing transverse cracks. At least 2-ft distance is recommended between transverse repair joints and the nearest transverse cracks in the existing CRCP. Figure 9 shows the distress caused by a transverse repair joint too close to a transverse crack in the existing CRCP.

Figure 9 – Repair joint too close to existing transverse crack

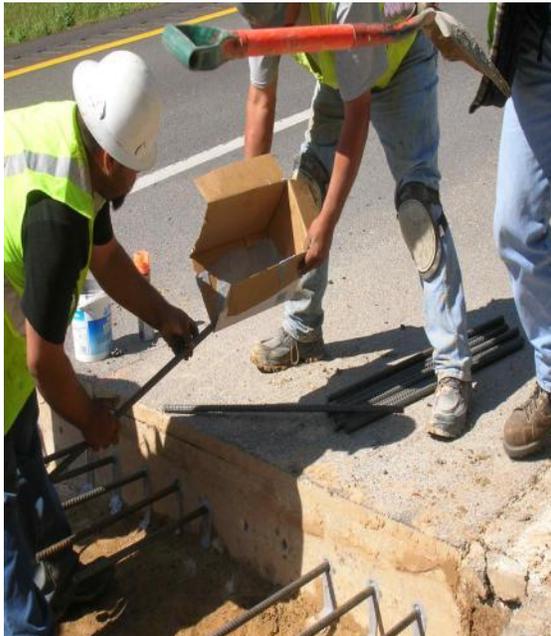
into the holes. DMS 6100 Type III, Class C is either a cartridge dispensed material or a bulk material for machine application only. When using bulk material, use a pneumatic dispenser or a static mixing nozzle. Never coat tie bars and insert them into the holes. The practice shown in Figure 11 should never be allowed. When epoxy is injected as shown in Figure 11, air inside a hole is compressed as a tie bar is inserted, which will push epoxy towards outside of a hole, creating voids between tie bar and concrete surface in a hole. The void space thus created will reduce bond strength substantially, resulting in a poor FDR performance. Figure 12 shows the condition of “simulated” inside holes when epoxy was injected in different ways. Epoxy was injected in accordance with Item 361 for the two tubes in the left. The space between tie bars and tube walls was completely filled with epoxy. In this case, epoxy was injected to the back end of the tubes, and tie bars were inserted. As tie bars were inserted, epoxy was pushing air, filling the space between tie bars and tube wall. On the other hand, in three tubes on the right, epoxy was injected the same way as shown in Figure 11. In this case, air inside the tubes was compressed as tie bars were inserted and pushed epoxy out of the tube. The voids shown in the three tubes in the right appear to be the primary cause for a poor performance of FDR.

Figure 11 – Incorrect way of injecting epoxy into the holes

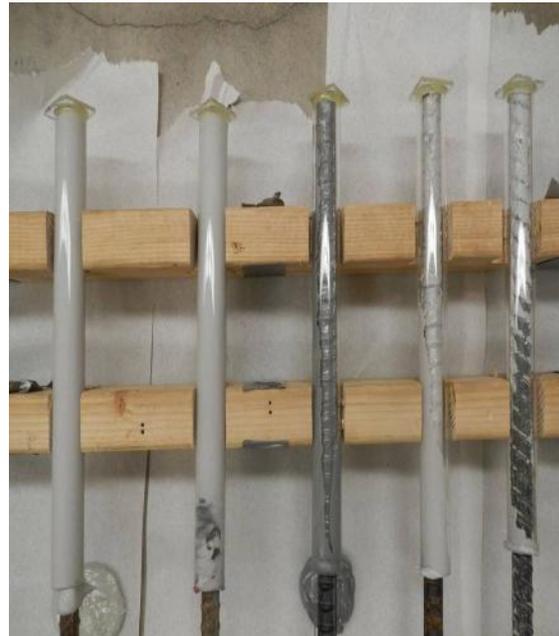
Figure 12 – Condition of epoxy inside holes

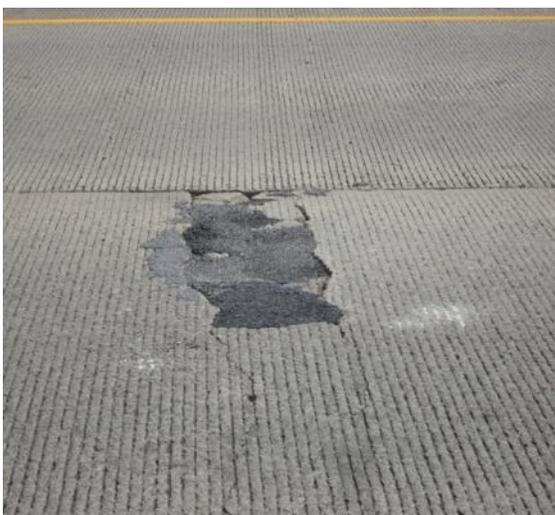
Figure 1 – Partial depth distress near longitudinal construction joint

In Figure 1, the distress is confined within two closely spaced transverse cracks. Note that there is no faulting at the longitudinal construction joint. The concrete within the distress fractured into smaller pieces and asphalt patching material was applied. In Figure 2, two longitudinal cracks occurred closely next to each other. Note that the two longitudinal cracks occurred within three closely spaced transverse cracks. No faulting is observed at the longitudinal construction joint.

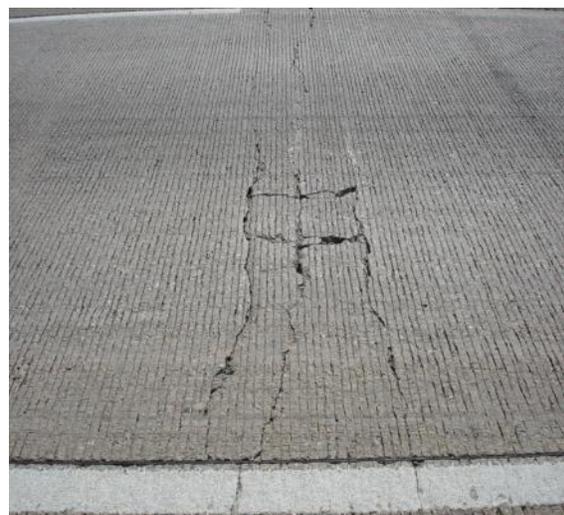
Figure 2 – Partial depth distress under wheel path

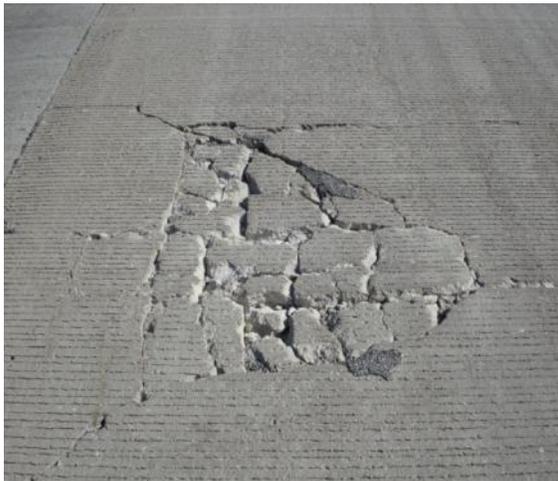
Figure 3 – Partial depth distress under wheel path with fractured concrete

In Figure 3, it is shown that the distress occurred under the wheel path and the surface of the concrete has been fractured into smaller pieces. Note that there is no faulting at the longitudinal construction joint. Figure 4 shows similar traits, with fractured pieces and no faulting at the longitudinal warping joint.

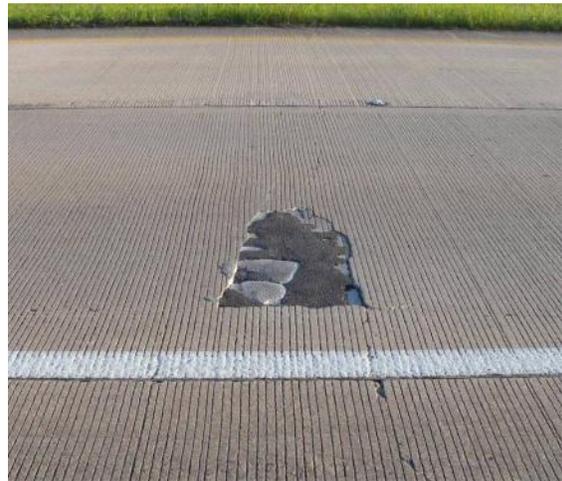
Figure 4 – Partial depth distress under wheel path

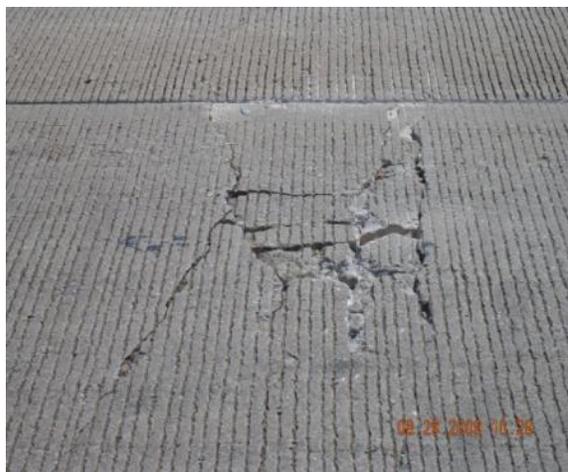
Figure 5 – Partial depth distress under wheel path
