TEXAS TECH UNIVERSITY

Testing of Alternative Supporting Materials for Portable Roll-Up Signs Used for Maintenance Work Zones

Research Project #: 0-6639
Research Report #: 0-6639-1
www.techmrt.ttu.edu/reports.php

May 2014

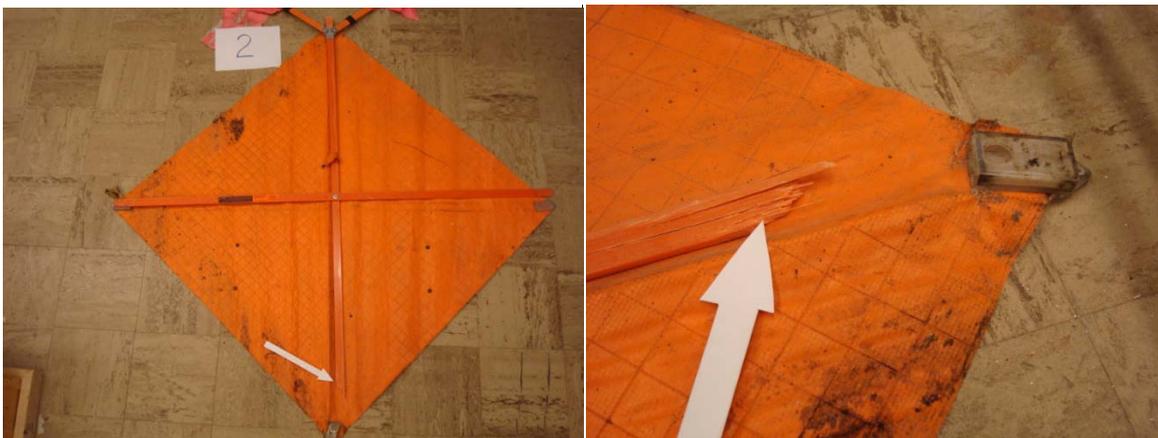
Fiberglass frame members used for portable roll-up signs flex in windy conditions and have a tendency to break, even in breezes caused by passing vehicles, as shown in Figure 1. When fiberglass frame members break, the sign is rendered useless. The Amarillo District traffic section has experimented aluminum frames of the same cross-sectional dimensions as the fiberglass frame members with little success due to the aluminum frames bending in high winds. This research project was initiated with the primary goal to find alternative materials and designs could provide more durable and reliable service in this application.

Figure 1.1 A Failed Portable Roll-Up Sign Provided by Amarillo District

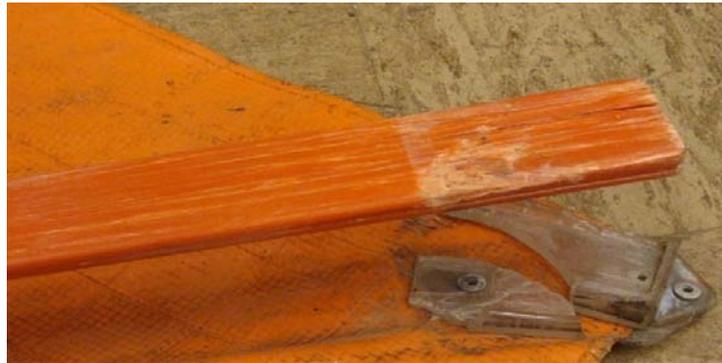
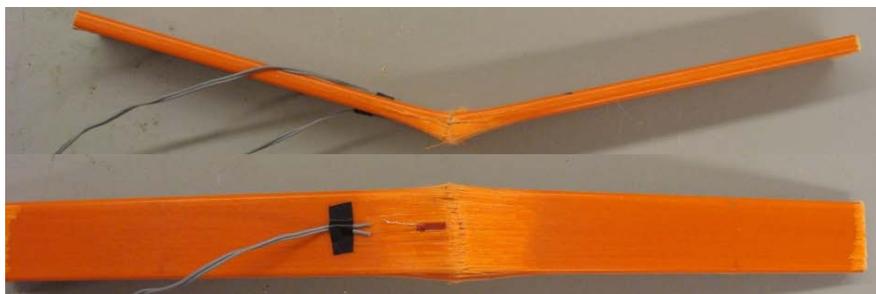
When this project was initiated, it was presumed that the failure of the roll-up signs could be due to the bending of the vertical batten. However, the torsional tests and the combined torsion-bending tests clearly revealed that the failure was due to cracking at the fiber-matrix interface due to torsion. Figure 3.18 compares the failure modes of three samples: (a) vertical batten of a roll-up sign during service, provided by TxDOT, (b) laboratory specimen failed due to bending, and (c) laboratory sample failed due to torsion. Therefore, it would be necessary to increase the torsional capacity of vertical battens to avoid the failure of roll-up signs.

(a) Vertical batten of a roll-up sign during service, provided by TxDOT

(b) Laboratory specimen failed due to bending

(c) Laboratory specimen failed due to torsion

Figure 3.18 Comparison of Failure Modes of Specimens Subjected to Various Loading Conditions.

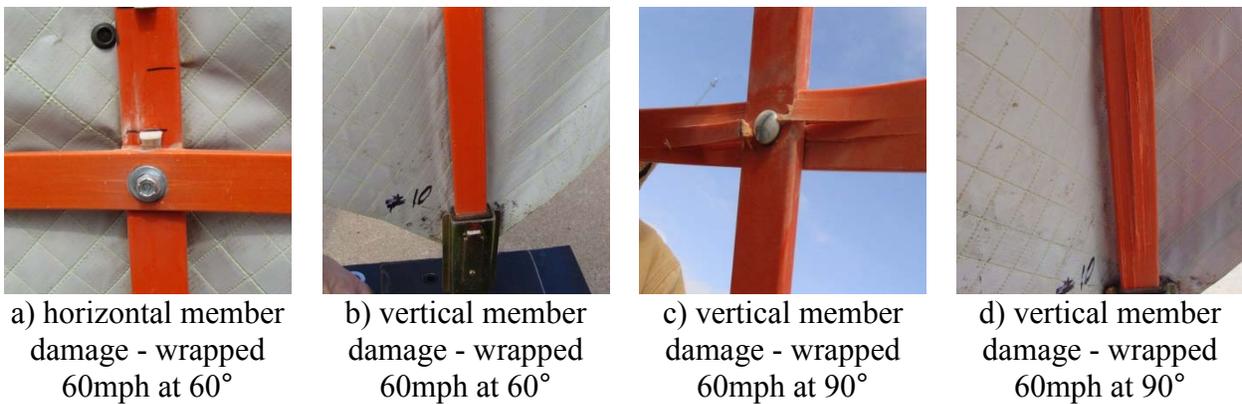
Figure 3.30 Sign Member Failure

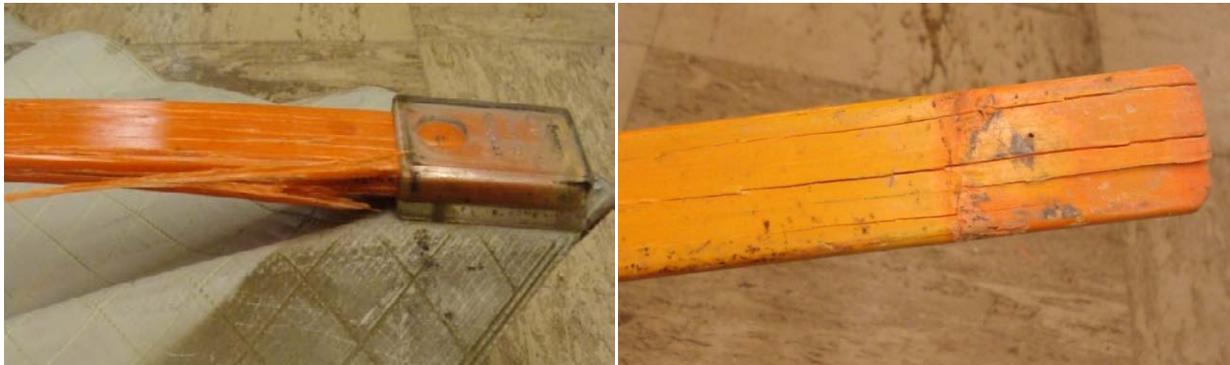
Cracking in the fiber direction of vertical battens were one of the primary reasons why roll-up signs failed. Figure 4.1 presents two failed sign samples provided by TxDOT Amarillo District, showing the typical cracking patterns in the fiber direction. This type of cracking also appeared to be the major cause for the failure of the signs subjected to the natural wind and the vehicle-induced wind, as shown in Figures 4.2 and 4.3, respectively. In order to find the causes to develop this type of cracking, different laboratory tests were conducted including bending and torsion tests. Based on the laboratory tests, it was concluded that the cracks in the fiber direction of vertical frames was caused by the torsional moment as shown in Figure 4.4.

Figure 4.1 Failed Samples Provided by TxDOT Amarillo District

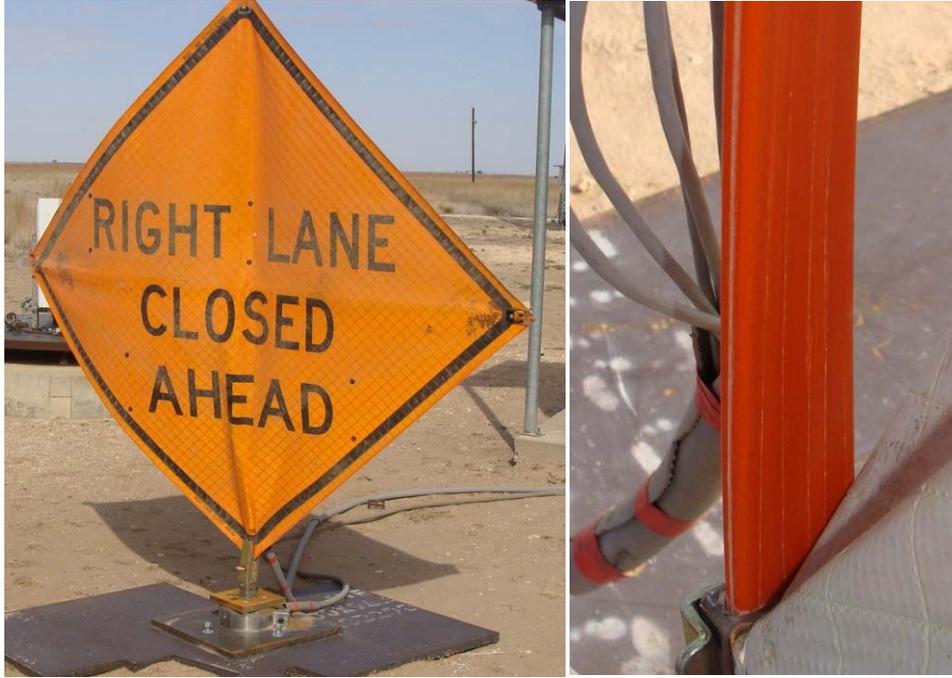
Figure 4.2 Failure of the Vertical Frame of the Sign Subjected to the Natural Wind

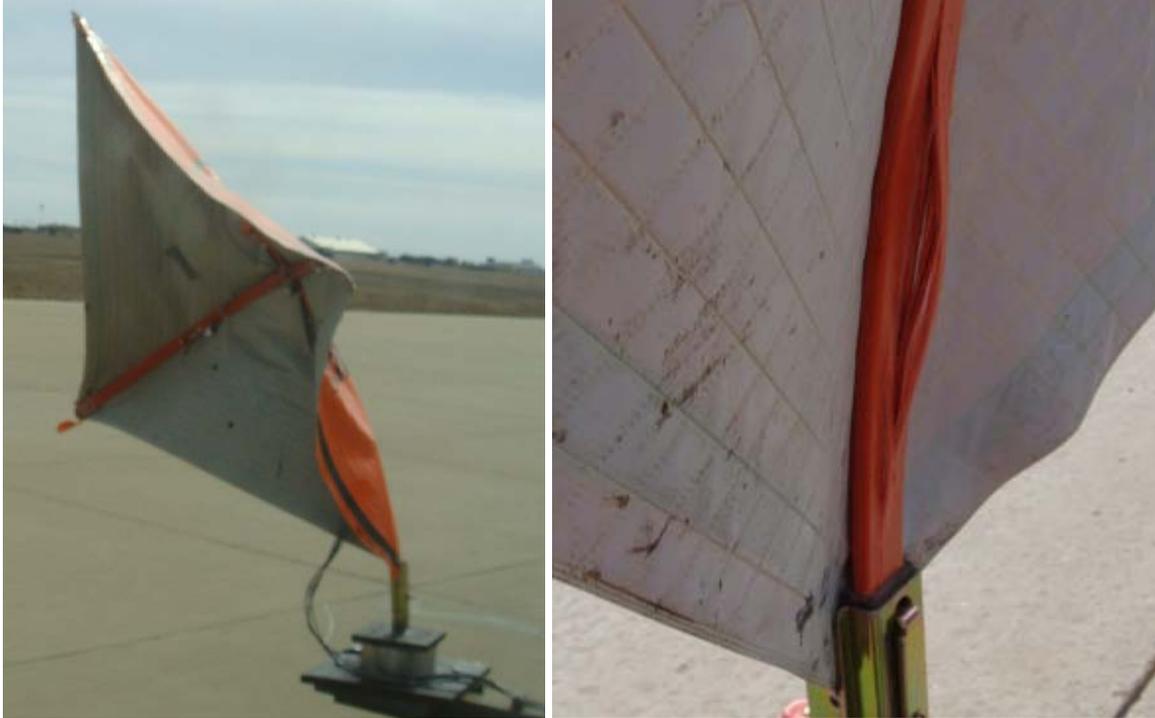
Figure 4.3 Failure of the Vertical Frame of the Sign Subjected to the Vehicle Induced Wind

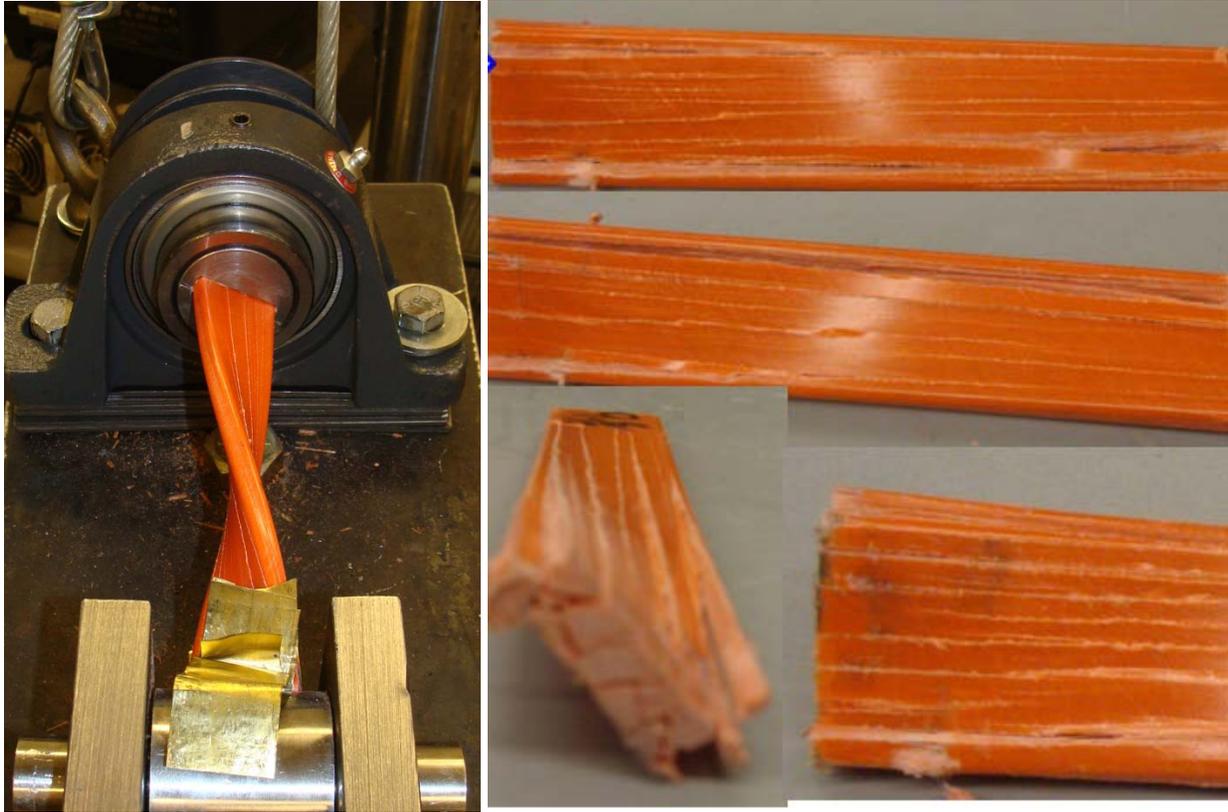
Figure 4.4 Failure of the Vertical Frame of the Sign Subjected to the Torsion Test

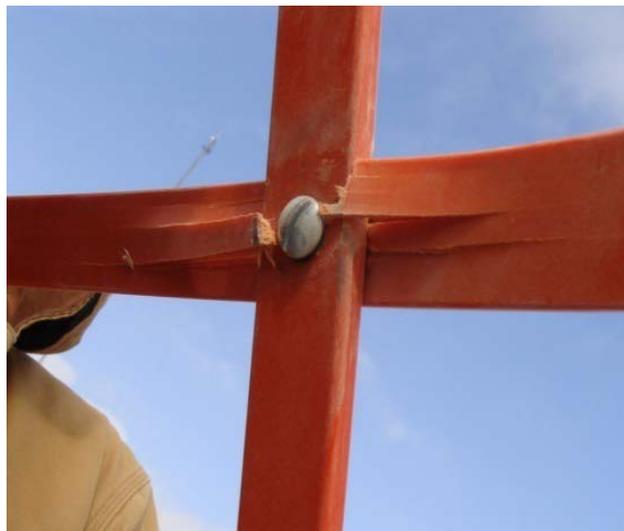
The horizontal member of a sign was ruptured due to bending moment as shown in Figure 4.5 during the vehicle-induced wind tests.

Figure 4.5 Rupture of the Horizontal Frame of a Sign Subjected to the Vehicle-Induced Wind

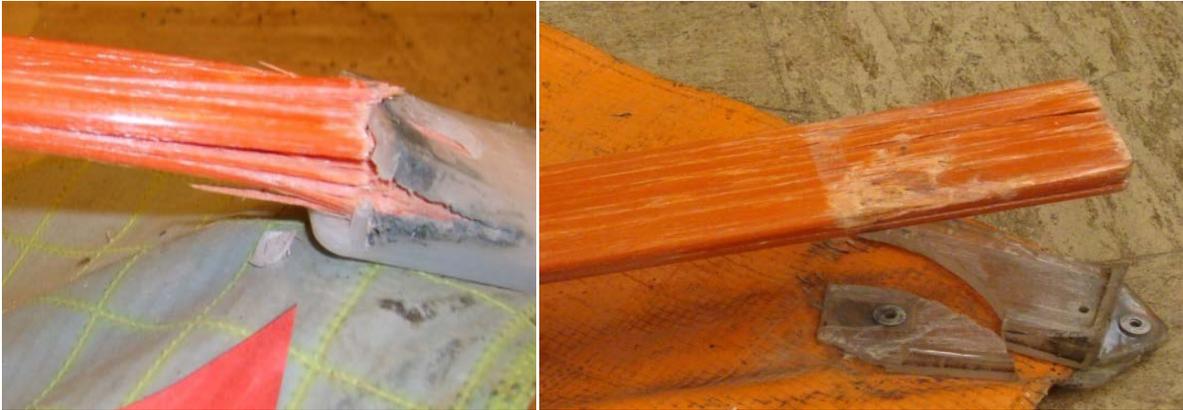
Some signs failed to function as intended due to the broken plastic corner pockets as shown in Figure 4.6.

(a) Failed Signs Provided by Amarillo District

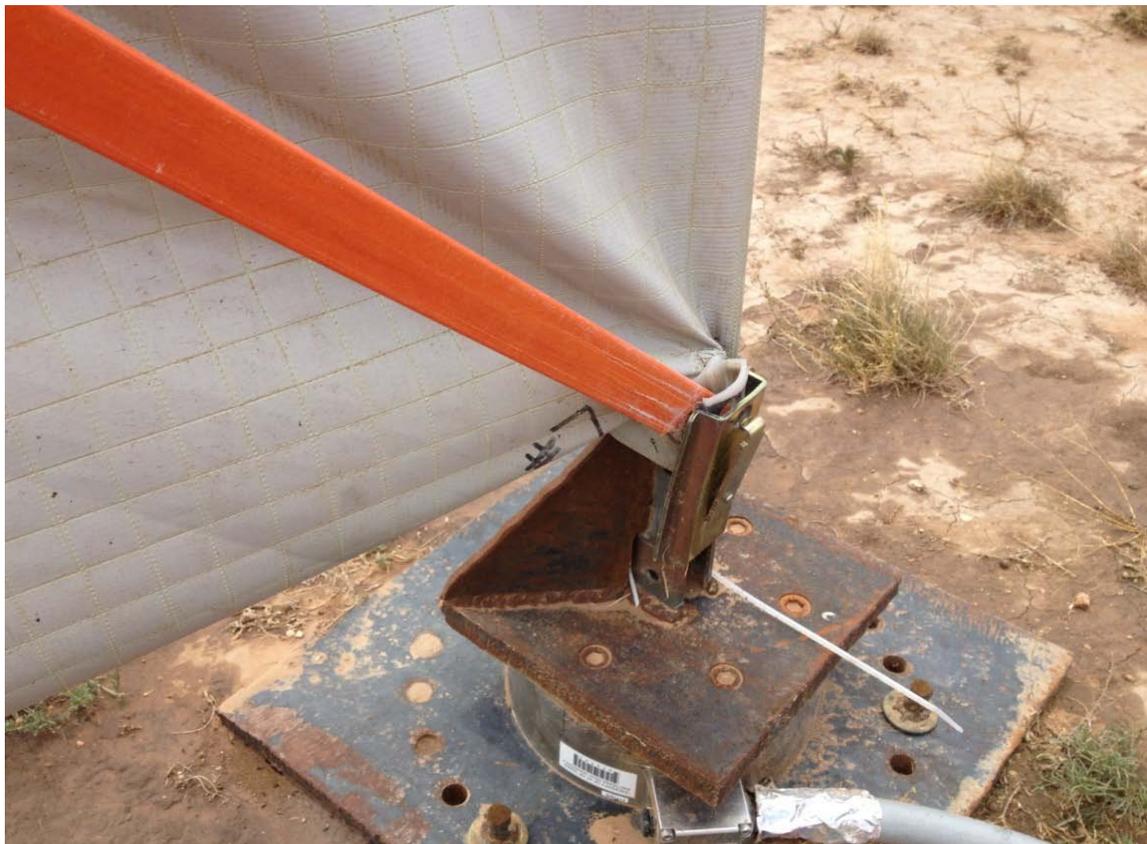
(b) Sign Subjected to the Natural Wind

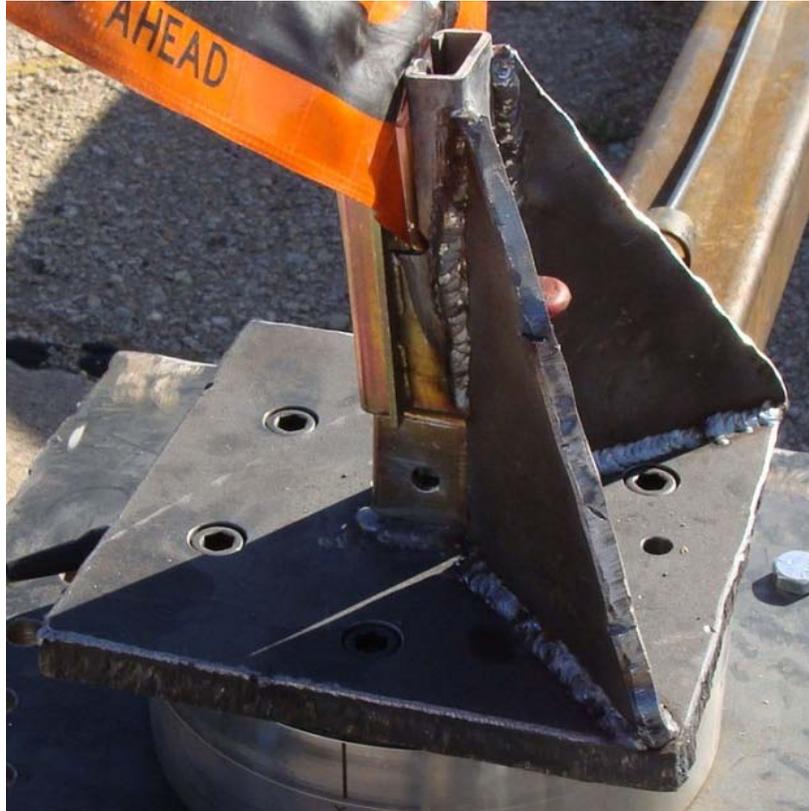
The steel bracket of a sign that connect the vertical frame to the base was bent over due to bending moment during the vehicle-induced wind tests. As a result, the bracket had to be reinforced with two steel bracings as shown in Figure 4.7.

Figure 4.7 Failure of the Steel Bracket

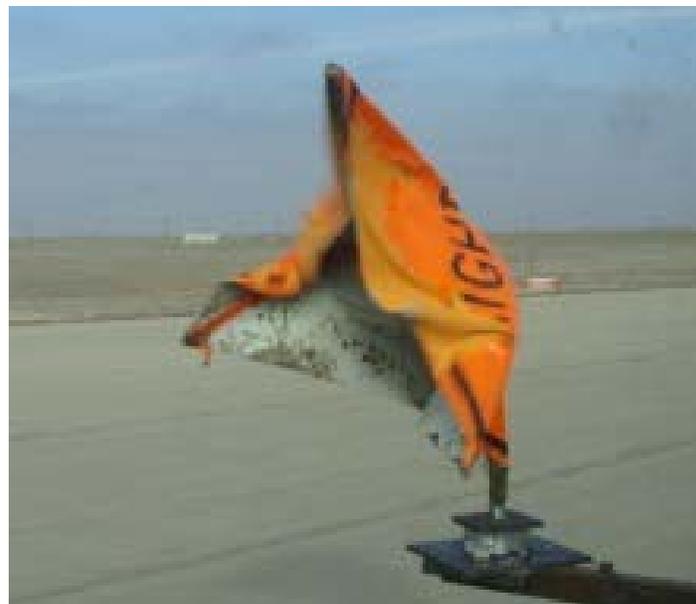
Another serviceability failure observed during the vehicle-induced wind tests was delamination of sign face due to excessive flapping when the wind direction was very oblique (i.e., more than 60 degree), as shown in Figure 4.8.

Figure 4.8 Fiberglass-Sign Face Delamination

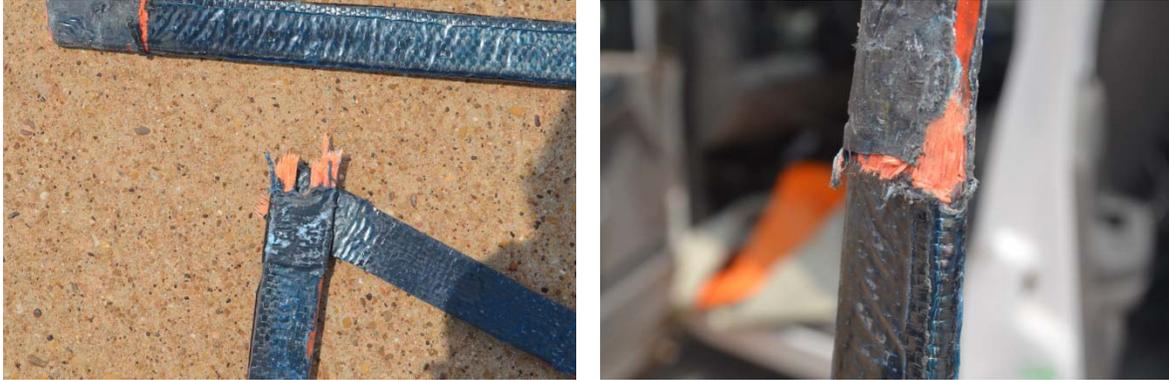
Figure 6.4 Modified Fiberglass Sign Ultimate Failures.

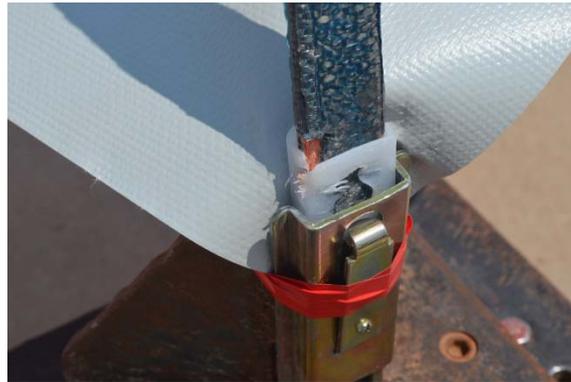
Figure 6.5 Failures of Plastic Pocket Holding the Modified Sign Frame.

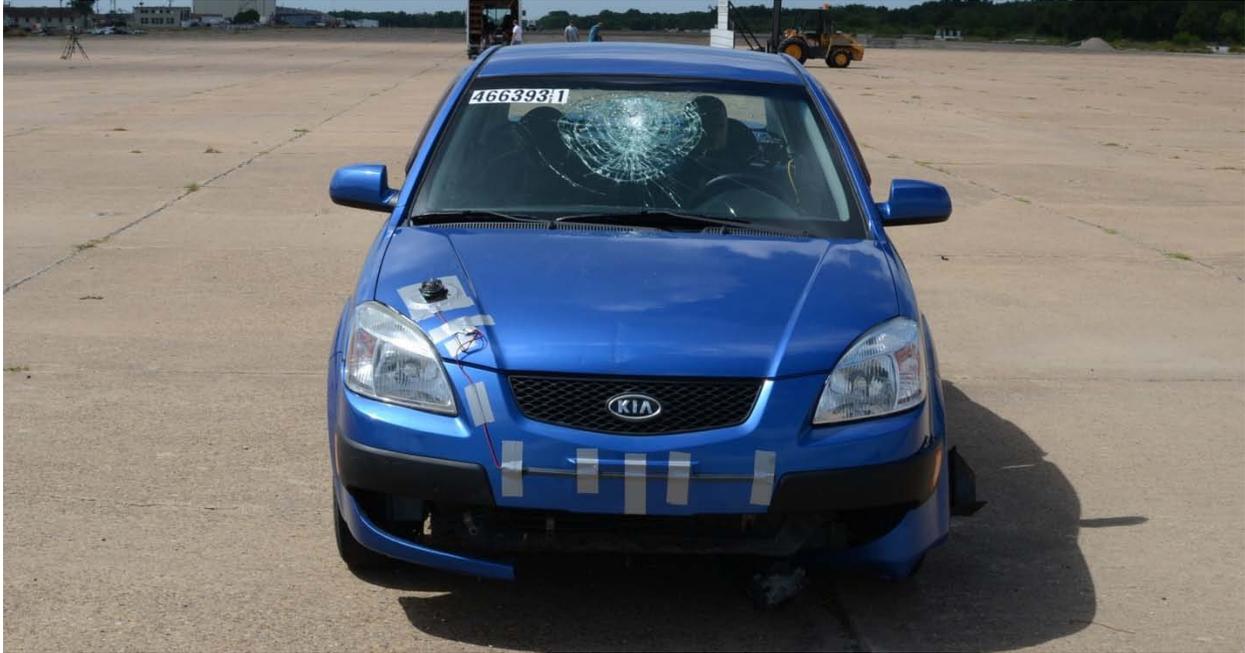
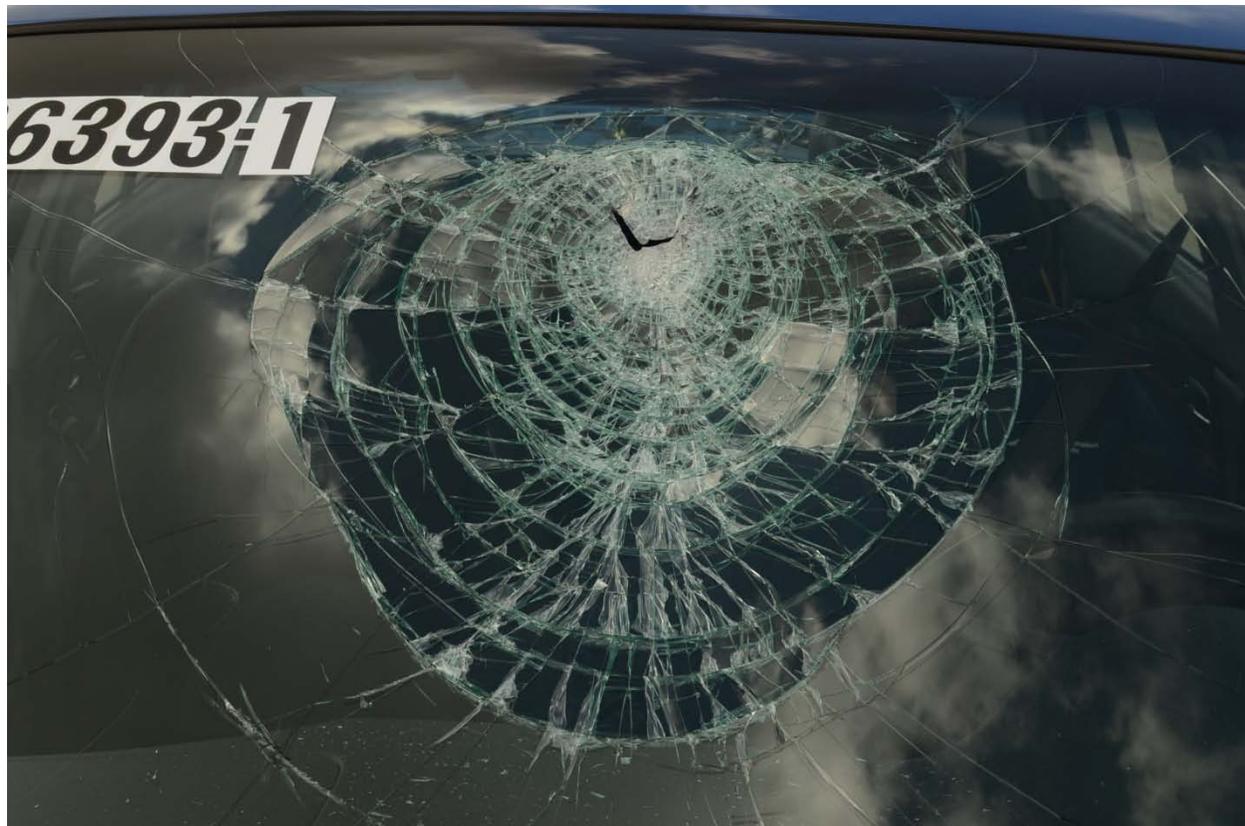
Sandbags did not change the behavior of Test Signs and thus the damage level of windshield. The spring loaded brackets could not hold the vertical members securely at the impact. As a result, the vertical members were released from the plastic pockets at the bottom, and the top of vertical member could make an impact on the windshield, creating a penetration hole. On the other hand, the through bolt bracket could hold the vertical members securely at the impact and thus, the vertical member did not make a direct impact on the windshield. Only a couple of broken pieces of the top plastic pocket flew into the windshield and hit it, leaving significant damages, but without penetration or intrusion of the broken parts. Therefore, it is recommended to use softer material than the plastic material currently used in the portable roll-up signs approved by TxDOT. The use of softer material will reduce the damage level of windshield.

Figure 6.18 Windshield Damage of Test 1 Vehicle

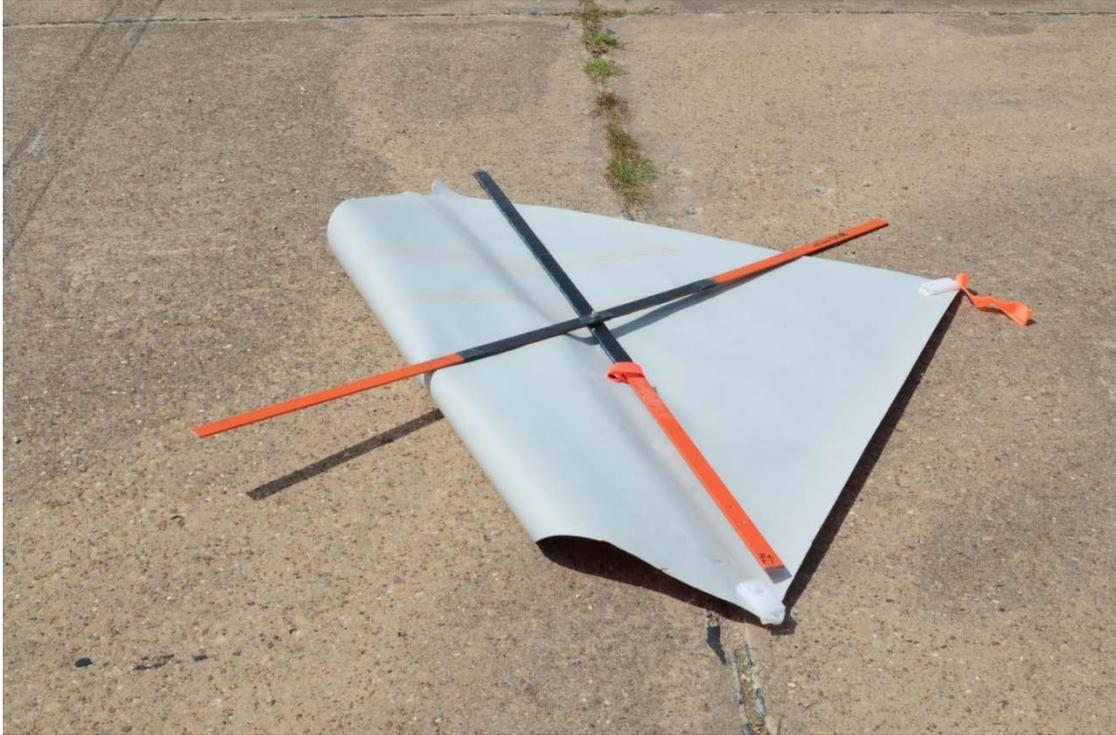
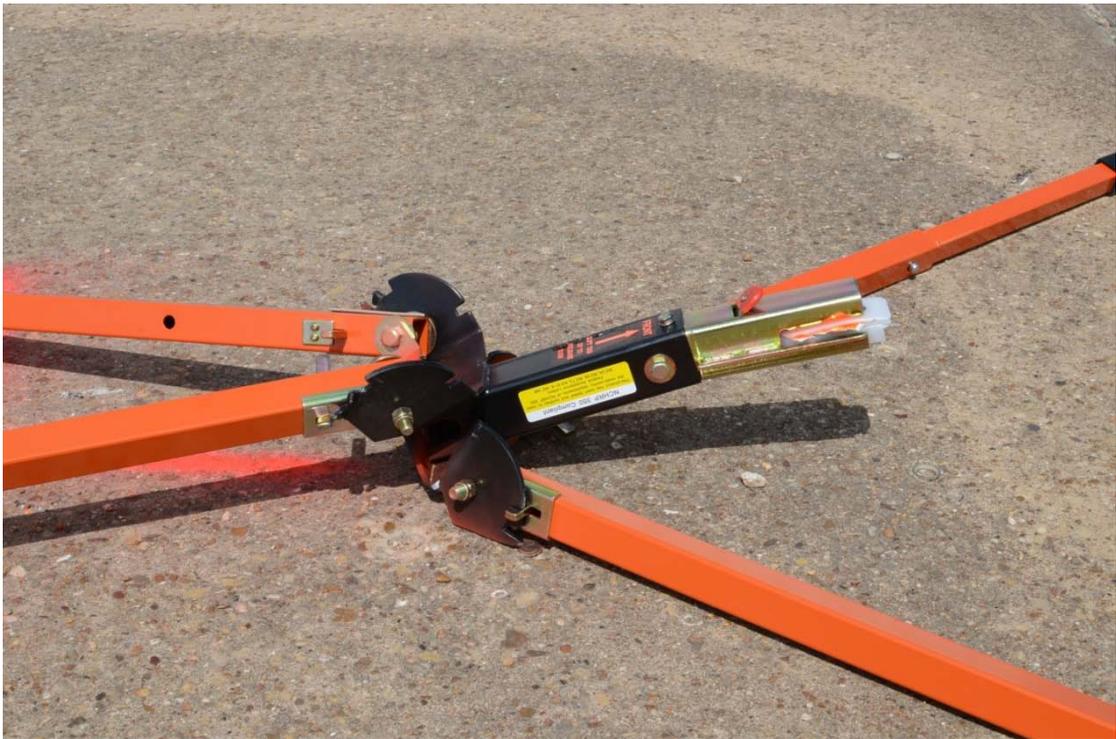
Figure 6.19 Sign Frames and Sign Surface after Impact and Sign Base Damage of Test 1

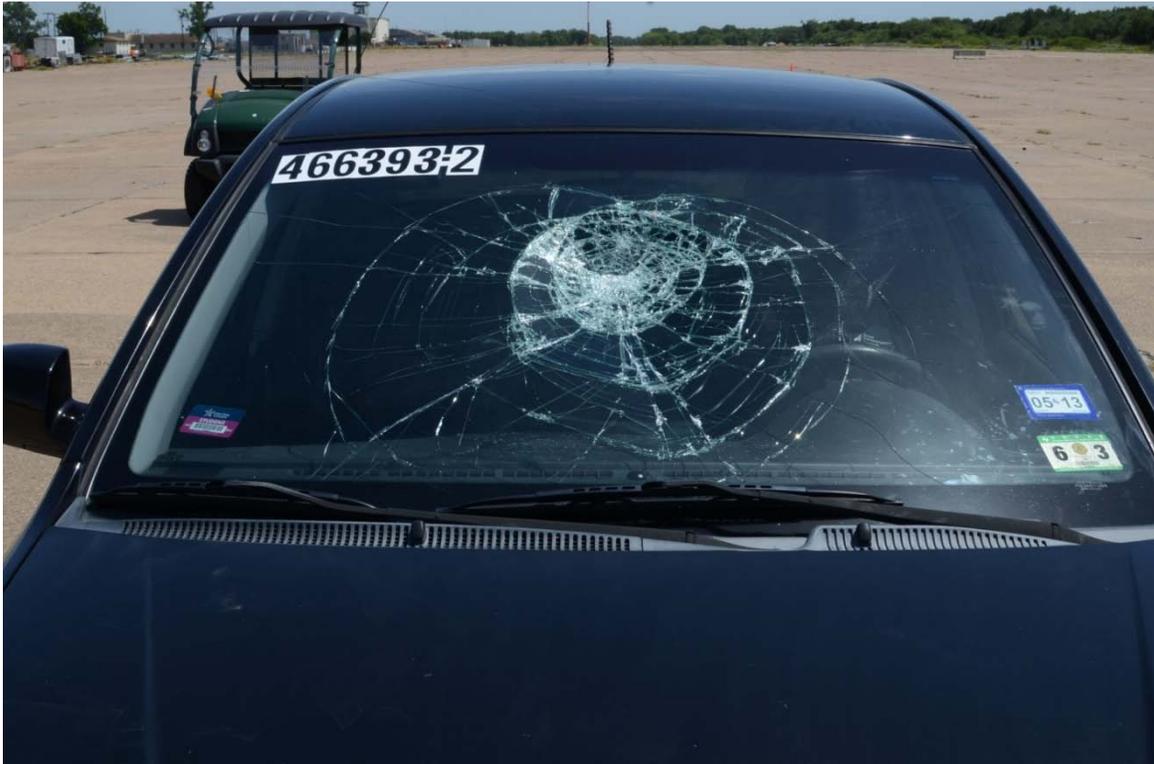
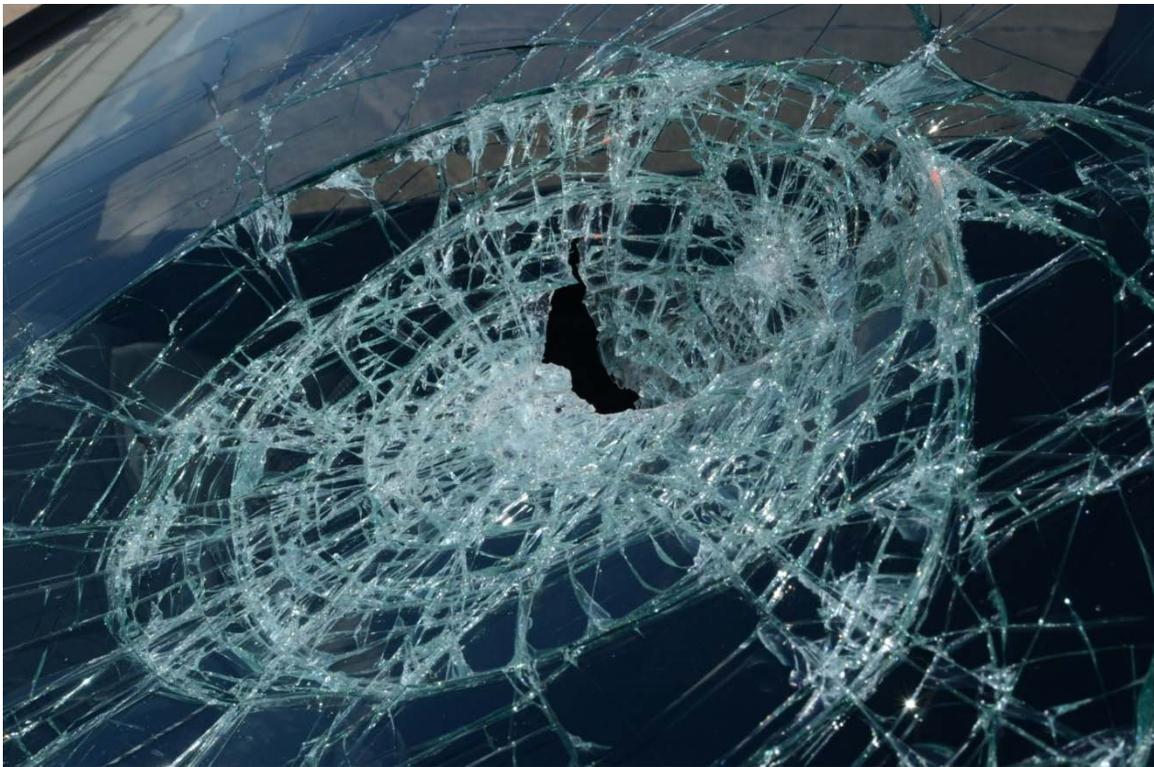
Figure 6.21 Windshield Damage of Test 2 Vehicle

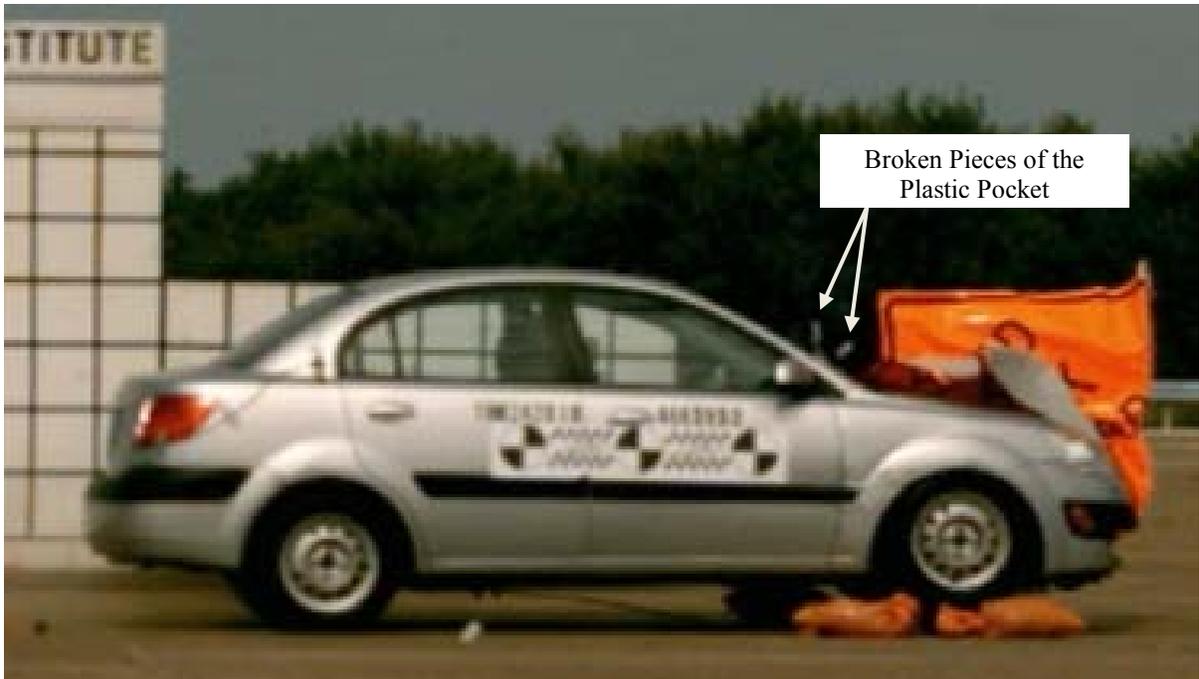
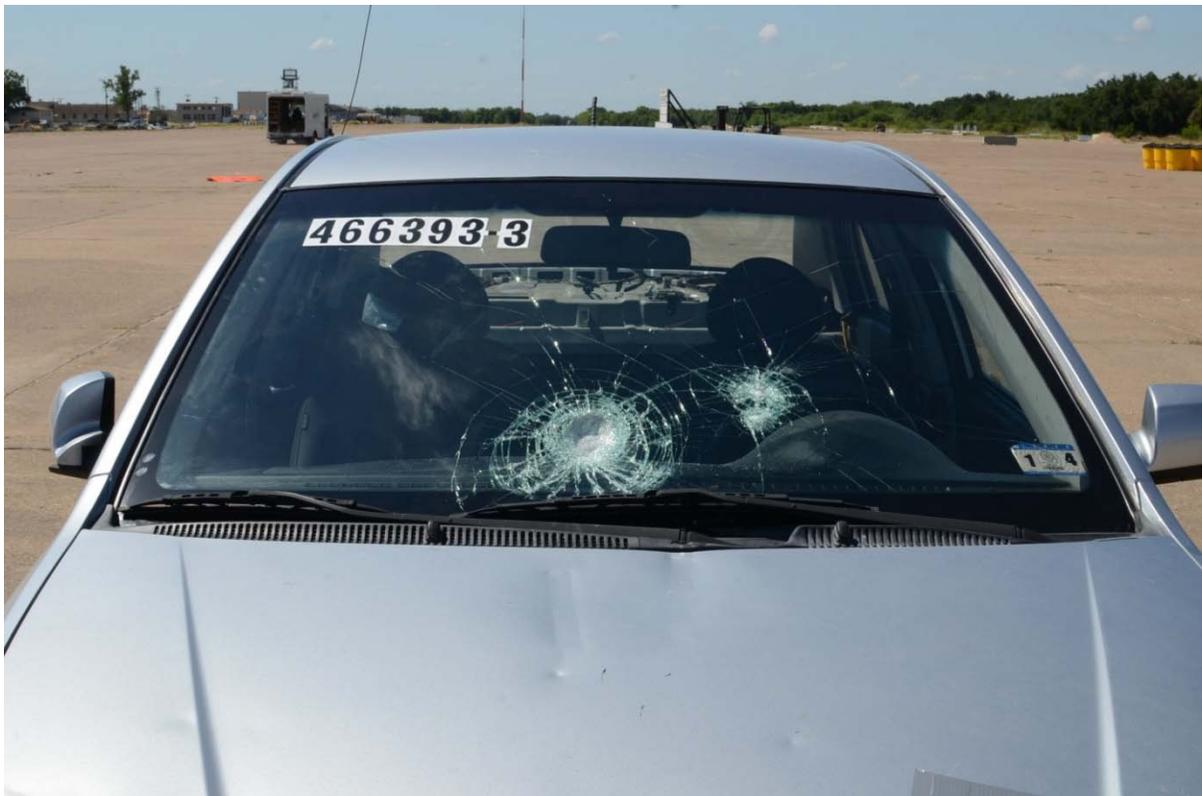
Figure 6.23 Windshield Damage of Test 3 Vehicle

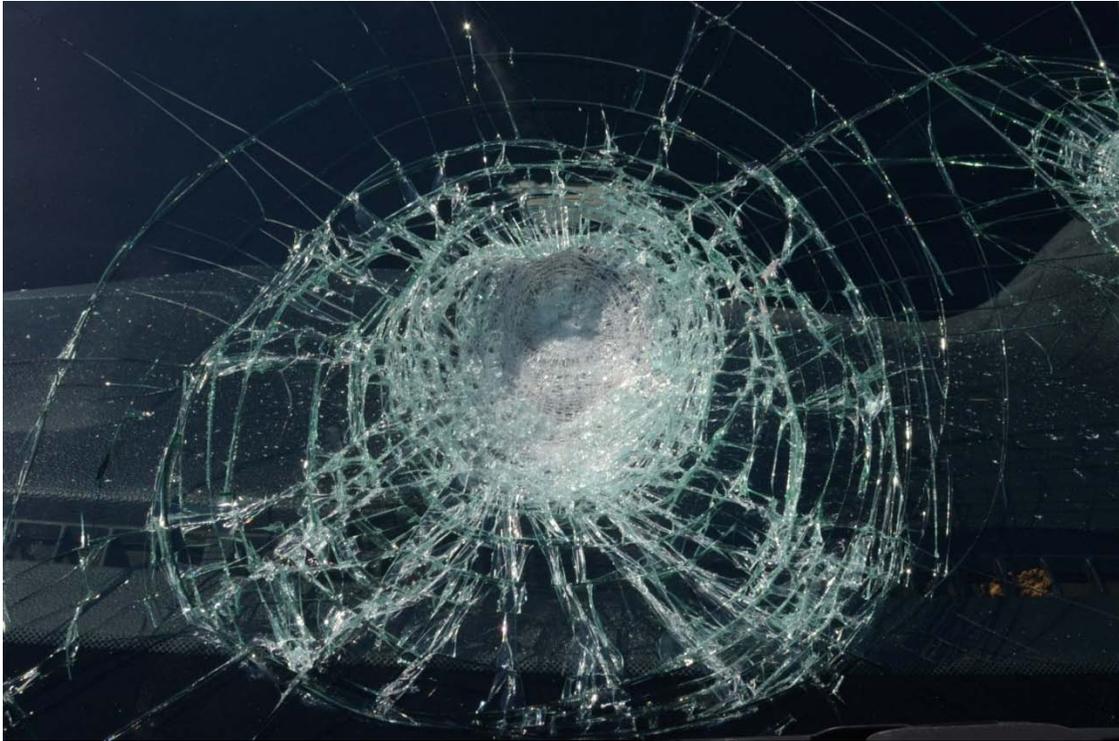
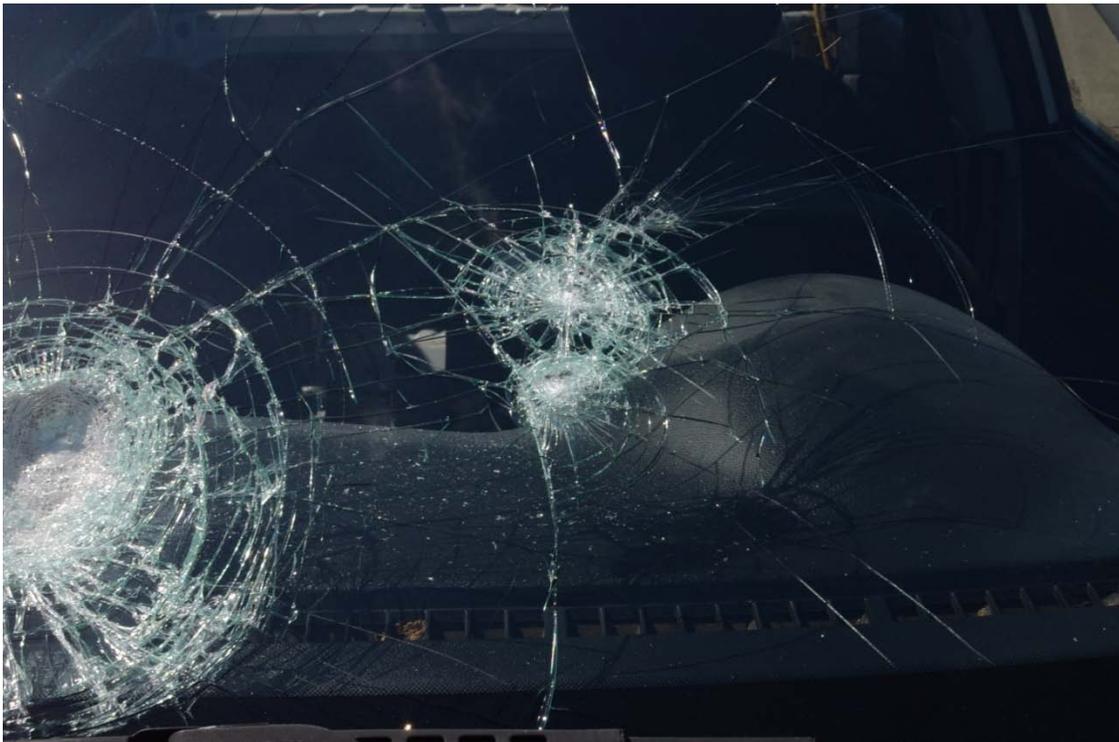
Figure 6.24 Close-Up of Windshield Damage of Test 3 Vehicle

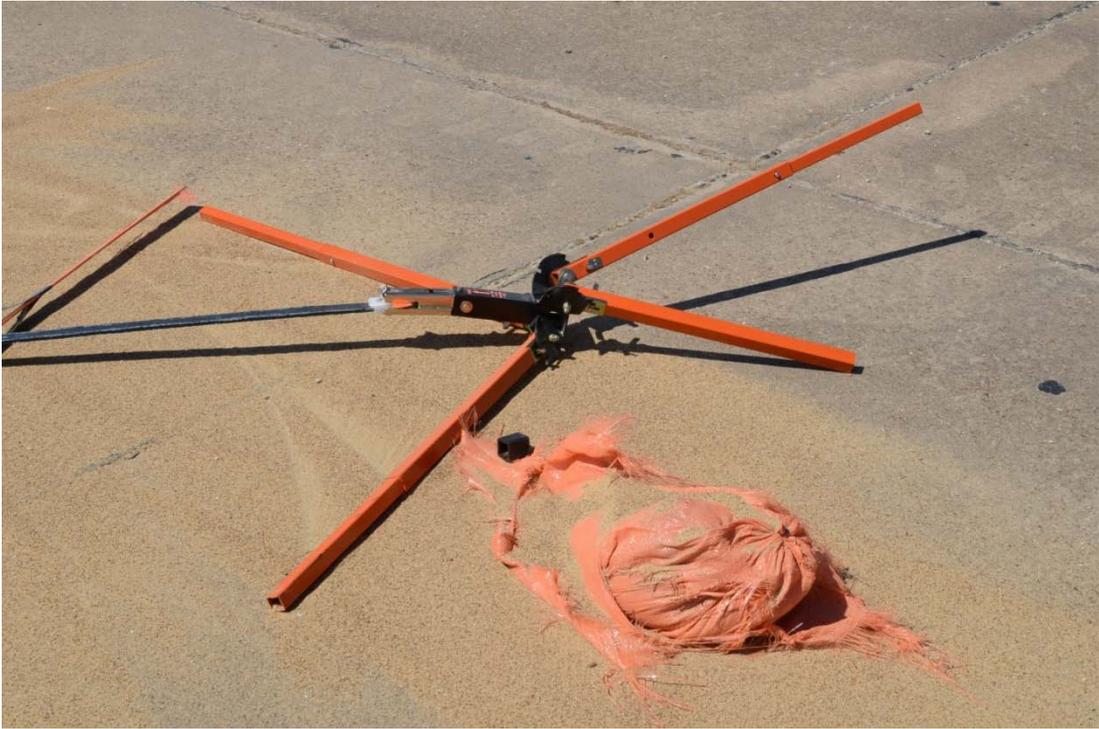
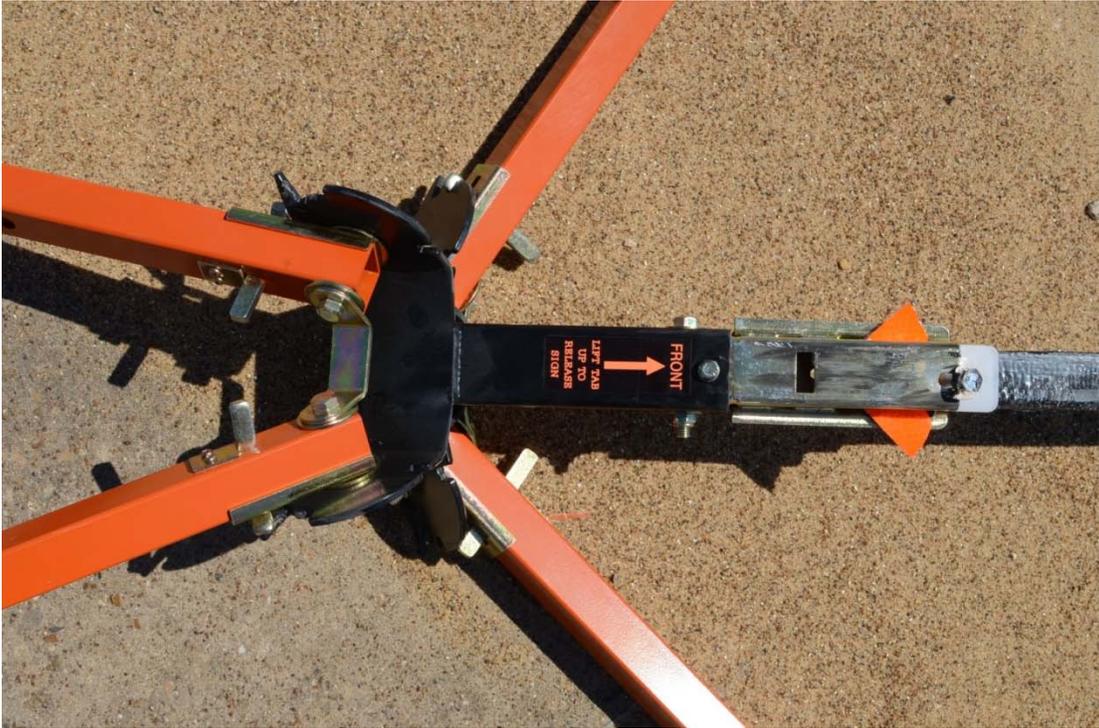
Figure 6.25 Sign Frames after Impact and Sign Base Damage of Test 3
