Minimize Premature Distresses in Continuously Reinforced Concrete Pavement

Sureel Saraf, Pangil Choi, Sungwoo Ryu,
Tewodros Ghebrab, Moon C. Won

Texas Department of Transportation

Research Project #: 0-6687
Research Report #: 0-6687-1
www.techmrt.ttu.edu/reports.php

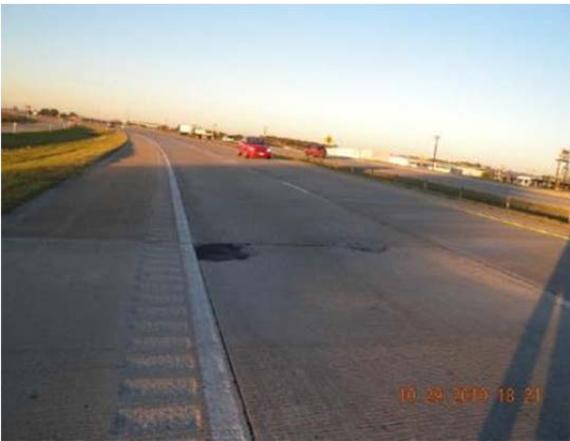
As shown in Table 2.1, about 40 percent of the total punchouts surveyed were at the transverse construction joint (TCJ) or repair joint. Figures 2.2 and 2.3 illustrate the distresses observed at TCJs. These types of distresses were not only observed at TCJs in new construction projects, but also where new CRCP was connected to old CRCP as shown in Figure 2.4 or at repair TCJs as shown in Figure 2.5.

Figure 2. 2 Distress at TCJ

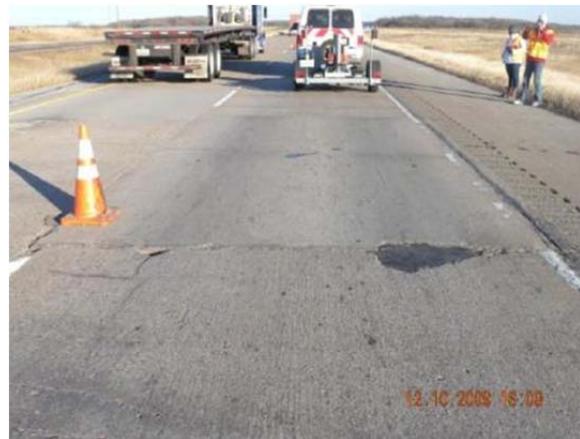
Figure 2. 5 Distress at Repair TCJ

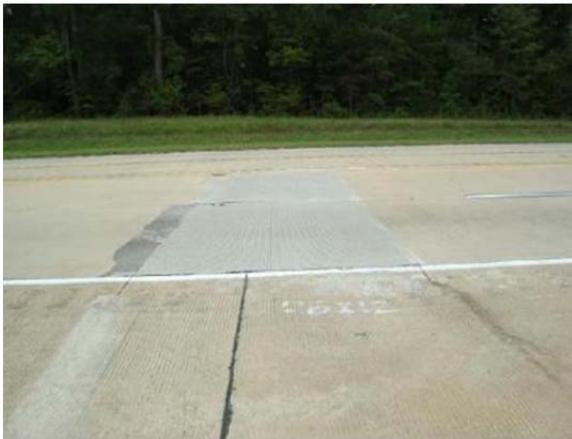
Figures 2.8 and 2.9 represent full depth repair sections in the south bound direction on US 59 in the Atlanta district. This section of US 59 was originally constructed in 2001 in Cass County. The pavement thickness is 12 in. with 4-in. asphalt concrete pavement as base and 8-in. lime treated subgrade were used. additional steel with on hundred percent was placed in the repairs carried out in this section. As shown in Figures 2.8 and 2.9, distresses were observed near the repair joints.

Figure 2. 8 Distresses at Repair Joint - US 59 in the Atlanta District

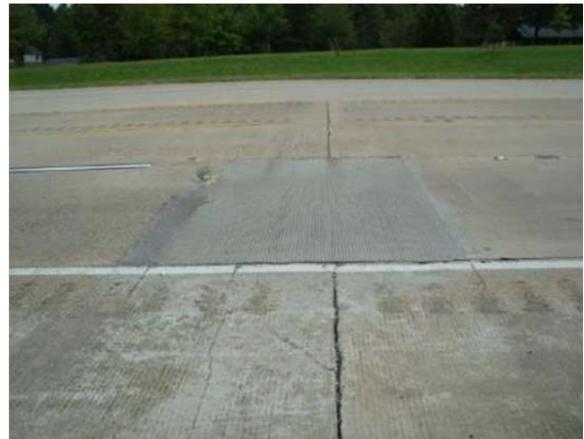
Figure 2. 9 Distresses at Repair Joint - US 59 in the Atlanta District

However, 100% additional steel was replaced by use of 50% additional steel in the repairs carried out in the north bound direction for the same highway section. No distresses were observed in the section with 50% additional steel. This observation indicates that too much steel at TCJ may affect the quality of concrete consolidation at the TCJ and could be a probable cause for occurrence of distresses at TCJ.

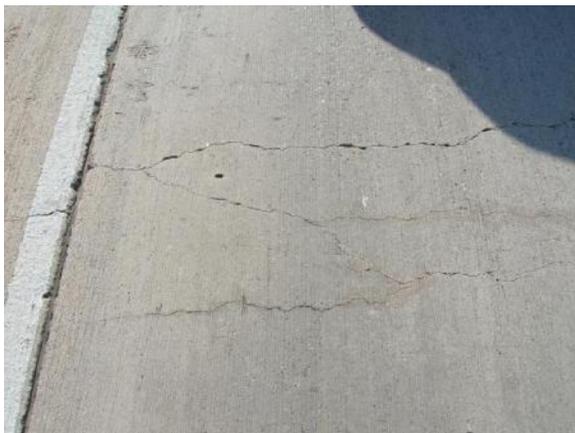
Figure 2.16 shows cracks on a section on US 287 in the Wichita Falls District. The shape of cracking are not of typical transverse cracks in CRCP, as Y-cracks and cracks with quite narrow crack spacing are noted. The core shown in Figure 2.17 was taken at the Y-crack location represented in Figure 2.16. The core shows that the concrete between the two cracks forming the Y-crack is disintegrating. The ambient temperature in this location during construction was reported to be quite high.

Figure 2. 16 Y-Crack on US 287 in the Wichita Falls District

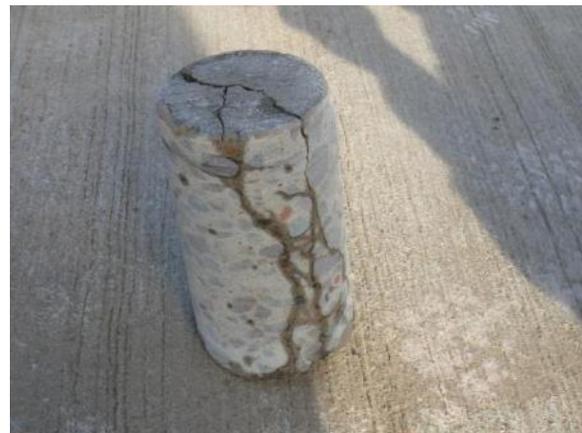
Figure 2. 17 Core Taken From Y-Crack on US 287 in the Wichita Falls District

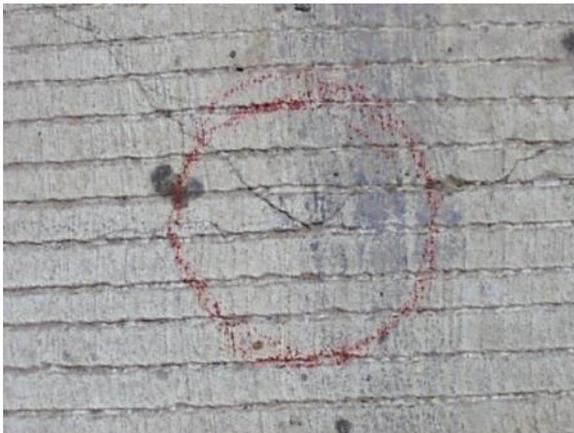
Figure 2. 18 Y-Crack on US 59 in the Atlanta District

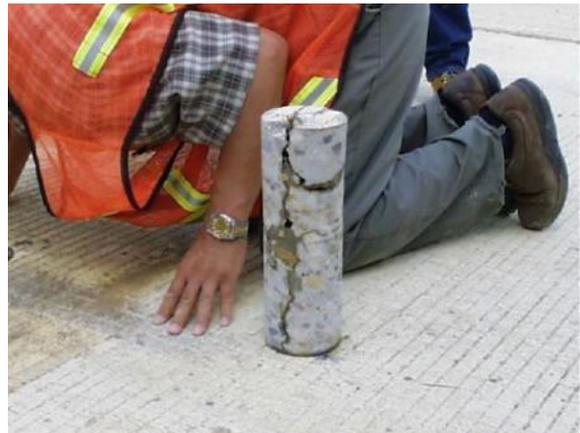
Figure 2. 19 Core Taken at Y-Crack on US 59 in the Atlanta district

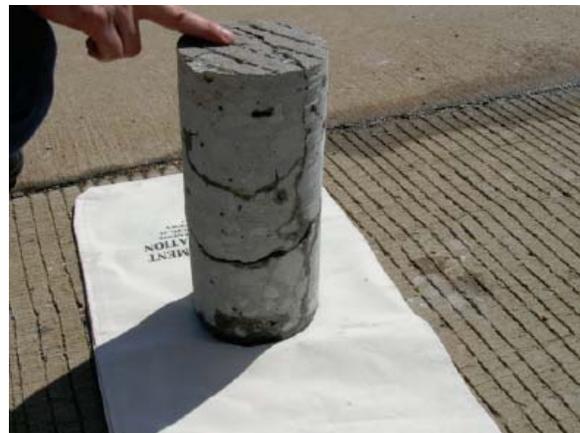
Figure 2.20 shows a Y-crack and Figure 2.21 illustrates the core taken at the Y-crack location. As shown in Figure 2.21, the core contains two horizontal cracks which may induce premature distresses in the form of partial-depth punchouts. The basic principle of CRCP design is based on the assumption of solid concrete that is bonded with longitudinal steel. Once this assumption is violated, the life of CRCP is reduced and premature distresses might develop.

Figure 2. 21 Horizontal Cracking at Y-Crack Location

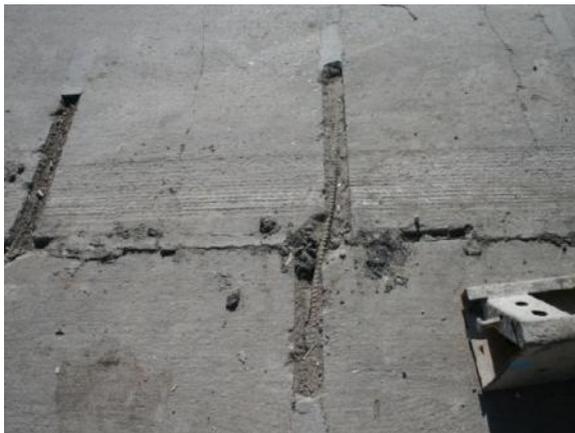
Figure 2. 22 Bent Stapling-bar at Longitudinal Joint on IH 45 in the Houston District

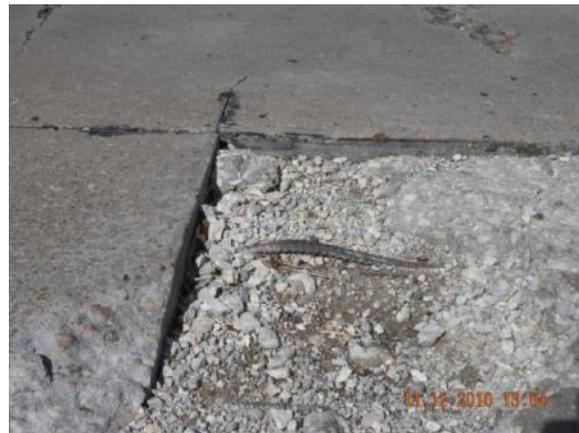
Figure 2.23 illustrates the expansion of a slab cut for full-depth repair. This section is located on the frontage road of Loop 610 in the Houston District. The expansion of the slab was noted to be 0.5 in. This shows that the tie bar inserted into the existing concrete for full-depth repair was bent by the expansion of the existing concrete, pushing the concrete in the repaired section to disintegrate.

Figure 2. 23 Bent Tie-Bar at Repair Section on Loop 610 in the Houston District

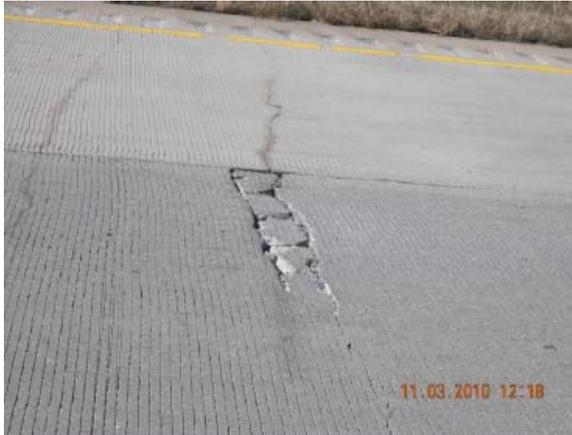
Figure 2. 37 Distresses Near LCJ

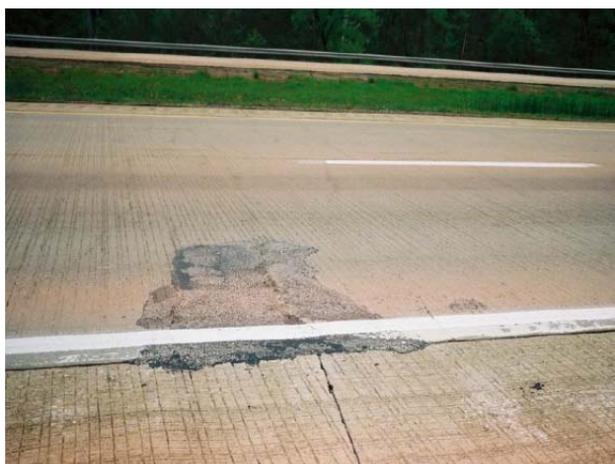
David Lippert, P.E. of Illinois DOT states that the distresses occurred about five years after construction. Interestingly, this project had a 5-year warranty. Mr. Lippert also stated that no comprehensive investigation was conducted and the exact mechanism was not identified. He also mentioned that in Illinois, they use tied CPCD as a shoulder for CRCP, and this type of distress is not common. It appears that large slab movements near the transverse warping joints in CPCD shoulder could cause distresses in CRCP, when certain conditions are met, such as larger movements of CPCD due to insufficient base friction.

Figure 2. 39 Distress at CRCP/CPCD
(Photo courtesy of M. Plei)

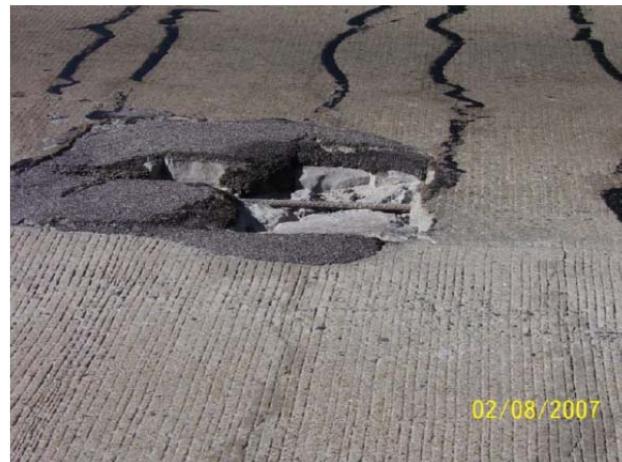
Figure 2. 46 Distress Associated With Reinforcing Steel Placed Too High
(Photo courtesy of M. Elfino)

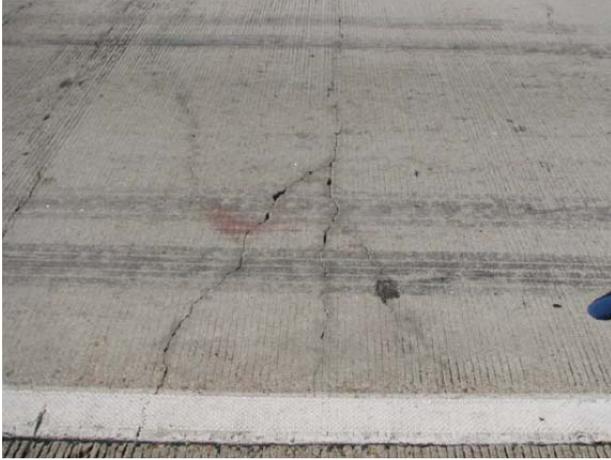
Figure 2. 47 Y-crack (Photo courtesy of M. Elfino)

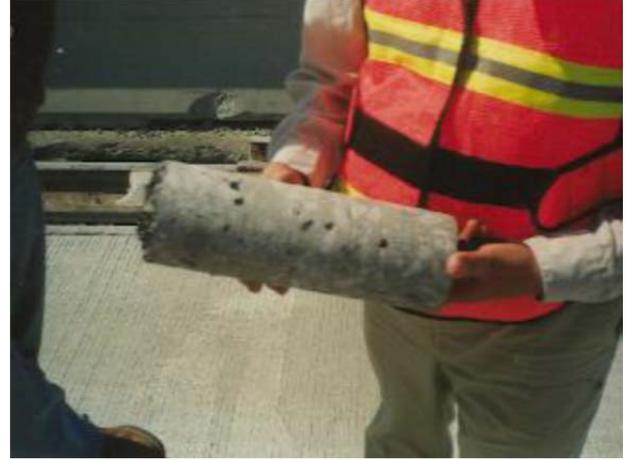
Figure 2. 48 Entrapped Air in Concrete From Y-Crack (Photo courtesy of M. Elfino)

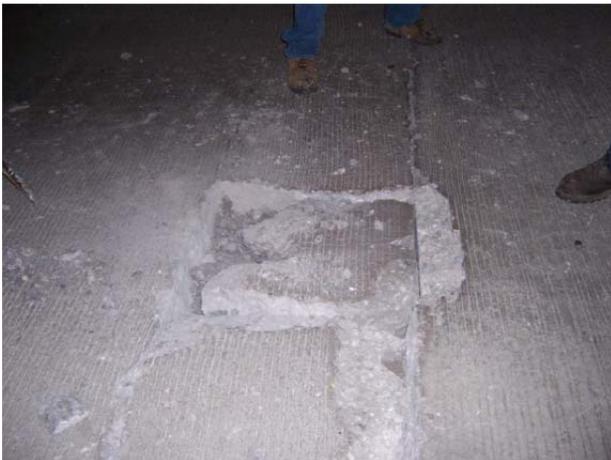
C. Distresses at transverse construction joints: Figure 2.49 shows a distress at a transverse construction joint. Mr. Elfino stated that poor consolidation of concrete near the joints, as shown in Figure 2.50, was partly responsible for the distress.

Figure 2. 49 Distress At Transverse Construction Joint (Photo courtesy of M. Elfino)

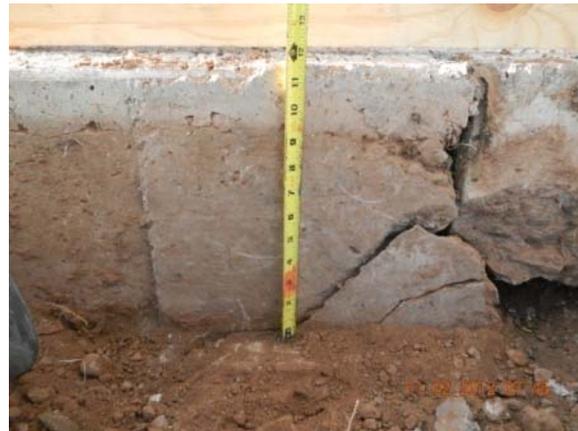
Figure 4. 14 Concrete Disintegration Near Transverse Construction Joint at Childress District Test Section

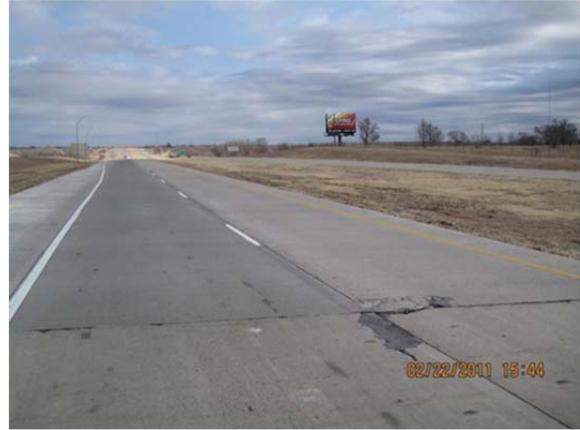
Figure 4. 16 Distresses near Longitudinal Construction Joint at Childress Test Section

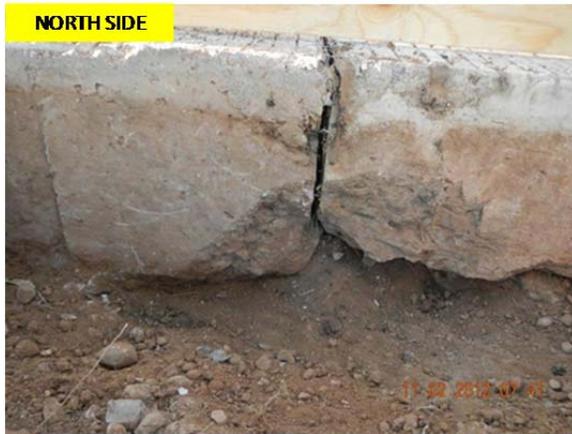
Figure 4. 21 Concrete Deterioration at Inside Shoulder of TCJ – Childress Test Section

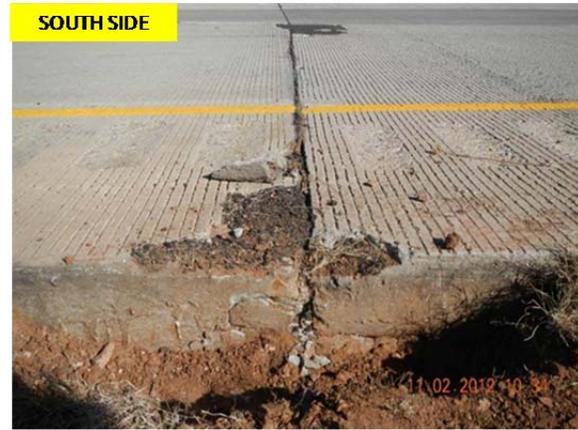
Figure 4. 22 Concrete Deterioration at Outside Shoulder of TCJ – Childress Test Section

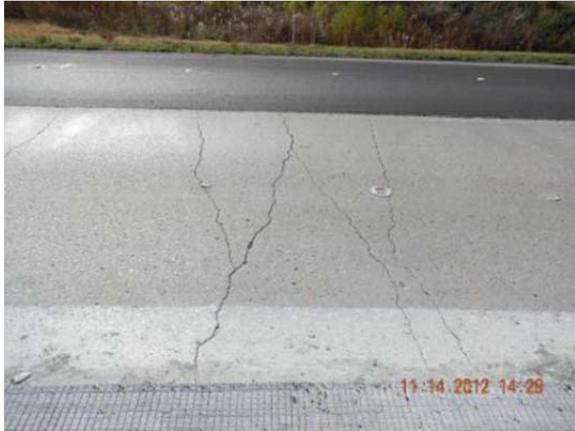
Figure 4. 48 Y-cracks on US 287 in the Wichita Falls District

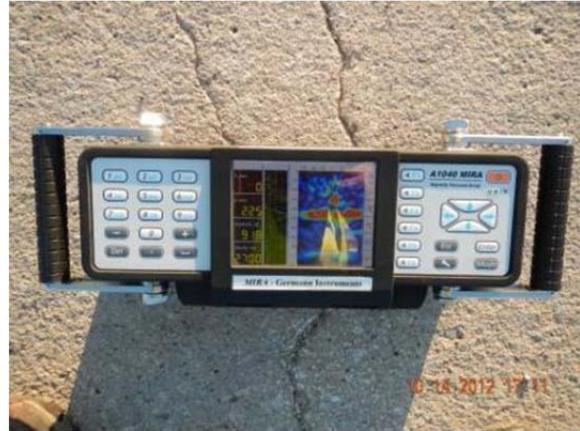
Figure 4. 49 Y-Crack on Top of Transverse Steel on US 287 in the Wichita Falls District

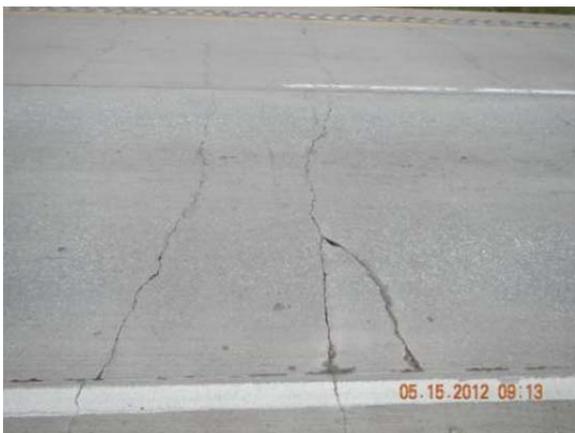
Figure 4. 50 Y-Crack on IH 35 in the Laredo District

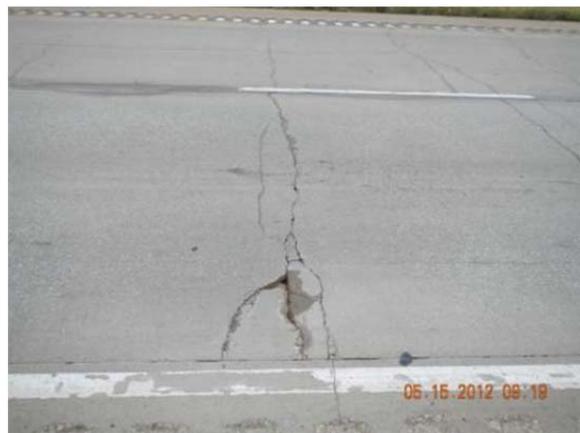
Figure 4. 51 Distress Due to Y-Crack on IH 35 in the Laredo District

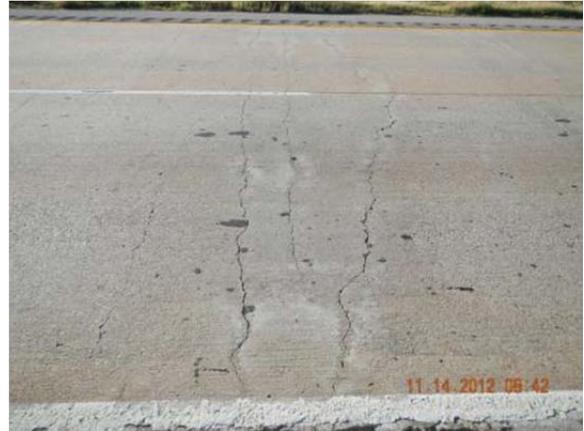
Figure 4. 53 Narrow Cracks on US 287 in the Wichita Falls District

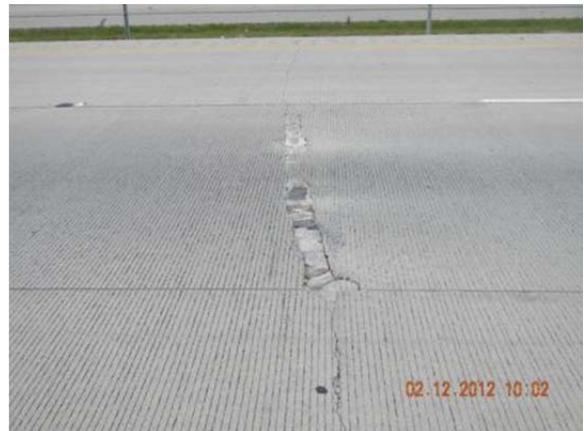
Figure 4. 55 Distress Due to Narrow Cracks on IH 45 in the Dallas District

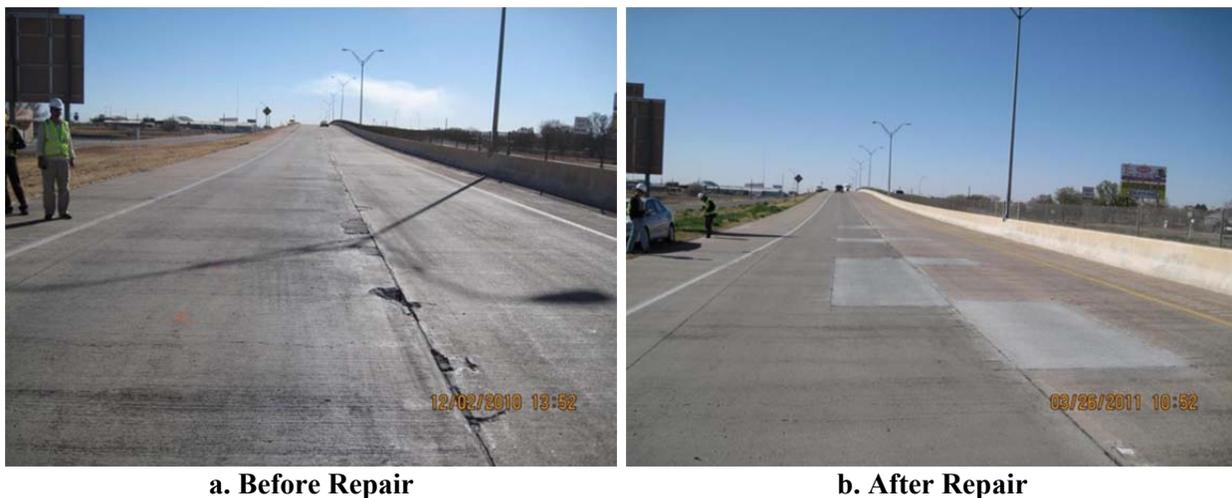
Figure 4. 72 LCJ Distresses on IH 27 in the Lubbock District

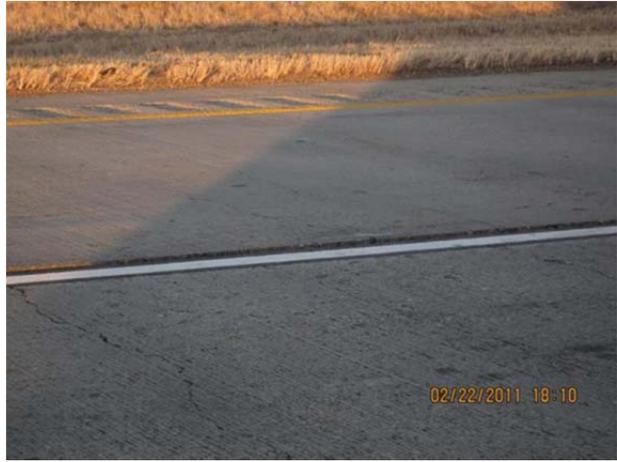
b. Longitudinal Joint Faulting
