Implementing the Ultra-High Pressure Water Cutter for Roadway Maintenance Applications: Final Report

Sanjaya P. Senadheera, Roderick B. Henderson,
James G. Surles, William D. Lawson

Texas Department of Transportation

Research Project 5-5230-01
Research Report 5-5230-01-2
www.techmrt.ttu.edu/reports.php

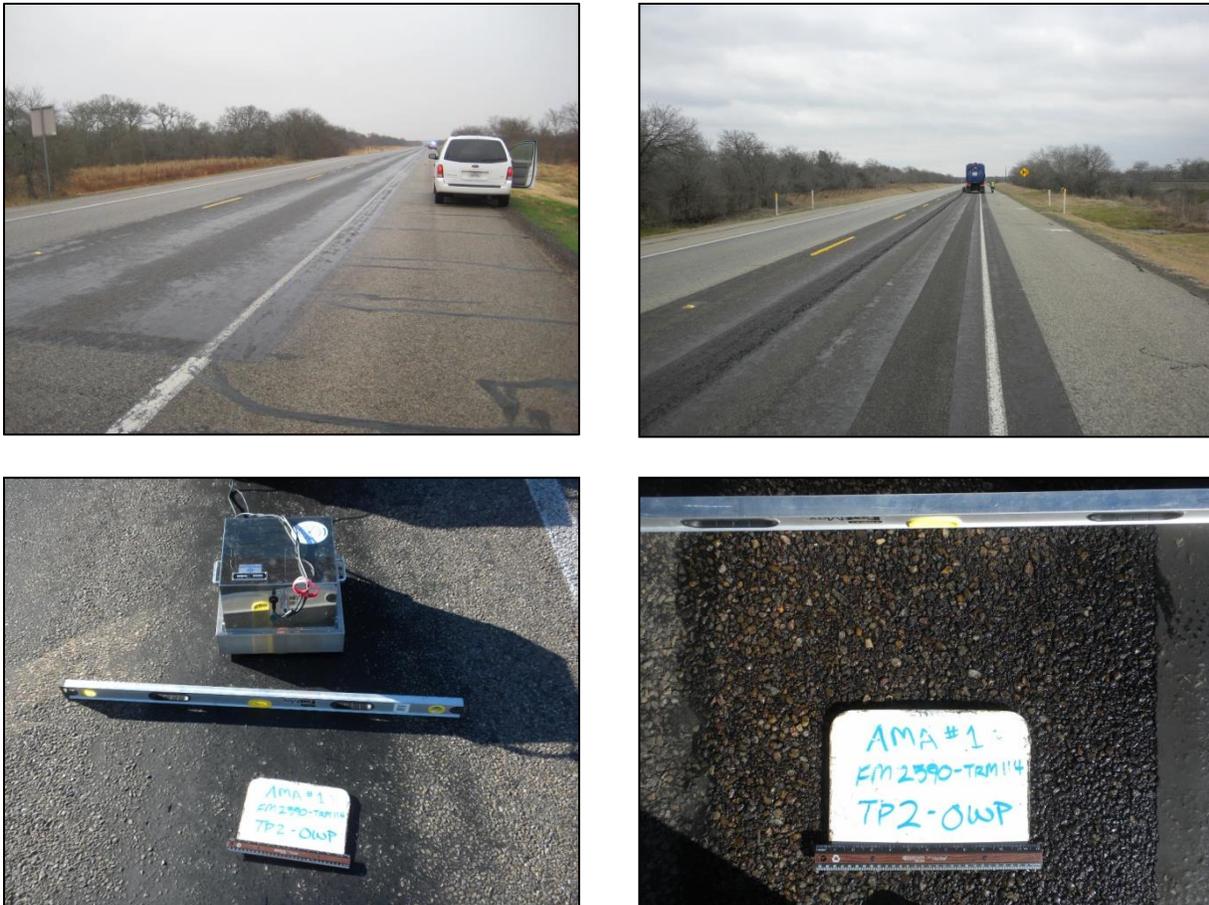
FIGURE 1.2 Pavement Surface Before Treatment (Left), and After Treatment (Right) Using the UHP Water Cutter

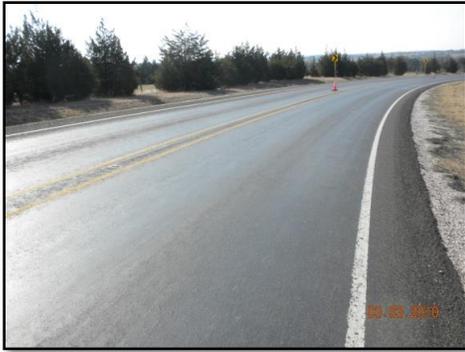
(a) FM 2562, Grimes County

As can be seen in Figure 1.3, the section of FM 2562 selected for treatment was very heavily flushed. The contractor made five passes with the UHP water cutter, varying the rate of advance to accomplish different degrees of asphalt removal. One finding of the demonstration was that Rampart's technology was actually superior, or more advanced, than the New Zealand/Australia technology previously identified by the research team. Rampart's UHP water cutter truck uses a *fixed* deck blaster rather than an umbilical-mounted deck blaster, eliminating the need to have a person walk behind the truck and operate the unit. Further, Rampart's truck relies on a hydrodynamic transmission to better control the rate of advance of the water cutter unit. The result is improved control of the asphalt surface treatment, and a safer maintenance process.

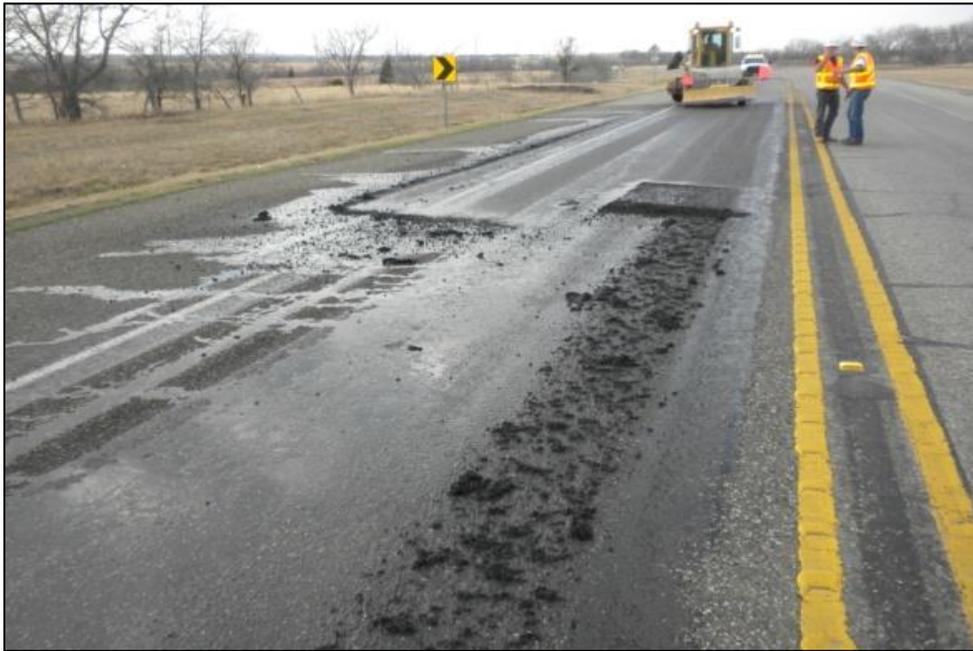
Figures 5.5 through 5.9 illustrate some situations we observed during the treatment process. The UHP water cutter removes a significant amount of excess asphalt material from the pavement surface. The actual quantity removed will depend on the travel speed, rotational speed of the spray bar, the nozzle configuration in the bar, extent of flushing on the road and the asphalt and aggregate material characteristics. Figure 5.5 shows the removed asphalt left on the road when the vacuum system is not operating. Under conditions that can be labeled as "typical," the vacuum system in the machine is capable of sucking up all the material. Typical conditions would mean desirably cool temperatures and modified binders. However, there can be situations where the vacuum system is unable to remove all the cut asphalt as shown in Figure 5.6. Figure 5.7 shows a power broom following the water cutter to ensure that all material is removed from the roadway before traffic is allowed back.

FIGURE 5.5. Flushed Asphalt Removed From Treatment Operation Left on Road When Vacuum Suction Pump Was Turned Off

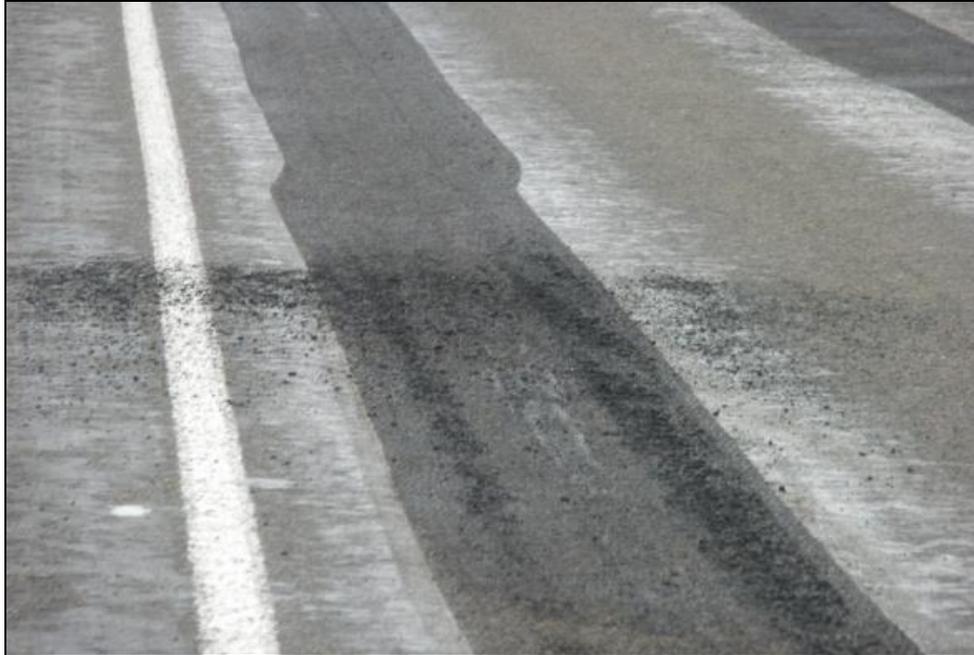
FIGURE 5.6. Traces of Removed Asphalt Left on Treatment Path

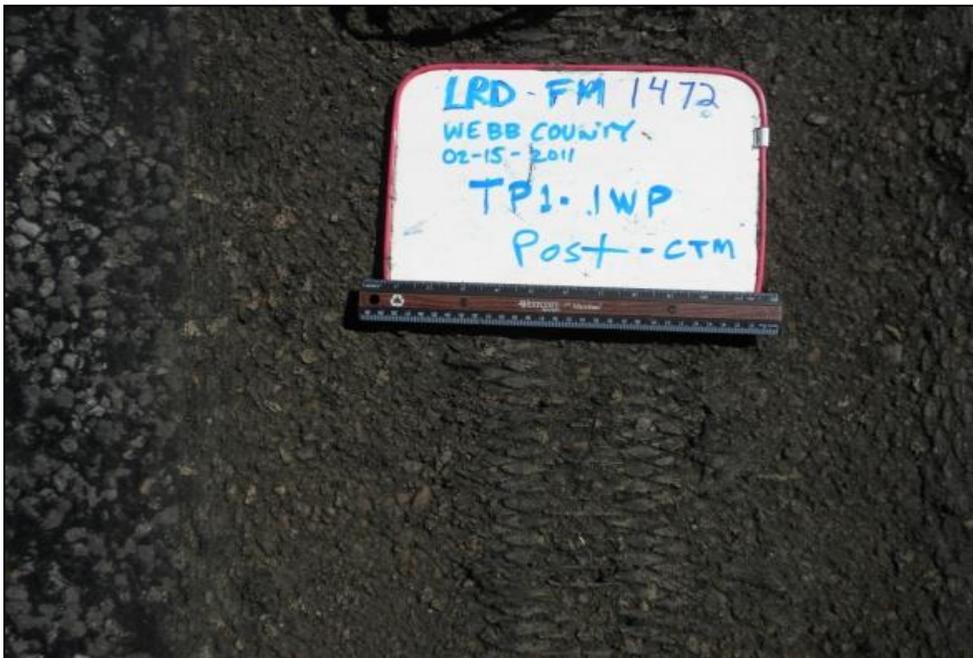
Figure 5.9 shows a narrow strip along the center of the treated strip where all excess asphalt was not removed. This results in a lightly-scored pattern on the surface, and is associated with pavement rutting. Here, the vertical distance from the spray bar to the pavement surface is wider at the center of the wheel path than at the edges, and this variation can be sufficient to diffuse water cutting energy in the middle of the wheel path. The outcome is variable, inadequate treatment. Figure 5.9 shows the effect of inadequate treatment in the middle of the wheel path associated with wheel path rutting of less than 3/8 inch.

FIGURE 5.9. “Holiday” Areas Not Subjected to Treatment Due to Ineffective Nozzle Coverage, in This Case Due To Rutting Along Center of Treatment Path

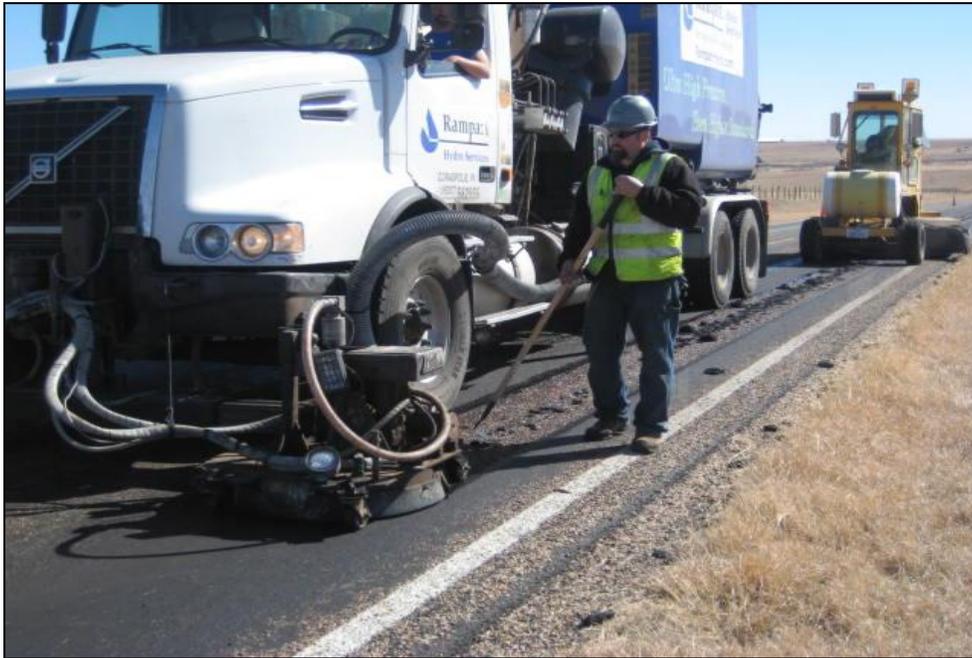
Figure 5.10 shows treatment of a pavement surface that was heavily flushed. When this section was being treated, the removed asphalt was found to be very sticky and was forming into balls of asphalt that were clogging the vacuum system. This picture shows a maintenance worker pulling out the asphalt lumps not picked up by the vacuum system to make sure they do not get pressed back on to the treated area of the roadway. This section of road had excessive flushing, and the asphalt used was unmodified AC-10. In this case, the stickiness of the asphalt arose in part because the binder was too soft at the working temperature. The binder type and grade is also an important consideration when planning water cutter treatment activities.

FIGURE 5.10. Maintenance Worker Using Shovel to Remove Excess Lumps of Asphalt

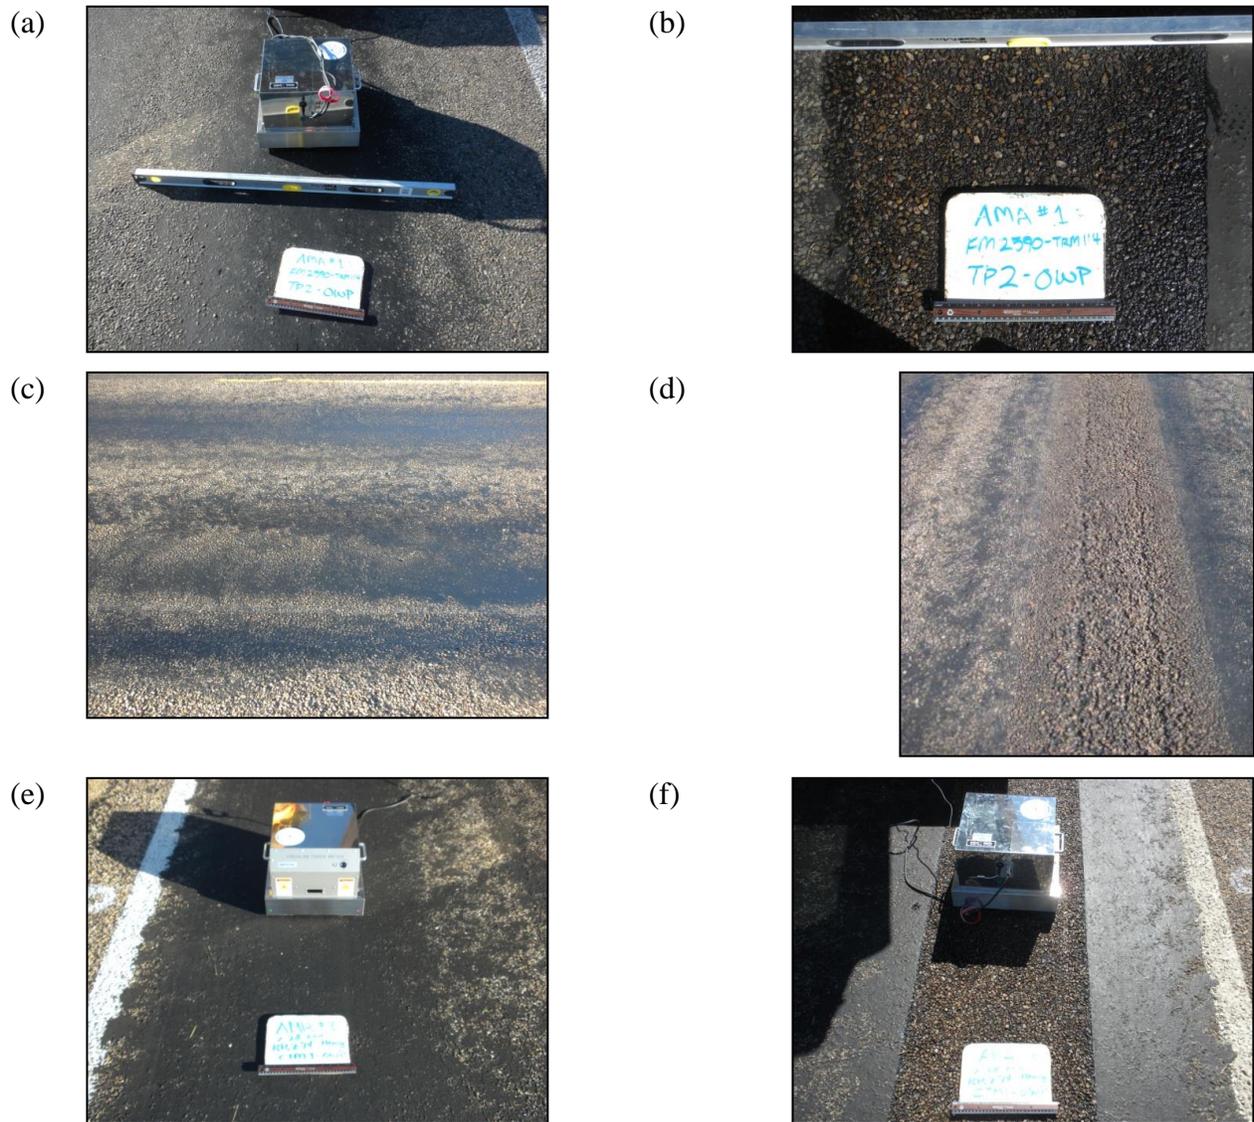
Snapshots of Amarillo test sections before and after treatment are shown in Figure 5.11. The first section (AMA1) was located near the city of Canyon and had a high ADT. AC20-5TR and siliceous aggregate was used in this section, and was part of a highway that has experienced significant flushing since its surfacing in 2008. Many maintenance treatments have been tried to correct its flushing with little long-term success. The second and third Amarillo District test sections were in rural settings and used unmodified AC 10 binder. AMA2 has significant truck traffic from aggregate pits in the area and AMA3 has very little traffic of any kind. The degree of flushing in AMA3 was extensive. Treatment of AMA1 was very successful. An alternate nozzle configuration was tried in AMA2, with the two larger (0.013") nozzles placed in the interior of the spray bar and the smaller 0.009" nozzles moved to the outside. This caused raveling in the middle of the treatment strip as shown in Figure 5.11(d). AMA3 treatment was difficult due to soft binder clogging the vacuum system. An additional maintenance worker had to pull the balled asphalt away from underneath the machine to prevent the removed asphalt from being pressed back into the roadway by the tires.

FIGURE 5.11. Test Pavement Pictures from Amarillo District (A) AMA1 Before Treatment; (B) AMA1 Soon After Treatment; (C) AMA2 Before Treatment; (D) AMA2 Soon After Treatment; (E) AMA3 Before Treatment; (F) AMA3 Soon After Treatment

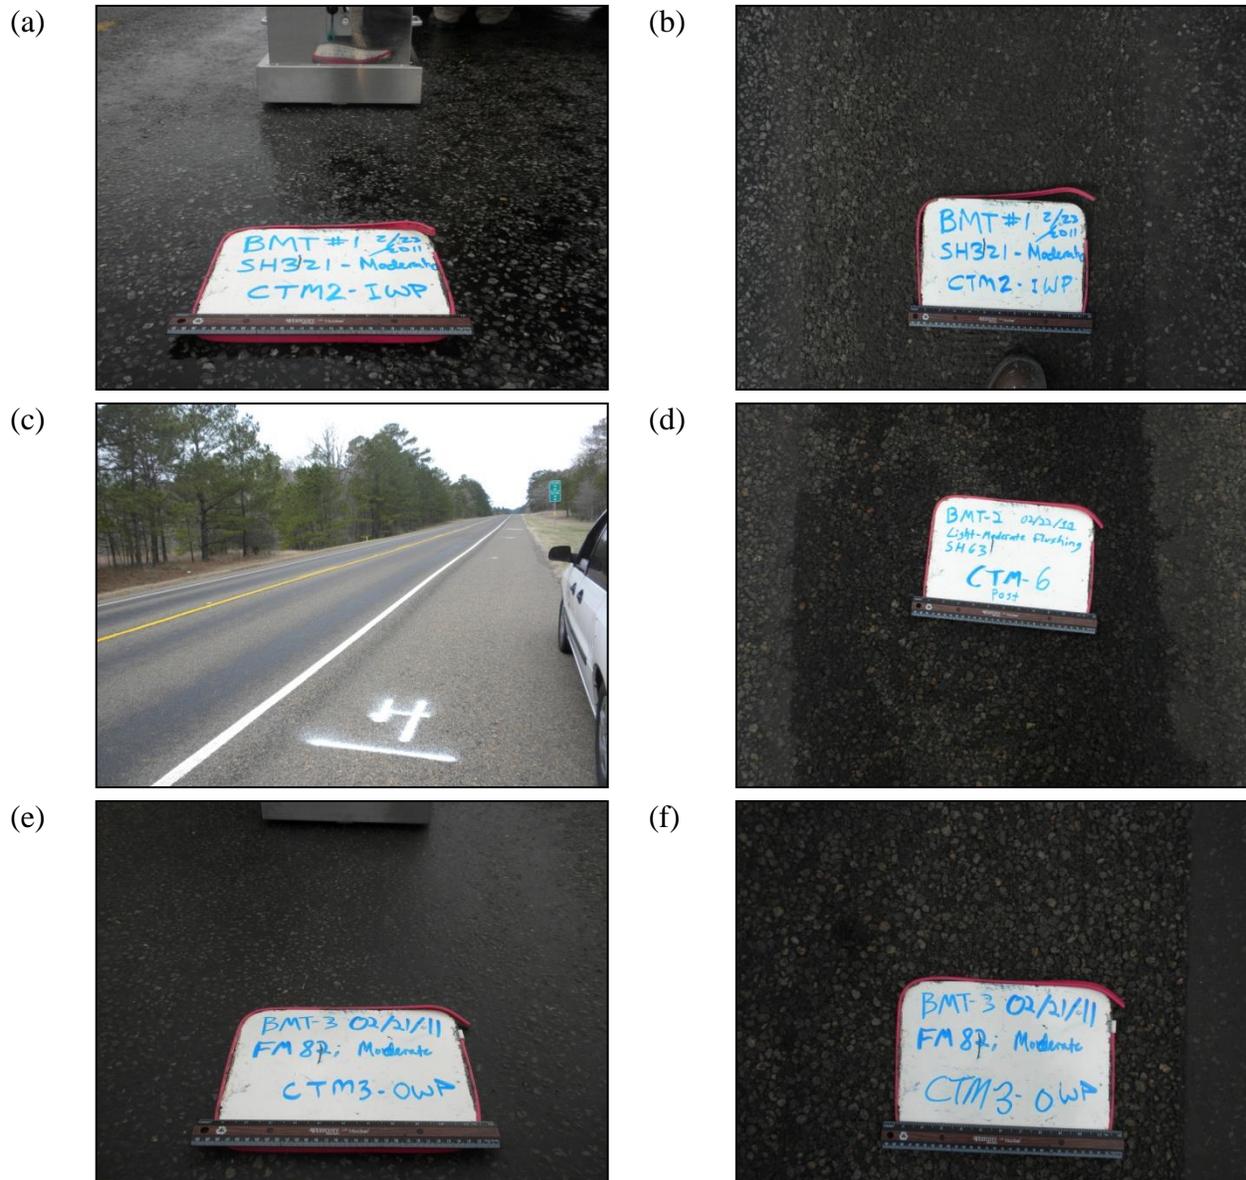
Snapshots of Beaumont test sections before and after treatment are shown in Figure 5.12. The first of the three Beaumont sections (BMT1) was located near the city of Cleveland and had high traffic including a significant level of trucks. The last surfacing on this section in 2008 used AC20-5TR and limestone aggregate. BMT2 was a rural section in a wooded area and carried some logging truck traffic. BMT3 was near the city of Kirbyville and had a low ADT. BMT2 and BMT3 used CRS-2P emulsion binder with lightweight aggregate. Treatment of these three sections was successful. There was some difficulty in getting the BMT2 section dry after the treatment to conduct the post-treatment CTM test.

FIGURE 5.12. Test Pavement Pictures from Beaumont District (A) BMT1 Before Treatment; (B) BMT1 Soon After Treatment; (C) BMT2 Before Treatment; (D) BMT2 Soon After Treatment; (E) BMT3 Before Treatment; (F) BMT3 Soon After Treatment

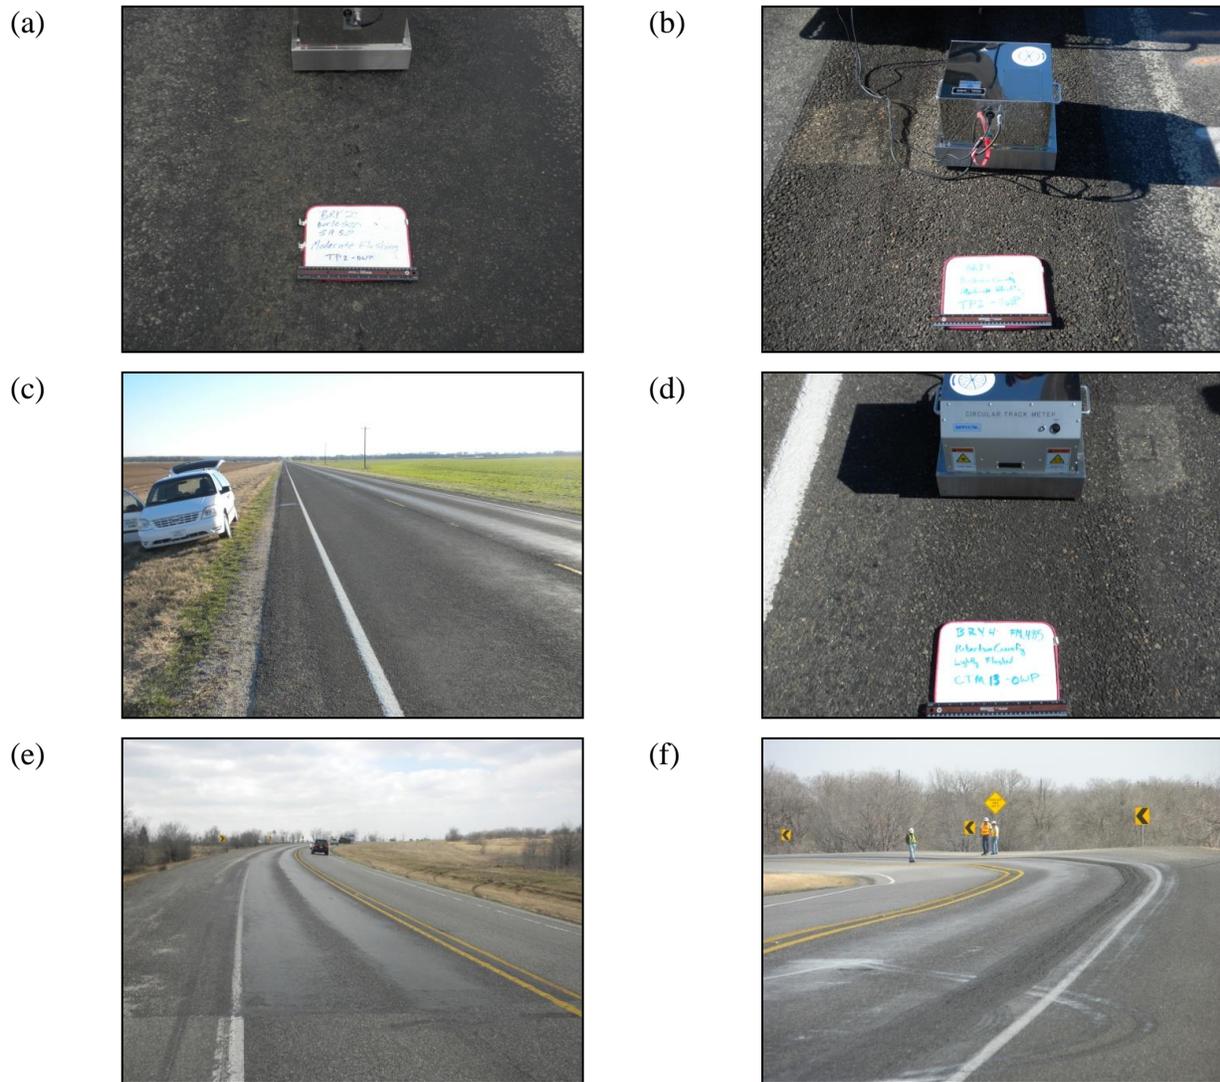
FIGURE 5.13. Test Pavement Pictures from Bryan District (A) BRY2 Before Treatment; (B) BRY2 Soon After Treatment; (C) BRY4 Before Treatment; (D) BRY4 Soon After Treatment; (E) BRY5 Before Treatment; (F) BRY5 Soon After Treatment

Prior to the second installment of treatment in BRY5, a decision was made to change the spray bar configuration to include 28 nozzles to produce a more uniform treatment.

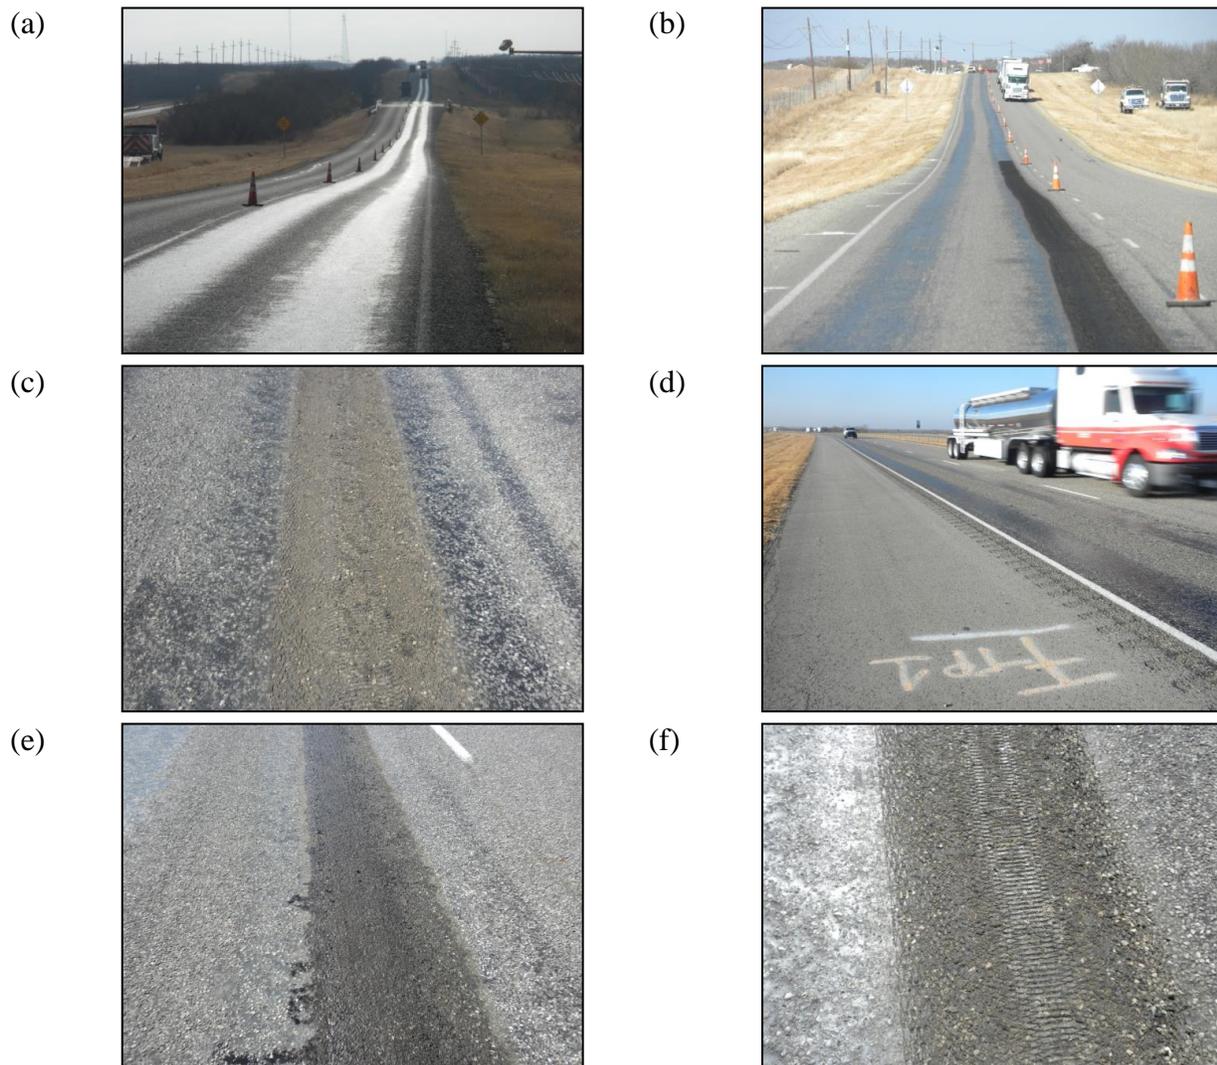
The two test projects in the Laredo District both had two lanes in each travel direction. Figure 5.14 illustrates the test project and its “before and after” treatment images. The section LRD2 was near a warehouse area and the outside lane of this roadway, as shown in Figure 5.14(a), was heavily flushed. The treatment in this section was not very successful, perhaps because the aggregate used in this section was a weak and dusty limestone, and it left residue on the roadway that stained the treated area [see Figure 5.14(c)]. On the other hand, the water cutter spray bar was operating at a lower rotational speed in the two Laredo sections, and that contributed to the zig-zag effect along the middle of the treated area. The second test section in Laredo (LRD3) was on IH-30 and had a very high level of truck traffic as well. The materials used on this surface were similar to LRD 2, and the observations were similar in nature.

FIGURE 5.14. Test Pavement Pictures from Laredo District (A) LRD2 Before Treatment; (B) LRD2 Soon After Treatment; (C) LRD2 Close-Up View Soon After Treatment; (D) LRD3 Before Treatment; (E) LRD3 Soon After Treatment; (F) LRD3 Close-Up View Soon After Treatment

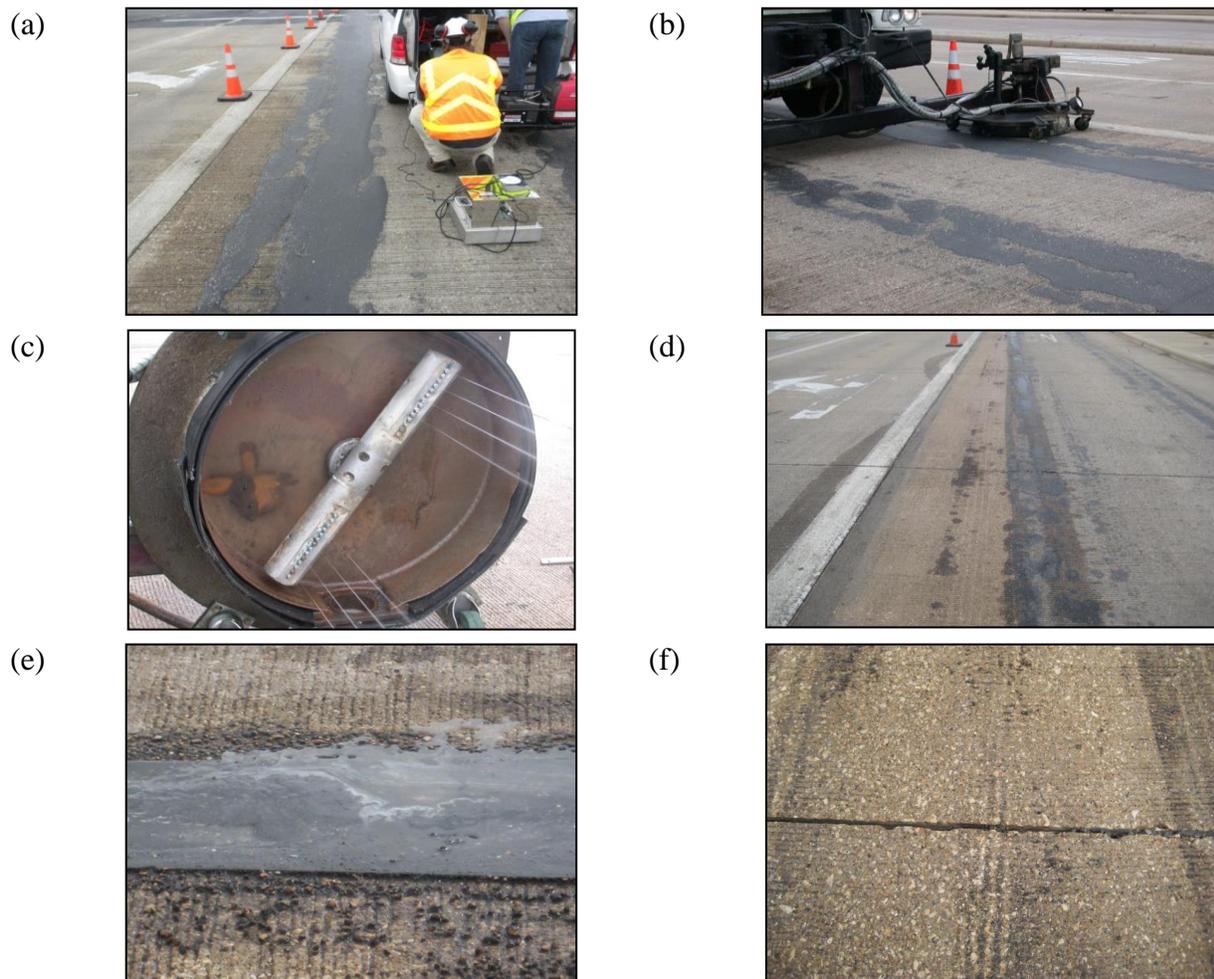
FIGURE 5.15. Test pavement pictures from Bryan District concrete pavement section where tracked asphalt was removed using UHP water cutter (a) tracked asphalt on inside wheel path; (b) removal of tracked asphalt using UHP water cutter; (c) 8-nozzle configuration used in spray
