Texas Tech University

# Implementation of Concrete Overlay Evaluation and Design

Research Project 5-6910-01  
Research Report 5-6910-01 R1  
<http://www.techmrt.ttu.edu/reports.php>

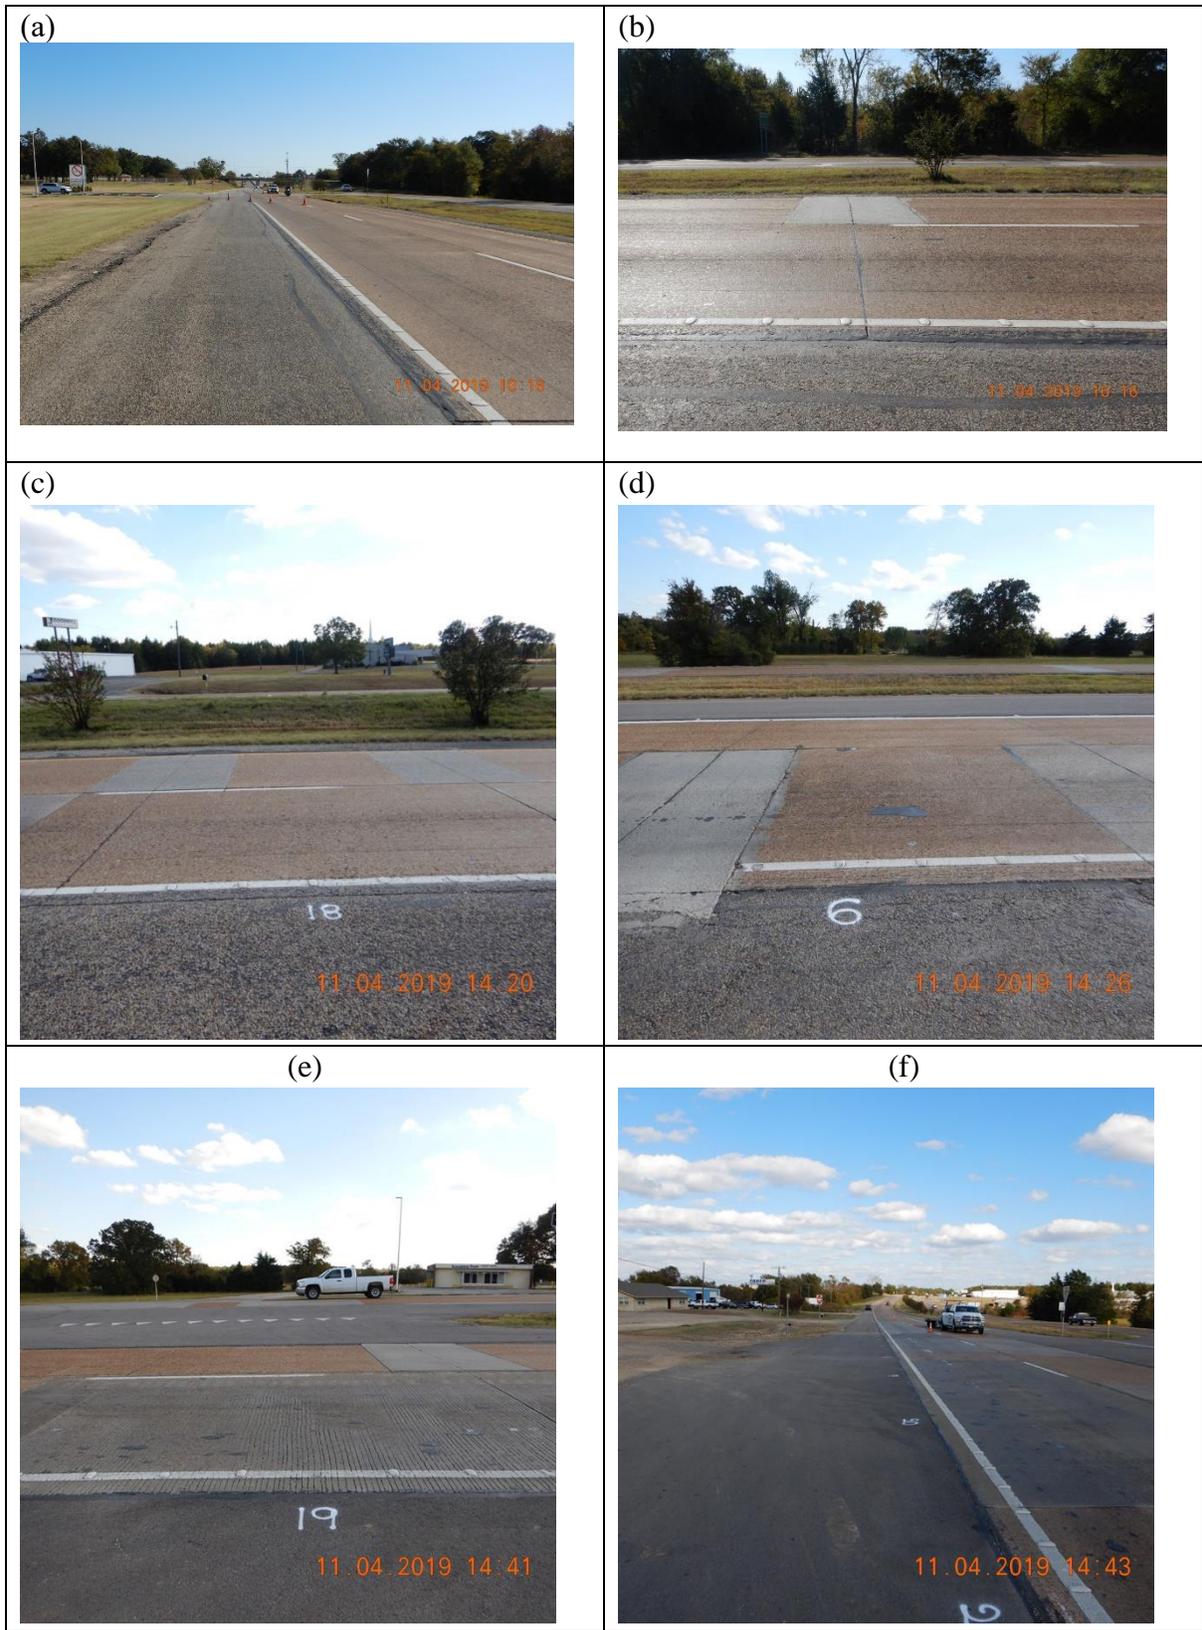
**Figure 6 Existing CPCD condition on Loop 286**

Figure 6 shows typical pavement condition. Figure 6-(a) shows the driveway to the Campbell Soup Company where the beginning of the test section is located. This is a two-lane highway where most of the trucks drive through the outside lane. It was observed that even though most of the truck traffic uses the outside lane, repair sections are also observed in the inside lane as shown in Figure 6-(b) and (c). This indicates that the distresses were not necessarily due to structural issues, but potentially due to a joint issue in the CPCD. Figure 6-(d) shows similar types of concrete patches in the outside lane as the inside lane, which supports the assumption that joint failures necessitated the repairs. Furthermore, it can also be observed that these are full depth repairs, mostly in the outside lane as shown in Figure 6-(e) and (f).

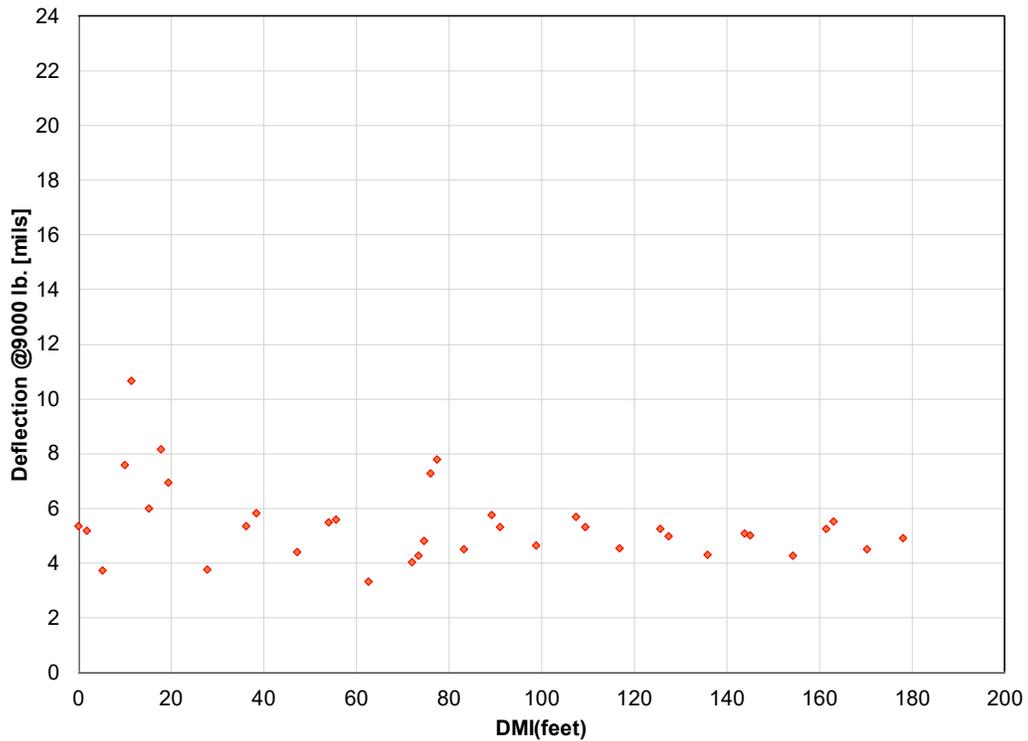
**Figure 11 Location 1 FWD deflections**

In Location 1 as shown in Figure 10, the deflection of 37 points were measured. Figure 11 shows the measured deflections in Location 1 segment. It is observed that 2 larger deflections are between 2 smaller deflections. The 2 larger deflections are those evaluated at a joint, and the other 2 smaller deflections are at mid-slabs. Most of the mid-slab deflections are about 4 mils, while the joint deflections vary from 4 to 8 mils. The variations at transverse contraction joints or repair joints may be attributed to various conditions of joints – some may be locked, and some may be fully separated. It can be recalled in the specifications that the dowels shall be coated or smooth. This is to prevent bonding of the dowel bar and concrete. However, when the dowel bars are bonded to the concrete at both sides of joints, joint movements are restrained, forcing slabs on both side of the joint behave like a continuous slab (“locked joints”). With this, some joints in Location 1 are potentially locked, resulting deflections comparable to those mid-slabs. Such

behavior suggests potential issues with dowel installation. It was also noticed that the LTE values obtained at those suspected locked joints were relatively high.

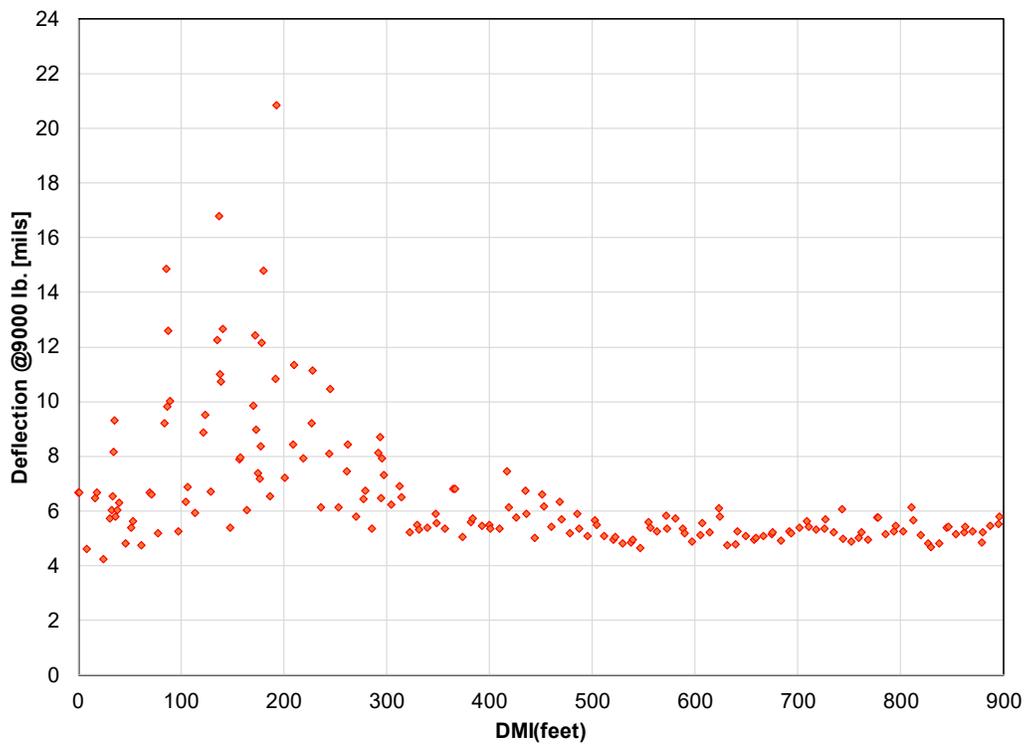
**Figure 13 Location 2 FWD deflections**

The Location 2 segment, shown in [Figure 12](#), had a total of 180 points covering 53 slabs. [Figure 13](#) shows the measured deflections across the entire segment. It can be observed that the first 300

feet of the segment have high deflections. The deflection recorded went up to 20 mils. Pavement condition information shows that these areas are repaired slabs, which indicates that the repairs were not done properly. Meanwhile, the deflections mid-slabs recorded after the first 300 feet of the segment were relatively consistent which ranges from 4 to 4.5 mils.

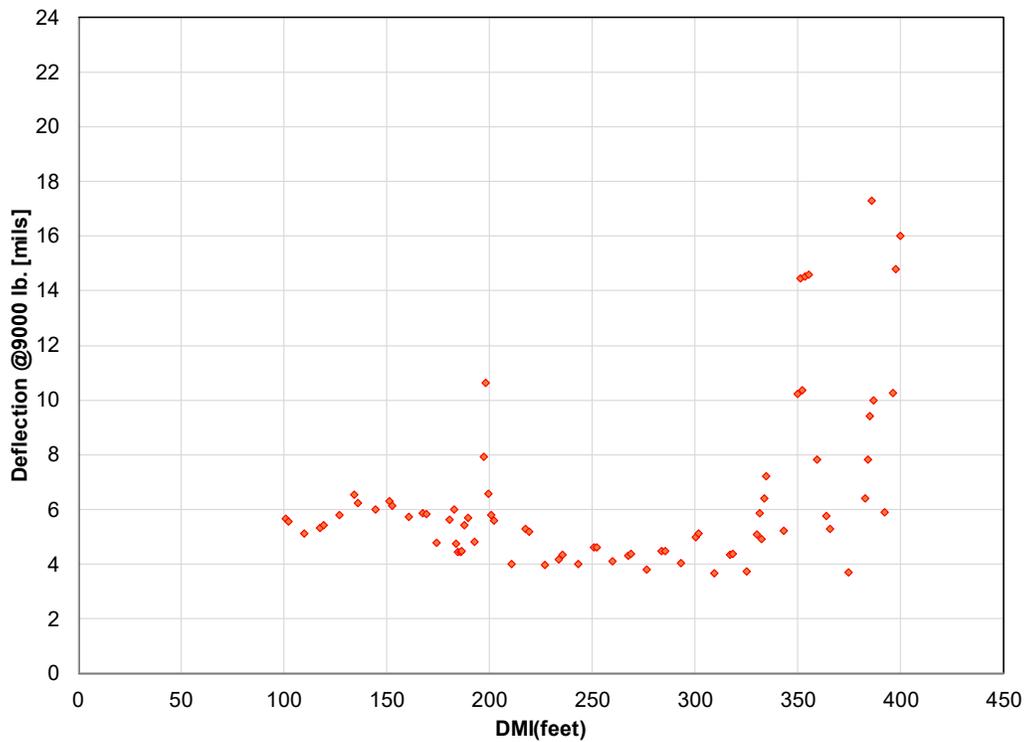
**Figure 15 Location 3 FWD Deflections**

The Location 3 segment, shown in [Figure 14](#), had a total of 74 points covering 25 slabs. [Figure 15](#) shows the measured deflections in the entire segment. It was also observed that the large deflections were measured on the repaired slabs. The highest deflection in the segment was recorded to be 17.3 mils whereas the lowest deflection was 3.9 mils.

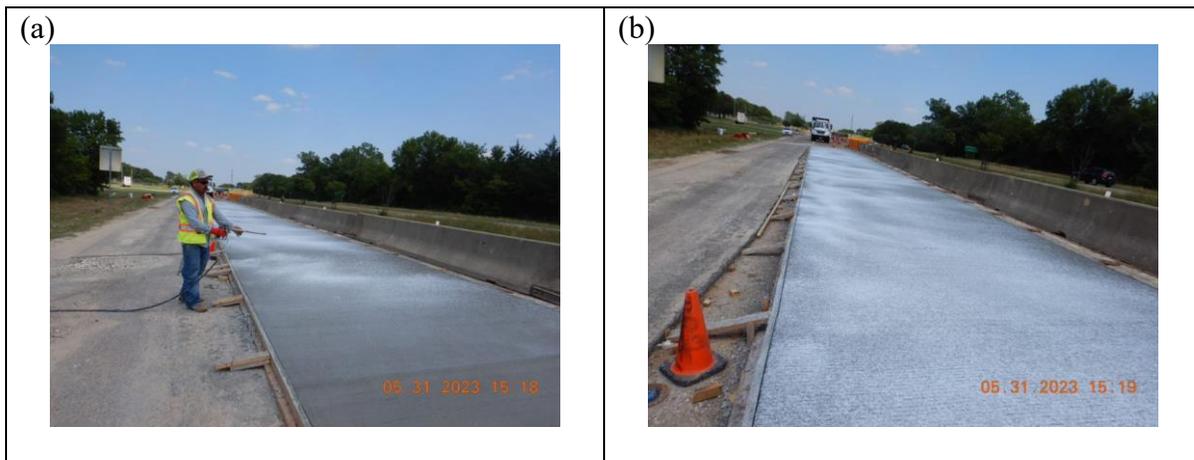
**Figure 45 Curing compound application after concrete placement.**

Figure 45 shows the curing operation. It is observed that there are areas with deficient curing. The grey areas were more dominant on the inside of the outside lane. The insufficient application of curing compound may not prevent moisture loss from the concrete surface, potentially increasing temperature loss and shrinkage of concrete.

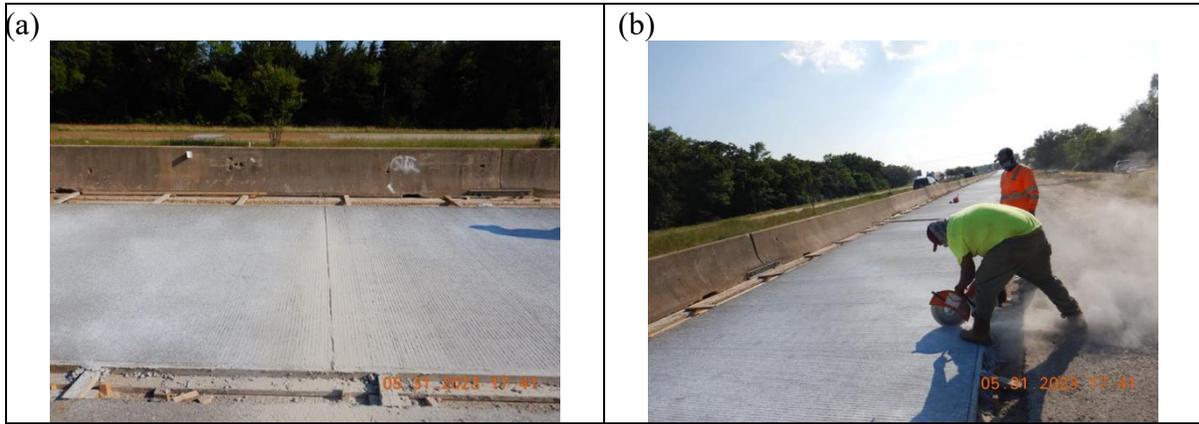
**Figure 46 Saw-cut on Segment 1A, Segment 2 and Segment 3**

The day after concrete placement, saw-cuts were made on the CRCP overlay as shown in Figure 46 even though saw-cuts are not needed in CRCP. As pointed out earlier, the saw-cut was made only on Segments 1A, 2 and 3. The effect of the saw-cut in crack propagation was monitored and will be discussed in the discussion of the results.

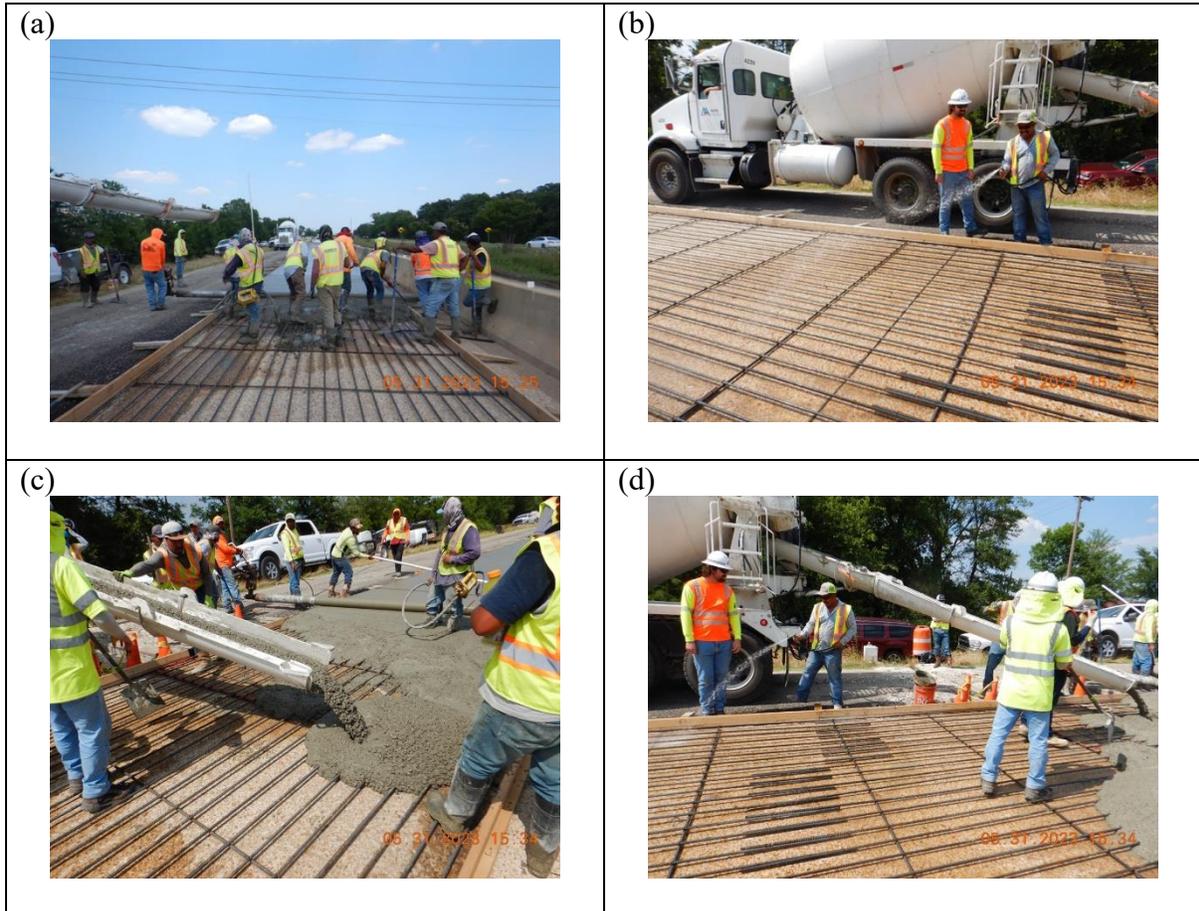
**Figure 47 Surface condition during concrete placement**

It was also observed that in some areas, the surface of the existing CPCD was not in SSD condition prior to the concrete placement. The need for SSD condition or damp condition on the existing surface is necessary to establish a good bonding at the CPCD and CRCP interface. However, as seen in [Figure 47 -\(a\)](#) to [Figure 47-\(d\)](#), there were areas where the surface of existing CPCD dried up before the concrete was placed. Those dry areas were mostly in the left half of the outside lane.

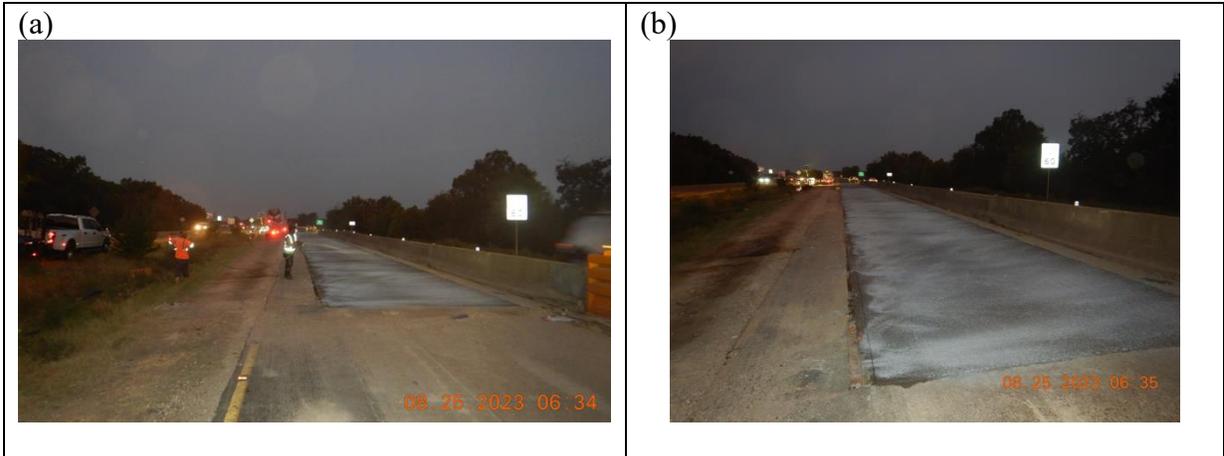
**Figure 50 Curing compound application after concrete placement**

Figure 50 shows the curing operation and the condition of curing membrane. It shows that the curing membrane was in a rather non-uniform condition.
