Strengthening of Existing Inverted-T Bent Caps— Volume 2: Experimental Test Program

Technical Report 0-6893-R1-Vol2

TEXAS A&M TRANSPORTATION INSTITUTE
COLLEGE STATION, TEXAS

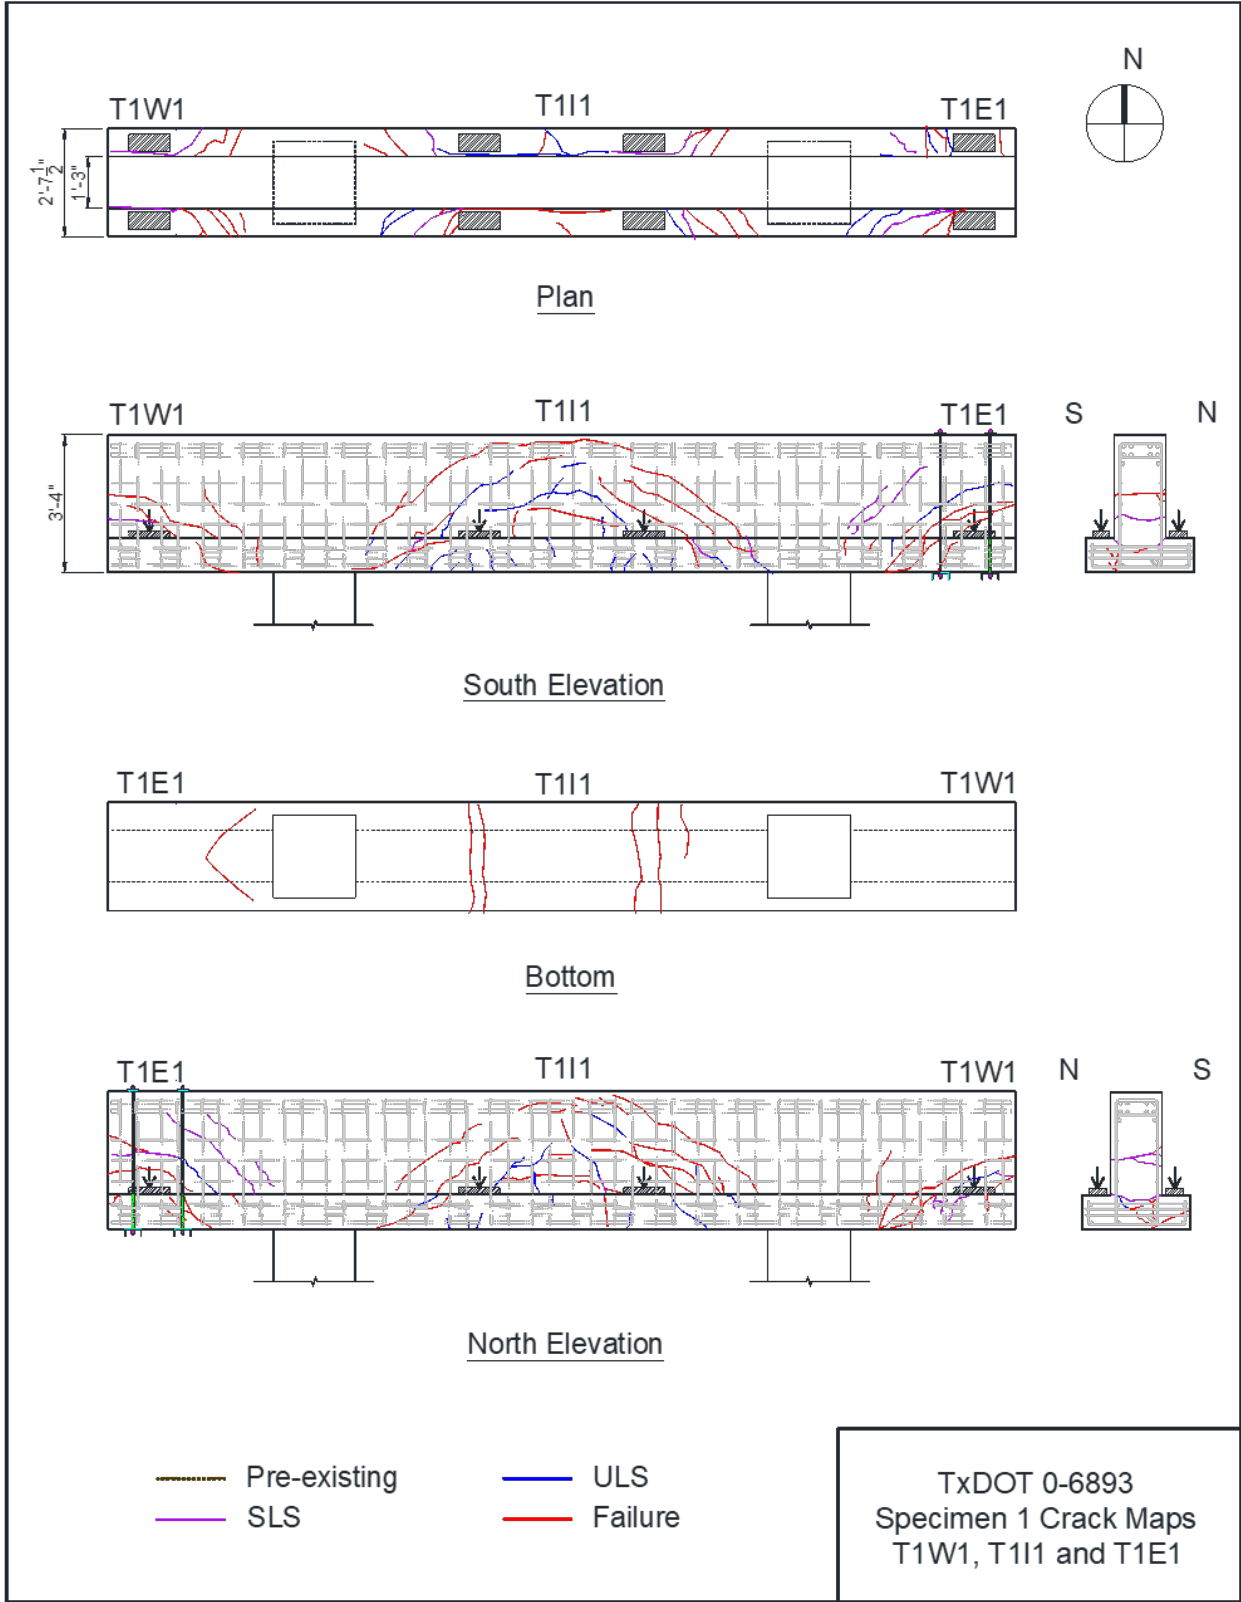
Figure 3.1. Crack Maps for Tests T1W1, T1I1, and T1E1.

The measured ultimate load of 66 kips was 57 percent larger than the estimated capacity of 42 kips, but 2 kips less than ULS (68 kips). Loads were removed after documenting damage at the measured ultimate load. The controlling failure mechanism was hanger failure, as expected. Figure 3.3 shows the observed damage for test T1W1.

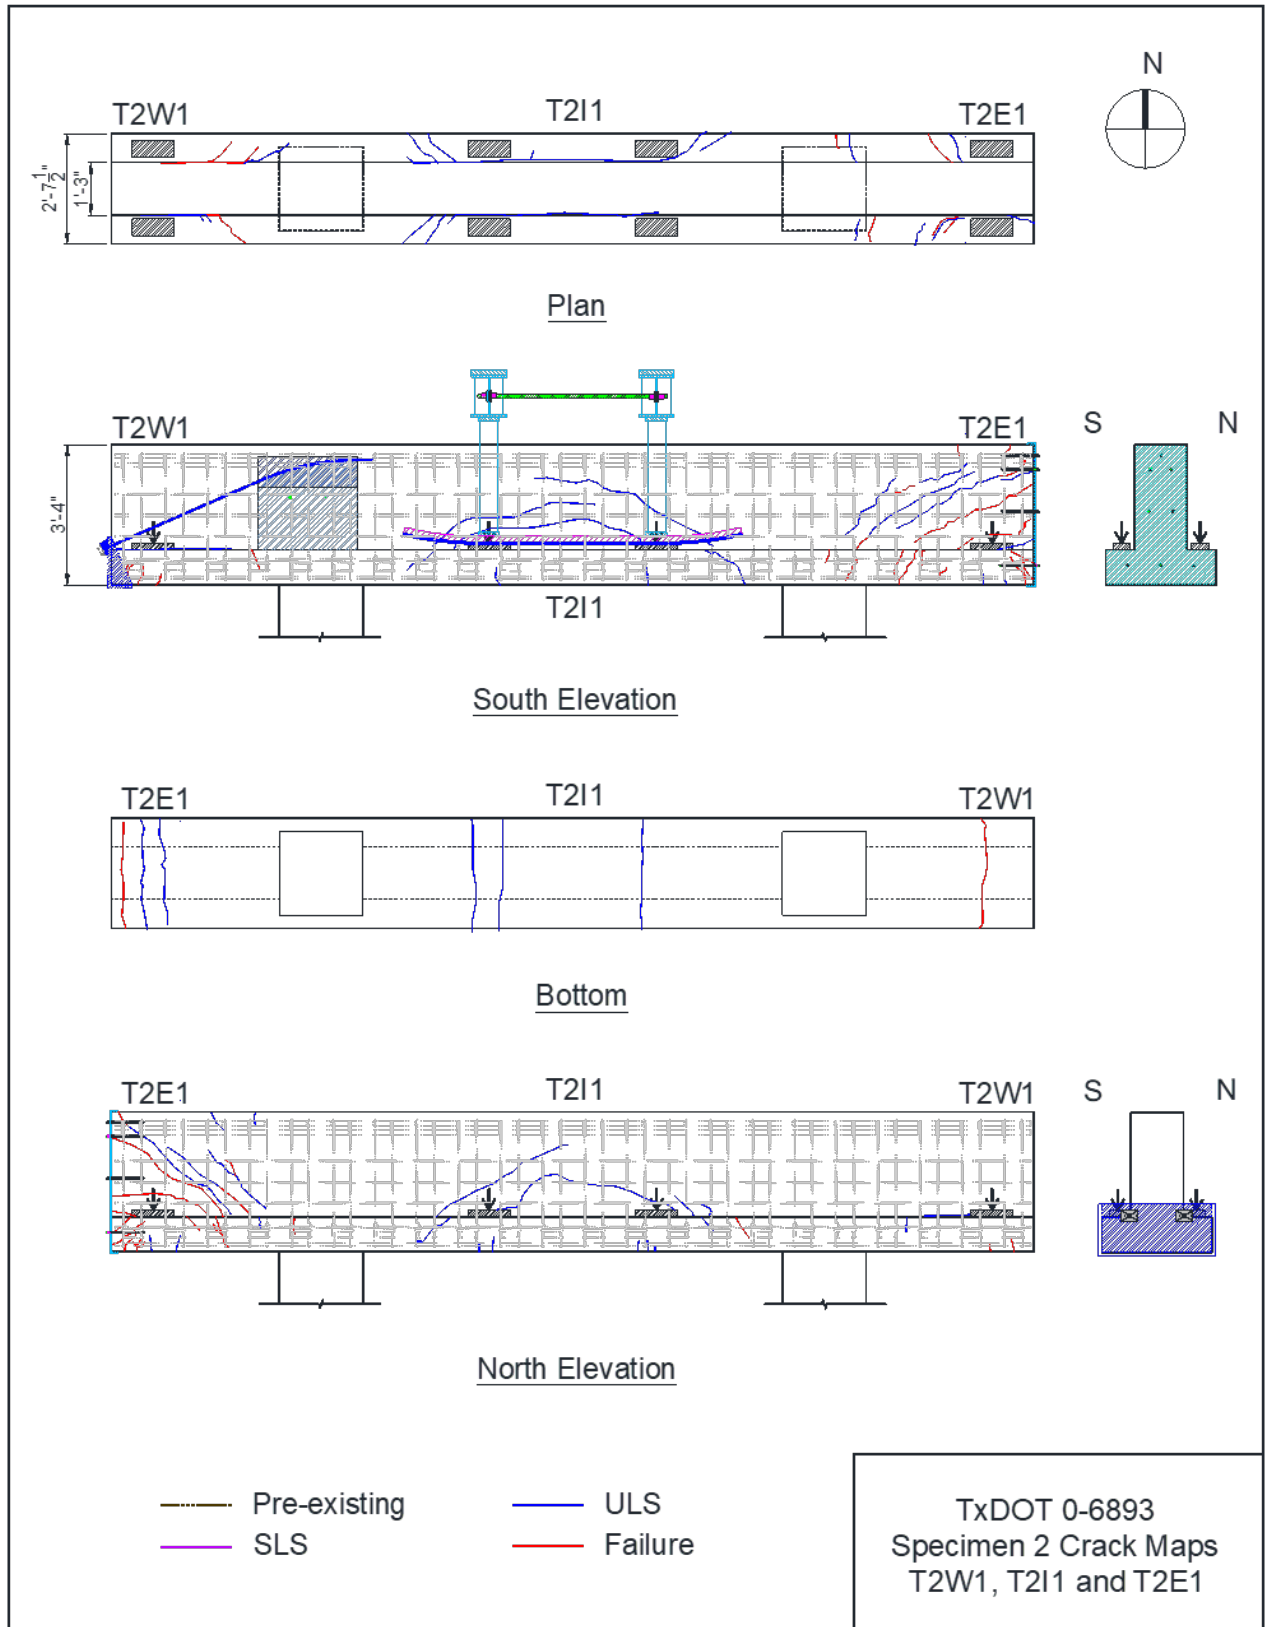
Figure 3.9. Crack Maps for Tests T2W1, T2I1, and T2E1.

At the measured ultimate load of 78 kips, the end plate was bent at the bottom tip and in the stem near the neutral axis. New cracks had formed on the web and the side of the ledge. There were fewer cracks at the inside of the bearing pad compared to the reference test, which may have been due to the restraint provided by the end plate. The diagonal cracks on the outside of the bearing pad were steeper than the inside cracks.

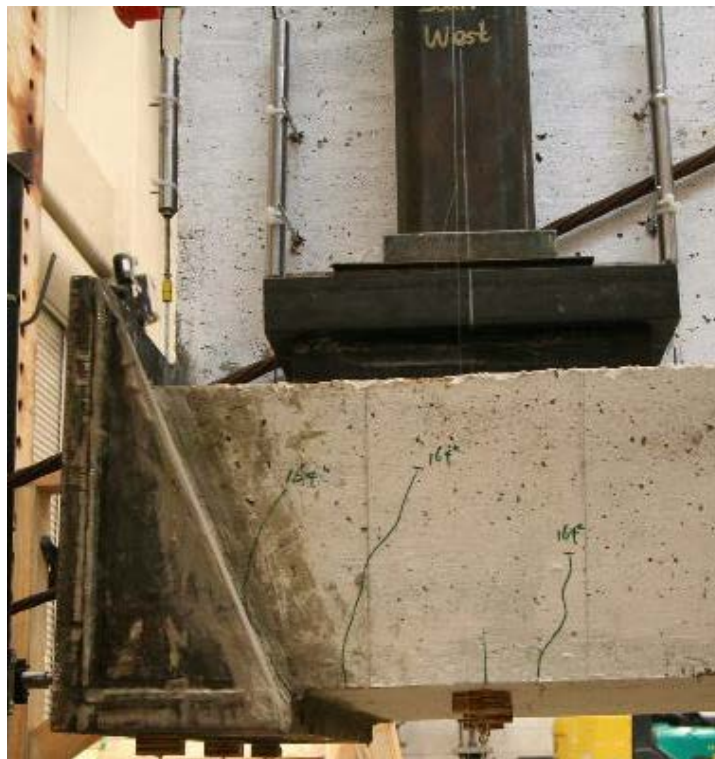
Figure 3.16. Observed Damage for T2W1 at Test Termination Load.

At the test termination load, new cracks formed on the ledge and bottom of the specimen. Diagonal cracks on the side face of the ledge under the bearing pads were detected on both sides. The cracks that started at the bottom of the bent cap propagated about half the depth of the ledge toward the center of the bearing pad from the outside. Diagonal cracks on the side of the ledge were hairline cracks. The width of the cracks at the web-ledge interface increased to 1 mm. New diagonal cracks were also detected on top of the ledge. One more horizontal crack formed on the bottom and 3 in. from the end of the specimen. It was detected after removal of the retrofit parts.

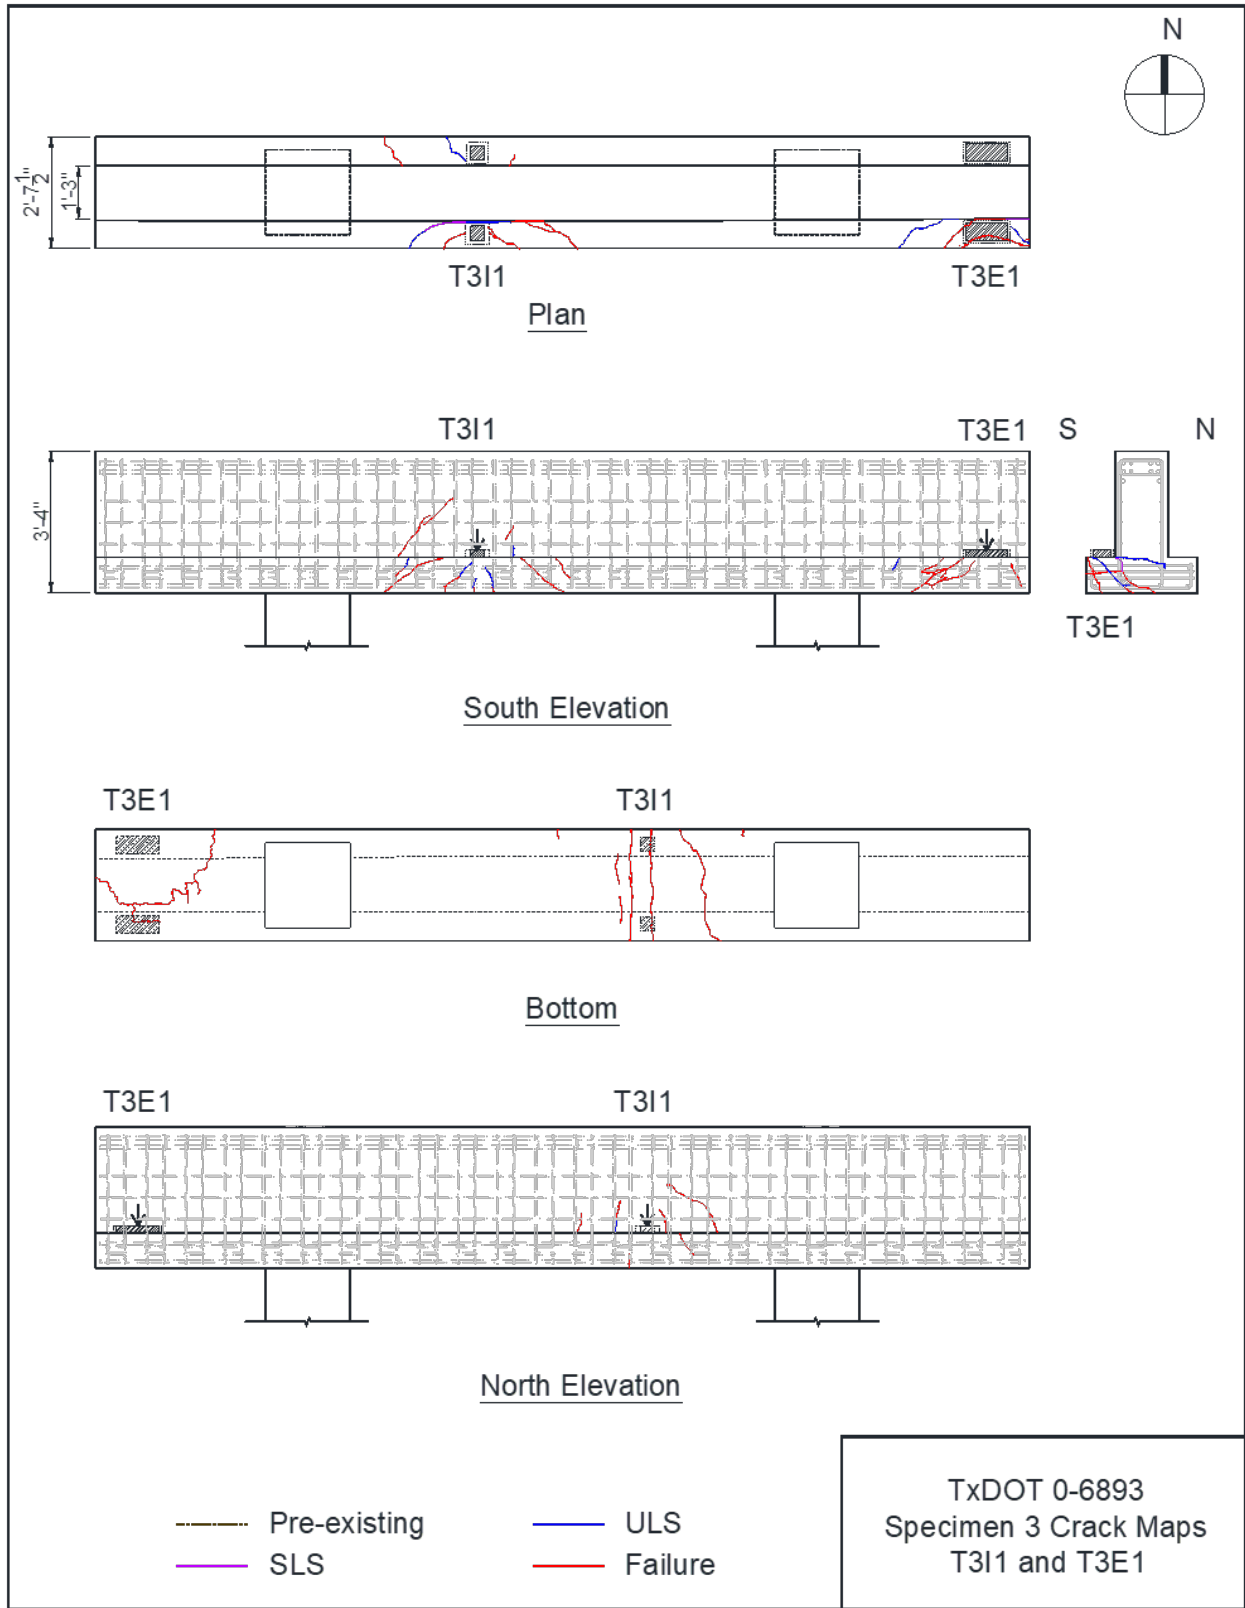
Figure 3.26. Crack Maps for Tests T3I1 and T3E1.

At the ULS of 68 kips, a new crack was found on the end surface that formed from the south reentrant corner and extended almost horizontally about 14 in. Another diagonal crack on the end surface that connected to the outside edge of the bearing pad and on the top surface of the ledge that also initiated from the inner edge of the bearing pad was also detected. Extensive cracks began to form as the load increased above ULS. Similar crack patterns as T3W1 were observed, and most of the cracks formed from the edge of the bearing pad and diagonally extended to the side of the ledge. The main concrete cone crack initiated at a load of 78 kips, accompanied by a slope change in the load-deflection curve. The crack quickly extended to the bottom of the bent cap. The measured ultimate load of 80 kips was observed shortly after the cone crack took place. The maximum width of the cone crack at the measured peak was 2 mm.

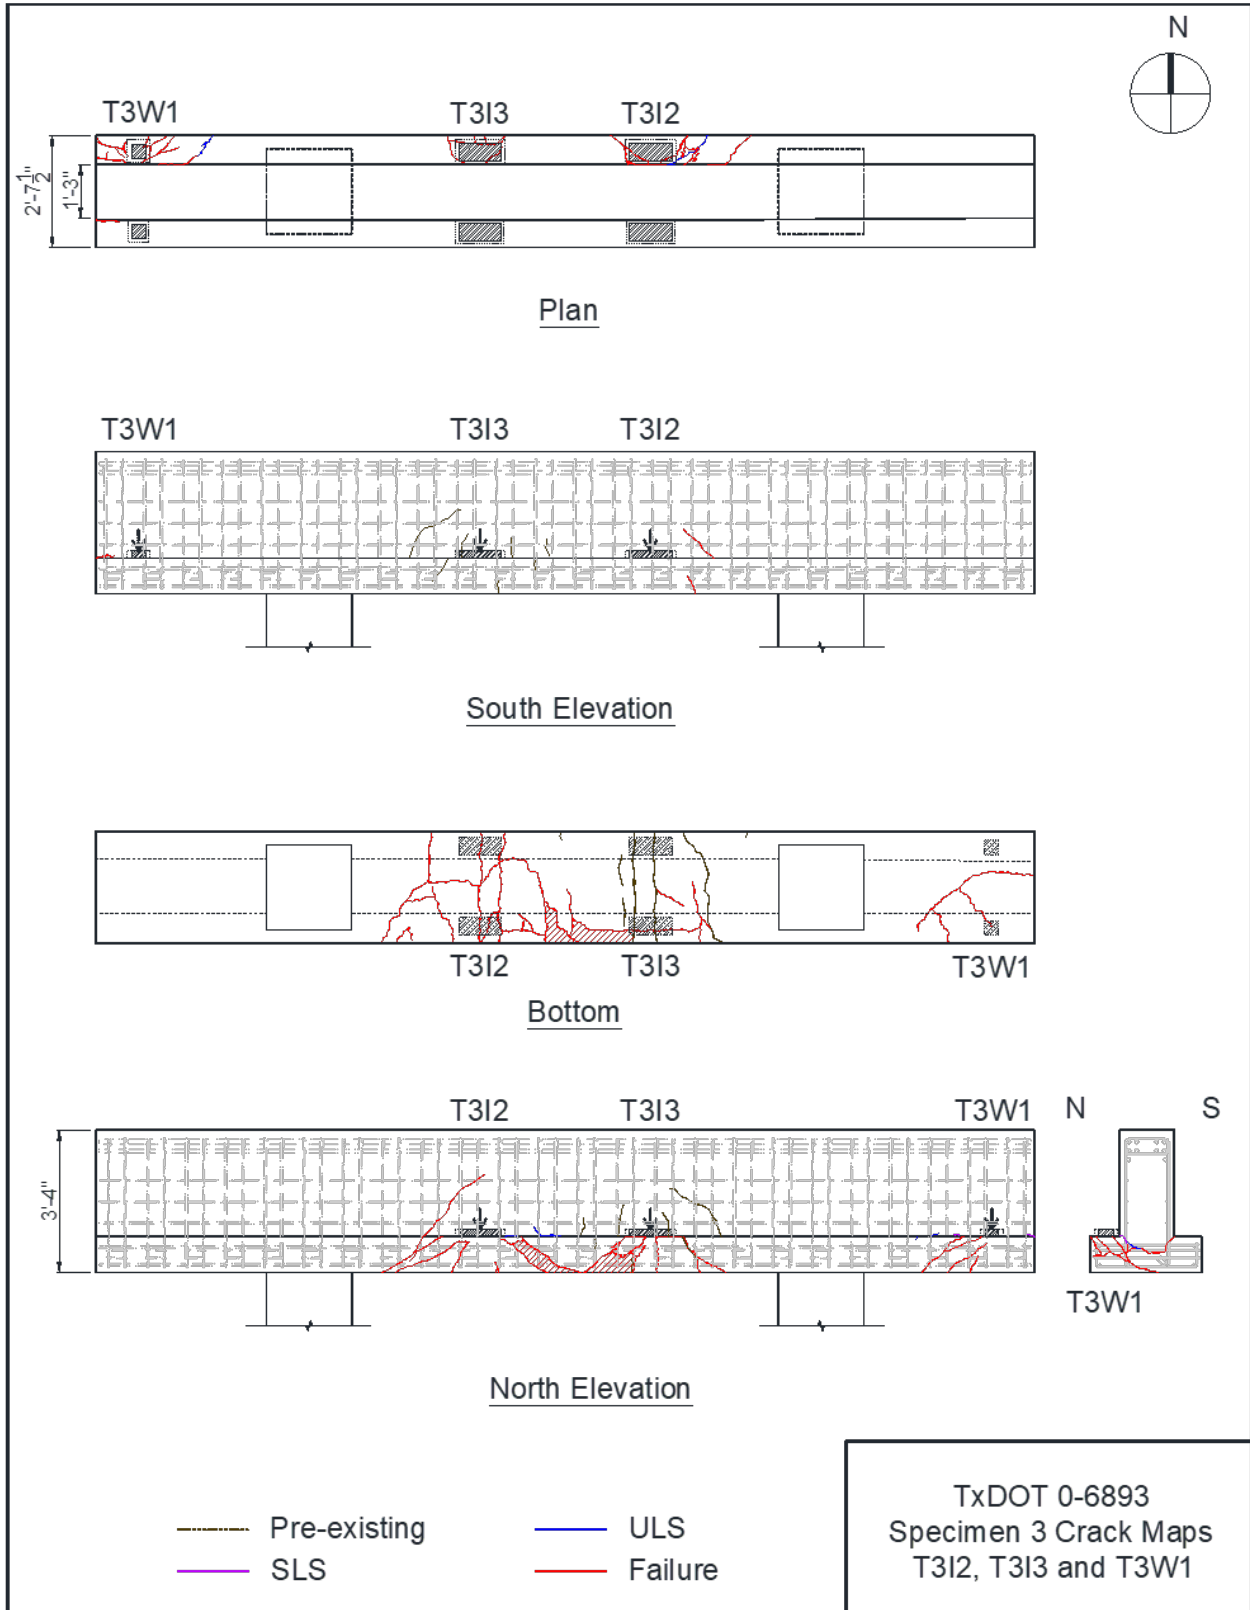
Figure 3.27. Crack Maps for Tests T3I2, T3I3, and T3W1.

The ledge failed as the concrete cone completely formed but with a relatively lower strength of 94 kips, even though it was loaded with the large bearing pad. Therefore, to have one more set of the data, T3I3 was conducted right beside the T3I2 location and loaded up to failure without stopping the load. A similar pattern was observed, and the ledge failed at the same load as T3I2 (94 kips), even though there were preexisting cracks at the location of T3I3 that were caused from T3I1. Moreover, the concrete cones from T3I2 and T3I3 intersected since the loading points were located closer to each other. The set of average crack angles for the concrete cone was 30 to 35 degrees and 40 to 45 degrees for T3I2 and T3I3, respectively.

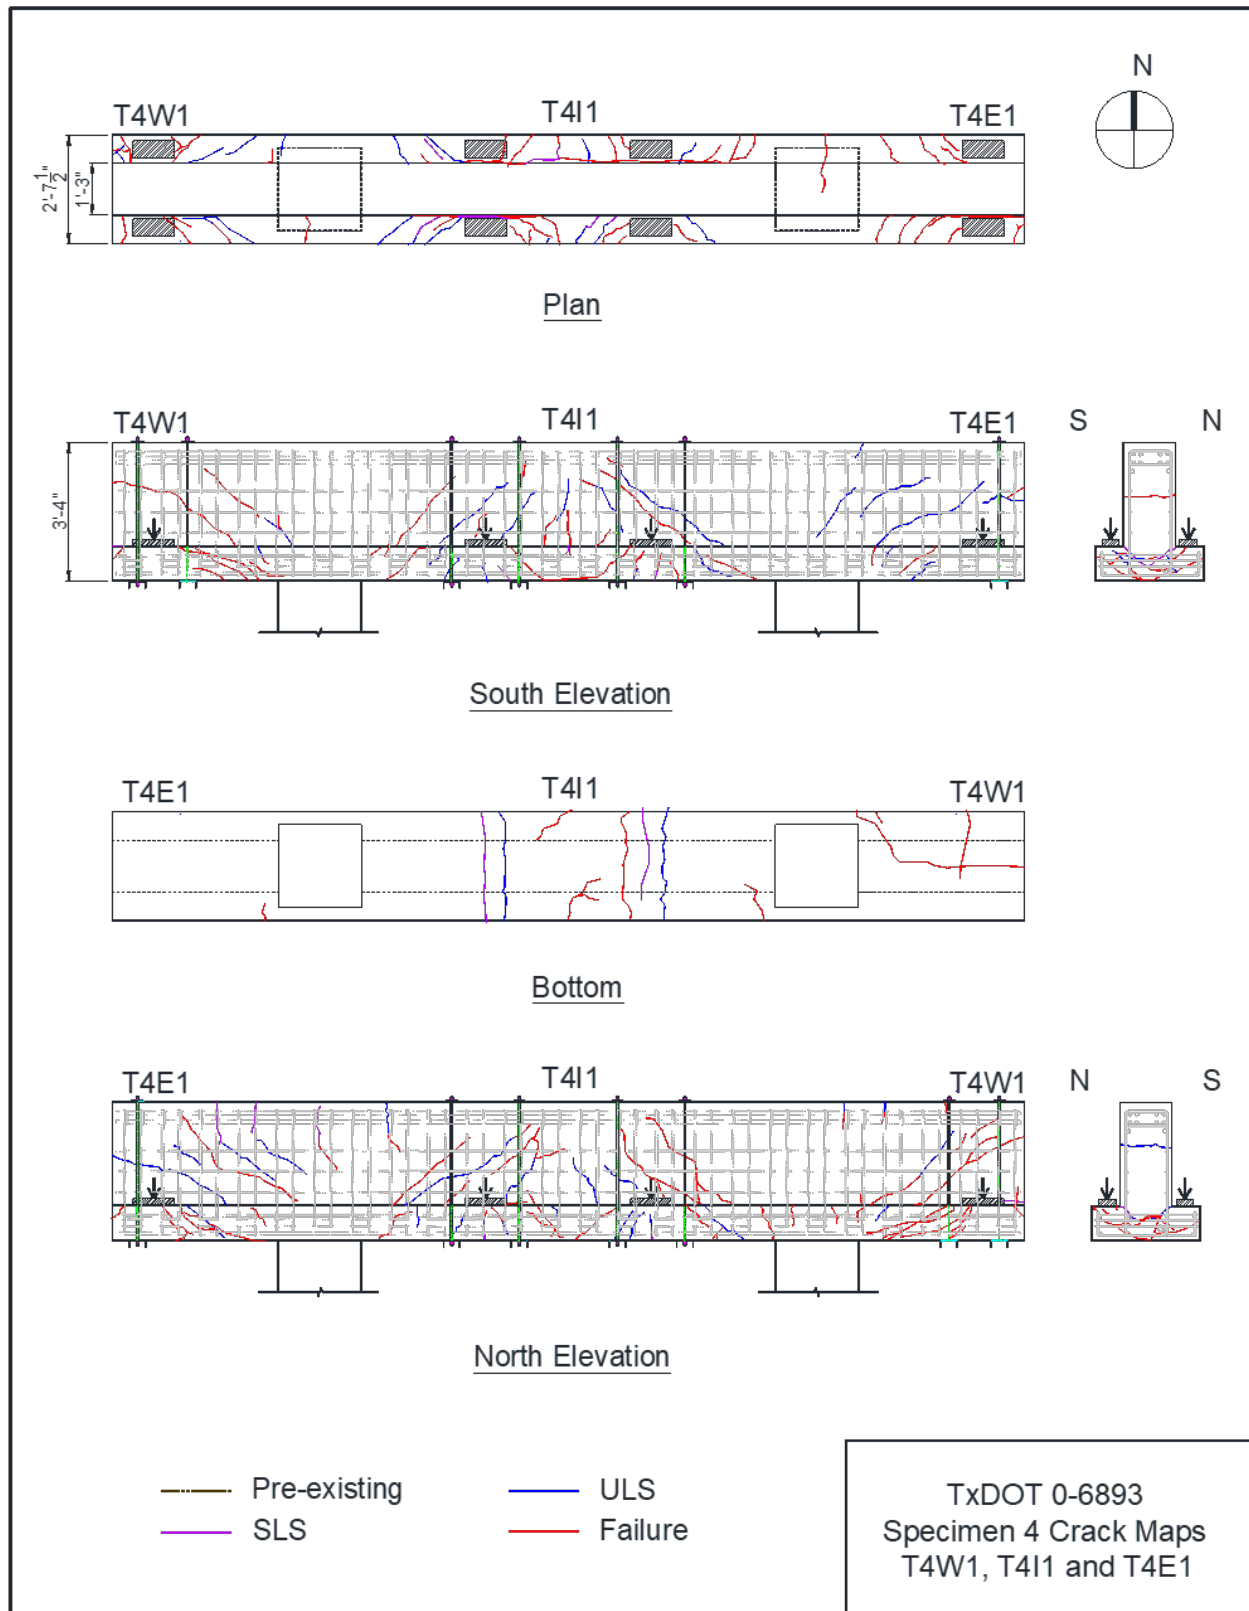
Figure 3.37. Crack Maps for Tests T4W1, T4I1, and T4E1.

After marking the cracks at the measured ultimate load, the bent cap was loaded further. Crack widths increased except on the hanger crack, with wider cracks on the south side ledge. The bent cap lost its load carrying capacity gradually. The test was ended when the load dropped to 71 kips, which was 20 percent lower than the measured ultimate load.

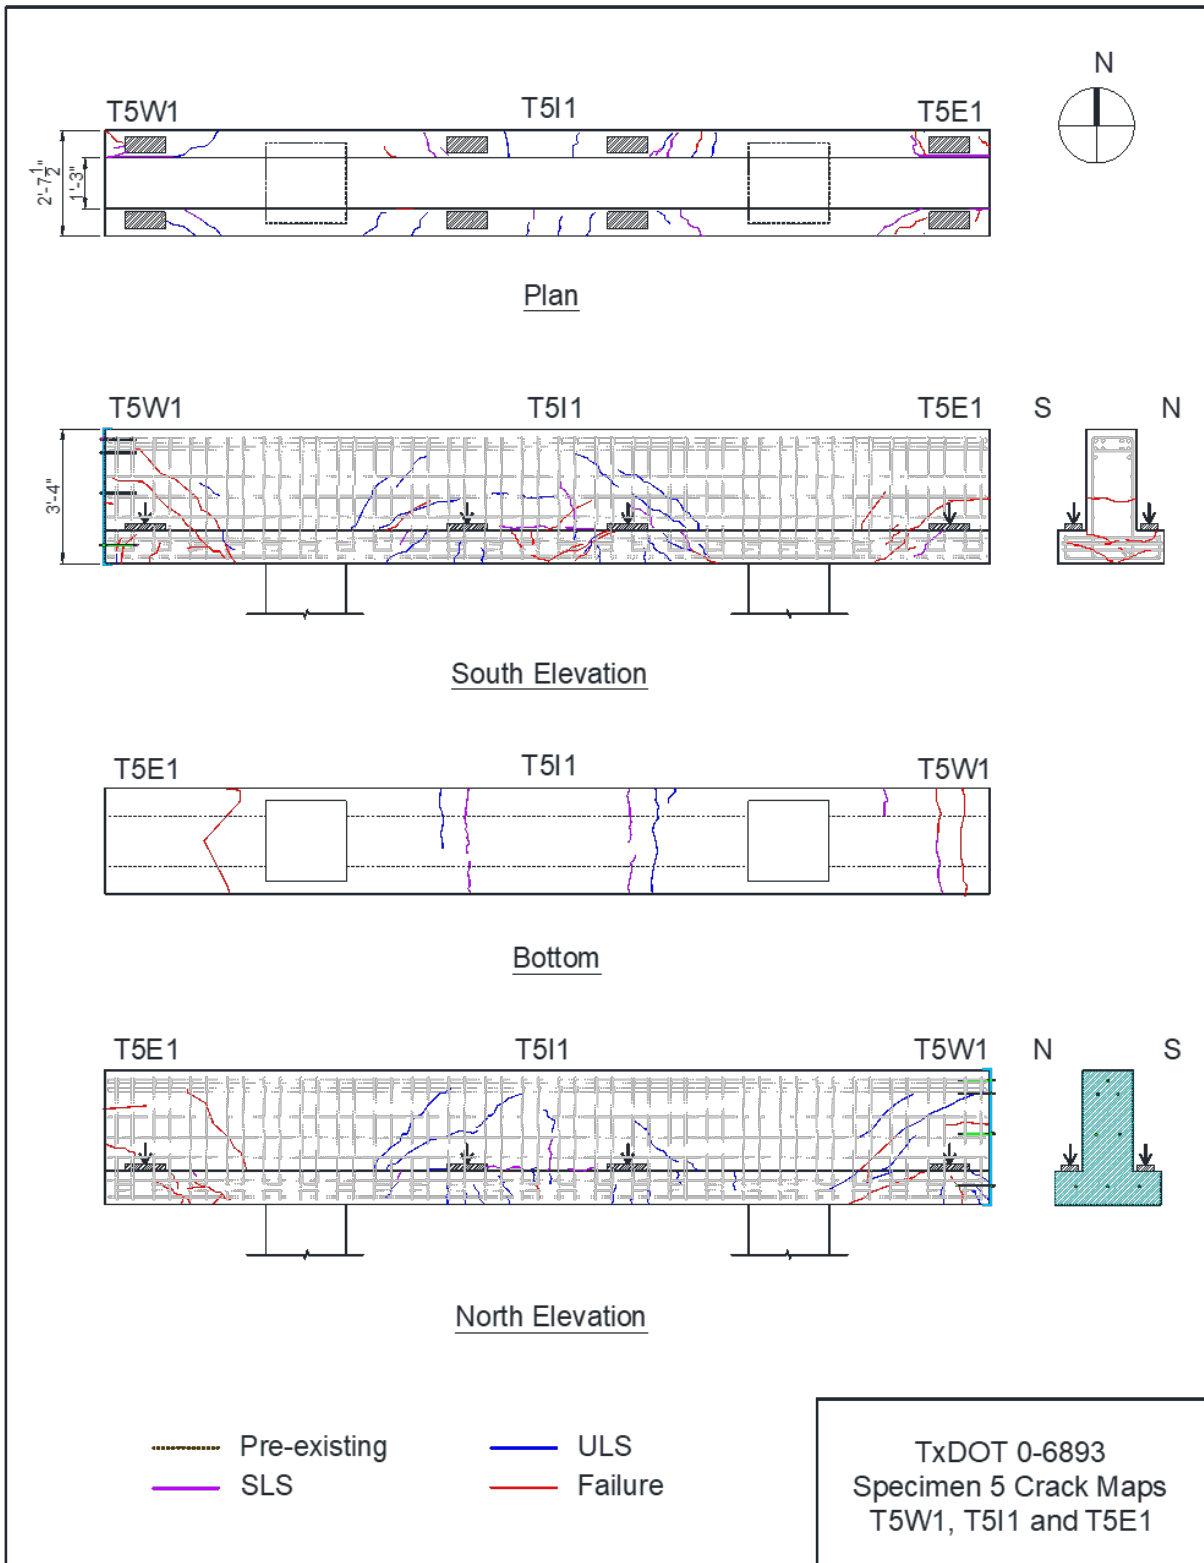
Figure 3.47. Crack Maps for Tests T5W1, T5I1, and T5E1.

The load reached the measured ultimate load of 66 kips, which was less than the ULS demand of 68 kips, and then dropped to 55 kips. Figure 3.49(c) shows the damage on the end face at the measured ultimate load. A hanger crack—horizontal crack through the web on the end face, as shown in Figure 3.49(c)—formed near the neutral axis of the bent cap. More ledge cracks formed on the flange on the end face. The crack near the web-ledge interface on the end face opened up to 2.5 mm. Diagonal shear cracks were present on both sides of the web about 20 in. from the edge of the bearing pad. More cracks also formed at the top and side faces of the ledge.

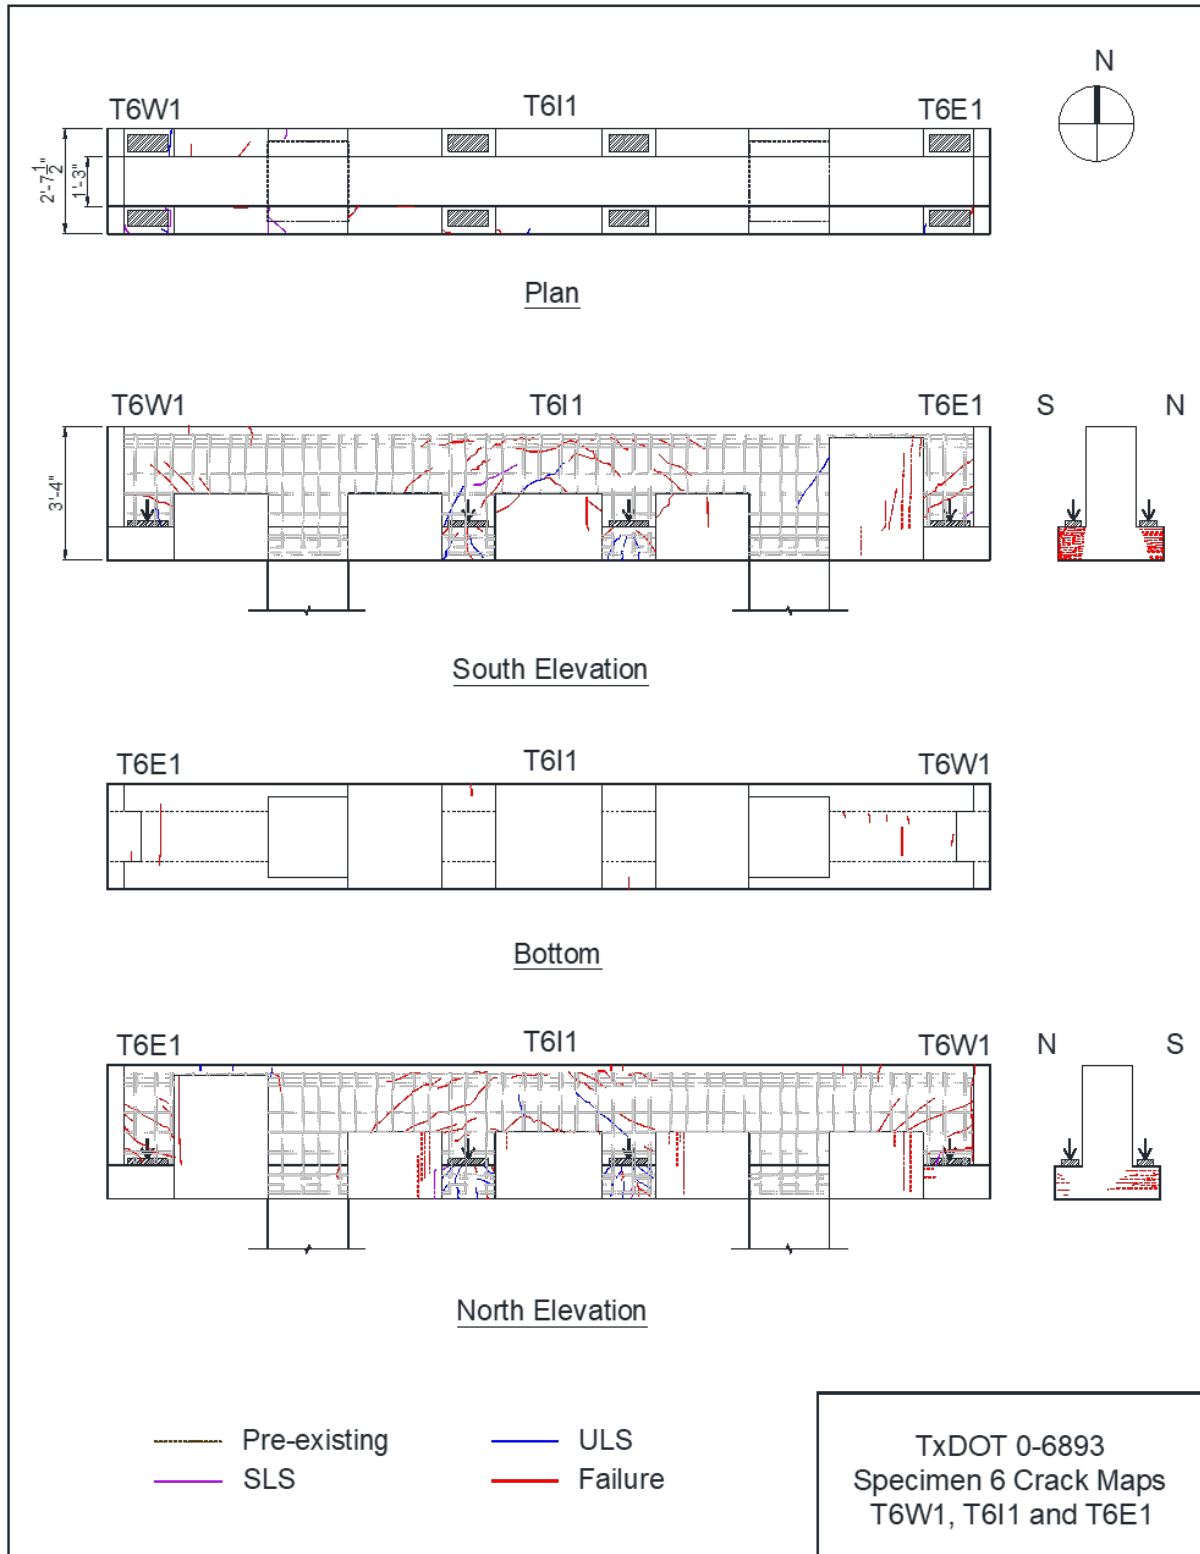
Figure 3.55. Crack Maps for Tests T6W1, T6I1, and T6E1.

After the described damage, the bent cap was loaded again from the load of 90 kips. The load reached a post-peak 90 kips and then gradually decreased. Significant extensions of existing cracks and new crack formations were detected. More horizontal cracks formed on the flange of the end face while the load decreased to 90 kips. Side FRP strip separation was observed at the web-ledge interface. Concrete cover separation was observed on the end of the concrete block and on the side face of the north side ledge. The south side ledge experienced more deflection than the north side. The test was ended when the load dropped to 60 kips, which was 40 percent lower than the measured ultimate load.

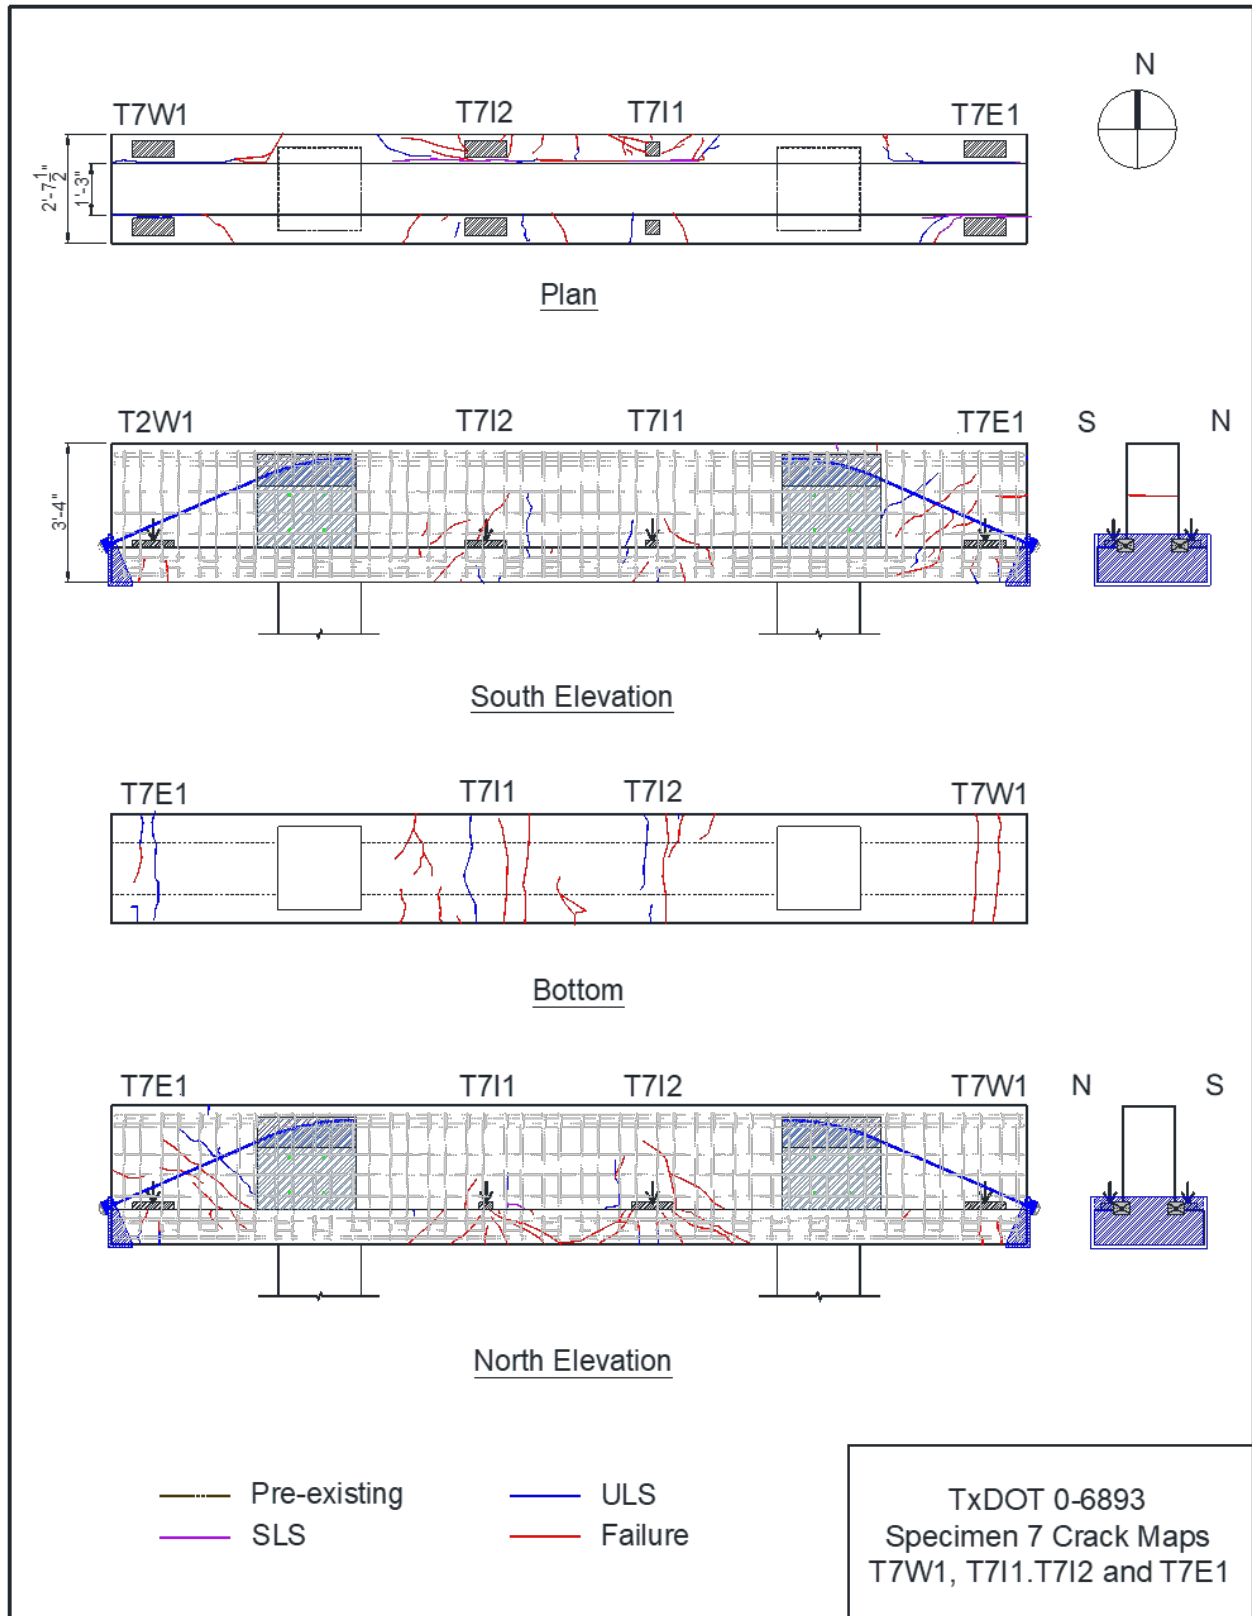
Figure 3.65. Crack Maps for Tests T7W1, T7I1, T7I2, and T7E1.

At the test termination load of 82 kips, the cracks at the web-ledge interface propagated diagonally to the side face of the ledge on both sides of the bent cap. Diagonal cracks on the side face of the ledge under the bearing pads were detected on both sides. Cracks at the bottom of the bent cap propagated at about two-thirds of the ledge toward the center of the bearing pad from the outside. The maximum widths of the interface and ledge cracks were 0.25 mm and 0.1 mm, respectively.
