Test Report No. 440863-03-1

**MASH TEST 4-12 EVALUATION OF A LUMINAIRE POLE BEHIND
SINGLE SLOPE TRAFFIC RAIL**

Texas Department of Transportation

TEXAS A&M TRANSPORTATION INSTITUTE PROVING GROUND

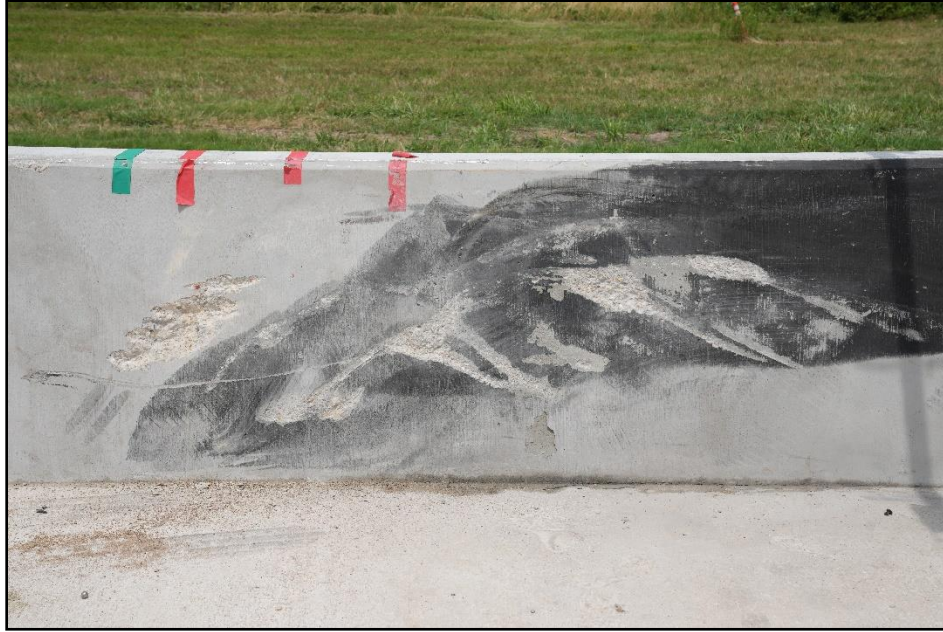
Test Parameter	Measured
Permanent Deflection/Location	0 inches
Dynamic Deflection	0 inches
Working Width ^a and Height	57.9 inches, at a height of 123.2 inches, at the back left corner of the box at impact with the luminaire pole

Figure 5.5. Perpendicular View of Luminaire Pole behind Single Slope Traffic Rail at Impact Location after Test 440863-03-1.

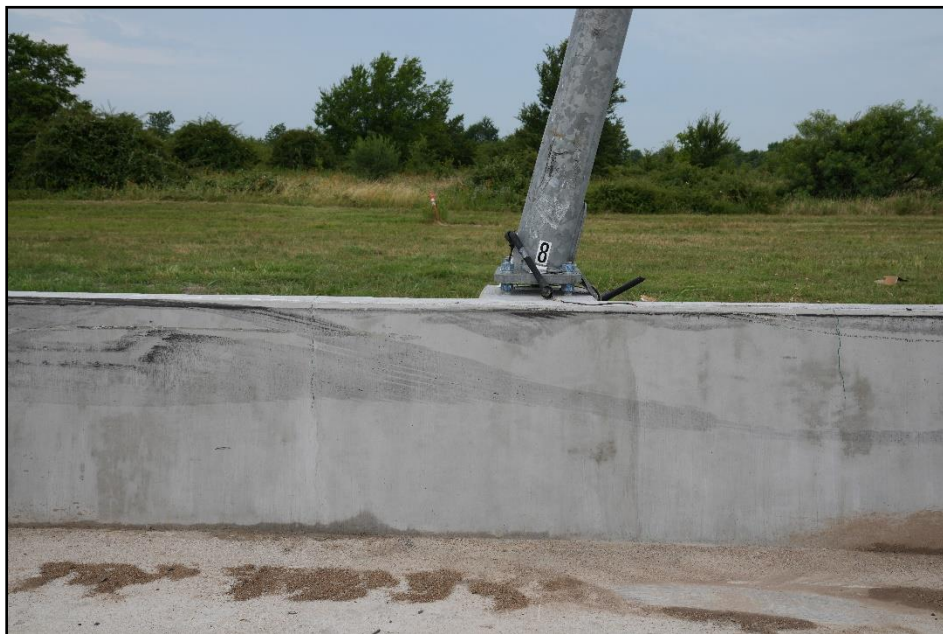
Figure 5.6. Traffic Side View of the Damage to the Base of the Luminaire Pole after Test 440863-03-1.

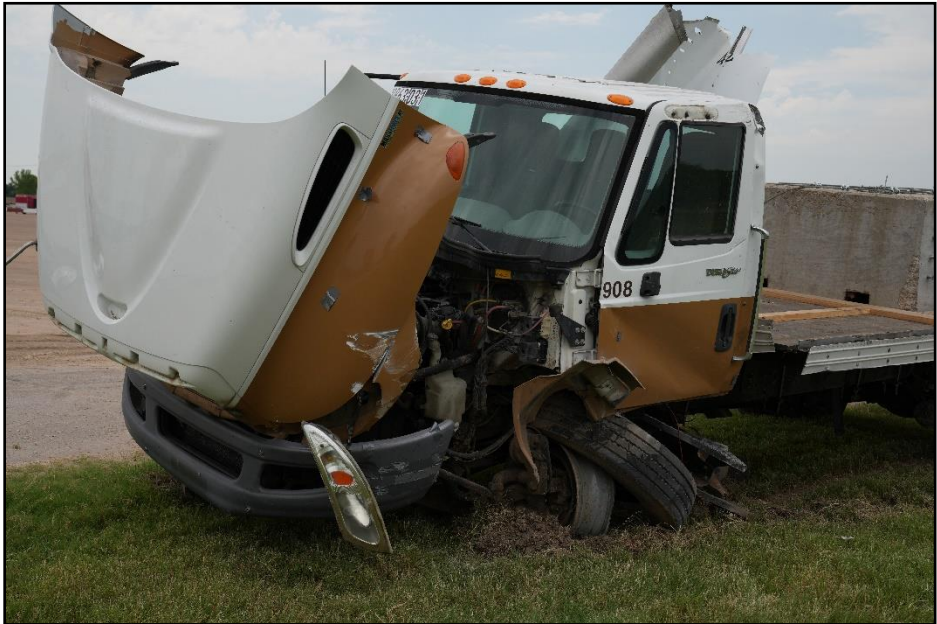
Figure 5.7. Impact Side of Test Vehicle after Test 440863-03-1.

Side Windows	Side windows remained intact.
Maximum Exterior Deformation	14 inches in the left fender.
VDS	11LFQ7.
CDC	01FLWH3.
Fuel Tank Damage	None.
Description of Damage to Vehicle:	The left front bumper, grill, left front headlight, left fender, left front wheel, left front tire, left side mirror, left door, top left side, top of box, steps, air tanks, and the left rear outer tire and wheel were damaged. There was a 3-inch-wide × 4-inch-long × 1-inch-deep dent on the top of the door frame on impact side. The top and sides of the box were pulled off. The floorpan had a 2-ft-long and 7-inch-high separation at a seam. The seam separation in the floor pan of the vehicle was not caused by intrusion of the test article, but due to the flexing of the vehicle during the crash.

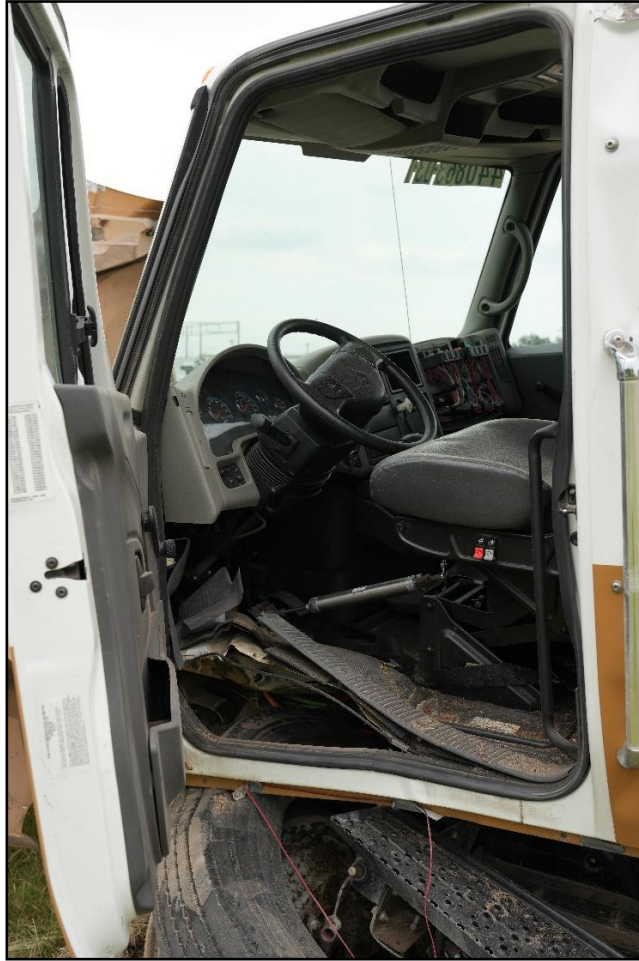
Figure 5.9. Overall Interior of Test Vehicle after Test 440863-03-1.

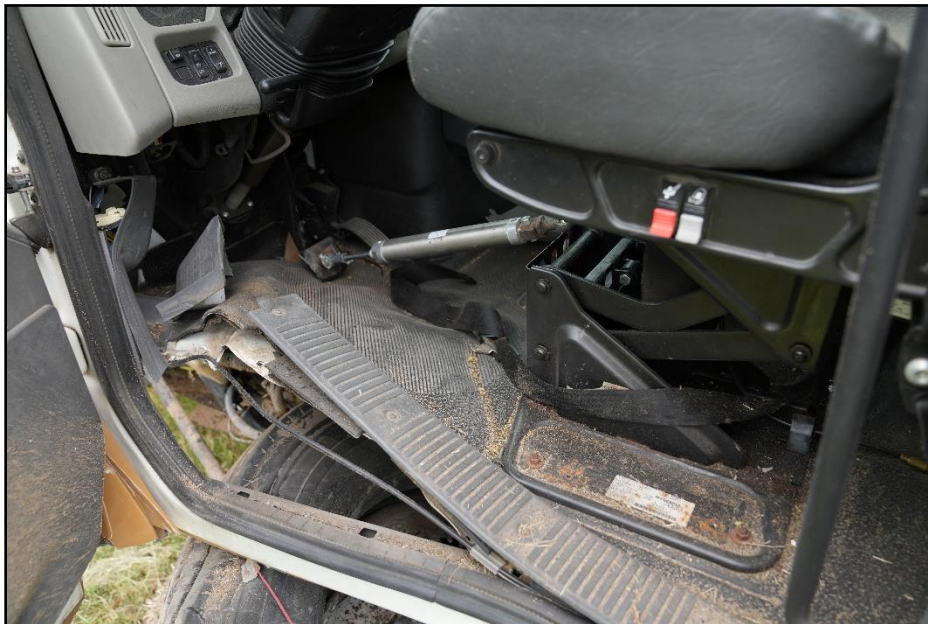
Figure 5.10. Interior of Test Vehicle on Impact Side after Test 440863-03-1.
