Evaluating Candidate Projects for Seal Coat Stability

Technical Report 0-7106-R1

TEXAS A&M TRANSPORTATION INSTITUTE
COLLEGE STATION, TEXAS

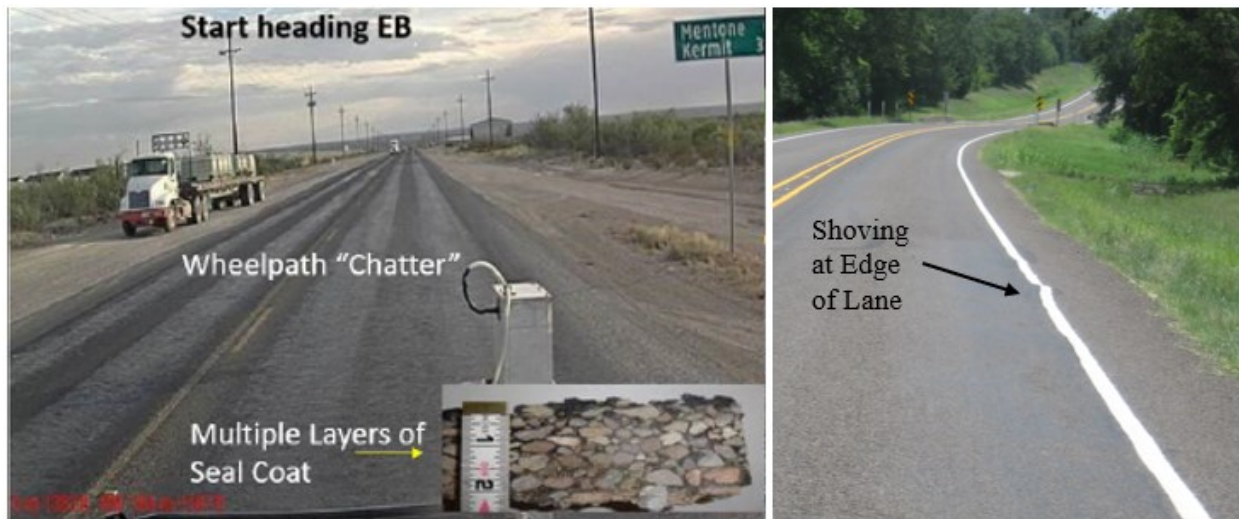
Figure 1. Potential Issues with Multiple Seal Coats on Pavement Sections.

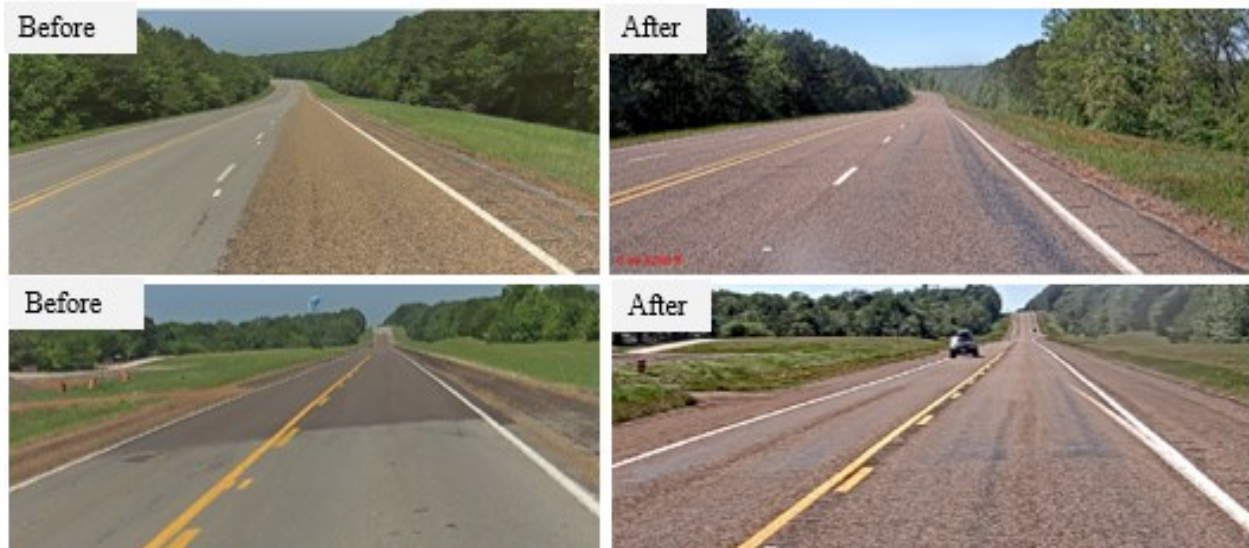
Figure 30. Site 1 Before and After Seal Coat Construction.

Description	Results
ADT (veh/day)	1,653
Trucks (%)	7.6
Precipitation (inches/year)	49
Climate zone	East Texas
Estimated date of first frost	12/1
Binder application rate (gal/yd ²): AC20-5TR	0.33
Aggregate application rate (yd ² /yd ³): PB ¹ grade 4	148
Construction date	2022
Texture (mils): 6/16/2022	n/a
Texture after seal coat (mils): 3/23/2023	93.4
Second texture after seal coat (mils): 5/9/2024	69.4
Observations	Preparatory work affected the seal coat. Otherwise, seal coat was applied at a good rate with no excessive flushing or rock loss.

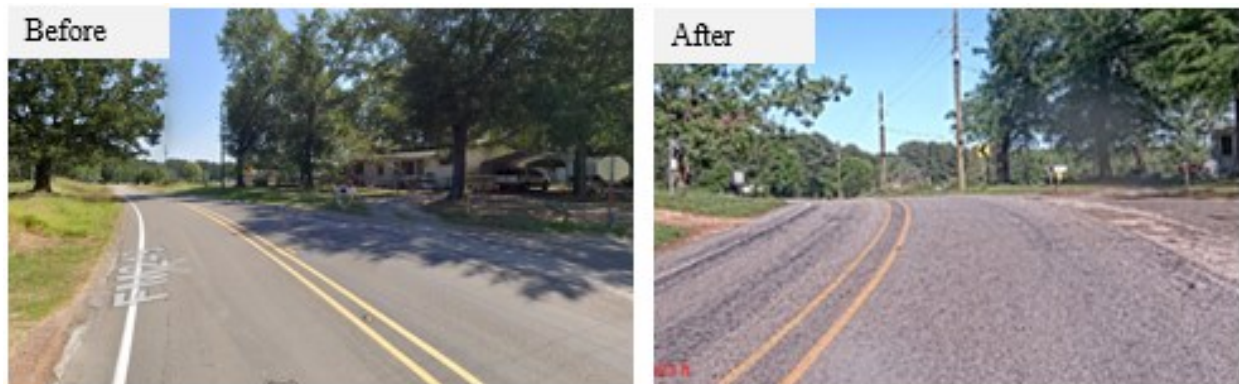
Figure 32. Site 3 Before [9] and After Seal Coat Construction.

Description	Results
ADT (veh/day)	1,197
Trucks (%)	6.9
Precipitation (inches/year)	49
Climate zone	East Texas
Estimated date of first frost	12/1
Binder application rate (gal/yd ²): AC20-5TR	0.36
Aggregate application rate (yd ² /yd ³): PB ¹ grade 4	142
Construction date	6/19/2023
Texture (mils): 5/15/2023	36
Texture after seal coat (mils): 7/7/2023	85.4
Second texture after seal coat (mils): 5/9/2024	56.6
Observations	Seal coat was applied at a good rate with no excessive flushing or rock loss. However, some signs of flushing were observed.

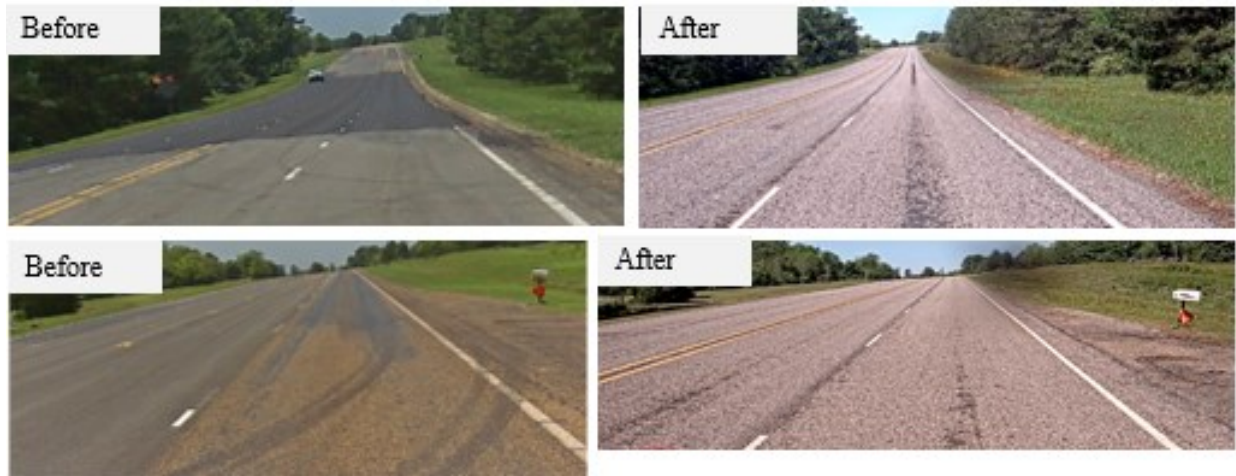
Figure 33. Site 4 Before and After Seal Coat Construction.

Description	Results
ADT (veh/day)	1,197
Trucks (%)	6.9
Precipitation (inches/year)	49
Climate zone	East Texas
Estimated date of first frost	12/1
Binder application rate (gal/yd ²): AC20-5TR	0.36
Aggregate application rate (yd ² /yd ³): PB ¹ grade 4	142
Construction date	6/19/2023
Texture (mils): 5/15/2023	36
Texture after seal coat (mils): 7/7/2023	85.4
Second texture after seal coat (mils): 5/9/2024	56.6
Observations	Seal coat was applied at a good rate with no excessive flushing or rock loss. However, some signs of flushing and raveling were observed between the wheel paths.

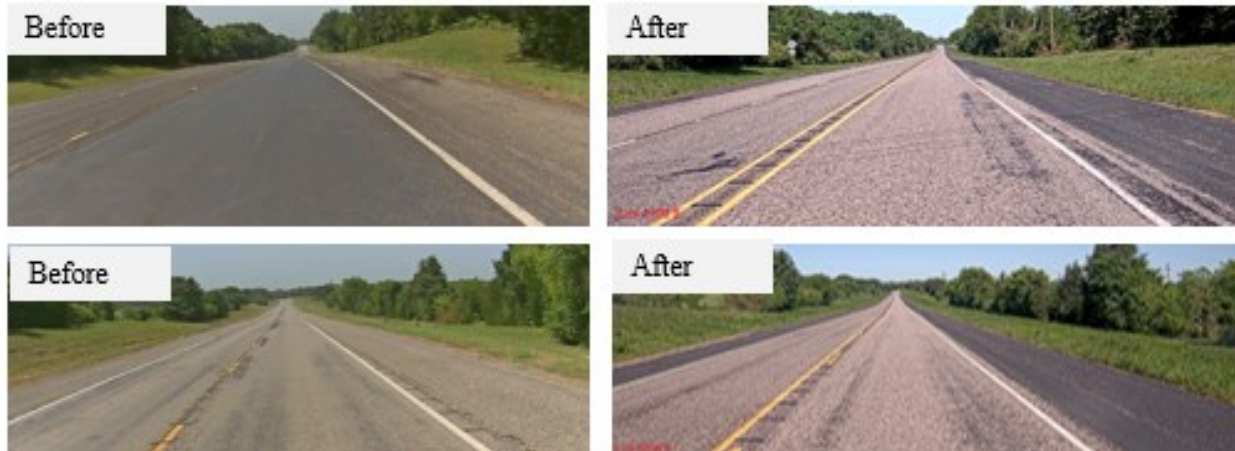
Figure 34. Site 5 Before and After Seal Coat Construction.

Description	Results
ADT (veh/day)	2,181
Trucks (%)	7.6
Precipitation (inches/year)	49
Climate zone	East Texas
Estimated date of first frost	12/1
Binder application rate (gal/yd ²): AC20-5TR	0.34
Aggregate application rate (yd ² /yd ³): PB ¹ grade 4	145
Construction date	6/24/2023
Texture (mils): 5/17/2023	46
Texture after seal coat (mils): 7/6/2023	92
Second texture after seal coat (mils): 5/13/2024	78
Observations	Preparatory work affected the seal coat. Some flushing was observed in the wheel paths.

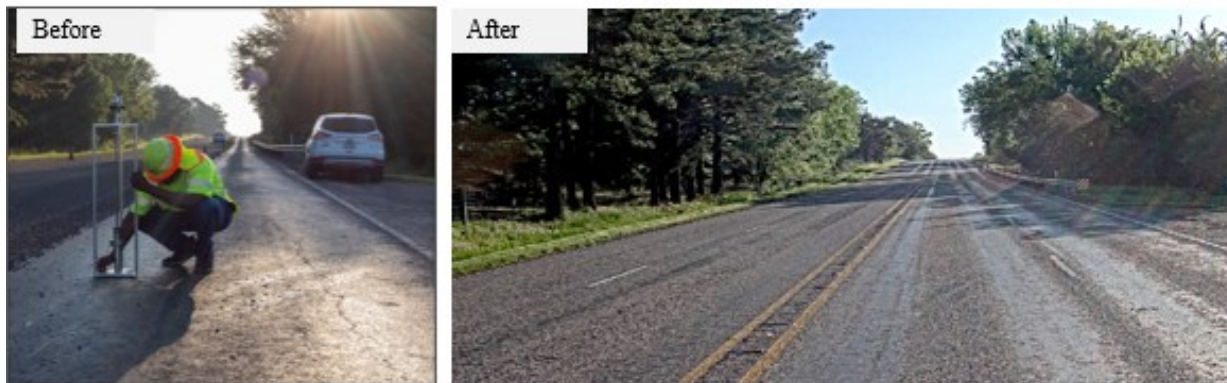
Figure 36. Site 6x Before and After Seal Coat Construction.

Description	Results
ADT (veh/day)	7,975
Trucks (%)	12.2
Precipitation (inches/year)	49
Climate zone	East Texas
Estimated date of first frost	11/27
Binder application rate (gal/yd ²): AC20-5TR	0.34
Aggregate application rate (yd ² /yd ³): PB ¹ grade 4	145
Construction date	6/29/2023
Before Construction Texture (mils): n/a	n/a
Texture after seal coat (mils): 7/7/2023	96.6
Second texture after seal coat (mils): 4/11/2024	79.4
Observations	Flushing was observed in the wheel paths.

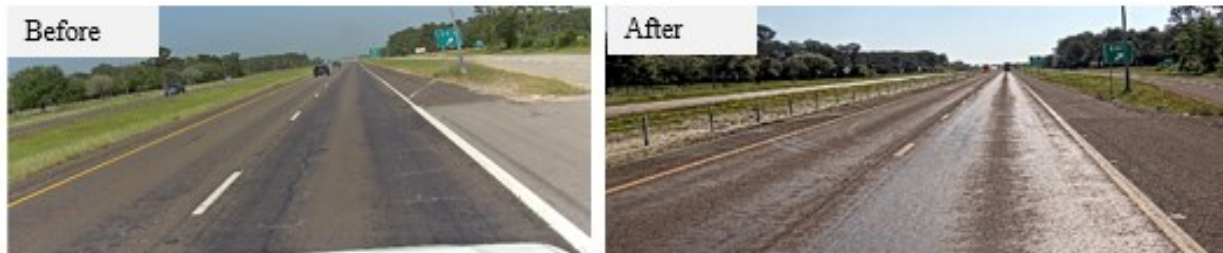
Figure 38. Site 8 Before and After Seal Coat Construction.

Description	Results
ADT (veh/day)	7,586
Trucks (%)	19.4
Precipitation (inches/year)	56
Climate zone	Upper Coast
Estimated date of first frost	1/
Binder application rate (gal/yd ²): AC20-5TR	0.34
Aggregate application rate (yd ² /yd ³): PL ¹ grade 4	129
Construction date	5/8/2023
Texture (mils): K1-3/15/2023, K2-3/16/2023	28.1
Texture after seal coat (mils): 5/24/2023	46.3
Second texture after seal coat (mils): 5/9/2024	28.1
Observations	Existing flushing affected the new seal coat, which has excessive flushing in the wheel paths. Rock loss may have led to the flushing.

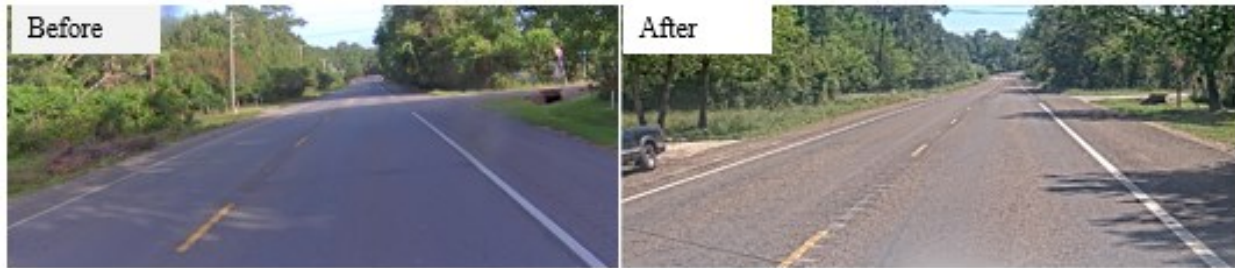
Figure 40. Site 10 Before and After Seal Coat Construction.

Description	Results
ADT (veh/day)	4,528
Trucks (%)	2.4
Precipitation (inches/year)	56
Climate zone	Upper Coast
Estimated date of first frost	1/1
Binder application rate (gal/yd ²): AC20-5TR	0.36
Aggregate application rate (yd ² /yd ³): PL ¹ grade 4	139
Construction date	5/3/2023
Texture (mils): 3/16/2023	25.1
Texture after seal coat (mils): 5/16/2023	78
Second texture after seal coat (mils): 5/9/2024	51.0
Observations	Slight flushing was observed in the wheel paths with some rock loss.

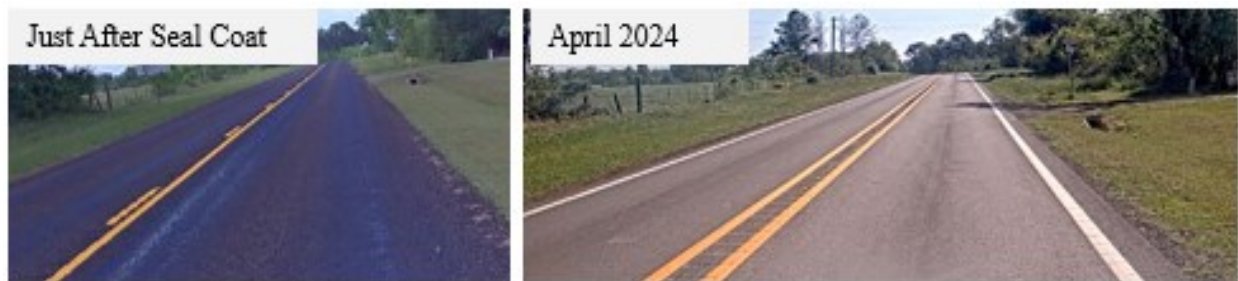
Figure 41. Site 11 Before and After Seal Coat Construction.

Description	Results
ADT (veh/day)	757
Trucks (%)	21
Precipitation (inches/year)	48
Climate zone	East Texas
Estimated date of first frost	12/1
Binder application rate (gal/yd ²): AC20-5TR	0.33
Aggregate application rate (yd ² /yd ³): PL ¹ grade 4	148
Construction date	2022
Texture (mils): 6/1/2022	83.04
Texture after seal coat (mils): 3/15/2022	66.3
Second texture after seal coat (mils): n/a	n/a, overlaid
Observations	Excessive bleeding led to an overlay within 1 year of construction. Seal coat application rate was fairly low, which may indicate that the existing pavement also had excessive bleeding in the wheel paths.

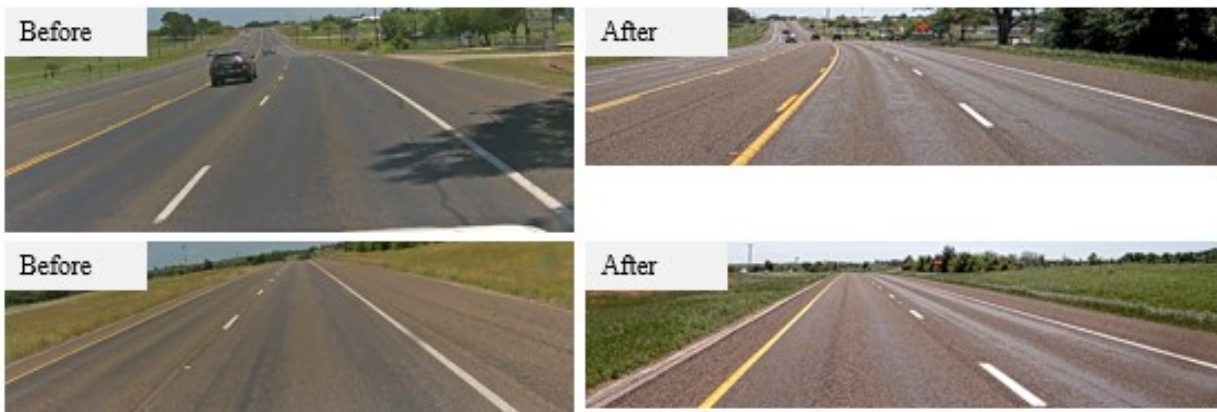
Figure 42. Site 13 Before and After Seal Coat Construction.

Description	Results
ADT (veh/day)	6,035
Trucks (%)	20.4
Precipitation (inches/year)	42
Climate zone	South Central
Estimated date of first frost	12/12
Binder application rate (gal/yd ²): AC20-5TR	0.34
Aggregate application rate (yd ² /yd ³): PL ¹ grade 4	132
Construction date	6/6/2023
Texture (mils): 4/25/2023	34.4
Texture after seal coat (mils): 6/12/2023	52.1
Second texture after seal coat (mils): 5/9/2024	33.0
Observations	Existing flushing affected the new seal coat, which has excessive flushing in the wheel paths. Rock loss may have led to flushing.

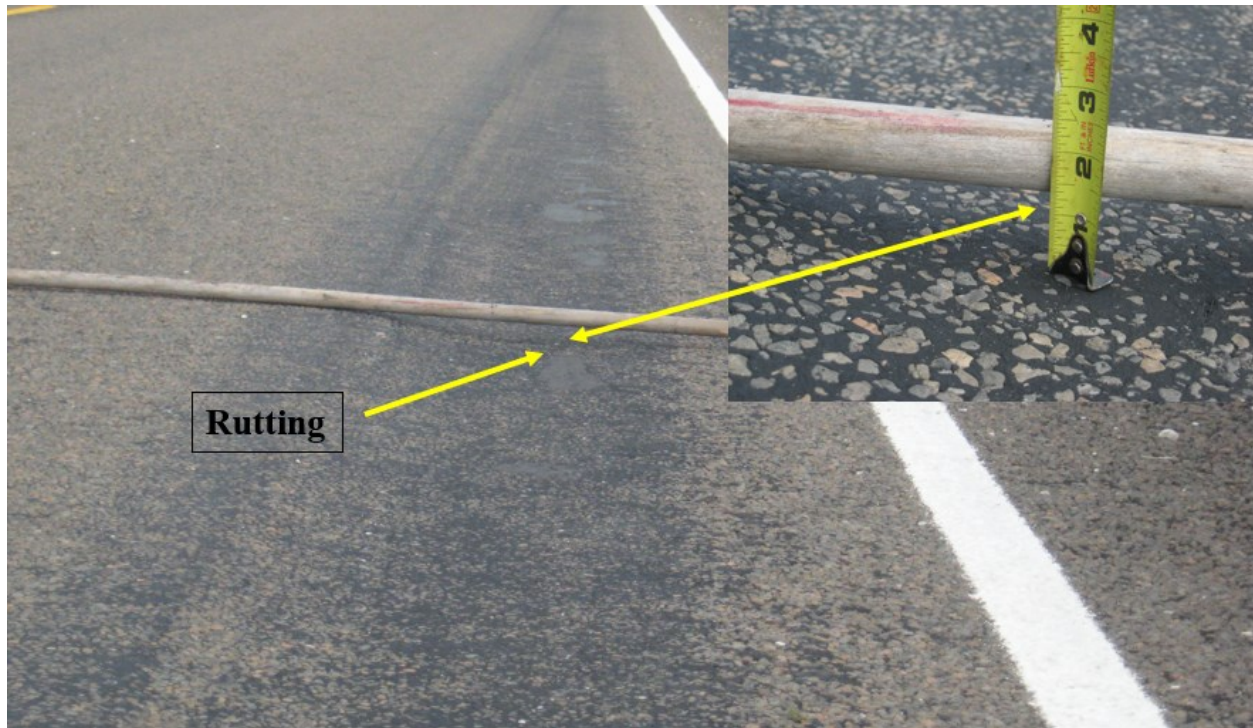
Figure 51 shows an example of severe rutting, with values ranging from 1.0 to 1.99 inches.

Figure 51. Example of Severe Rutting (from 1.0 to 1.99 inches).

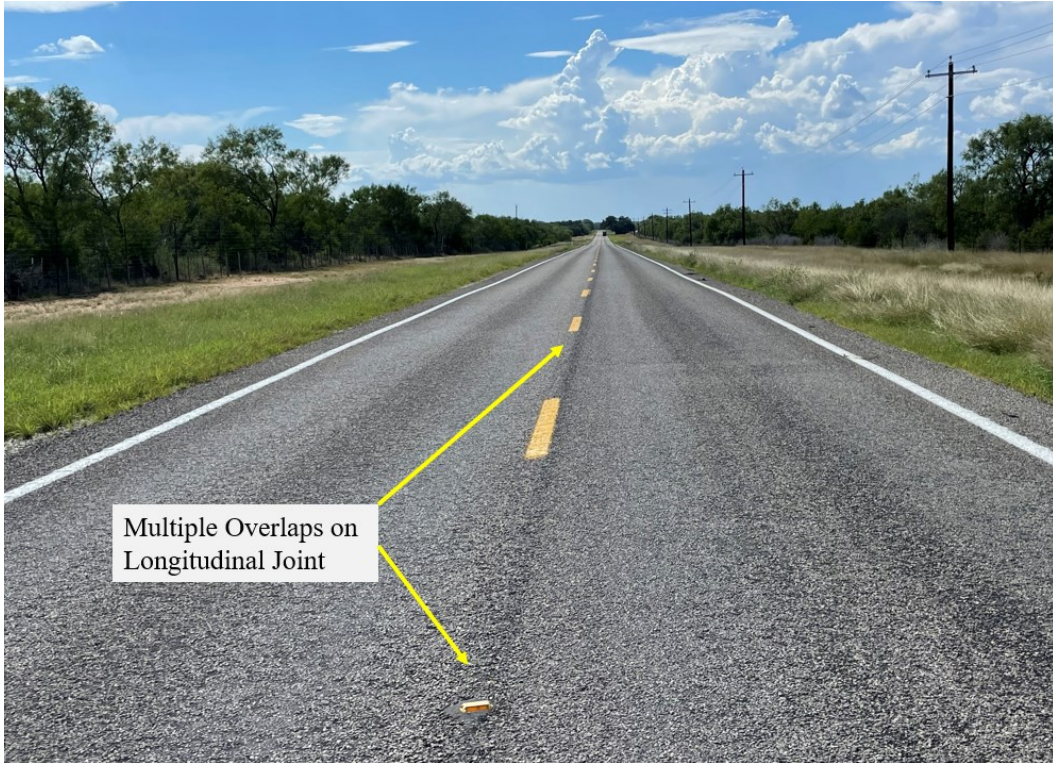
Figure 52. Example of Multiple Seal Coats Overlapping Along a Longitudinal Joint.

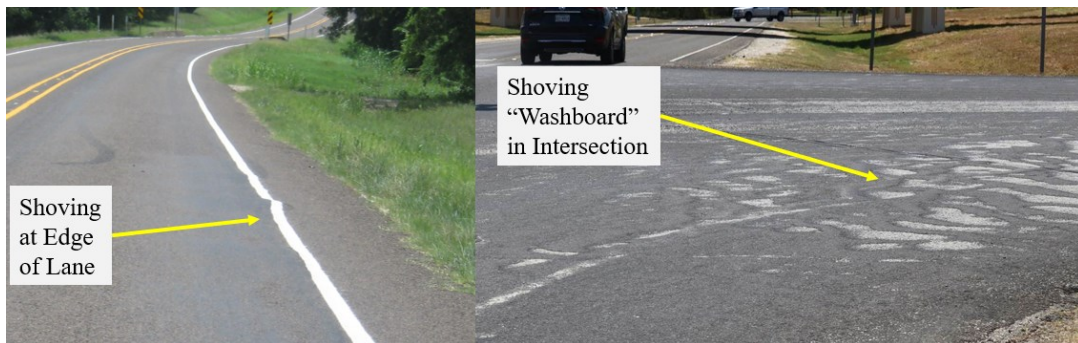
Figure 53. Examples of Shoving at an Edge Line and Intersection.

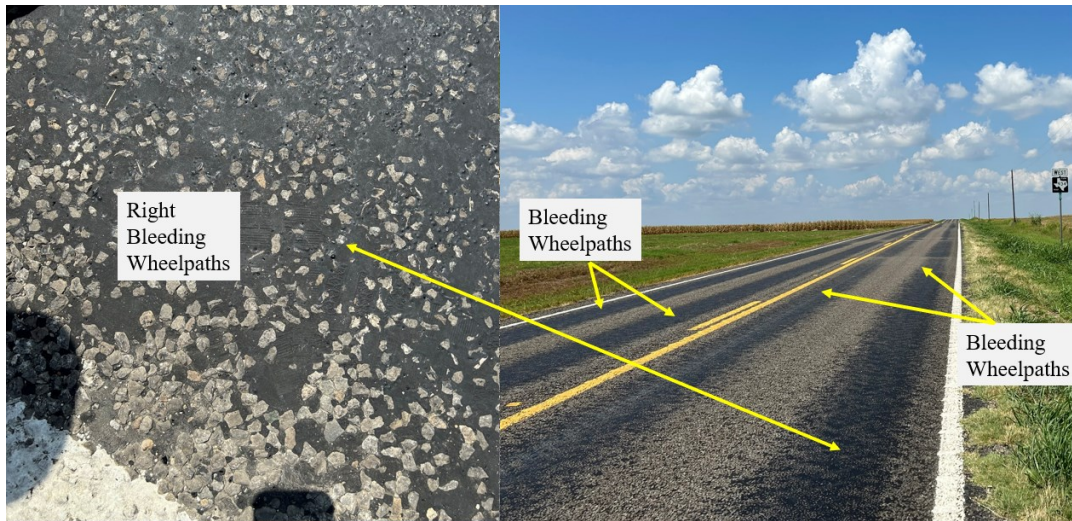
Figure 54. Example of Bleeding in the Wheel Paths.

2. If bleeding or flushing is the only concern:
 - a. Use single-size gradation for grade 3 aggregate and transverse variable rates during construction.

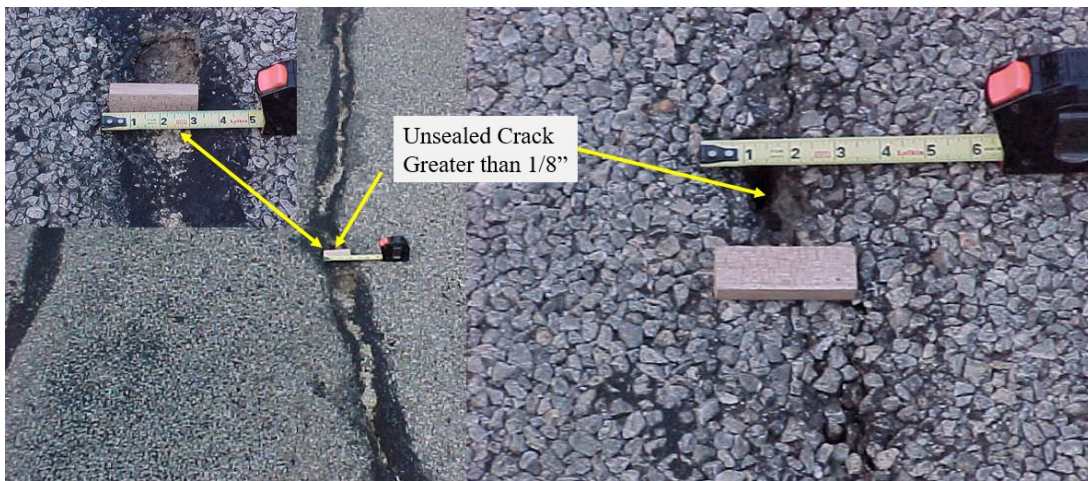
Figure 55. Example of Unsealed Cracks Greater than 0.125-inch Wide.

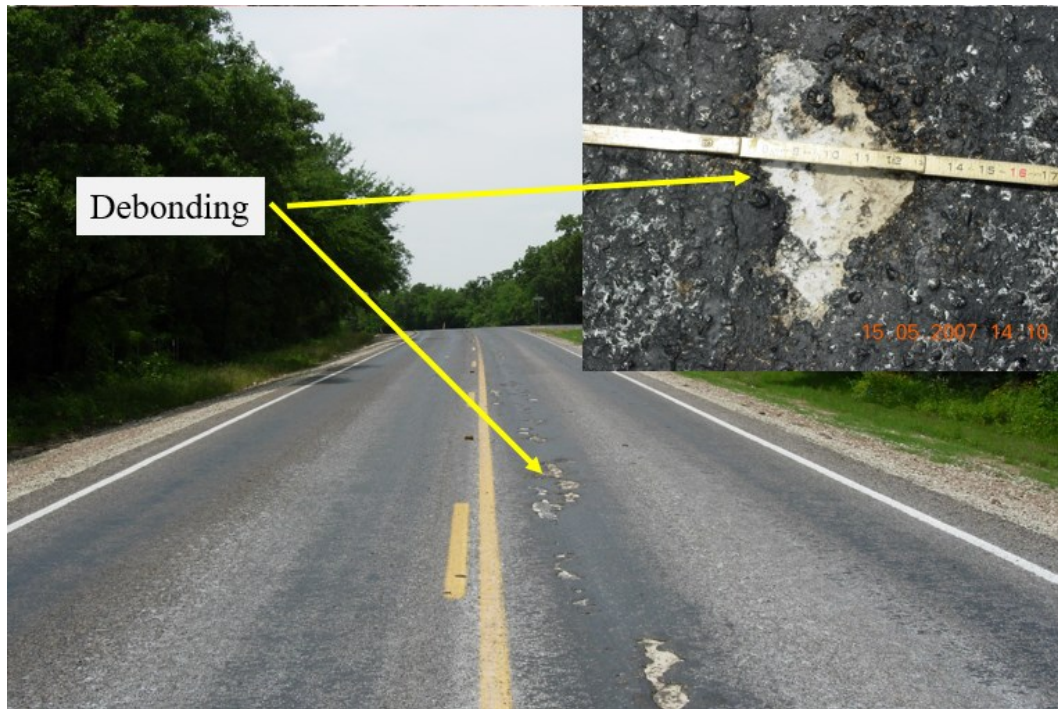
Figure 56. Example of Seal Coat Debonding from the Base Course.

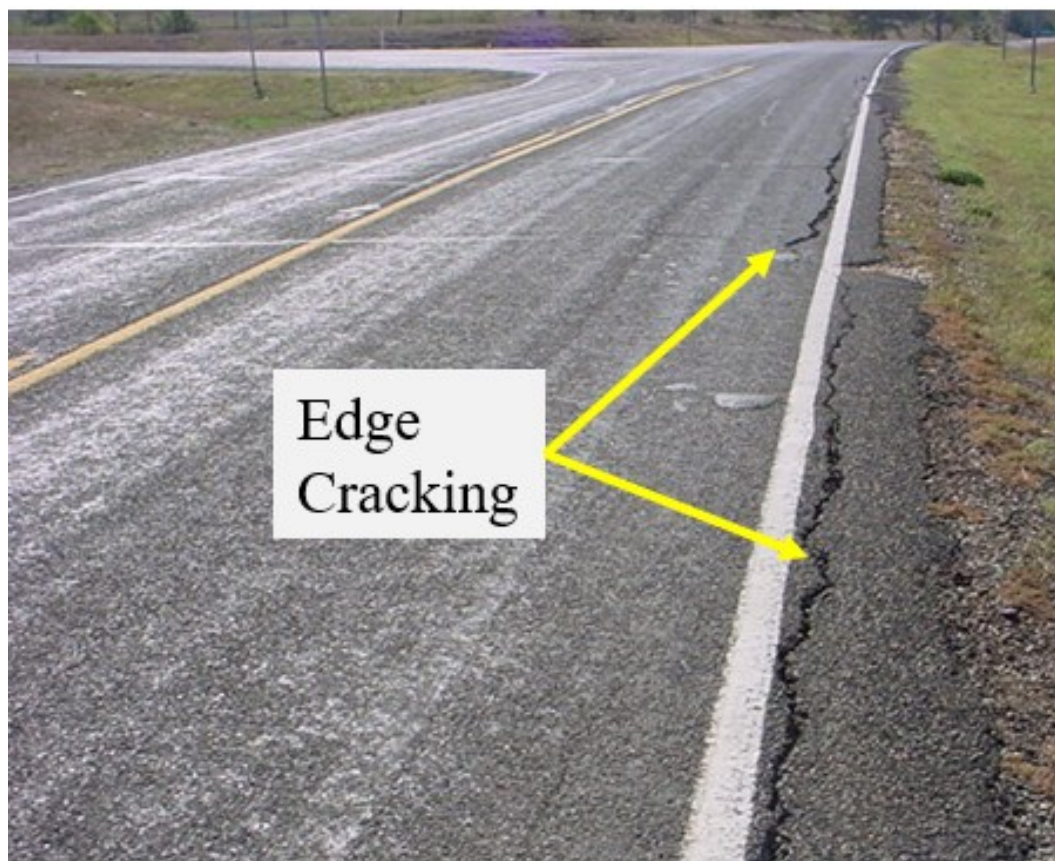
Figure 57. Example of Edge Cracking.
