COMPLIANCE TESTING OF AN END TREATMENT FOR THE LOW-PROFILE CONCRETE BARRIER

Report 1403-S
Research Study Number 0-1403
Research Study Title: Development of a High-Speed
Low-Profile Concrete Barrier

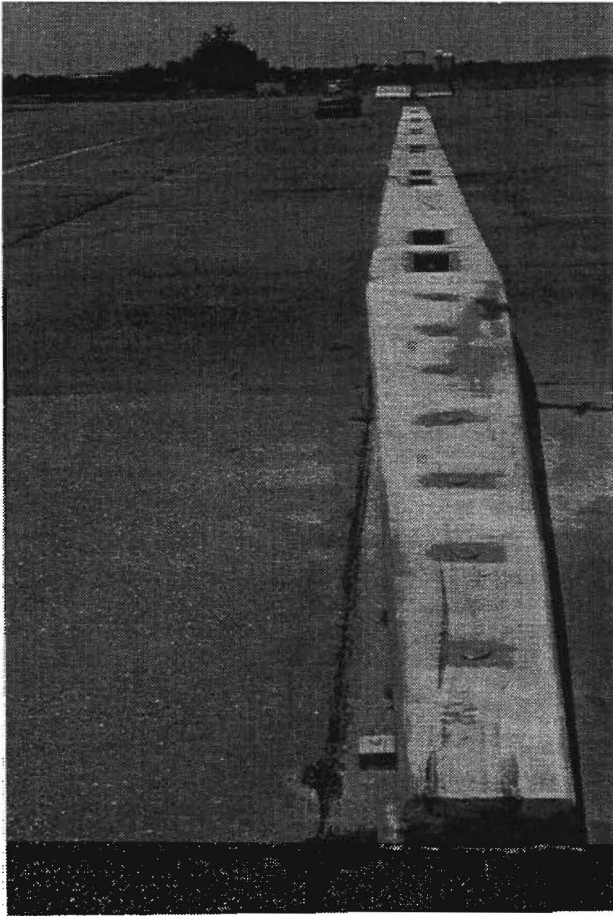
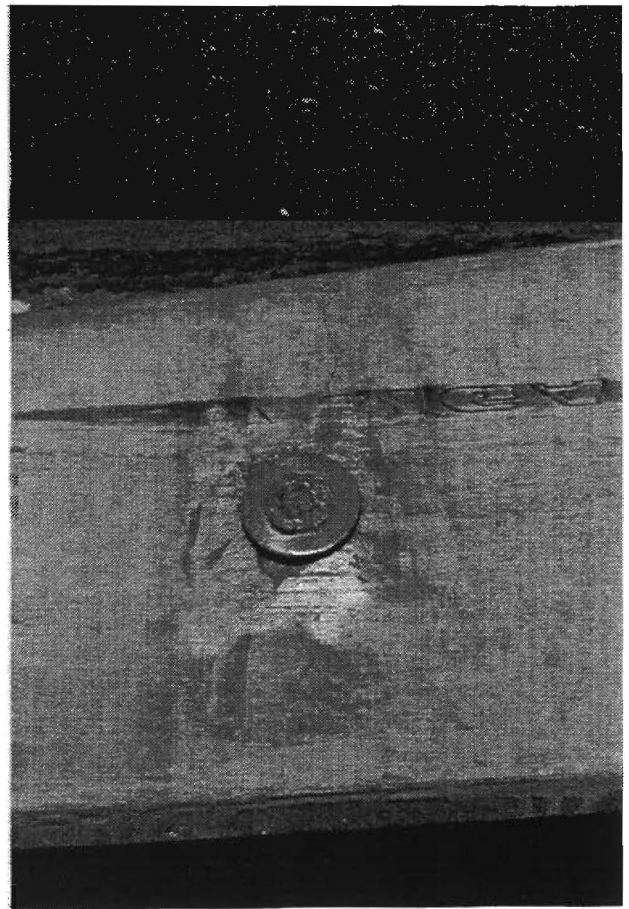
Figure 9. Low-Profile End Treatment After Test 1949A-2

The end treatment received minimal damage. Cosmetic damage (i.e., tire marks) occurred, as shown in Figure 9, and there was a hairline crack across the end treatment at the first bolt location on the end treatment (0.8 m from the end). The end treatment showed no movement. The vehicle was in contact with the installation for 14.1 m.

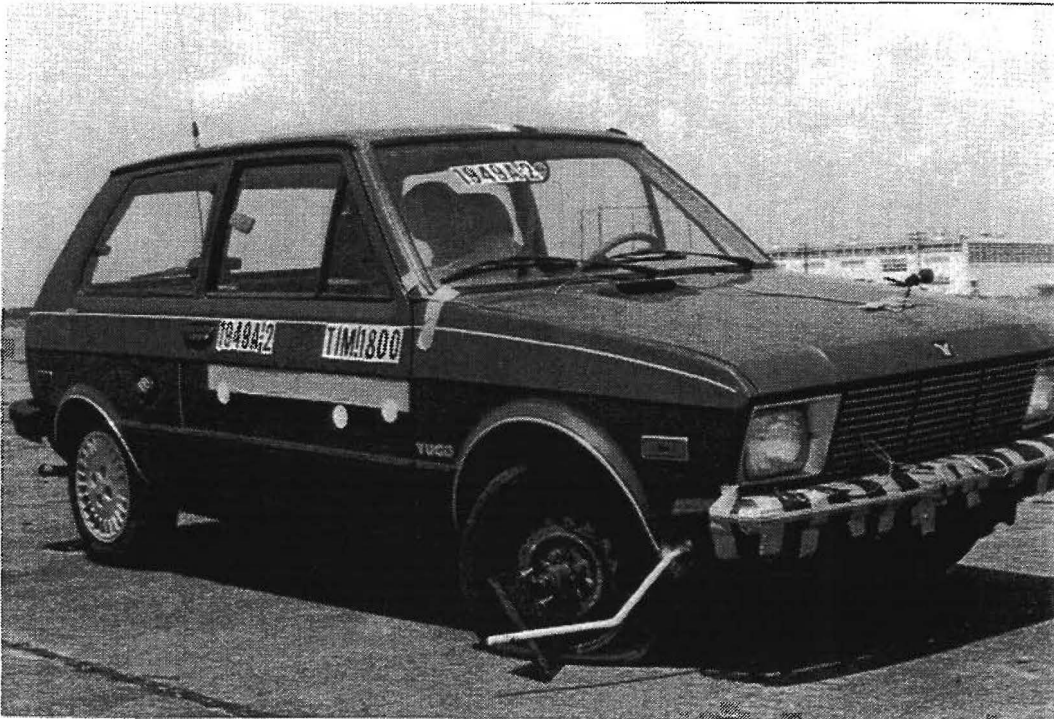
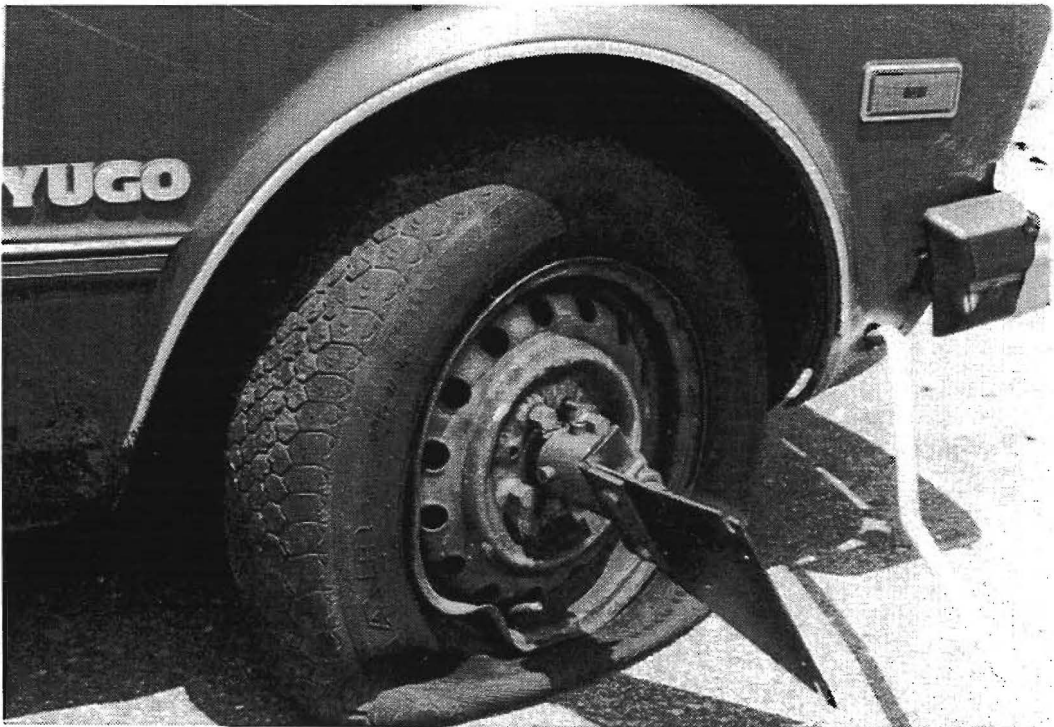
Figure 10. Vehicle After Test 1949A-2

The vehicle sustained damage to the right front wheel as shown in Figure 10. There was no direct crush to the vehicle. The only other damage was a small dent in the roof on the rear passenger side. The dent measured 150 mm x 100 mm x 60 mm and was considered to be due to the twisting motion induced in the vehicle body as the right side of the vehicle traversed the end treatment.

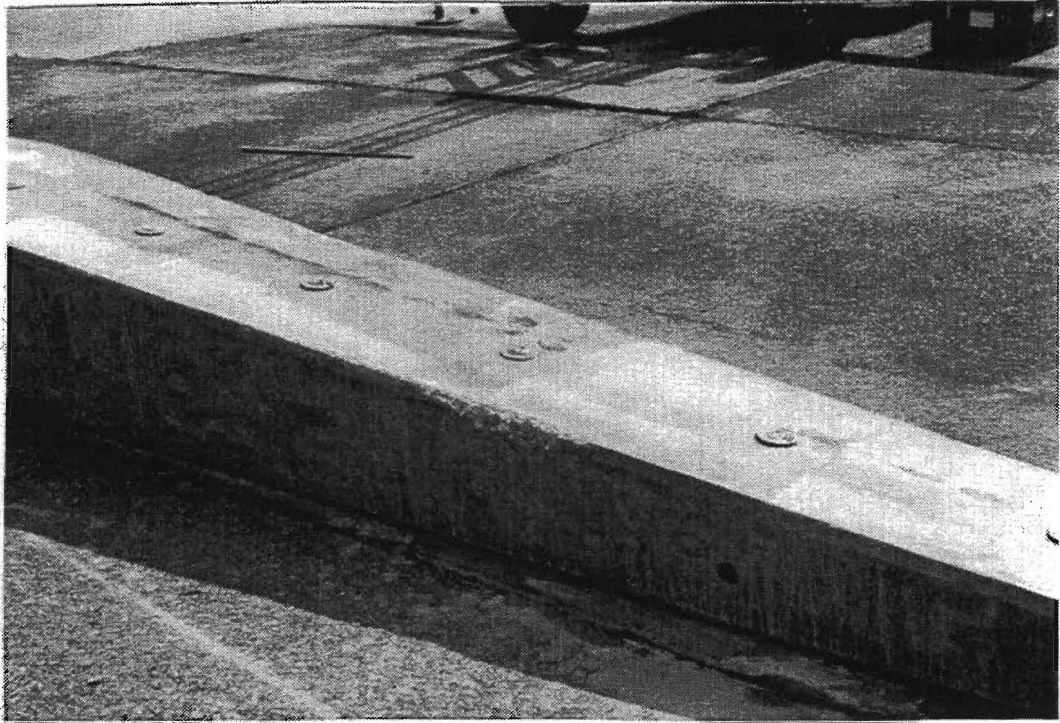
Figure 14. Low-Profile End Treatment After Test 1949A-3

As can be seen in Figure 14, the end treatment received minimal damage. There was cosmetic damage (i.e., tire marks) and the edges of the end treatment were chipped. A minor crack occurred around the location of the steel pin in the end treatment. There was no movement of the end treatment.

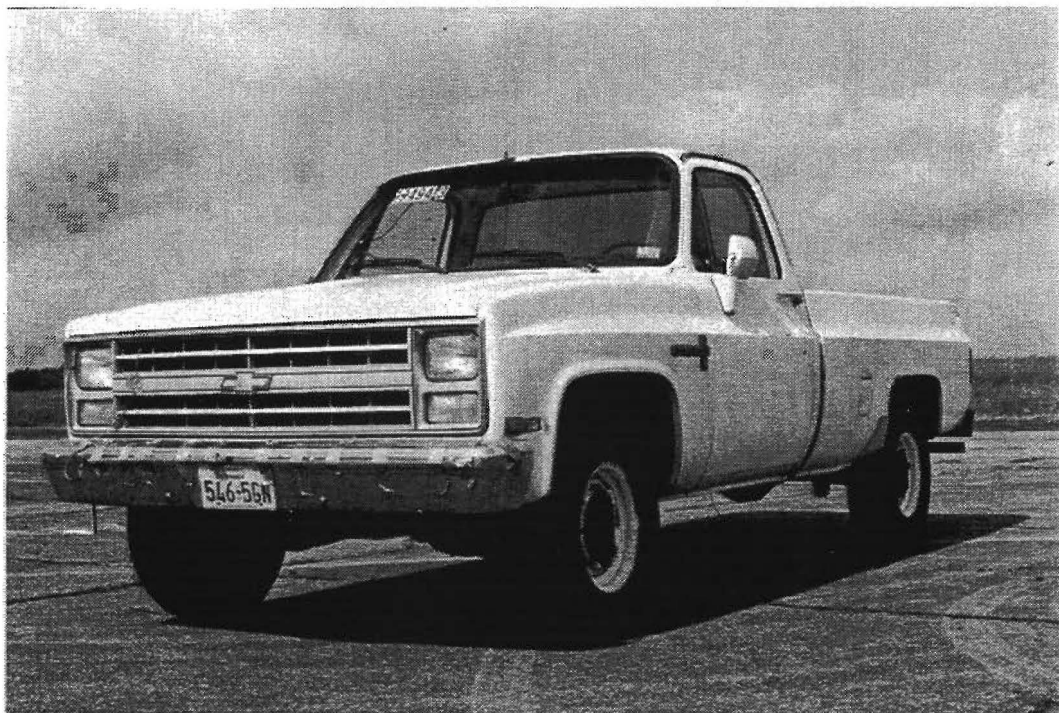
Figure 15. Vehicle After Test 1949A-3

As shown in Figures 15 and 16, the vehicle sustained damage to the undercarriage only. The cross member, lower A-arms and differential housing were scraped as the vehicle straddled the installation.

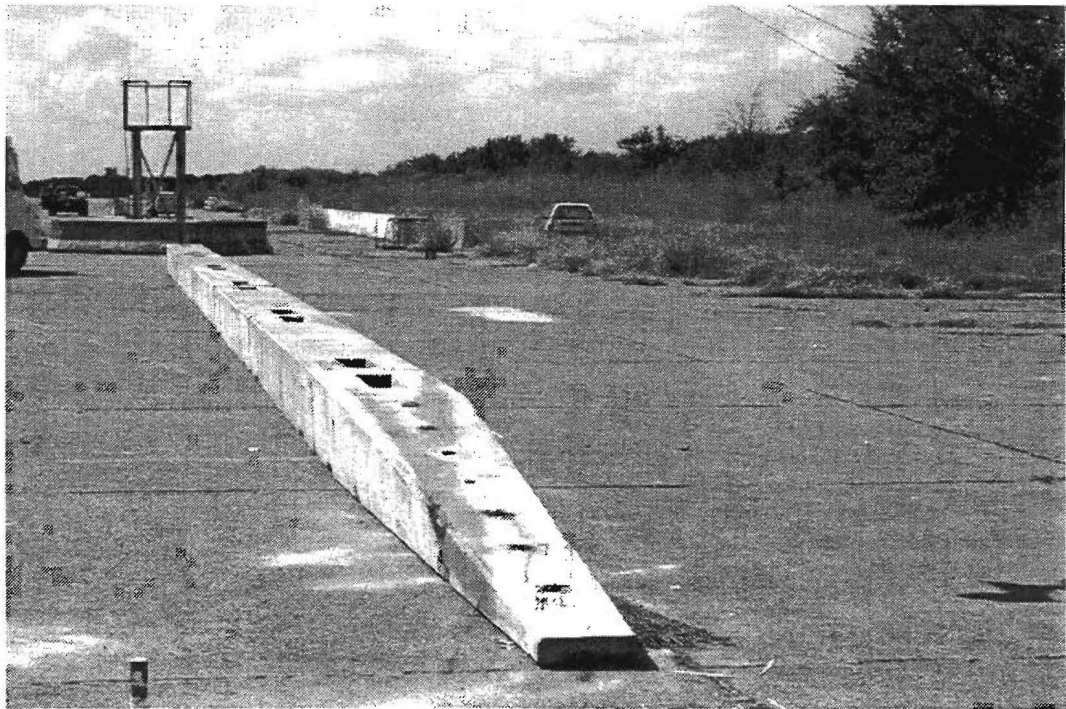
Figure 21. After Impact Trajectory for Test 414038-2

The end treatment was not damaged as shown in Figures 21 and 22. Tire marks were found on the top surface from 1.37 m from the end to 2.46 m. The undercarriage scraped the end treatment from 300 mm from the end to 1880 mm. There were tire marks on the pavement 15.2 m down from impact where the vehicle touched ground.

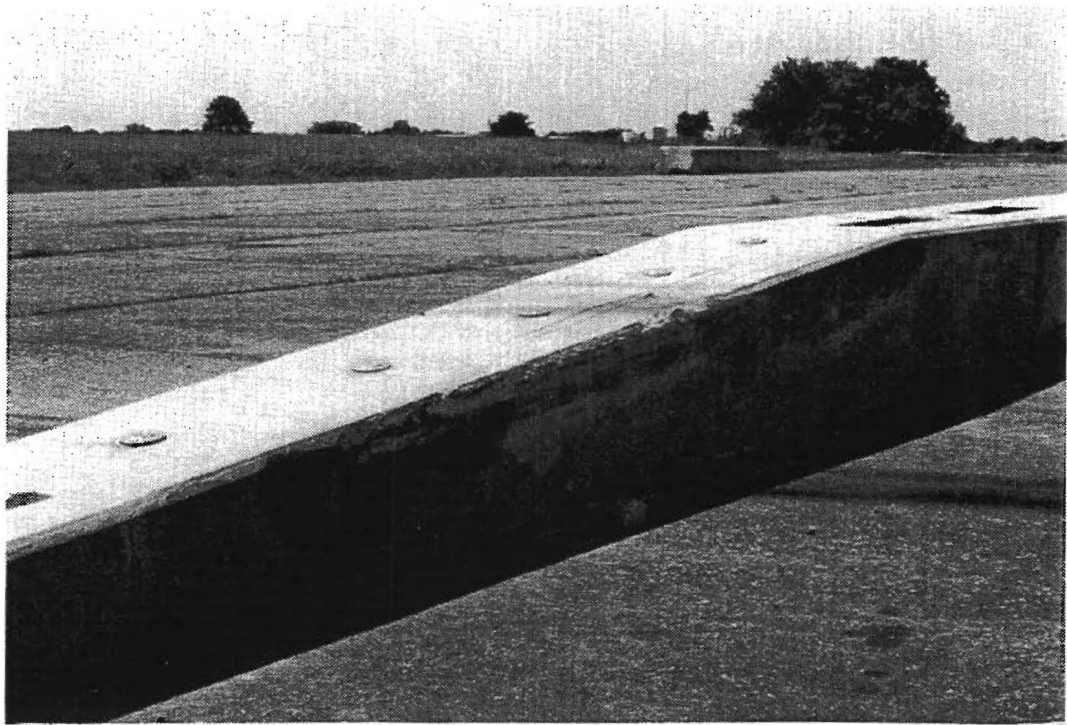
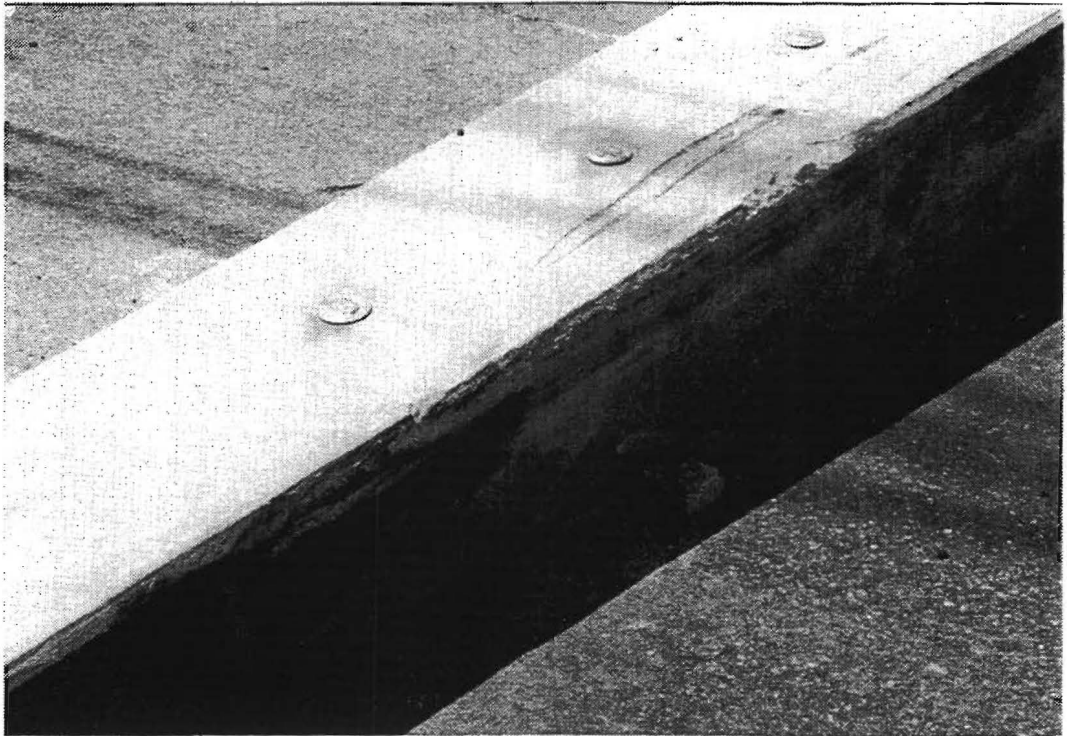
Figure 28. Low-Profile End Treatment After Test 1949A-1

As can be seen in Figure 28, the end treatment received minimal damage. There was cosmetic damage (i.e., tire marks) along the 3.0 m of end treatment where the vehicle was in contact. In addition, the edge of the end treatment was chipped. There was no movement of the end treatment.

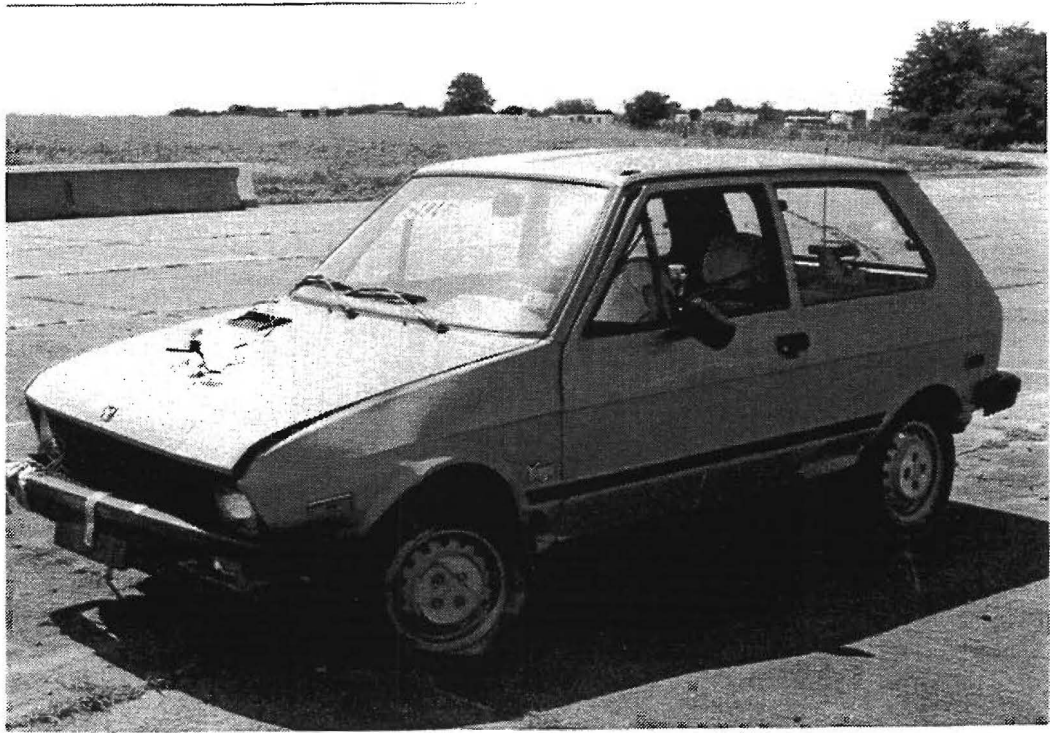
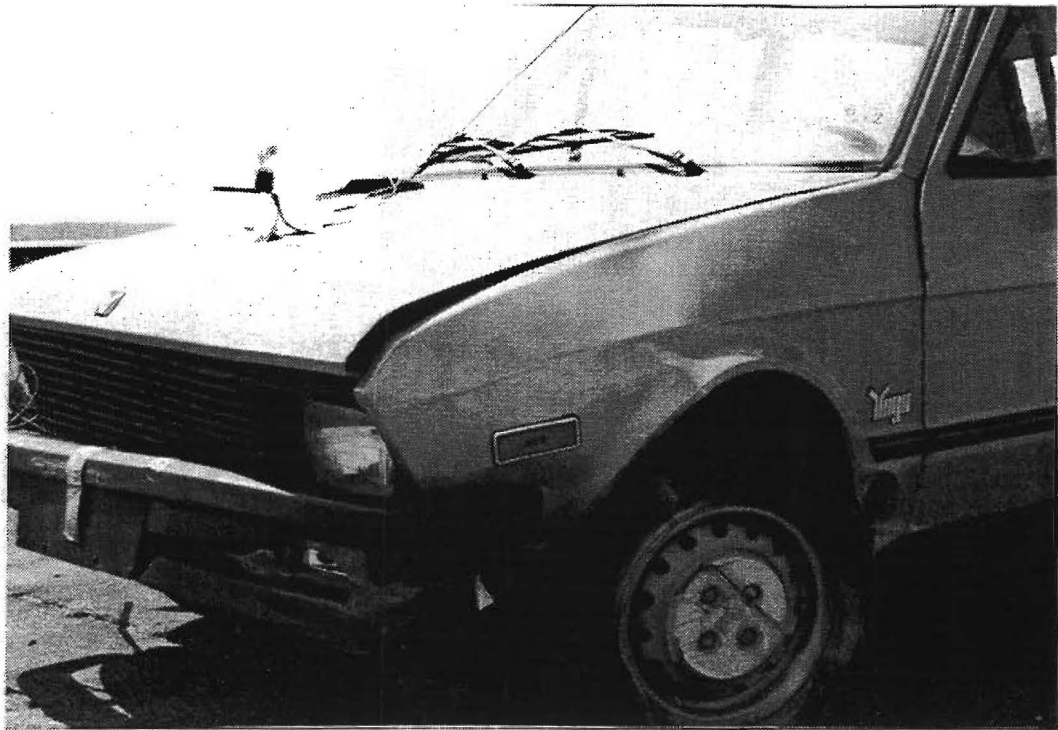
Figure 29. Vehicle After Test 1949A-1

The vehicle sustained damage to the left side as shown in Figure 29. Maximum crush at the left front corner at bumper height was 127 mm. The driver's door was deformed outward, the driver's side window was broken out, and the door was jammed. There was a 25 mm dent in the roof just above the door caused by the twisting motion of the vehicle as it was redirected. Also, damage was done to the front bumper, grill, the left front strut, left front quarter panel, left rear panel, and left front tire and rim.

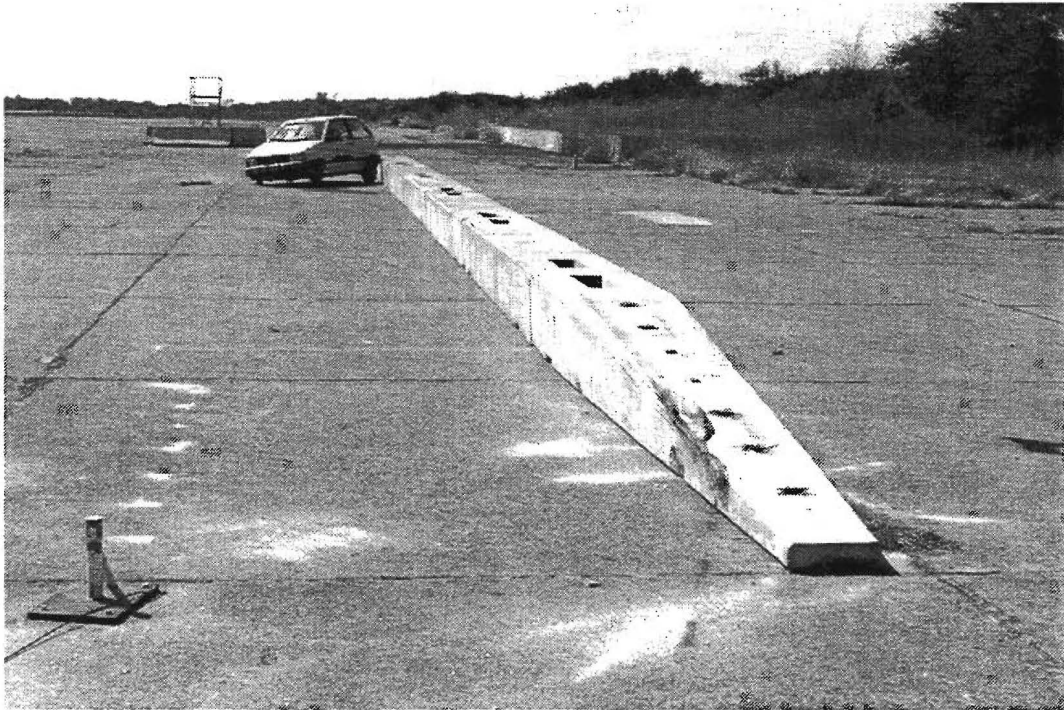
Figure 33. After Impact Trajectory for Test 414038-1

There was minimal damage to the end treatment as shown in Figures 33 and 34. The vehicle was in contact with the end treatment and low-profile barrier for 8.3 m during the first contact and 2.4 m during the second contact. There was no sign of movement in the end treatment or the barrier. The last joints crumbled when the vehicle came to rest at the end of the installation.
