FLEXBEAM REDIRECTIONAL SYSTEM FOR THE
MODULAR CRASH CUSHION

Research Report Number 146-3
Studies of Field Adaptation
of Impact Attenuation Systems
Research Study Number 2-8-68-146

TEXAS TRANSPORTATION INSTITUTE

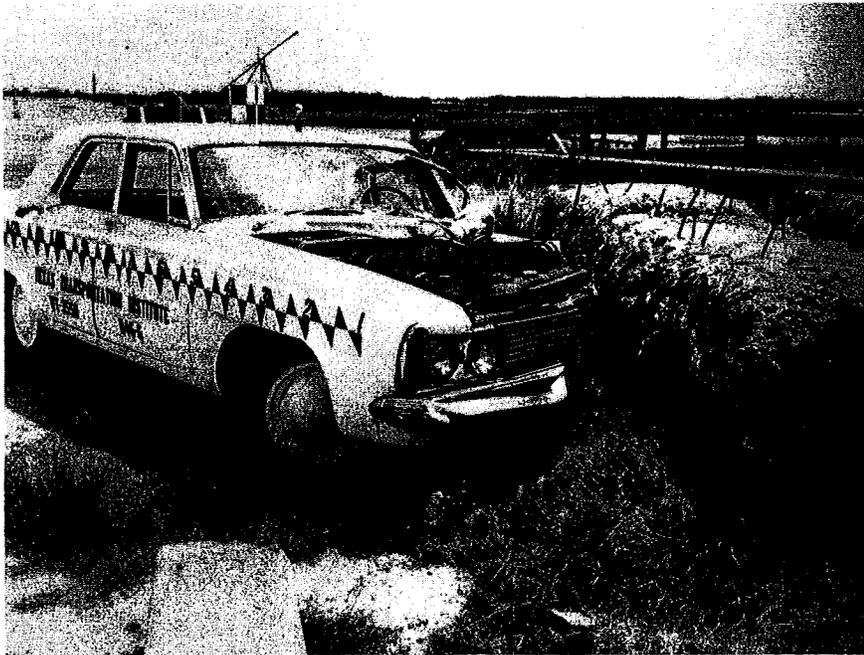
Figure 4, Vehicle After Test 1146-6.
(Note barrier in background
visible above roof of vehicle.)

In this test, a 1963 Plymouth sedan (Figure 3) impacted the guard-rail portion at the rear of the cushion and was redirected. The vehicle traveled about 150 feet before striking a large piece of concrete (which was not associated with the test) and coming to rest (see Figure 4).

There was only minor damage to the crash cushion (Figures 6 and 7). The vehicle sustained considerable damage to the left front end. The amount of damage due to the collision with the concrete block was undetermined. The broken windshield resulted from the vehicle's hood breaking free during the primary impact (Figures 4 and 5).

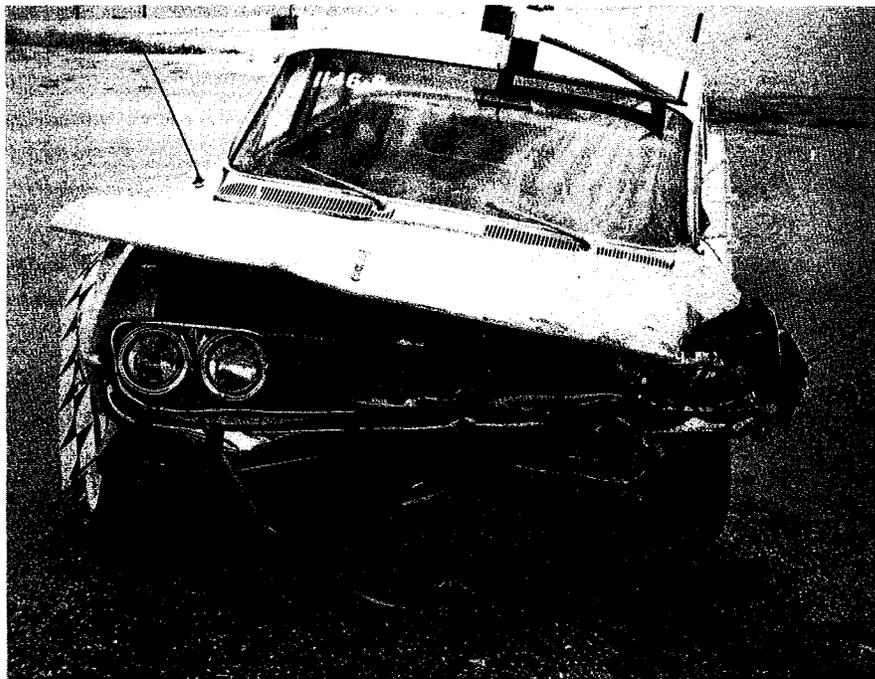
Figure 16, Vehicle After Test 1146-8.

Several modifications were made to the cushion before this test was run. These included extending the W-section guardrail 22 feet beyond the rigid wall, adding more drums to the system and enclosing more drums with the W-section guardrail, relocating and removing some of the 6 B 8.5 support posts, and using a single 7/8" diameter anchor cable (with swage connectors) on each side. A 1963 Oldsmobile impacted the guardrail section at the same point as in Test 1146-6. The vehicle did not redirect as intended and contacted the steel bulkhead after 0.148 sec, causing a high peak deceleration. The vehicle then rebounded slightly, rotated, and came to a stop as shown in Figure 20. The guardrail was damaged beyond repair, and some of the I-beams were ripped from their plates. Damage to the front end of the vehicle was severe as shown in Figure 16.
