1. Report No. FHWA/TX-01/1792-3	2. Government Accession No.	3. Recipient's Catalog No.	
4. Title and Subtitle TESTING AND EVALUATION OF A PEDESTAL BASE SIGN SUPPORT		5. Report Date January 2001

TESTING AND EVALUATION OF A PEDESTAL BASE SIGN SUPPORT

Report 1792-3
Project Number 0-1792
Research Project Title: Roadside Safety Hardware
for Traffic Control Devices

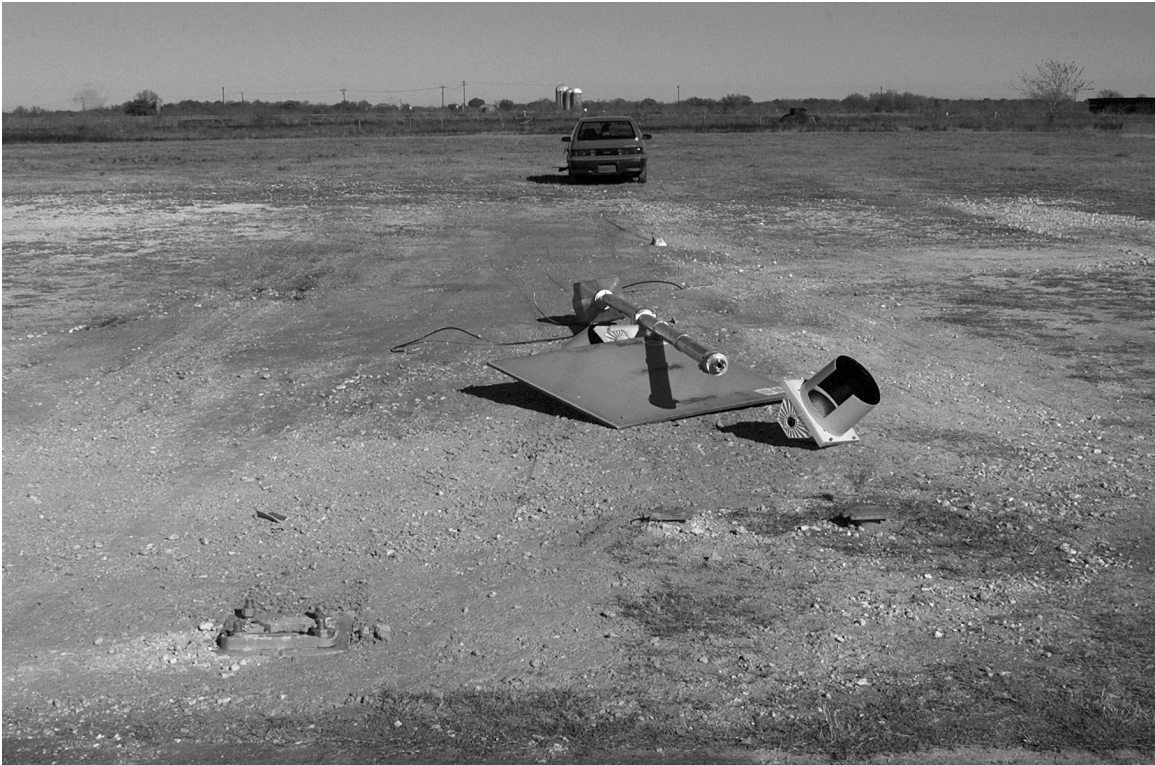
Figure 7. After Impact Trajectory for Test 417920-1.

The pedestal base fractured into several pieces, as shown in [Figures 7 and 8](#). The base of the pedestal moved 15 mm (0.6 inch) on the right front side and 10 mm (0.4 inch) on the left rear side. The sign panel detached from the top bracket. The top beacon detached, and the bottom beacon was cracked but remained attached to the pole. The debris extended 9.0 m (30.0 ft) downstream from the impact point.

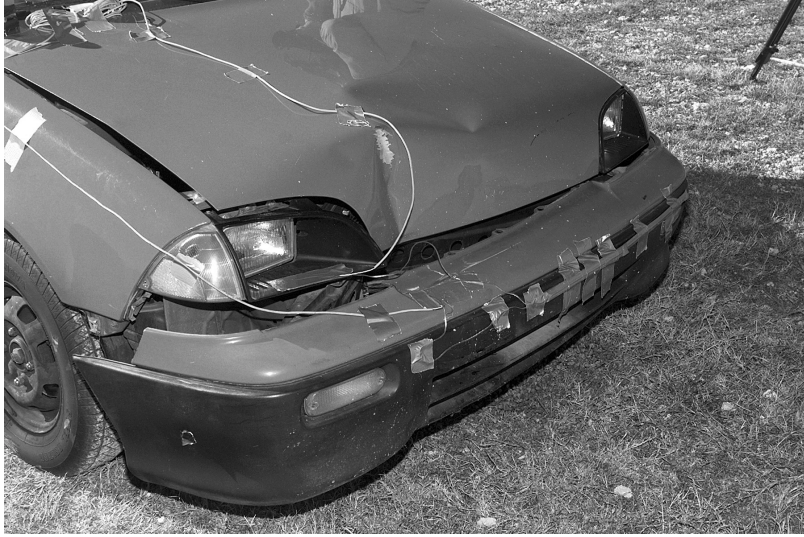
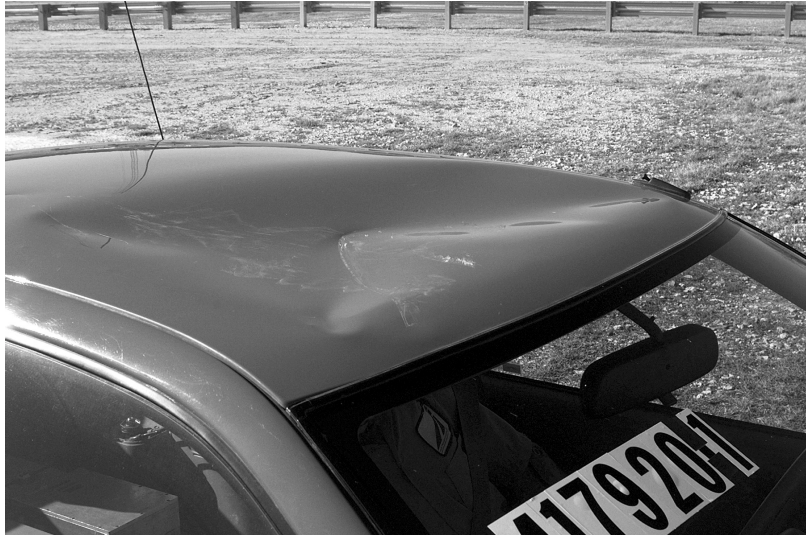
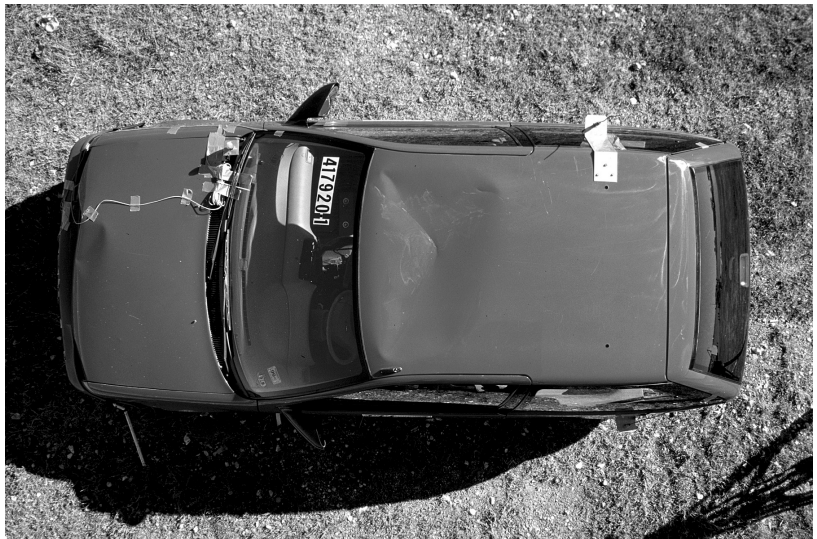
Figure 9. Vehicle after Test 417920-1.

As shown in [Figure 9](#), the vehicle sustained minimal damage to the bumper, hood, fan, radiator, and radiator support. Maximum exterior crush to the vehicle was 140 mm (5.5 inch) to the right front inner bumper at bumper height. Maximum deformation of the occupant compartment was 30 mm (1.2 inch) to the center of the roof. The interior of the vehicle is shown in [Figure 10](#). Exterior vehicle crush and occupant compartment measurements are shown in [Appendix B, Tables 3 and 4](#).

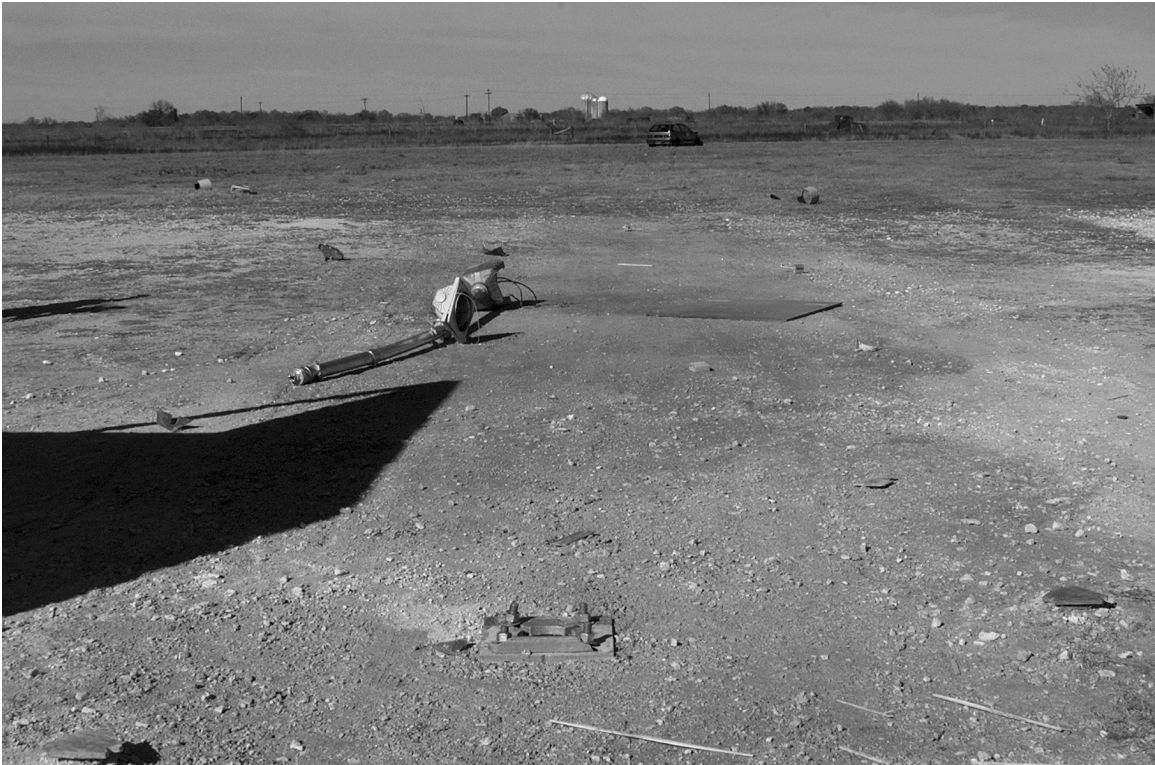
Figure 14. After Impact Trajectory for Test 417920-2.

The pedestal base fractured into several pieces, as shown in [Figures 14 and 15](#). The base of the pedestal sign moved 8 mm (0.3 in) on the right front side and 15 mm (0.6 in) on the left rear side. The sign panel detached from the pole. The top beacon signal detached, and the bottom beacon broke but stayed attached to the pole. The debris extended 30.0 m (98.4 ft) downstream, 1.5 m (5.0 ft) to the right, and 5.3 m (17.4 ft) to the left of the impact point.

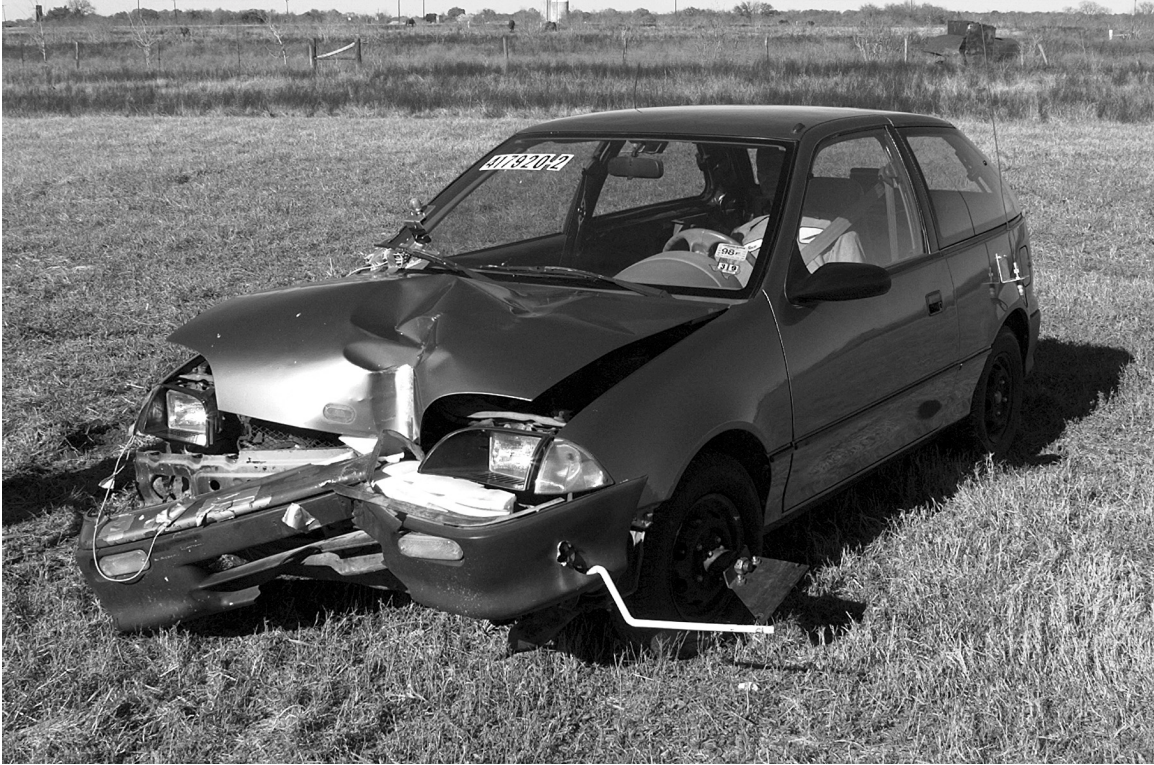
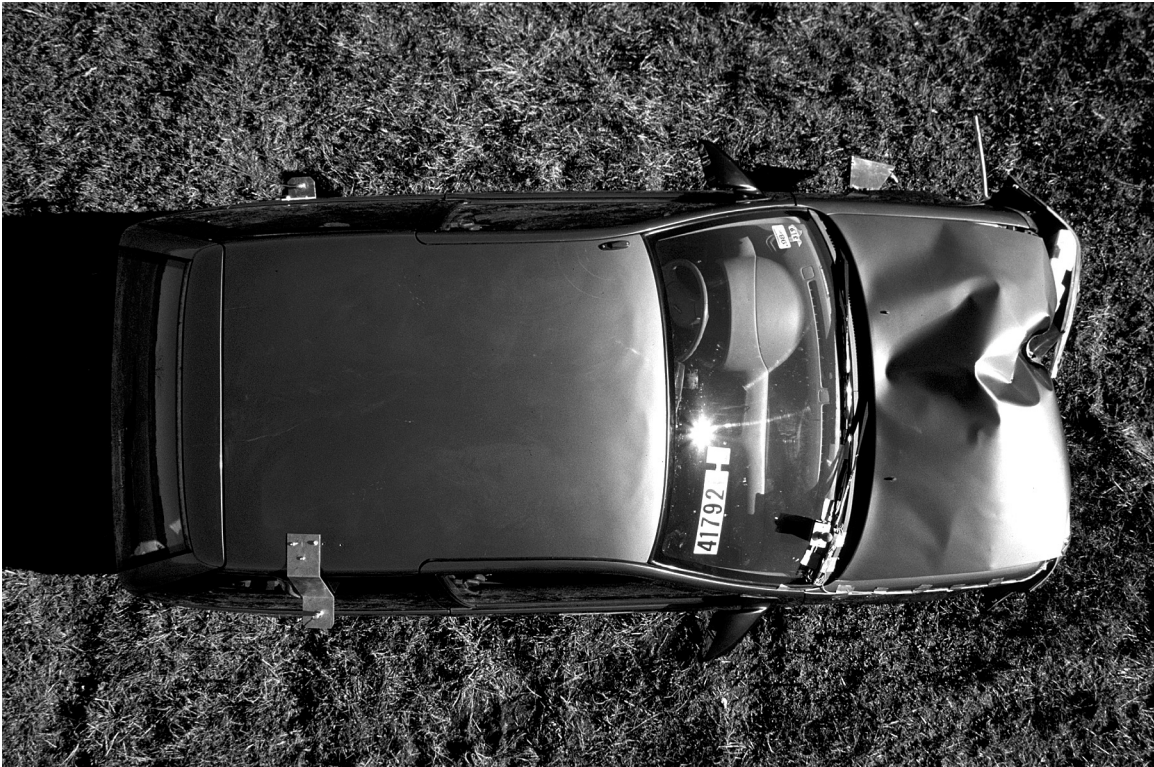
Figure 16. Vehicle after Test 417920-2.

As shown in [Figure 16](#), the vehicle sustained minimal damage to the bumper, hood, fan, radiator and radiator support. Maximum exterior crush to the vehicle was 200 mm (7.9 inch) to the left front inner bumper at bumper height. The interior of the vehicle is shown in [Figure 17](#). Exterior vehicle crush and occupant compartment measurements are shown in [Appendix B, Tables 5 and 6](#).
