1. Report No. FHWA/TX-04/4564-1		2. Government Accession No.		3. Recipient's Catalog No.	
4. Title and Subtitle EVALUATION OF GUARDRAIL TO CONCRETE BRIDGE RAIL TRANSITIONS				5. Report Date October 2003

EVALUATION OF GUARDRAIL TO CONCRETE BRIDGE RAIL TRANSITIONS

Report 4564-1
Project Number 0-4564
Research Project Title: Guardrail to Concrete Bridge Rail Transitions

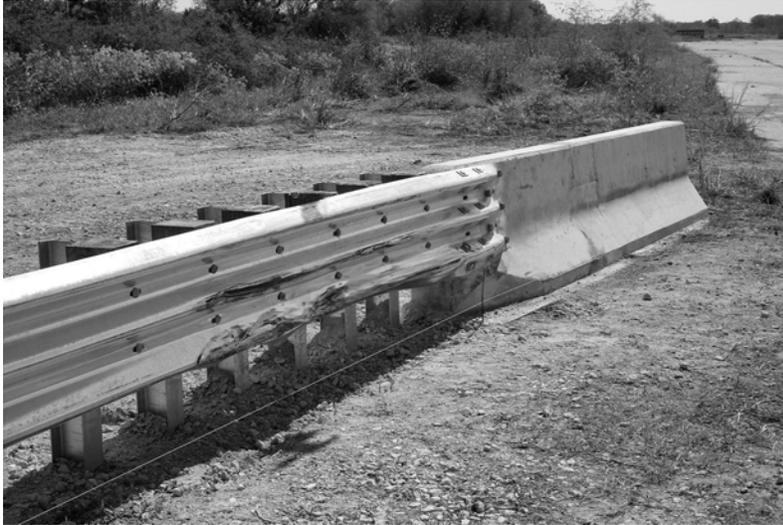
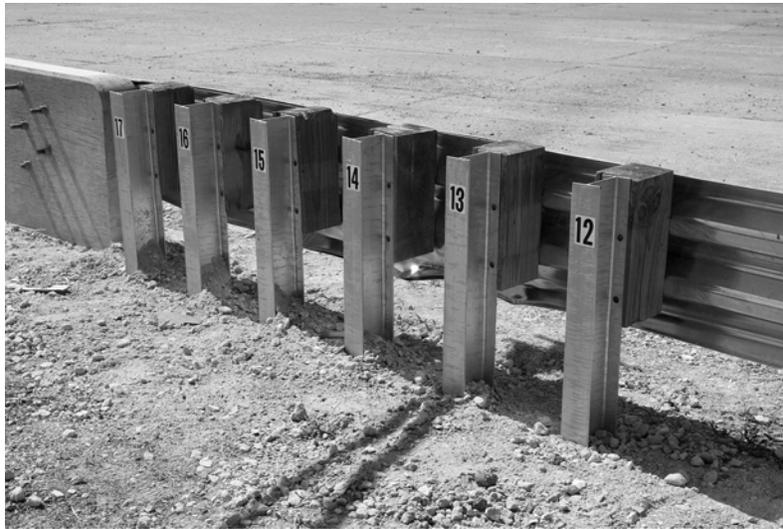
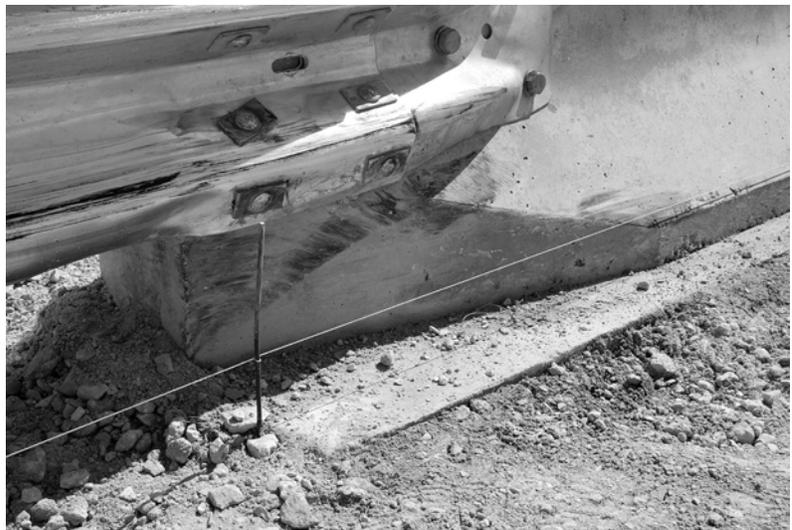
Figure 7. Installation after Test 445643-1.

Figures 6 and 7 show the transition sustained minimal damage. The lower edge of the thrie beam was folded under and flattened 2.4 in (60 mm) adjacent to the concrete parapet. Tire marks found on the end of the parapet extended 1.8 in (45 mm) from the traffic face, and compacted dirt extended another 1.8 in (45 mm) beyond the tire mark, for a total distance of 3.6 in (90 mm). The wood blockout at post 15 was split on the traffic face and the corners of the blockouts on posts 15 through 17 were shaved off approximately 1.6 in (40 mm). No tire marks were observed on the posts. Maximum dynamic deflection during the test was 4.1 inches (105 mm). Maximum residual deformation was 2.3 in (59 mm) between posts 15 and 16. Working width was 25 in (636 mm) and total length of contact of the vehicle with the transition was 135 in (3425 mm).

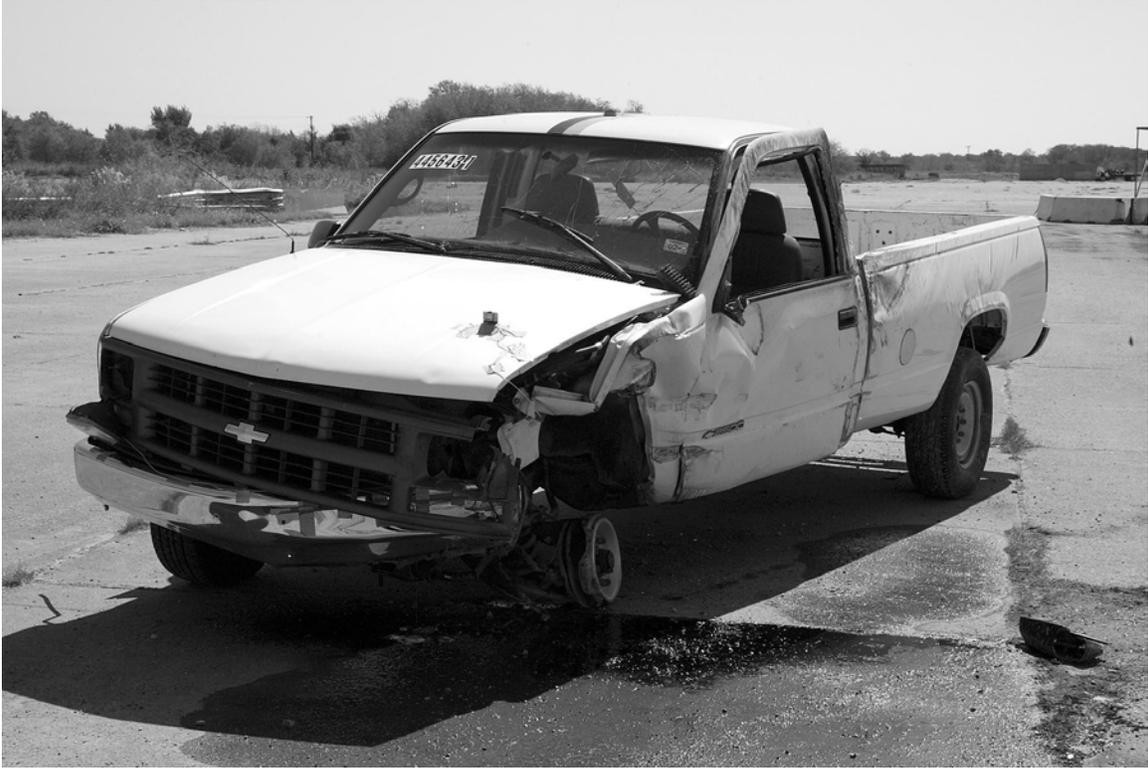
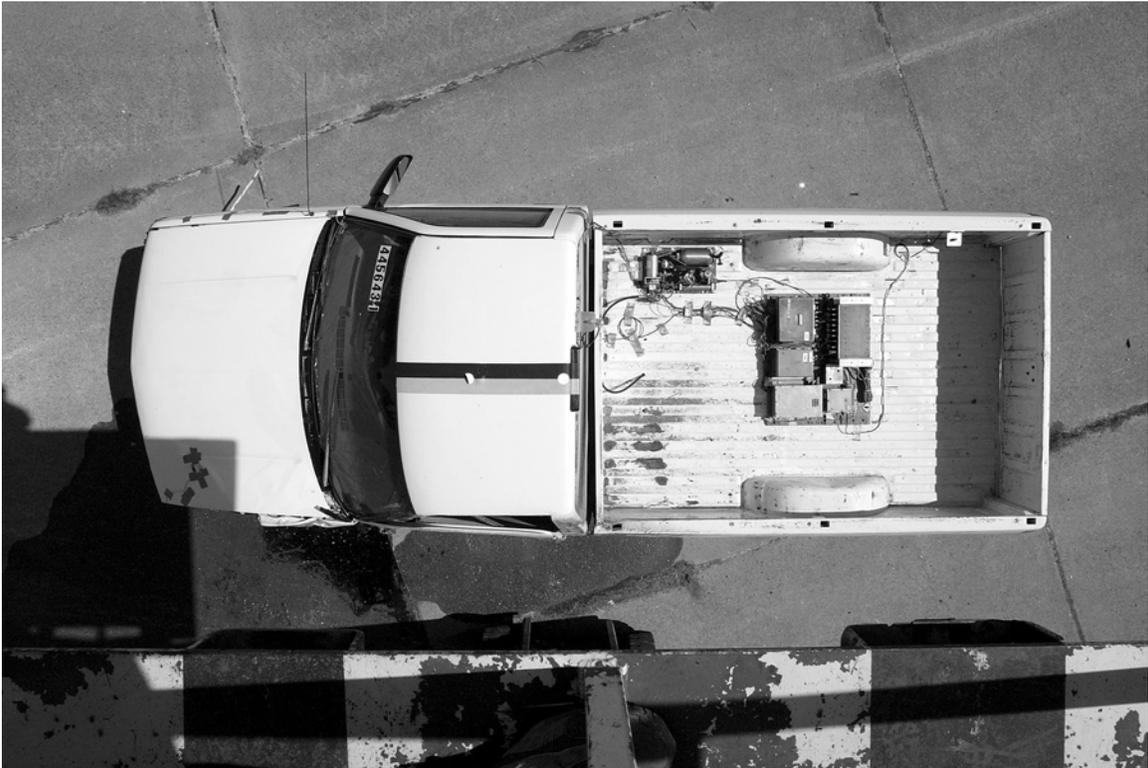
Figure 8. Vehicle after Test 445643-1.

The vehicle came to rest on its left side. Figure 8 shows photographs of the vehicle after it was uprighted. Structural damage was imparted to the left upper A-arm and ball joint, outer tie rod, left frame rail, sway bar and cross member. Also damaged were the front bumper, grill, radiator, fan, left front quarter panel, left door and glass, and left rear bed; and the right rear wheel rim was deformed. The windshield was cracked. The outer section of the left front wheel rim separated from the inner section by fracturing the rivets that held them together. Maximum exterior crush to the vehicle was 20.1 in (510 mm) in the frontal plane at the left front corner near bumper height. Within the occupant compartment, the instrument panel was deformed and the floor pan was deformed and separated at the seams in the left toe pan. Maximum occupant compartment deformation was 6.8 in (172 mm) in the center floorpan area over the transmission tunnel. Figure 9 shows photographs of the interior of the vehicle before and after the test. Appendix B, Tables 3 and 4 show occupant compartment and exterior vehicle deformation.

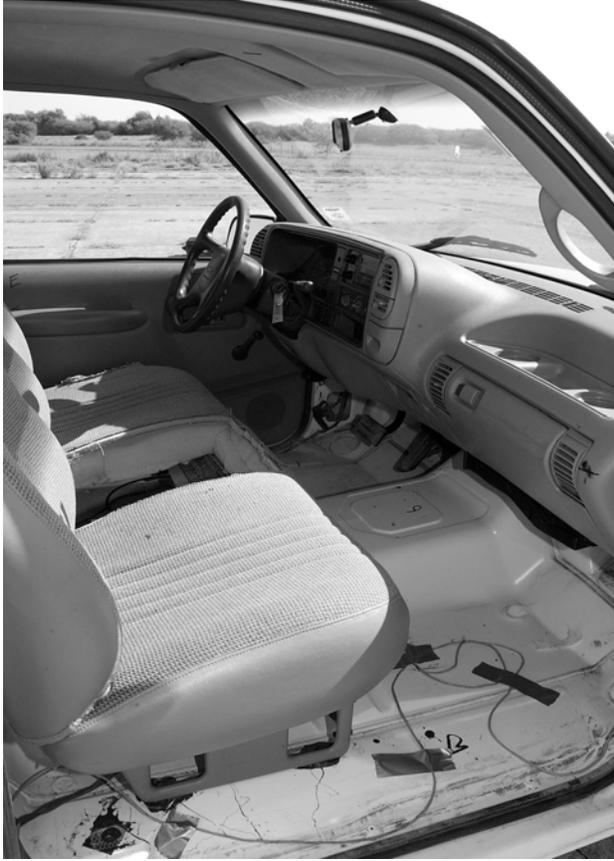
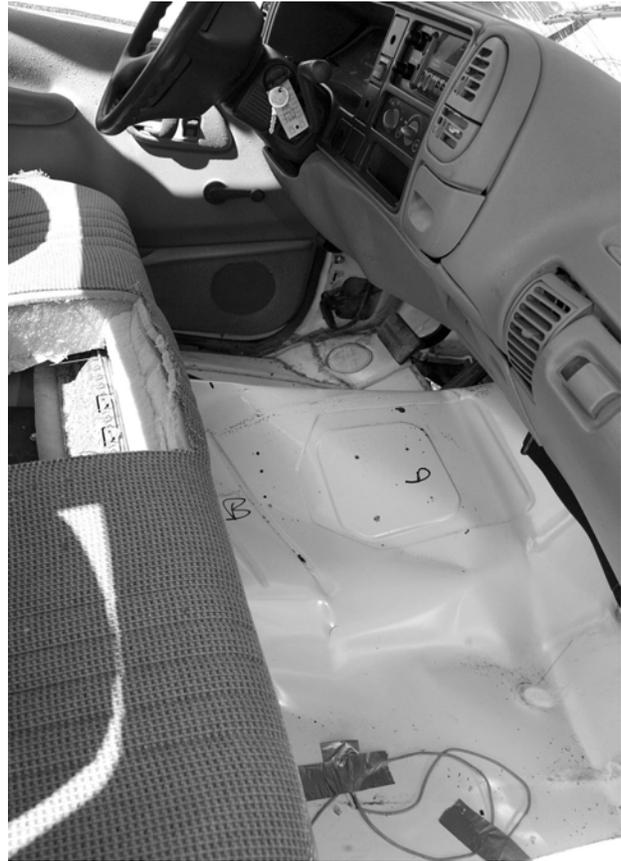
Figure 9. Interior of Vehicle for Test 445643-1.

Results: No detached elements, fragments, or other debris were present to penetrate or to show potential for penetrating the occupant compartment, or to present undue hazard to others in the area. Maximum occupant compartment deformation was 6.8 in (172 mm) in the center floorpan area over the transmission tunnel. (*FAIL*)

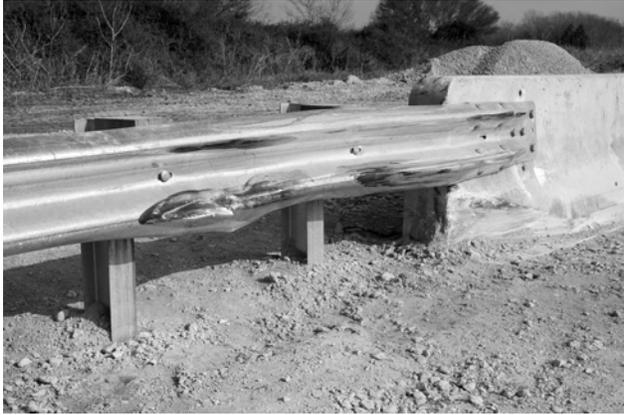
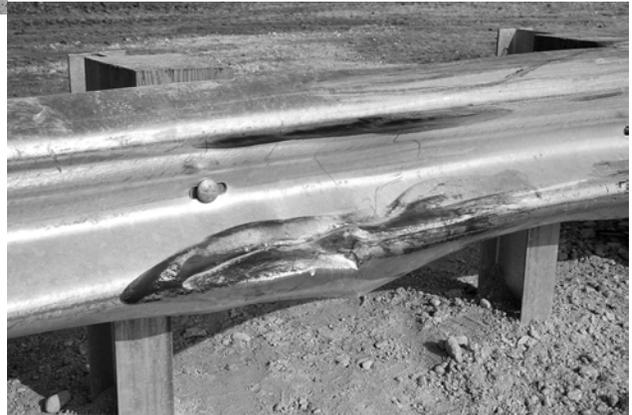
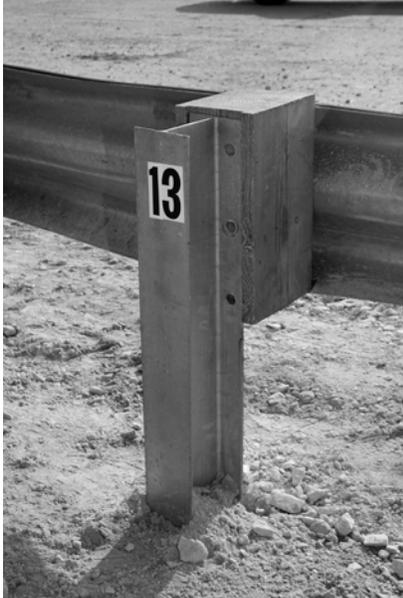
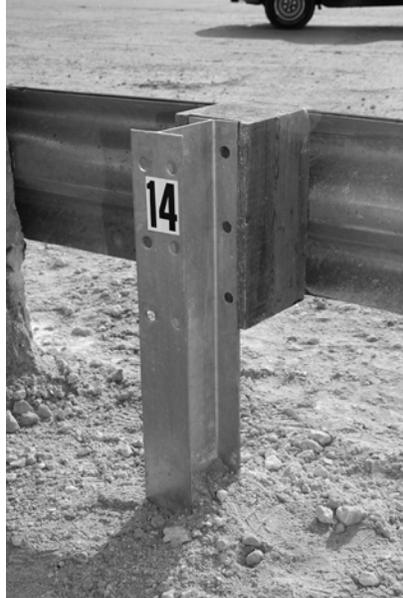
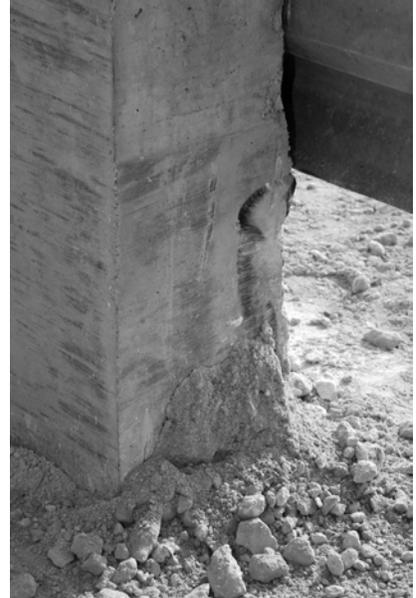
Figure 16. Installation after Test 445643-2.

As Figures 15 and 16 show, the transition sustained minimal damage. The lower corrugation of the W-beam was gouged and flattened in the immediate vicinity of impact. Tire marks were found on the end of the parapet extending 3.5 in (90 mm) from the traffic face. There were no tire marks observed on the posts. Maximum dynamic deflection of the transition during the test was 2.6 in (65 mm). Maximum residual deformation was 1.6 in (42 mm) near post 13. Working width was 17.6 inches (448 mm), and total length of contact of the vehicle with the transition was 106 inches (2704 mm).

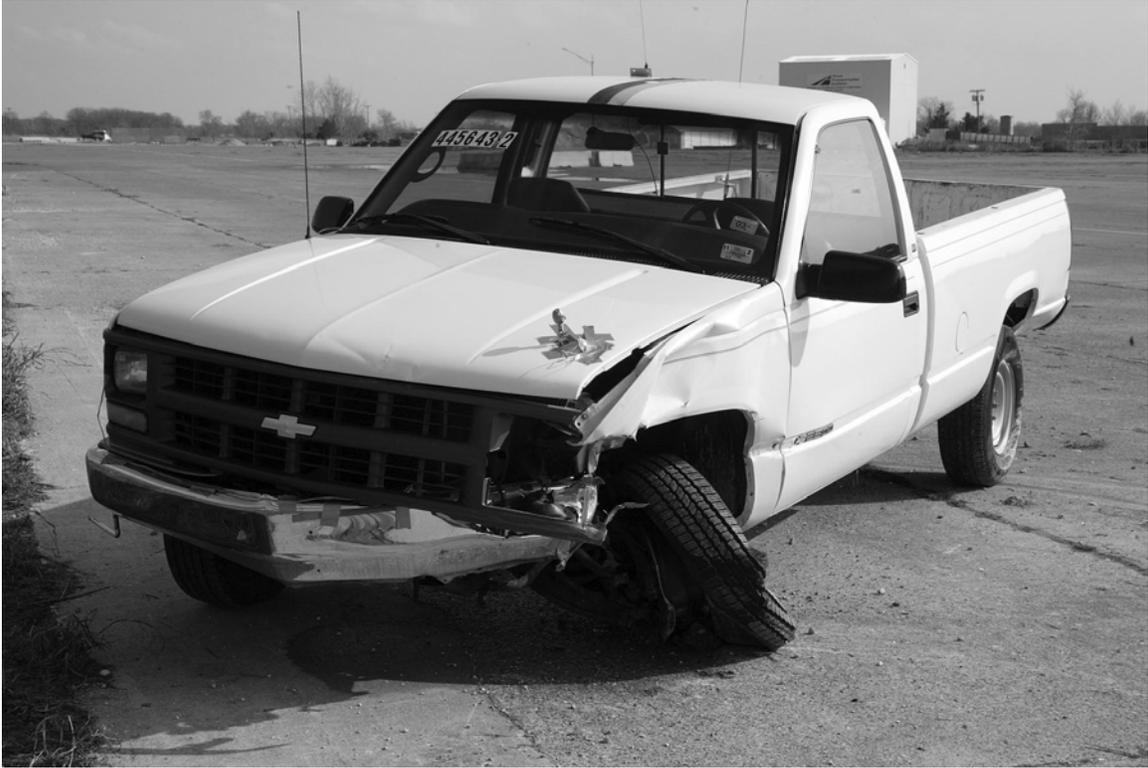
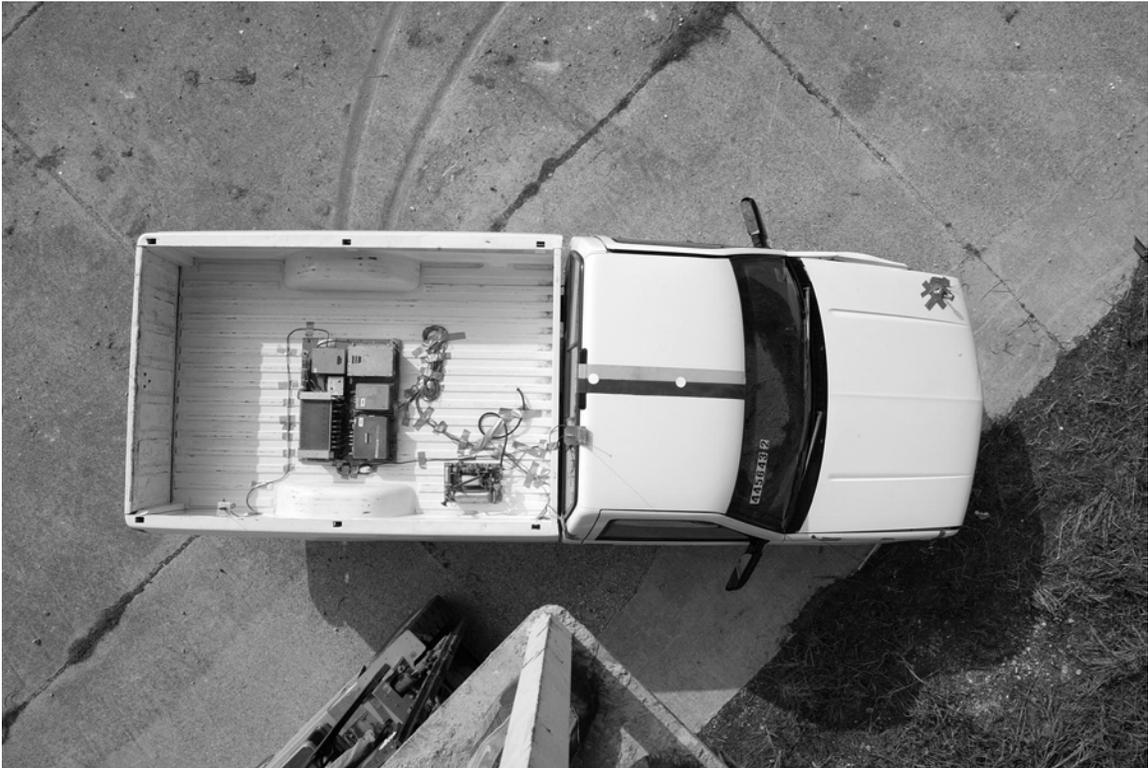
Figure 17. Vehicle after Test 445643-2.

Figure 17 shows the vehicle damage. Structural damage was imparted to the left lower A-arm, left outer tie rod end, left frame rail. Also damaged were the front bumper, grill, radiator, fan, left front quarter panel, left door, left rear bed, and rear bumper; and the right rear wheel rim was deformed. The windshield was stress-cracked. The left front tire was cut and the wheel rim was deformed. Maximum exterior crush to the vehicle was 17.7 in (450 mm) in the frontal plane at the left front corner near bumper height. In the occupant compartment, the floor pan was deformed and separated slightly at the seam with the left toe pan. Maximum occupant compartment deformation was 0.4 in (11 mm) in the left floorpan area. Figure 18 shows photographs of the interior of the vehicle, and Appendix B, Tables 5 and 6 shows occupant compartment and exterior vehicle deformation.

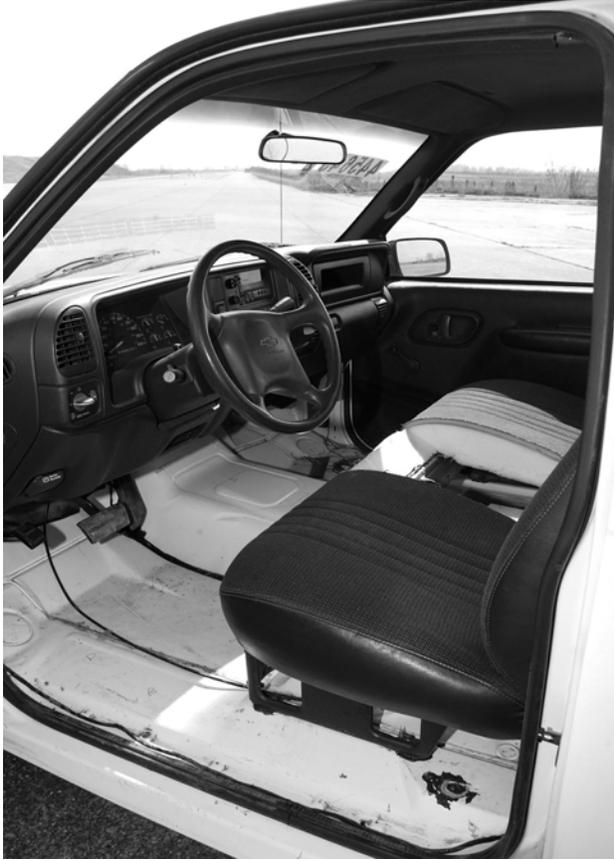
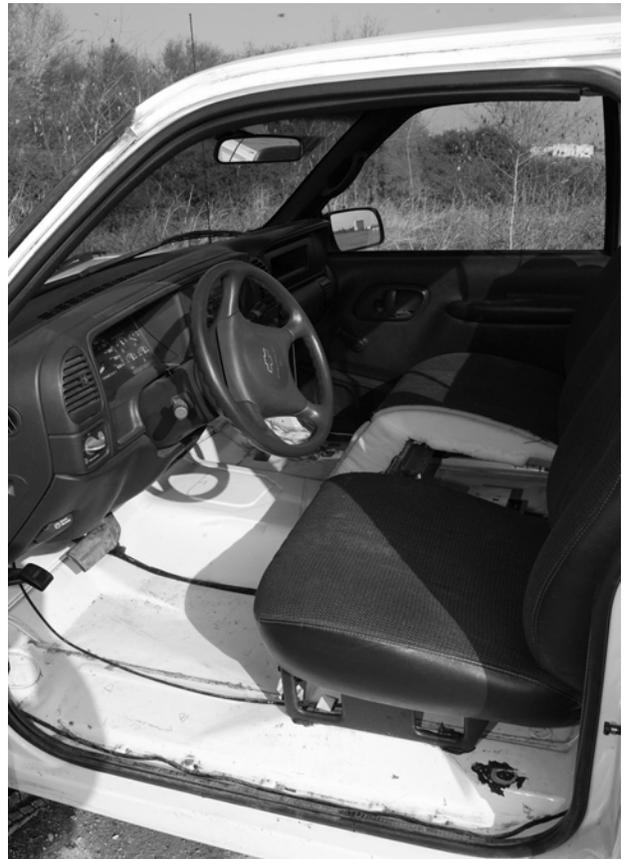
Figure 18. Interior of Vehicle for Test 445643-2.

Results: No detached elements, fragments, or other debris were present to penetrate or to show potential for penetrating the occupant compartment, or to present undue hazard to others in the area. Maximum occupant compartment deformation was 0.4 in (11 mm) in the left floorpan area. *(PASS)*
