CRASH TEST AND EVALUATION OF THE TxDOT T224 BRIDGE RAIL

Test Report 9-1002-15-5

TEXAS A&M TRANSPORTATION INSTITUTE
COLLEGE STATION, TEXAS

TEXAS DEPARTMENT OF TRANSPORTATION

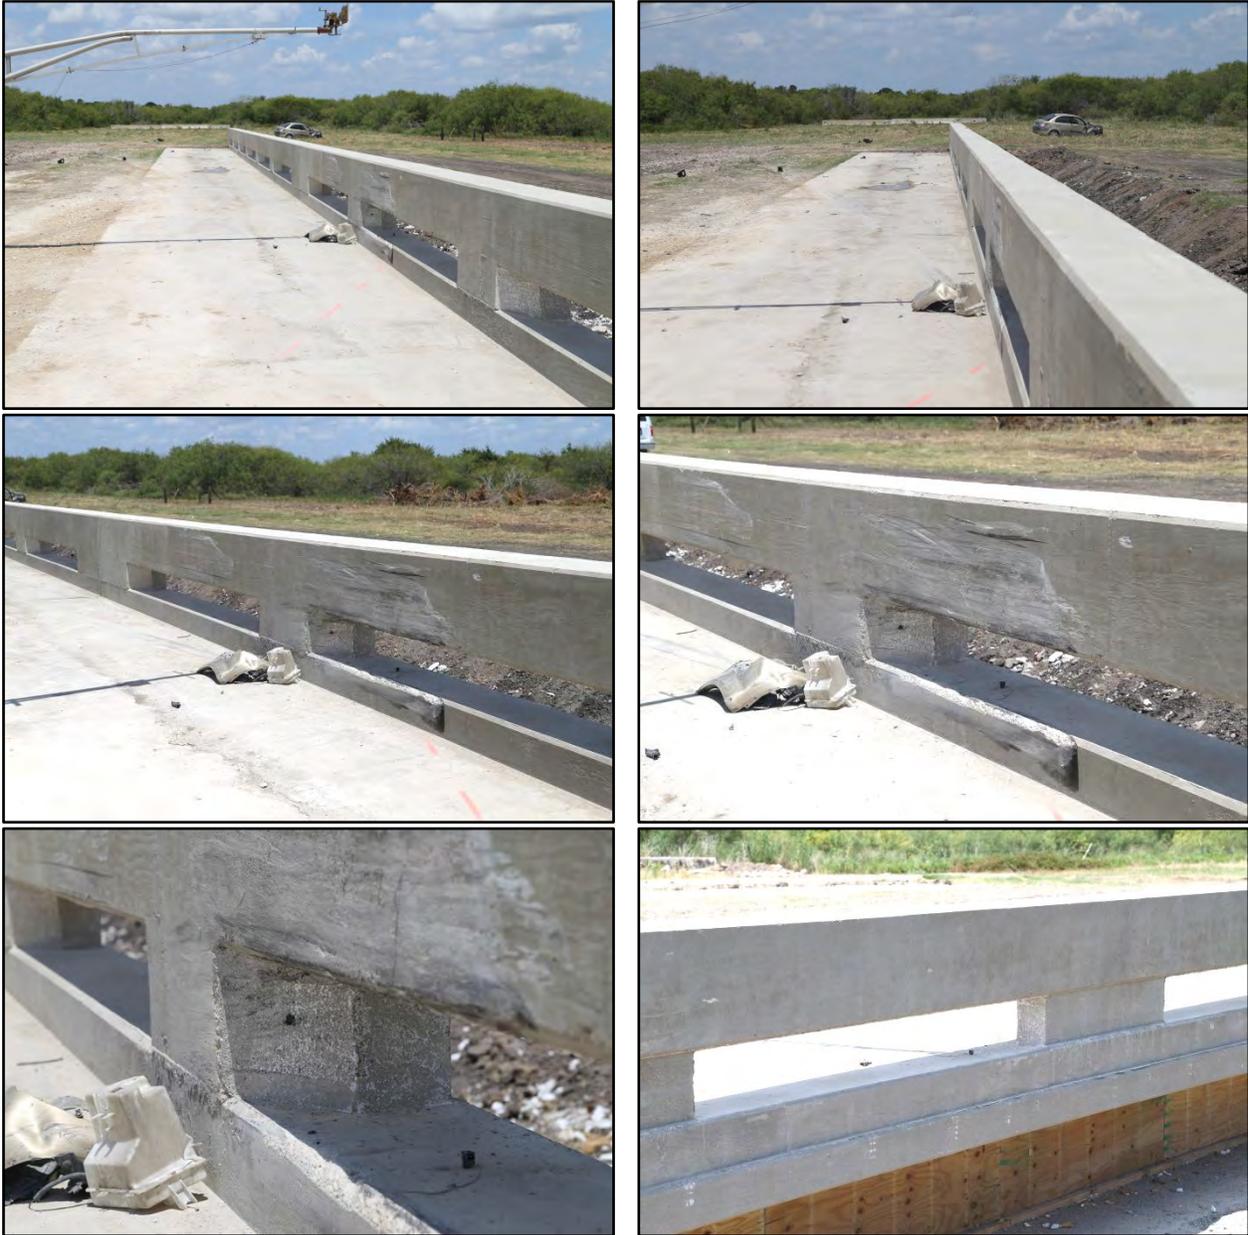
Figure 5.3. TxDOT T224 Bridge Rail after Test No. 490025-2-2.

Figure 5.3 shows the damage to the TxDOT T224 Bridge Rail after *MASH* Test 5-10. The traffic face of the bridge rail sustained mostly cosmetic damage in the form of scrapes and tire marks. Some concrete was scraped off the traffic side edge of the curb, and there were tire marks and gouges caused by the wheel rim on the upstream side of post 4. The 1100C vehicle was in contact with the bridge rail a total distance of 17.5 ft. Working width was 16.5 inches. Maximum dynamic deflection during the test was not obtained due to view being blocked by the vehicle and dust, and no maximum permanent deformation after the test occurred.

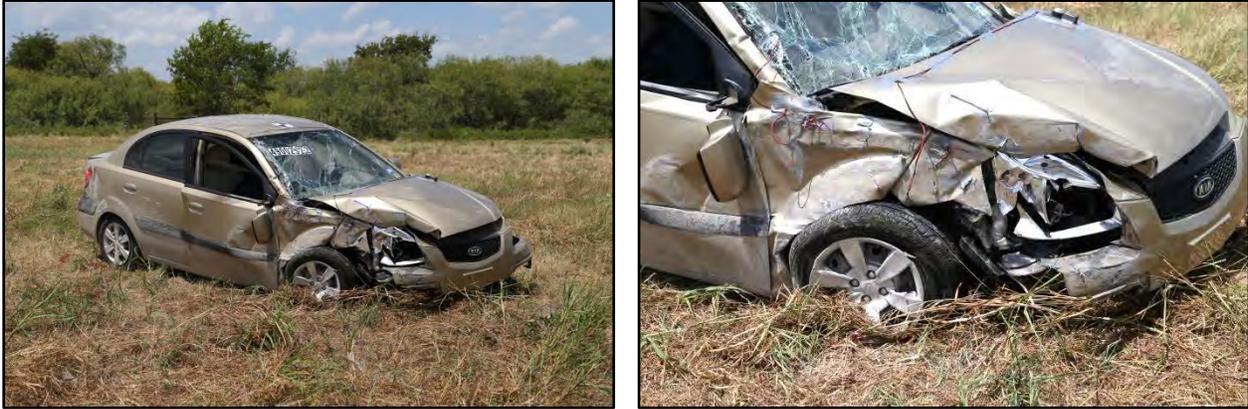
Figure 5.4. Test Vehicle after Test No. 490025-2-2.

Figure 5.4 shows the damage that the 1100C vehicle sustained. The right front strut and tower were deformed. The front bumper, hood, radiator, right front tire and rim, right front fender, right front door and door glass, roof, right rear door, and right rear quarter panel were damaged. The A-pillar was deformed and caused the windshield to fracture. Maximum exterior crush to the vehicle was 13.0 inches in the front plane at the right front corner at bumper height. Maximum occupant compartment deformation was 4.0 inches in the right side instrument panel.

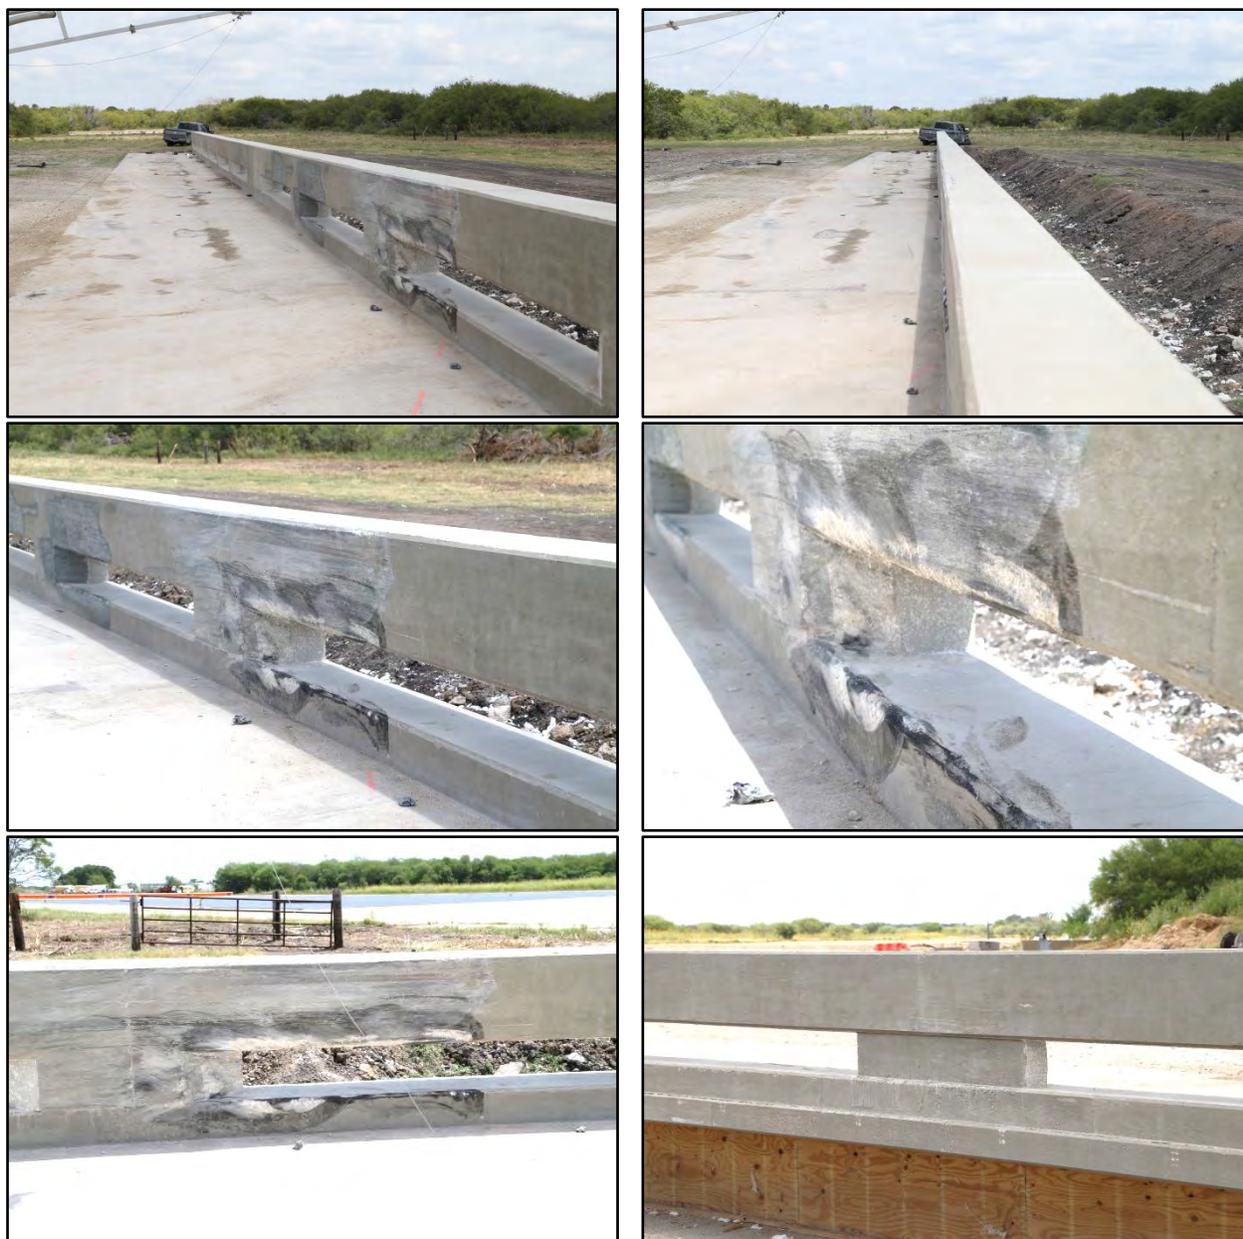
Figure 6.3. TxDOT T224 Bridge Rail after Test No. 490025-2-3.

Figure 6.3 shows the damage to the TxDOT T224 Bridge Rail. The traffic face of the bridge rail sustained mostly cosmetic damage in the form of scrapes and tire marks. Some concrete was scraped off the traffic side edge of the curb, and there were tire marks and gouges caused by the wheel rim on the upstream side of post 3. The 2270P vehicle was in contact with the bridge rail a distance of 14.2 ft. Working width was 16.5 inches. Maximum dynamic deflection during the test was negligible. No measureable permanent deformation was noted.

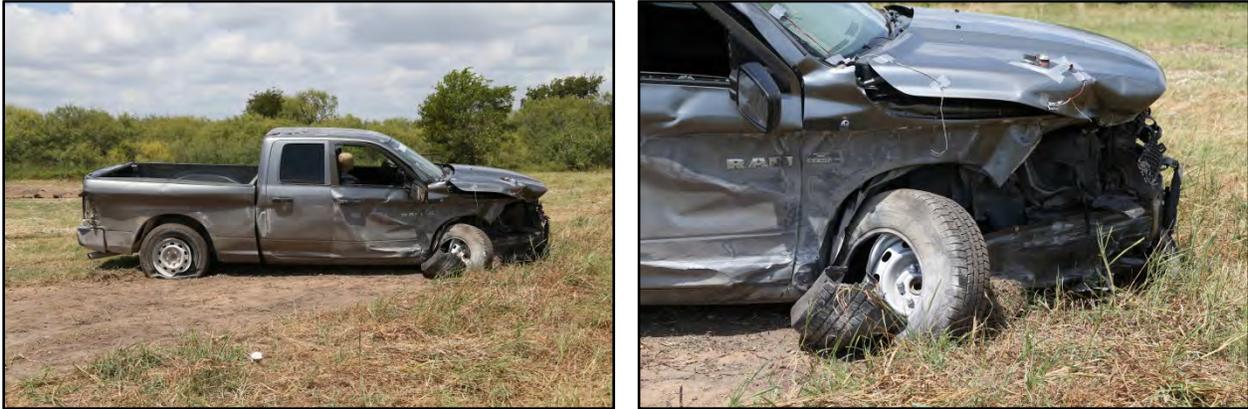
Figure 6.4. Test Vehicle after Test No. 490025-2-3.

Figure 6.4 shows the damage that the 2270P vehicle sustained. The right front rail, the right front upper and lower A-arms, and the right upper and lower ball joints were deformed. Also damaged were the front bumper, grill, hood, right front fender, right front tire and rim, right front door and door glass, right rear exterior bed, right rear tire and rim, and rear bumper. The A-pillar was deformed causing the windshield to fracture. Maximum exterior crush to the vehicle was 18.0 inches in the front plane at the right front corner at bumper height. Maximum occupant compartment deformation was 5.0 inches in the right firewall area. Figure 6.5 shows the interior

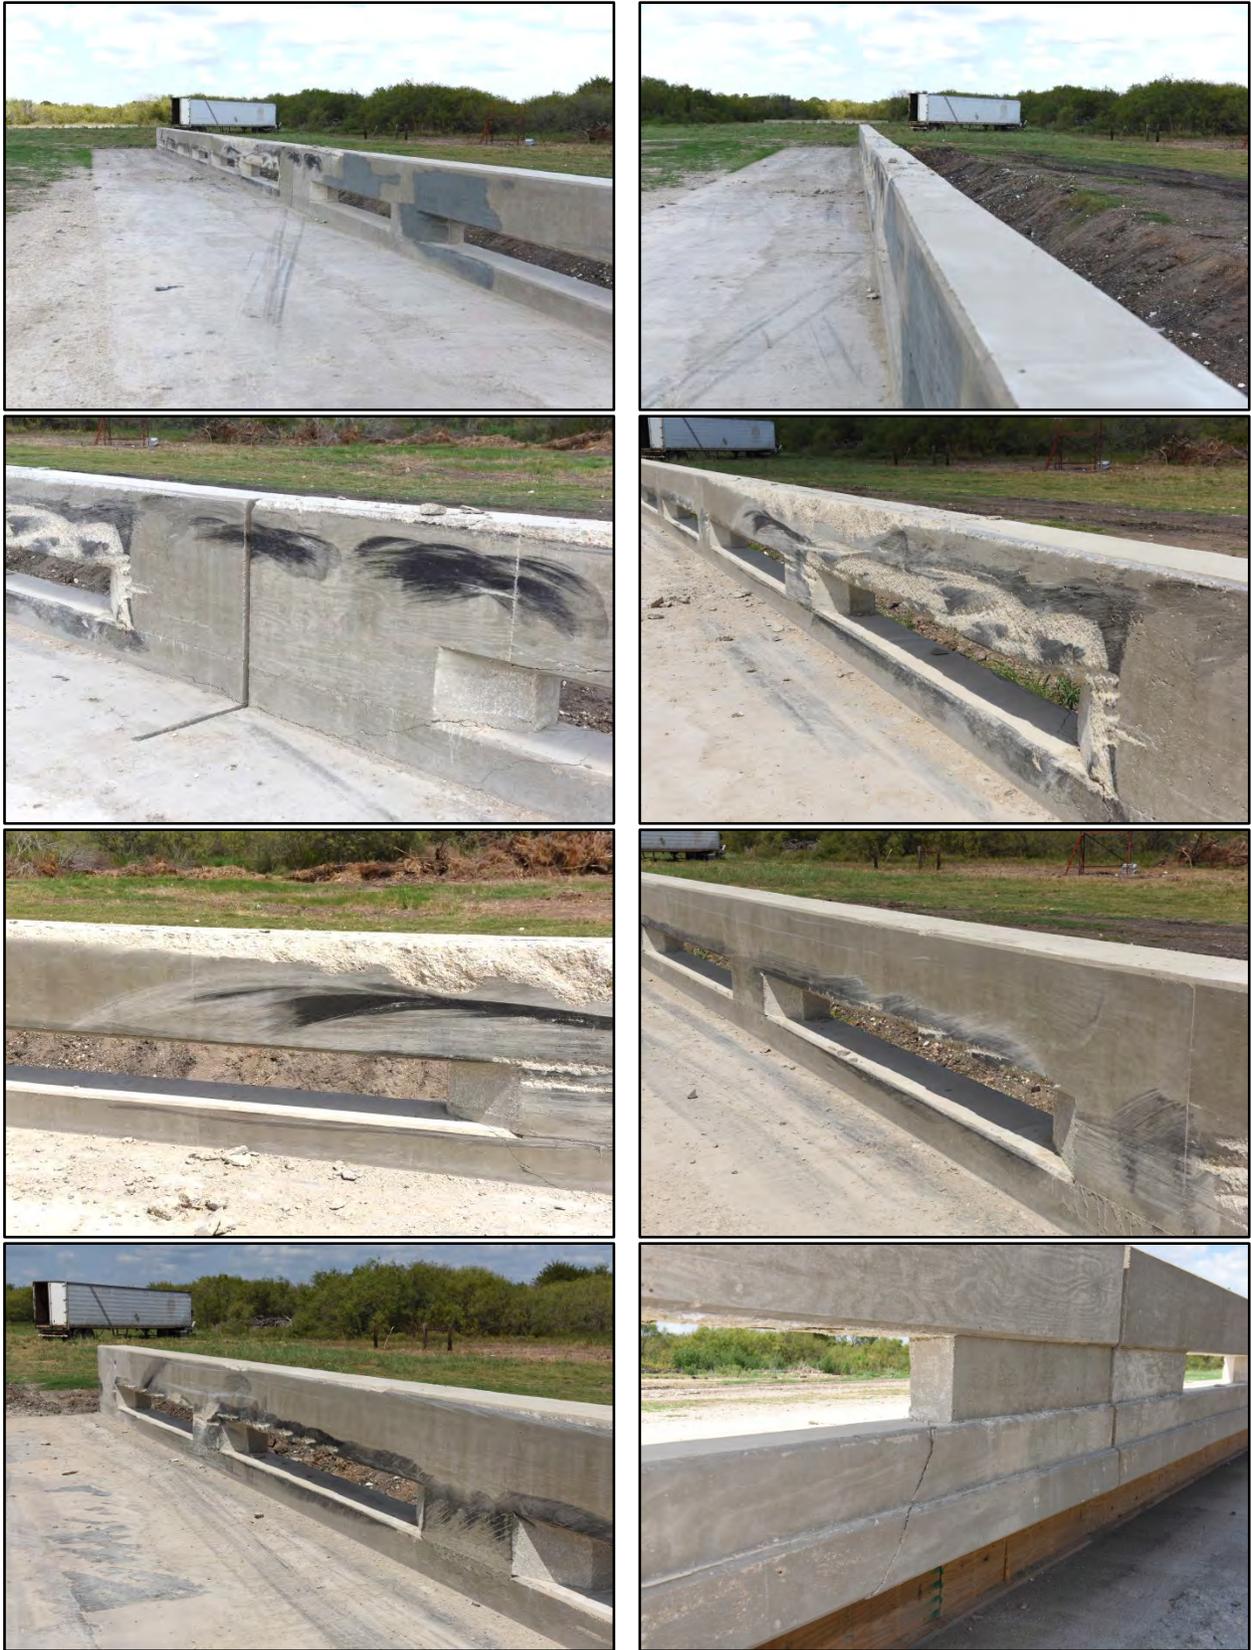
Figure 7.3. TxDOT T224 Bridge Rail after Test No. 490025-2-1.

Figure 7.3 shows the damage to the TxDOT T224 Bridge Rail. The curb was fractured at its connection with the deck 3.5 ft both upstream and downstream from the joint. The curb was also cracked over a length ranging from 6 ft upstream to 17 ft downstream of the joint. The upper rail was cracked from the joint extending downstream for 18 ft, and two cracks in the rail were noted from the joint extending upstream 12.5 ft (primary crack) and 17 ft 8 inches (secondary crack). The field side of the deck was cracked upstream of post 5. Working width was 38.5 inches from the traffic side of the bridge rail to the farthest extent of the vehicle. Maximum dynamic deflection during the test was 2.1 inches, and maximum permanent deformation as 1.4 inches.

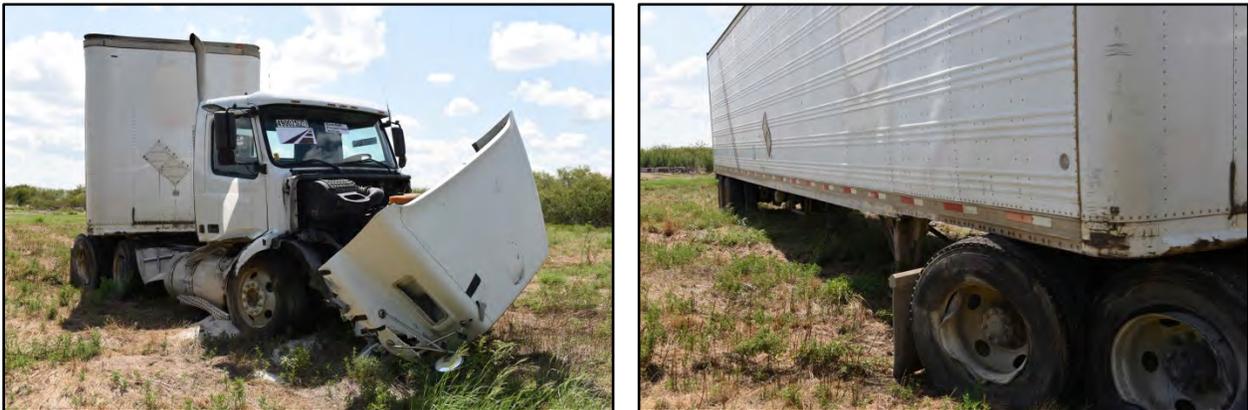
Figure 7.4. Test Vehicle after Test No. 490025-2-1.

Figure 7.4 shows the damage that the vehicle sustained. The front axle was pushed rearward 36 inches, and the right tie rod, right U-bolts, and right front shock and mount were deformed. Also damaged were the front bumper, hood, right front tire and rim, right front fender, right fuel tank, right side steps, and right rear outer tires and wheel rims of the tractor tandem. The right side lower edge of the trailer was also deformed and scraped. Maximum exterior crush to the vehicle was 12.0 inches in the front plane at the right front corner at bumper height. No occupant compartment deformation occurred. Figure 7.5 shows the interior of the vehicle.
