# Project Summary

Texas Department of Transportation

## 0-6650: Fatigue Failure and Cracking in High Mast Poles

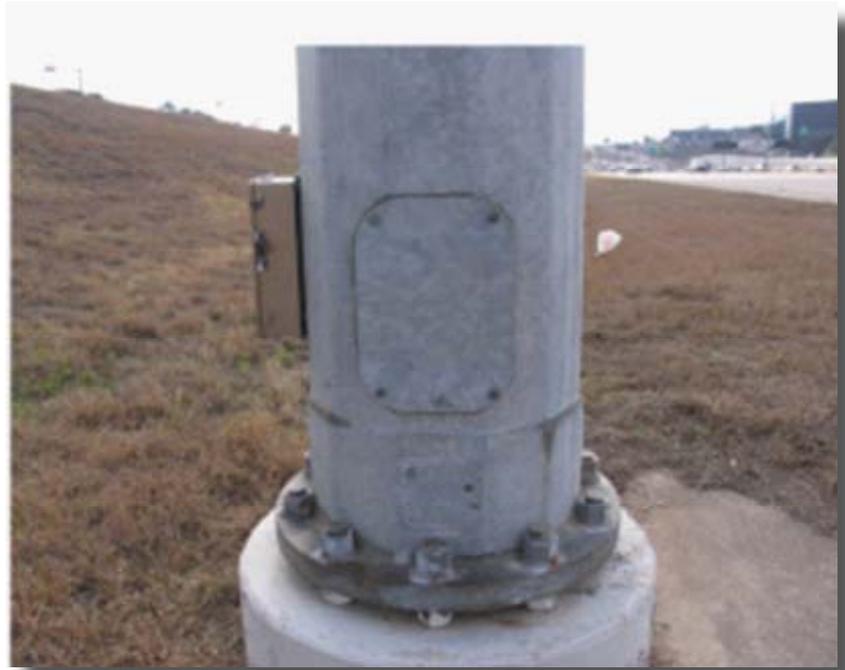
Figure 1. High Mast Illumination Pole Base.

Research indicates that these types of structures are particularly susceptible to galvanization induced cracking near the weld that connects the pole shaft to the base plate (see Figure 1). Cracks can form during fabrication and crack propagation can be driven by repeated, cyclic wind loading. While there have been no reported failures of TxDOT owned and maintained HMIPs due to galvanization induced cracking, similar types of failures have been reported elsewhere.
