Texas Tech University

Proper Overlay Type and Designs for PCC Pavement

Research Report 0-6910-R1

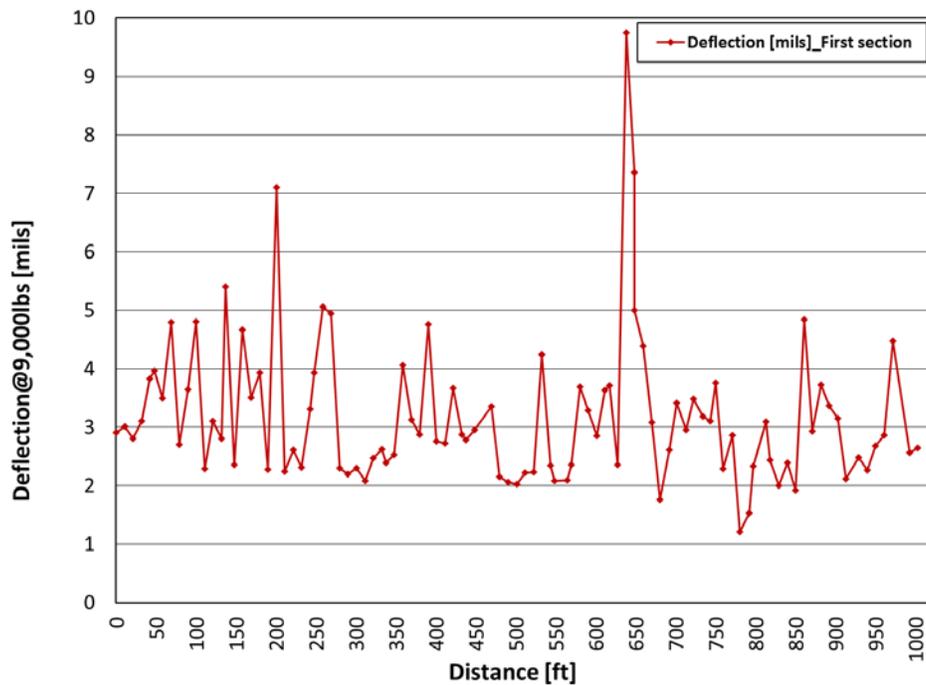
Figure 3.4 FWD testing result at poor section (with distresses)

FWD testing was conducted at 10-ft intervals over approximately 1,000-ft for each section. **Figures 3.4 and 3.5** show deflections measured in poor and good sections, respectively. It is observed that overall deflections and their variability were larger in the poor section than in the good section. In the poor section, deflections greater than 7 mils were recorded at two locations, which coincided with PFC distress locations, whereas the deflections in the good section were smaller and more uniform. It appears that delamination or debonding at the poor section was also responsible for larger deflections. Field testing was conducted in 2010 on the existing 8-in. CRCP prior to the overlay, which included Total Pavement Acceptance Device (TPAD) testing, DCP testing, and deflection testing with FWD. Also, bond strength testing was conducted in November 2012, prior to the opening of the 4-in. BCO to traffic. Those field-testing results are discussed in Chapter 4.

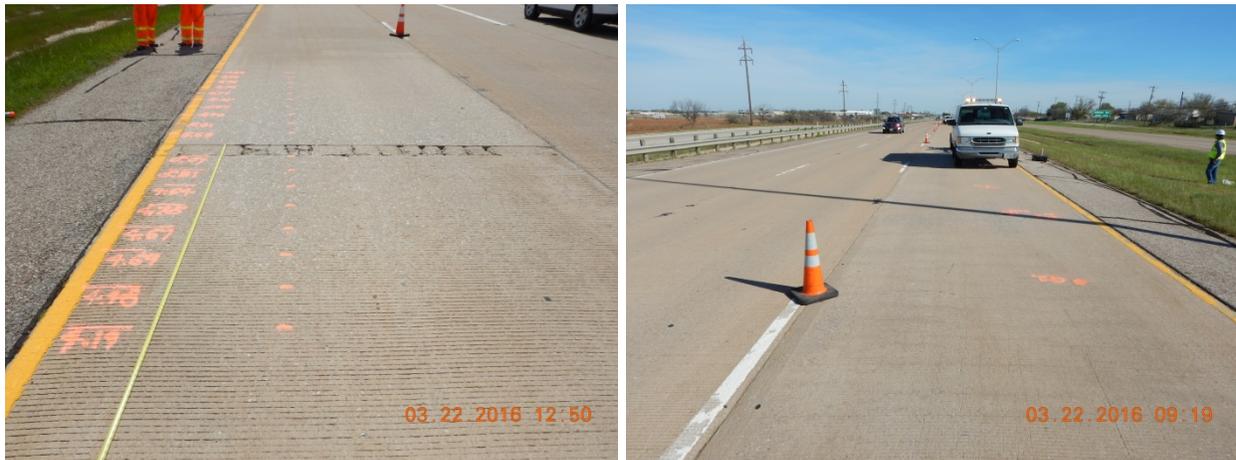
Figure 3.12 Overall pavement condition at poor and good sections

The overall BCO condition on US 281 was good, without any distresses except at a transverse construction joint (TCJ) area. Based on the visual survey results, two sections were selected as good and poor sections, as with the US-287 test section in Bowie. **Figure 3.12-(a)** shows a distress near a TCJ at the poor section and **Figure 3.12-(b)** provides an overall view of the good section selected. **Figure 3.13** shows the testing location on US 281 in Wichita Falls.

(a) Distress at construction joint (poor section)

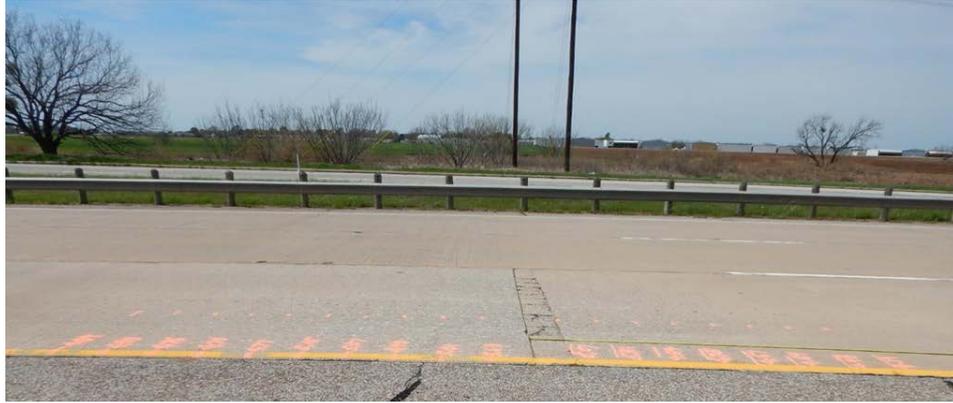
Figure 3.16 FWD deflection near the TCJ

MIRA testing was also conducted at every FWD testing location, and delamination was detected near the TCJ at the overlay interface (4-in. depth from the top) and within the existing CRCP (8-in depth from the top) as shown in [Figure 3.17](#). This delamination indicates that there was an existing horizontal crack within the existing 8-in. CRCP. On the other hand, delamination and horizontal crack disappeared away from the TCJ, as shown in [Figure 3.18](#). [Figure 3.19](#) shows slabs removed at this location during FDRs, and horizontal cracks were observed. In Texas, horizontal cracks at the depth of longitudinal steel and resulting distresses such as slab segmentation are the primary distress type in CRCP. Punchout due to closely spaced transverse cracks and cantilever action is rarely observed.

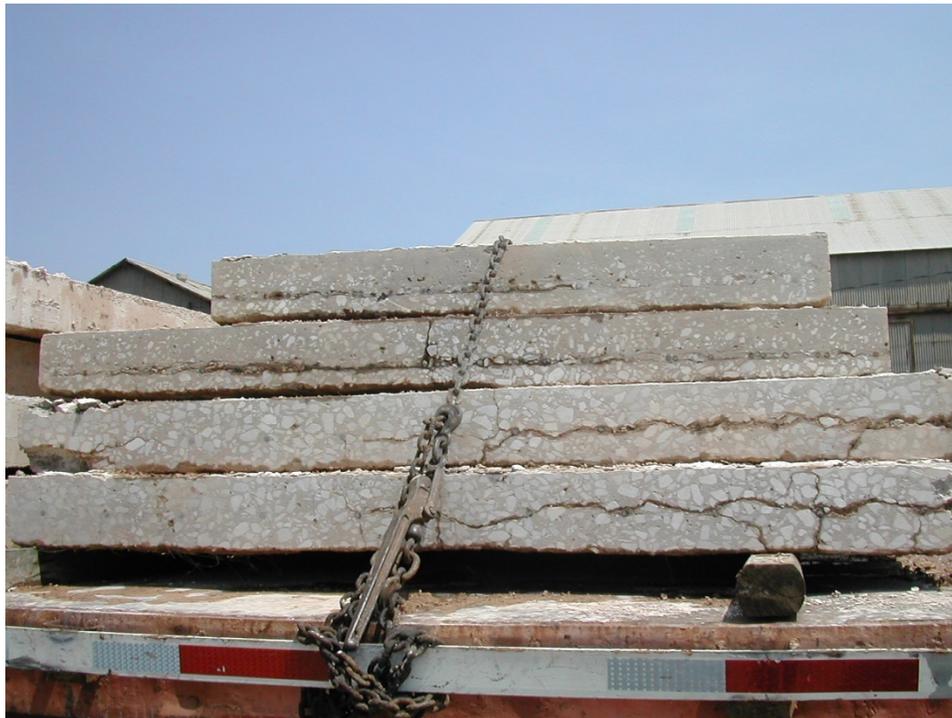
Figure 3.19 Horizontal cracks at the depth of longitudinal steel

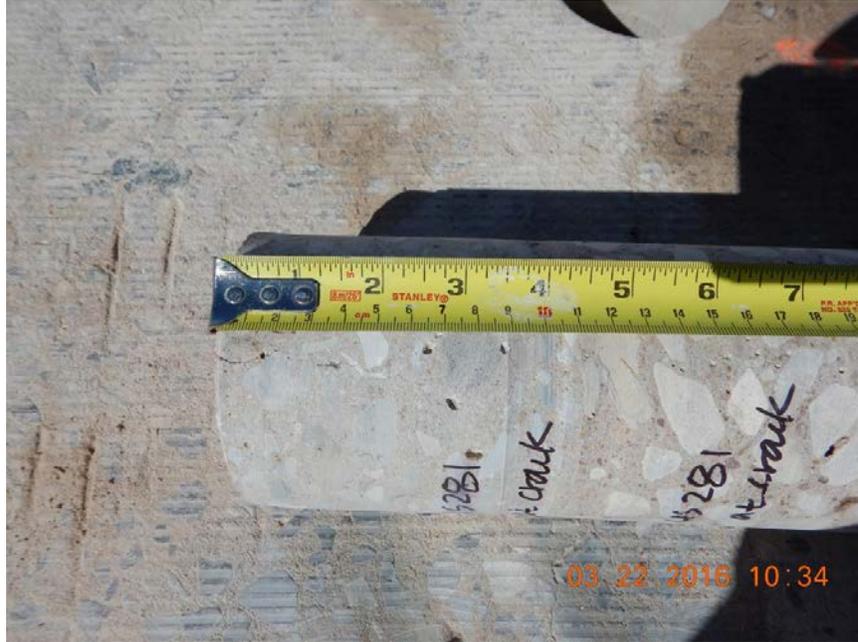
Figure 3.25 Close-up view of G3 core taken at transverse crack

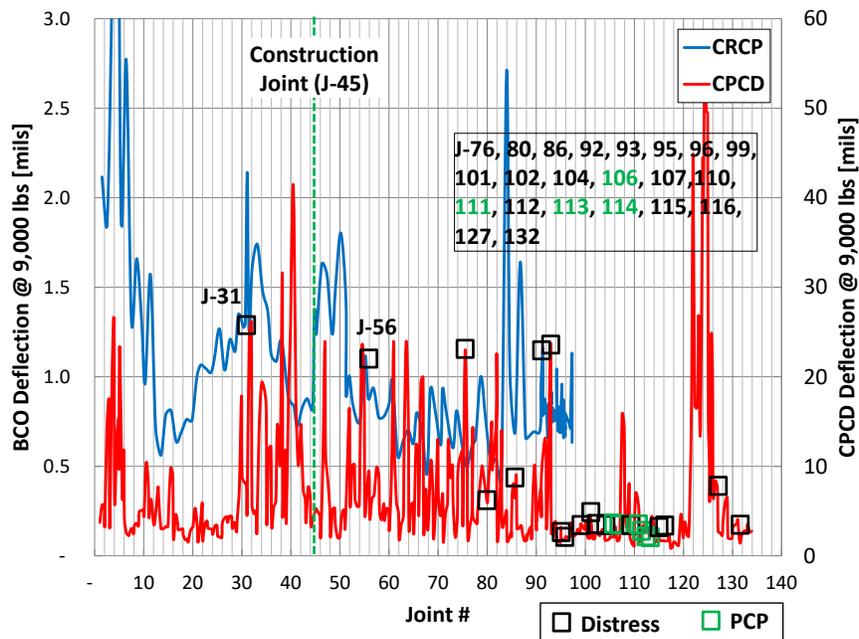
Figure 3.32 Deflection comparisons between BCO and CPCD with BCO distresses

deflections in CPCD did not necessarily experienced distresses in BCO; however, deflections in CPCD where distresses developed in BCO were above a certain value. It appears that large deflections in CPCD are not a sufficient condition, but rather a necessary condition for distresses in BCO. This finding is a little different from the findings at US 287 in Bowie, where large deflections in 8-in. existing CRCP were close to sufficient condition for 4-in. BCO. The difference appears to be the thickness of CRCP BCO—7-in. at this location versus 4-in. at the US-287 site in Bowie. Figure 3.34 illustrates the same information from Joint 81 to Joint 120, where deflections in CPCD were quite small, while a number of distresses and PCCPs were observed in BCO. It is not clear whether BCO construction practice or other conditions, such as poor-quality repairs of CPCD, were responsible for the large frequency of distresses and PCCPs in this area.

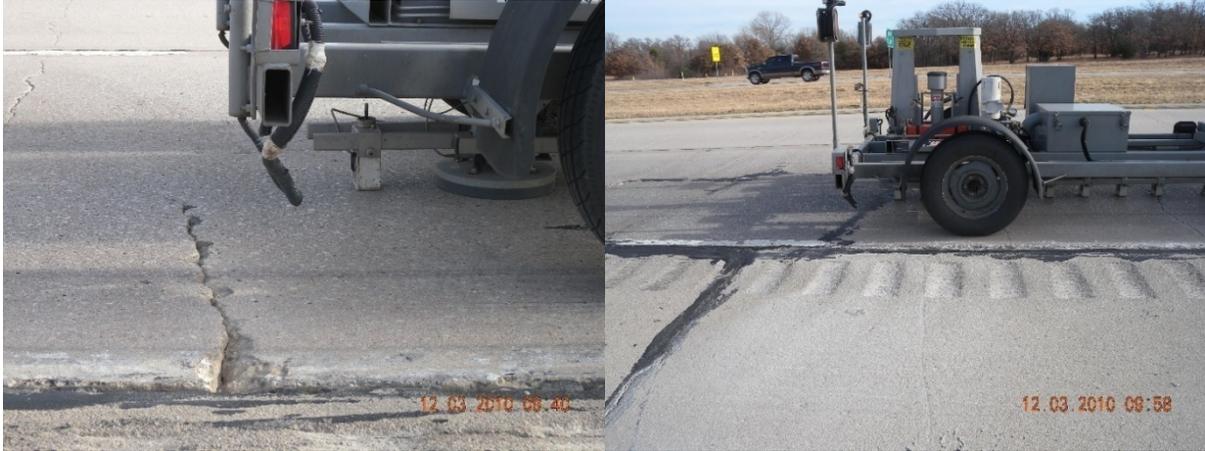
On US 287 in Bowie, distresses appeared in existing CRCP at several locations, in the form of punchouts and half-moon-shaped longitudinal cracks. Also evident were transverse cracks with large crack widths and concrete chipping. FWD deflections in these locations were much higher than at other locations. It would be of great importance to identify whether these distresses with high deflections will reflect through to BCO and cause distresses in BCO. **Figure 4.2** shows typical distresses in the existing CRCP, and the FWD deflections near those distress locations are shown in **Figure 4.3**.

a. Chipping at transverse crack in old CRCP

b. FDR in old CRCP

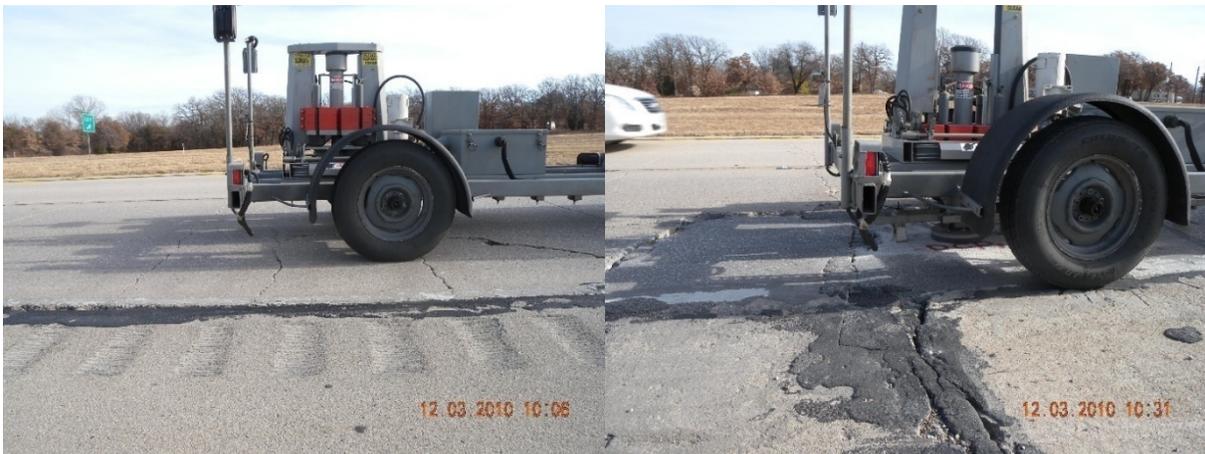
c. Diagonal cracking in old CRCP

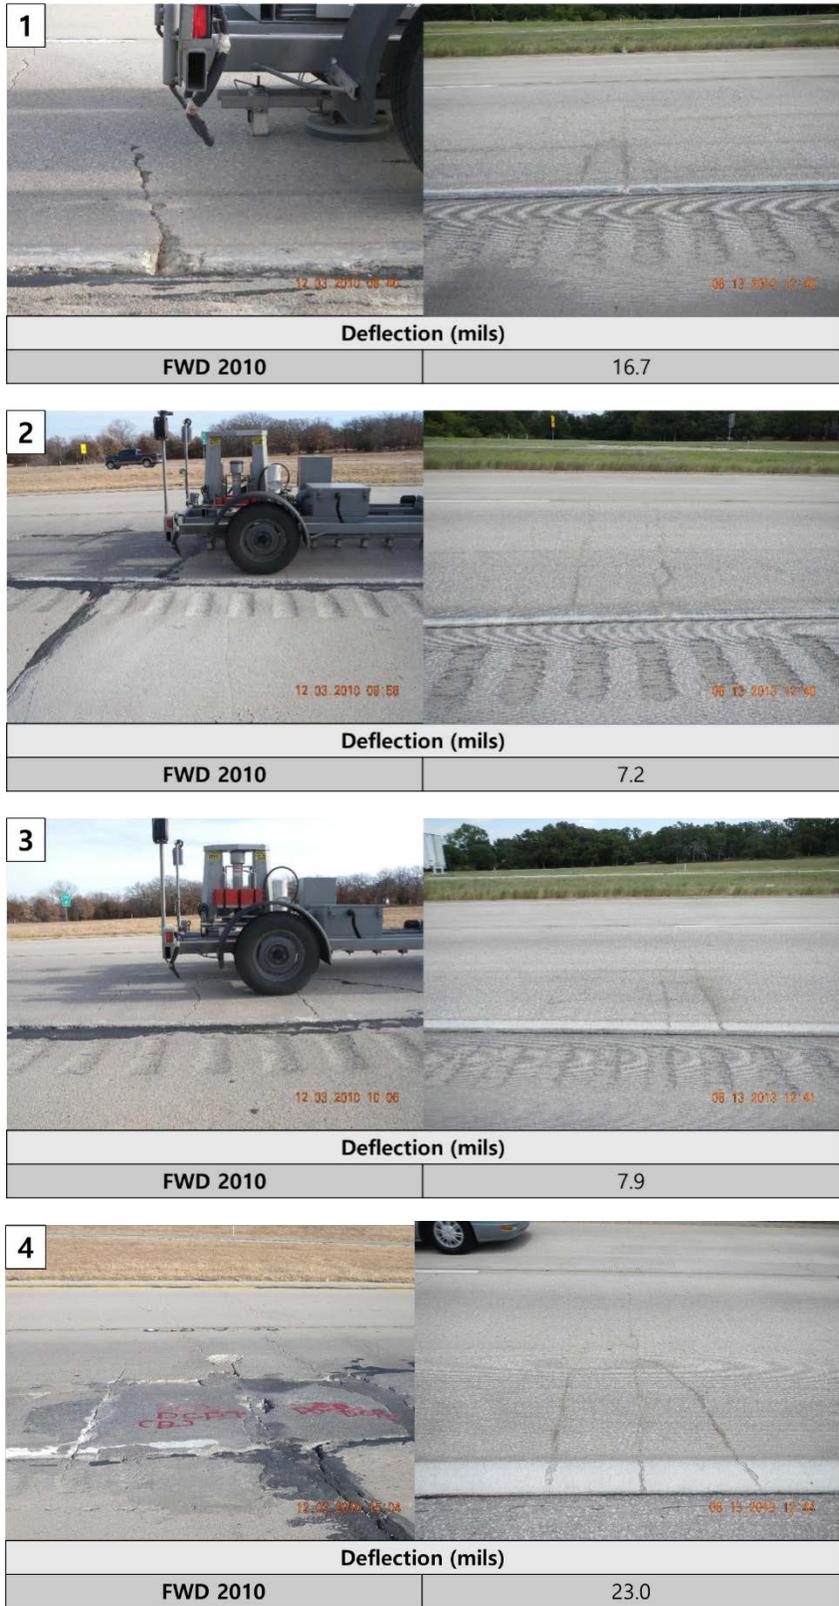
Figure 4.5 Distress comparison between old CRCP and BCO

Figure 4.5 shows comparisons between FWD deflections on existing CRCP measured in 2010 and distresses in BCO. It is interesting to note that the distresses in BCO are of similar shapes to those in the existing CRCP, even though some of these distresses were repaired prior to BCO placement.

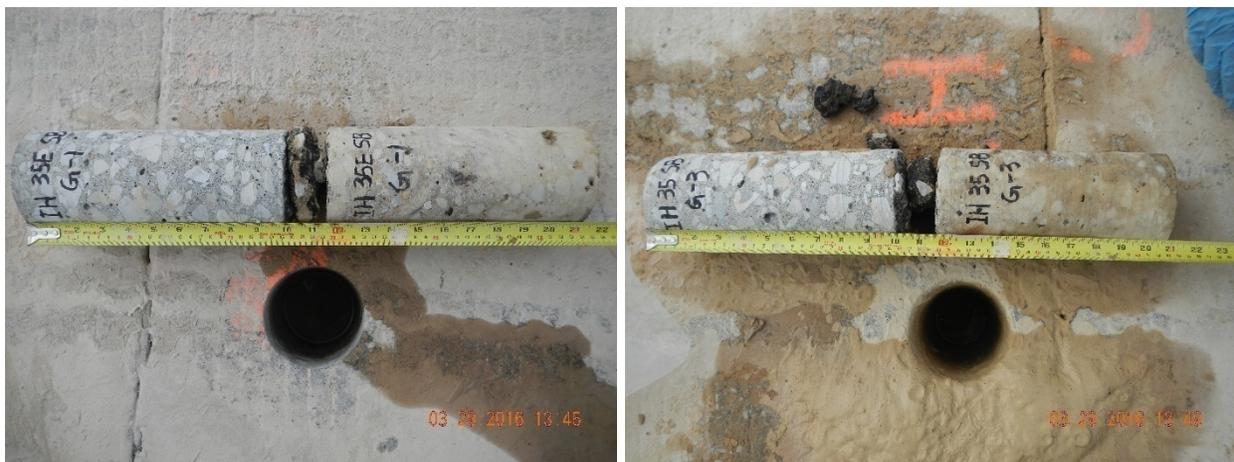
Figure 4.35 Deteriorated AC interlayer in a good section of IH 35E

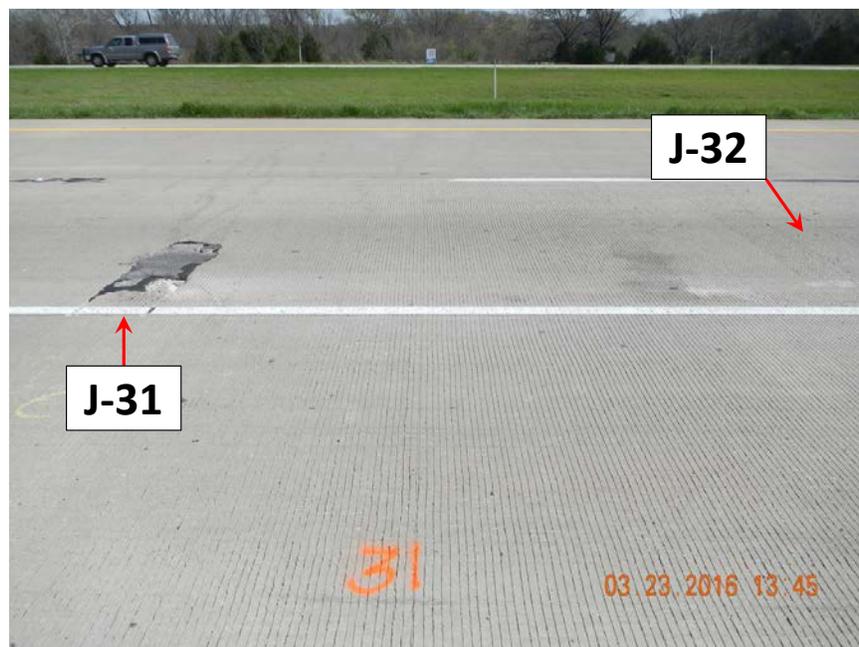
Figure 5.4 Distress in CRCP BCO on CPCD (US 75 in Sherman #1)

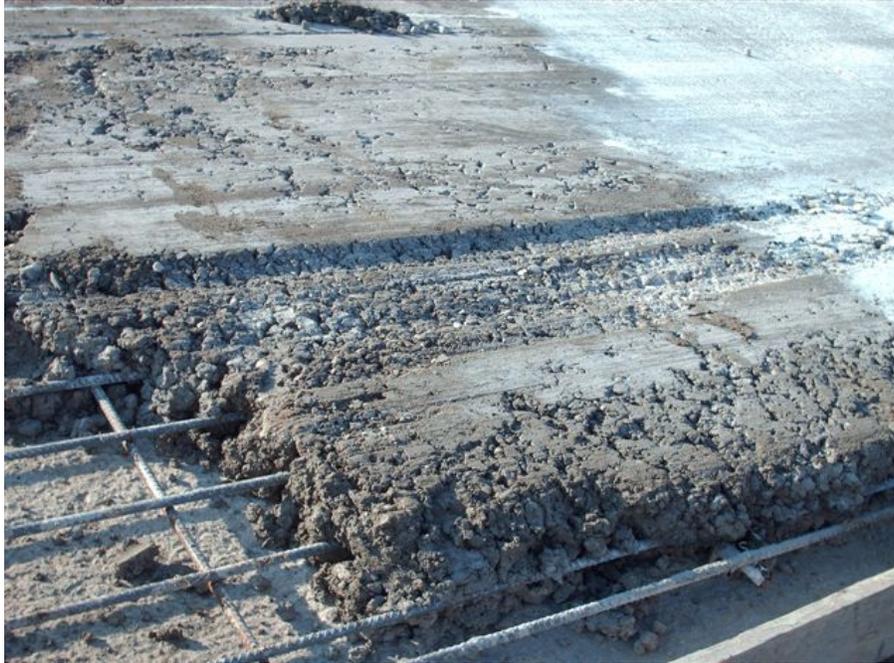
Figure 5.9 Dry concrete in BCO that was removed and replaced

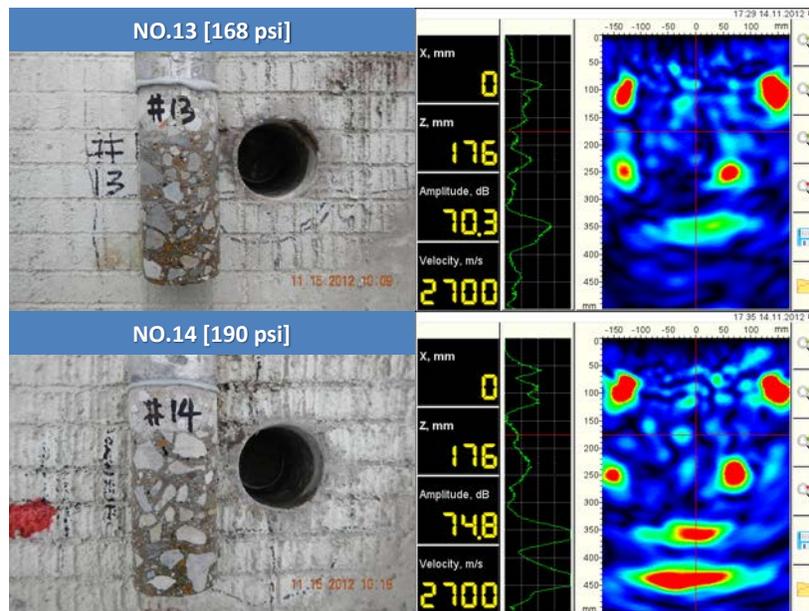
Figure 6.7 Bond strength and MIRA testing (interface failure)

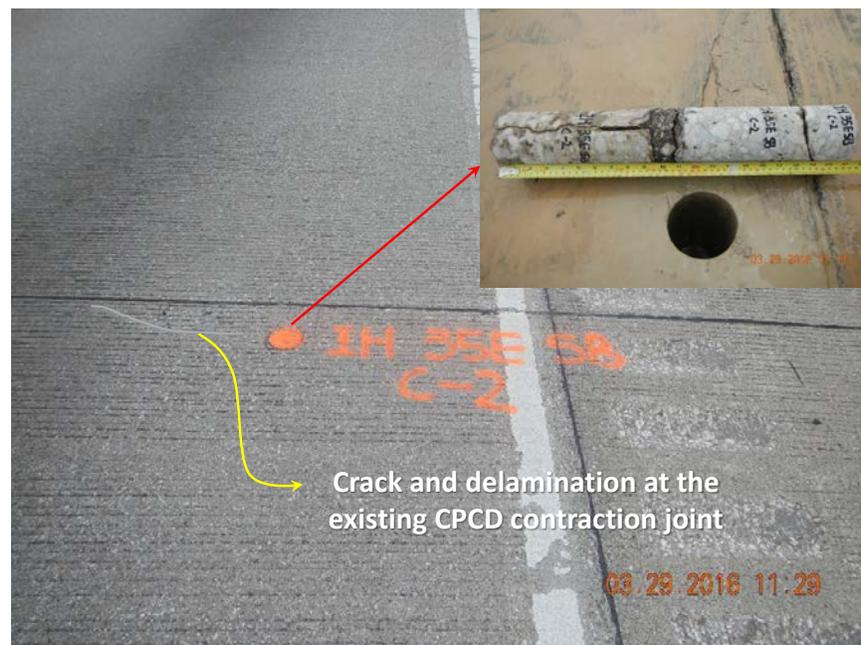
Figure 6.12 Delamination and crack due to joint mismatch between existing CPCD and overlaid CPCD
