# Design and Rehabilitation Strategies for Permeable Friction Course Pavements

Technical Report 0-7110-R1

TEXAS A&M TRANSPORTATION INSTITUTE  
COLLEGE STATION, TEXAS

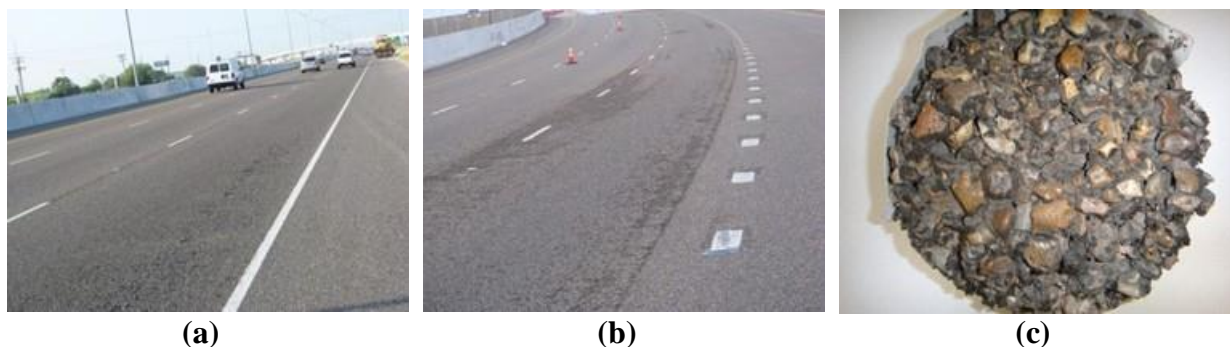
In Texas, PFC pavements have an average life of 7–10 years, with some projects failing early and others lasting longer. For example, a PFC pavement found on US 281 in Pharr, Hidalgo County, showed excessive amounts of raveling on the outside (far right) lane. A section of the pavement had minor to no distress, while another section had severe raveling. The pavement was constructed in 2004 using river gravel and a design binder content of 9.1 percent AC-10 with 17.7 percent crumb rubber. Pictures captured during the forensic inspection of the pavement conducted in 2010 are shown in Figure 2. Field measurements showed that the raveled section had faster water flow; also, measurements on field cores obtained from the pavement showed higher average AV content (i.e., 24.8 percent versus 19.3 percent) and lower total binder content (i.e., 4.5 percent versus 5.7 percent) in the raveled section (Arámbula et al. 2013).

**Figure 2. PFC pavement located in Pharr: (a) general view of raveled section, (b) detailed view of raveled section, and (c) field core with apparent stripping (Arámbula et al. 2013).**

Potential causes of the observed raveling were attributed to the following (Arámbula et al. 2013):

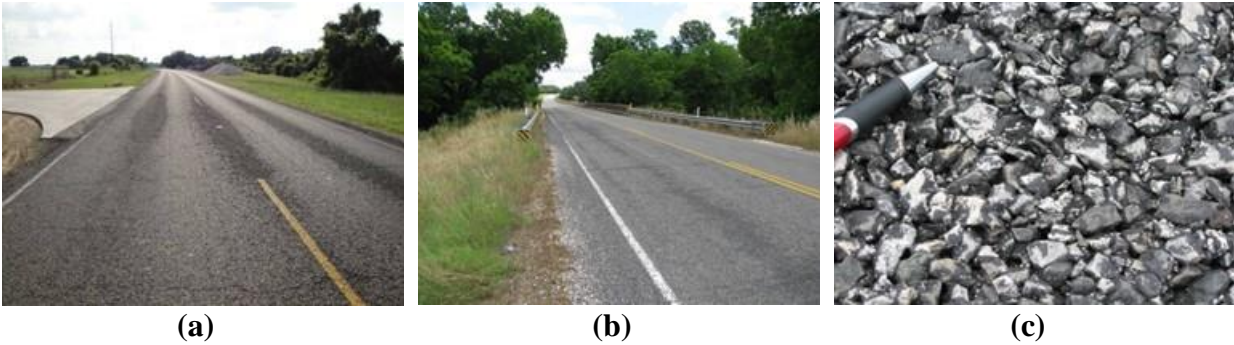
Another instance of raveling in Texas after several years in service was a PFC pavement located on US 90 in Houston, Waller County. The pavement was built in 2004 using a design 8.3 percent AC-10 with 18 percent Centex Grade B rubber. The performance of this PFC pavement was adequate during the first years of service; however, after this period, excessive stripping and raveling were observed throughout the pavement surface. Figure 3 illustrates the condition of the pavement. Field measurements showed that the pavement was impervious, and measurements on field cores yielded an average AV content of 11.5 percent. Potential causes of the observed distress were attributed to excess fines in the mix and low AV content on the wheel paths, which likely trapped water on the other areas of the lane, promoting raveling.

**Figure 3. PFC pavement located in Houston: (a) raveling distress near a turning access, (b) raveling distress near a bridge, and (c) close-up view of the pavement surface (Arámbula et al. 2013).**

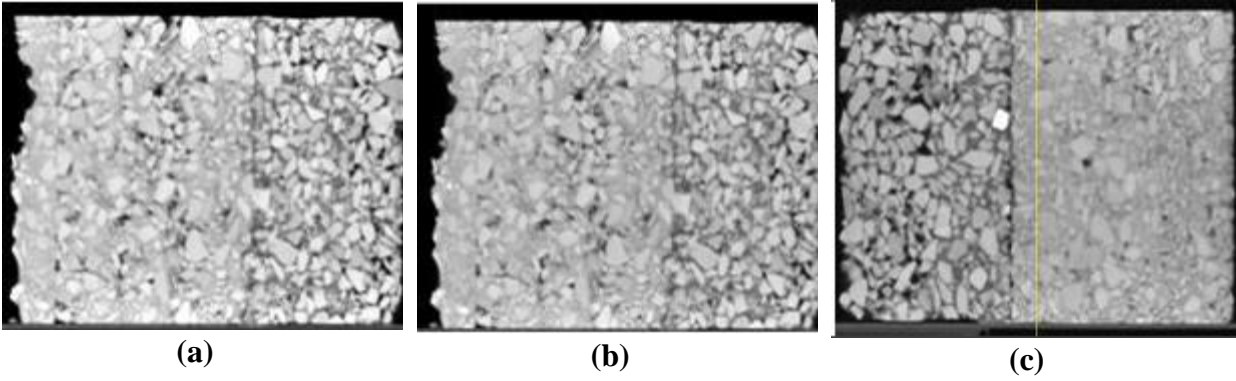
Figure 15 shows images of the computed tomography scans and Figure 16 the estimated AV for the cores extracted from US 359. The results indicate that the estimated AV was higher at the top half-inch of the PFC and reduced toward the center, where the AV detected was below 10 percent (the typical AV of a new PFC pavement is about 20 percent). The reduction was more prominent on the inner lane (3W) than the outer lane (1W) and shoulders (3S). A similar trend was noted during the field flow test. There is a spike in the middle of the AV plot, which represents the joint between the pavement bottom dense layer and the PFC mix. At that point, there was no effect on water flow initiating from the surface.

**Figure 15. Images of the X-ray computed tomography scans obtained from the PFC pavement on US 359: (a) outer lane 1W, (b) inner lane 3W, and (c) Shoulder 3S (Scullion et al. 2020).**

The recommendation to the district was that no seal was necessary since this pavement had already ceased to drain and was no longer truly functioning as a PFC pavement. While it may have been a suitable candidate to overlay, the district ultimately milled off the PFC pavement.

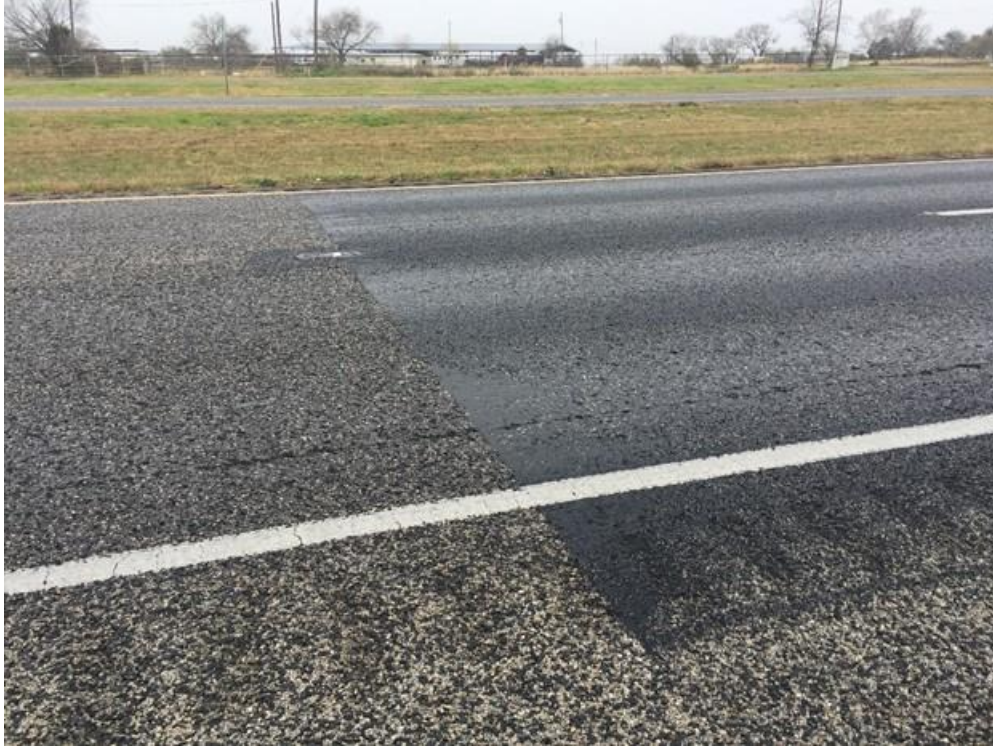
**Figure 29. IH 35 after 3 years of traffic showing wear off the Onyx surface treatment.**

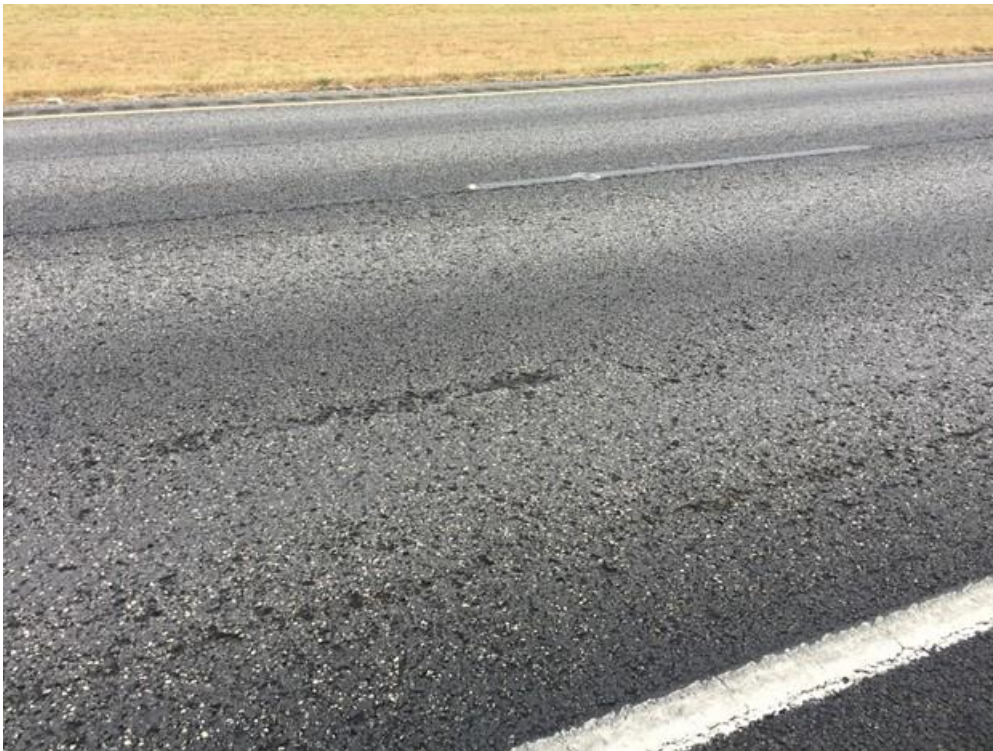
**Figure 30. IH 35 after 3 years of traffic showing signs of raveling.**

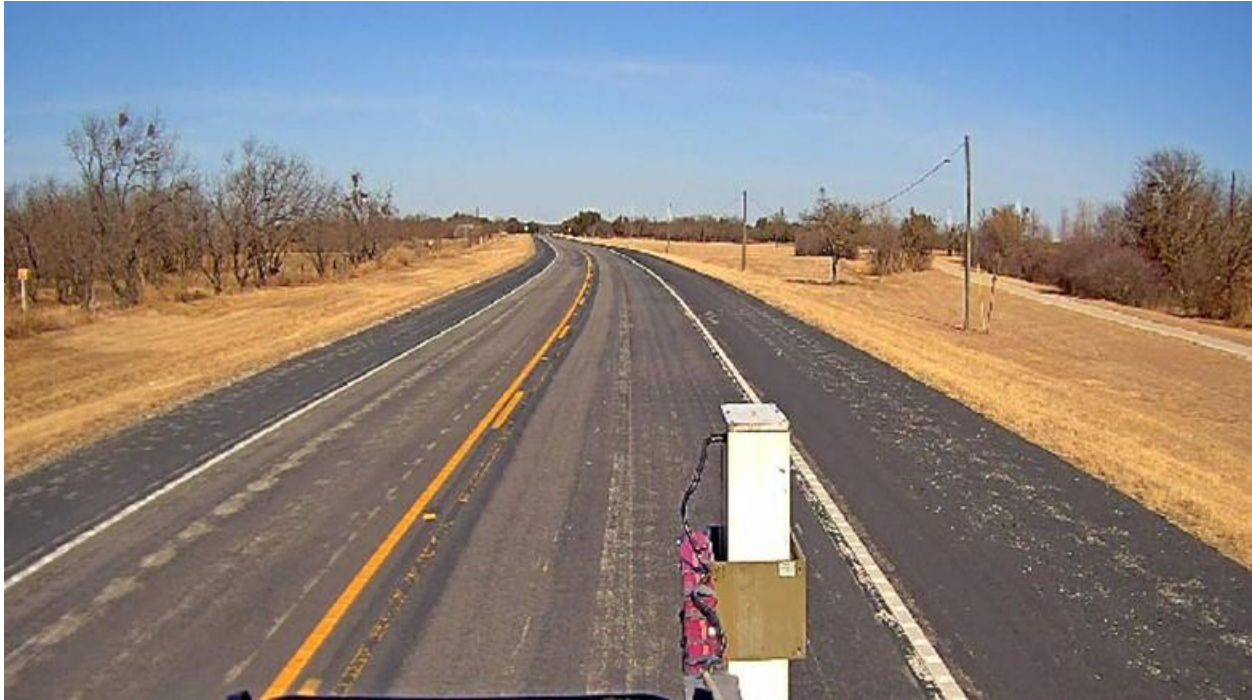
**Figure 33. Condition of US 183 after about 2 years of traffic (February 2022).**

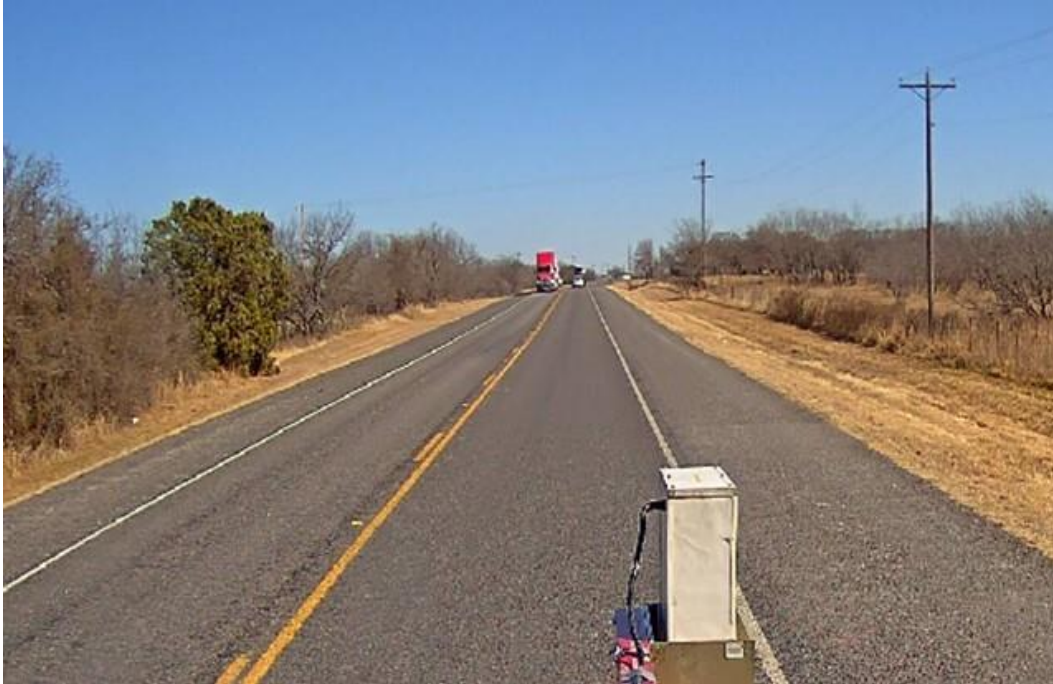
**Figure 35. Current condition of seal coat on SH 36 in Brownwood District (February 2022).**

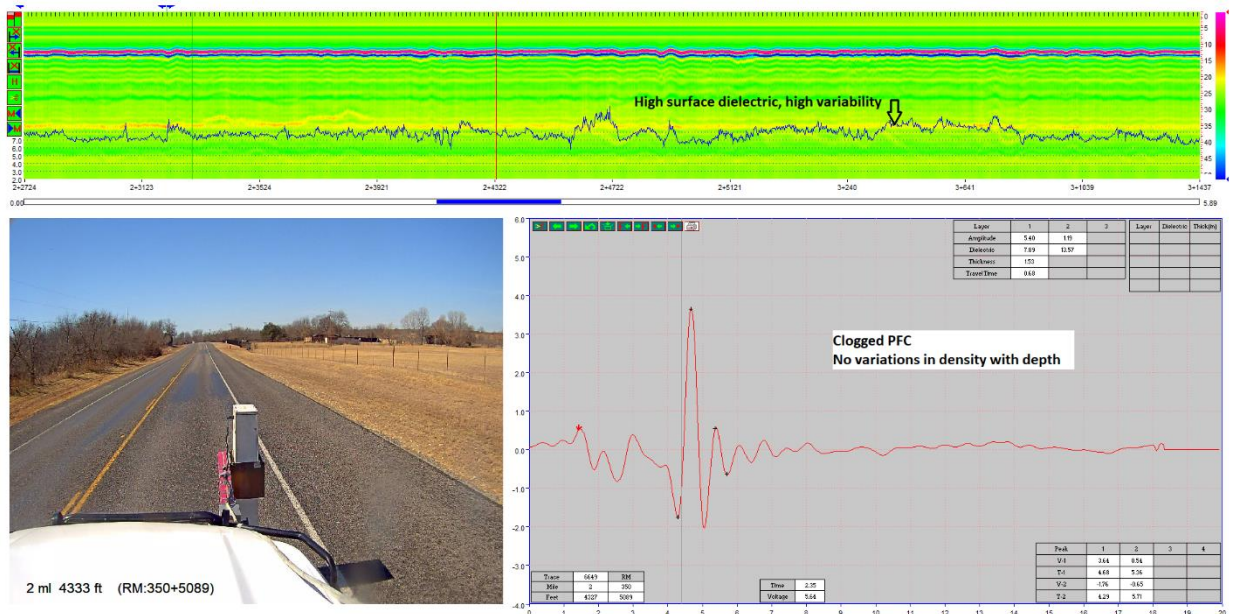
A GPR survey was conducted in February of 2022, and examples of the GPR survey are shown in Figure 36 and Figure 37. Based on the GPR, most of the project seems to be clogged (not draining) since there is no variation in density with depth, as shown in Figure 36 and schematically depicted in Figure 38. This finding indicates that the pavement was no longer functioning as a PFC at the time of seal coating. However, in some areas (as shown in Figure 37), there appears to be a portion of low density at the bottom of the PFC, meaning that the PFC is clogged in the top portion but open in the bottom portion (as illustrated in the schematic of Figure 39). While this could be an area to potentially hold water, there do not appear to be any surface distresses causing concern.

**Figure 36. GPR evaluation of SH 36 indicating PFC is clogged.**

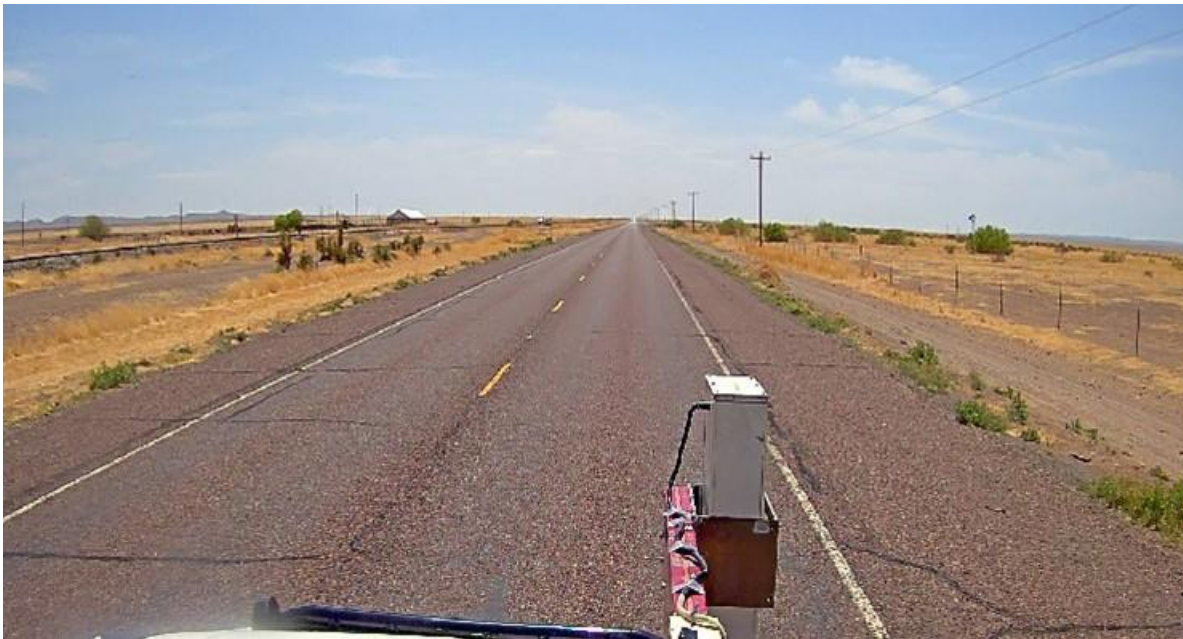
The El Paso District placed a seal coat on an older PFC on US 90. The PFC was in good condition, and no adverse performance has yet resulted from sealing off the PFC. This satisfactory performance may also be attributable to the dry climate of the area.

**Figure 42. Current condition of US 90 at western end of project near Presidio County Line (April 2022).**

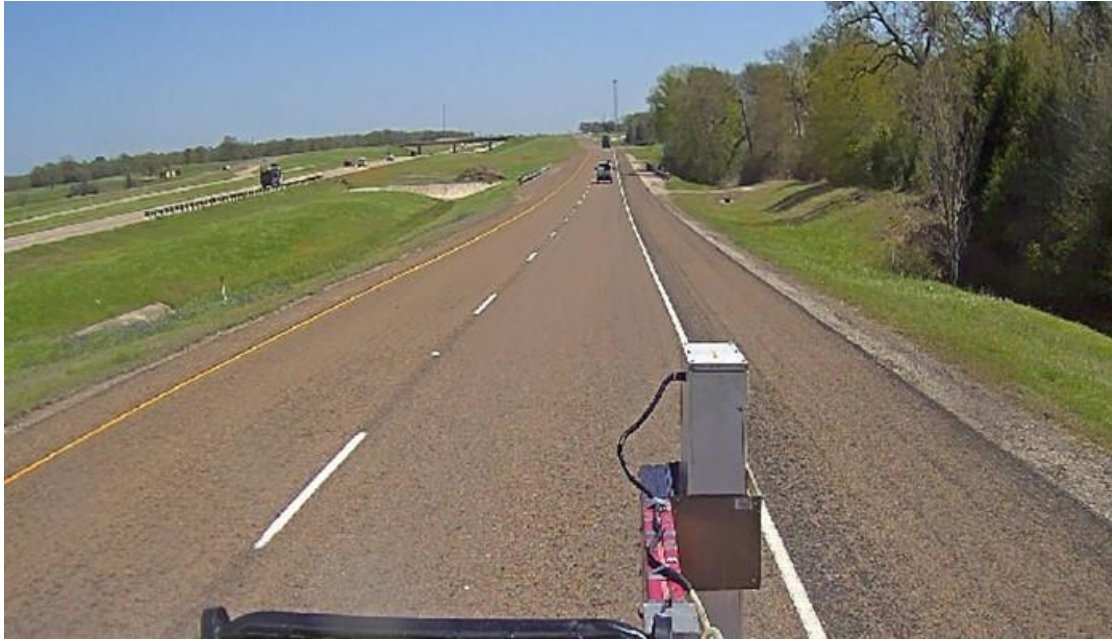
**Figure 44. Current condition of SH 6 FR (April 2022).**

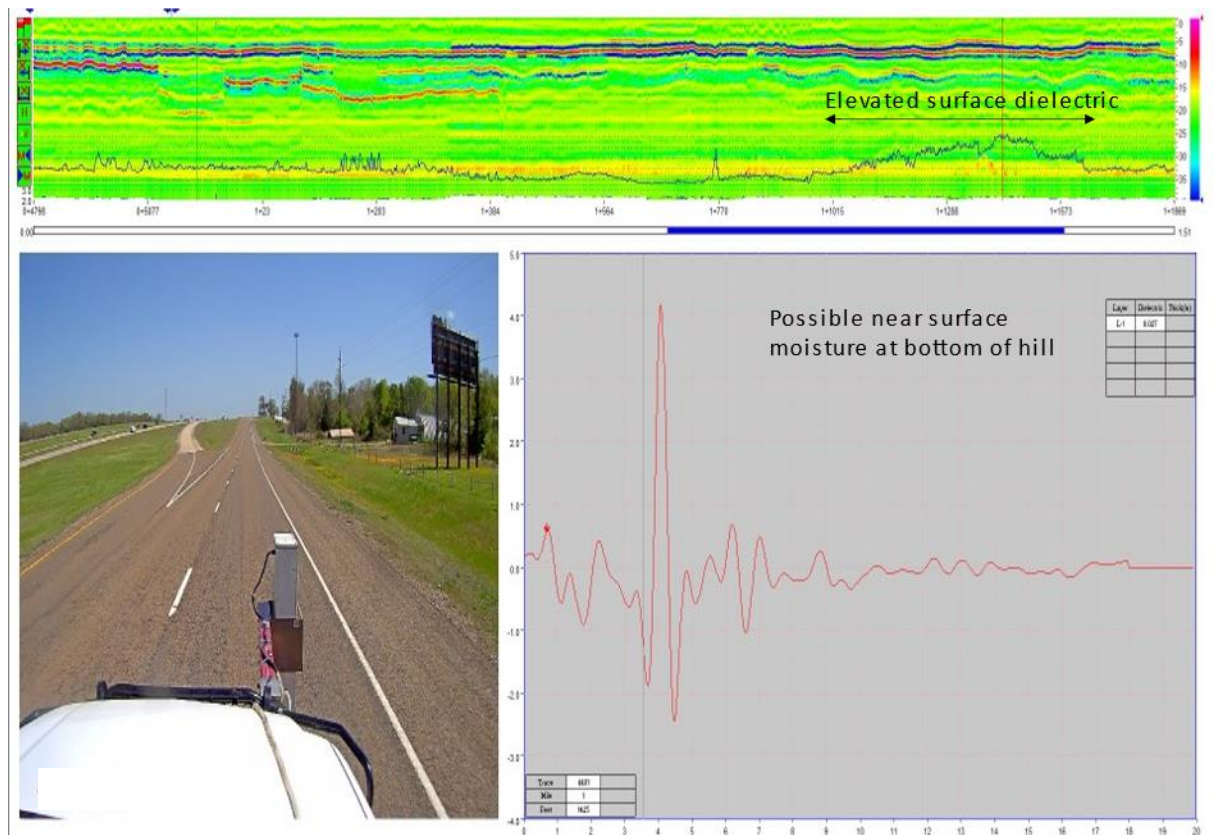
Figure 46. GPR evaluation of SH 6 showing possible moisture.

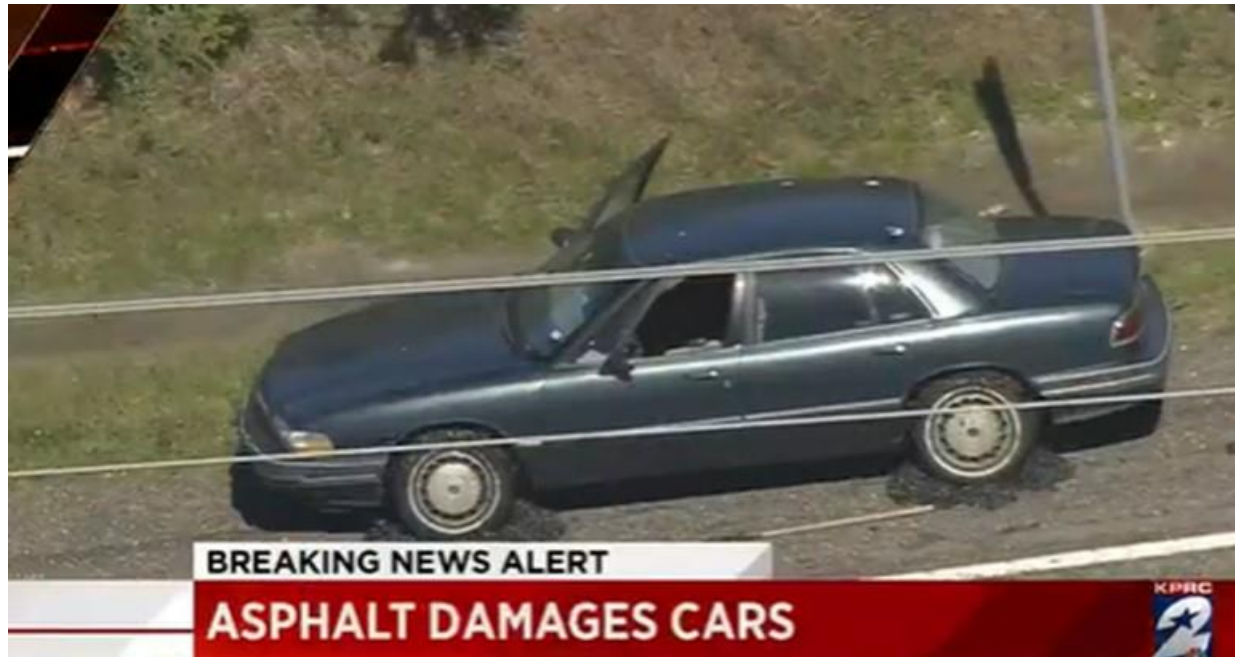
**Figure 47. Seal coat stuck to vehicle tires (from TV news report).**

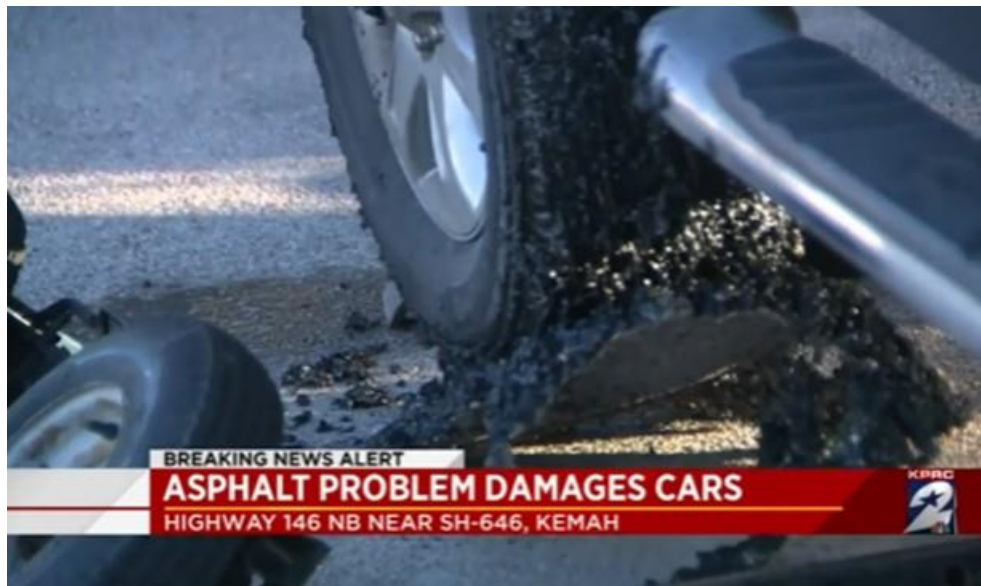
Figure 49. Seal coat causing damage to cars and tires (from TV news report).

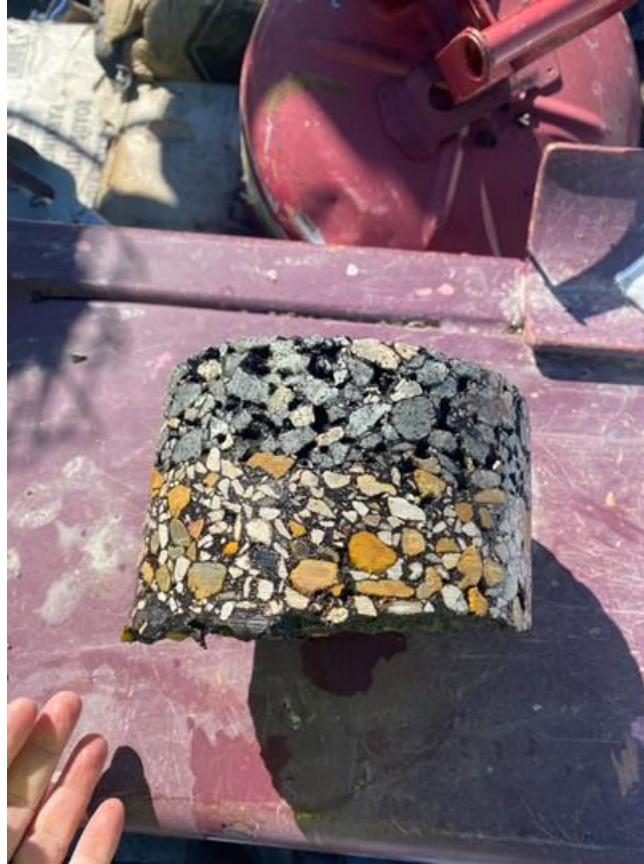
**Figure 58. Core from US 69 showing PFC bonded to underlying HMA.**

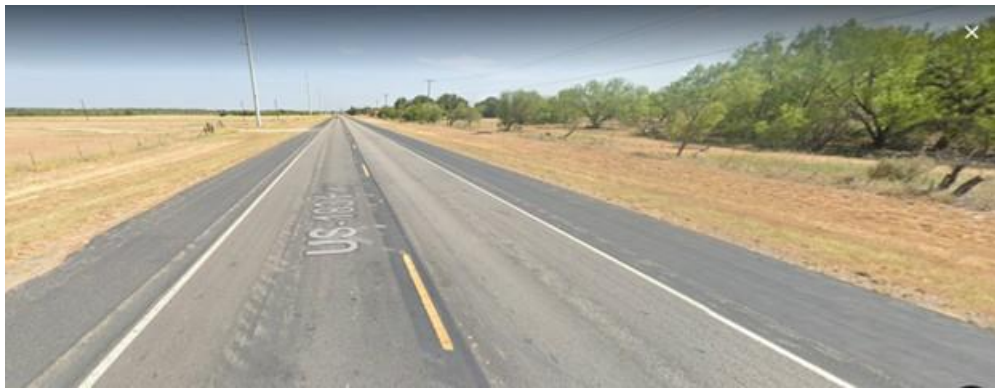
**Figure 70. Condition of US 183 PFC from July 2022, Google Maps.**

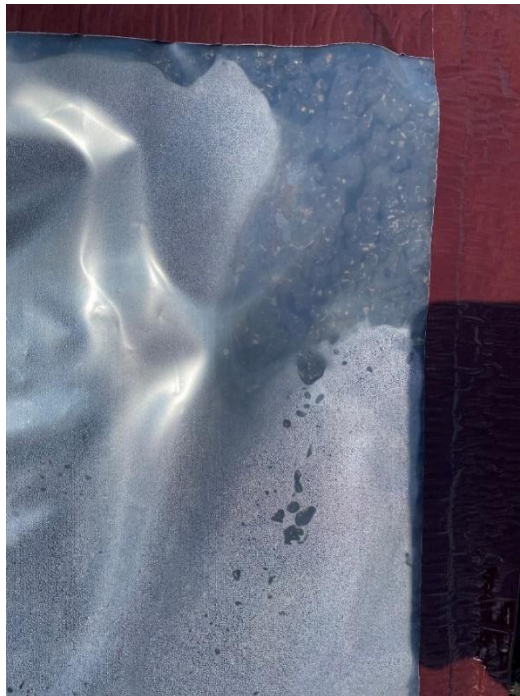
**Figure 94. Moisture condensation on the underside of the plastic.**

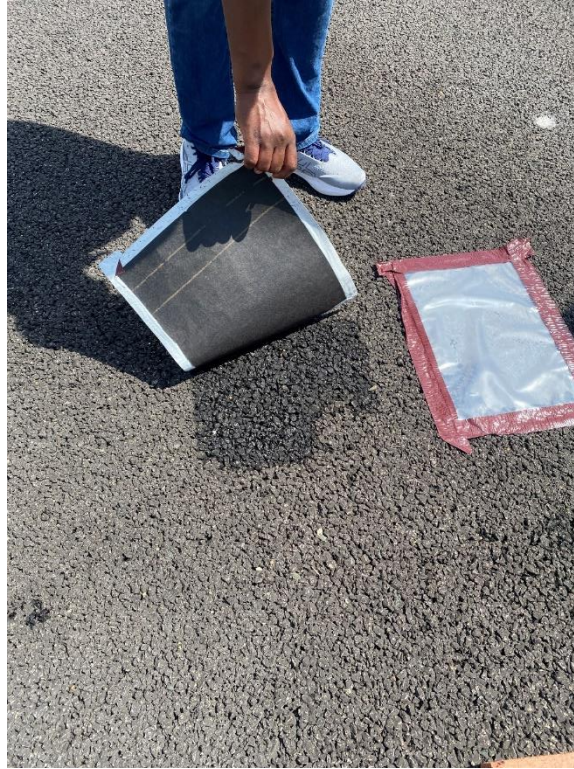
**Figure 95. Moisture condensation on the underside of the roofing paper.**

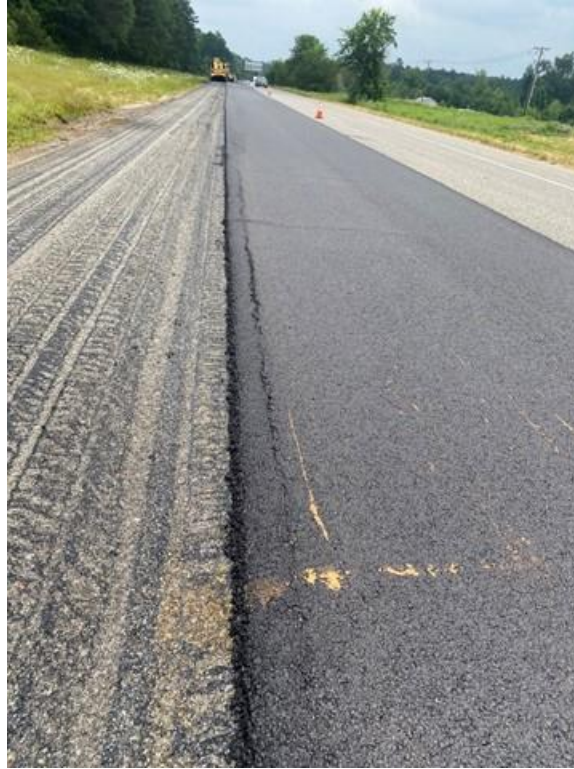
**Figure 104. Bulges and cracking appearing after additional rolling in an isolated section.**

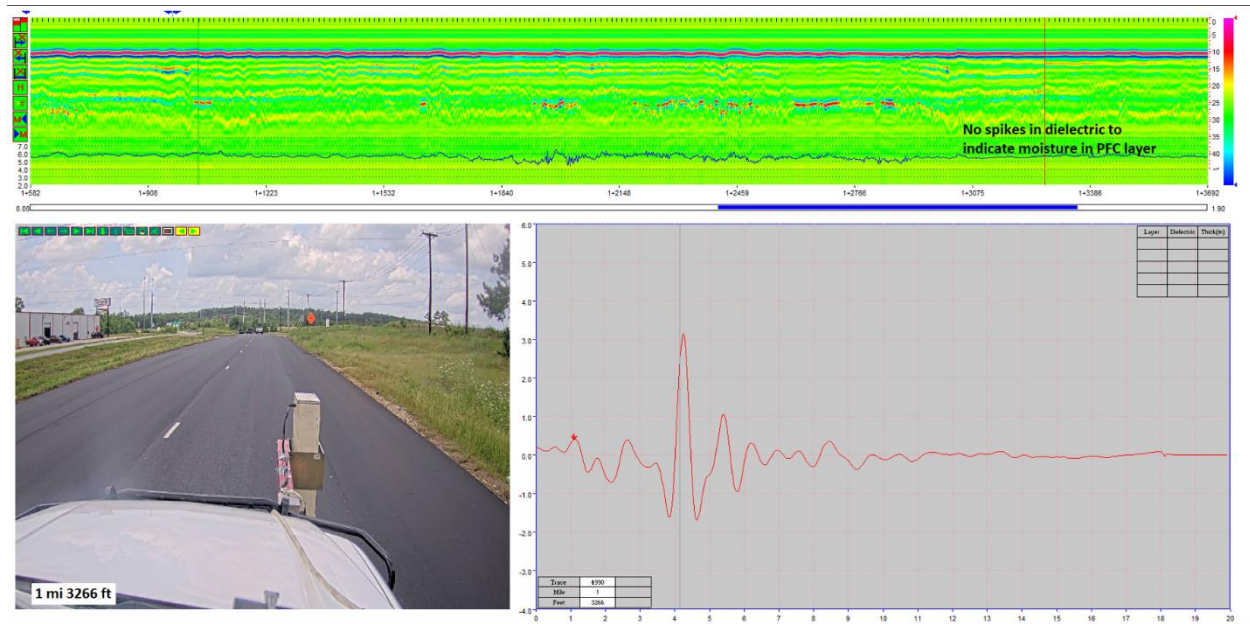
**Figure 109. GPR taken 1 week after construction showing overall satisfactory performance and no trapped moisture.**

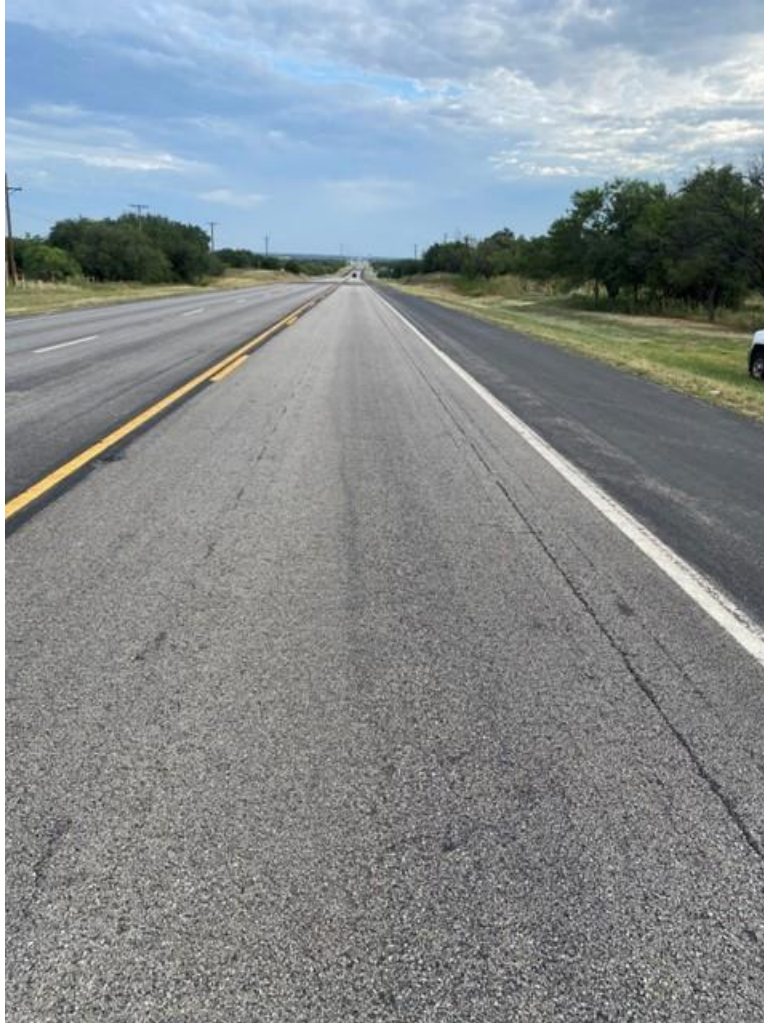
**Figure 111. PFC in March of 2023 prior to seal coat showing typical distresses and evidence of the Onyx still visible on shoulder.**

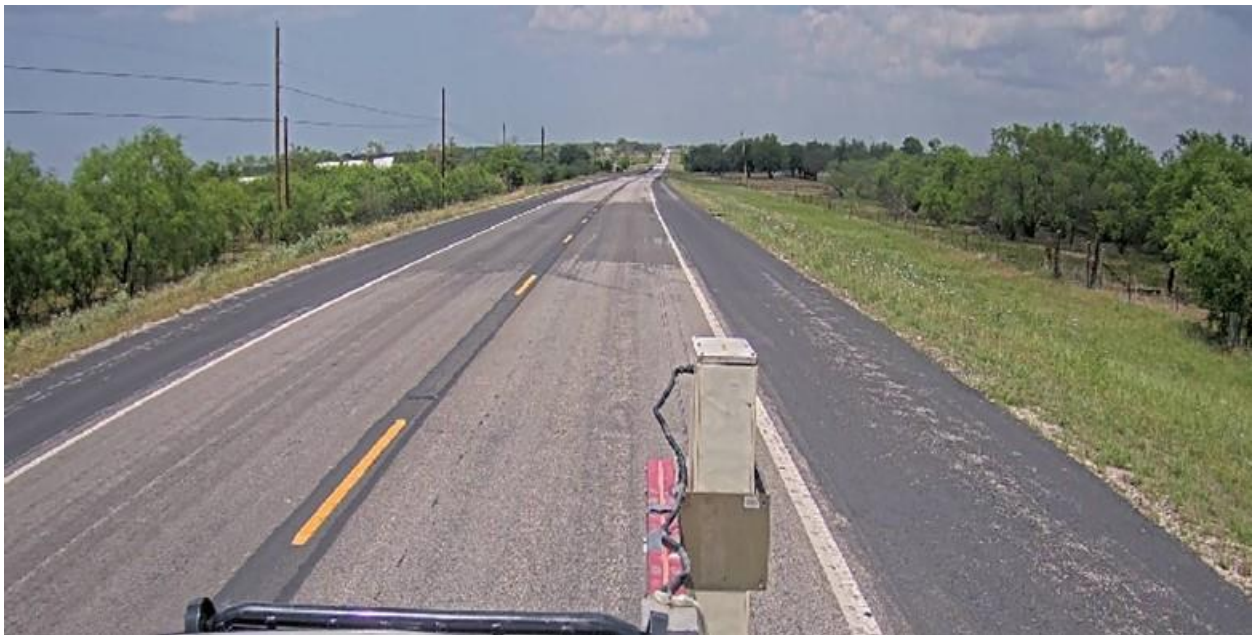
**Figure 113. Several level-up cold-mix patches located throughout the project.**

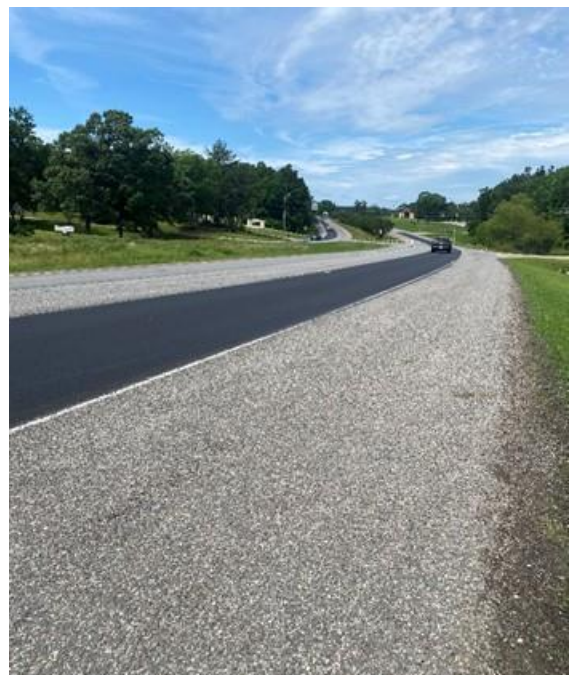
**Figure 9. PFC repaired with inlaid, dense-graded hot-mix asphalt since PFC on shoulder was clogged.**
