EVALUATION OF BREAKAWAY LIGHTPOLES
FOR USE IN HIGHWAY MEDIANS

Research Report 146-5

A Joint Report From
Research Study Number 2-8-68-146
Studies of Field Adaptation
of Impact Attenuation Systems
and
Research Study Number 2-8-69-137
Roadway Illumination Systems

May, 1972

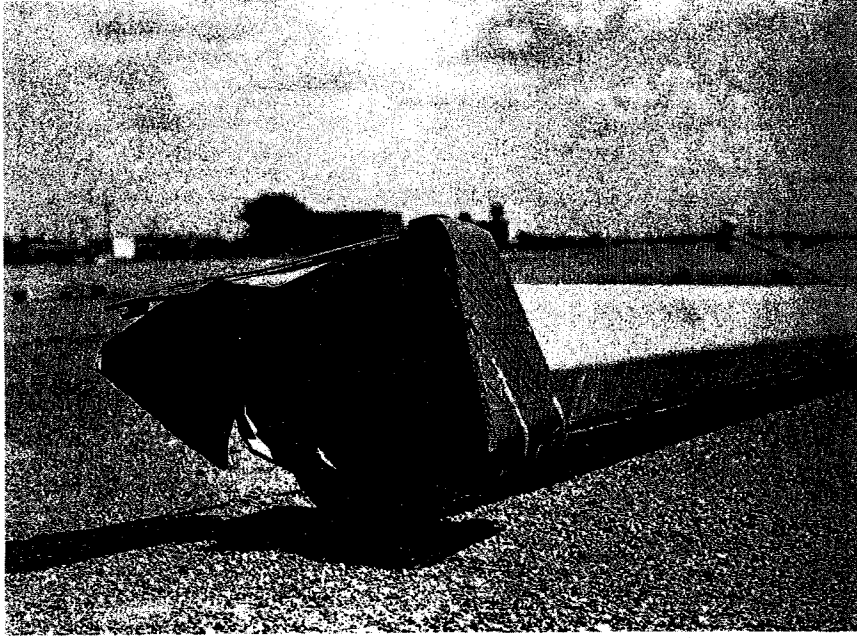
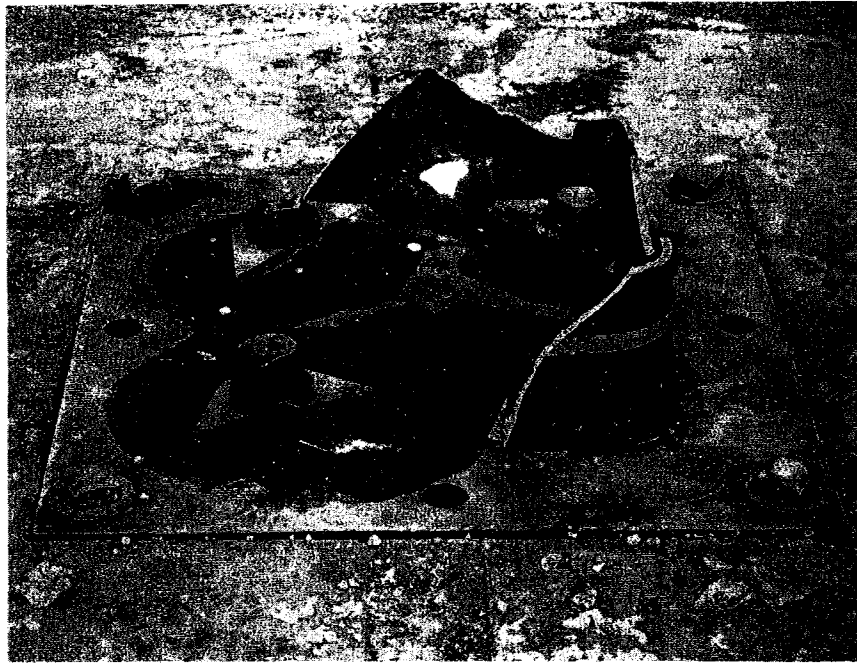
FIGURE 3, FRANGIBLE TRANSFORMER BASE AFTER TEST LS-1.

The vehicle contacted the pole 18 inches to the right of the vehicle's centerline, but the base shattered, allowing the support to rotate up and clear the vehicle as intended. Sequential photographs of the test are shown in Figure 2. Figure 3 shows the fragmented base after the test. The front of the vehicle before and after the impact is shown in Figure 4. The vehicle sustained a residual deformation to the right front of 0.6 ft.

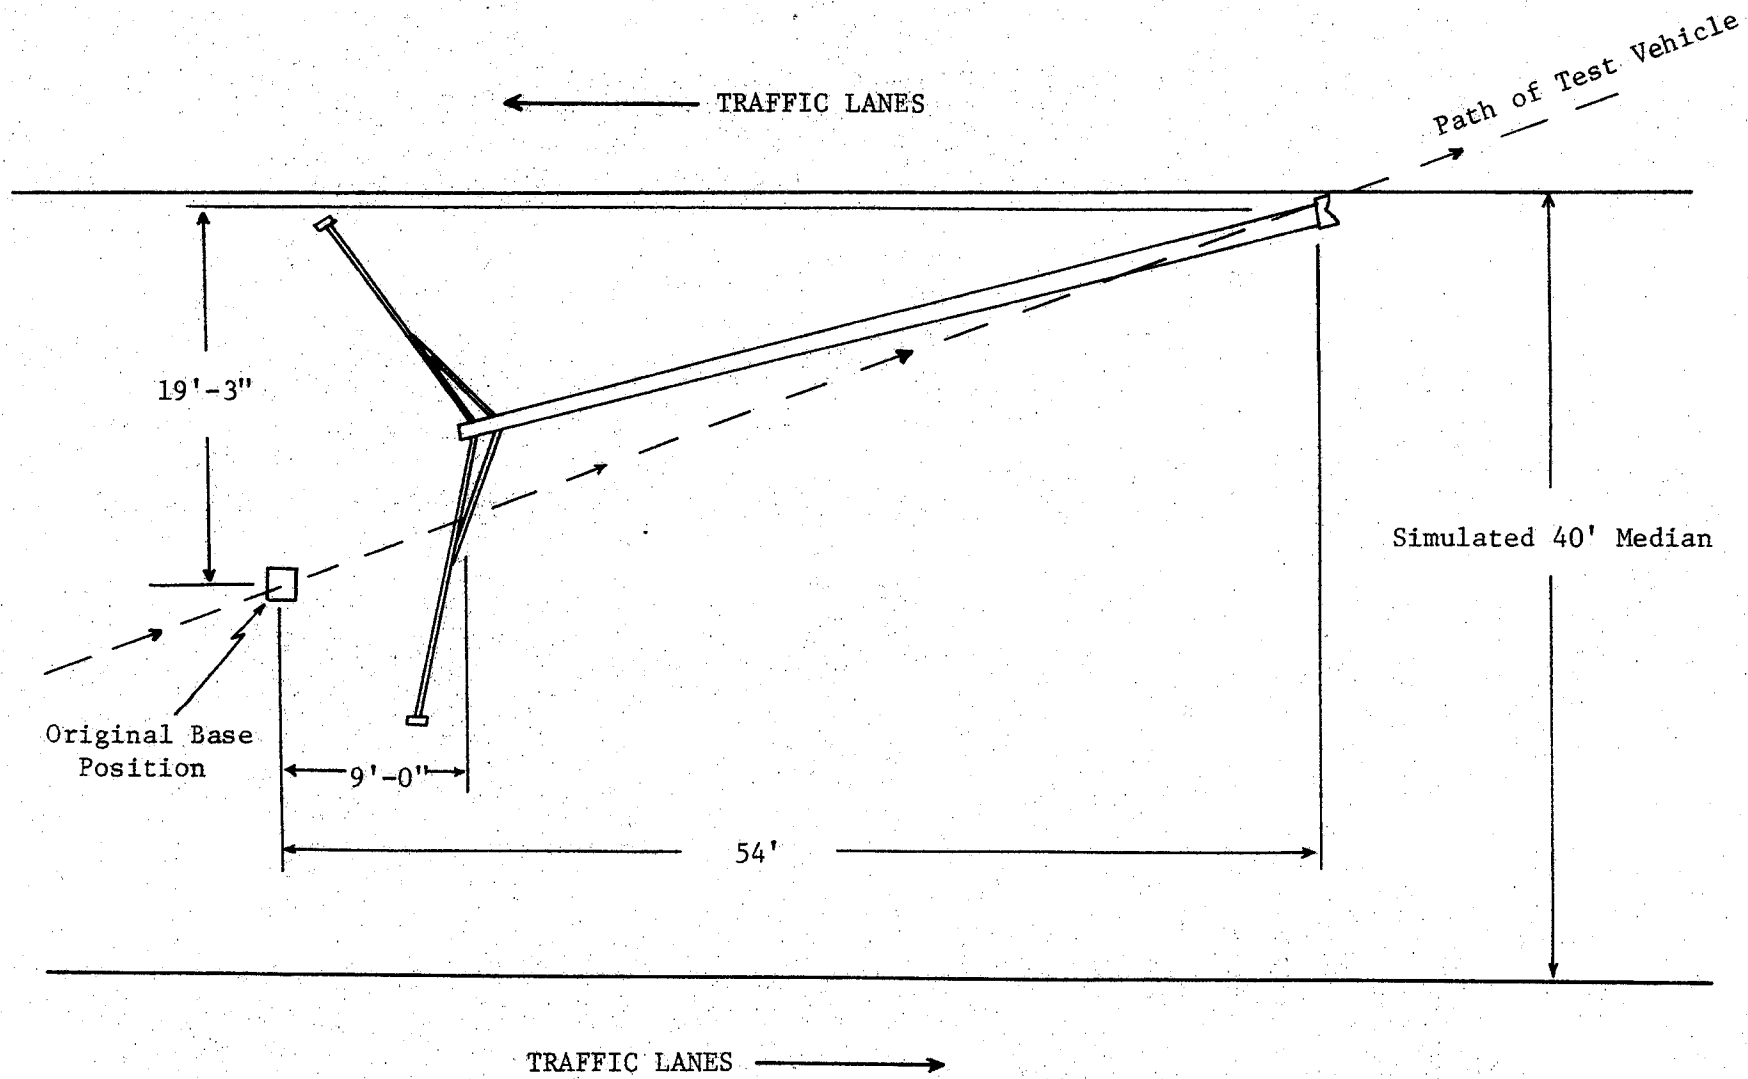
FIGURE 5, FINAL POSITION OF LUMINAIRE SUPPORT IN TEST LS-1.

The final position of the luminaire support in relation to its original position and a hypothetical 40 ft median strip is shown in Figure 5. In this case, the support would have remained within the median. However, the errant vehicle entered the oncoming traffic lanes without significantly altering its course. The only conclusion that can be drawn from this is that if the vehicle was traveling straight at an angle to the road upon impact with no driver control, and if the median was flat and level, then such an impact would cause encroachment of the oncoming traffic lanes by the errant vehicle.

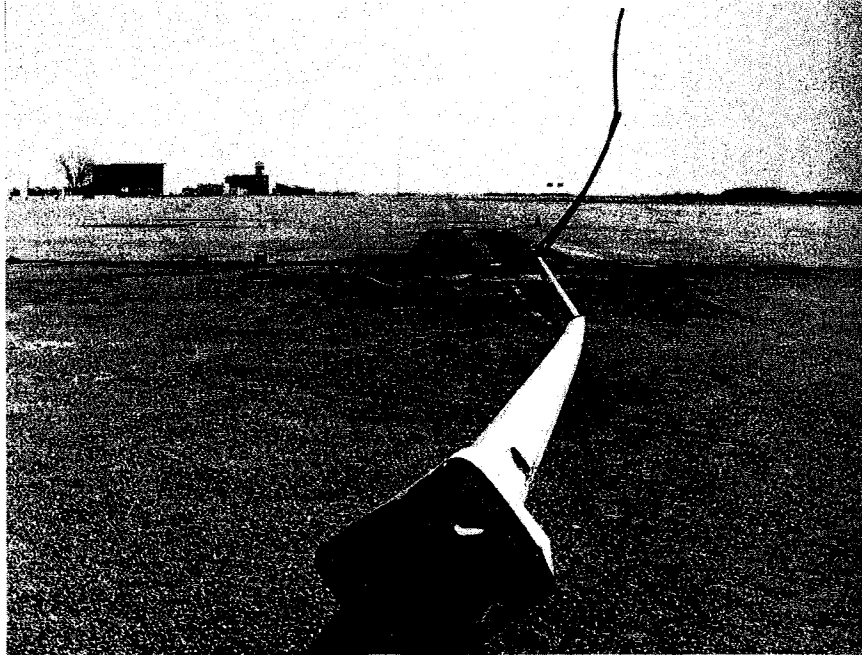
FIGURE 7, FRANGIBLE TRANSFORMER BASE AFTER TEST LS-2.

The cast aluminum transformer base, shown in Figures 6 and 7, shattered as expected and the pole rotated up and cleared the vehicle as the vehicle continued on its course. Sequential photographs of the test are shown in Figure 8.

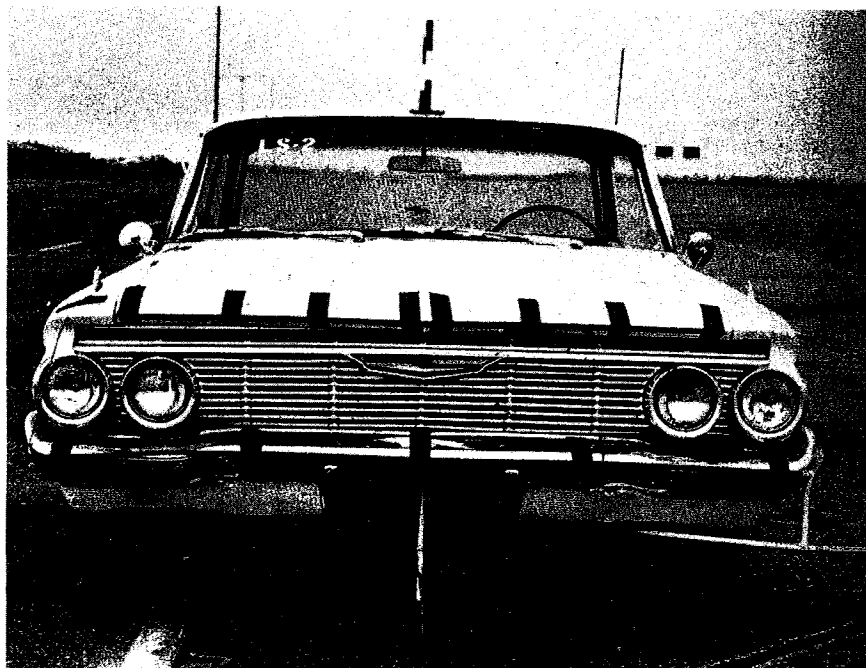
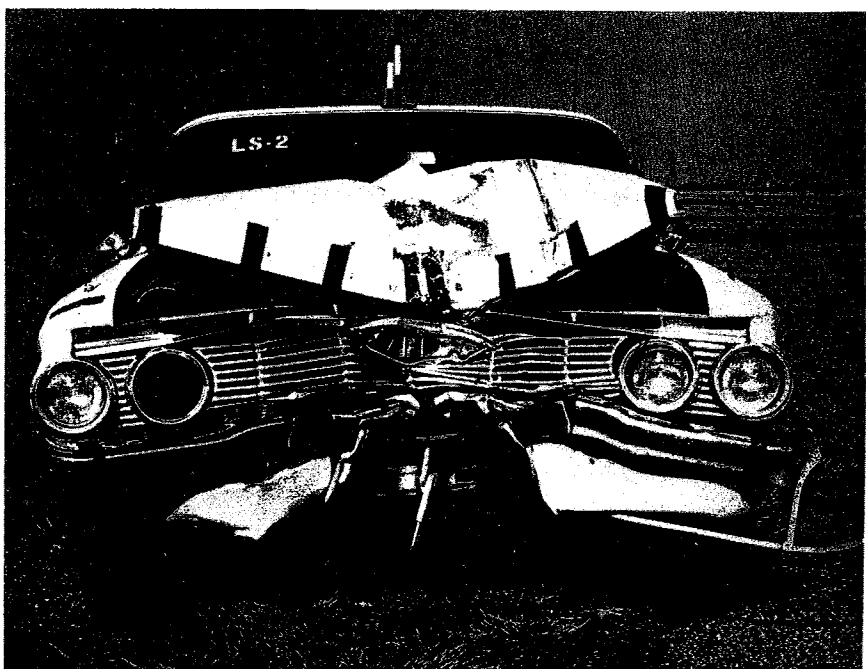
FIGURE 9, FRONT OF TEST VEHICLE BEFORE AND AFTER TEST LS-2.

The front end of the vehicle had a residual deformation of 1.5 ft, as shown in Figure 9. The increased damage is primarily due to the higher impact speed.

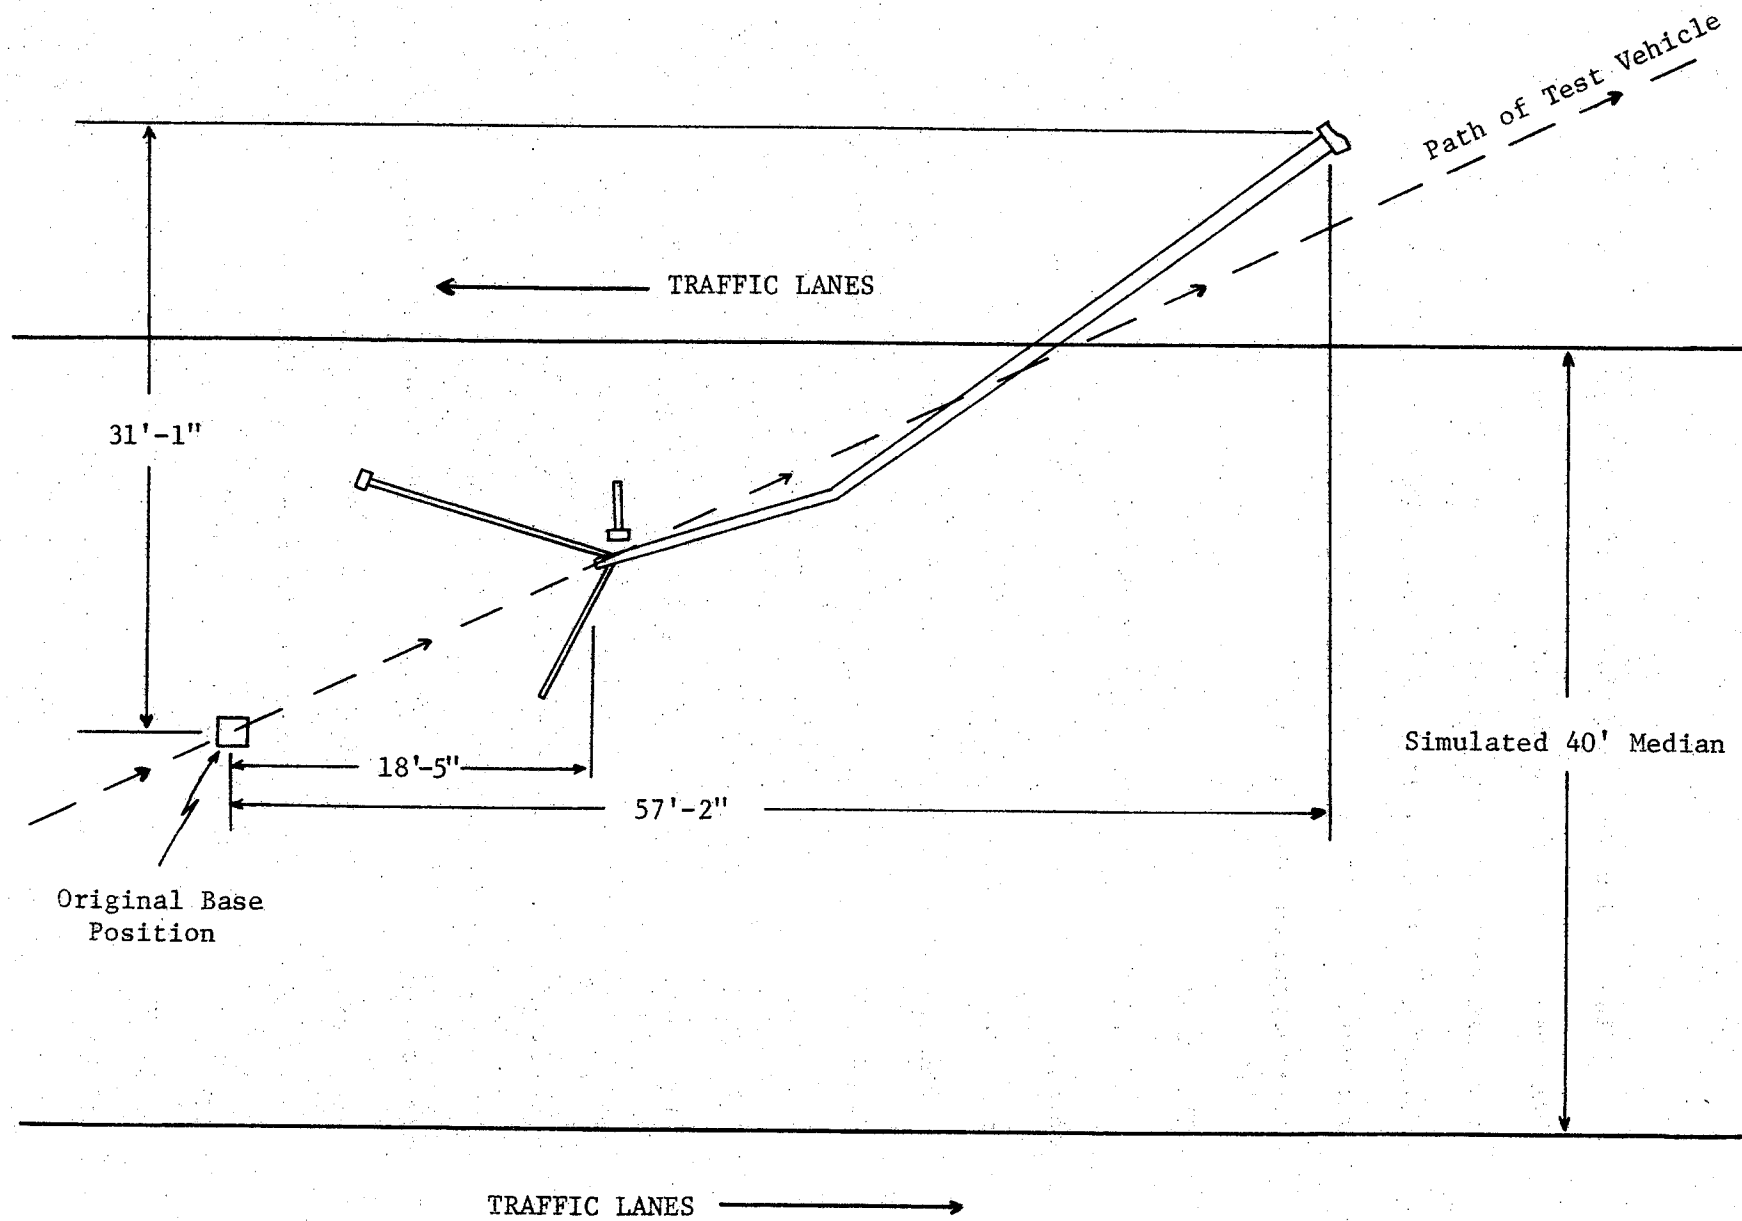
FIGURE 10, FINAL POSITION OF LUMINAIRE SUPPORT IN TEST LS-2.

Figure 10 shows the final position of the support. If the pole had been mounted in the center of a 40 foot median, the base after the test would have projected eleven feet horizontally into the oncoming "inside" traffic lane at an angle of 33 degrees to the roadway. Under these simulated conditions, the vehicle would have crossed the oncoming lanes.

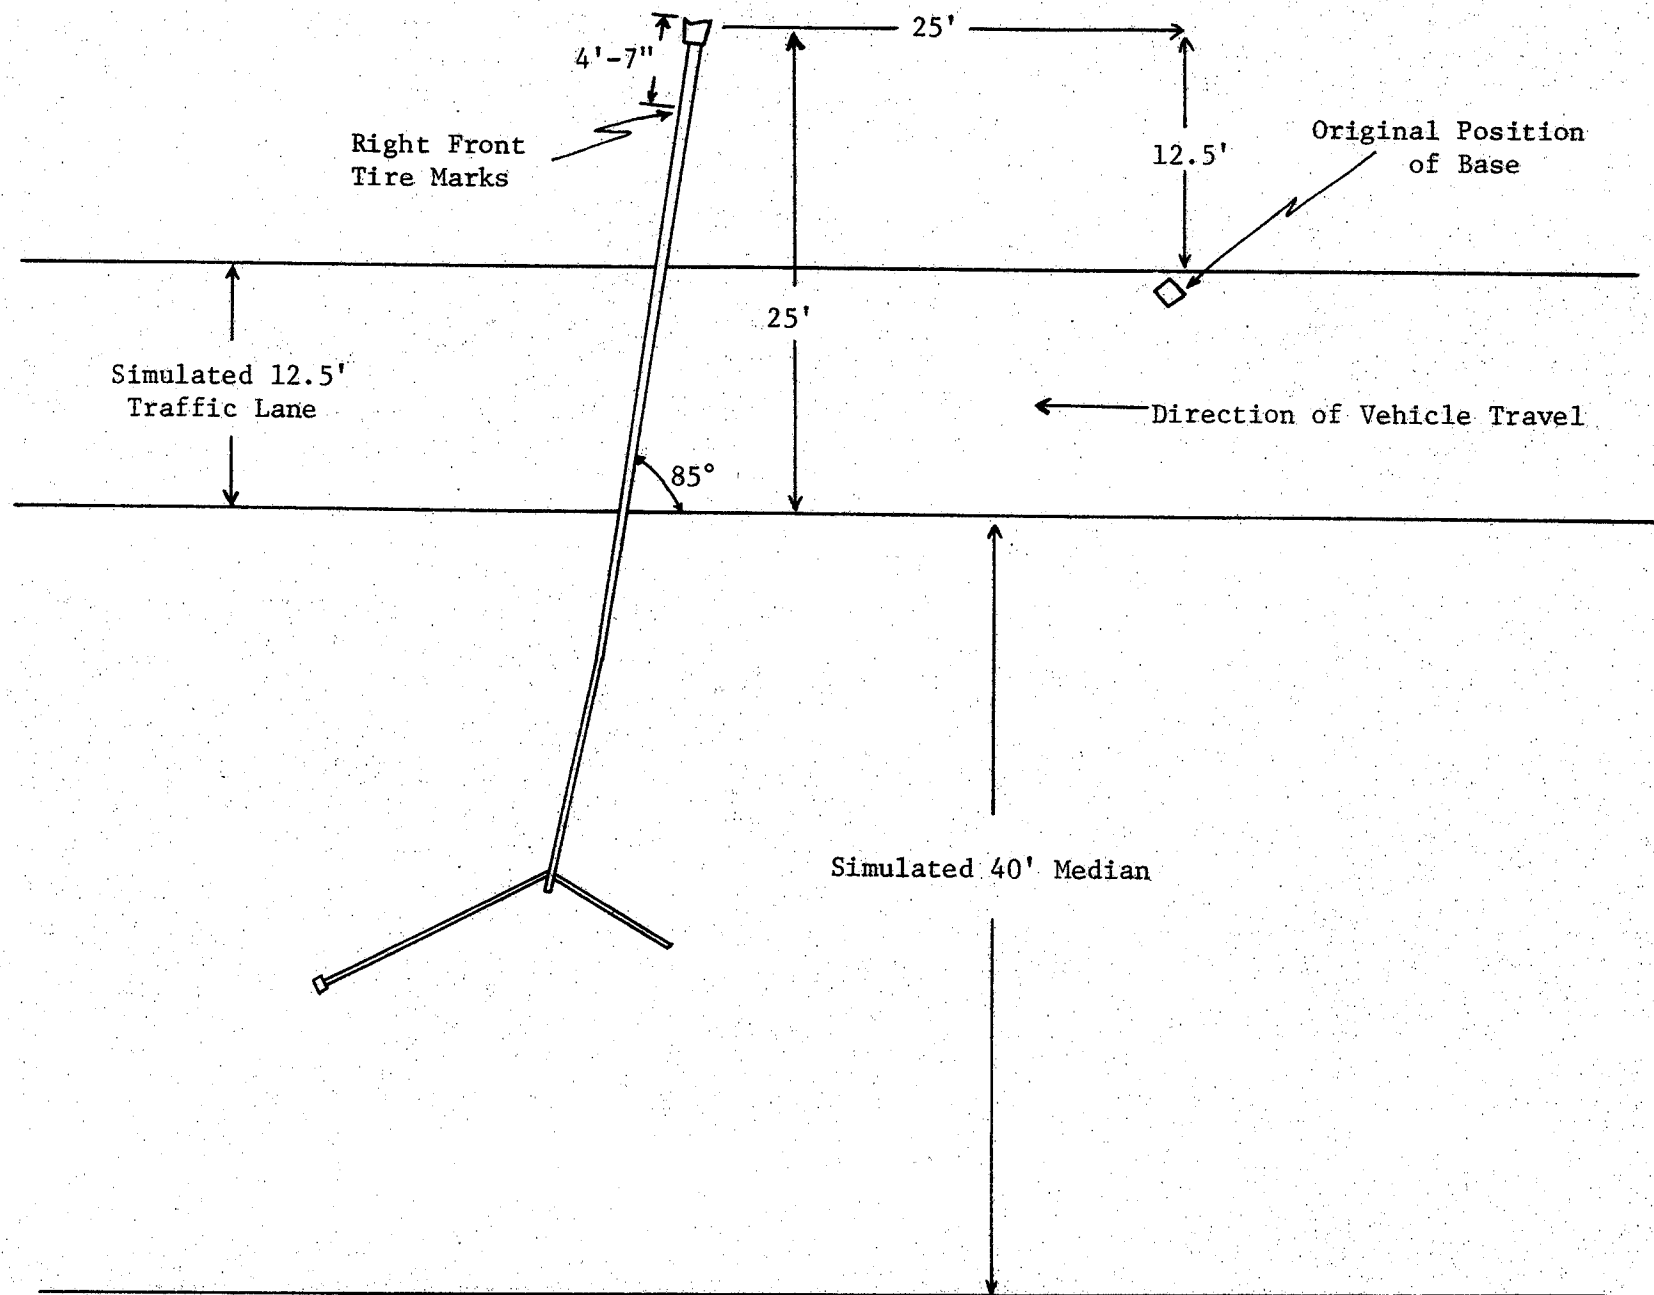
FIGURE 15, POSITION OF LUMINAIRE SUPPORT AFTER TEST LS-3.

The luminaire support was pushed around to an angle of 85 degrees to the roadway, and extended 25 feet into the traffic lanes after the test. Note in Figure 13 that the vehicle did not contact the fragmented base, but ran over the shaft only.
