Technical Report Documentation Page	
1. Report No. FHW A /TX-04/9-8132-1	2. Government Accession No.	3. Recipient's Catalog No.	
4. Title and Subtitle		5. Report Date	
TESTING AND EVALUATION OF	F THE FLORIDA JERSEY	February 2004	
SAFETY SHAPED BRIDGE RAIL		6. Performing Organization Code

TESTING AND EVALUATION OF THE FLORIDA JERSEY SAFETY SHAPED BRIDGE RAIL

February 2004

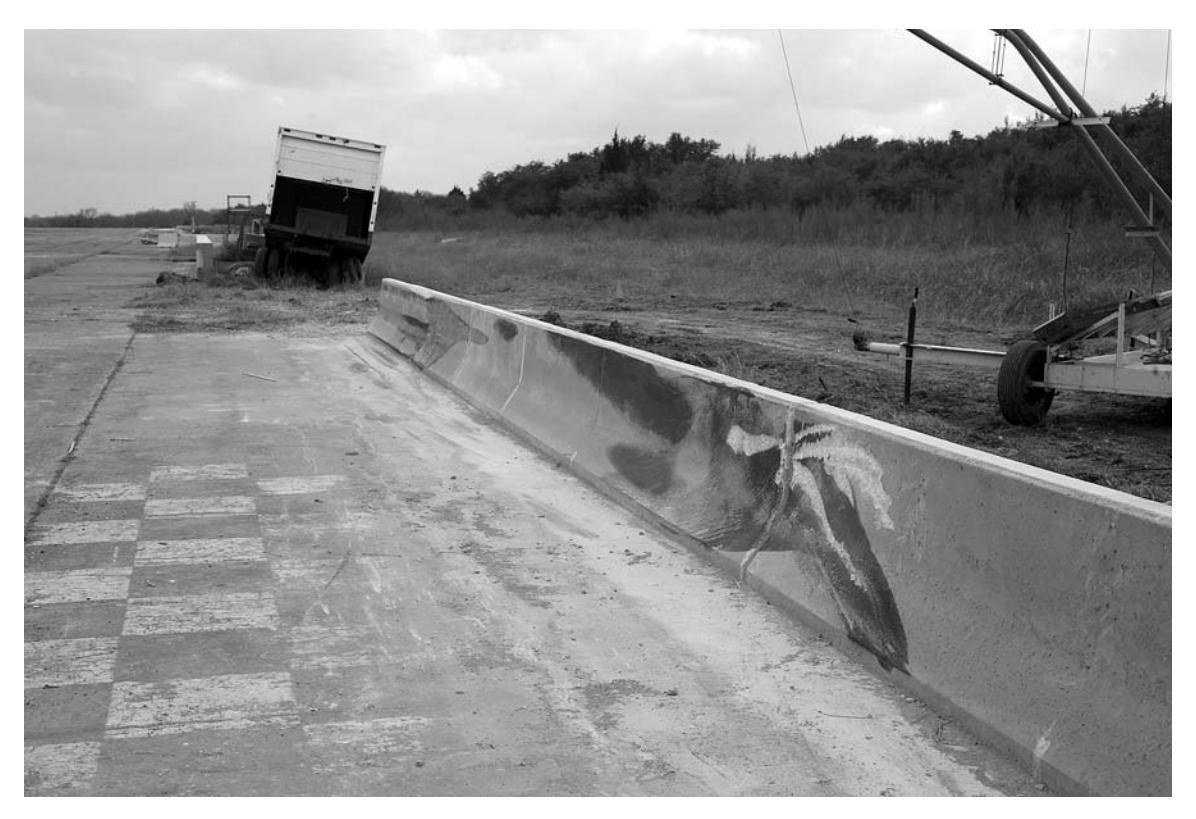
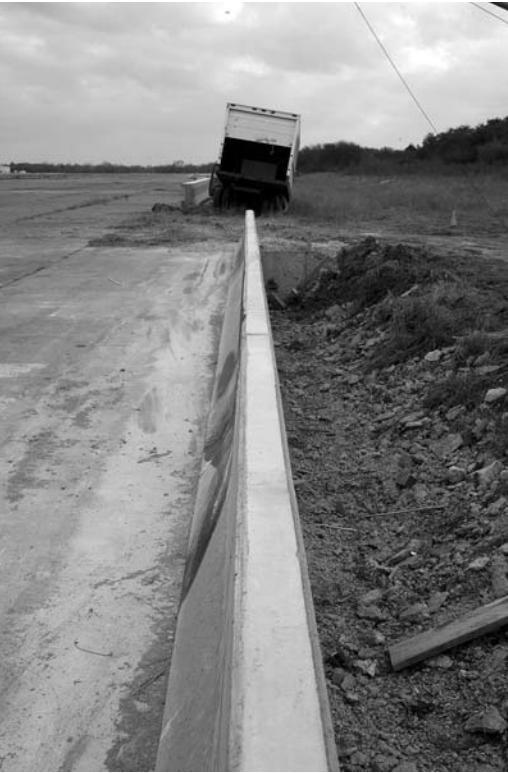
Figure 6. After Impact Trajectory Path for Test 421323-1.

Figures 6 and 7 show that the Florida bridge rail sustained cosmetic damage only. A small section on the edge of the first segment of bridge rail was chipped off, measuring 16.5 inches (420 mm) tall by 5.1 inches (130 mm) wide and starting 3.3 inches (85 mm) below the top of the segment. The truck contacted the bridge rail 5.6 ft (1.7 m) upstream of the joint and remained in contact with the bridge rail until it rode off the end.

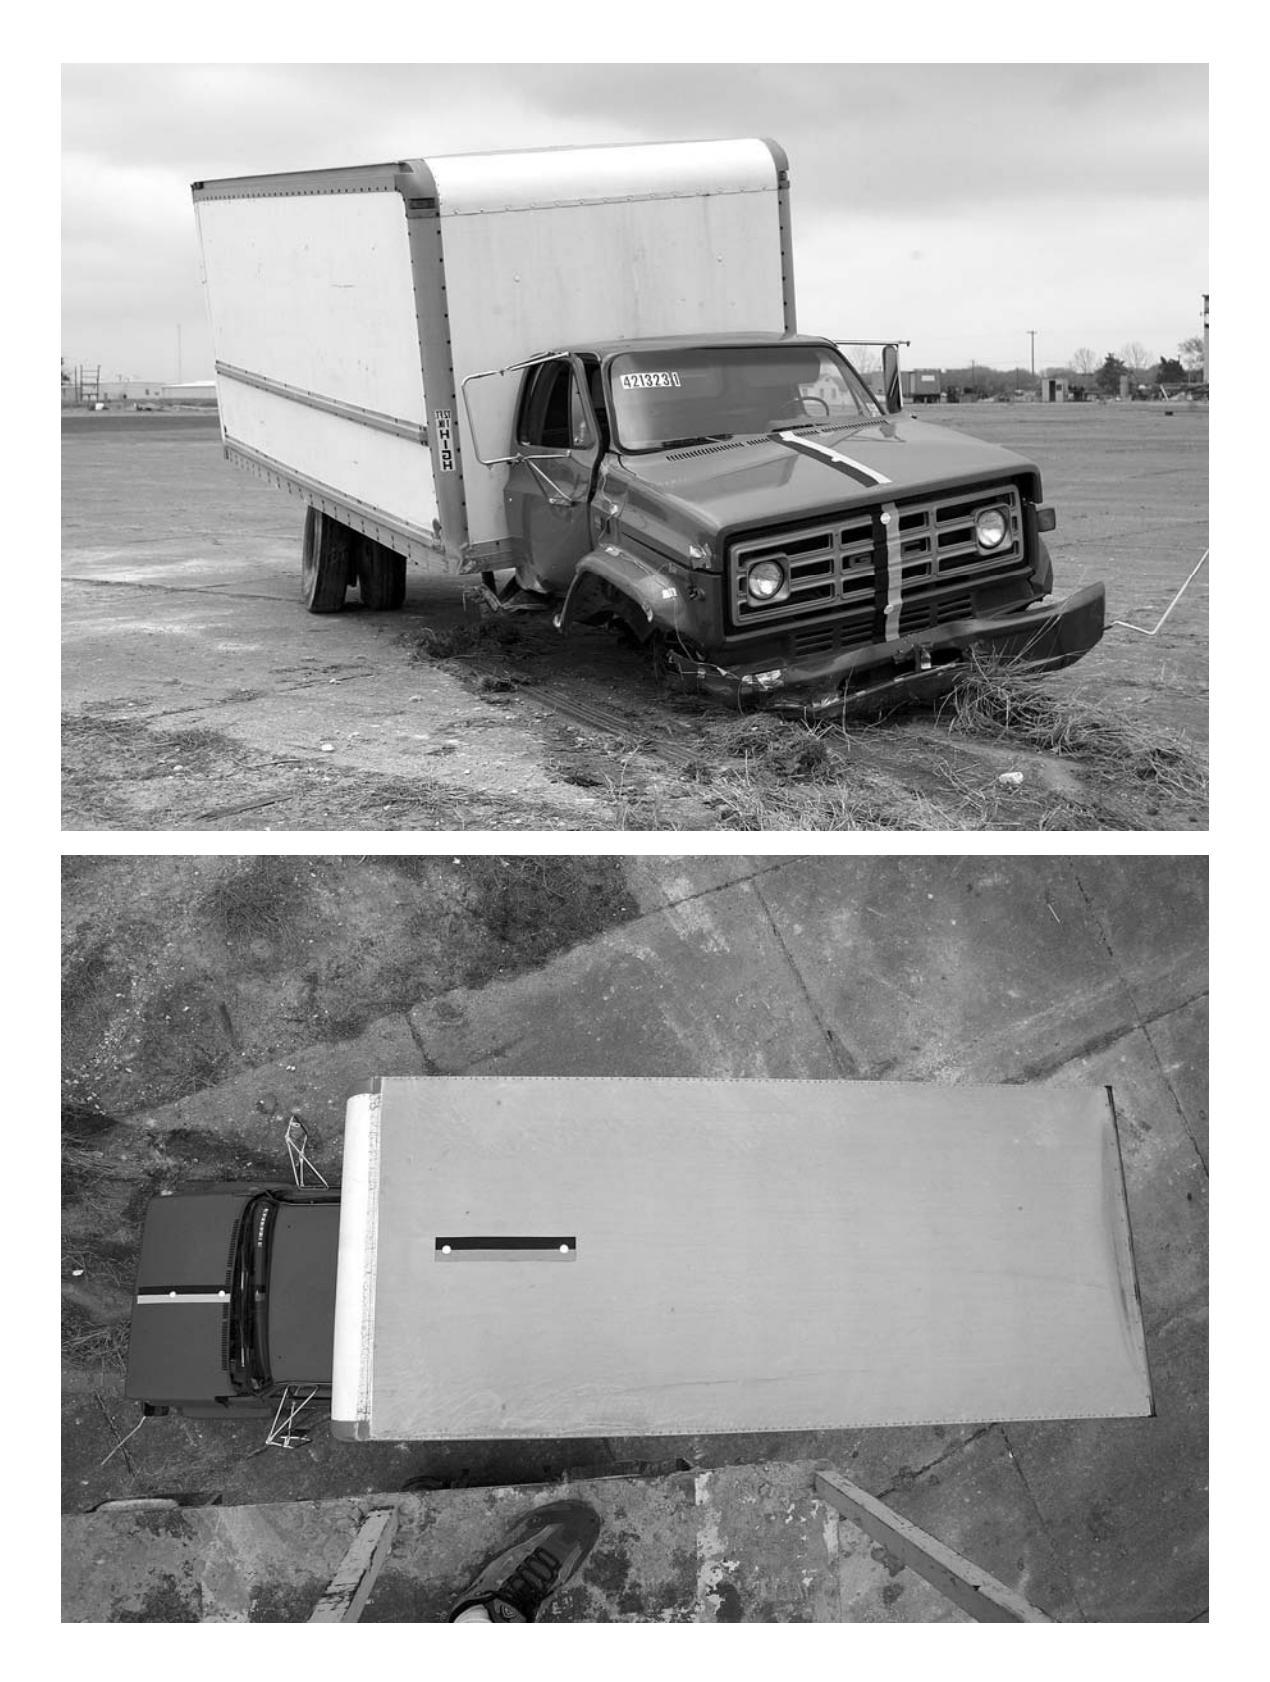
Figure 8. Vehicle after Test 421323-1.

Figure 8 shows damage to the vehicle. The front axle was separated from the truck and the right rear wheel rim was bent. The lower right side of the cab and box were deformed. No measurable occupant compartment deformation occurred. Figure 9 shows photographs of the interior of the vehicle.

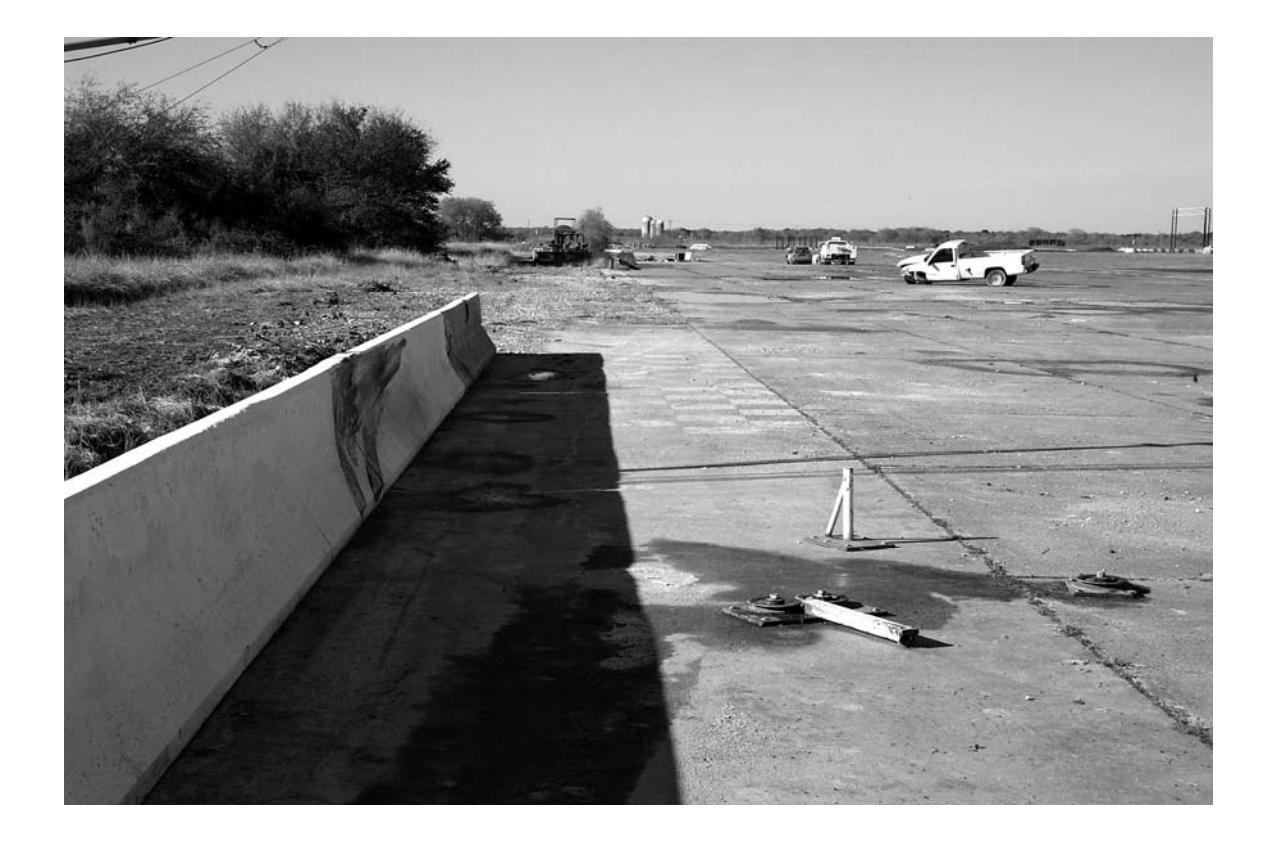
Figure 13. After Impact Trajectory Path for Test 421323-2.

Figures 13 and 14 show that the Florida bridge rail sustained moderate structural damage on either side of the joint just upstream of impact. A small section on each of the edges of the first and second segments of bridge rail were cracked, extending a maximum distance of 42.9 inches (1090 mm) upstream on the first segment and a maximum distance of 33.7 inches (855 mm) downstream on the second segment. A hairline crack in the deck radiated downward from the field side corner of the downstream segment and extended 6.0 inches (152 mm) under the deck. Maximum dynamic deflection was not attainable, and maximum permanent deformation was 0.75 inches (19 mm). The truck contacted the bridge rail 4.1 ft (1.25 m) upstream of the joint and remained in contact with the bridge rail for a distance of 17.2 ft (5.23 m).

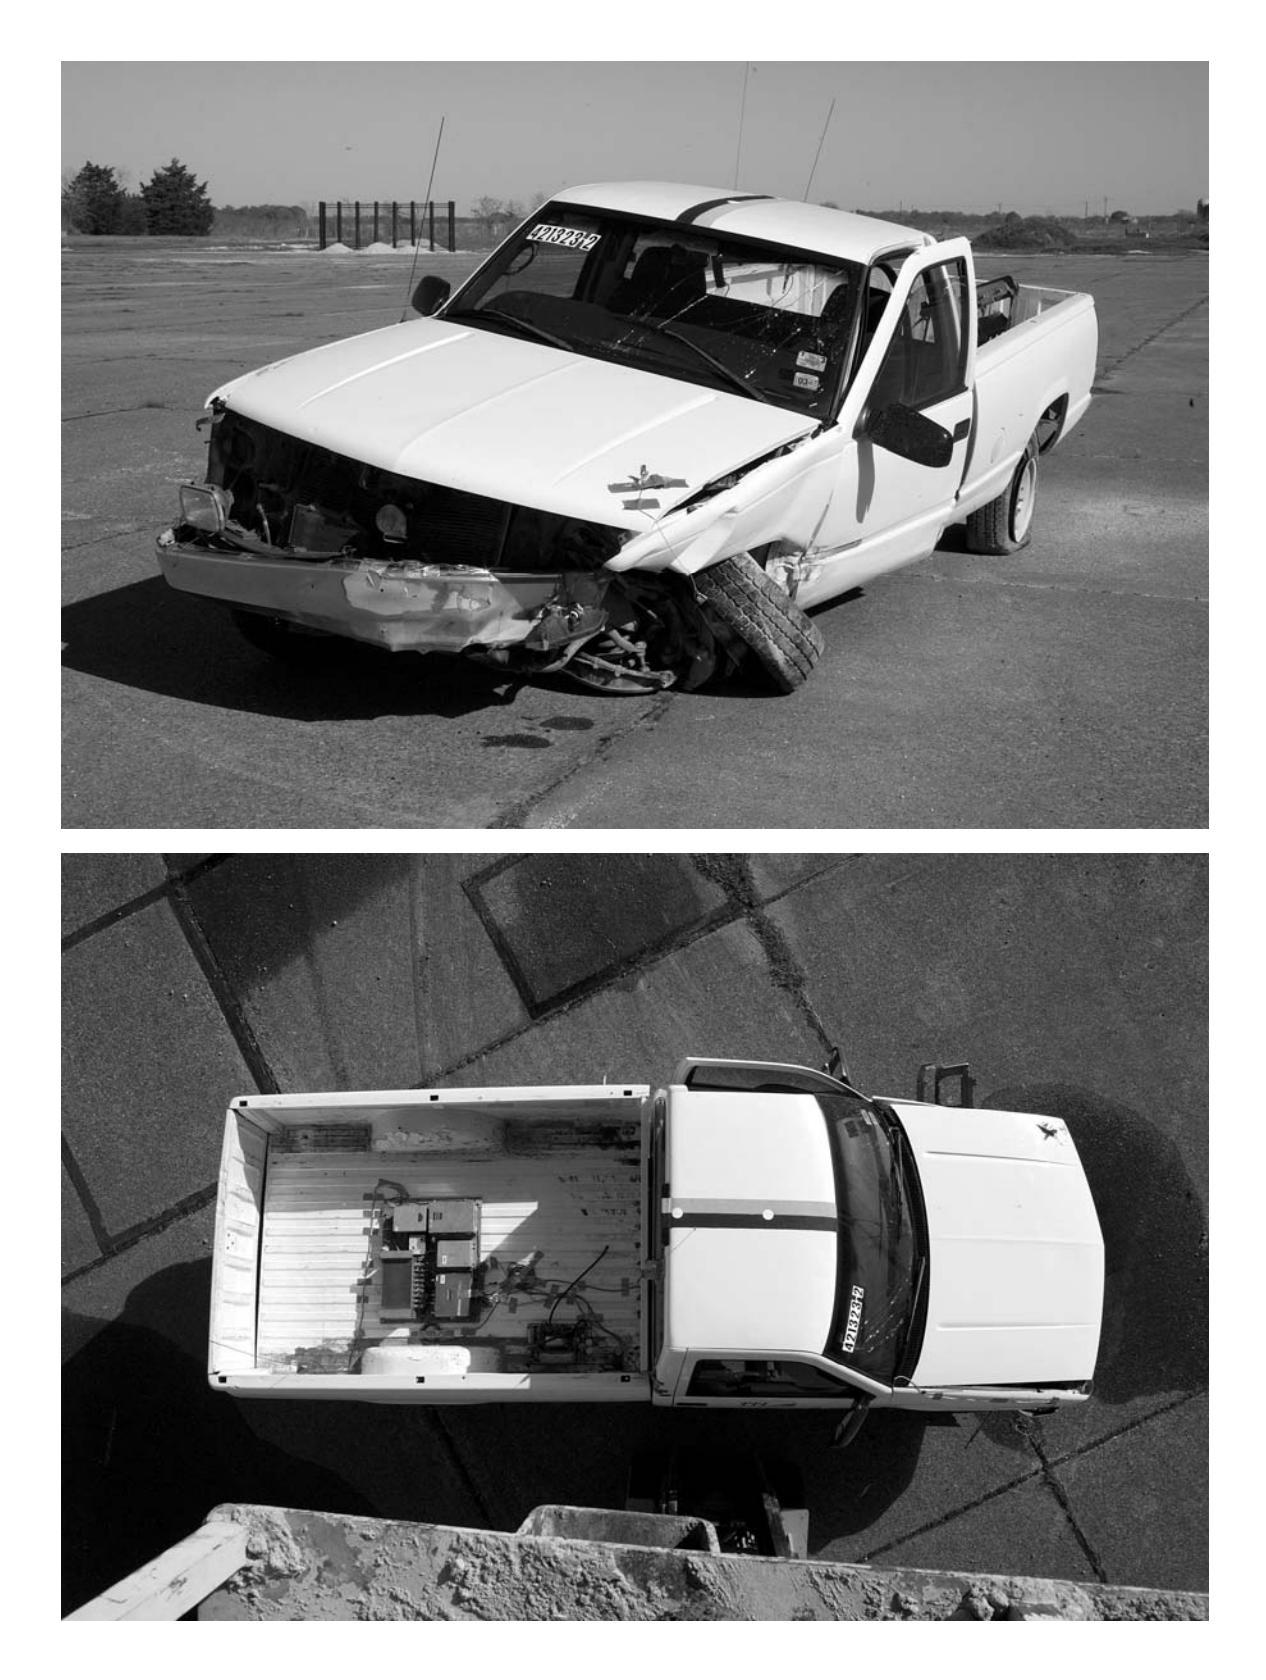
Figure 15. Vehicle after Test 421323-2.

Figure 15 shows the damage to the vehicle. Structural damage was imparted to the left outer tie rod end, lower A-arm and spindle, front of the frame rail, and the firewall and floor pan. The inner rim of the left wheel separated from the outer rim. Also damaged were the front bumper, grill, radiator, left front quarter panel, left door, left rear exterior bed, left rear tire, and the right rear of the bed. The windshield also sustained stress cracks and the door glass was broken out. Maximum exterior crush to the pickup was 25.2 inches (640 mm) in the side plane at the left front corner just above bumper height. Maximum occupant compartment deformation was 3.4 inches (87 mm) in the left side firewall area. Figure 16 shows photographs of the interior of the vehicle. Tables 3 and 4 in Appendix C show exterior crush profile and occupant compartment deformation.

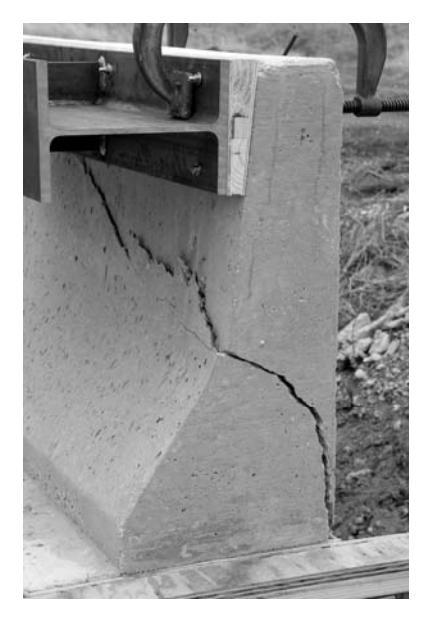
Figure 20. Failure Mode for Test 421323-S1.

Test S-1 was on the upstream end of the test installation and was intended to represent the loading at a construction joint. The maximum load attained was 35.1 kips (156 kN). The anticipated load from the yield line analysis was 41.5 kips (185 kN). Subsequent review of the installation showed the last stirrup was approximately 6 inches (152 mm) from the end of the parapet wall and likely contributed to the lower fracture load. Figure 19 shows the results of the static test S-1. Figure 20 shows the failure mode.

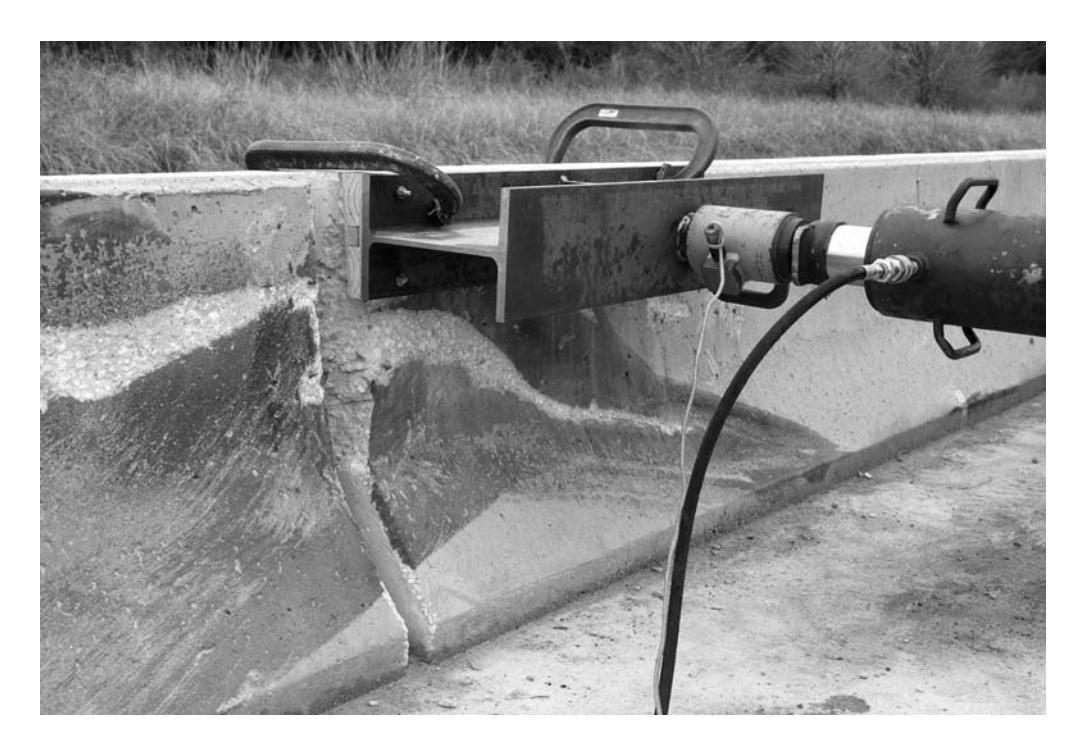
Figure 22. Failure Mode for Test 421323-S2.

Visual inspection of the bridge parapet after the TL-4 test did not reveal any perceptible cracking. Since the test setup was readily available, the impact region of the barrier was statically tested to failure at the expansion joint. The maximum load was 45.1 kips (201 kN) and the test results are shown in Figure 21 below. Figure 22 shows the failure mode.

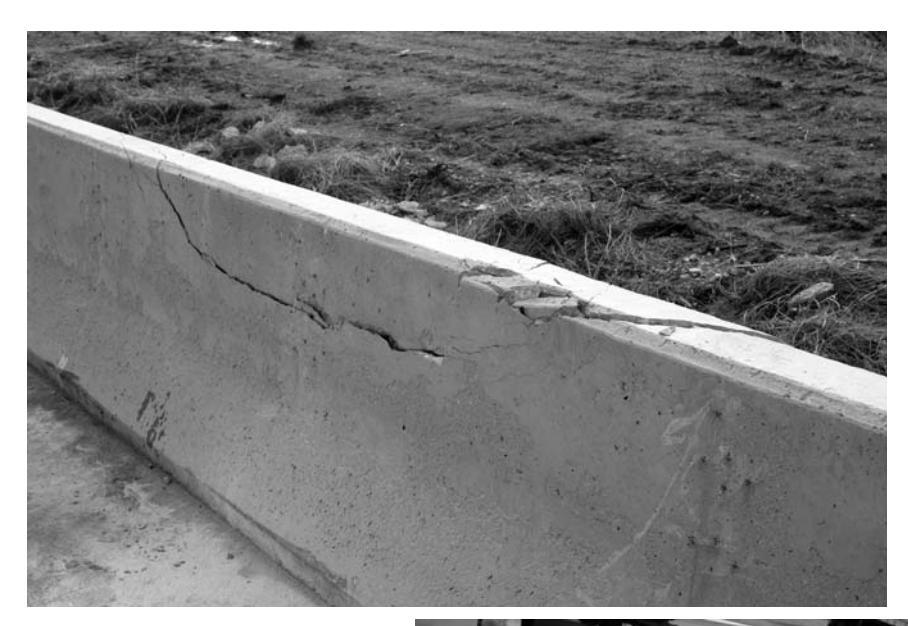
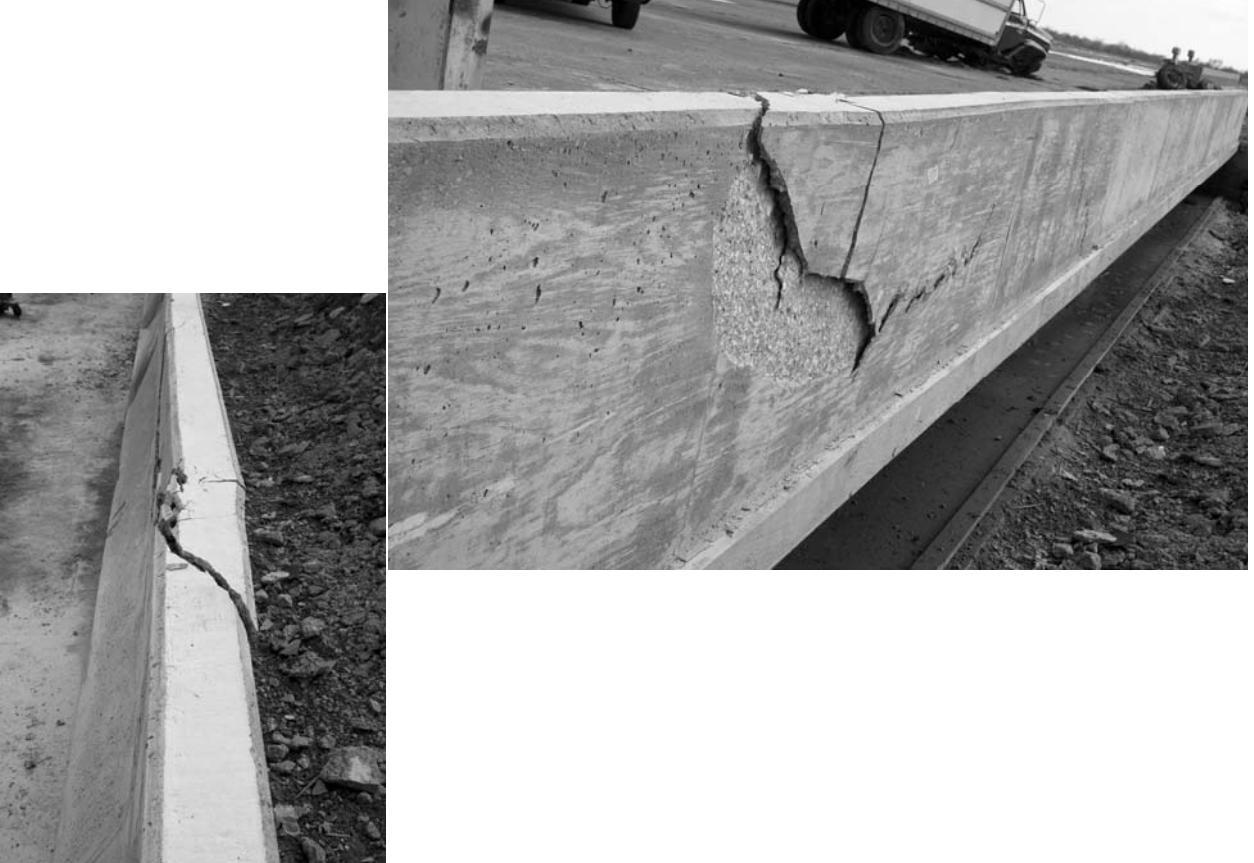
Figure 25. Failure Mode for Test 421323-S3.

Test S-3 was at mid-span of the undamaged rail section as shown in Figure 23. The predicted failure load was 62.1 kips (276 kN). The maximum load obtained was 73.1 kips (325 kN). Figure 24 shows test results. Yield lines were confined to the upper, slender portion of the parapet as shown in Figure 25.
