**ANALYSIS OF THE VISUAL CHARACTER OF THE MAJOR HIGHWAY  
CORRIDORS OF EL PASO, TEXAS**

Research Report 944-2  
Research Study Number 7-944  
Research Study Title: Construction Landscape Program

Sponsored by the  
Texas Department of Transportation

November 1994

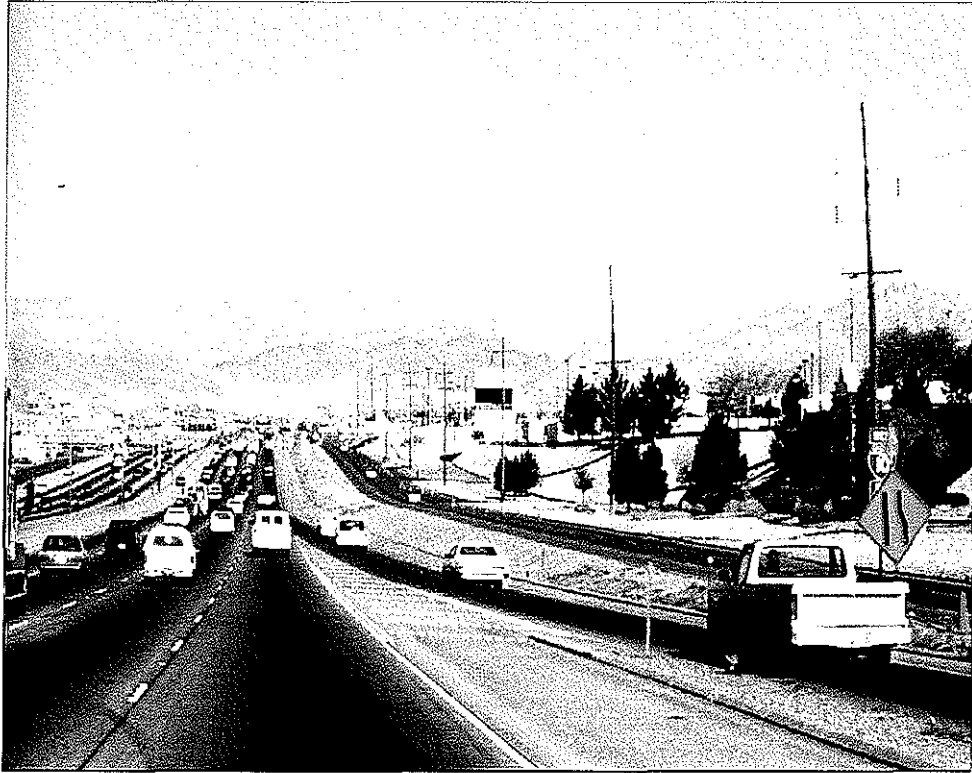
FIGURE 4. INTERSTATE 10 AT CIELO VISTA MALL.

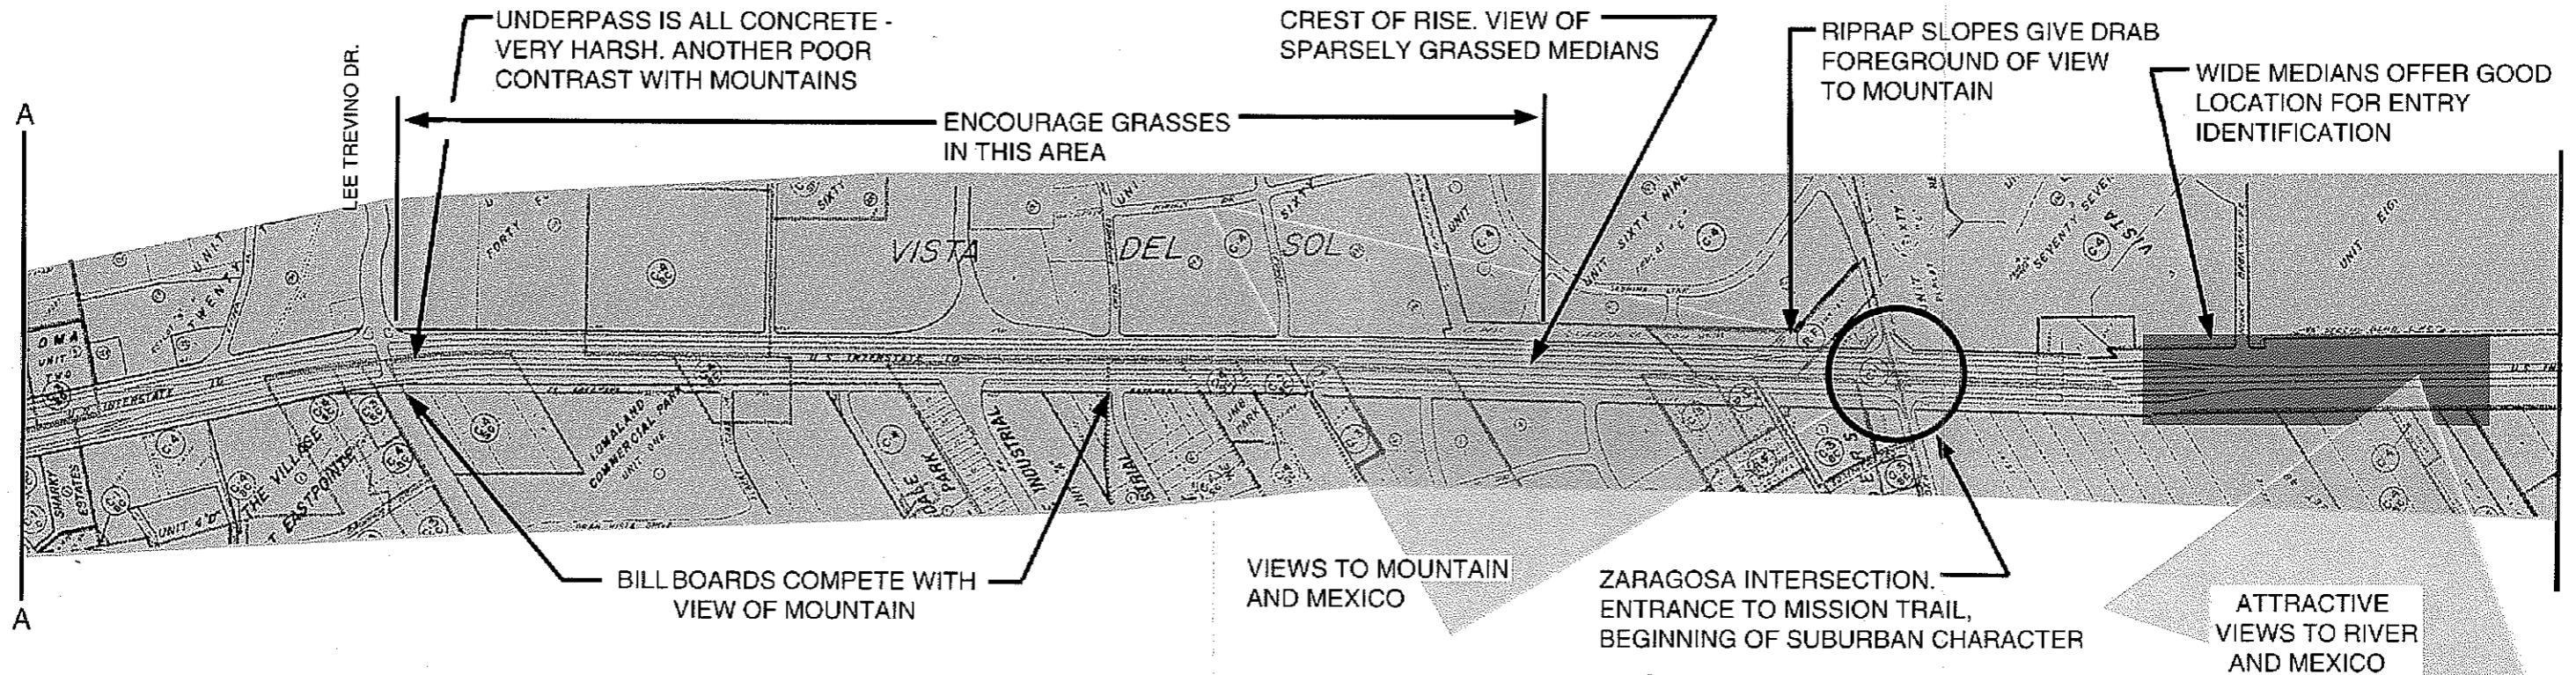
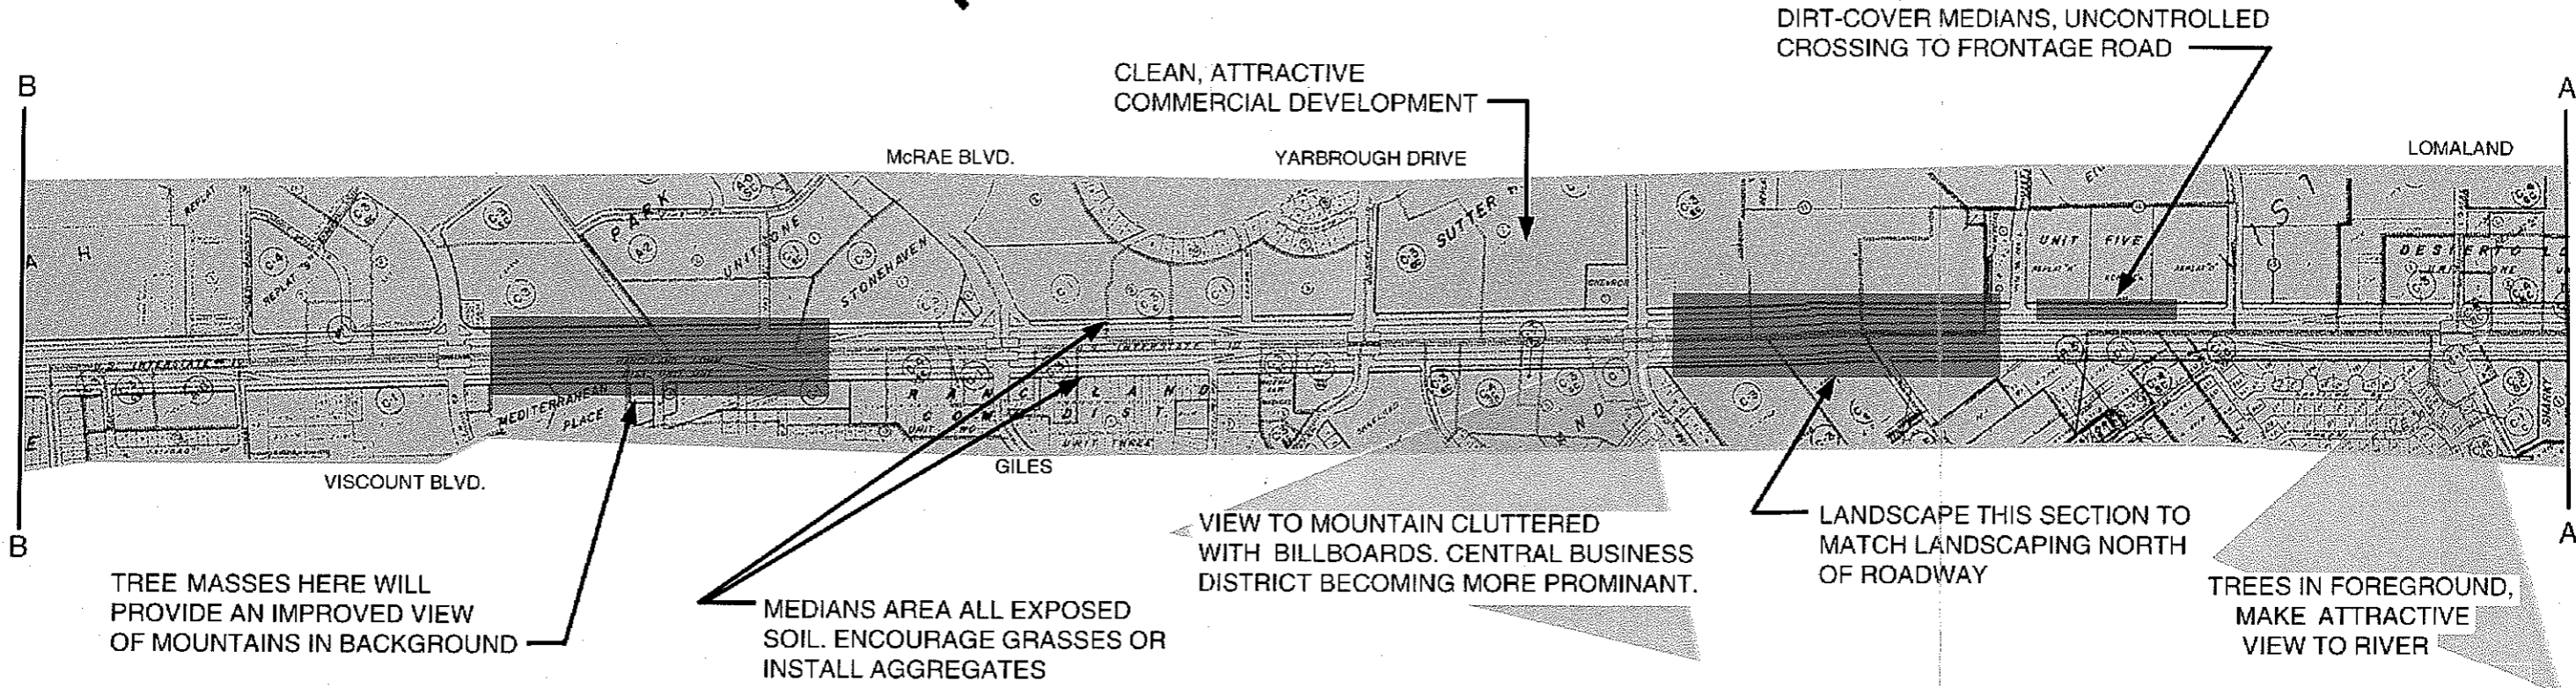
FIGURE 6.I-10 from ZARAGOSA RD. to GERONIMO DRV. (cont. on next sheet)

SUBURBAN CLUTTER INCREASES AFTER COMING UP OUT OF UNDERPASS AT LEE TREVINO

DEVELOPEMENT INCREASES

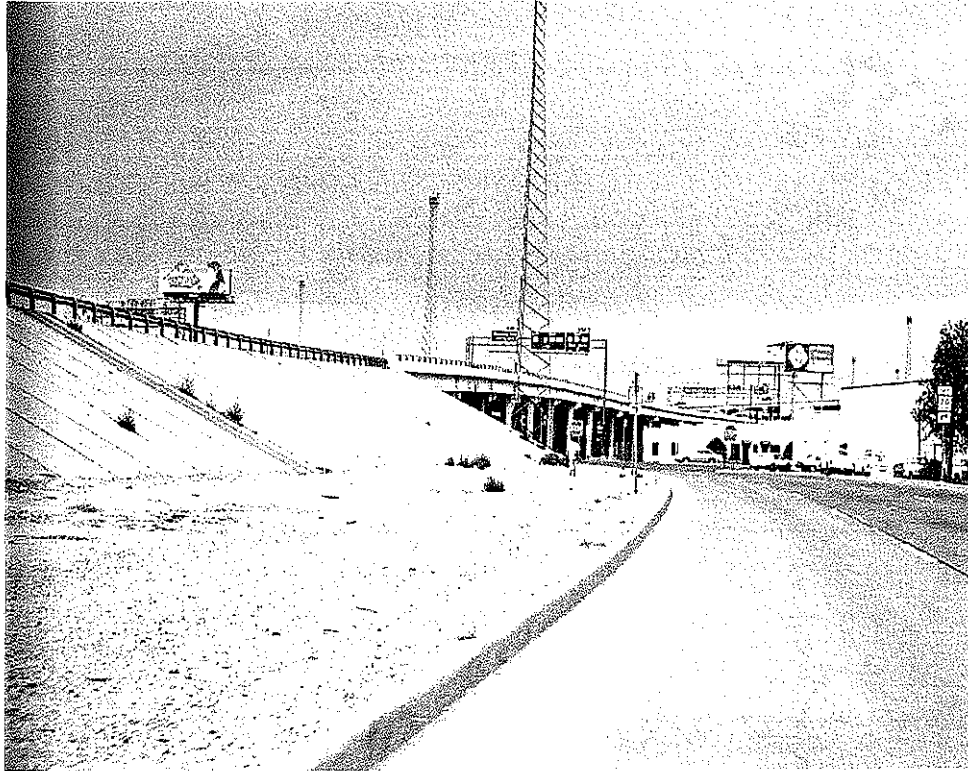
FIGURE 9. TYPICAL RIPRAP SLOPES AS SEEN FROM FRONTAGE ROAD.

1. Cover the riprap slopes with native stone or use planters at the base of the riprap to elevate tree masses (see Figures 9 & 10).
2. Color should be added to the roadway by introducing color onto the median barrier, median fences, and overhead structures.
3. Install tree masses in plantable areas. Cover exposed soil with aggregate.
4. Keep the edges of the detention ponds within the I10 and US 54 interchange neat and close to the mainlanes.

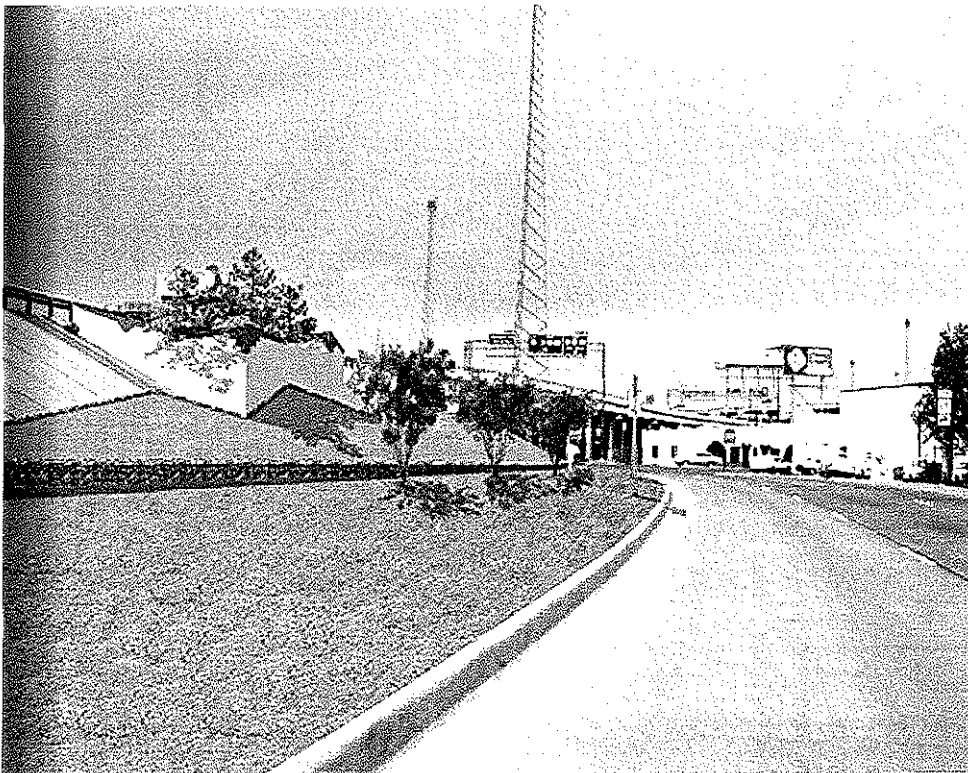
FIGURE 10. EFFECT OF ADDING AGGREGATE WITH PLANTER AND TREES.

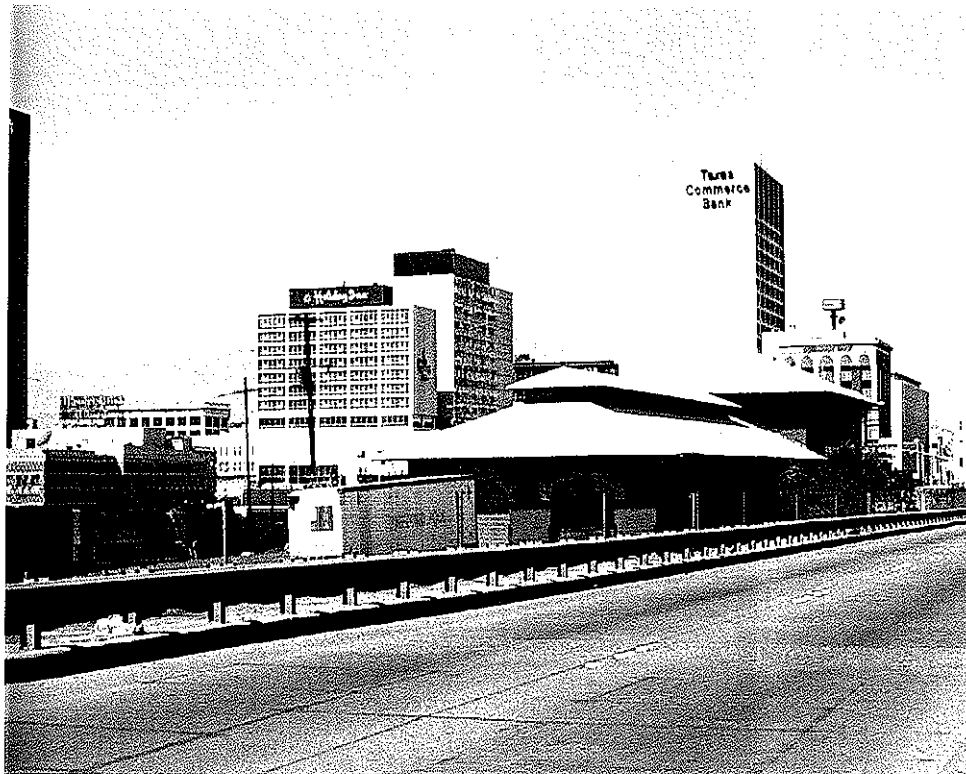
FIGURE 11. VIEW OF OLD TRAIN DEPOT

1. Introduce trees masses into available areas to add color and soften the foreground view.
2. Remove the chainlink fence alongside the train yard. Filter the view of the yard with a partial screen made of materials that will relate to those used in the depot.

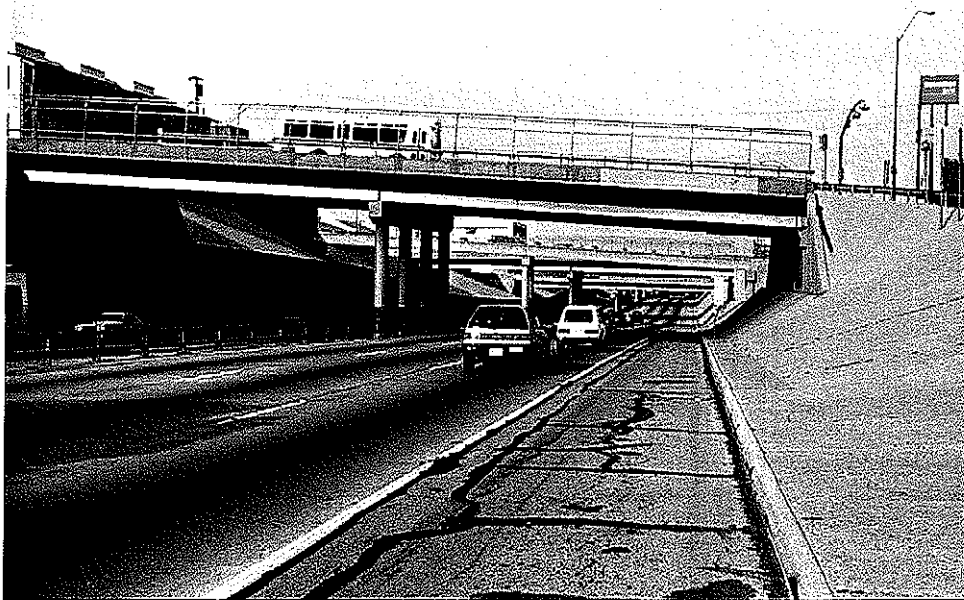
The strong sense of arrival so recently felt is abruptly replaced with a sinking feeling. This section has been referred to as the "concrete canyon" and rightly so (see Figure 16). This is an oppressive section in its own right, but it is made worse due to the contrast with the intimate views of downtown just experienced above. The extensive use of concrete riprap continues out of the canyon and extends to the Schuster exit and UTEP. The feel of this section of roadway is so conflicting with that of the rich urban scene above that it can leave a strong negative impression. This is the last scene the motorist sees of the heart of the city. The exit to the Sunset Heights Historic District occurs just after leaving the "canyon." This exit is marked, but entrance to the area is not inviting, and motorists have little time to make their decisions.

FIGURE 14. ENTERING CONCRETE CANYON FROM WEST

1. Improve the character of the underpass zone by introducing color in the structures. This may be accomplished by staining the overpasses and the support structures. The long retaining wall on the north side of the roadway should be painted in a mural-like pattern which will accentuate the movement along its length. Lighting under the overpasses should also be considered (see Figures 14 & 15).

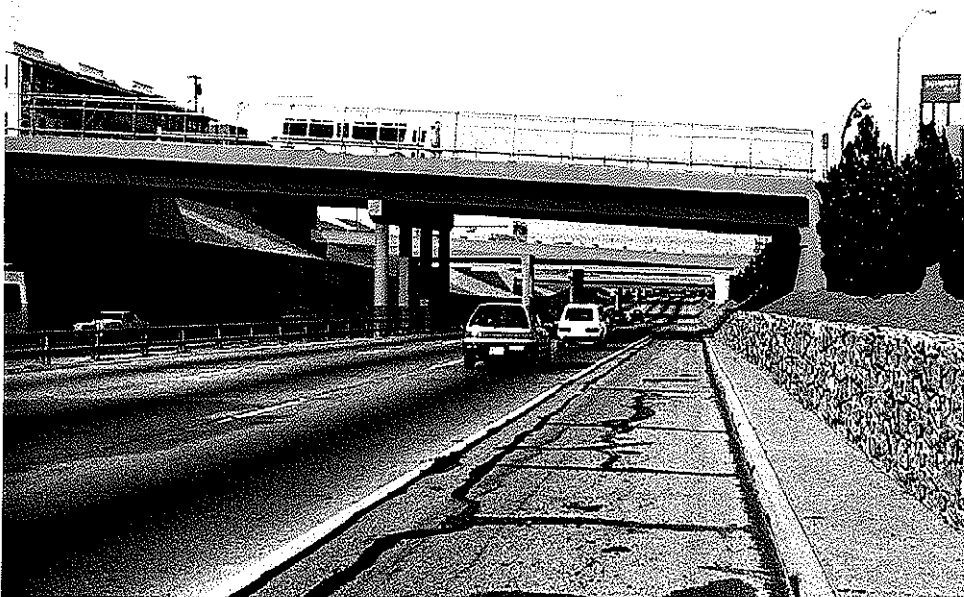
FIGURE 15. EFFECT OF INTRODUCING COLOR AND PLANTING AREAS.

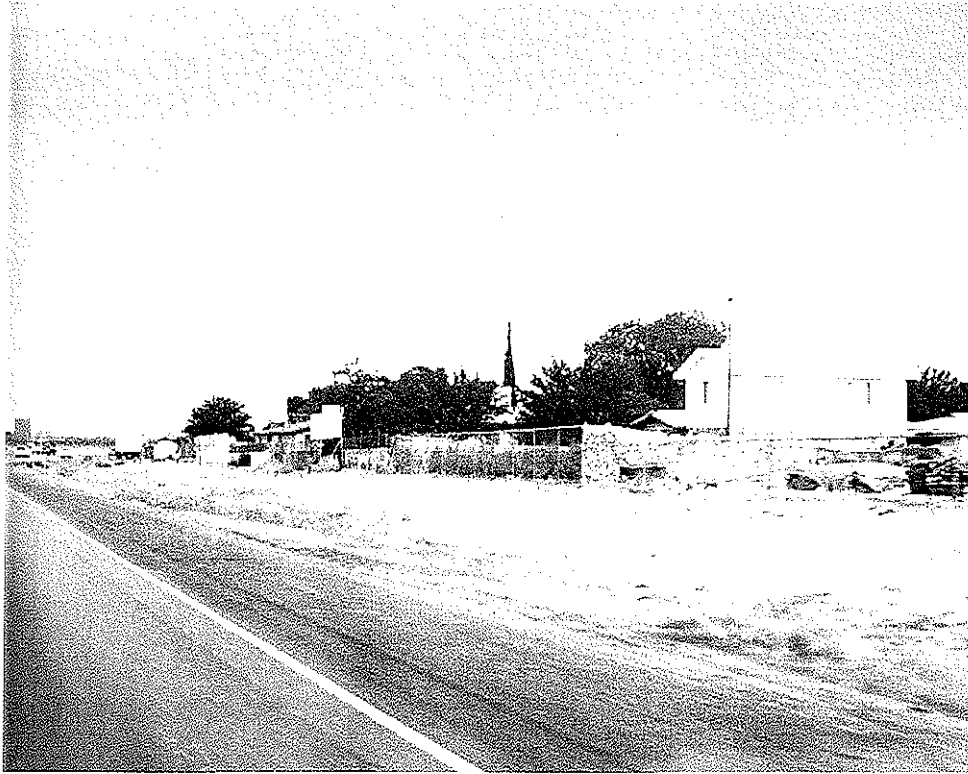
FIGURE 19. UNSCREENED RESIDENTIAL ALONG THE BORDER HIGHWAY.

1. Screening fences along existing commercial and residential developments in some areas should be erected. (Ordinances should be reviewed to ensure that residential areas assume responsibility for maintaining a visual screen along the subdivision.)
2. Isolated groves of trees should be planted to screen commercial and residential areas and to frame some of the views towards downtown El Paso. Groups should be small, 5 to 10 maximum, staggered in random patterns. Mesquite or Willow are the only species that should be used (see Figures 19 through 22).

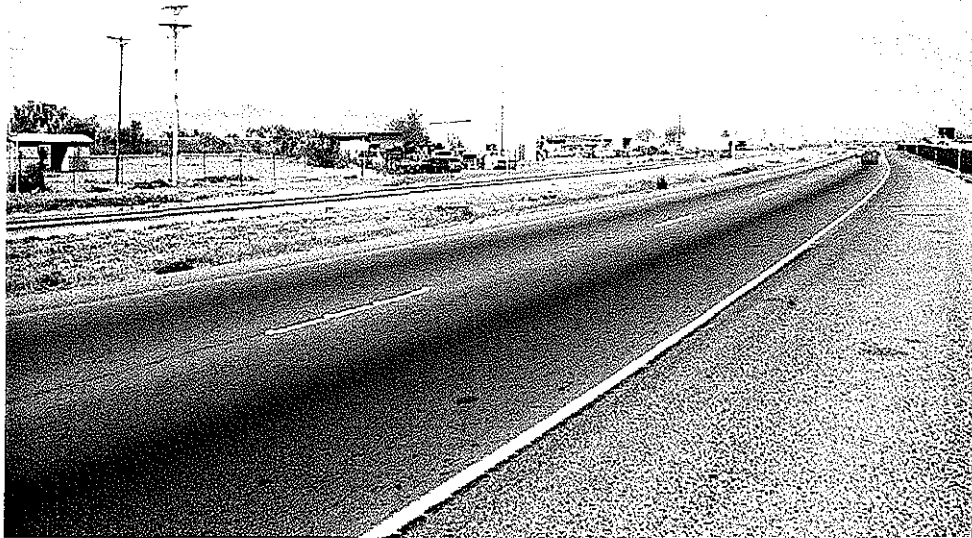
FIGURE 21. UNSCREENED COMMERCIAL AREA ON BORDER HIGHWAY.

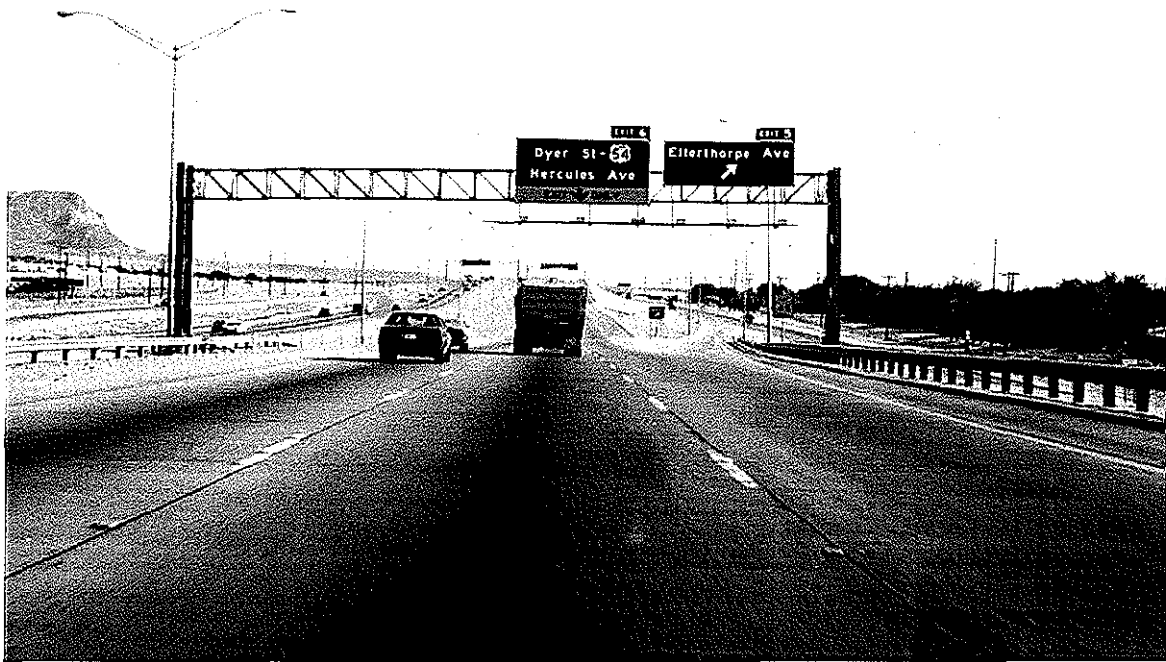
FIGURE 27. BARE SOILS CONTRAST POORLY WITH DENSE TREES OUTSIDE ROADWAYS

1. Install large masses of trees in the median areas along the roadway (see Figures 26 & 27). These trees should be randomly spaced in large groves. The groves should be nearly continuous but open and close to allow views. Tree varieties should include Mesquite, Eldarica Pine, and Desert Willow. It would require an enormous quantity if shrubs were to be used in this large space; therefore, they should be avoided except where screening at fences warrants.

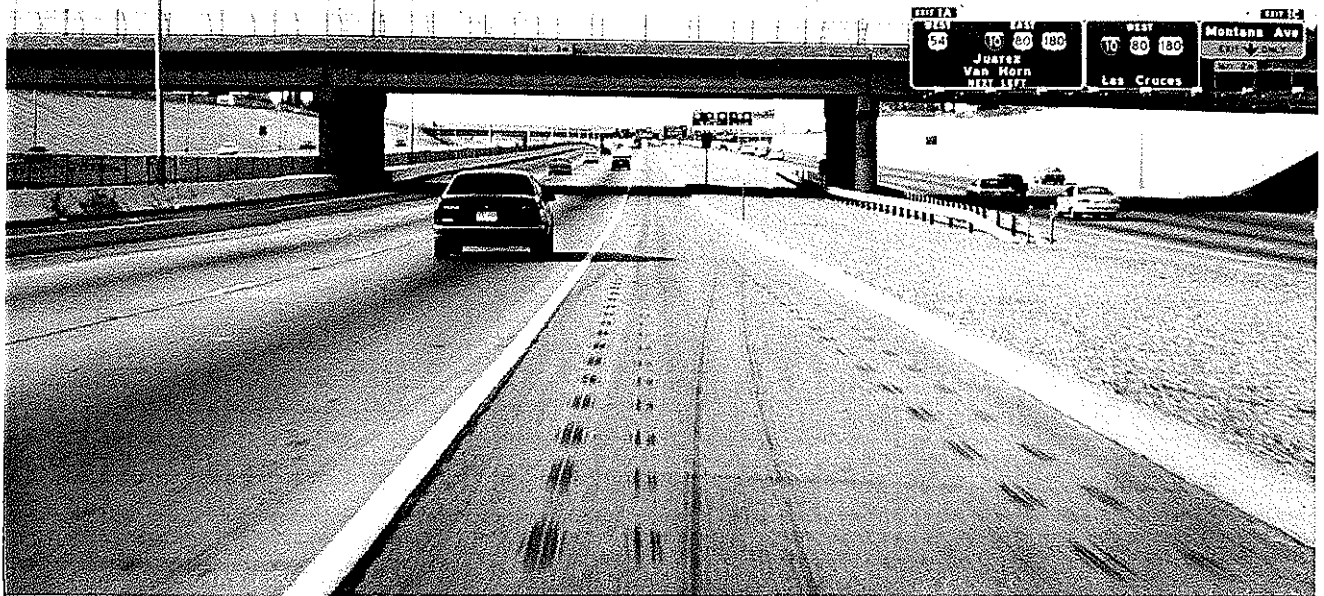
The end of this open land to the east marks the beginning of a very inhospitable segment of roadway that is very wide, monotone in color, and almost wall-to-wall concrete. The motorist still has a long view straight ahead but loses the residential areas to the sides as the roadway dips below the local streets. A lot of the same problems exist here that are found in the concrete canyon with respect to concrete overload. The scale of this section, because of its extreme width, is also uncomfortable. The median is paved in a grey aggregate. This has the effect of visually blending the median with the driving surface making the grey of the concrete even more oppressive.

FIGURE 30. EXISTING VIEW OF DEPRESSED SECTION  
BETWEEN PERSHING AND I-10

1. Introduce color into structures by staining overpasses and supporting structures. The possible colors of these structures are varied, but generally darker shades of earthtones should be considered. Support structures are susceptible to ugly streaking due to the runoff of dirt and oils. Staining these columns darker than the overpasses would help hide this condition.
2. Add color to the groundplane by replacing existing grey aggregate with aggregate in the dark red or dark green range. This will make the edges of the roadway more prominent and reduce glare.
3. Install raised stone planters in medians to provide space for tree plantings. This will

add stronger separation between the travel lanes and reduce the apparent scale of the roadway.

4. Construct stone planter walls at the base of the riprap slopes. These slopes are not overly steep. Some of the riprap behind these walls should be removed to provide space for trees to be installed. A continuous line of trees will hide most of the concrete riprap and significantly reduce glare.

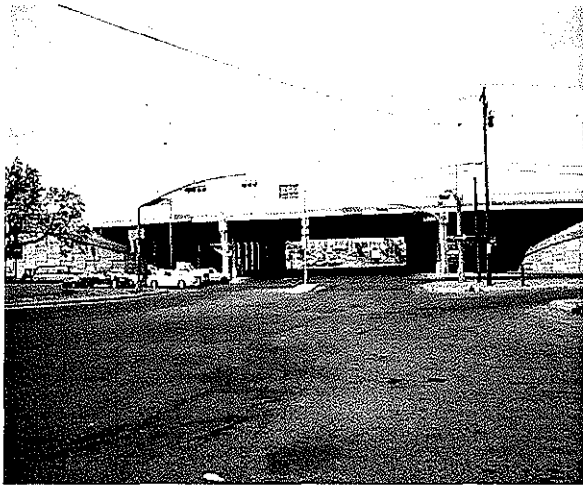
FIGURE 34. EXISTING OVERPASS AT AIRWAY & I-10.

Figures 34 through 39 offer some examples that illustrate some important guidelines in color selection. It is easy to see that light shades will not provide enough of a distinction against the background sky. Darker accent colors give much stronger lines and make for a neater looking structure. The addition of these darker colors on supports and other connecting structures (Figure 39) create an even more pleasant effect.
