TECHNICAL REPORT 0-6804-5
TxDOT PROJECT NUMBER 0-6804

Traffic Noise Barrier Study on SH 190 in Rowlett, Texas

November 2020; Published July 2021

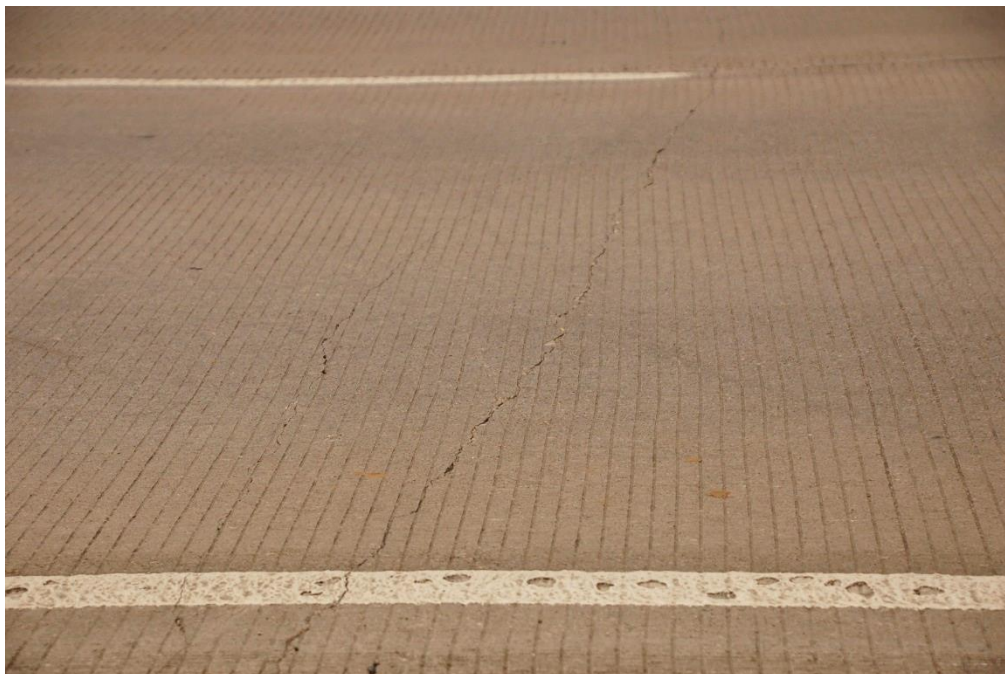
Figure 3.11 Northbound frontage road. Transverse cracks

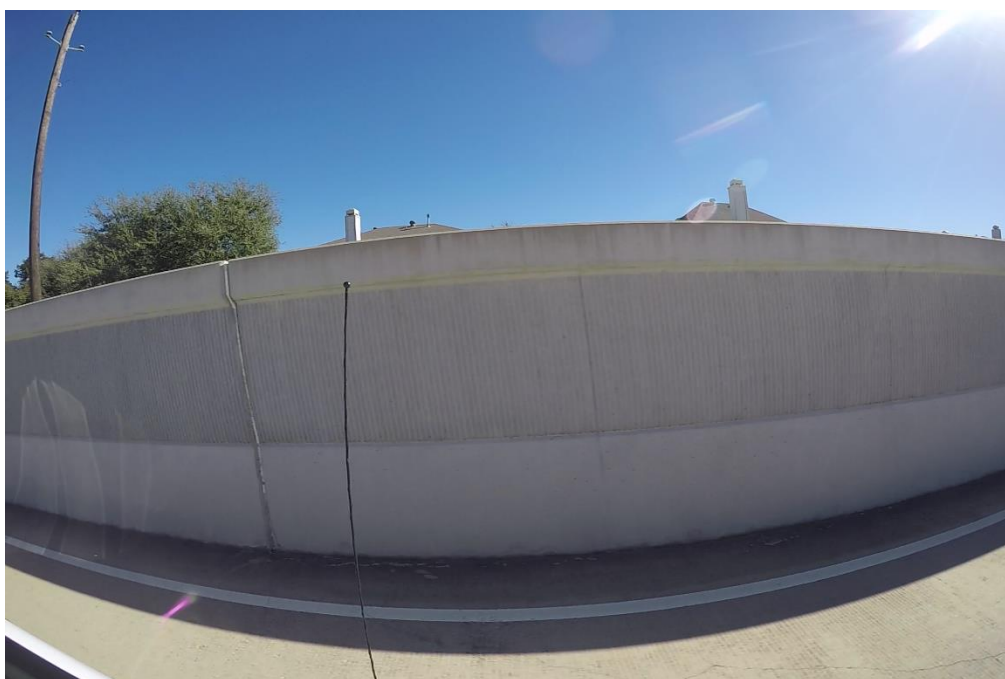
Figure 3.12 Northbound frontage road. Longitudinal crack as recorded by video

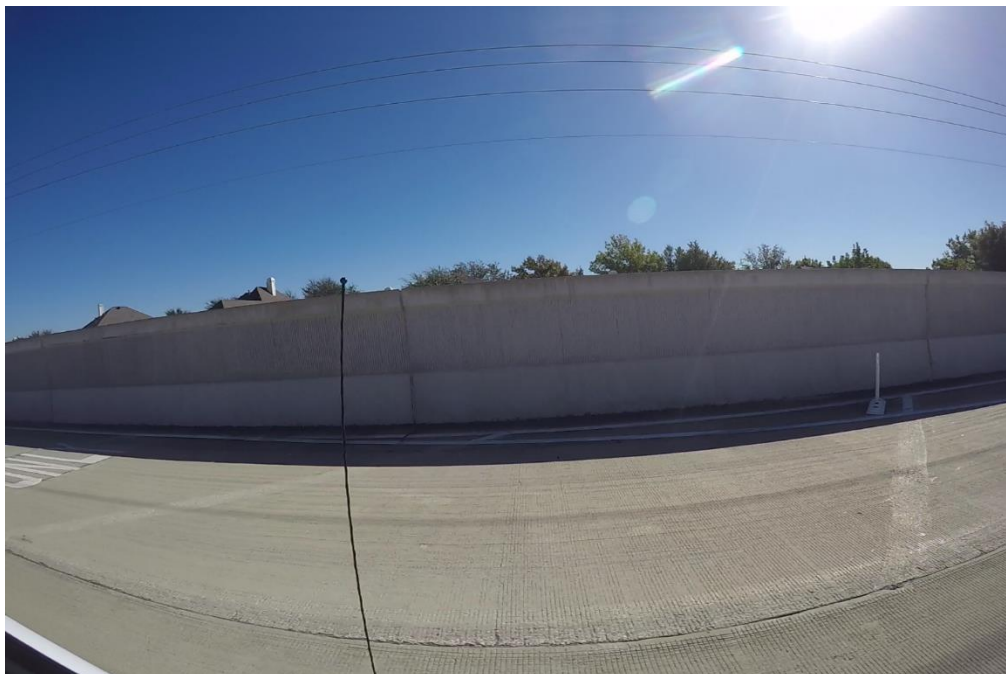
Figure 3.13 Northbound frontage road. Minor spalling of the longitudinal joint as recorded by video

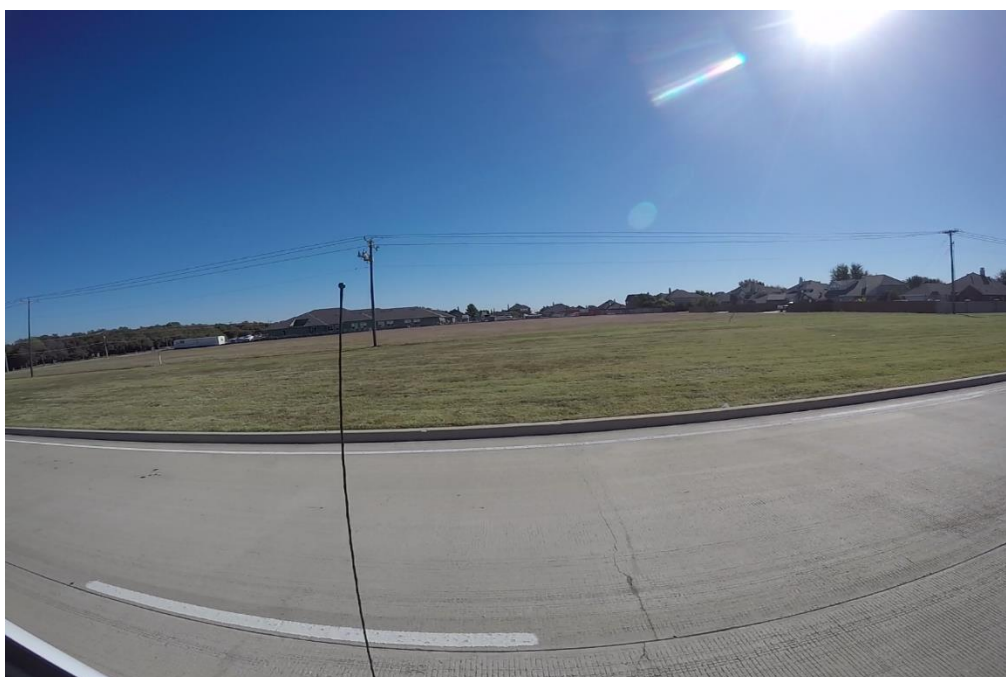
Figure 3.14 Northbound frontage road. Minor spalling of the transverse crack as recorded by video

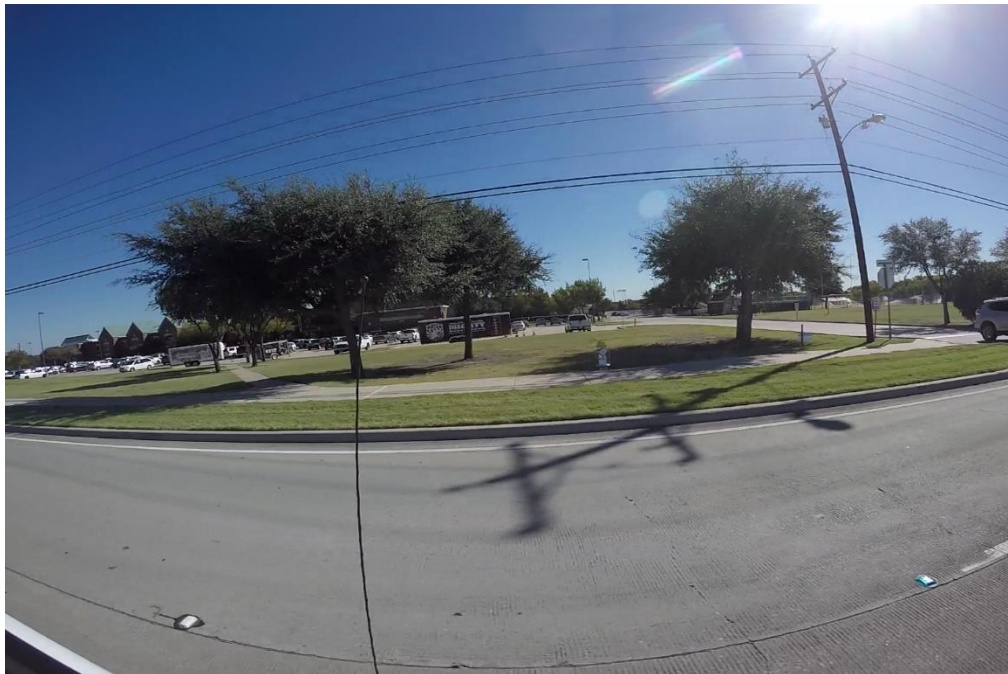
Figure 3.15 Northbound frontage road. Transverse cracks as recorded by video

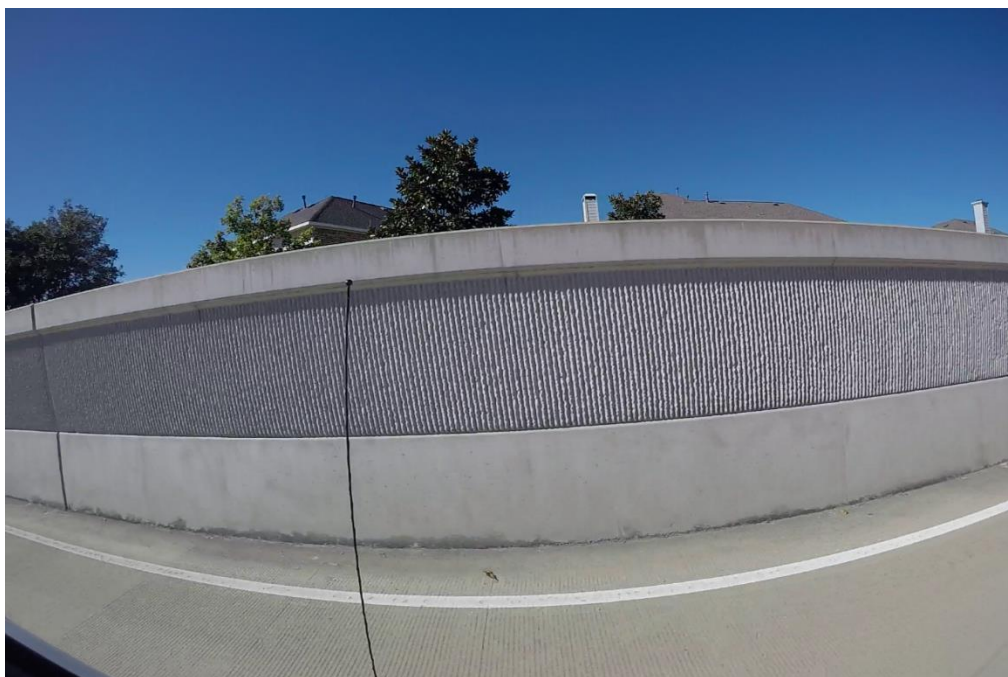
Figure 3.16 Southbound frontage road. Pavement in excellent condition as recorded by video

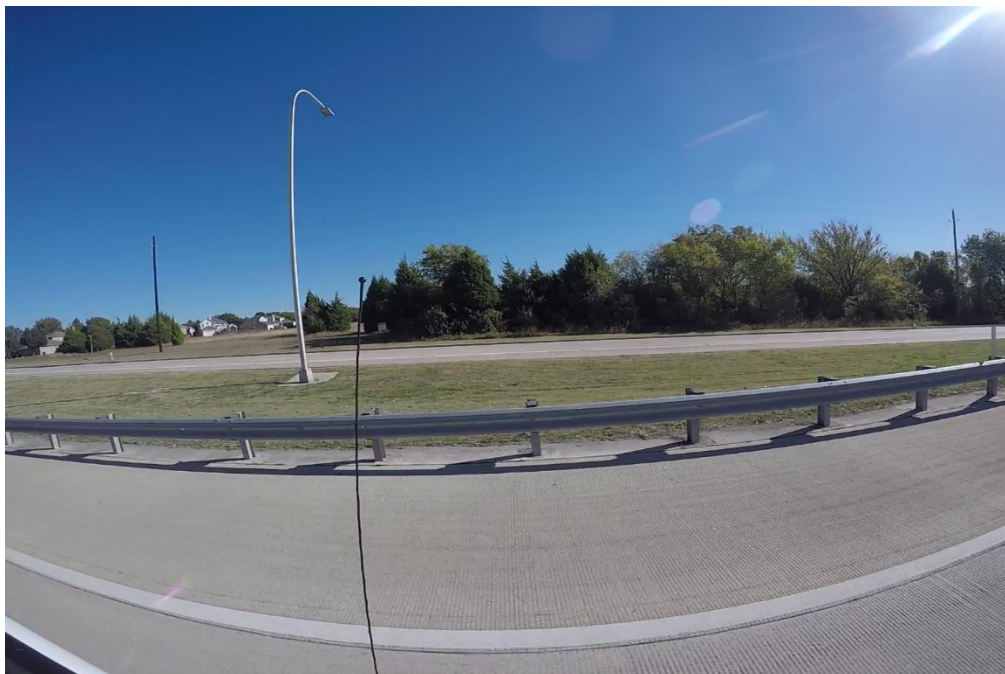
Figure 3.17 Northbound main lane. Pavement in excellent condition as recorded by video

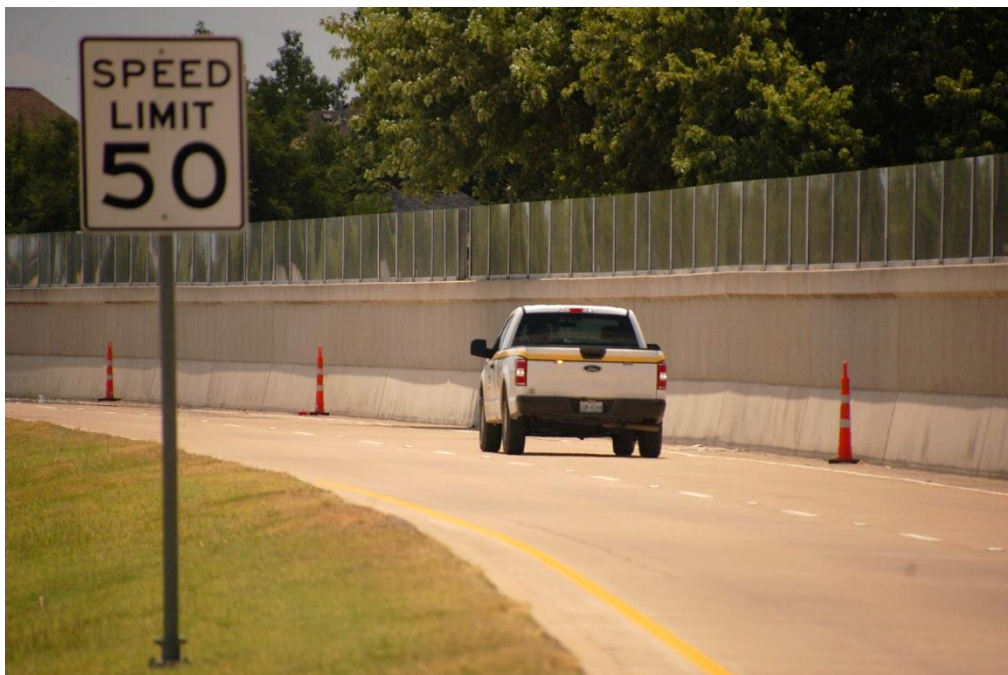
Figure 7.17 Contractor's (Select Striping) vehicle inspects the west side wall approaching one of the missing panels (July 24, 2019)

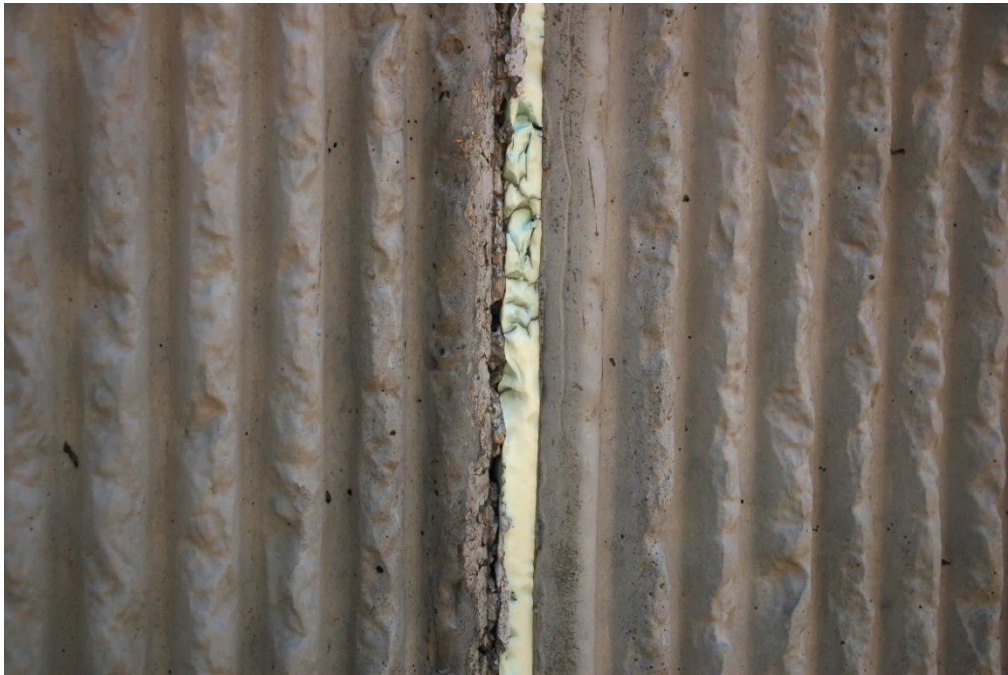
Figure 7.34 Expansion joint with sealant material in good condition

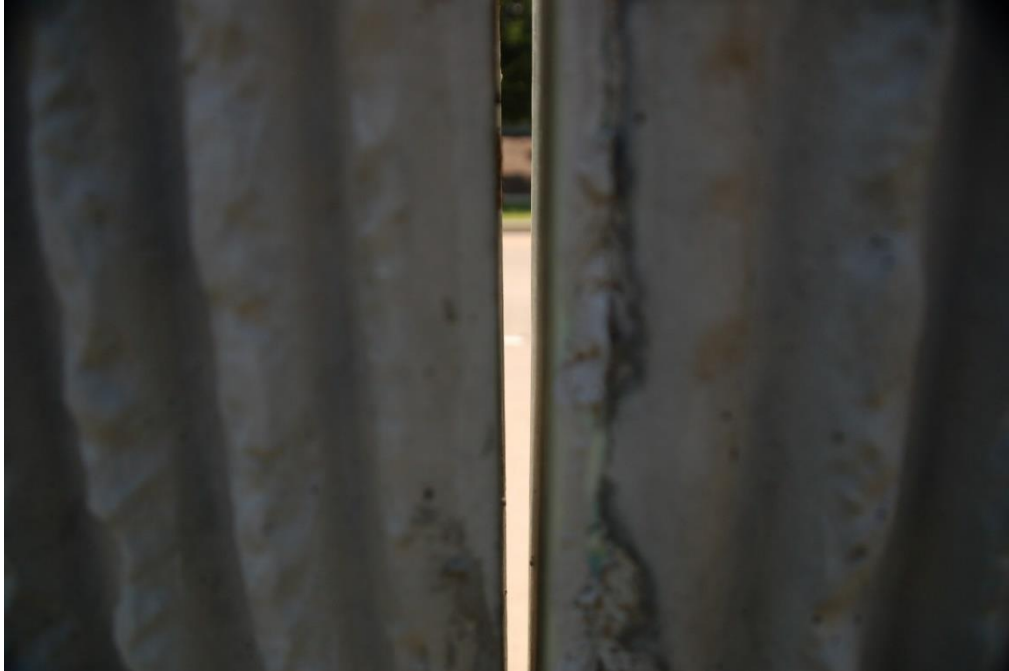
Figure 7.35 Open expansion joint without sealant material

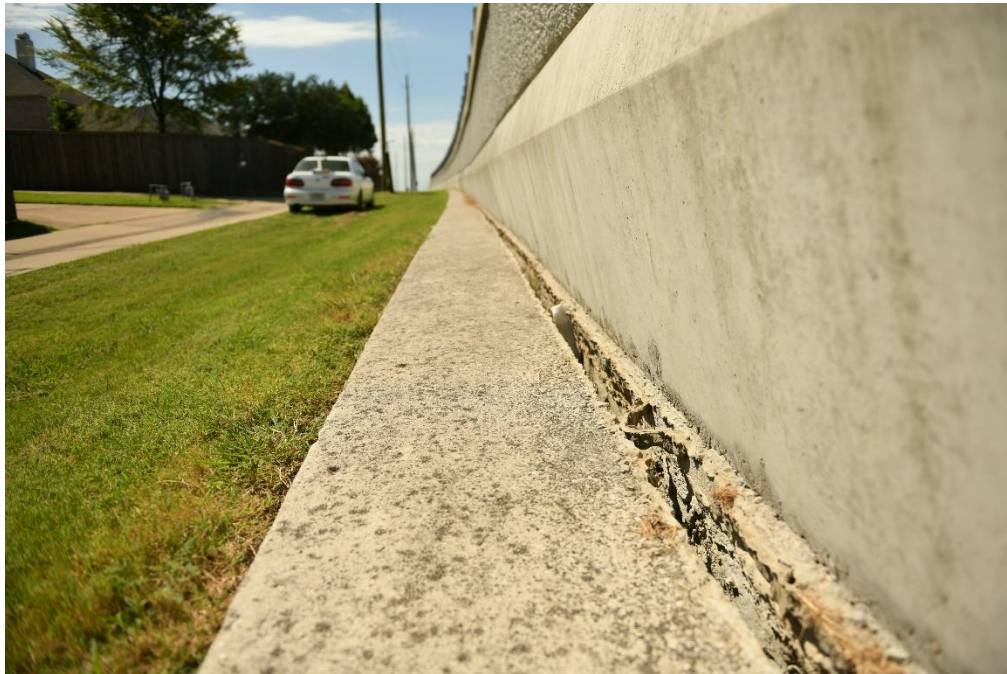
Figure 7.37 Separation between noise wall and concrete base, east side wall, close to receiver R#1
