TESTING AND EVALUATION OF WORK ZONE

TRAFFIC CONTROL DEVICES

PROVIDED BY FLASHER EQUIPMENT COMPANY

Project No. 71770

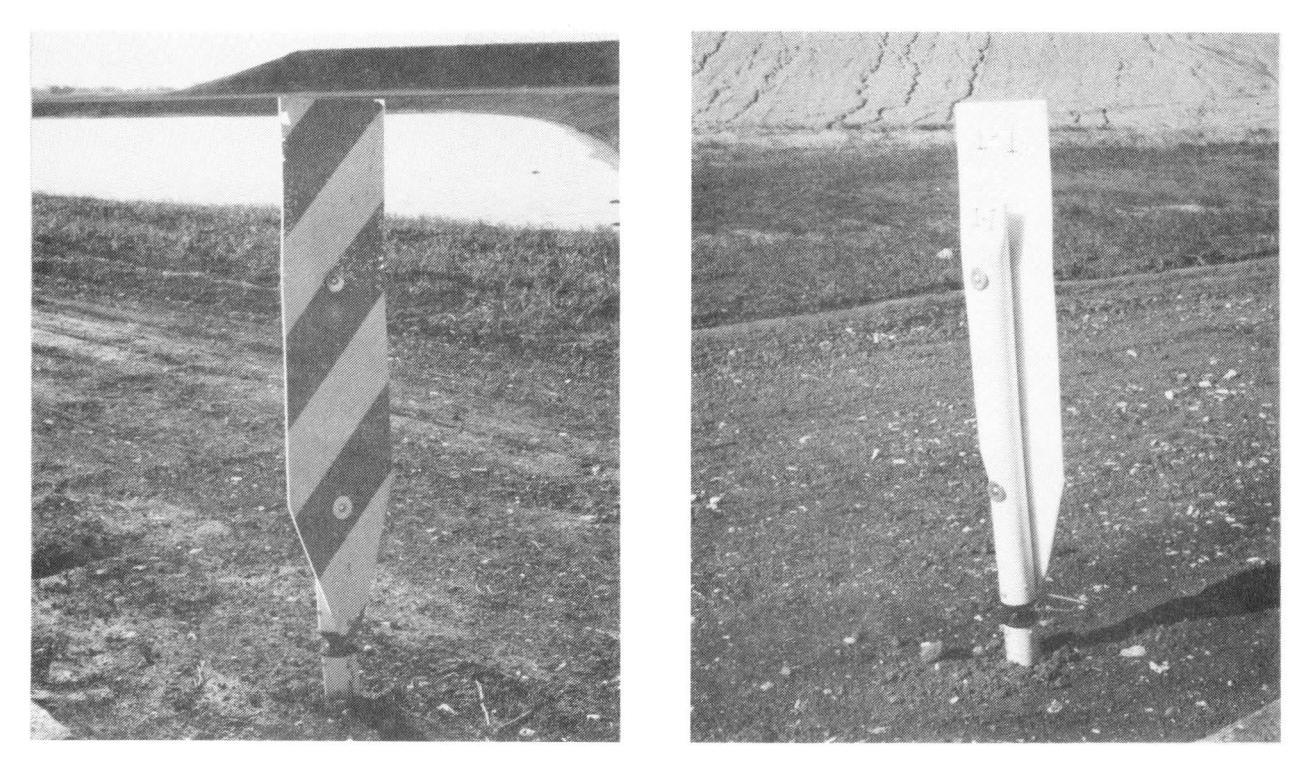
Figure 5. Damage to first device, test 7177-1.

adjacent traffic lanes. The vehicle remained stable throughout the test sequence. The vertical panels remained intact and sustained only minor damages.

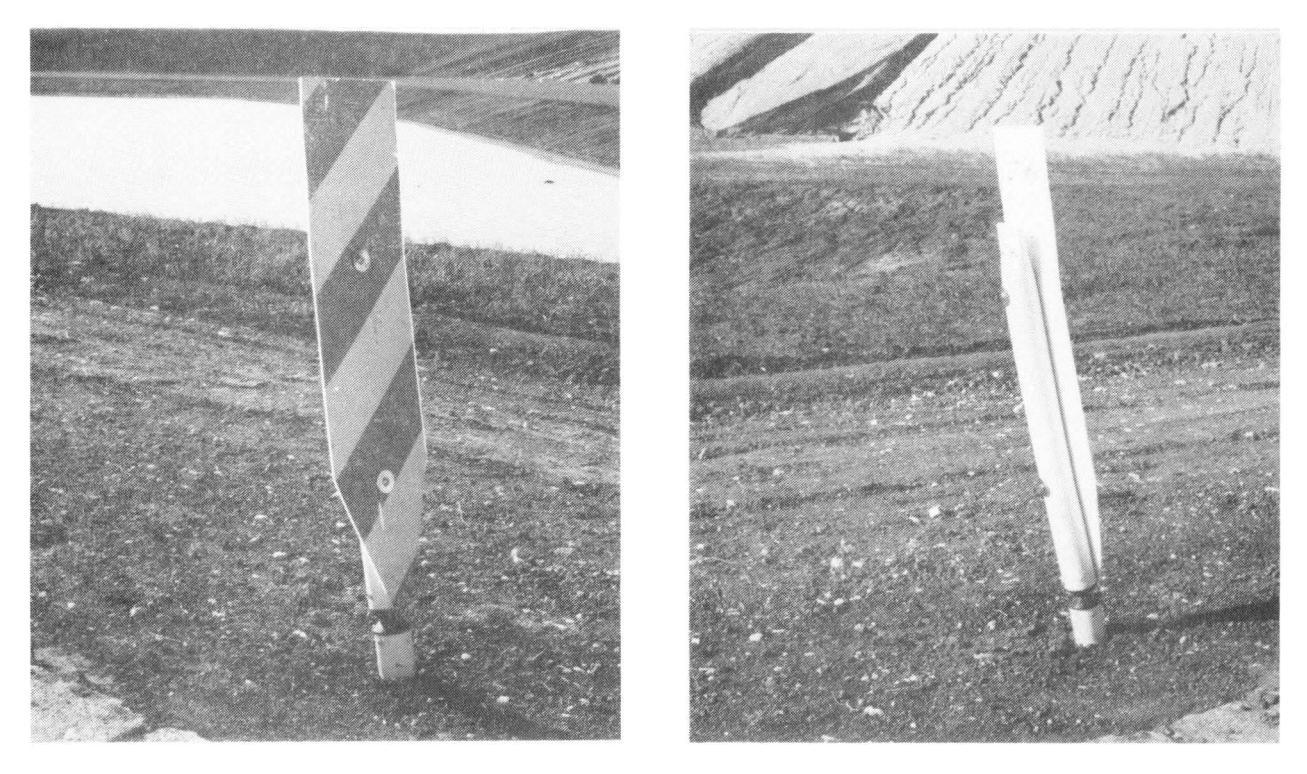
Figure 6. Damage to second device, test 7177-1.

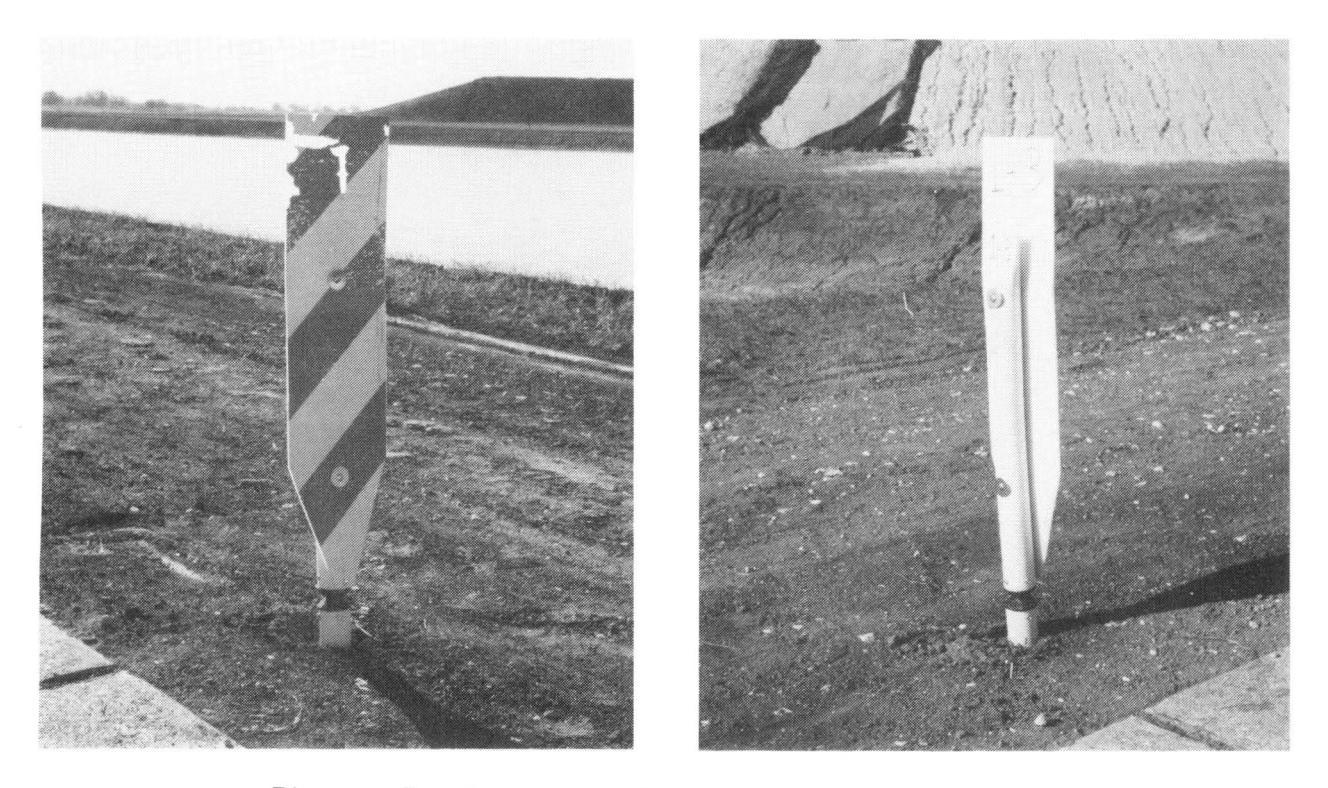
Figure 7. Damage to third device, test 7177-1.

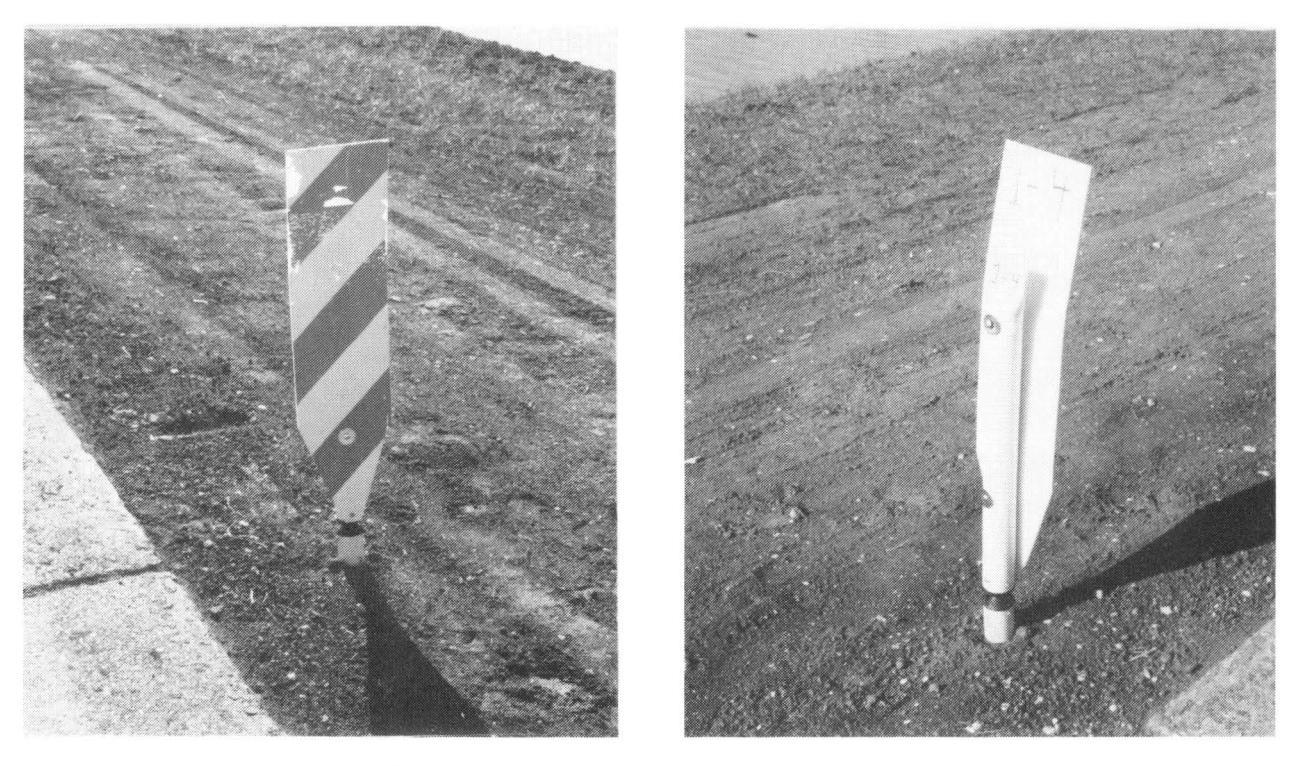
Figure 8. Damage to fourth device, test 7177-1.

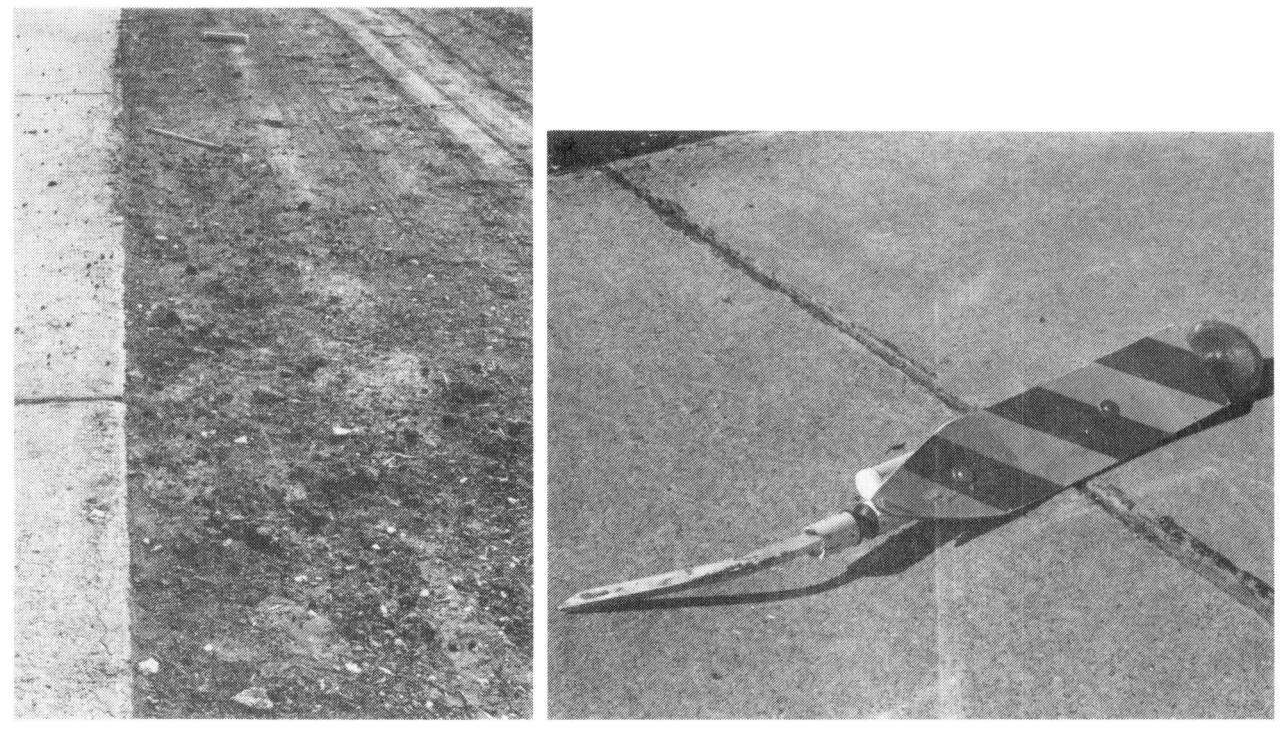
Figure 13. Damage to first device, test 7177-2.

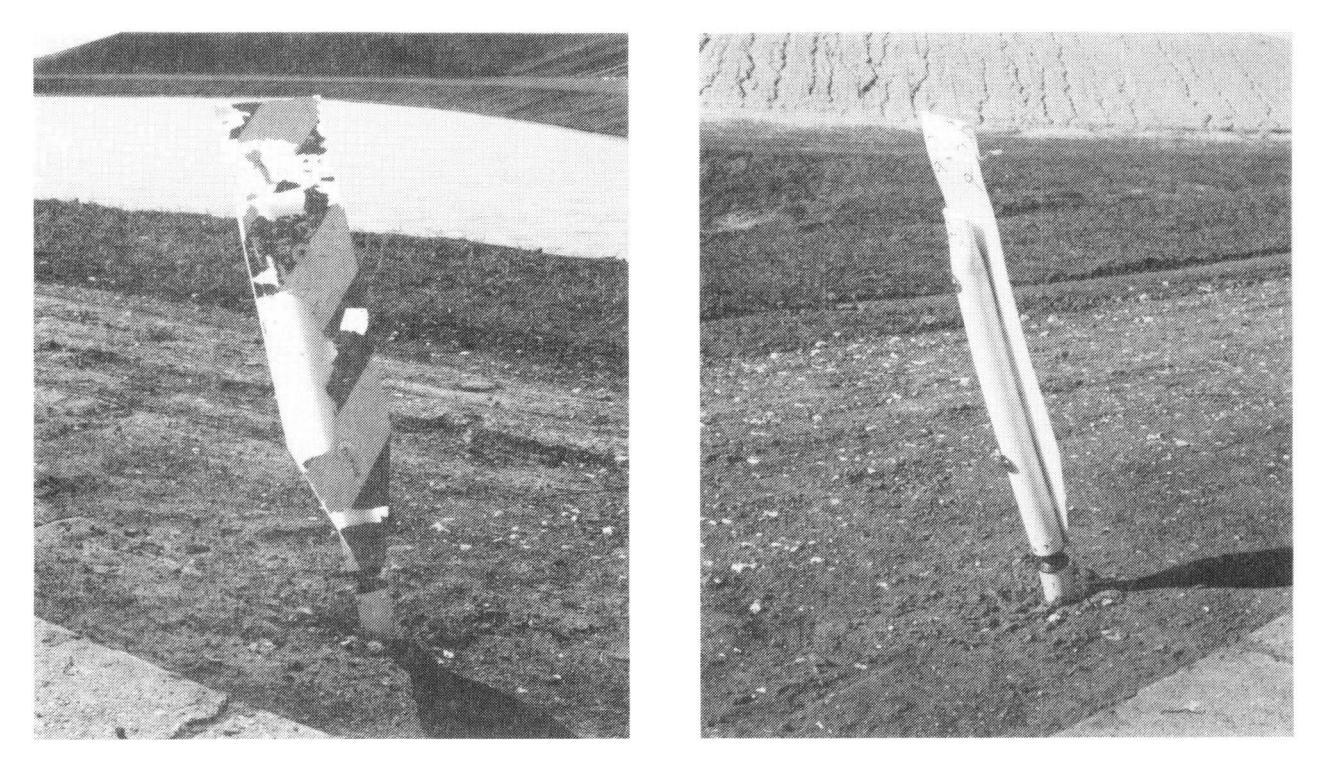
Figure 14. Damage to second device, test 7177-2.

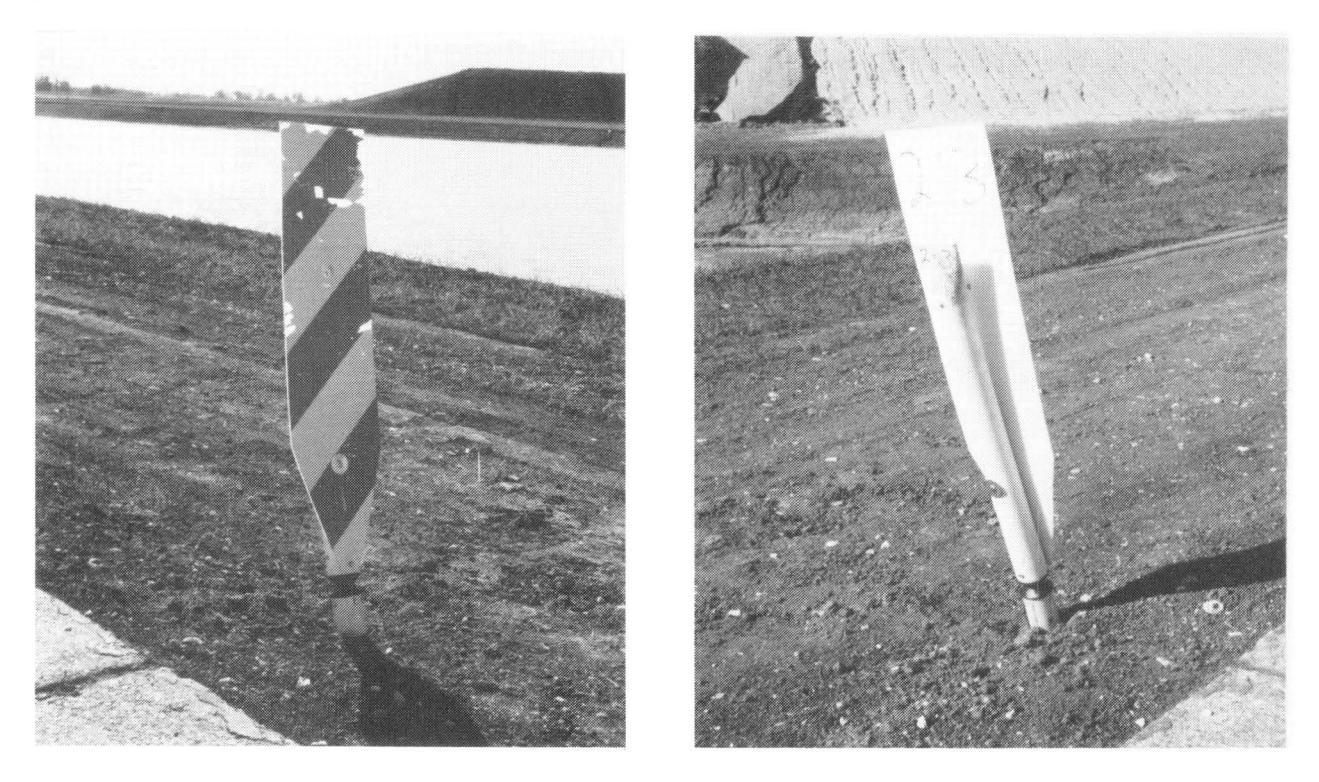
Figure 15. Damage to third device, test 7177-2.

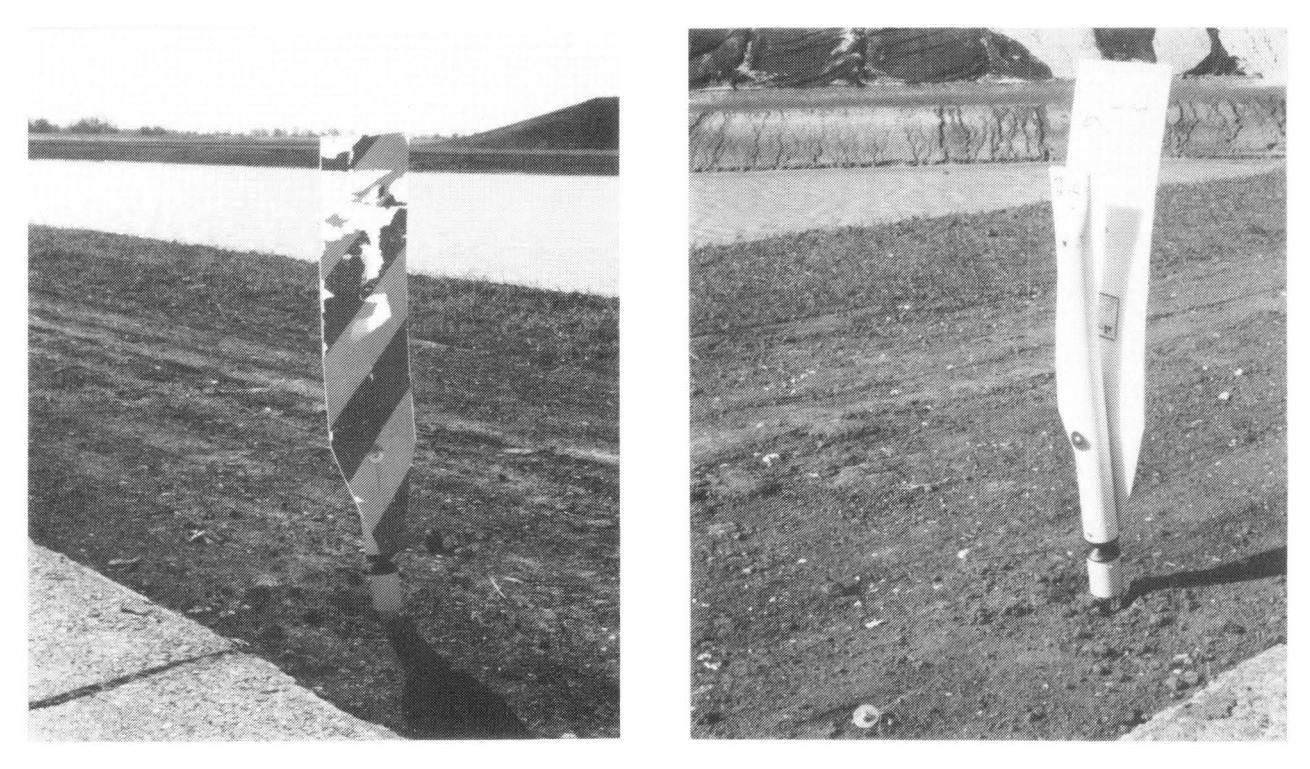
Figure 16. Damage to fourth device, test 7177-2.

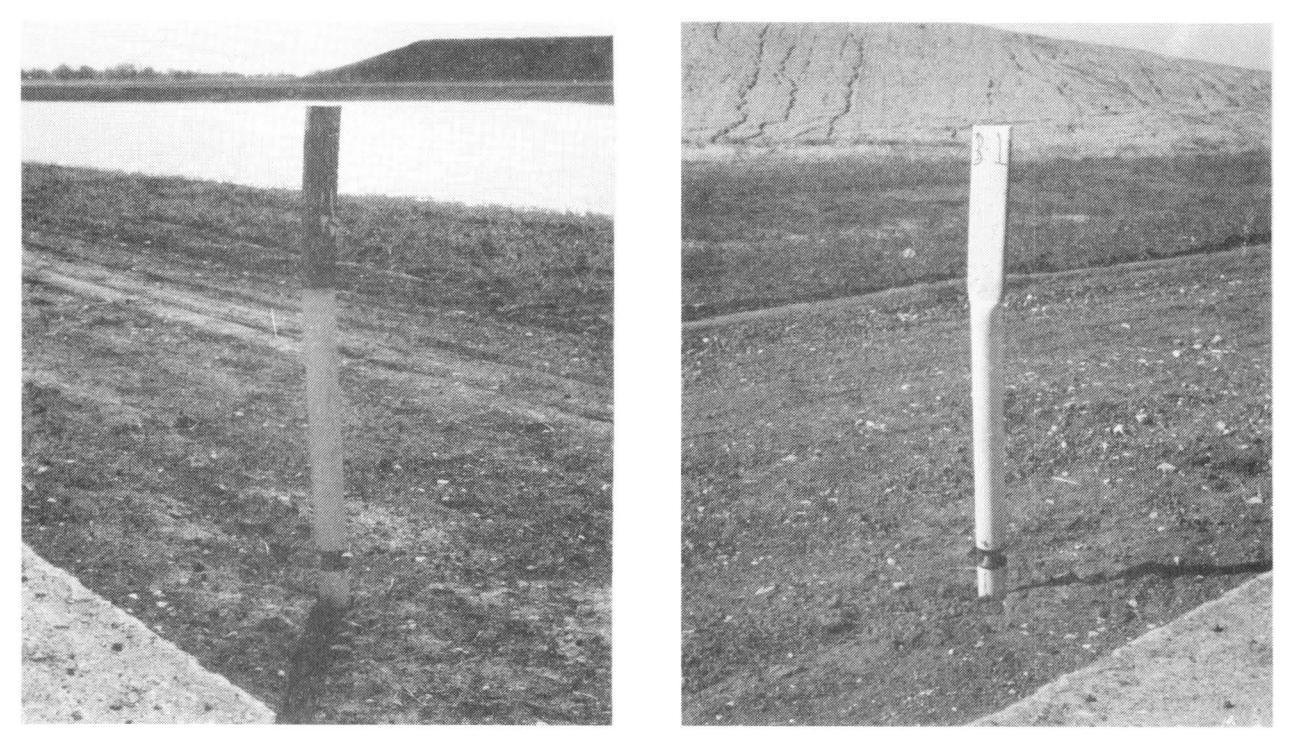
Figure 20. Damage to first device, test 7177-3.

into adjacent traffic lanes. The vehicle remained stable throughout the test sequence. The delineators remained intact and sustained only minor damages.

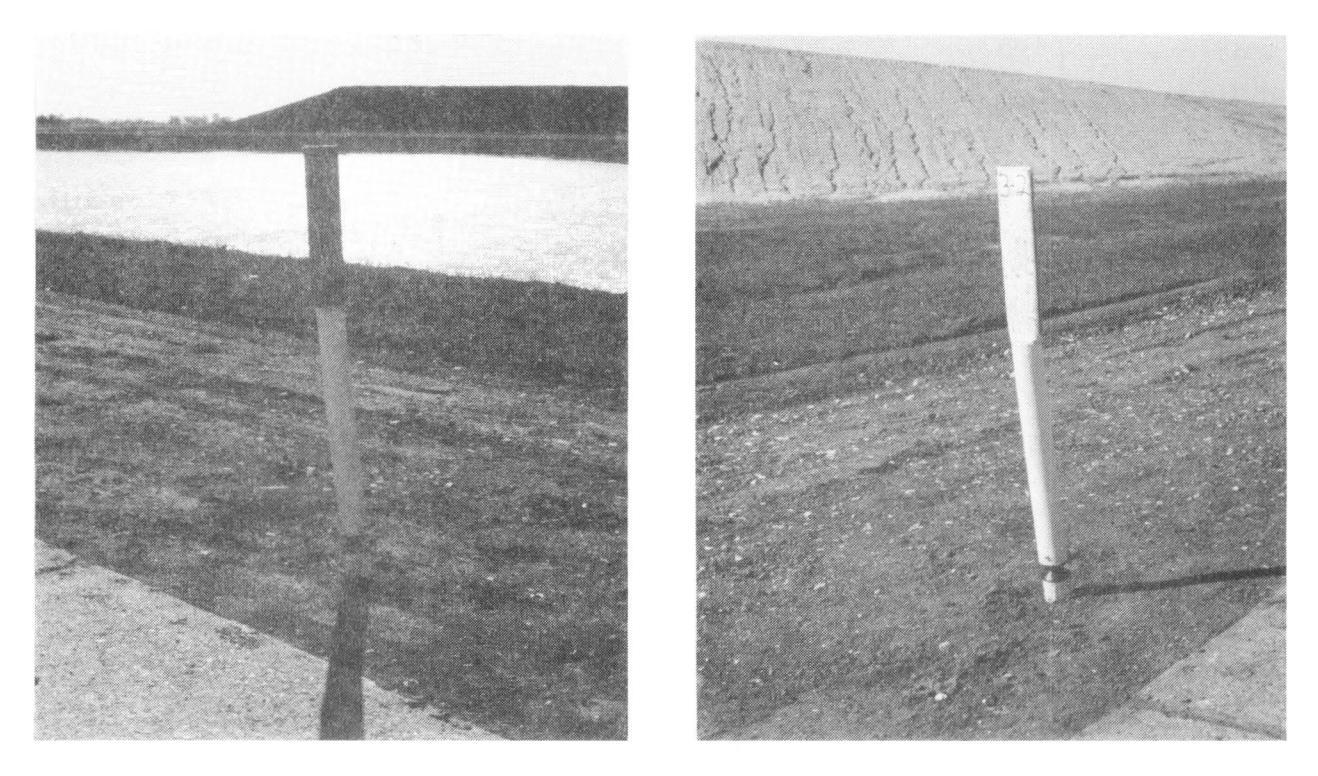
Figure 21. Damage to second device, test 7177-3.

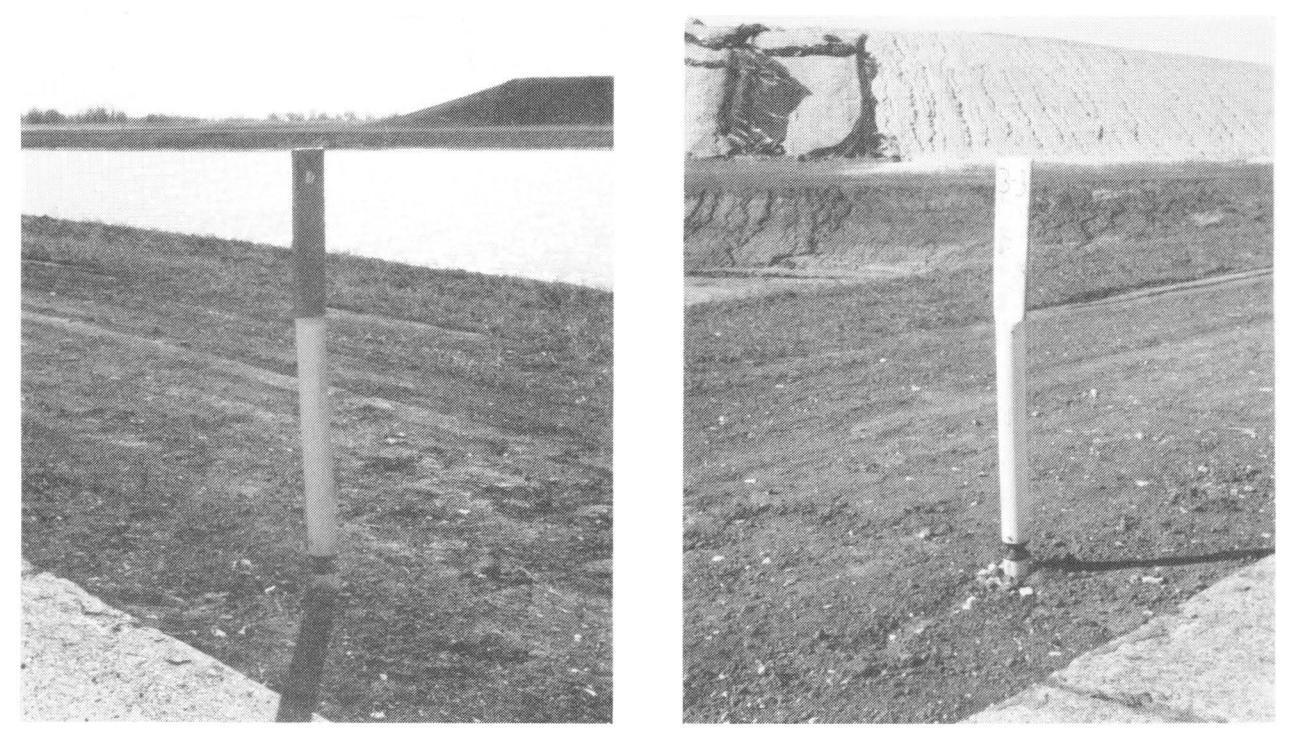
Figure 22. Damage to third device, test 7177-3.

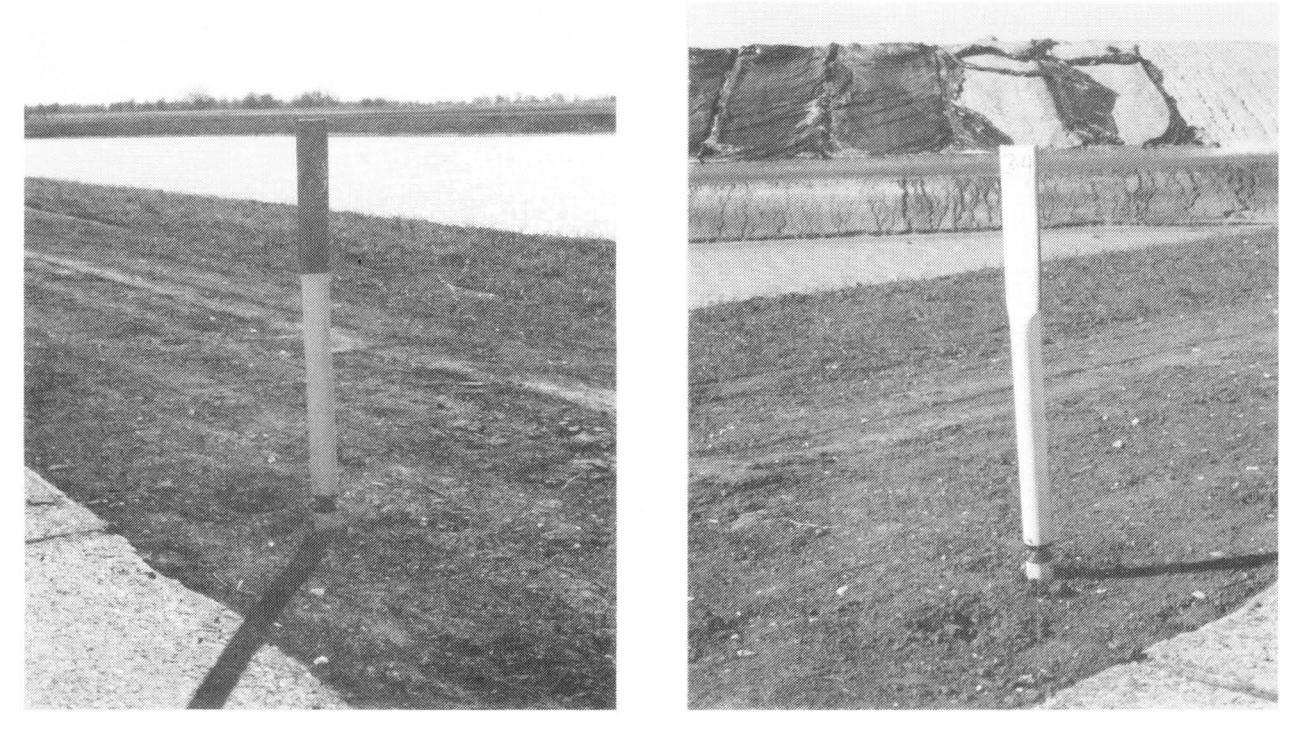
Figure 23. Damage to fourth device, test 7177-3.

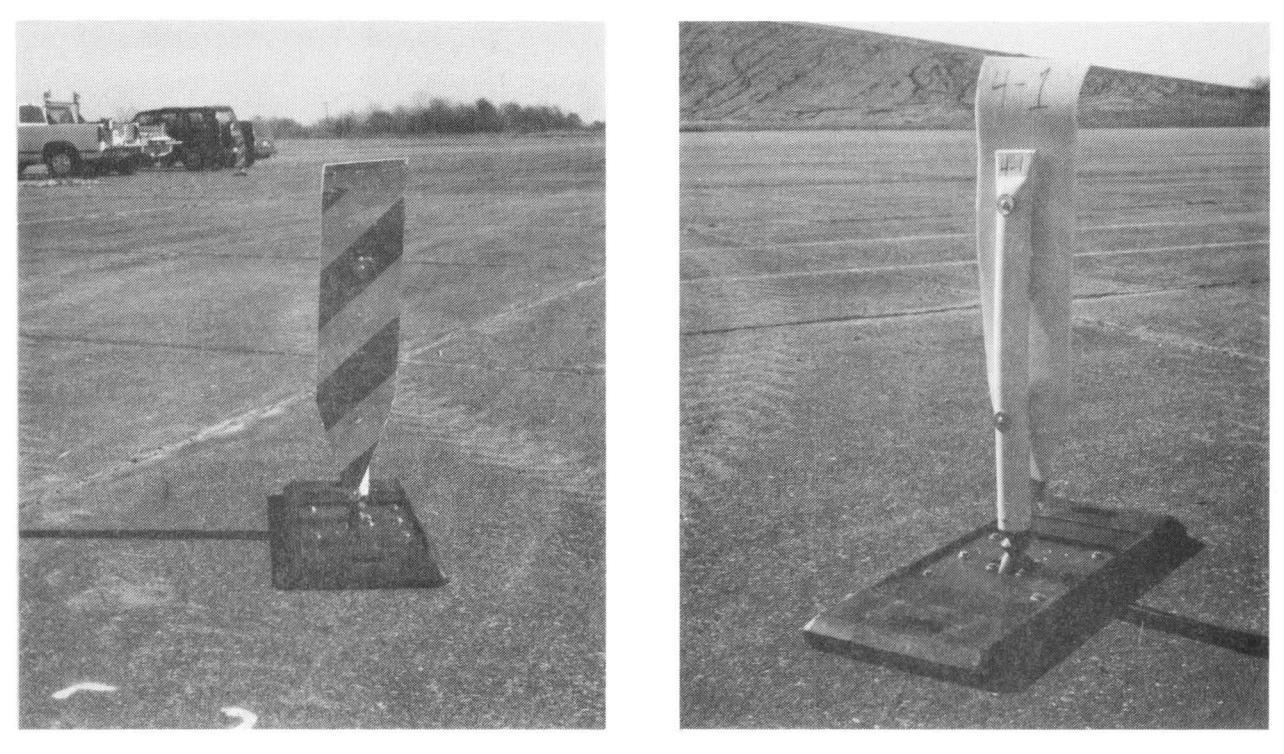
The vehicle impacted the first device at 59.7 mi/h with the right quarter point of the vehicle bumper. There was no driver input as the vehicle traversed over the devices. Both devices were moved slightly from the impacts by the vehicle. The first device moved 5.2 feet down and 0.25 feet to the left, and the lower fastener was pulled from the panel. The second device moved 8.2 feet down and 0.5 feet to the left, and the lower fastener was also pulled from the panel. The knuckle on the second device was cracked, but remained functional. Damage to the devices is shown in Figures 26 and 27. There was no damage to the vehicle.

Figure 26. Damage to first device, test 7177-4.

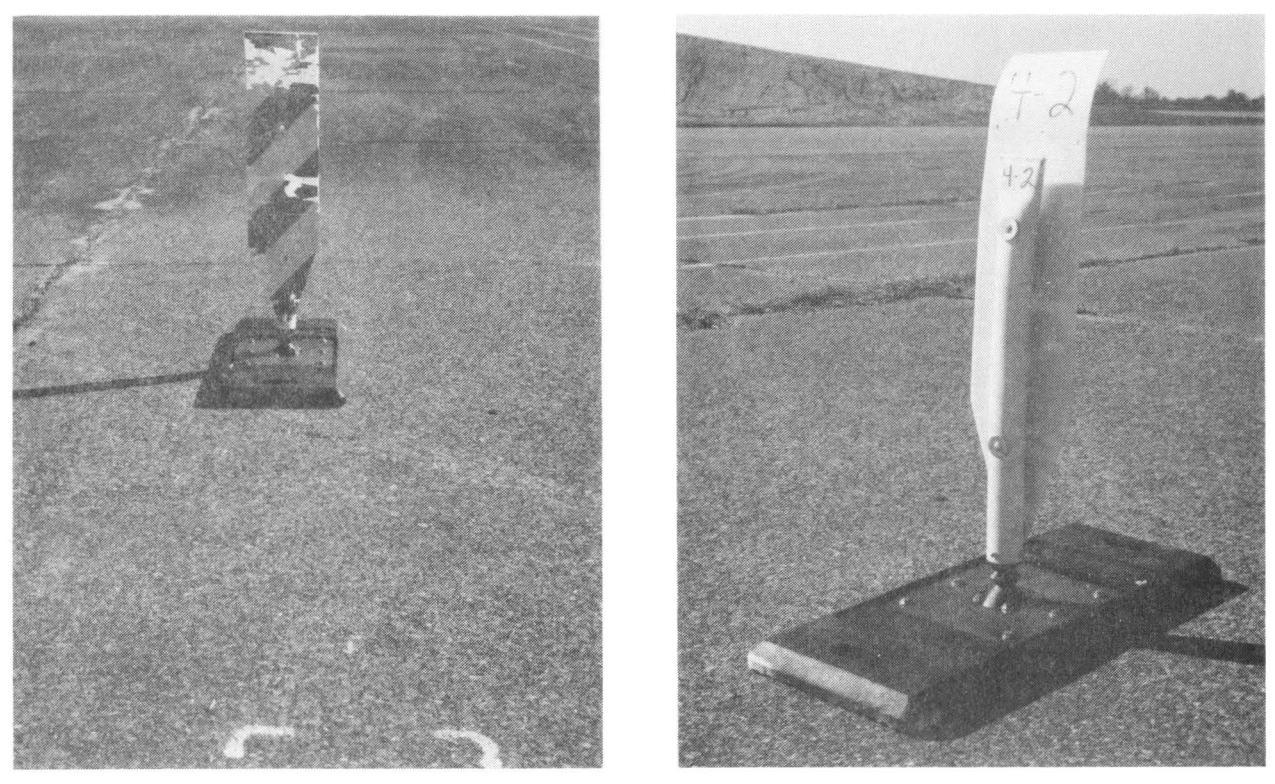
Figure 27. Damage to second device, test 7177-4.

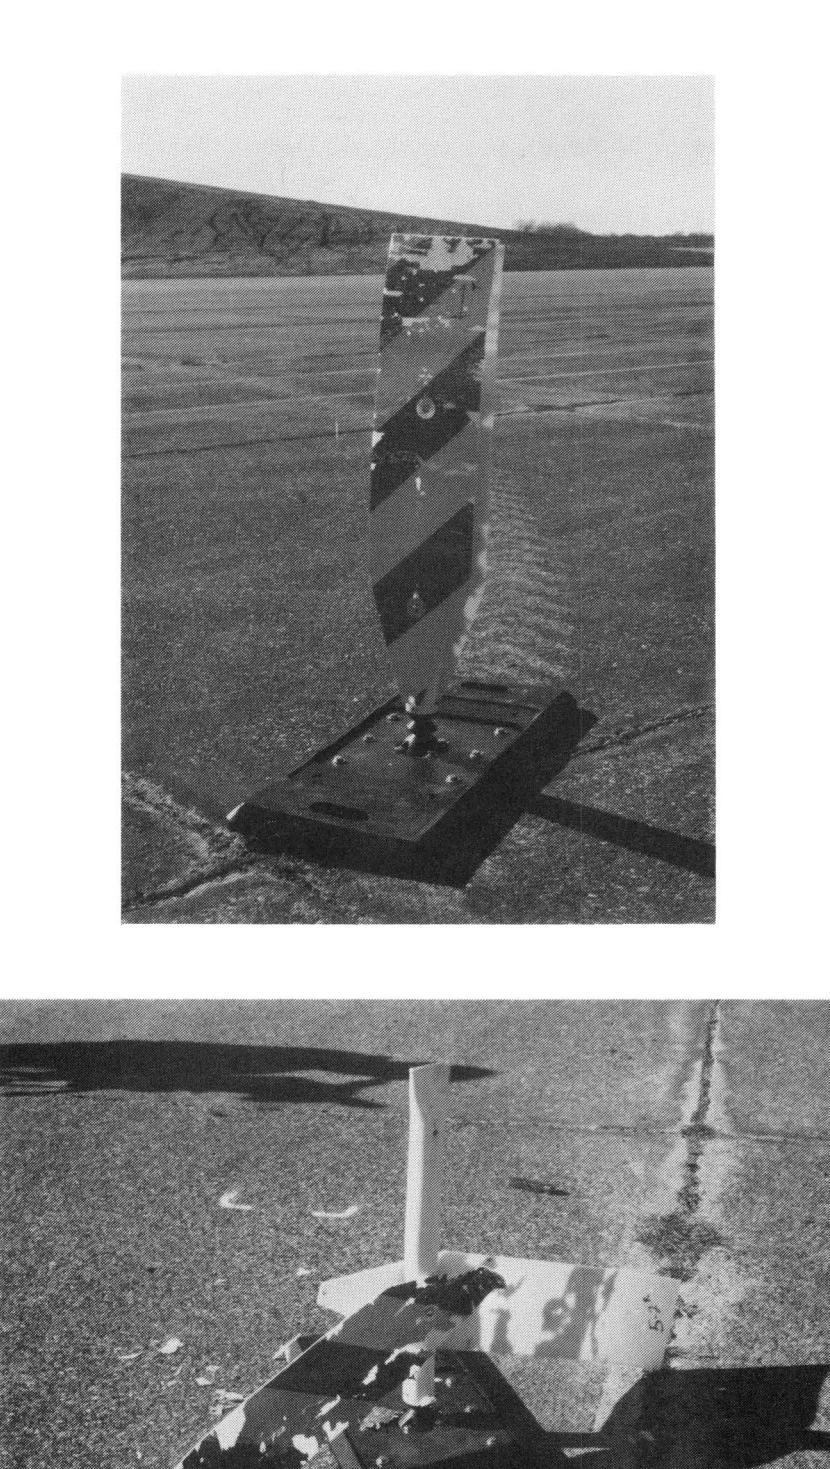
came loose and the vertical panels were partially detached from the posts. Also, a 1-in x 1-in x 6-in lead insert broke loose from the portable base. As the vehicle traversed the second device, the rear wheel rode over the device, moving it 5.1 feet down and 2.0 feet to the left. The vehicle sustained no damage as shown in Figure 30. After-test photographs of the devices are shown in Figures 30 and 31.

There was no damage to the vehicle and no penetration or intrusion of the occupant compartment of the vehicle. The vehicle remained on a straight, smooth path through the test site with no intrusion into adjacent traffic lanes. The vehicle remained stable throughout the test sequence. The devices were moved slightly due to impacts by the vehicle, but remained relatively close to the vehicle path. The base of the first assembly bounced off the ground as the vehicle cleared the device. A piece of lead insert was found separated from the base. It was explained by Flasher Equipment Company personnel that the lead insert was a temporary setup for the prototype base and will be eliminated from the production unit. The vertical panels on the first assembly were badly scraped and partially detached from the post as a result of the top fasteners pulled out from the panels. The vertical panels on the second assembly were also scraped and slightly bent.

Figure 31. Damage to devices, test 7177-5.

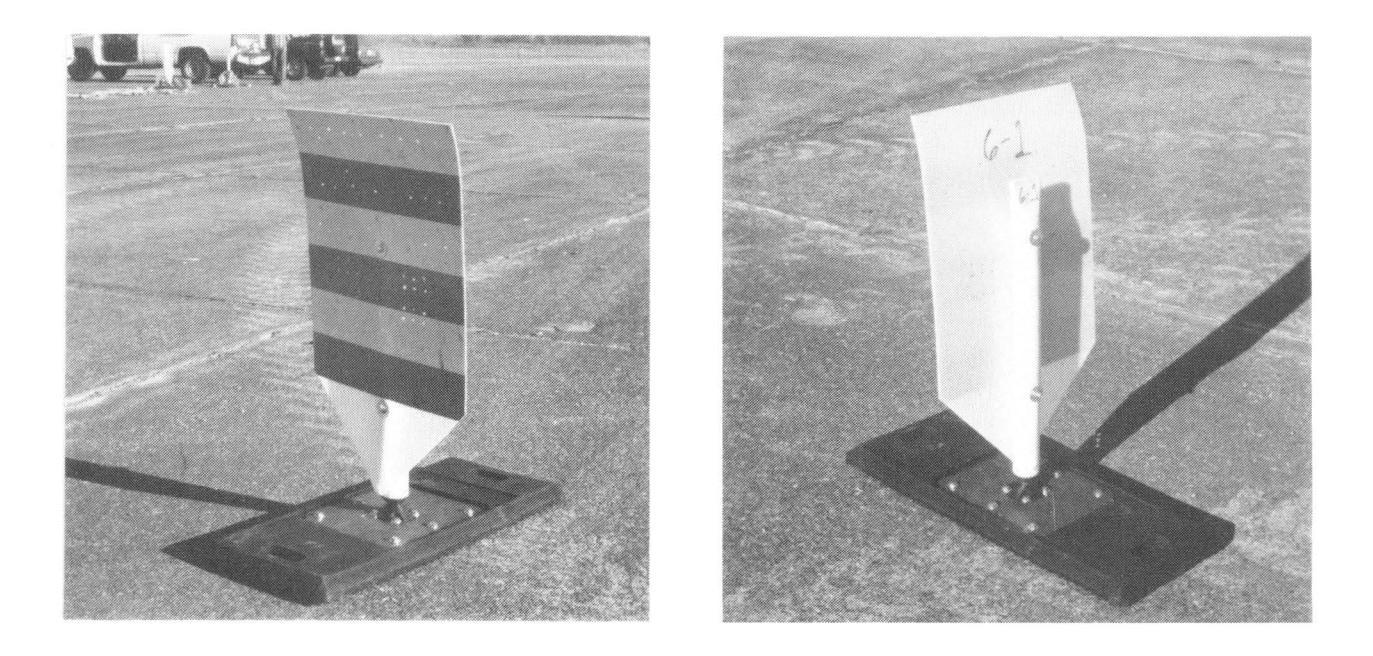
The vehicle sustained cosmetic damage only and there was no penetration or intrusion of the occupant compartment of the vehicle. The vehicle remained on a straight, smooth path through the test site with no intrusion into adjacent traffic lanes. The vehicle remained stable throughout the test sequence. The devices moved but remained relatively close to the vehicle path. The sign panels were slightly bent with minor scrapes to the reflective surfaces.

Figure 34. Damage to first device, test 7177-6.

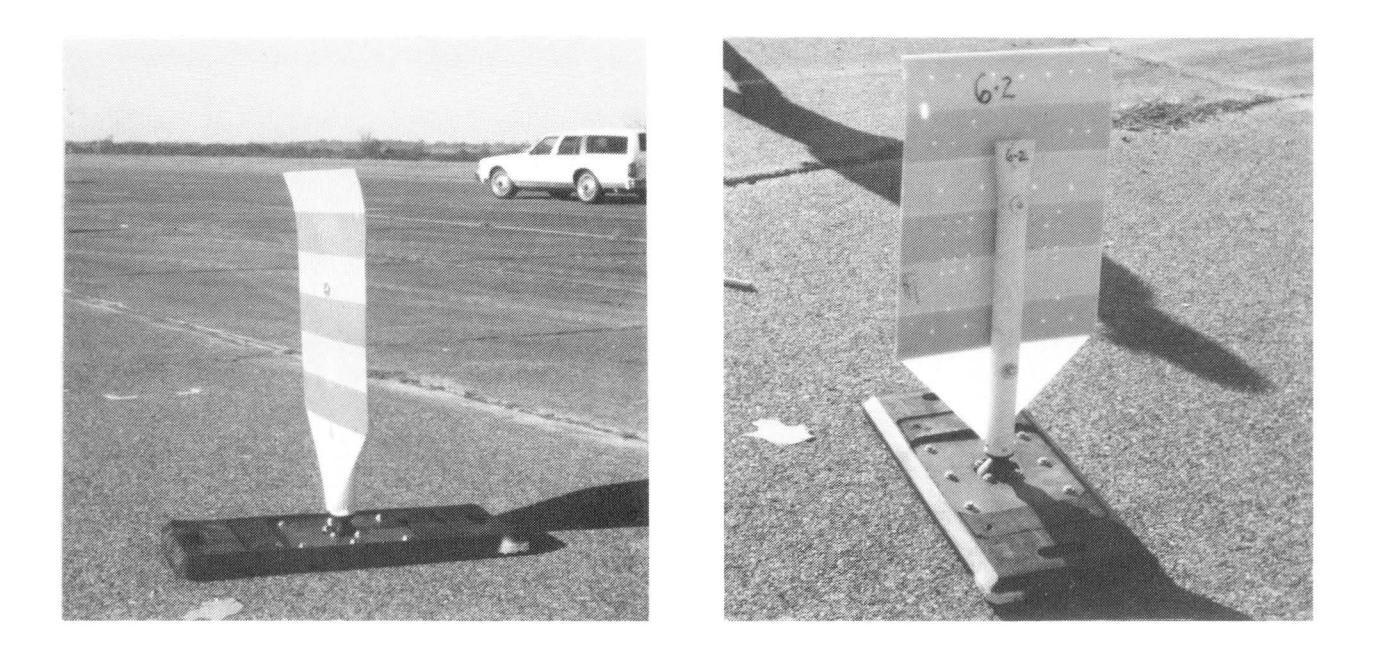
Figure 35. Damage to second device, test 7177-6.

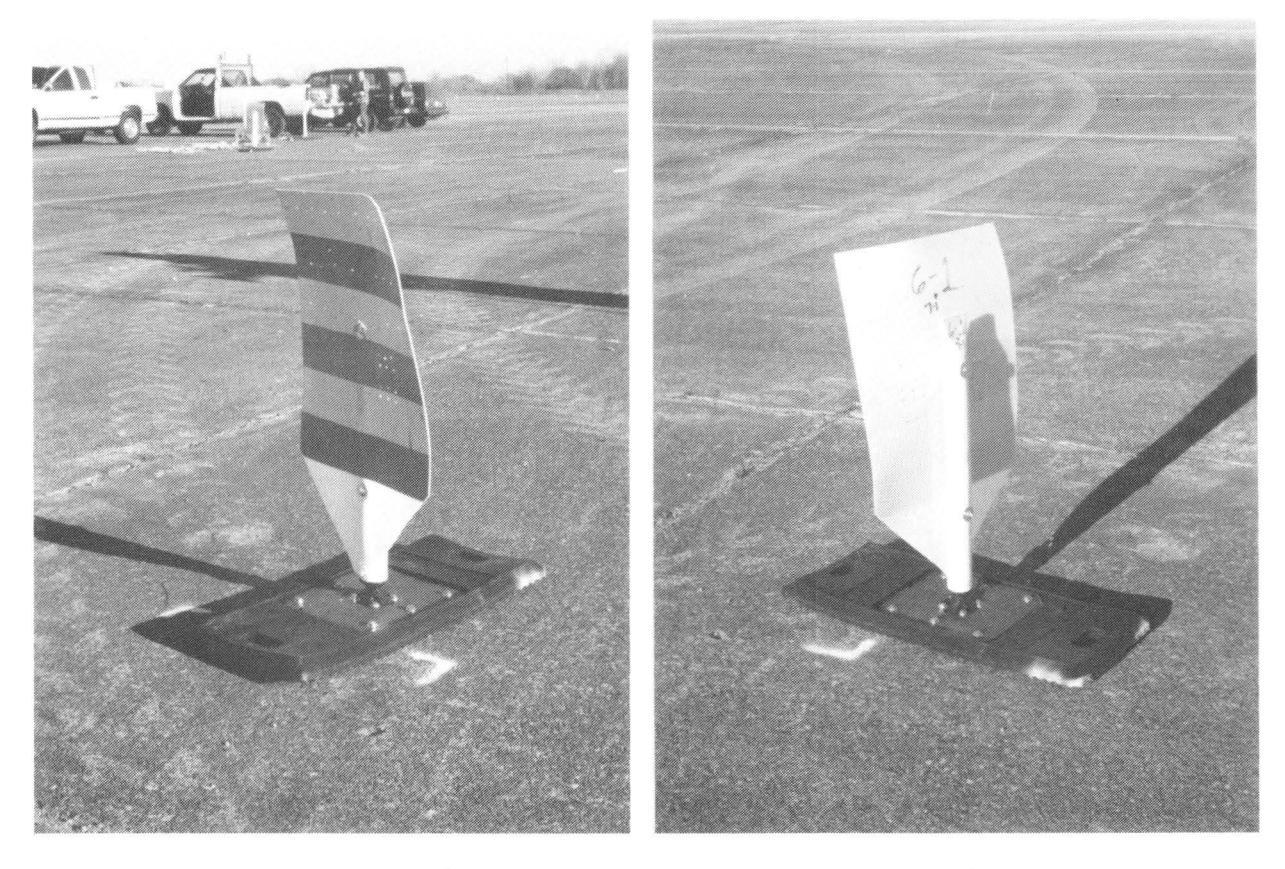
Figure 38. Damage to device, test 7177-7.

traffic lanes. The vehicle remained stable throughout the test sequence. The device was moved slightly by the impact, but remained near the point of impact.

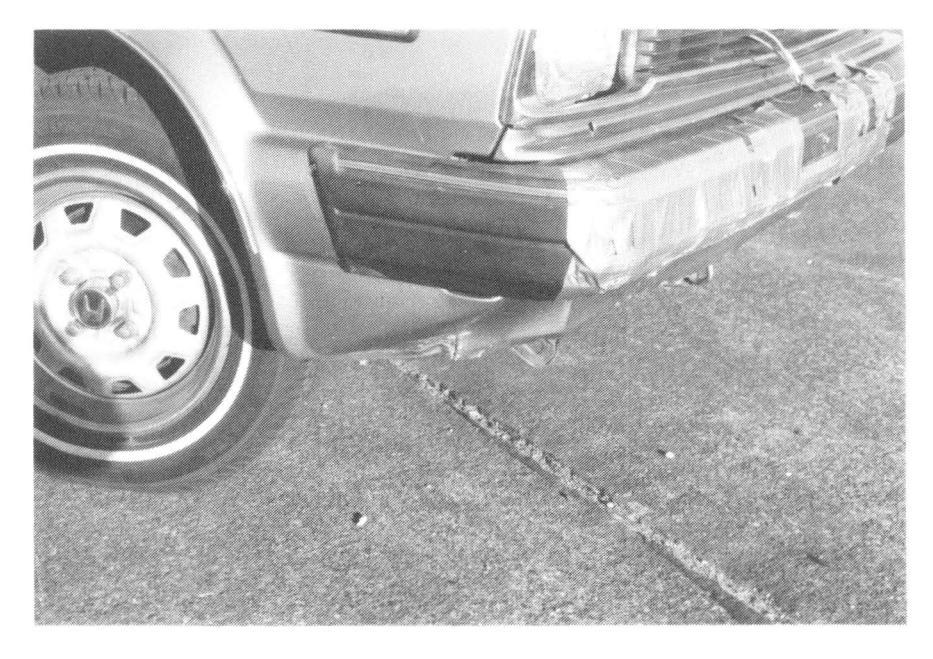
The vehicle sustained minor damage and there was no penetration or intrusion of the occupant compartment of the vehicle. The vehicle remained on a straight, smooth path through the test site with no intrusion into adjacent

Figure 39. Damage to vehicle, test 7177-7.

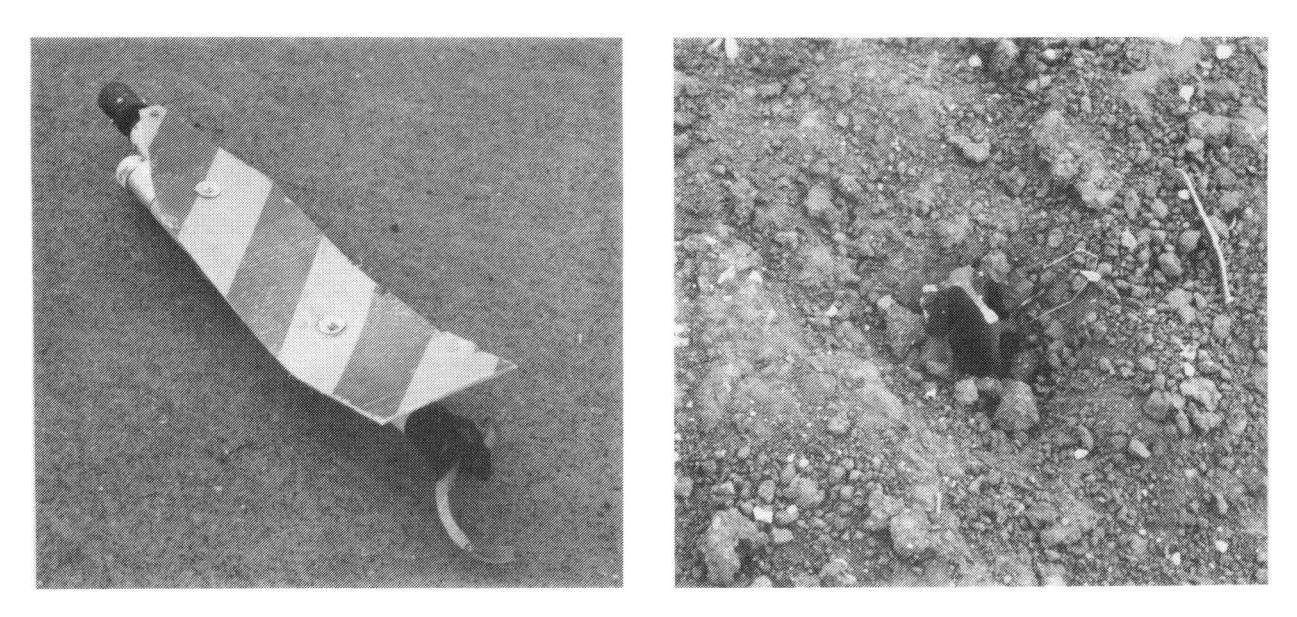
Figure 44. Damage to first device, test 7177-8.

The vehicle received cosmetic damage only and there was no penetration or intrusion of the occupant compartment of the vehicle. The vehicle remained on a straight, smooth path through the test site with no intrusion into adjacent traffic lanes. The vehicle remained stable throughout the test period. The post and panel unit of the first assembly broke off from the driveable base and was thrown for some distance.

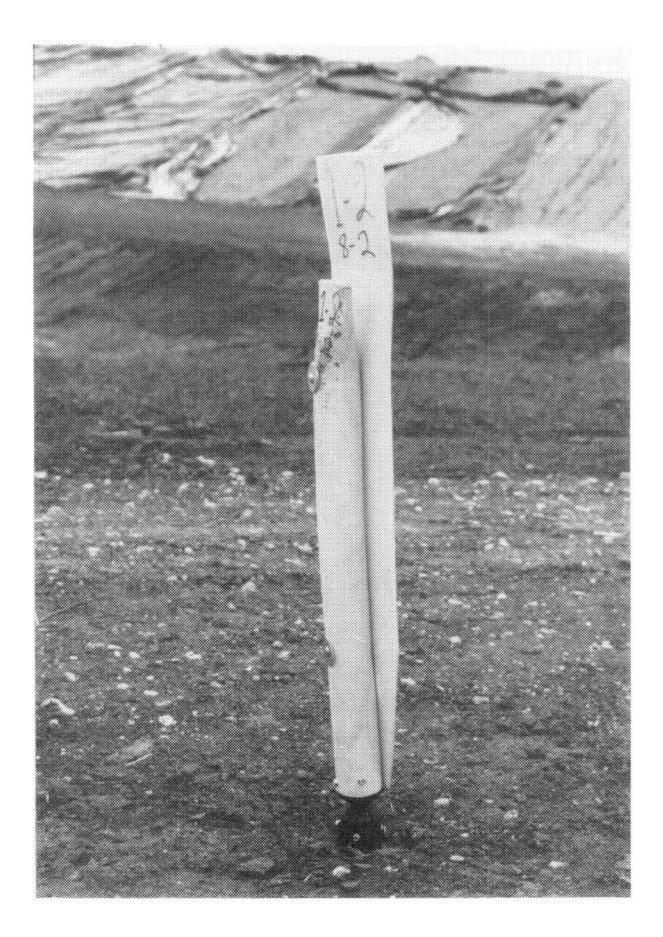
Figure 45. Damage to second device, test 7177-8.

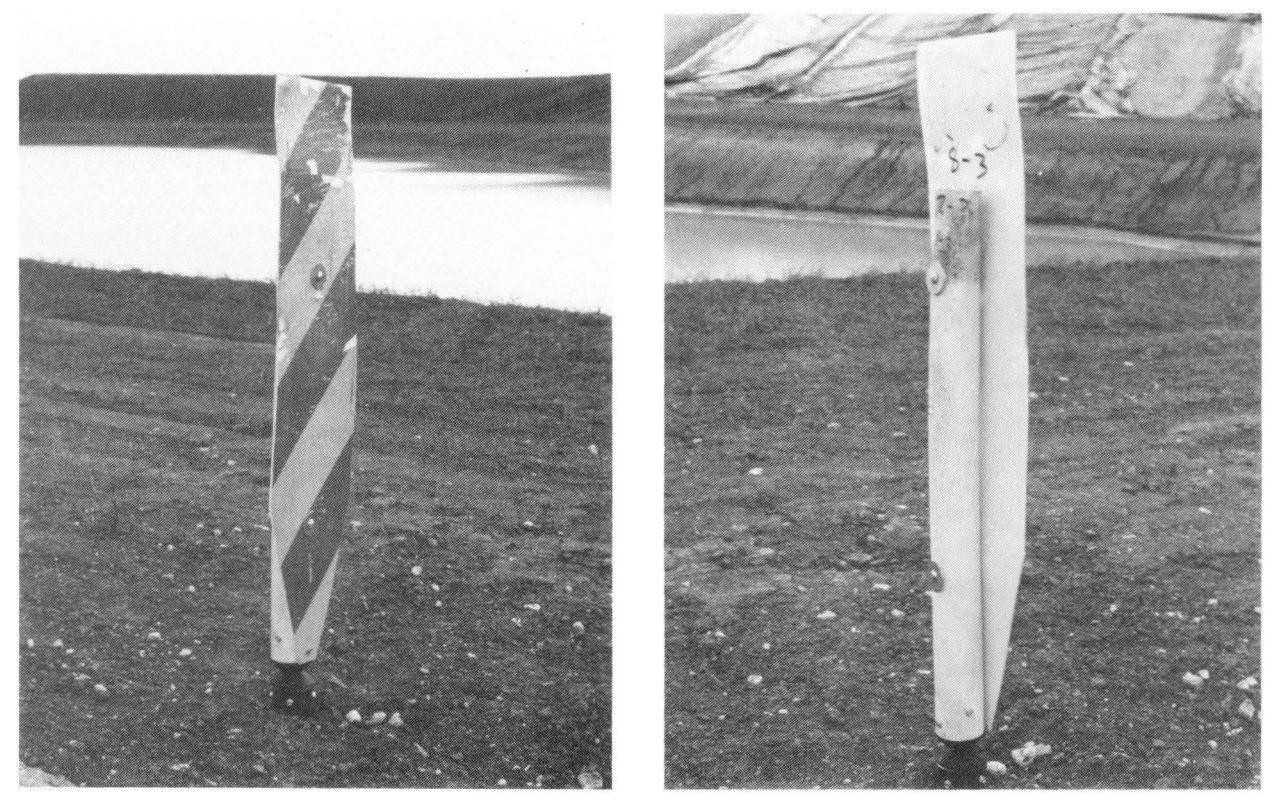
Figure 46. Damage to third device, test 7177-8.
