TESTING AND EVALUATION OF WORK ZONE

TRAFFIC CONTROL DEVICES

PROVIDED BY FLASHER EQUIPMENT COMPANY

Project No. 71770

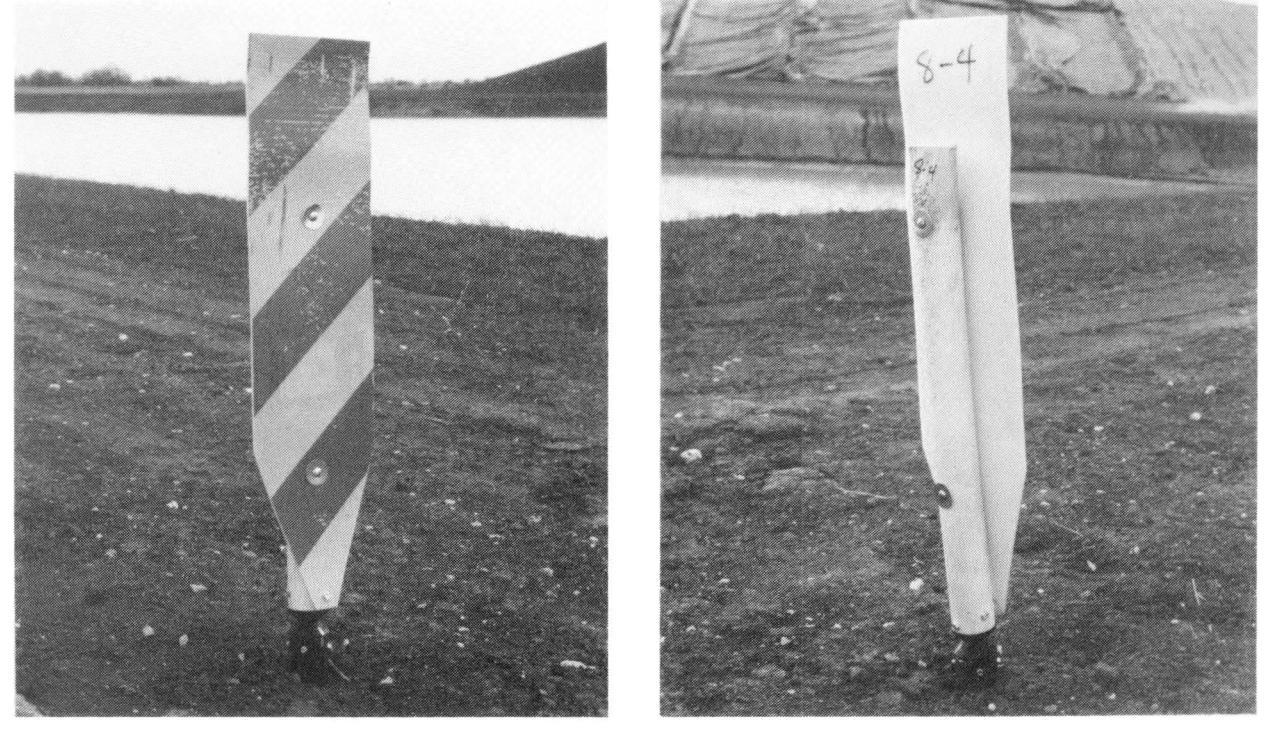
Figure 47. Damage to fourth device, test 7177-8.

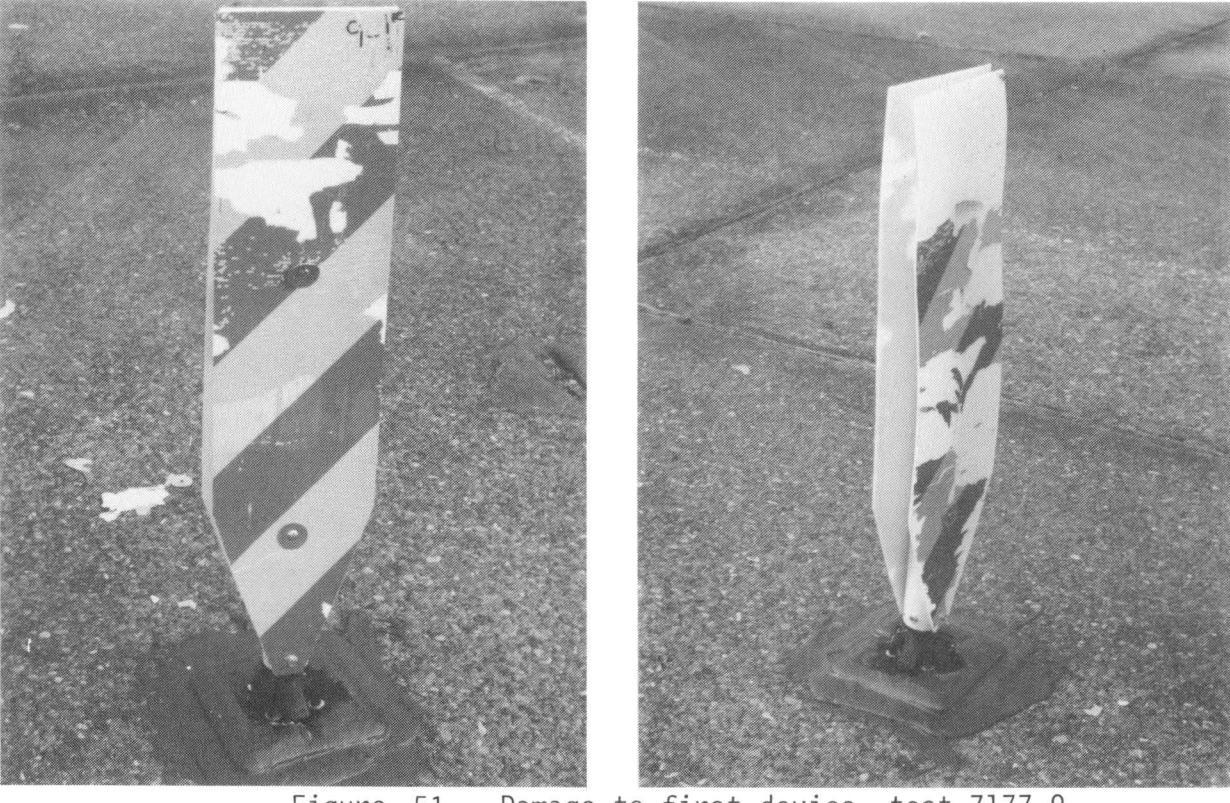
The vehicle received cosmetic damage only and there was no penetration or intrusion of the occupant compartment of the vehicle. The vehicle remained on a straight, smooth path through the test site with no intrusion into adjacent traffic lanes. The base of the fourth assembly with the flashing light unit and accompanying battery packs were pulled loose from the pavement and the assembly was thrown some distance from the impact point.

Figure 51. Damage to first device, test 7177-9.

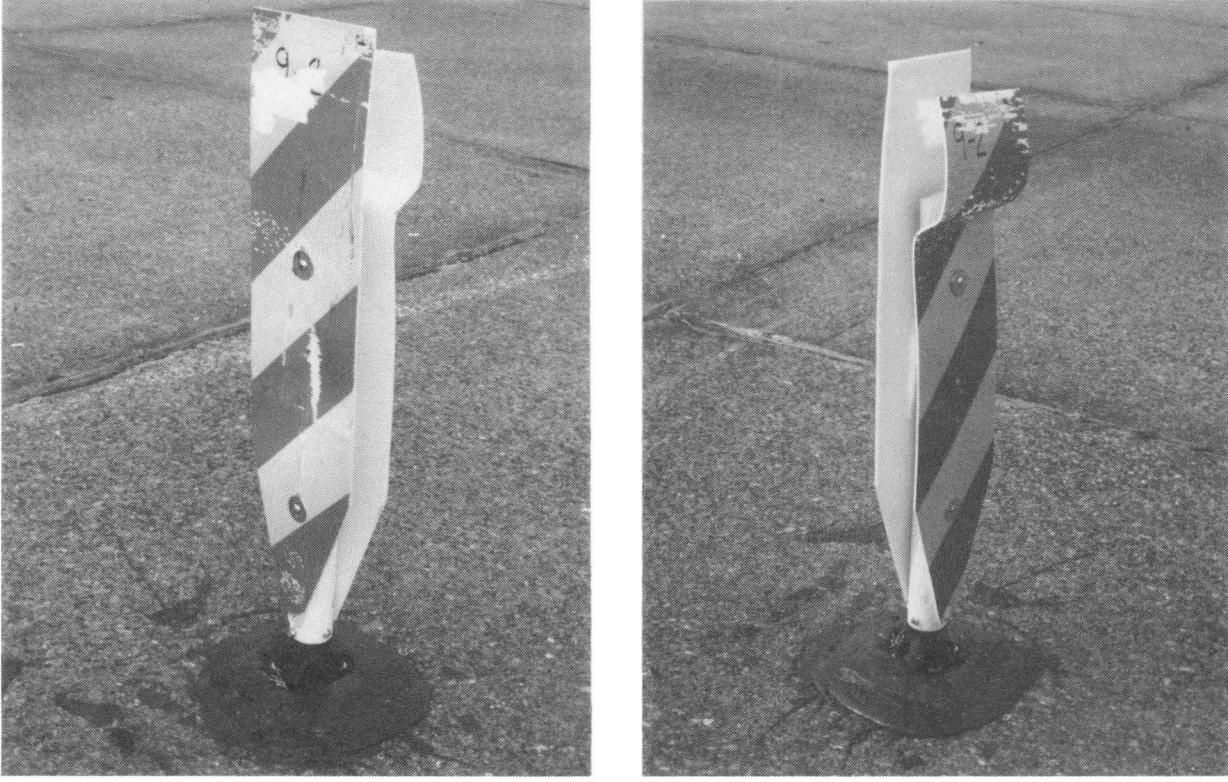
Figure 52. Damage to second device, test 7177-9.

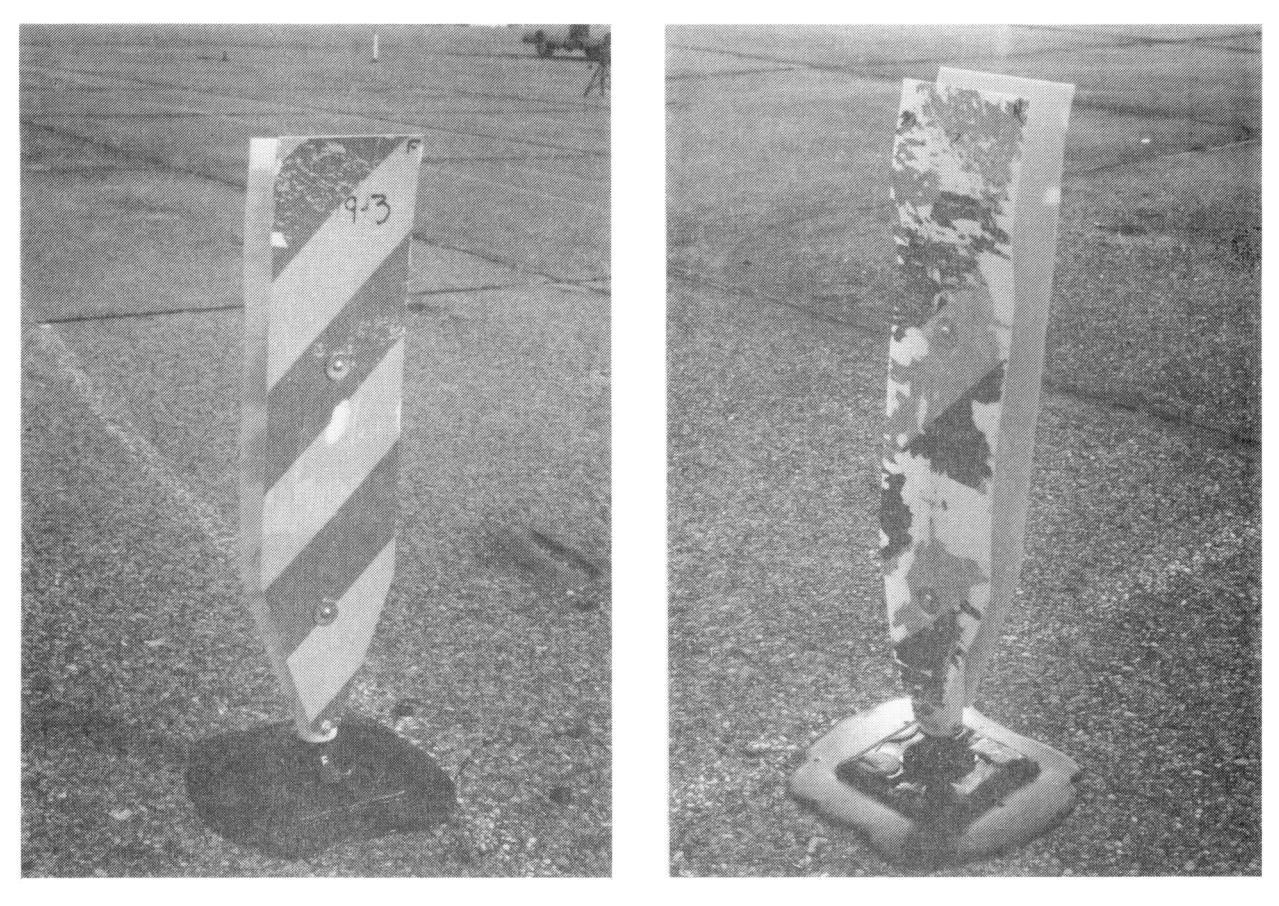
Figure 53. Damage to third device, test 7177-9.

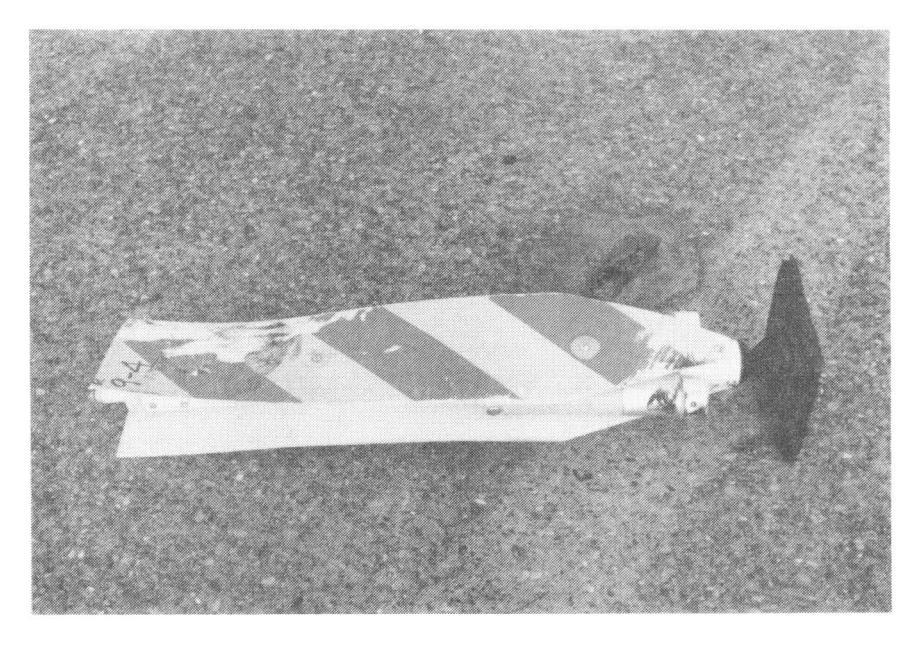
Figure 54. Damage to fourth device, test 7177-9.

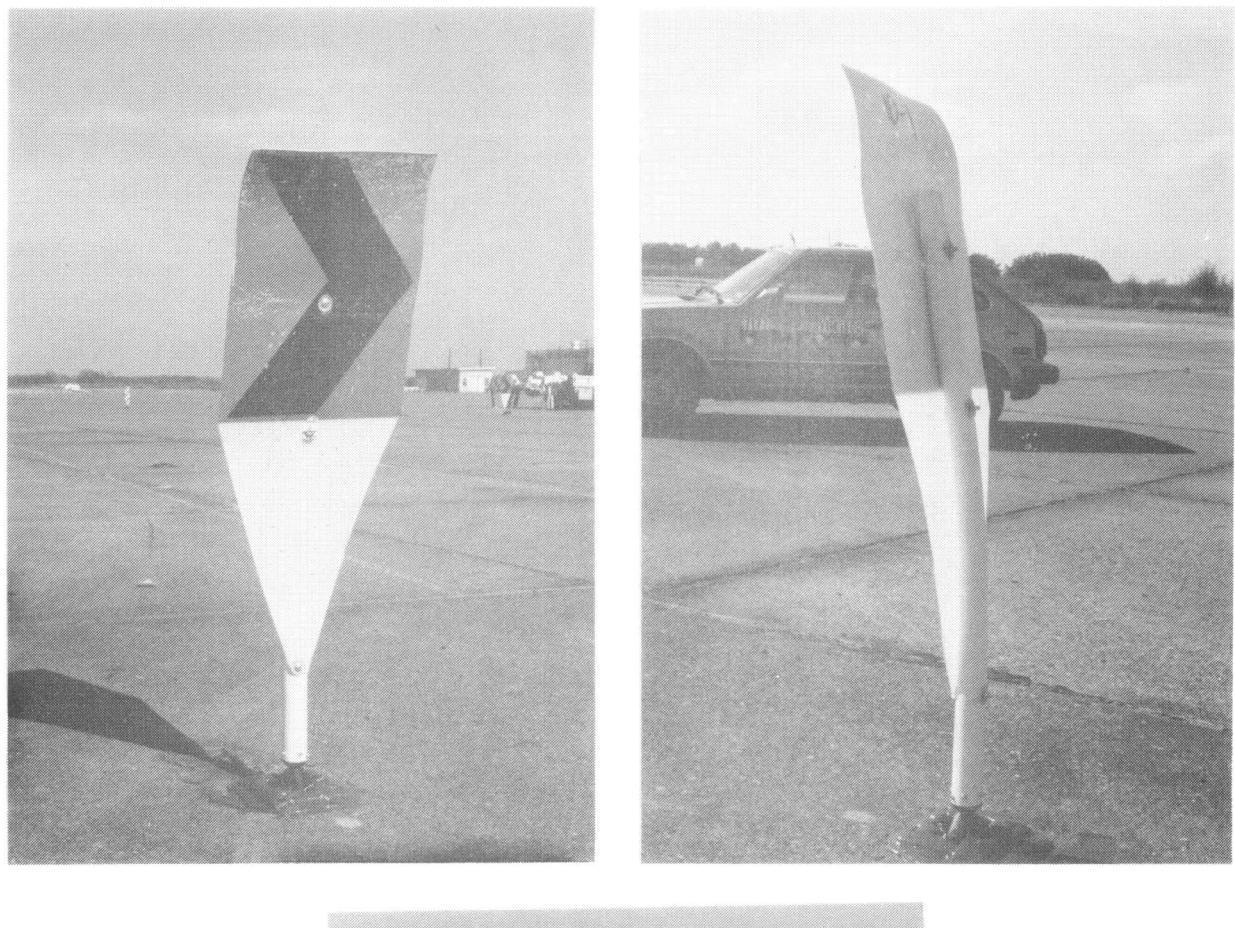
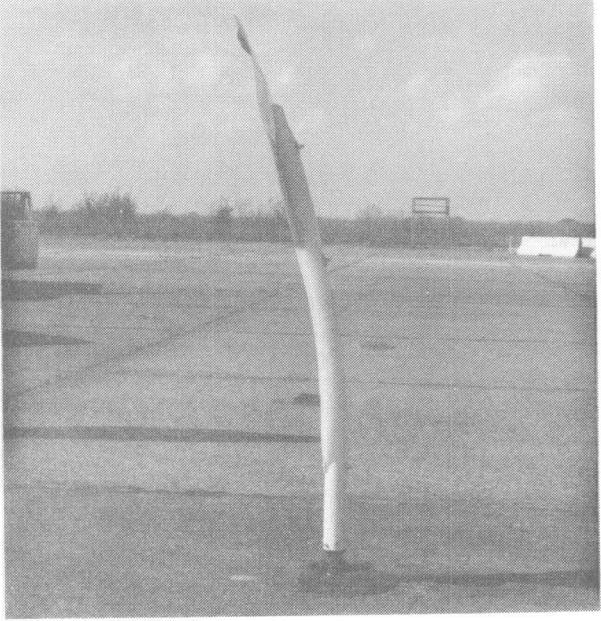
The vehicle sustained minor damage to the hood, bumper and headlight rings and there was no penetration or intrusion of the occupant compartment of the vehicle. The vehicle remained in a stable manner and maintained a straight, smooth path through the test site with no intrusion into adjacent traffic lanes. The chevron sign assemblies remained intact with slight bending to the posts and panels and minor scrapes to the reflective surfaces of the panels.

Figure 58. Damage to first device, test 7177-10.

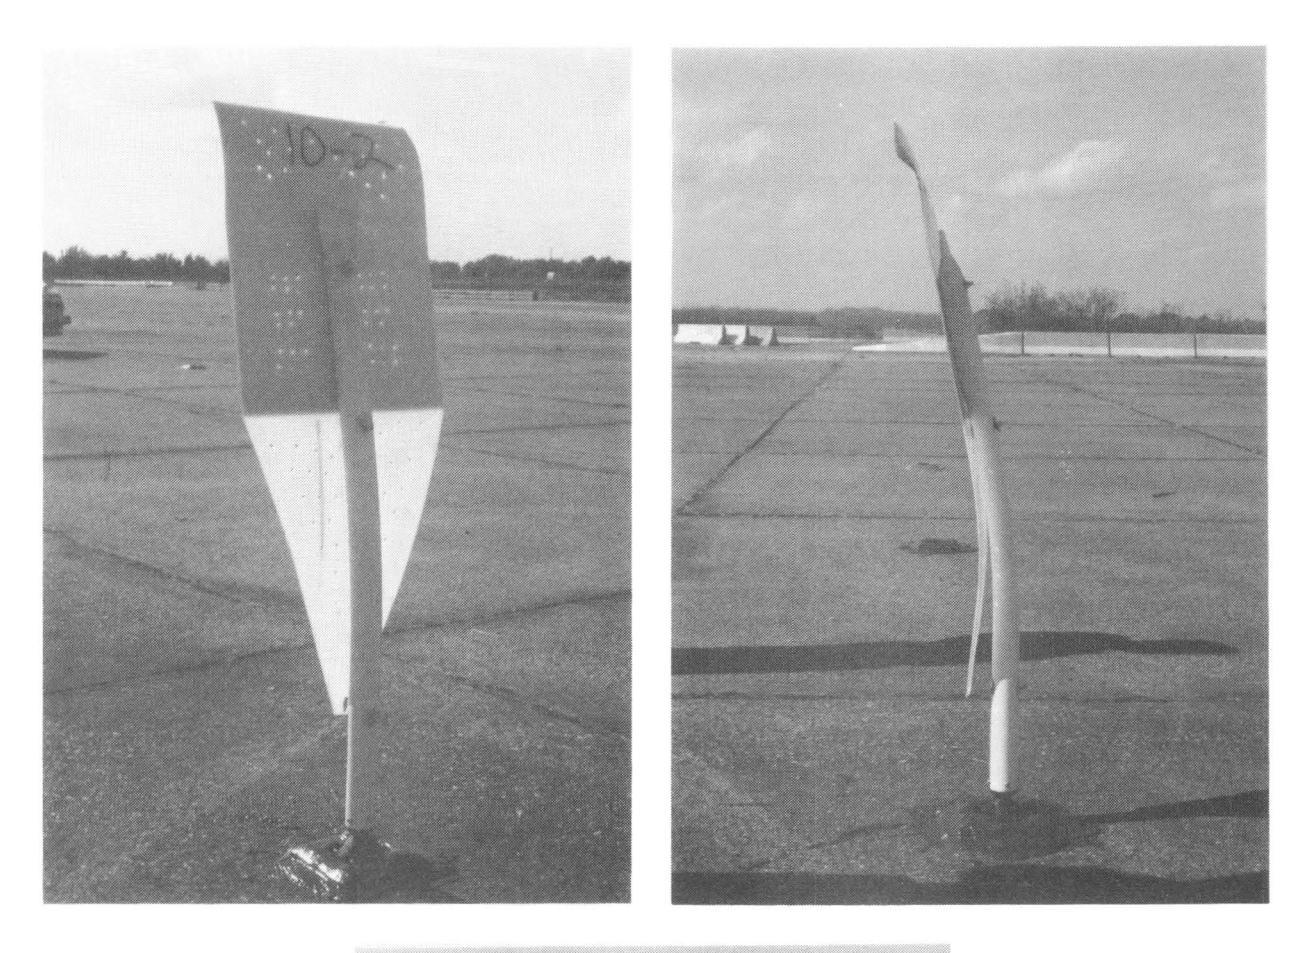
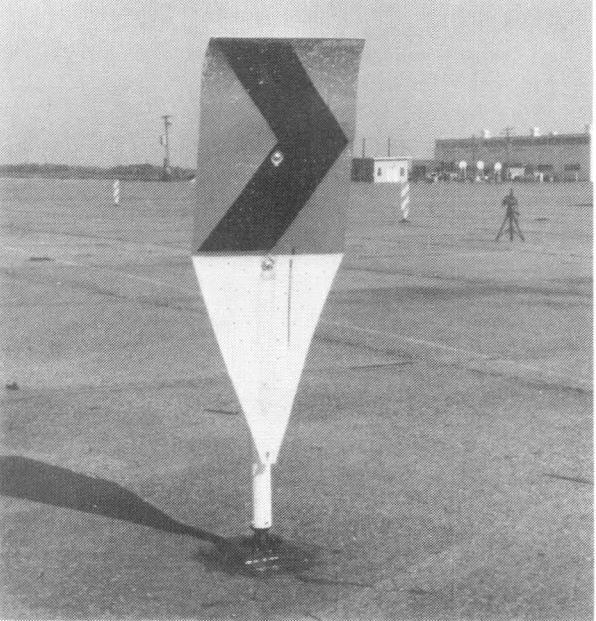
Figure 59. Damage to second device, test 7177-10.

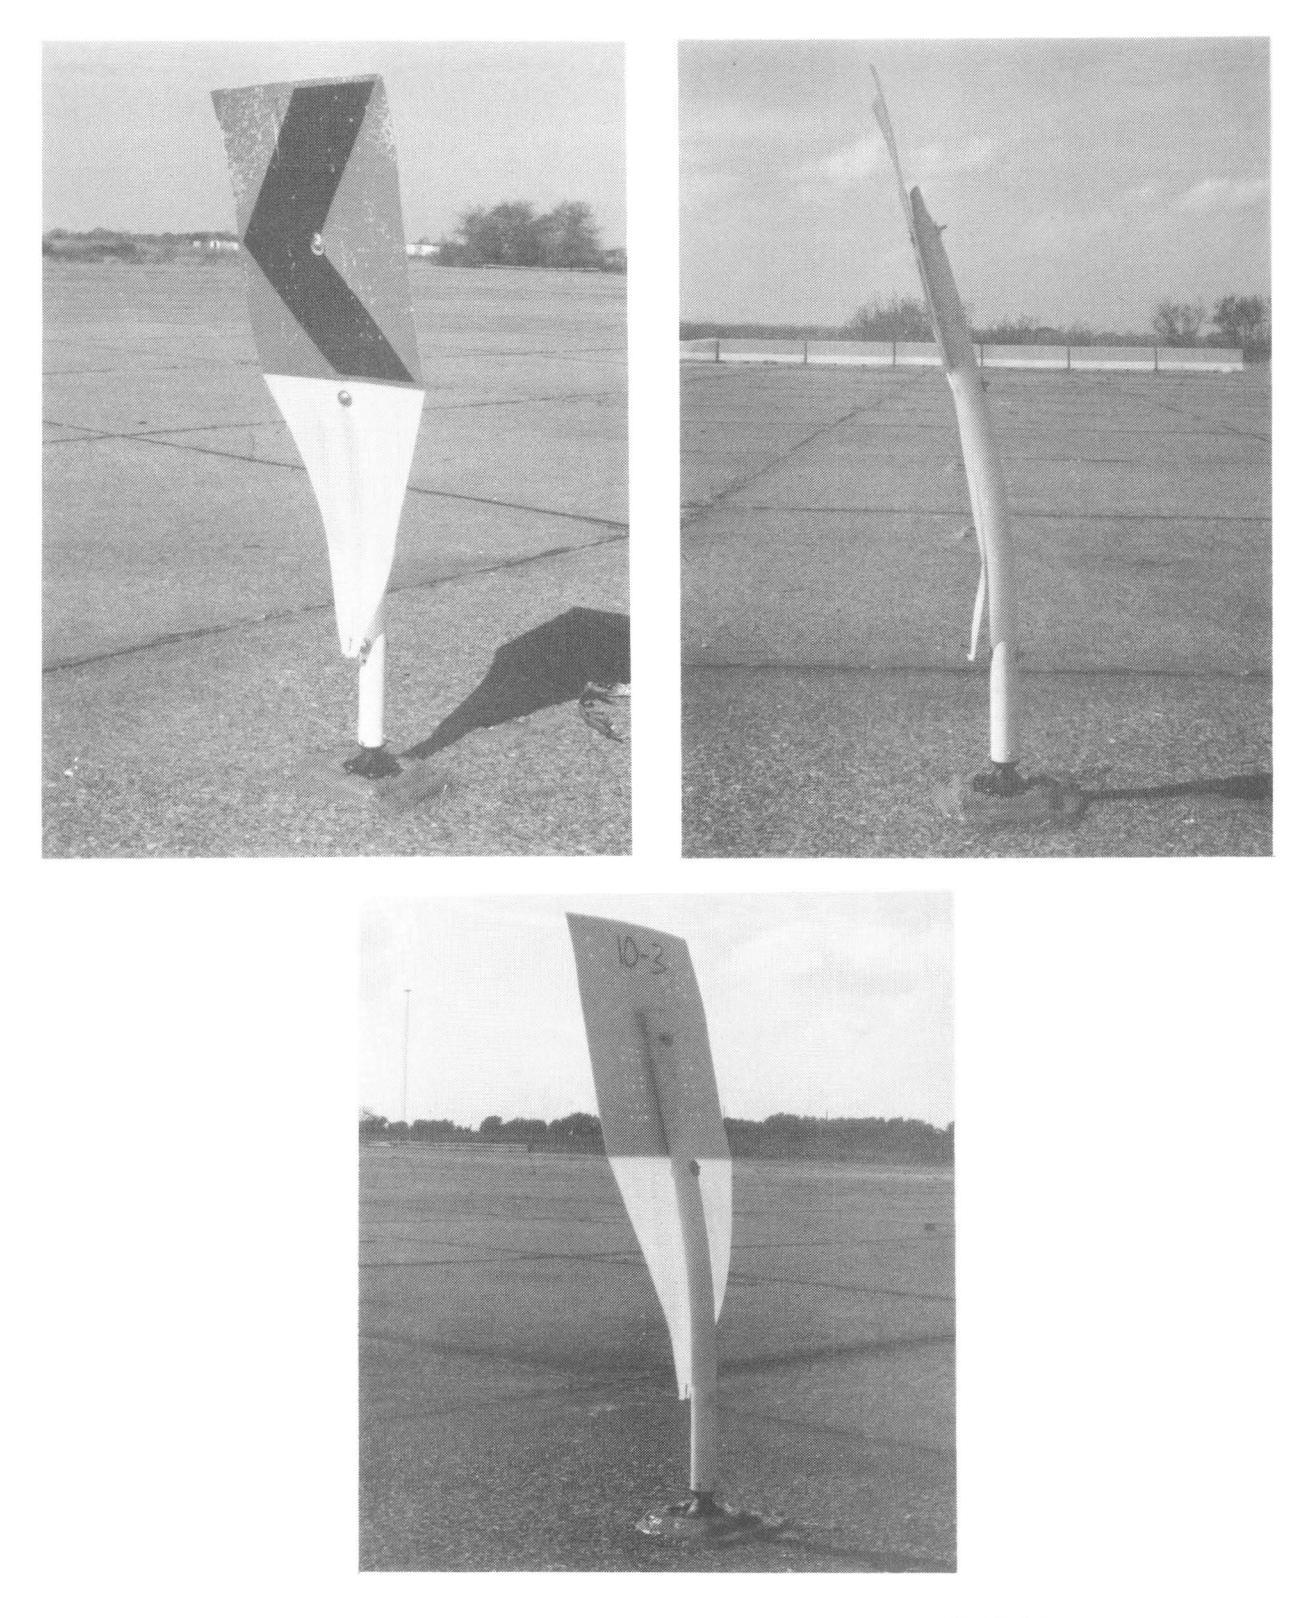
Figure 60. Damage to third device, test 7177-10.

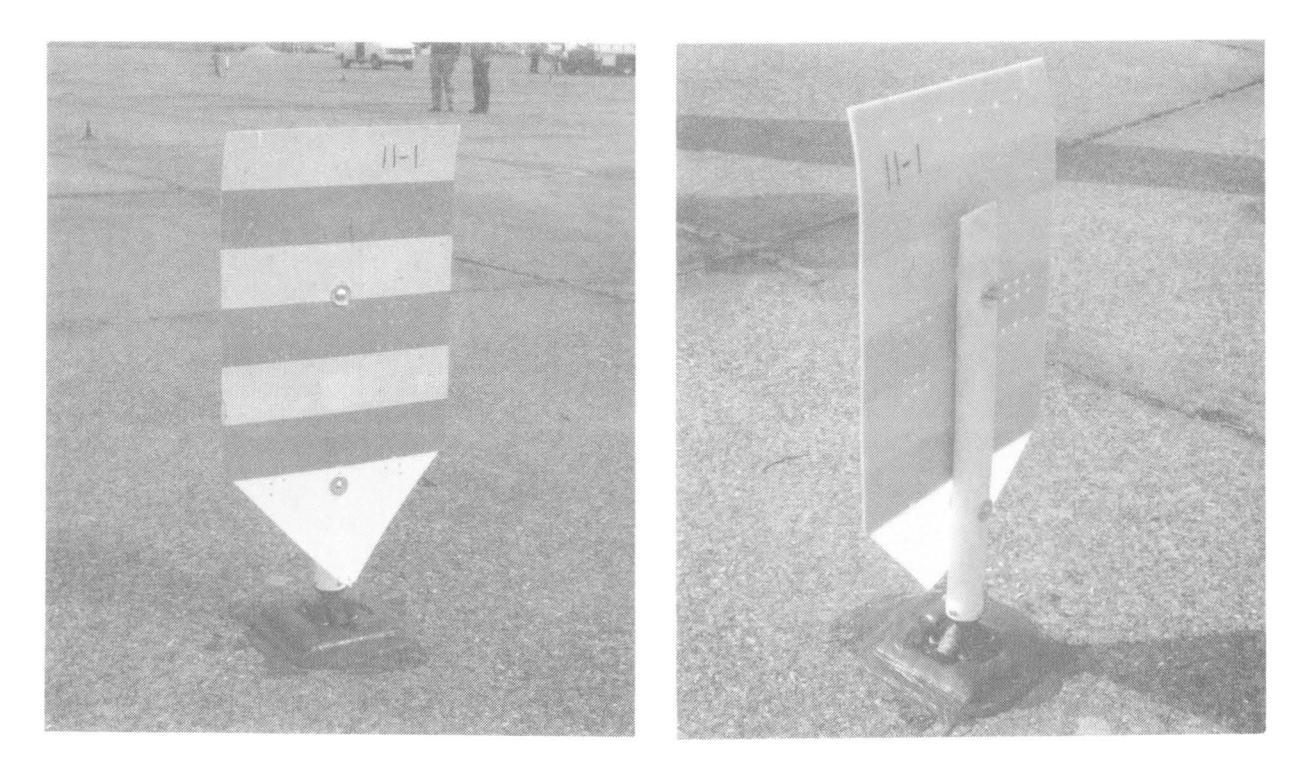
There was no damage to the vehicle and little damage to the devices as shown in Figures 62 through 65.

Figure 62. Damage to first device, test 7177-11.

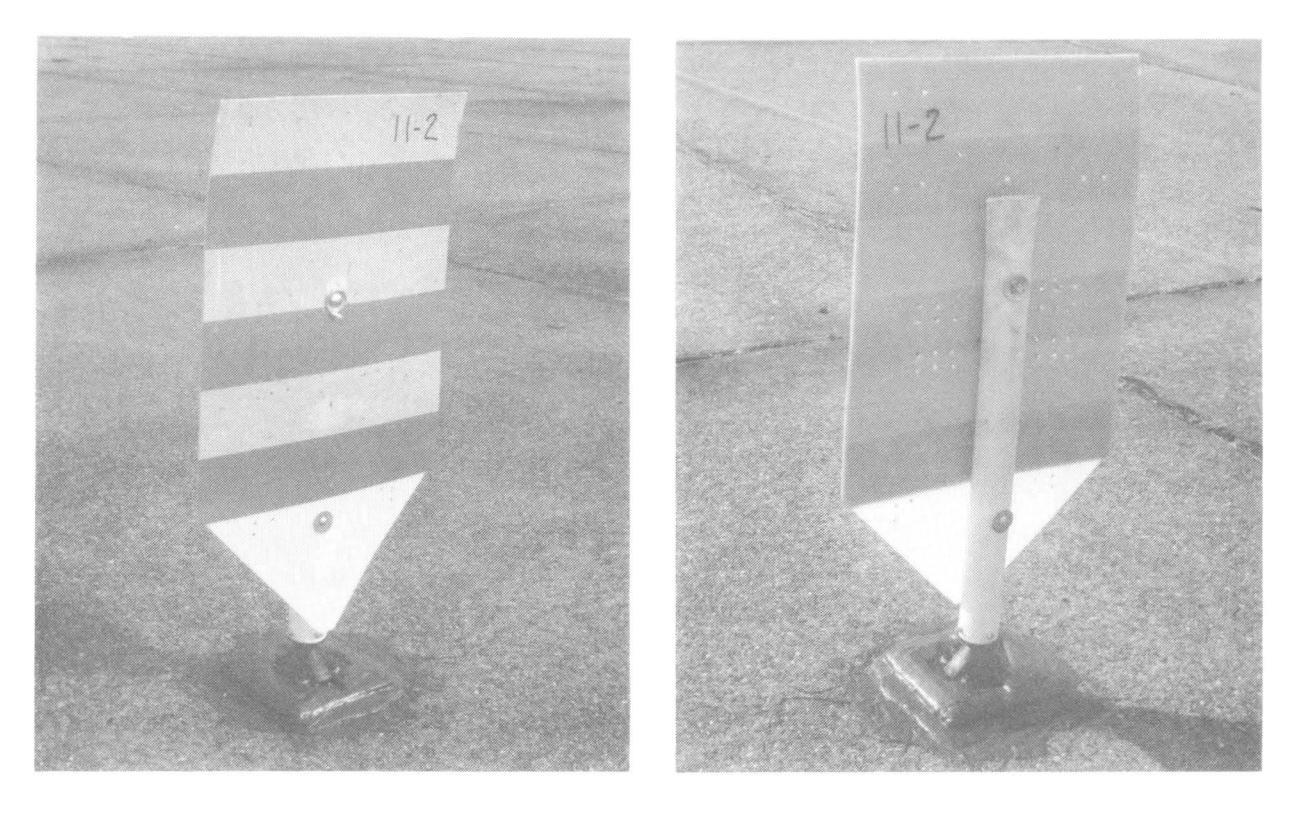
Figure 63 . Damage to second device, test 7177-11.

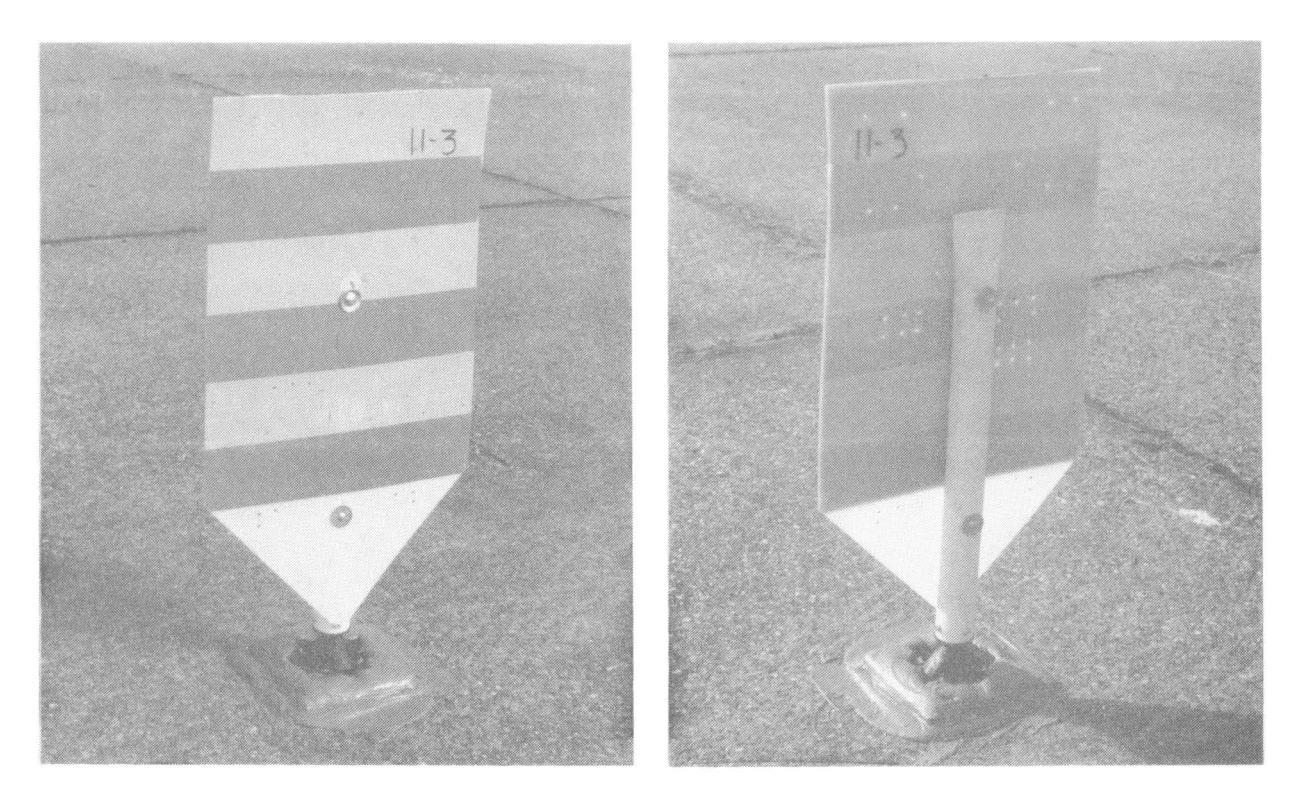
Figure 64 . Damage to third device, test 7177-11.

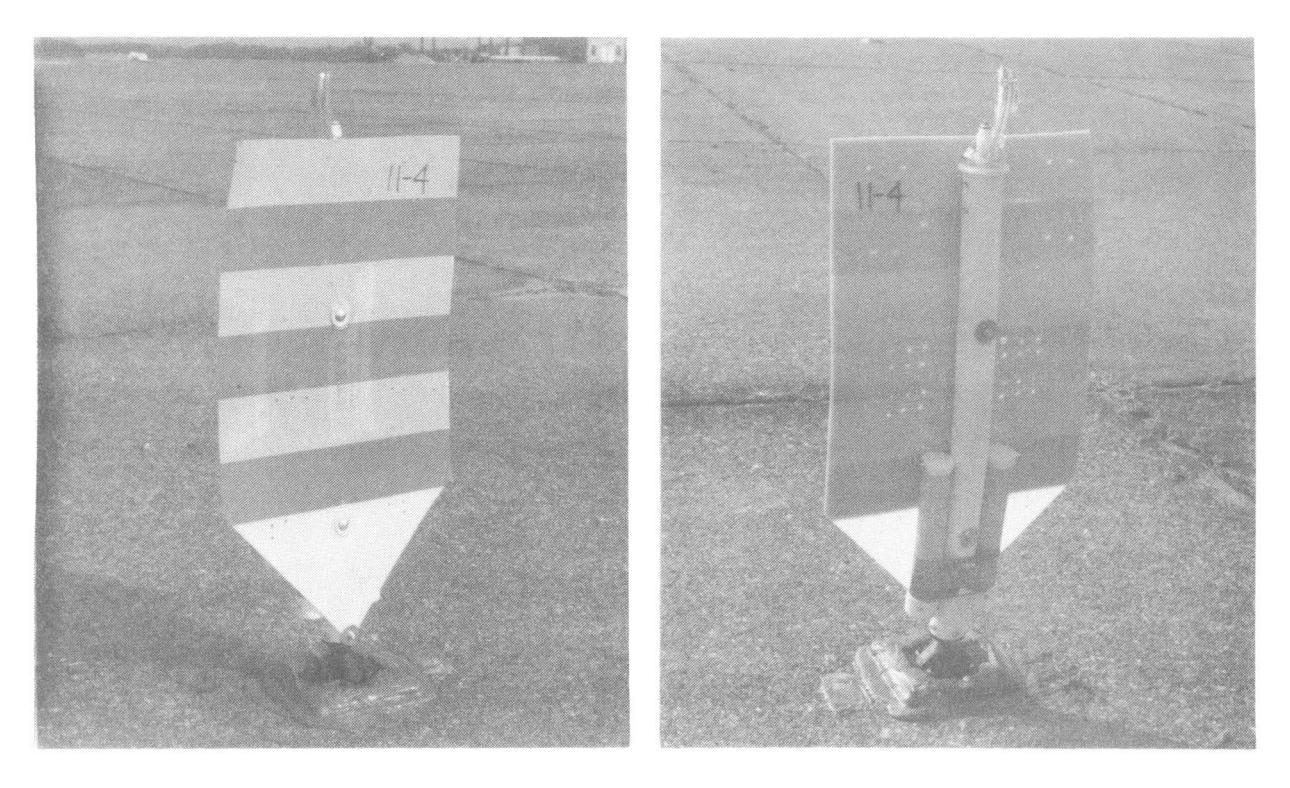
No damage was sustained by the vehicle and there was no penetration or intrusion of the occupant compartment of the vehicle. The vehicle remained on a relatively straight, smooth path through the test site with no intrusion into adjacent traffic lanes. The vehicle remained stable throughout the test period. The devices remained in place and sustained little damage except for the broken lens of the flashing light unit attached to the fourth assembly.

Figure 65 . Damage to fourth device, test 7177-11.

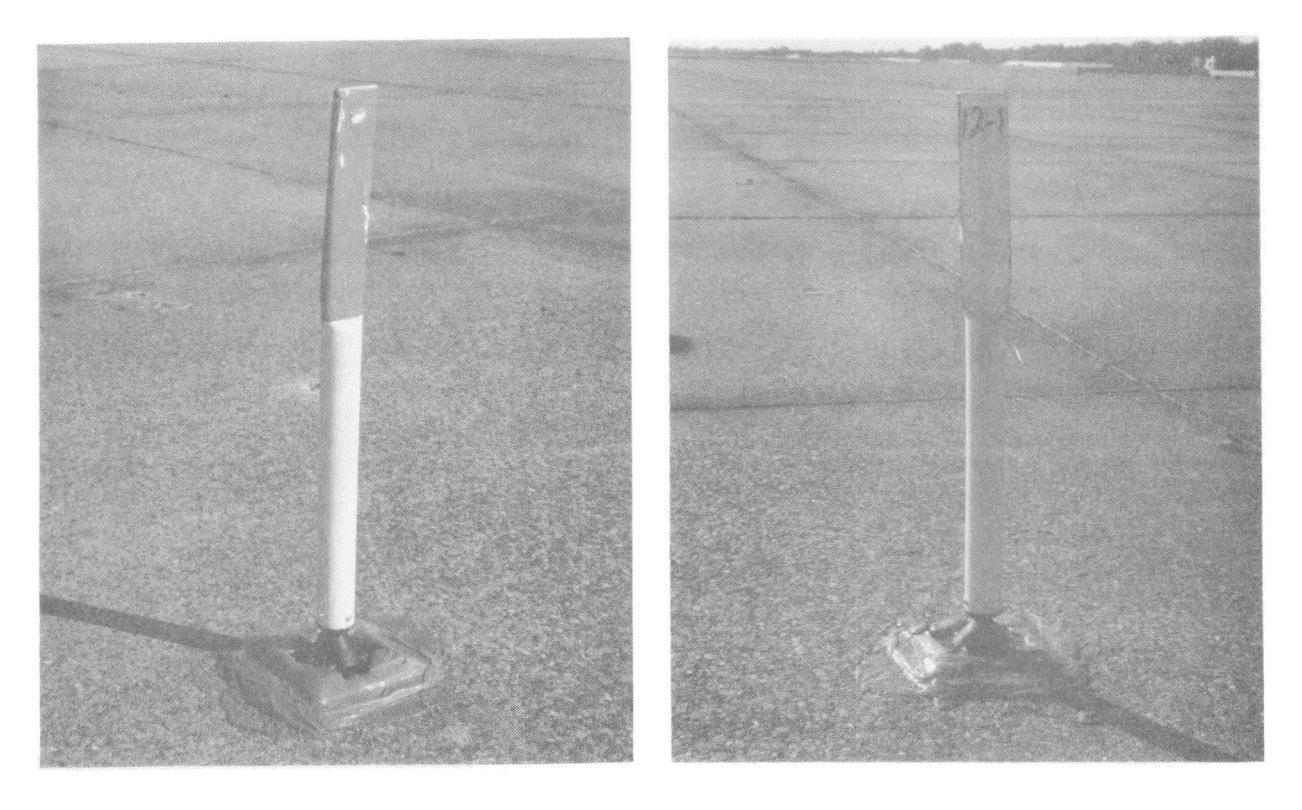
The vehicle impacted the first delineator post at 61.1 mi/h with the right quarter point of the vehicle bumper. The vehicle travelled smoothly through the test site with no driver input. There was little damage to the delineator posts as shown in Figures 68 through 71, and no damage to the vehicle.

Figure 68. Damage to first device, test 7177-12.

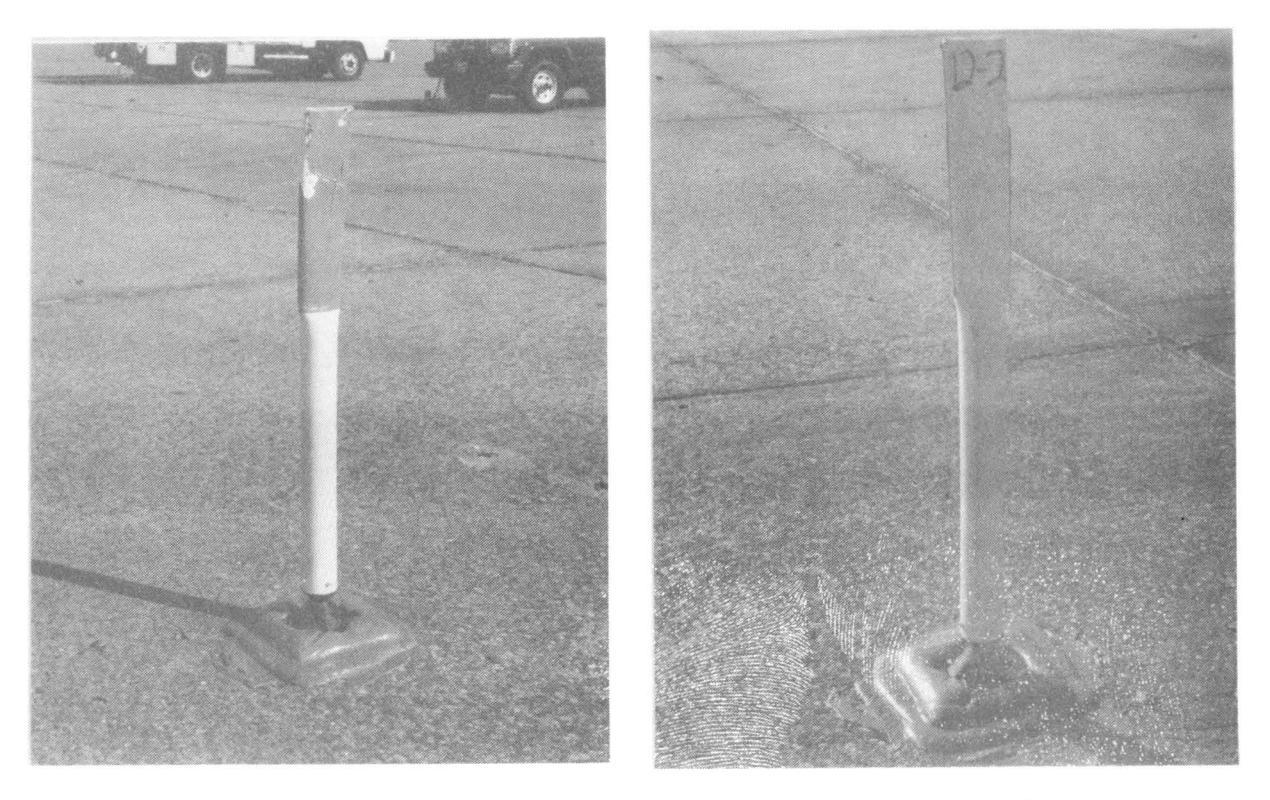
Figure 69. Damage to second device, test 7177-12.

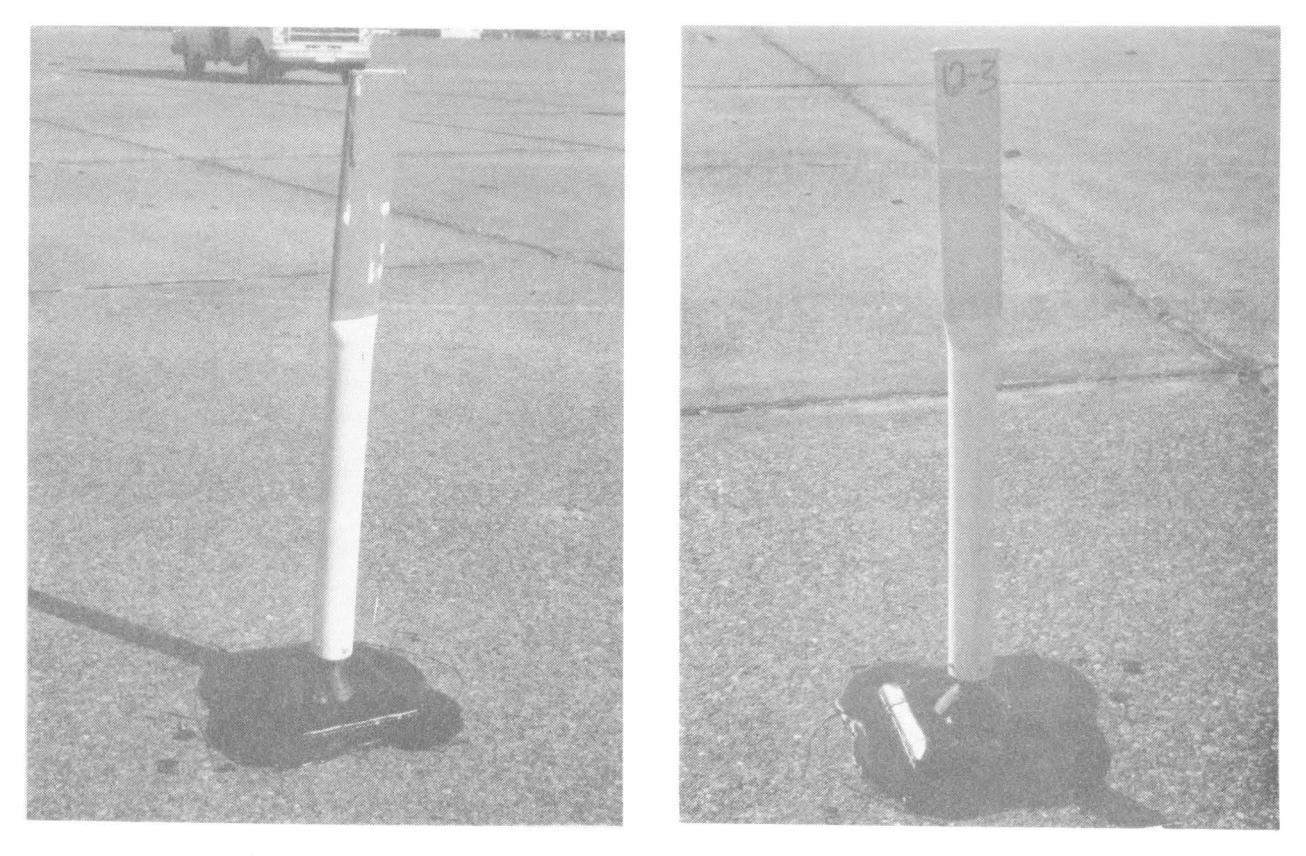
Figure 70 . Damage to third device, test 7177-12.

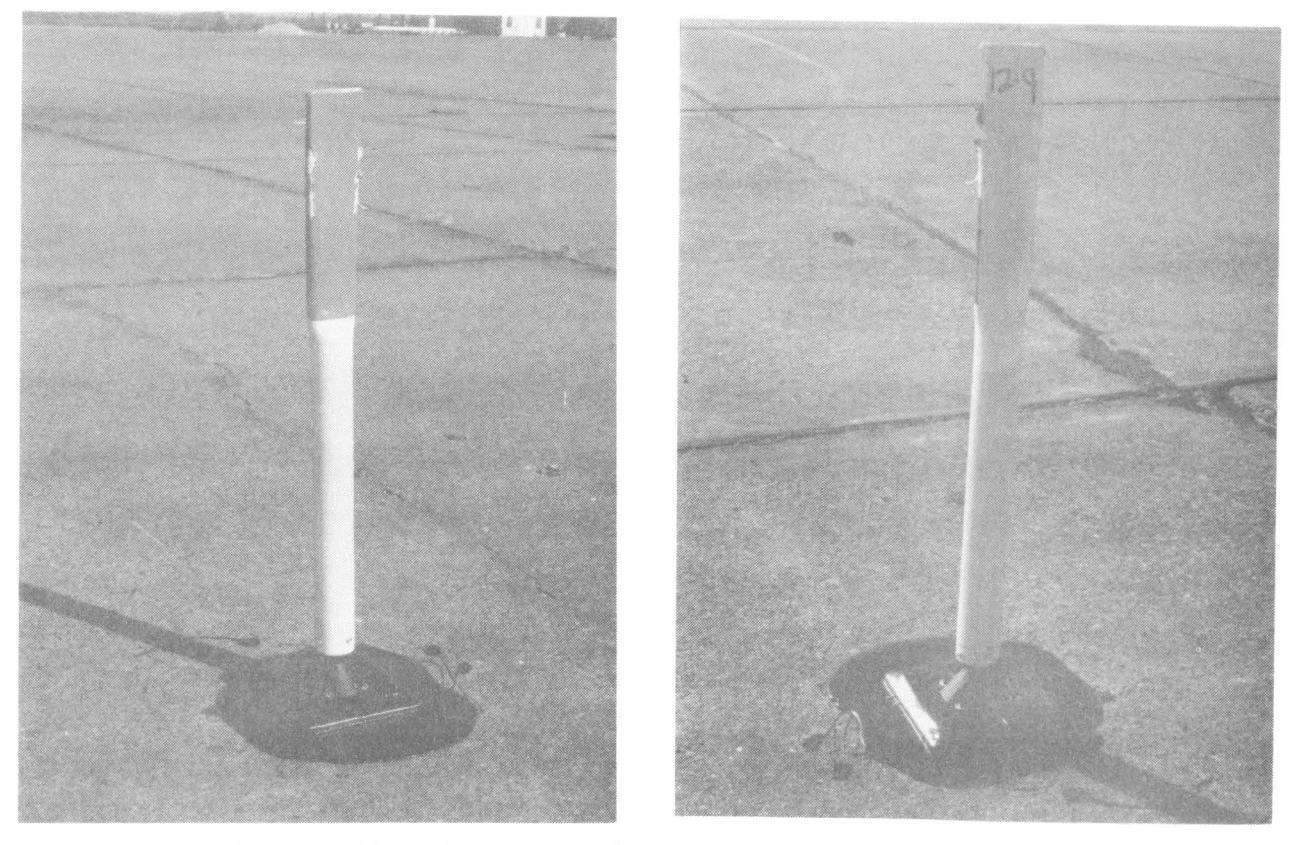
Figure 71. Damage to fourth device, test 7177-12.

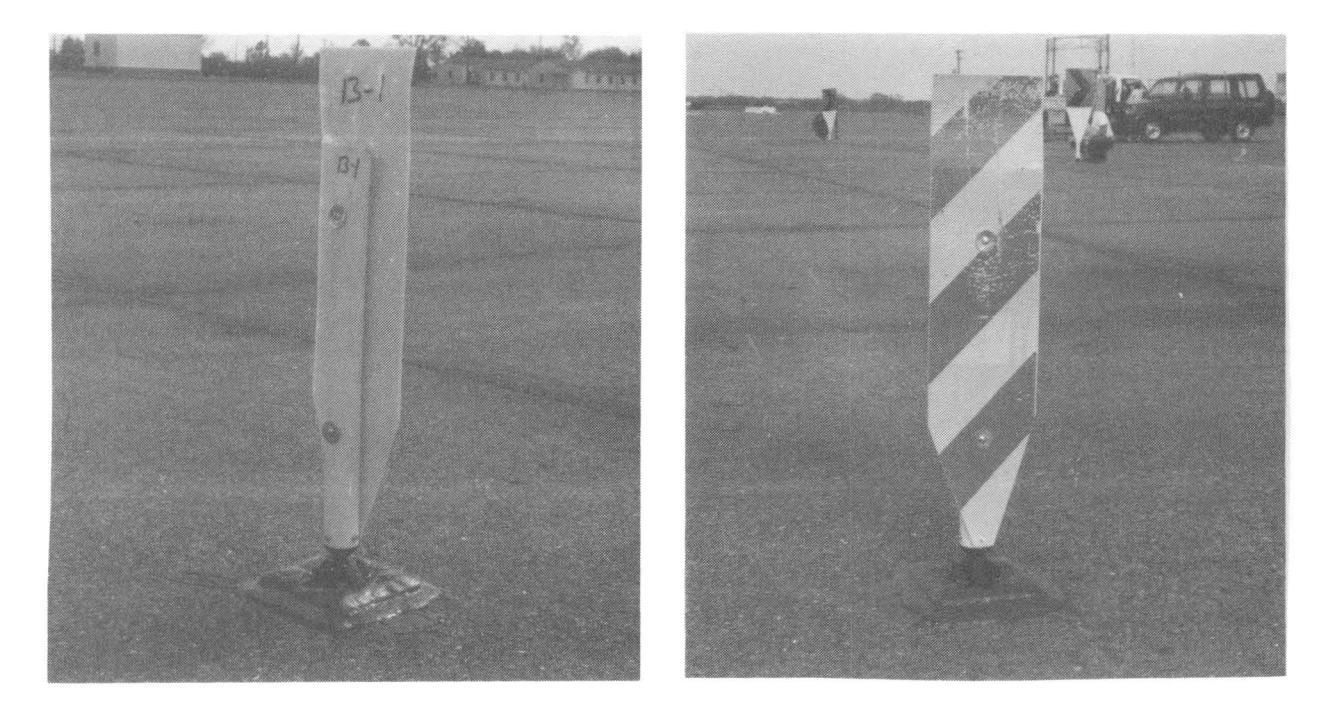
Figure 73 . Damage to first device, test 7177-13.

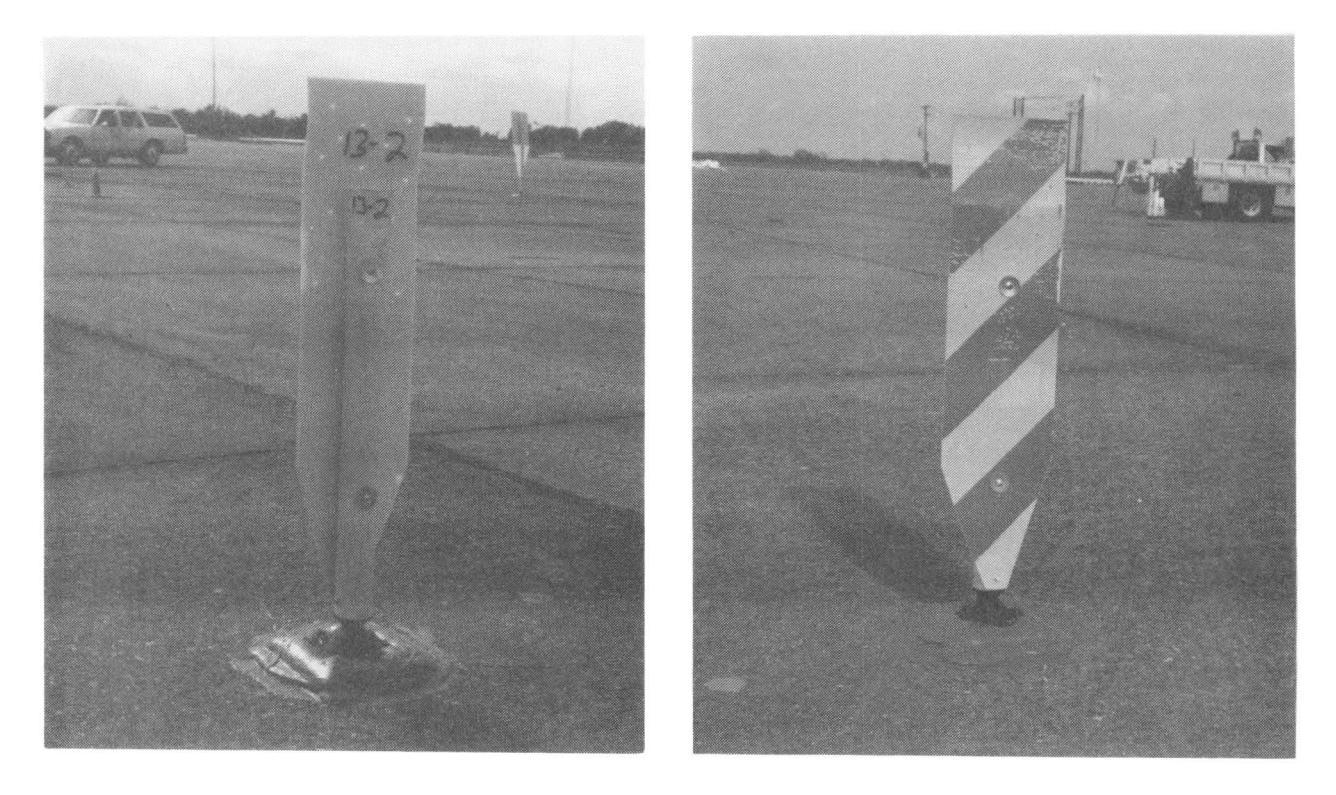
Figure 74. Damage to second device, test 7177-13.

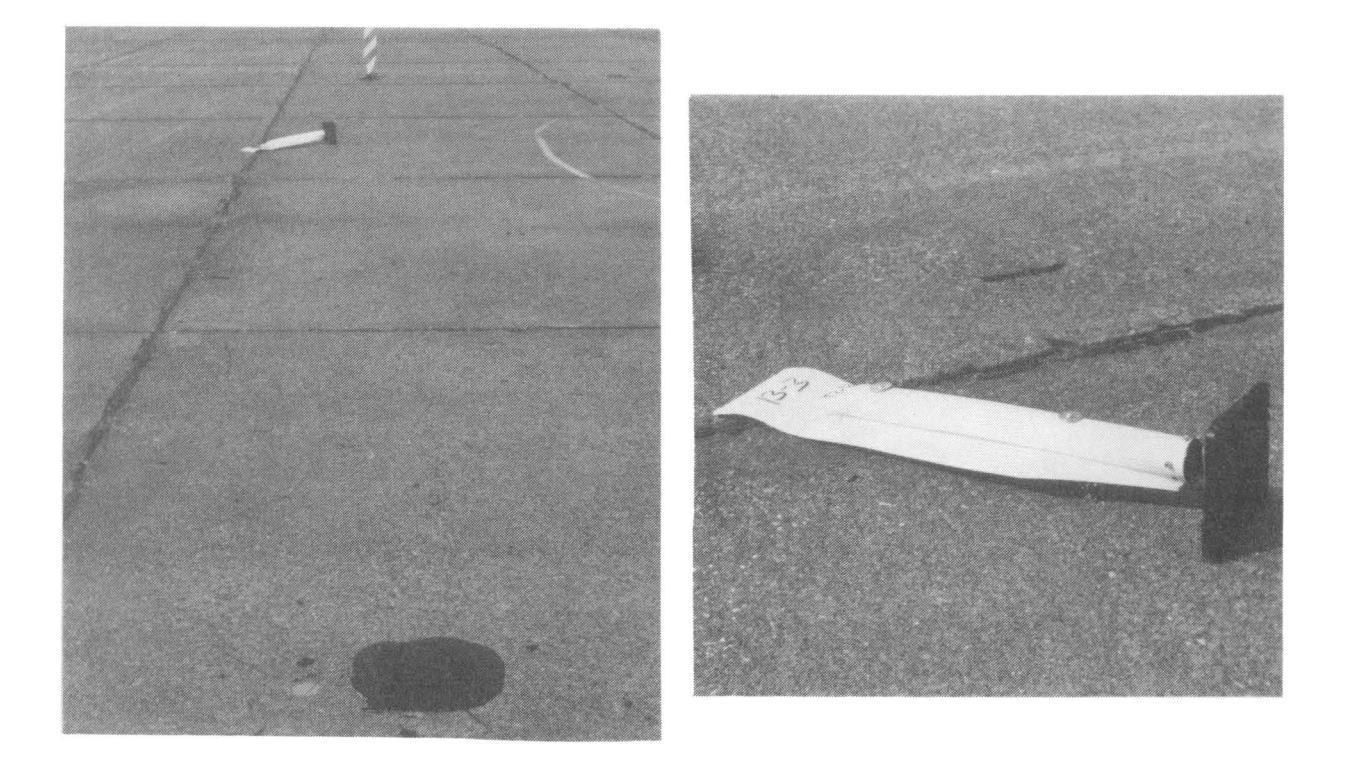
Figure 75. Damage to third device, test 7177-13.

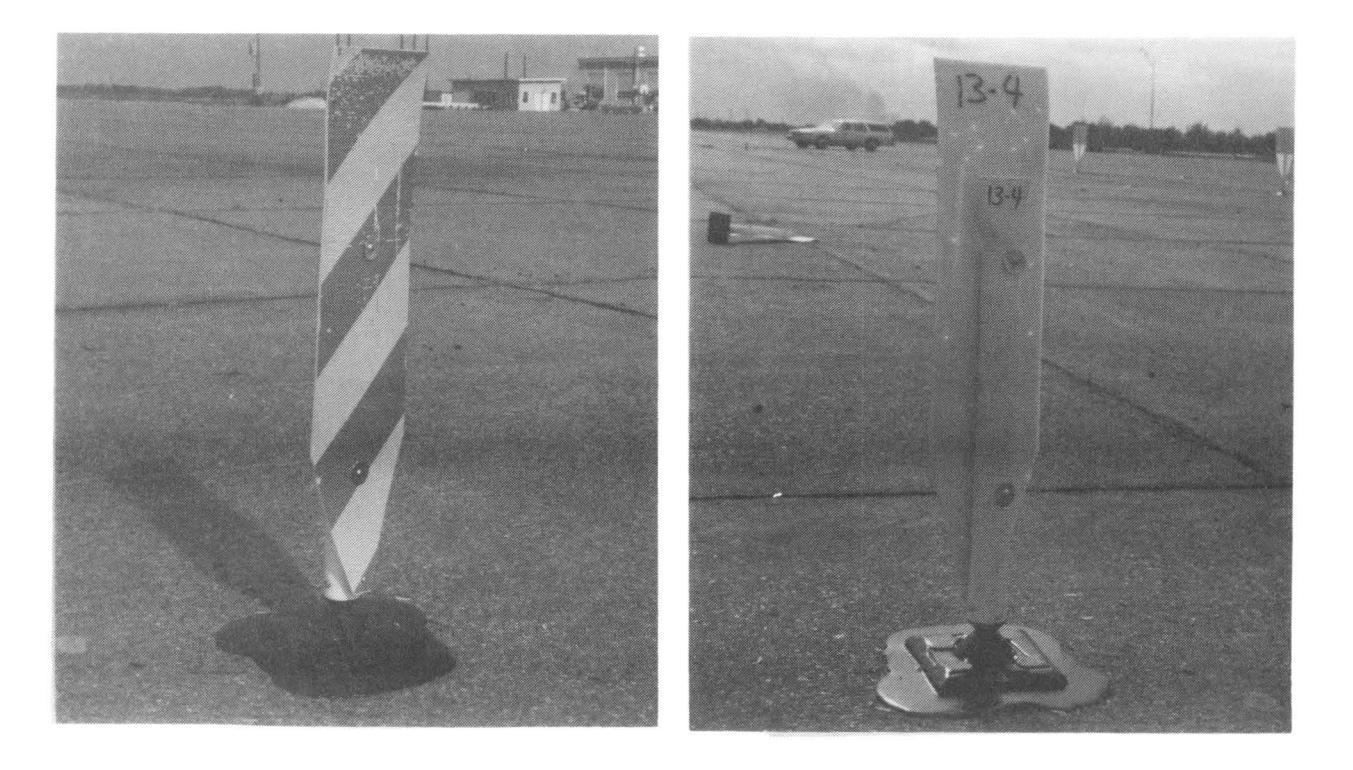
Figure 76. Damage to fourth device, test 7177-13.
